Vegetation-Hydrogeomorphology Interactions in a Low-Energy, Human-Impacted River

Gurnell, AM; Grabowski, RC

This is the peer reviewed version of the following article: Gurnell, A.M., Grabowski, R.C. 2016. Vegetation-hydrogeomorphology interactions in a low-energy, human-impacted river. River Research and Applications 32(2) 202-215, which has been published in final form at DOI: 10.1002/rra.2922. This article may be used for non-commercial purposes in accordance with [Wiley Terms and Conditions for Self-Archiving](#).

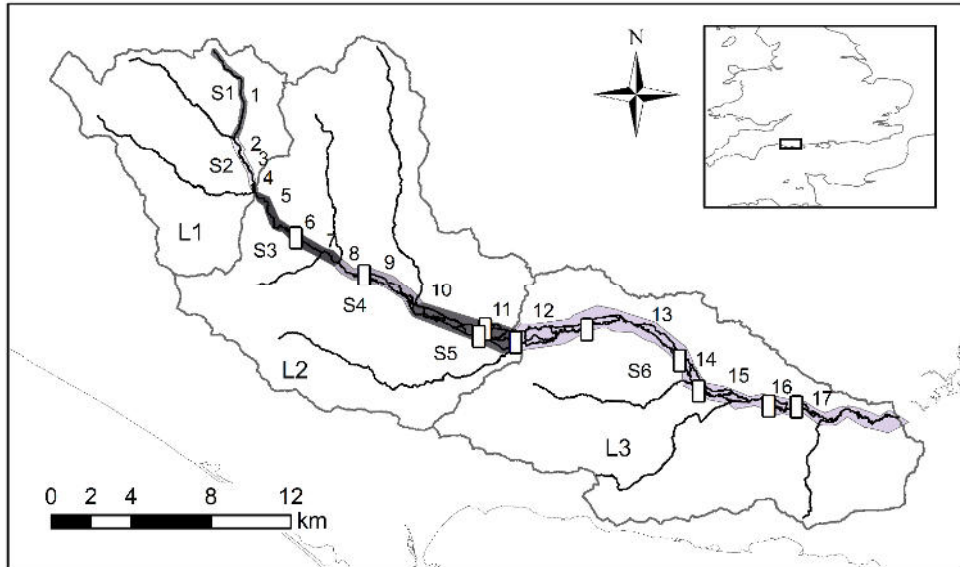
Figure 1. The River Frome catchment is delineated into 3 landscape units based on elevation, geology and land cover/use (L1 to L3), 6 segments based on valley setting and major tributary confluences (S1 to S6) and 17 reaches based on planform and longitudinal discontinuity (e.g. major weirs – indicated as open rectangles).

Using the hierarchical hydrogeomorphological assessment framework developed within the REFORM project (Gurnell et al., 2015b; Figure 1), the catchment has been subdivided into 3 Landscape Units (LU), reflecting contrasts in elevation, geology and land cover. Land use is predominantly agriculture. Arable land covers 26%, 55%, and 44% and pasture covers 72%, 39% and 29% of the area in the upper (LU1), middle (LU2) and lower (LU3) parts of the catchment, respectively. The 66 km main stem has been divided into 6 river segments (S1 to S6, Figure 1), mainly reflecting changes in catchment area at major tributary confluences, and 17 river reaches (1 to 17, Figure 1) according to changes in planform and disruption of longitudinal continuity by major weirs (rectangles, Figure 1). The main stem is unconfined by its valley and its planform changes from predominantly sinuous and meandering in LU1 to increasingly low-energy anabranching (anastomosing) through LU2 and LU3.

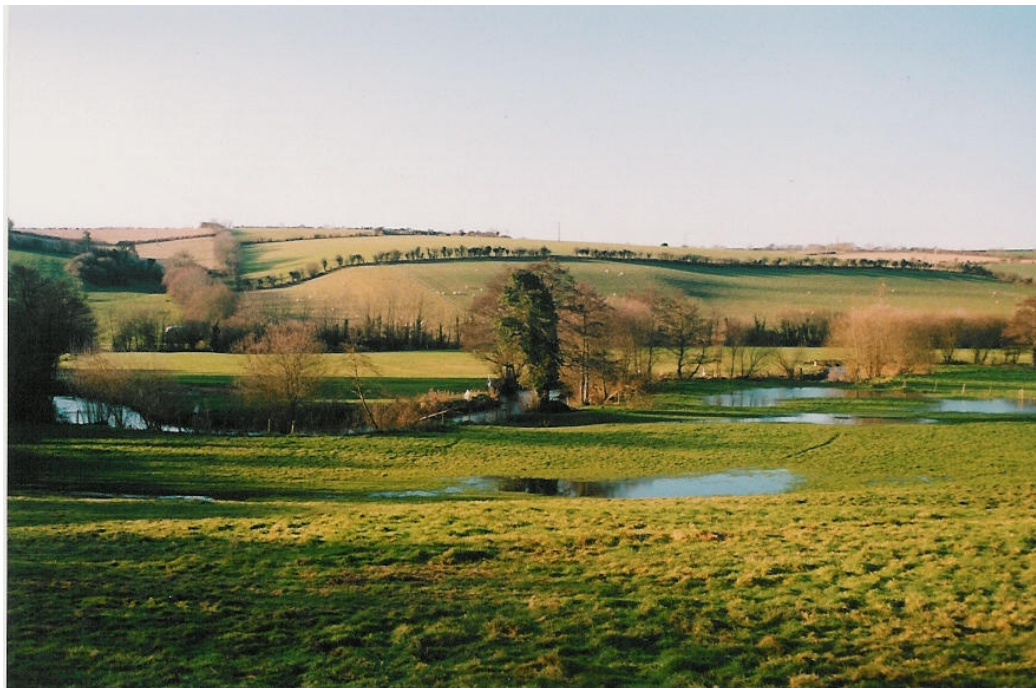
Figure 2. A section of the River Frome in reach 5, showing the low hilly landscape, unconfined valley, extensive agricultural land use and very narrow strip of riparian trees and shrubs bordering the main channel. . The photograph was taken in April shortly after a flood – the standing water in the foreground and middle distance picks out depressions marking old channel positions on the floodplain. (photograph: A.M. Gurnell)

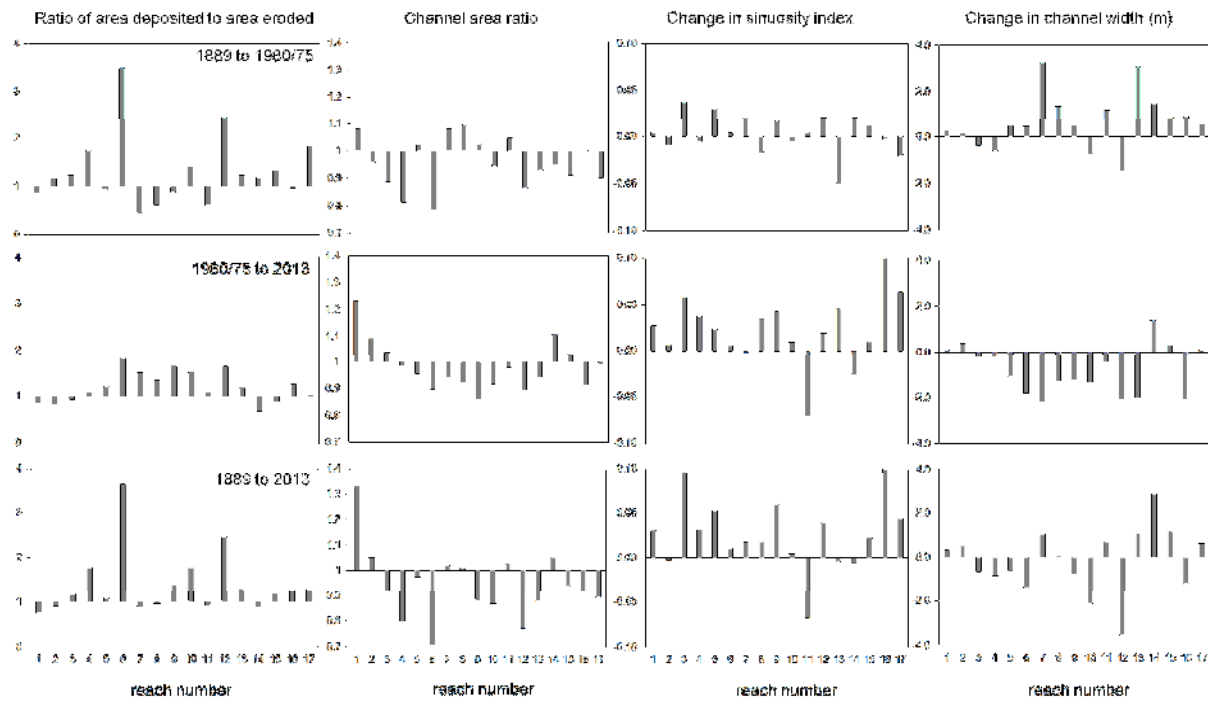
Figure 3. Changes in the planform of seventeen reaches of the River Frome identified from historical maps. The graphs show changes between 1889 and 1960/1975 (top row); 1960/75 and 2013 (middle row); and 1889 and 2013 (bottom row) in four indicators of channel planform change: left column - the land area that started the time period as river channel and ended as floodplain (area deposited) divided by the land area that started as floodplain and ended as river channel (area eroded) (dimensionless ratio); second column - the area of the river channel at the end of the time period divided by the channel area at the start of the period (dimensionless ratio); third column - the change in channel sinuosity between the start of the time period and the end of the period (dimensionless index change); right column - the change in average channel width between the start of the time period and the end of the period (in m).

Changes in five river planform properties were estimated for all seventeen reaches of the Frome between 1889 and 1960/75, 1960/75 and 2013, and 1889 and 2013. Estimates of the area converted from river channel to floodplain (deposited area) were divided by the area converted from floodplain to river channel (eroded area) to provide a ratio. This ratio and the remaining three planform properties extracted from channel edge overlays (change in channel area; change in sinuosity index; change in channel width) are all displayed in Figure 3 as columns of three graphs, one for the early period (1889 to 1960/75), one for the recent period (1960/75 to 2013), and one for the entire period of over a century from 1889 to 2013.

The ratio of area deposited to area eroded is mainly positive in all time periods and the channel area ratio is generally negative. These both indicate a reduction in channel area as a result of net deposition

within the channel in all time periods, and this trend is particularly consistent along virtually the entire river length in the recent time period (1960/75 to 2013). The remaining two indicators (change in sinuosity and change in channel width) illustrate how this net loss of channel area has been achieved. Sinuosity has generally increased, particularly in the recent period, so that in 2013 it ranges from 1.08 in reach 2 to 2.08 in reach 16. An increase in sinuosity lengthens the channel so that any change in channel area is distributed along a longer channel length. Despite this, average channel width has generally decreased, so that it in 2013 it increases steadily downstream from 2.8 m in reach 1 to 14.1 m in reach 17. The increase in sinuosity and reduction in channel width are both particularly consistent along the river in the recent period (1960/75 to 2013). The estimated reduction in average channel width is small, rarely exceeding 2m in a period that spans approximately four decades, but this constitutes a significant proportion of the channel width (average 11% width reduction in reaches 3 to 13 between 1960/75 and 2013). Although such small estimated changes may be strongly affected by the cumulative errors involved in the map sources and the manipulation of the channel edge data extracted from those sources, the consistency in the trends revealed in Figure 3 suggest genuine reductions in channel area and width and increases in sinuosity, even if the absolute values of those changes may incorporate significant error. These trends were explored further using recent aerial images and field observations.

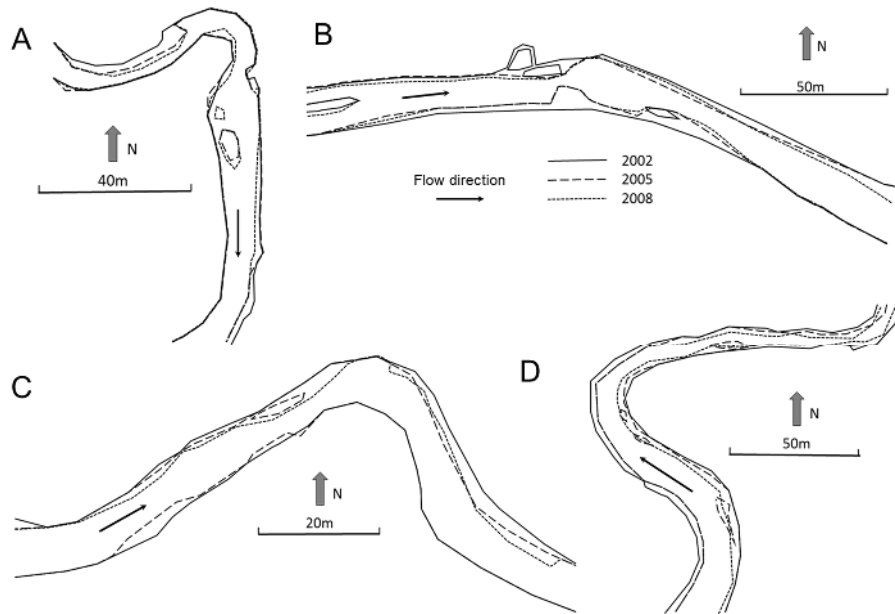
Figure 4. The position of vegetated channel edges and islands extracted from colour aerial images captured in 2002, 2005 and 2008 for sub-reaches of A. reach 9; B. reach 7; C. reach 9; D. reach 12 of the River Frome.

Recent channel adjustments in six sub-reaches of the River Frome between 2002 and 2008 are illustrated in Figures 4 and 5. It is important to stress once again that these reaches were selected not only because they were relatively free of riparian trees and thus clearly visible on the images but also because they showed changes that were sufficiently large to be clearly captured using image overlays for this six year period.

Four sub-reaches (Figure 4) showed quite simple styles of adjustment over the six year period, providing evidence for channel narrowing in all of the sub-reaches, and an increase in sinuosity in three sub-reaches (Figures 4 A, B and C). These short-term trends are similar to those identified over a longer period from the analysis of historical maps, although the rates of change are considerably larger. However, the historical and recent changes were identified using different criteria (edge of normal winter flow, edge of vegetation) and in the latter case for reaches that were deliberately selected because they show clear change in this six year period. Furthermore, one might expect short term changes to fluctuate quite widely through time, with changes often reversing direction so that the long term average trend would be expected to be much more gradual than any trends observed in the short term. A further important feature of the channel changes shown in Figure 4 is the presence of small islands in some images, many of which become incorporated into areas of encroaching river edge in later images (Figures 4 B, C, D) or in some cases they remain as islands that enlarge in later images (Figures 4 A, B).

All of the subreaches illustrated in Figures 4 and 5 are unshaded heavily vegetated reaches, where the in-channel features are associated initially with the presence of emergent aquatic vegetation.

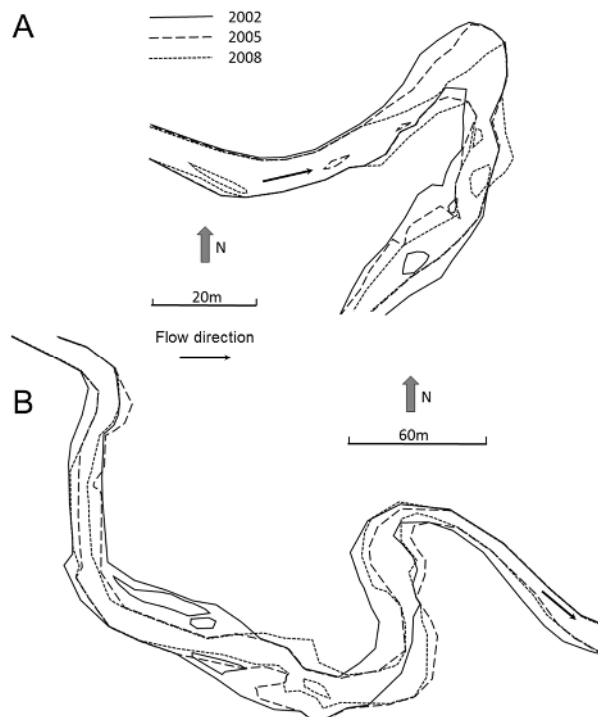
Figure 5. The position of vegetated channel edges and islands extracted from colour aerial images captured in 2002, 2005 and 2008 for sub-reaches of A. Reach 5; B. reach 13 of the River Frome.

More complex channel adjustments are shown in Figure 5. Channel narrowing, increased sinuosity, the formation of islands and their incorporation into the channel edges are all still clearly apparent, and are more marked than in the examples shown in Figure 4, but in addition, channel changes in these two particularly dynamic sub-reaches are sufficiently large that lateral channel movements are also evident at tight river bends.

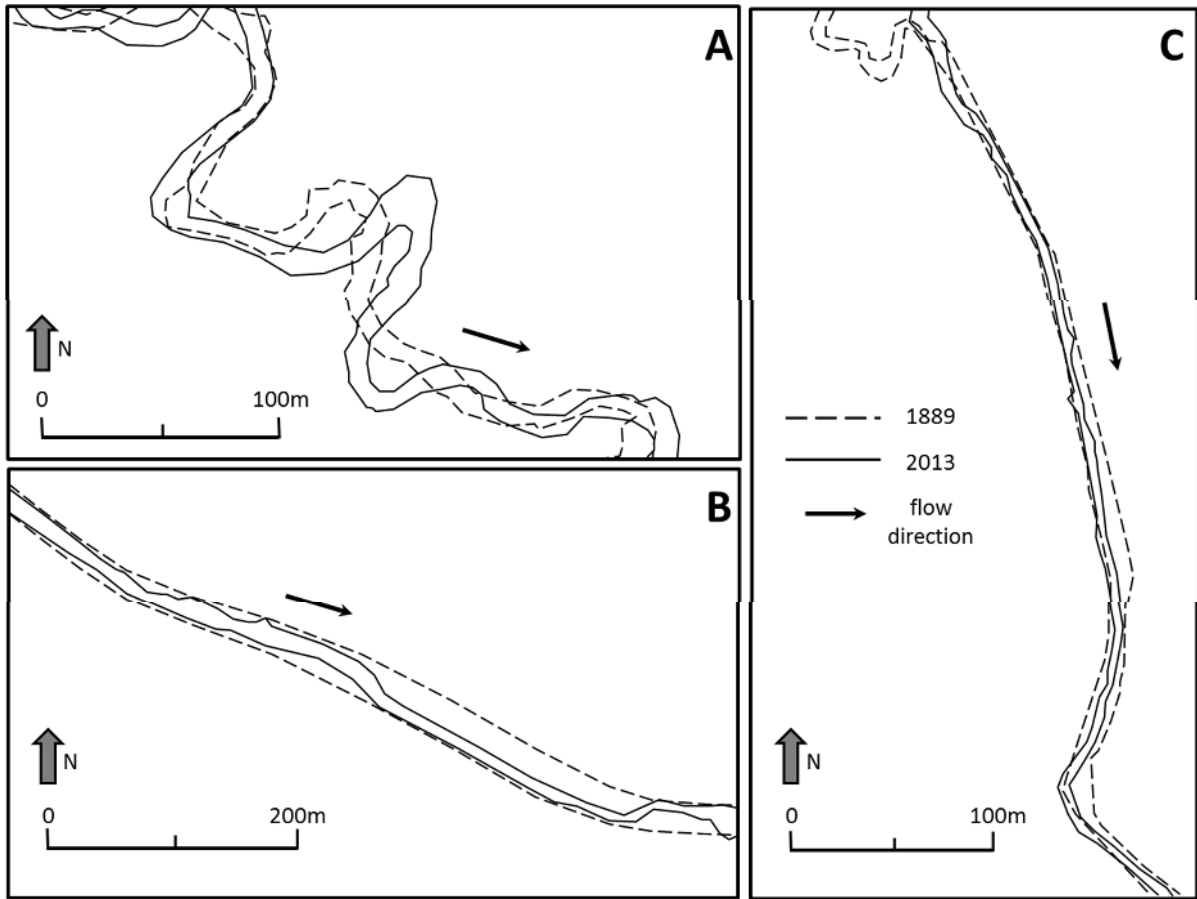
Figure 6. Changes in river width and planform 1889 to 2013 in sub-reaches 4 (A); 5 (B); and 6 (C).

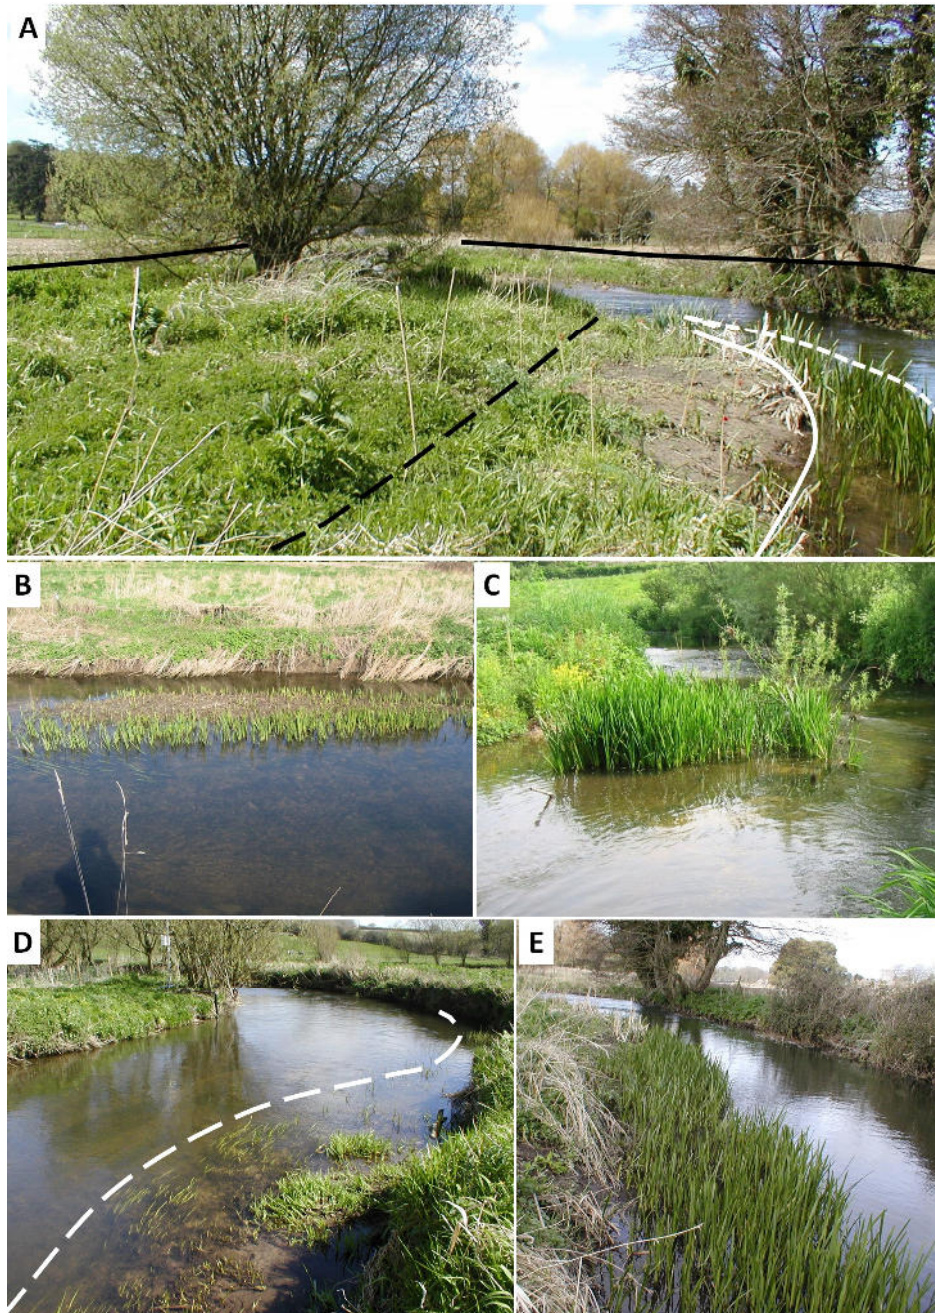
Figure 7. River channel narrowing and the role of fine sediment trapping and stabilisation by emergent aquatic plants, particularly *Sparganium erectum*. A. Landform development associated with channel narrowing in sub-reach 6, showing the initial channel width (black solid lines approximate the 1889 channel edge), the inner edge of a bench (black dashed line), the inner edge of a vegetated bar/berm (solid white line) and the inner edge of a submerged shelf retained by *S. erectum* (dashed white line). B. A vegetated bar in early spring in reach 6 – *S. erectum* sprouts around the edges of the bar but its centre has aggraded to the baseflow water surface level and so no longer supports *S. erectum*. C. A similar bar feature to that shown in B. but photographed in early summer in reach 5 and showing colonisation by other plants including a young willow. D. Channel narrowing driven by *S. erectum* in early spring in reach 5. E. Channel narrowing driven by *S. erectum* in late spring in reach 6. (photographs: A.M. Gurnell)

Field evidence of channel narrowing and island development within the subreaches of reach 5 and 6 are shown in Figure 7. In both subreaches, a gravel bed is exposed in the middle of the channel, but fine sediment has infiltrated the gravel and buries it in slackwater areas. The emergent species *Sparganium erectum* is abundant in both reaches and is associated with the island and marginal vegetated features observed in the aerial images and the leading edges of areas of channel narrowing observed in the map overlays for the recent period (1960/75 to 2013). Channel narrowing and increased sinuosity at the downstream end of the sub-reach of reach 6 (Figure 6B) is illustrated in Figure 7A. The approximate position of the 1889 channel edge is indicated by a black solid line, and a sequence of three depositional features can be seen within the 1889 channel: (i) a relatively high, bench feature, the upper (outer) edge of which is approximately 0.5 m below floodplain level (just below the black line on the left of Figure 7A) and appears to mark the current 'bankfull' level (approximately 1 m above the river bed); (ii) a lower, vegetated berm which extends from the lower (inner) edge of the bench (black dashed line, Figure 7A), and shows recent sediment deposition and aggradation, and (iii) a submerged shelf of predominantly silt (between the solid and dashed white lines, Figure 7A) below the low flow water level that is colonised by *S. erectum*, and abuts onto the gravel bed of the river. The role of *S. erectum* in stabilising the silt at the margins of the gravel bed is clearly crucial to the lateral and vertical development of this silt shelf at the outer edge of the vegetated bar. The other photographs in Figure 7 illustrate how silt is retained and stabilised within the inundated part of the channel by *S. erectum*, and how the aggrading silt initiates and extends island (Figures 7B and 7C) and marginal shelf-berm-bar features (Figures 7D and 7E) within the two visited reaches. Without the above ground biomass of *S. erectum* to trap and aggrade fine sediment (e.g. Figure 7E) and its below ground web of rhizomes to stabilise and retain the aggrading submerged shelf of fine sediment through the winter (e.g. Figure 7B), the fine sediment would either move on downstream, or would further infiltrate and bury the exposed gravel bed.

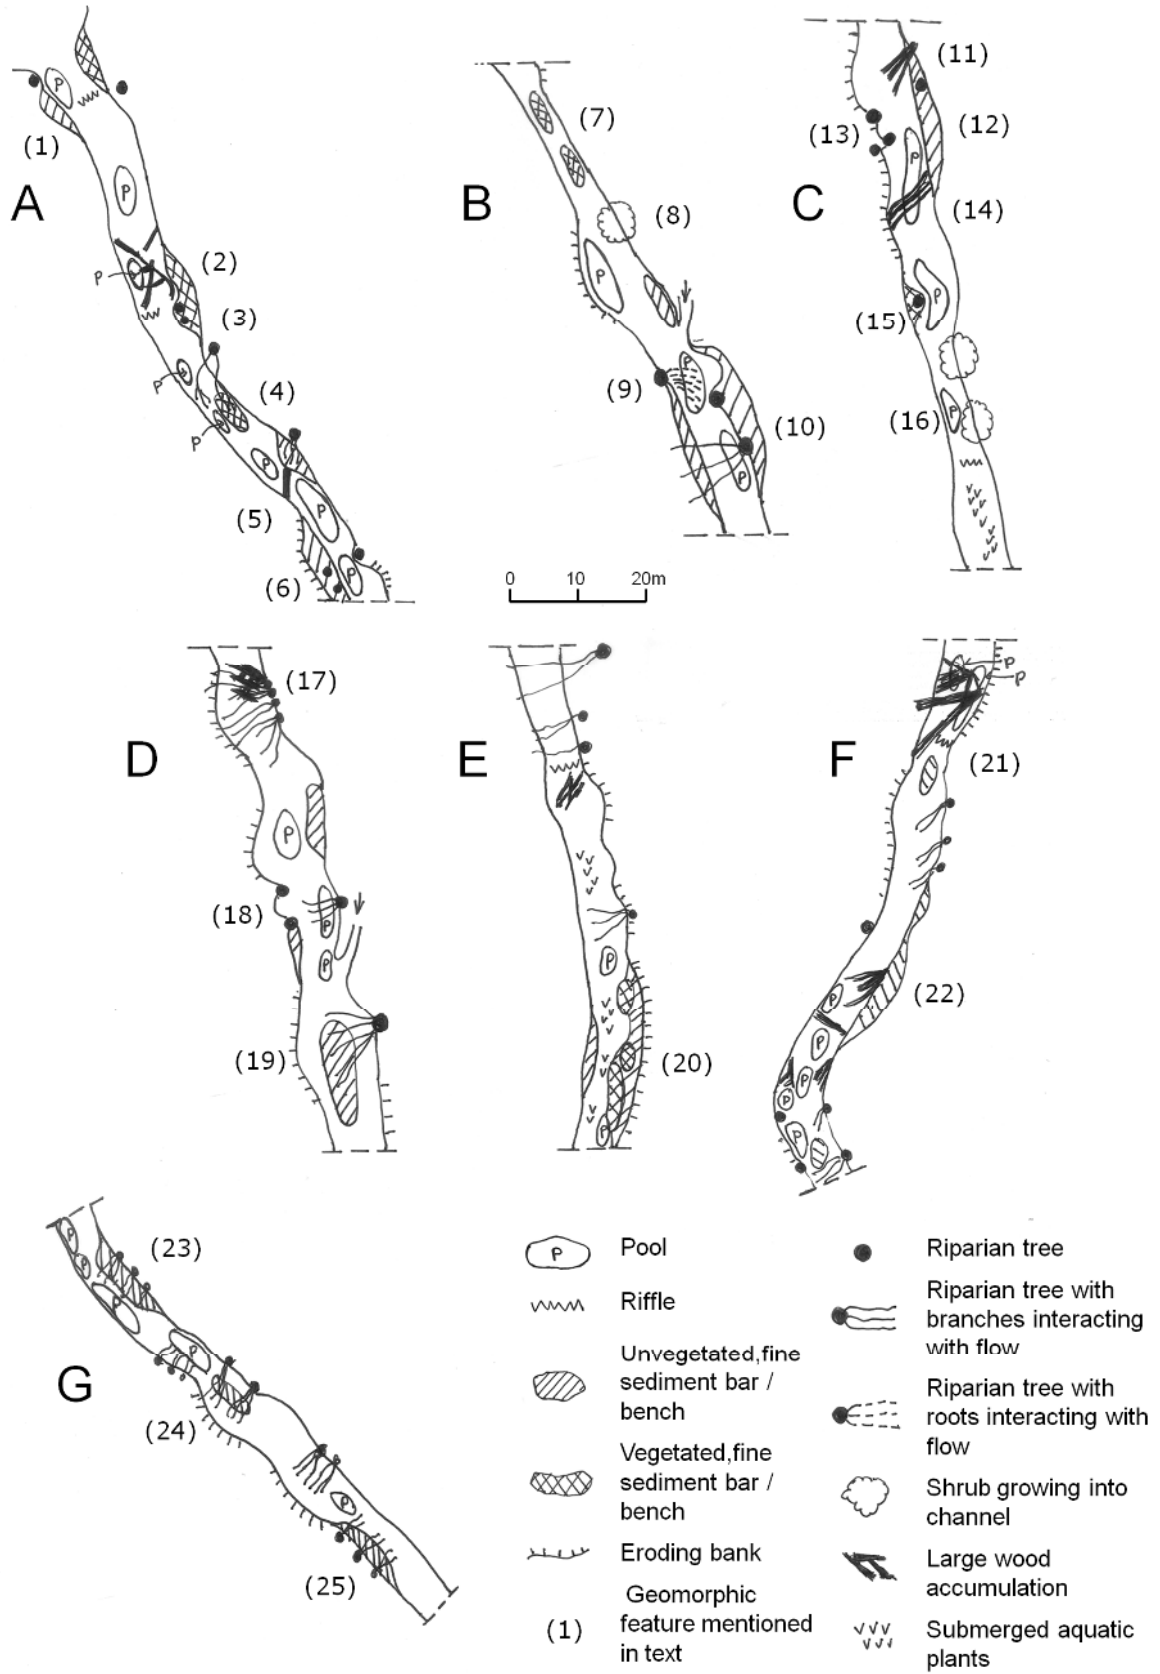
Figure 8. Sketch maps of tree and wood related features in reach 4 from upstream (A) to downstream (G).

Figure 8 shows geomorphological sketch maps of seven contiguous sections (A to G) of the sub-reach, with the direction of flow running from A to G and from the top to the bottom of each mapped section. This field survey revealed that, although the gravel river bed is occasionally exposed, much of the bed in this part of reach 4 is buried by fine sand and silt deposits, and this finer sediment is an important component of many of the landforms that are being created as a result of interactions among fluvial processes, riparian trees and large wood.

Dead wood features include small log steps (Figure 8 - features 5 and 14), a jam completely spanning the channel but with water flowing freely through it at low flow (Figure 8 - feature 2), an hydraulically active jam that creates a step in the water surface profile even at low flow (Figure 8 - feature 21, Figure 9A), and several flow deflection jams (Figure 8 - features 11, 17, 22).

There are also many features linked to standing riparian trees and 'living' (sprouting) wood. Dense areas of exposed roots (Figure 8 - feature 9; Figure 9C) and branches (Figure 8 - feature 19) trail into the channel, forming jam-like and bar features, respectively, and in one case rooting into the bed and retaining wood and sediment to build an island (Figure 8 - feature 4, Figure 9B). This latter feature appears to be the final stage of bar development induced by rooted trailing branches. The island is comprised of large quantities of wood and silt that have been trapped by the young trees that have sprouted from branches that touched the channel bed (and are still connected to their parent tree on the bank). The accumulation of wood and sediment around the sprouting branches has raised the surface of the island to the level of the surrounding floodplain. In section G, trailing branches, leaning and J-shaped trees and adventitious roots contribute to the development of lateral and mid-channel submerged shelves, bars and benches comprised of fine sediment (Figure 8 - 23, 24, 25; Figures 9D

and 9F), which, when combined with intervening areas of eroding banks, are leading to the development of a more sinuous channel planform. Indeed, the leaning and J-shaped trees are indicative of bank instability that is being arrested locally by bar and bench-development at the bank toe. Several other sections of the river support large riparian trees that are buttressing the river bank and leading to the development and, through root reinforcement, the retention of fine sediment benches (Figure 8 – features 1, 3, 6, 10, 12, 13, 15, 18; Figure 9I). In many cases, these trees appear to grow out of the bank face, with the upper part of their J-shaped trunk growing vertically, and with adventitious roots growing vertically downwards from the base of the trunk's 'J' shape into the channel bed. At the same time, other adventitious roots grow horizontally into the bank face, reinforcing bench features (Figure 9I) between the tree trunk and the original river bank. In several locations, shrubs are also growing into the channel, retaining sediment and wood, and narrowing the channel (Figure 8 - 8, 16).

One of the most striking features of the sketch maps in Figure 8 is the widespread occurrence of lateral bars and benches, comprised of fine sediment and usually associated with riparian trees. In addition, immediately upstream of a large active jam (Figure 8 - feature 21, Figure 9A) in section F is a complex of vegetated and unvegetated bench and bar / ridge features in the downstream part of section E (Figure 8 – feature 20; Figure 9E). Individual, steep-sided, fine sediment bars / ridges (both unvegetated and vegetated) also occur elsewhere in sub-reach 4, for example, just upstream of the confluence of small side channels in sections B and D, and also in the middle of the channel in section B (Figure 8 - feature 7; Figure 9G). Although the origin of these features is unclear, they appear to result from a combination of smaller pieces of sprouting wood and aquatic plants retaining fine sediment. The complex of these features in section E (Figure 8 - feature 20, Figure 9E) is comprised of scroll-like vegetated ridges, with intervening, lower areas that are exposed during low flows. The lower areas are reinforced by tree roots and probably act as flood channels when the water surface is elevated upstream of the active jam during high flows. The jam also supports complex in-channel flow pathways, which have resulted in the scour of pools under the jam, and these flow pathways probably propagate upstream during flood-ponding to create the feature complex at location 20 (Figure 8 – feature 20). A similar explanation could be proposed for scroll-like unvegetated ridges observed upstream of the two minor stream confluences (Figure 8 – sections B and D (located upstream of the confluence and adjacent to a pool)).

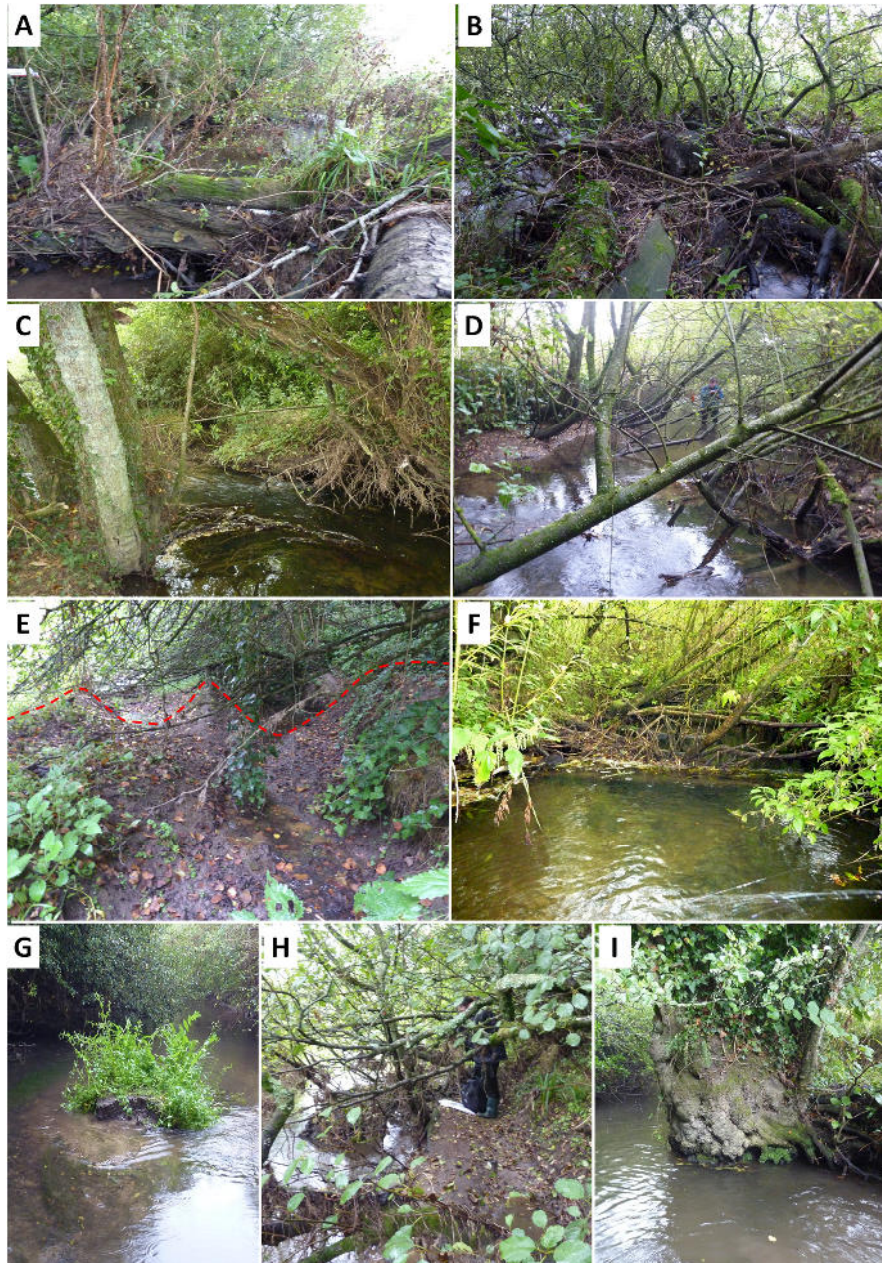
Figure 9. Living vegetation and large wood trapping fine sediment to build landforms in sub-reach 4 (bracketed numbers refer to features identified in Figure 5). A. Active wood jam (21). B. Island formed by large wood and fine sediment trapped by branches rooted into the channel bed (3). C. Wood jam created by living tree roots (9). D. Leaning and J-shaped trees inducing lateral bar development (23). E. Side channels separated by vegetated ridges (to left and in the middle distance) that are above the low flow water level (20). The river bank is on the right. F. Leaning trees trapping wood and rooting into the channel bed (24). G. A vegetated mid-channel bar of fine sediment (7). H. Fine sediment bench protected by a flow deflection jam and riparian trees (11, 12). I. Alder tree buttressing river bank (15). Note the old roots growing downward from the base of the 'J' shaped trunk, and also into the river bank to support a bench (right of picture) that is significantly lower than the flood plain at the rear of the photograph (photographs: R.C.Grabowski) .
