# MOVING IN, OUT AND AROUND THE HOME: SOLUTIONS FROM OLDER ADULTS WITH LONG-TERM MOBILITY IMPAIRMENT

## ABSTRACT

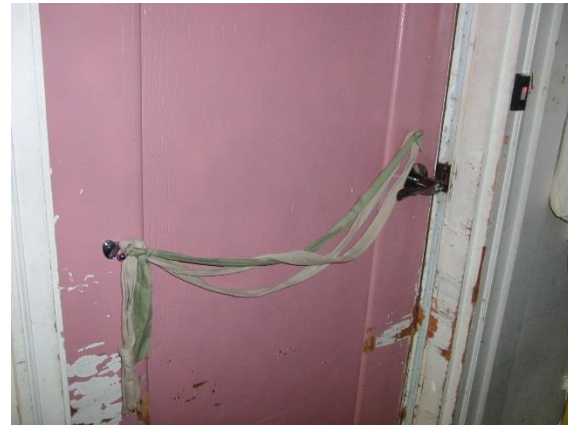
**Figure 1.** Example of a homemade door pull. Damage from the user's wheelchair to the doorframe can also be seen.

*Opening and closing doors.* Participants shared a number of solutions to assist with opening and closing doors (n=8). Examples included installing automatic or remote control doors (n=3), utilizing help from service dogs (n=2), and attaching items to a door to assist with pulling (n=6). These door pull items included: loops, rubber bands, scarves,

bungee cords, and additional handles. An example of one of these door pull solutions is featured in Figure 1. Of the eight participants documented using such solutions to open/close doors, six reported limited upper body functioning related to their mobility impairment and one reported being unable to use his/her arms.
