Interpretation of laser scanner 3D data used to determine circular failure surface of shallow landslides

Oppikofer, T., Jaboyedoff, M., Baillifard, F., Pedrazzini, A. and Travelletti, J.

University of Lausanne, Institute of Geomatics and Analysis of Risk (IGAR), Amphipole, CH-1015 Lausanne, Switzerland, email: Michel.Jaboyedoff@unil.ch

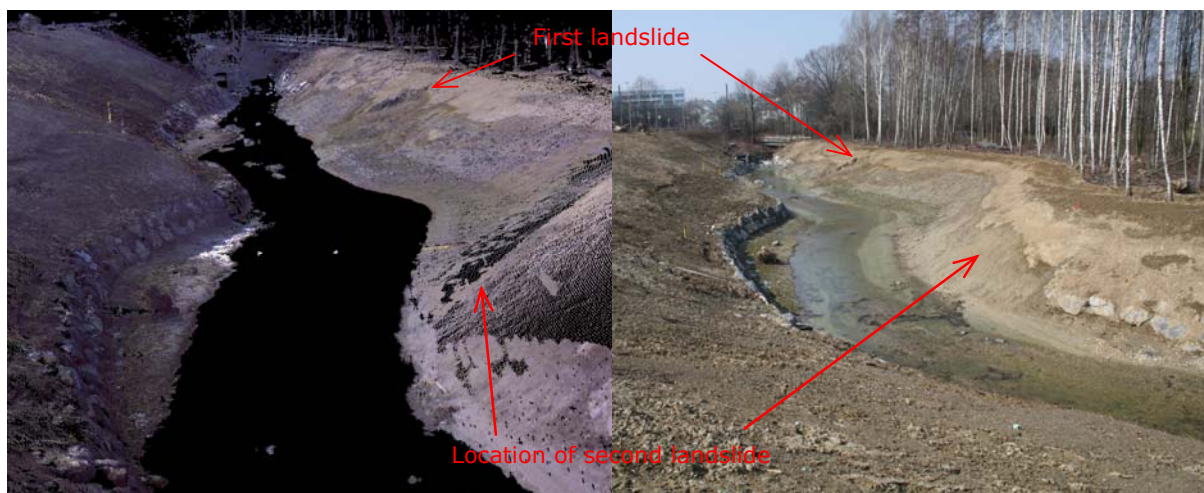
Figure 1: Views of the Sorge River to the West (taken on March 16th 2006). The point cloud of the laser scanner and the photograph show the area of the remedial works that were done in 2005. The scar of the first landslide is also shown.

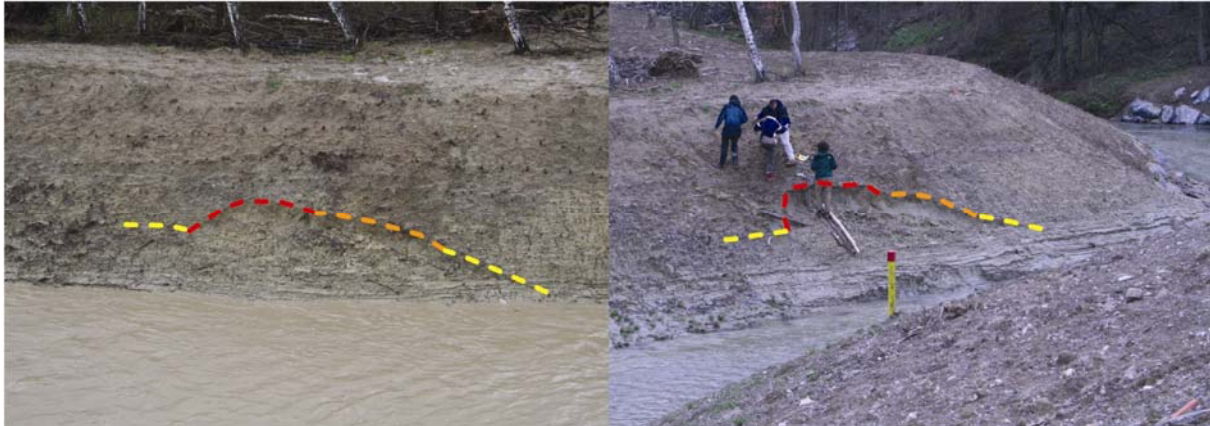
Figure 6: Photographs of the second landslide (left: taken on 10th of April 2006 during the flooding; right: situation on April 12th 2006). The main scarp (red), the secondary scarp (orange) and the minor scarps (yellow) are discernable on both pictures. The landslide continued its rotational movement in the interval of the two pictures.

The second landslide in the eastern part of the study area occurred in the period between the two scanning campaigns (Figure 6). It was probably caused by the intense rainfall event of 8th to 10th April 2006 and the increased river flow rate. The landslide is composed of a main rotational slide and a smaller secondary rotational slide. Small scarps are also observable on both sides of the landslide. The main scarp is circular and reaches a height of 0.6 m in the central part. The lateral extent of the landslide is approximately 5.5 m. Apparently, the landslide initiated already during the flooding of 8th to 10th of April 2006, but displacements continued after the decrease of the river's water table (Figure 6).
