Retrofitting Adobe Buildings

Senior Project

Arce 453/460

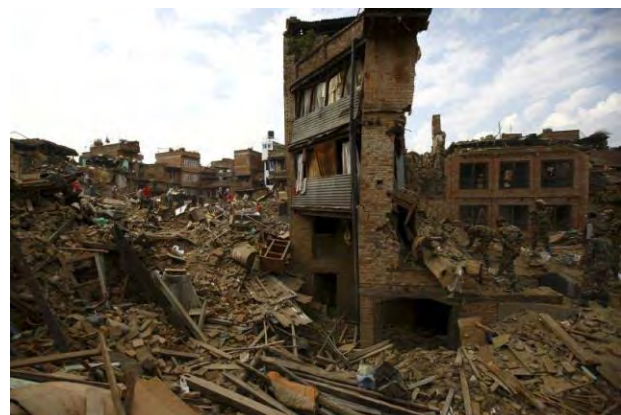
Figure 4: Adobe building after the earthquake

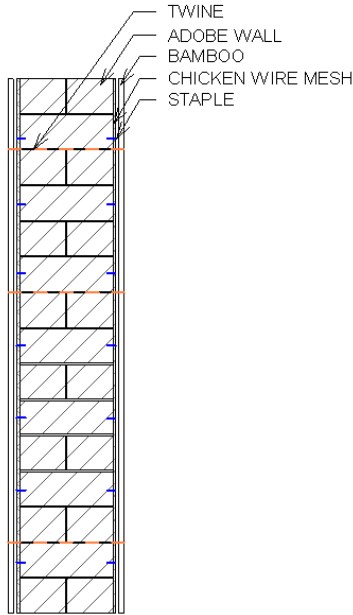
Figure 7: Proposed retrofit scheme -
Section

In order to not only provide cost-effective but also substantial seismic improvements to these houses, the scope of this testing will be limited to materials easily accessible in these secluded areas. Therefore, an adobe wall will be built and tested for out of plane loads. The same wall will then be retrofitted with bamboo spaced at 18" o.c. tied on either side, attached with plastic rope threaded through the wall (shown in Figure 7). Chicken wire mesh will then be placed across the wall to minimize further cracking in the wall. Referring once again to Figure 7 and 8, it shows that the bamboo reinforcement and wire mesh will be low in cost, but is assumed to provide high seismic safety. Once the retrofit is completed, the wall will be tested once more to determine whether the materials strengthened its load capacity.

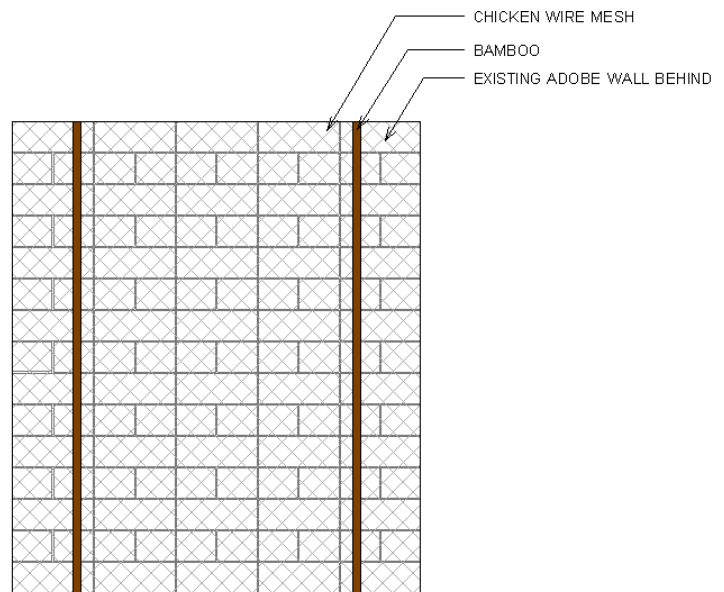
Figure 8: Proposed retrofit scheme -
Elevation

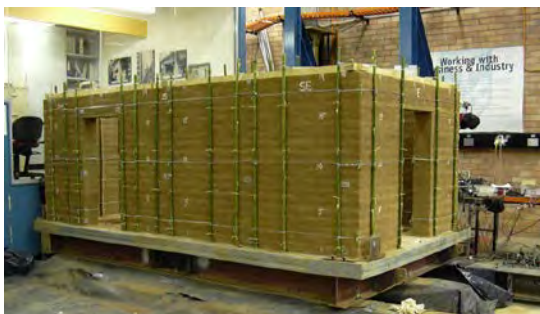
Figure 9: Bamboo reinforcement full scale testing

At the University of Technology in Sydney, Australia Dominic Dowling attempted to create a simple and affordable retrofit scheme attainable by individuals in underprivileged communities in Asia, the Middle East, and Latin America. The scheme utilized the use of bamboo to provide the currently lacking tension reinforcement to the structure. The institute tested and retested multiple schemes of retrofits until the following came to be considered, "QuakeSafe Adobe." Using the research by Dominic Dowling, this project utilizes a similar scheme but incorporates the use of chicken wire mesh to help decrease cracking.

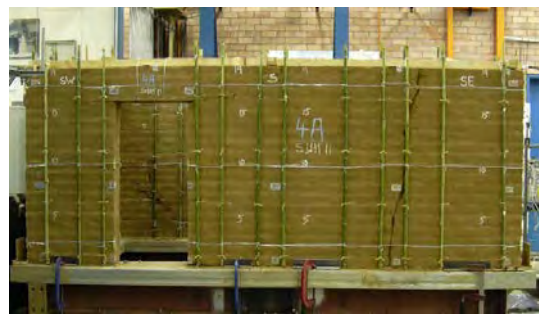
Figure 10: Bamboo reinforcement full scale testing -
Elevation

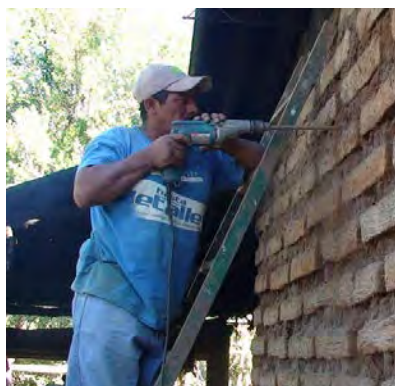
Figure 11: Drilling into Adobe wall

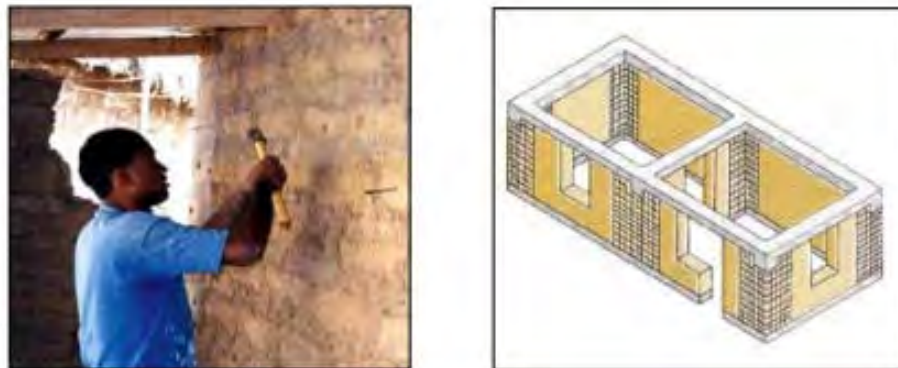
Figure 13: Retrofitting Adobe wall in Peru

This project will utilize a similar tactic to the one mentioned previously. The figure above illustrates chicken wire mesh placed at corners of the building, acting like beams and columns. However since the scope of this project focuses more so on out-of-plane forces on a singular wall, the mesh will be placed across the entirety of the wall to act more as confinement. Unfortunately, the research done in Peru was also based on fired adobe bricks that are stabilized with cement. Although the bricks are majorly composed of soil, the compressive strengths of the sun-dried bricks compared to the fired bricks would undeniably differ.

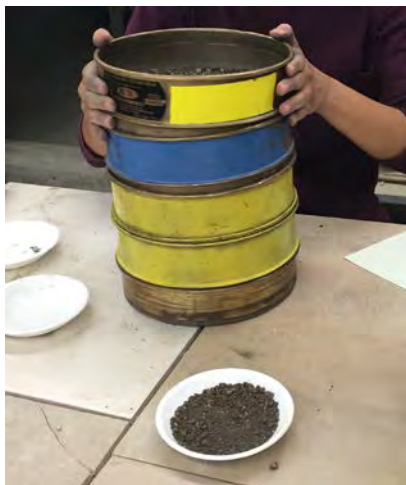
Figure 14: Sieve analysis of soil

Performing a sieve analysis (as shown in Figure 14) on the soil obtained for the project, the resulting ratios noted in Table 3 below.

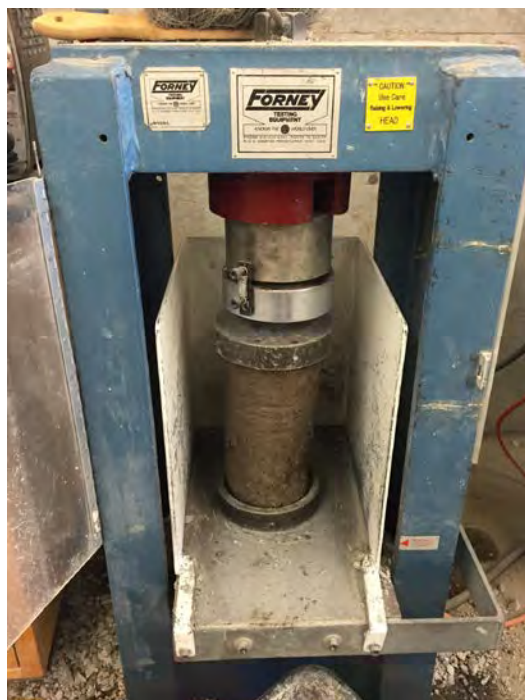
Figure 15: Cylinder testing

Testing the compressive strength of the adobe bricks was done by creating a cylinder consisting of the same soil consistency as the bricks. Once the cylinder had dried completely, the Forney Compressive Machine was used to test its strength.

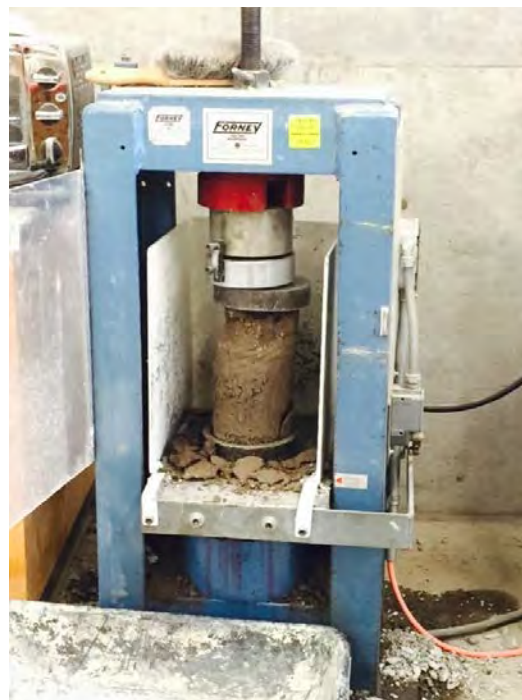
Figure 16: Results of Cylinder testing

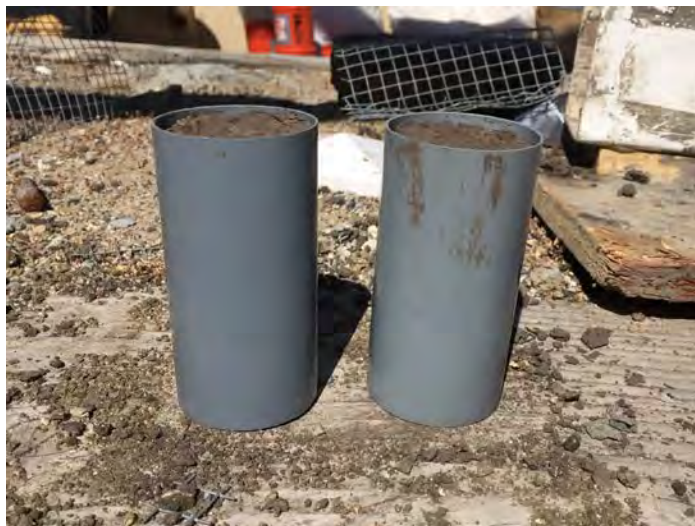
Figure 17: Cylinders Two and Three

Since the testing machinery for the first cylinder is used for concrete (which withstands substantially more load than mud bricks), the remaining two cylinders had a slightly different set-up. The new

cylinders were 4” tall and used in the Tinius Olsen Machine in an attempt to produce more accurate results.

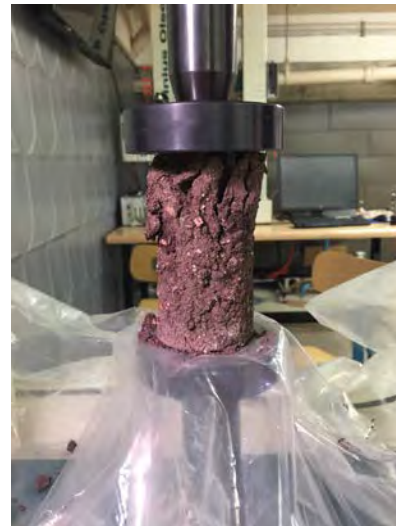
Figure 18: Results of testing cylinders

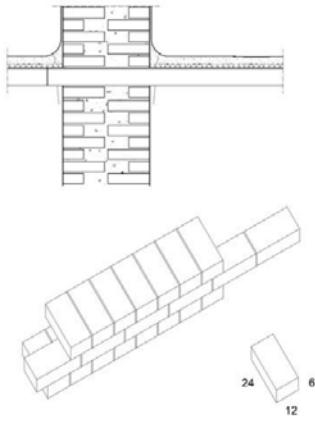
Figure 19: Layout of adobe brick wall

When researching the possibility of purchasing adobe bricks in the United States, it was determined that the type of brick used in Nepal construction was much weaker than any found in the area. Much of the adobe produced in the United States is manufactured to perform better structurally by adding portland cement or through kiln-drying. Since the objective of this project is to focus primarily on aiding in retrofits for underprivileged areas of the country the bricks were required to be sun-dried and not cement-stabilized. Therefore, it was necessary to produce the bricks manually by building formwork. The brick sizes were determined to be 4.5”x 9” x 2.5” (representative of the dimensions shown in centimeters in Figure 19) to imitate those found in Nepal. Since the wall is constructed with courses

alternating direction as shown in Figure 19 below, the length of one brick is equal to the width of two bricks.

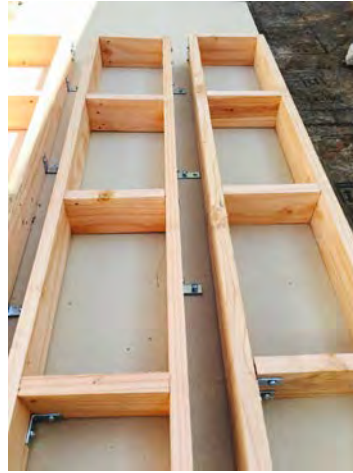
Figure 20: Adobe brick formwork

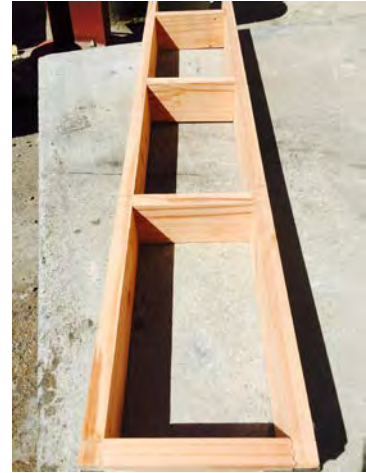
With the formwork completed, it was necessary to begin constructing the bricks. Unfortunately, on the first attempt at creating the bricks, the soil had consisted of too much clay. Attempting to compact the clay soil into the formwork was difficult and laborious, resulting in bricks that were cracked and structurally incapable of withstanding much load.

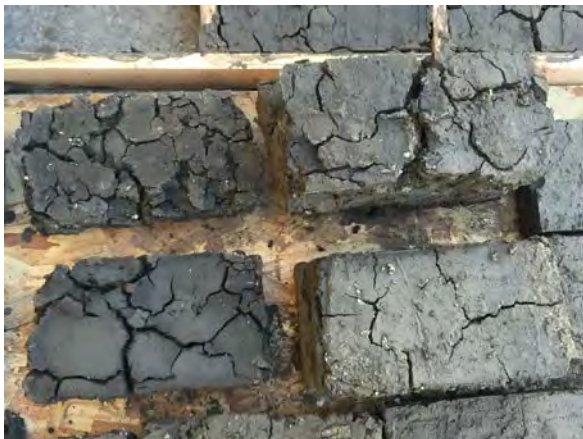
Figure 21: Clay Bricks – Attempt One

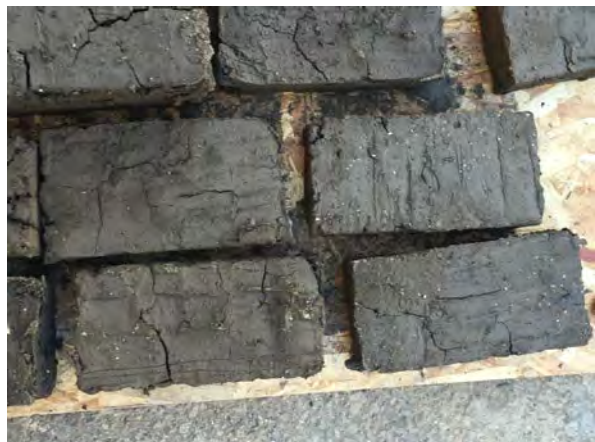
Figure 22: Clay Bricks – Attempt Two

Since the clay bricks were prone to break apart, it was decided to utilize a soil mixture consisting of less clay and more sand and silt, which led to the use of soil used in the sieve analysis.

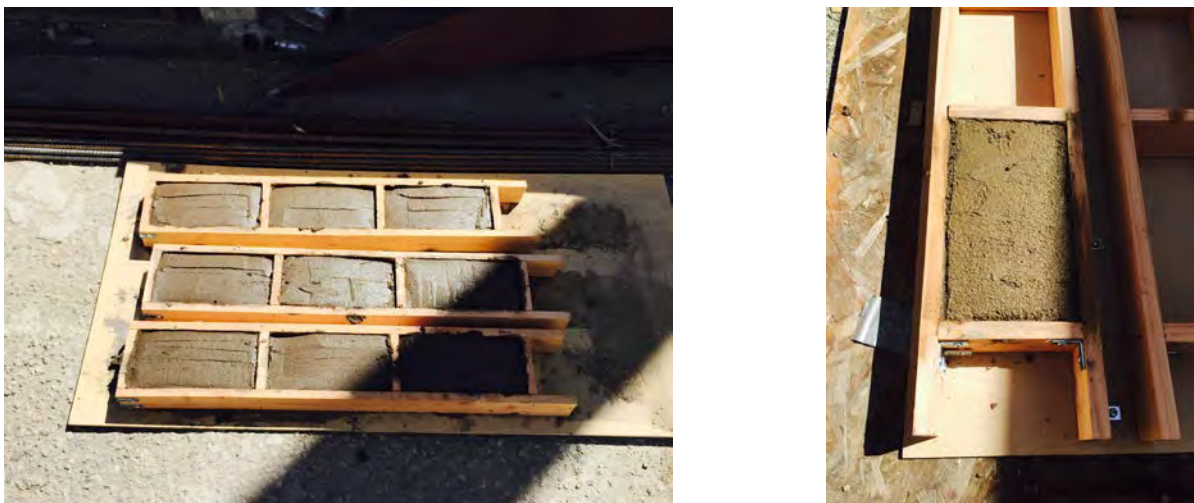
Figure 23: Adobe bricks in formwork

The final brick mixture consisted of more sand and silt and much less clay, allowing for better workability with the compound. The final result was comparable to bricks produced in Nepal.

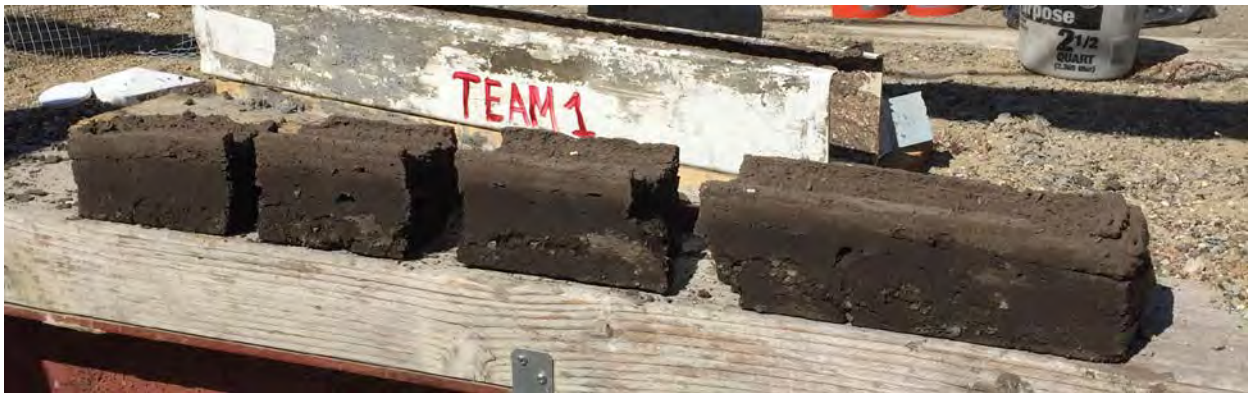
Figure 24: Flexural beam test – Attempt One

In order to obtain the tensile strength of the mortar, a flexural test was performed on small beams made of adobe. At first, we created a 24” beam made of the same mixture as the beams. However, after a day of drying they had cracked in the formwork preventing testing from occurring (shown in Figure 24) . This is assumed to be due to the fact that the mixture was incapable of maintaining adequate cohesion for that amount of length. It became understandable why the bricks were made to be 4.5” x 9” and not any larger.

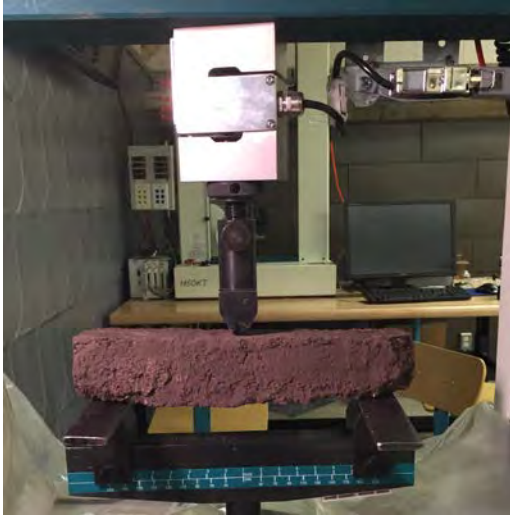
Figure 25: Flexural beam test set-up

Since the option of crushing the two foot beam was no longer feasible, the beams were reconstructed at a smaller scale and tested on the Tinius Olsen machine. Two beams were formed (as shown in Figure 25) and left to dry for a week prior to testing. The results of the testing were used to find the Modulus of Rupture which would indirectly be utilized in calculating the mortar strength of the adobe wall.

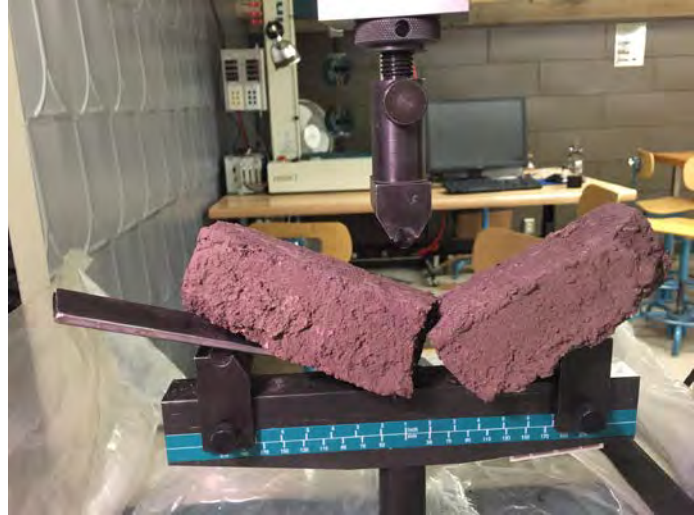
Figure 26: Results of flexural beam test

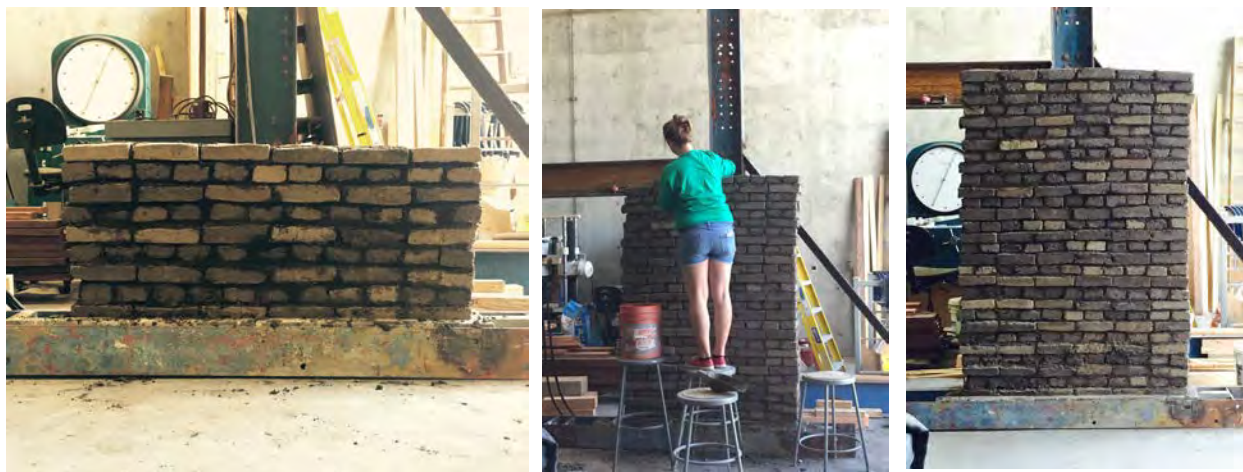
Figure 27: Construction of the adobe wall

The wall was built within an 11” wide flange beam bolted to the ground. This provided fixity to the base of the wall and allowed for more accurate results. This fixity imitates the foundation of the wall, creating a simply supported beam that does not rotate at the base.

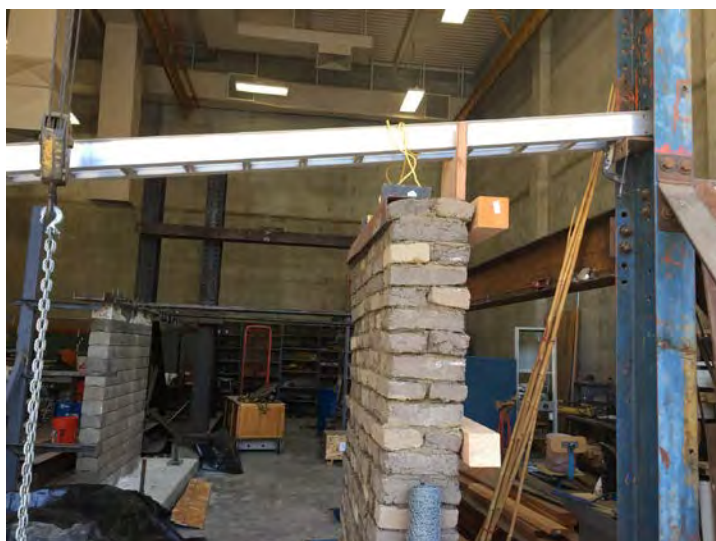
Figure 28: Adobe wall test set-up – Side View

In order to test the unreinforced, and then retrofitted, wall it was required to form a set up that would create out of plane bending in the wall. It was also decided that the test setup should try to mimic a uniform load across the height of the wall rather than a single point load at any location on the wall. In order to accomplish this timber frame was created that would be situated between the wall and the hydraulic ram providing the load. An 80 pound channel beam was also placed on the top of the wall in order to provide an axial dead load, as well as a location to provide fixity at the top of the wall. The setup is demonstrated in the Figure 28 below.

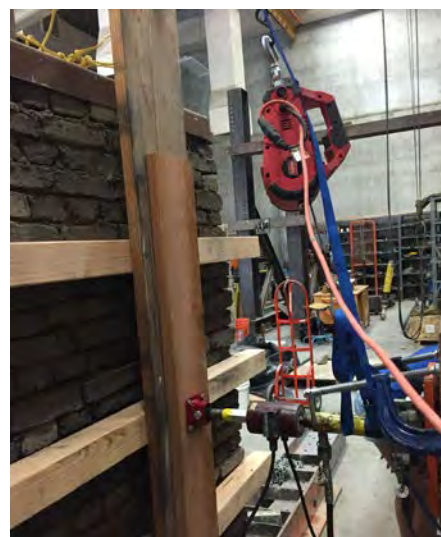
Figure 29: Adobe wall load cell and ram

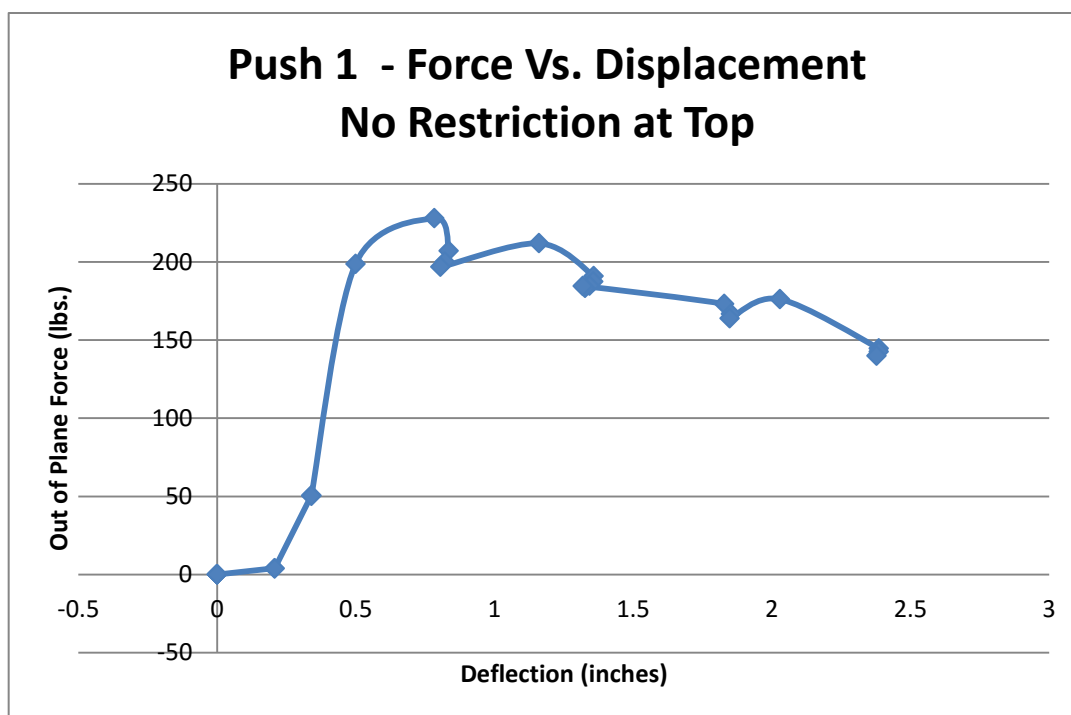
Figure 30: Force v. Displacement Graph – Push One

was recorded. From this data a Force versus Displacement curve was found, which can be seen in Figure 30. The failure observed at the maximum force of 227 pounds was tension failure in the mortar on the tension face (the side of the wall the load was being applied) at the base of the wall. This was expected, as the highest flexural demand occurs at the fixed base of cantilevers.

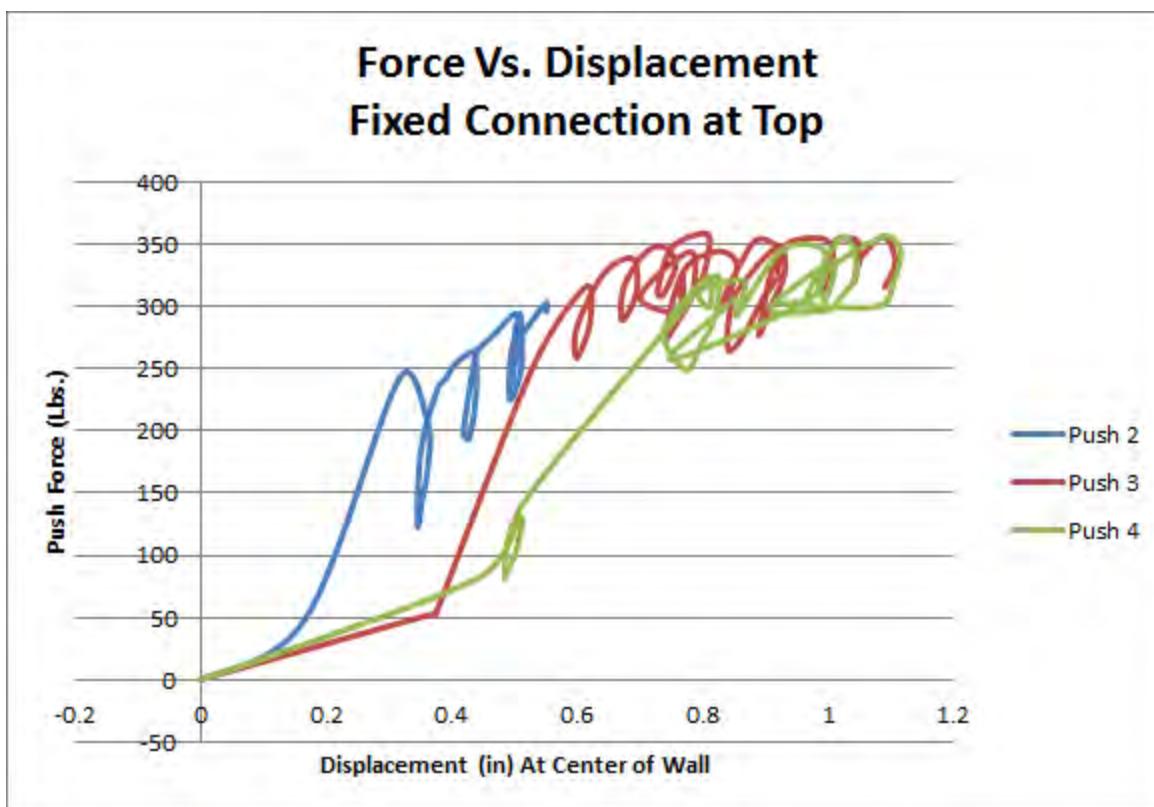
Figure 31: Force v. Displacement Graph – Push 2/3/4

The second test condition was with the top of the wall restrained. The connection was not quite a fixed connection, but had much more fixity than a pin connection. In order to achieve this, the channel beam that had been placed on the top of the adobe wall was connected back to the steel frame that was supporting the ram. This prevented displacement at the top of the wall, which led to a higher maximum force capability of 350 pounds, and a smaller maximum displacement of 0.66 inches. The change in end conditions also led to failure occurring in a different location. For this test, failure was observed again from mortar tension failure, but located at the top of the wall two courses below the connection. This can also be expected, as the two end connections act similarly to fixed connections, and the maximum flexural demand of a fixed-fixed specimen occurs at the two ends.

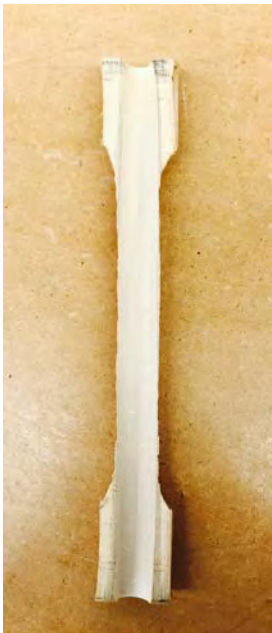
Figure 32: Bamboo Specimen

Bamboo is quite abundant in Nepal and commonly used for construction applications. A majority of the diaphragms of houses are constructed using a mixture of bamboo and mud. Unfortunately finding bamboo that grows solely in Nepal was difficult to obtain in the Central Coast. Instead, the bamboo used for the research was *Phyllostachys Bissetii* which is commonly found in China. To understand the material properties of the bamboo, tensile testing was completed with the Tinius Olsen Machine. The bamboo was carved to force fracture in the middle of the specimen.

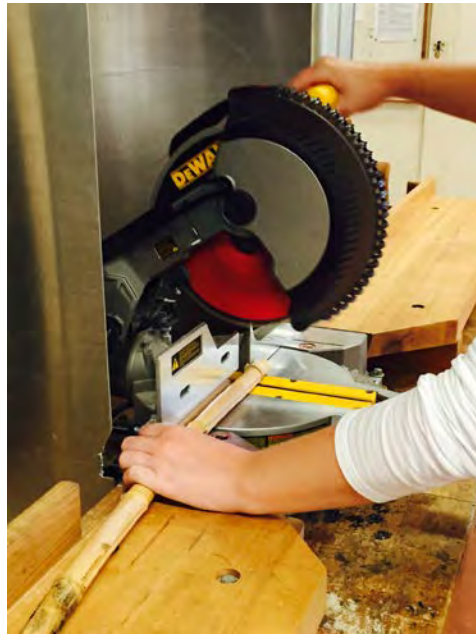
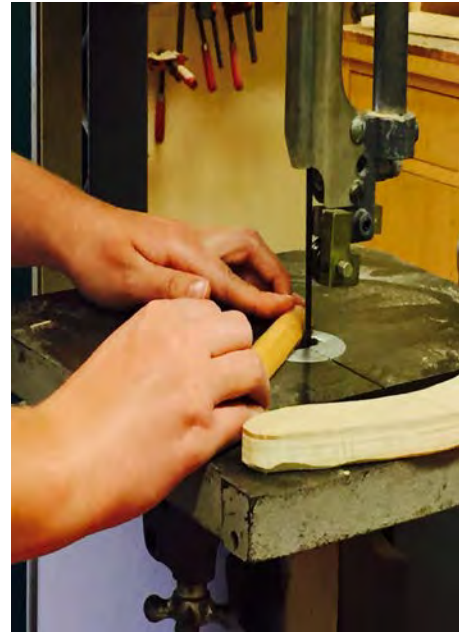
Figure 33: Construction of bamboo dog-bone specimen

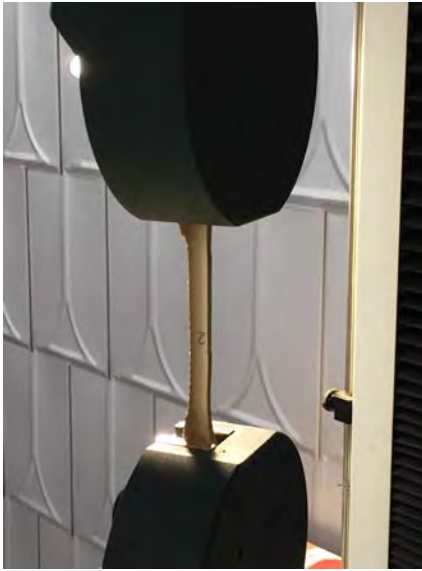
Figure 34: Bamboo tensile testing

Since bamboo is thick and rounded, it was nearly impossible to create a flattened specimen to test. This caused the bamboo to crack slightly below the clamps in an attempt to flatten out the midsection of the specimen. The capacity of the bamboo declines as this process ensues and then once again quickly increases. This caused for some unusual peaks on the force v displacement plot. However, despite these complications the maximum allowable tension load of the bamboo resulted to be around 720 lbs.

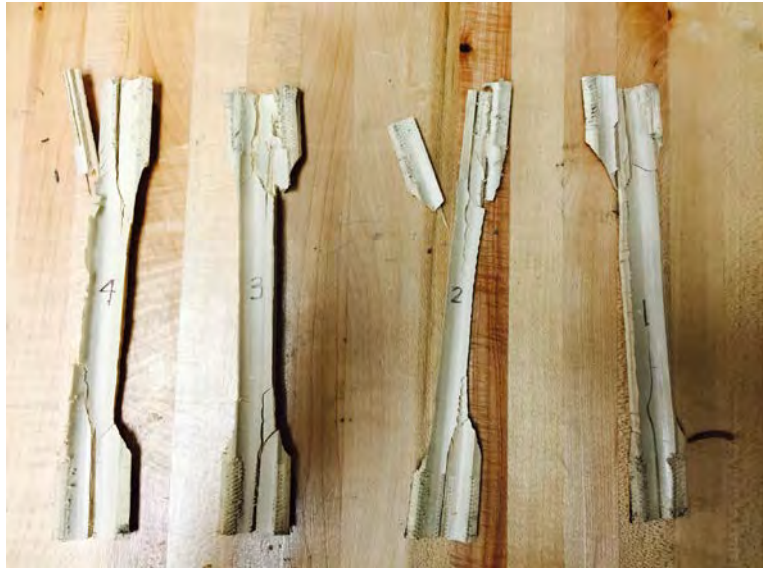
Figure 35: Results of bamboo tensile testing

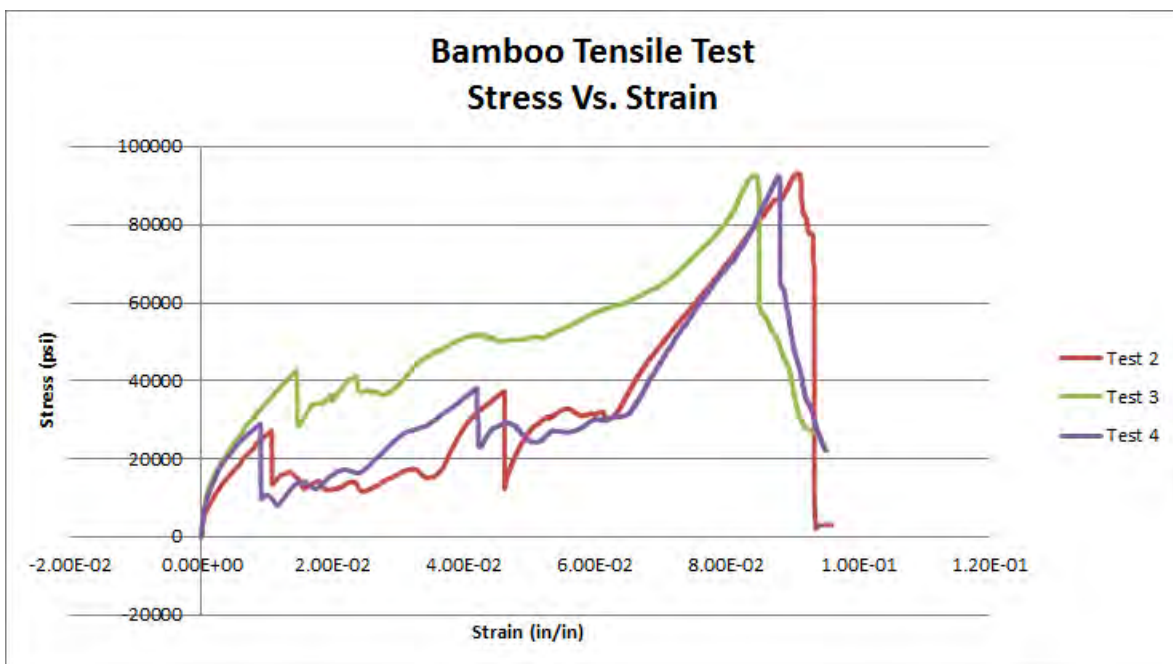
Figure 36: Stress v. Strain Graph for Bamboo Tensile Testing

Based on the data obtained from the Tinius Olsen Machine, which provided a force versus displacement relationship, Stress versus Strain curves were created (Figure 36). From these curves the Modulus of Elasticity, tensile yield strength, and ultimate yield strength of each specimen was found. These values can be seen in Table 6 below.

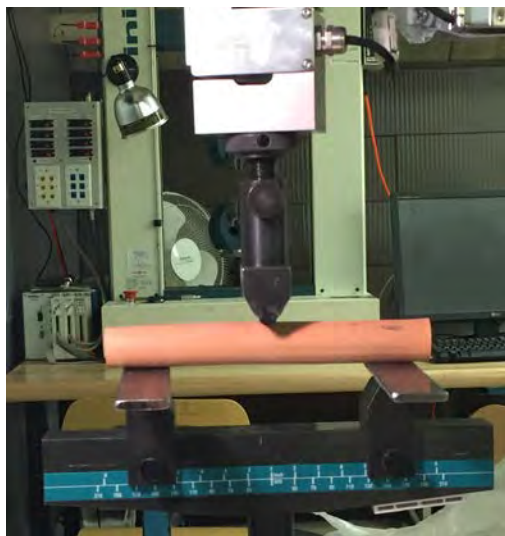
Figure 37: Bamboo Flexure Test Set-Up

The ultimate flexural strength of the bamboo used for the retrofit was found using the testing set up shown in Figures 37 and 38 shown below. The testing specimens were placed so that they had a set span and were pinned at both ends. A load was then applied using the Tinius Olsen machine at midspan until rupture. Using this data the maximum bending stress for the bamboo, base off of the maximum tension stress, was found to be 1349.6 psi. This then led to a maximum moment capacity of 630 pound-inches (52.5 pound-feet).The calculations for this can be found on Appendix page 6 and 7.

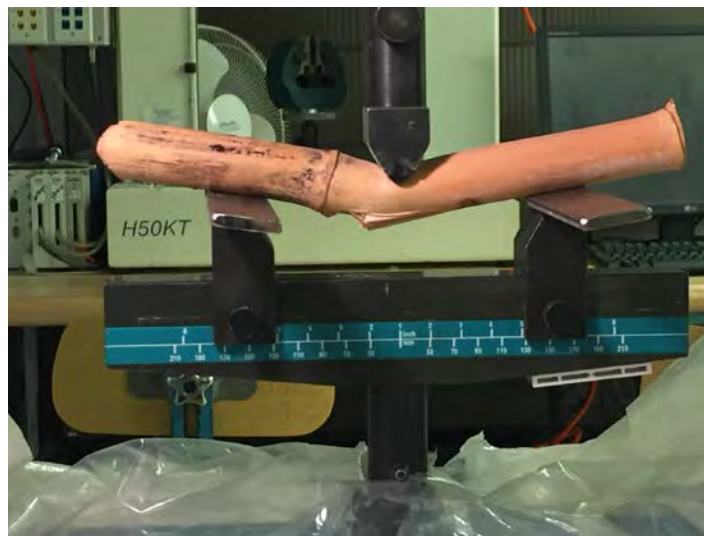
Figure 38: Results of Bamboo Flexure Test

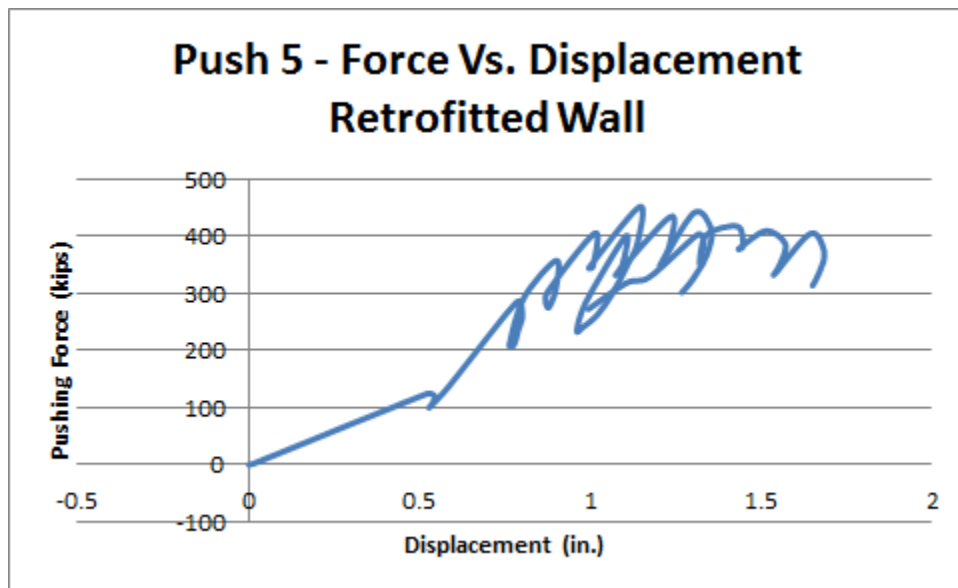
Figure 40: Force v. Displacement Graph of Retrofitted Wall Test

During the testing the ram applied force to the wood frame and then to the wall. Similar behavior to the second unreinforced masonry test was observed, though a higher maximum load (450 pounds) was achieved. This can mostly likely be completely attributed to any confinement that the chicken wire mesh provided to the adobe. The force-displacement curve seen in Figure 40 below that was created based on data from this testing indicates that there was an increase in maximum allowable force. Because the bamboo was not placed on both sides of the wall, it is thought that the bamboo did not add any significant bending or tension capacity to the wall. The failure that was observed during loading was at the same location as during the last test. This was again a tension failure of the mortar near the end condition at the top of the wall. Unfortunately, this is thought to be caused by the fact that the chicken wire mesh was not able to be wrapped around the very top of the wall due to the placement of the steel channel beam. The maximum predicted loads were not able to be obtained for both the unreinforced testing and the retrofit due to the test set up acting more as a fixed-fixed connection rather than a pin-pinned. This led to the maximum moments being at the top and bottom of the wall. This would explain the mortar failure seen in the top courses of the wall.

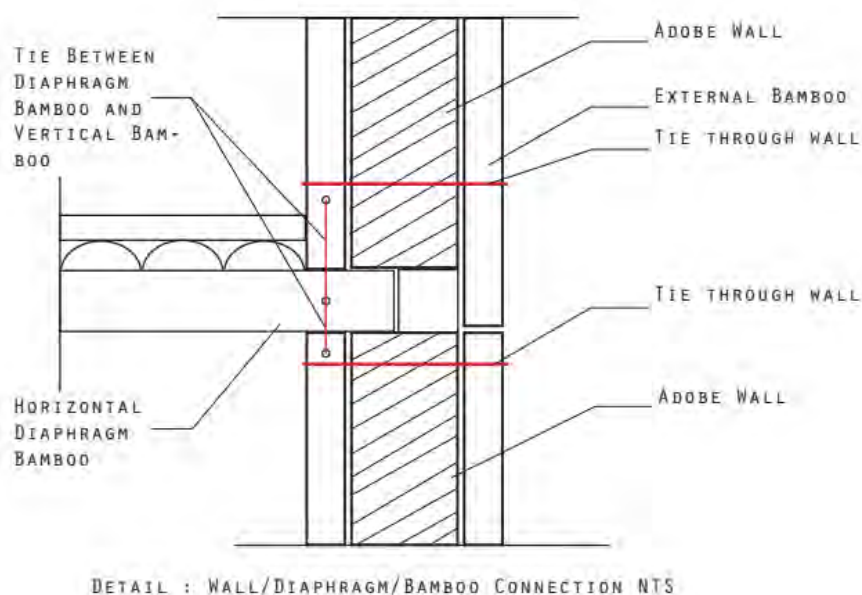
Figure 41: Diaphragm – Wall Retrofit Connection schematic

However, that would require the construction of a full scale adobe building which was not feasible at the time. Figure 41 shown below illustrates the initial design for the bamboo to diaphragm connection.

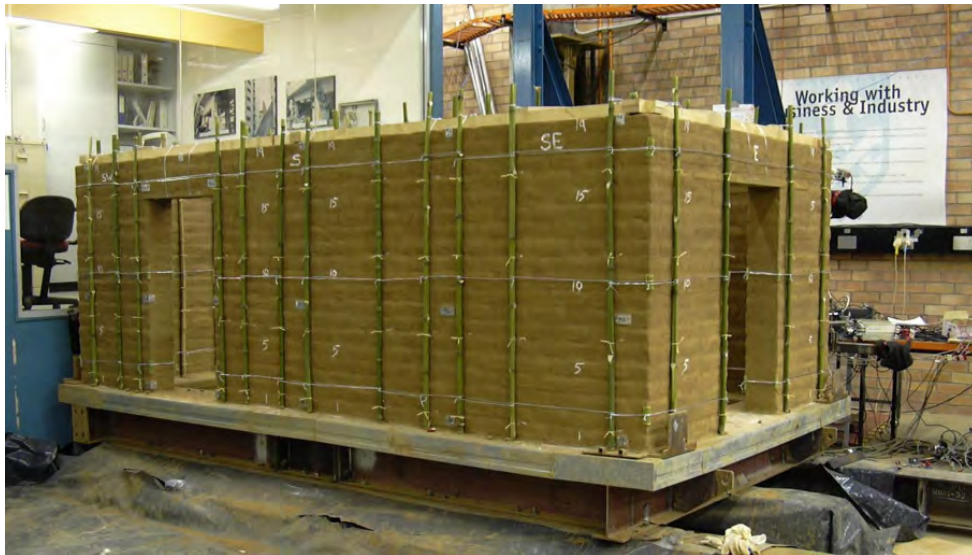
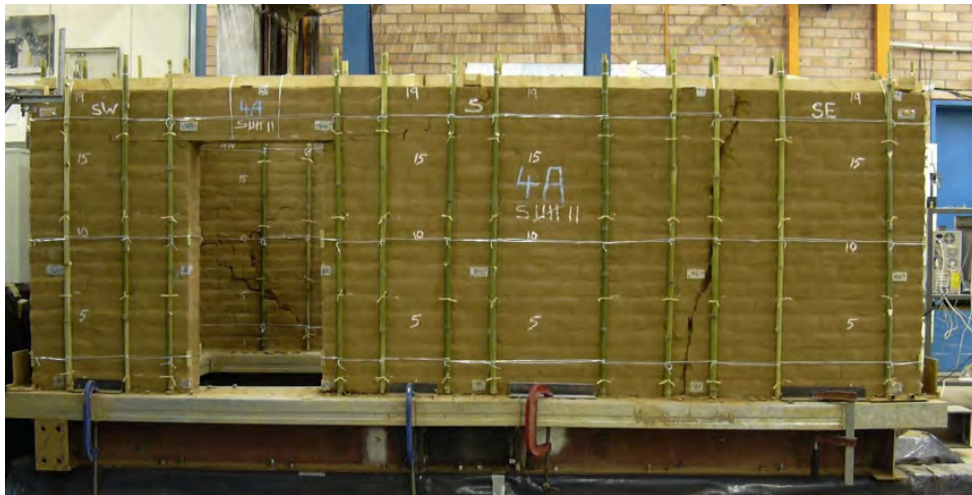
The pictures above show the orientation of the bamboo (used for external reinforcement) as a means to decrease cracking of the wall and out of plane bending. The following application was used as research into seismic strengthening of adobe structures, ultimately used in El Salvador and India. The system above uses chicken wire mesh internally, with polypropylene ties woven through the wall in order to allow for an attachment to the bamboo. The ring beam, lastly, placed on top of the wall attaches the bamboo on either side. The research was based on improving new construction practices, while the purpose of this project would be to adapt these ideas for existing structures.

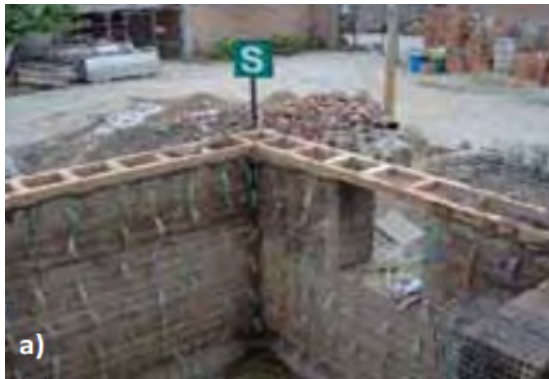
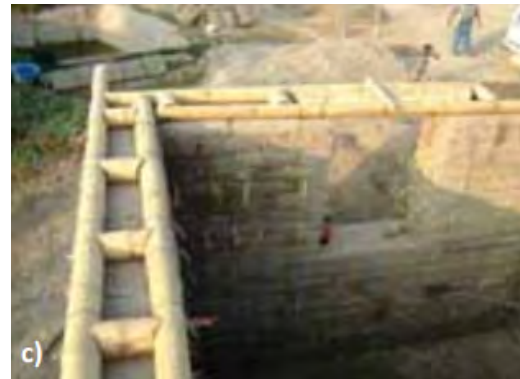
The ring beam, however, would not be a feasible option for retrofitting buildings but would be used more for new construction. The beams in the pictures on the previous page were made of timber, which would be replaced with bamboo because it is easily acquired throughout Nepal.

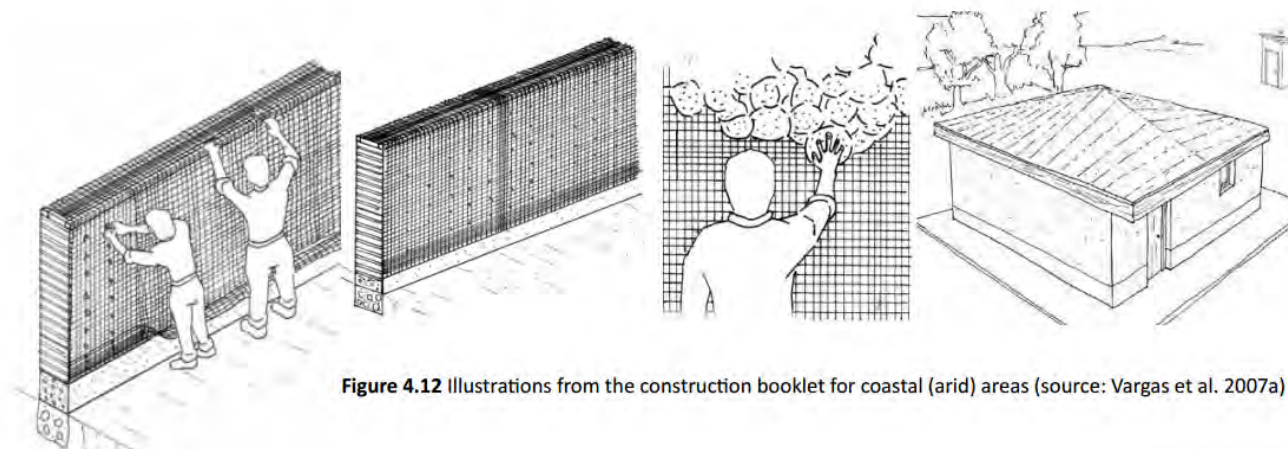
Figure 4.12 Illustrations from the construction booklet for coastal (arid) areas (source: Vargas et al. 2007a)

For the retrofit option, and as a replacement for the ring beam, we propose adding wire mesh (or chicken wire) to specific locations on the adobe walls. These locations would mainly be located at the corners and boundary edges of the walls. Adding wire mesh has shown to be beneficial in testing done in Peru, and performed well during seismic events that had occurred soon after.

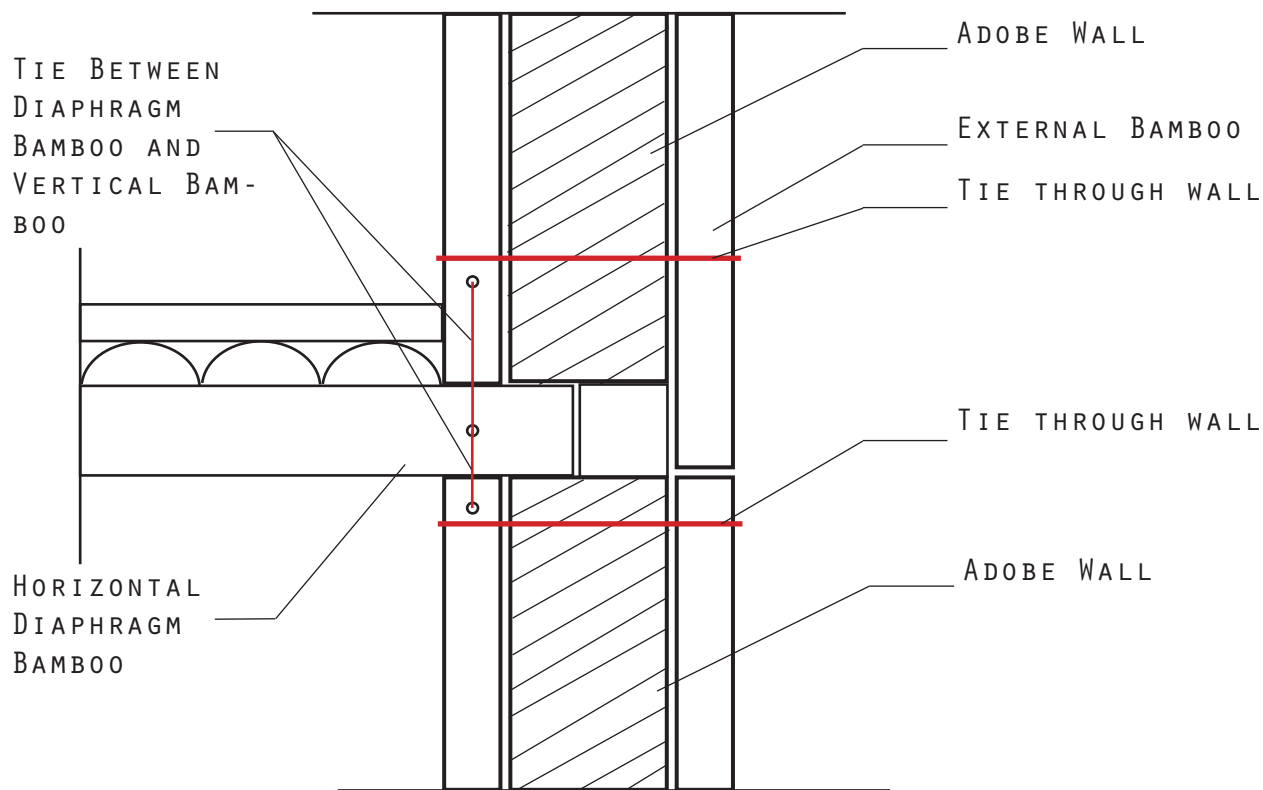
DETAIL : WALL/DIAPHRAGM/BAMBOO CONNECTION NTS

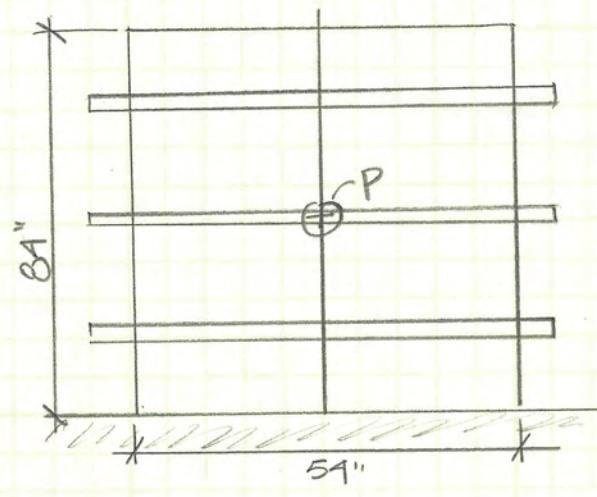
MAXIMUM TESTING FORCE ON WALL:
LOOKING AT 1 FOOT SEGMENT.

ASSUME FRAME APPLIES UNIFORM LOAD ALONG ENTIRE WALL.

$$\text{OUT OF PLANE FORCE} = \frac{P}{(84'')(54'')} = \frac{P}{4536} \text{ \#/in}^2$$
