Fire and Life Safety Analysis of a Regional Office Building

Submitted by: Peter Dwan

California Polytechnic State University, San Luis Obispo

FPE 596 Culminating Experience

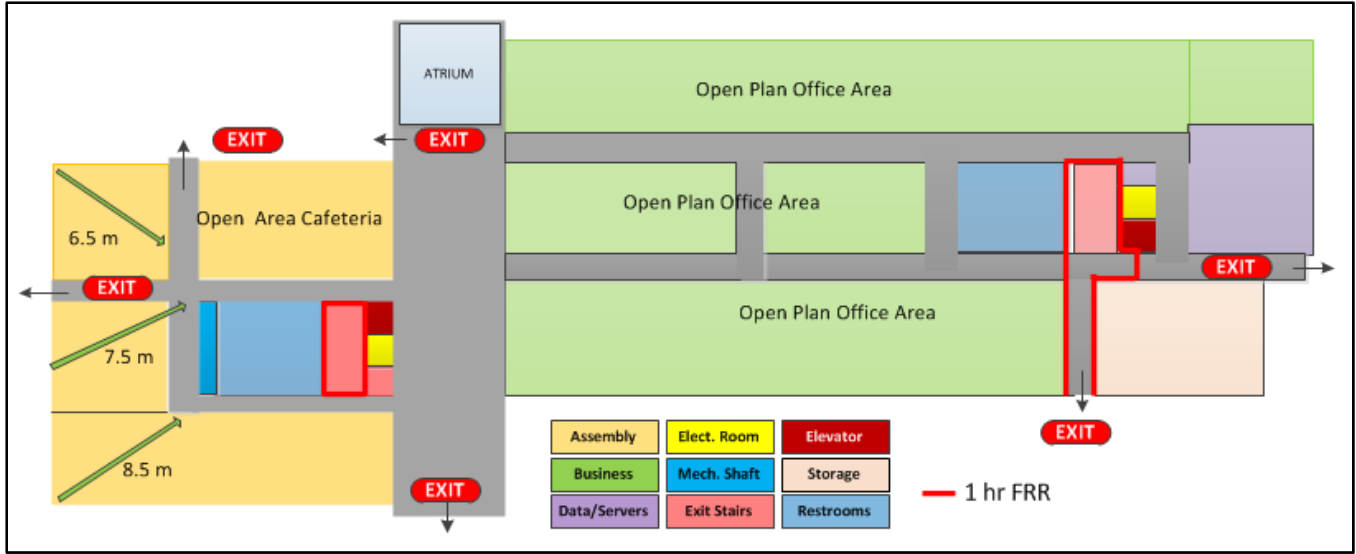
Common travel paths in the Business Occupancy spaces are short due to the open-plan design. The longest common path of travel was found is the Assembly areas on the main and basement floors as shown in Figure 6 and 7 respectively.

Figure 6: Common path of travel on the main floor. Most of the main floor is open plan space with multiple paths to the exits.

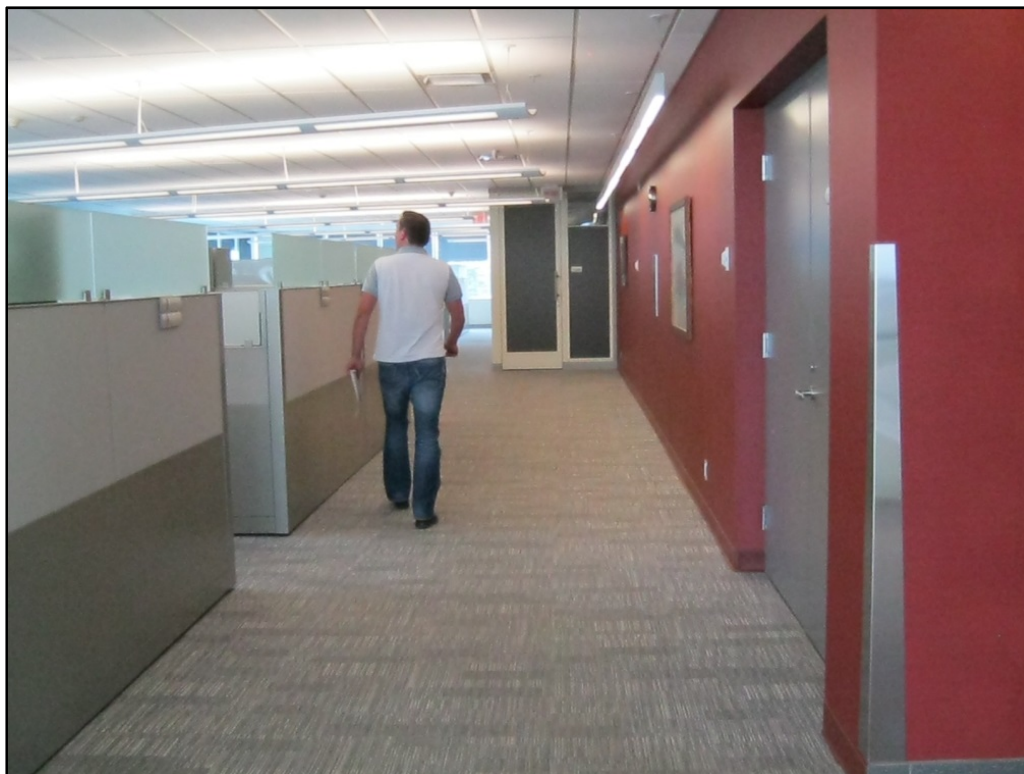
Figure 8: Third floor, 72" wide corridor along the north side of the building.

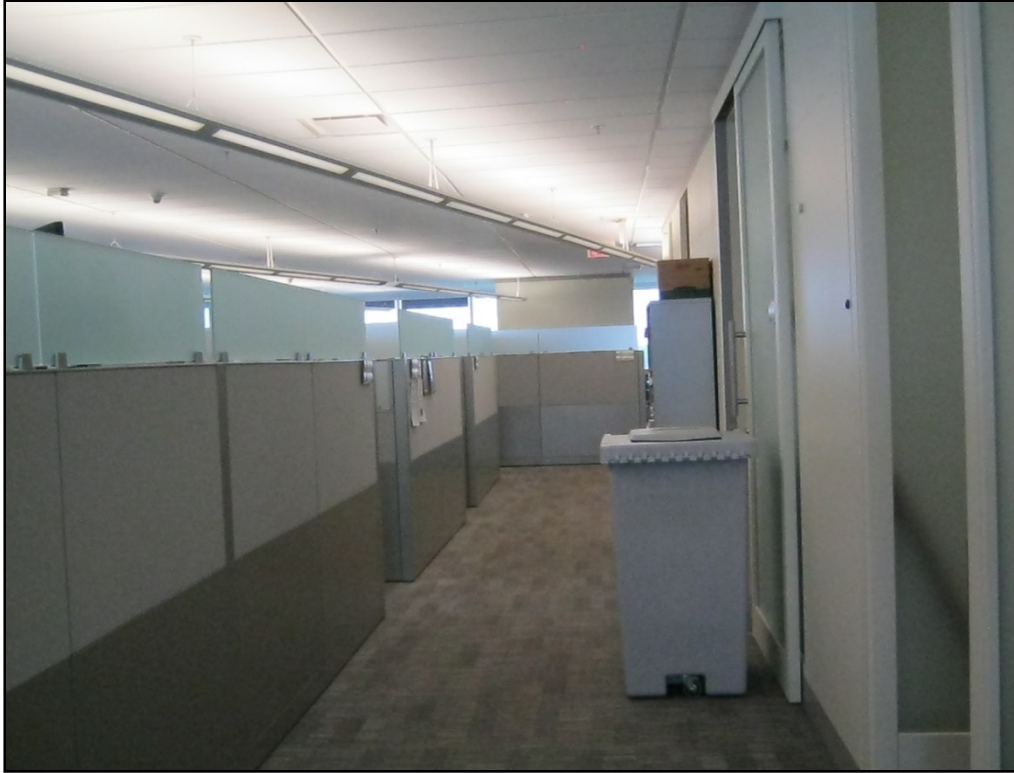
For both Business and Assembly Occupancies, the minimum clear width of corridors serving 50 or more persons shall not be less than 44 in (1120 mm). The project building is designed and constructed with wide corridors which exceed the LSC requirements as shown in Figure 8. However, the building occupants have installed items such as stand-alone shelving and paper recycling bins which reduce the corridor width to less than the prescribed 44 inches in some locations as shown in Figure 9.

Figure 9: Second floor corridor obstructed by the shelving and paper recycling bins

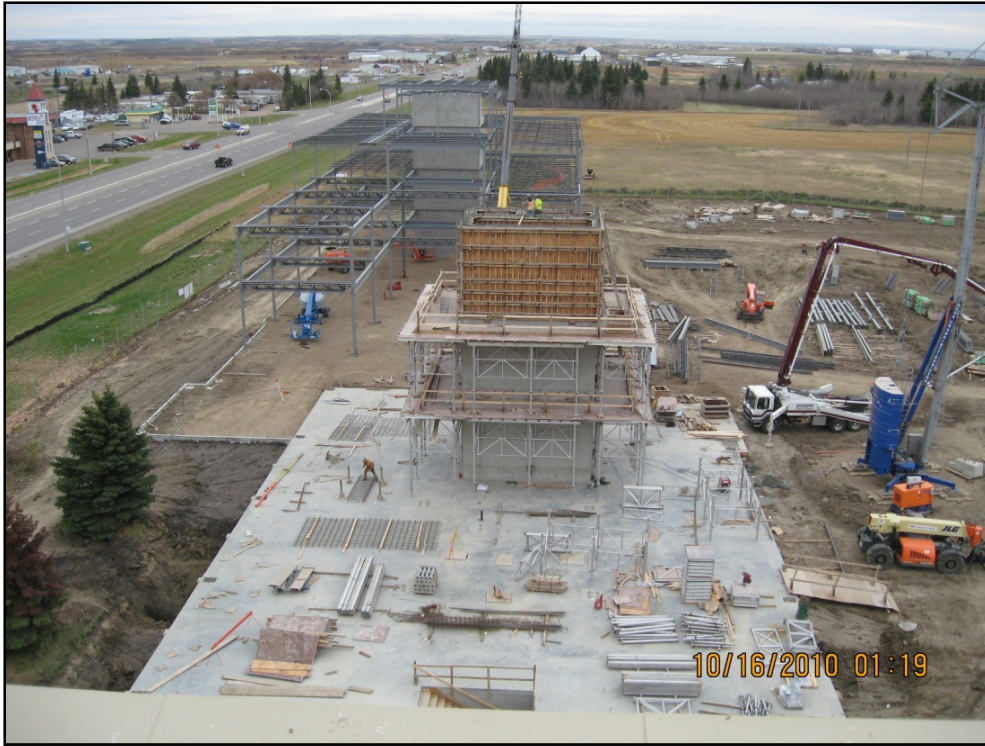
Figure 10: East and west exit enclosures during the project building construction.

Where the occupant load is greater than or equal to 50, the LSC requires more than one exit. This requirement is met throughout the project building. The building provides two exits from each above-grade floor which pass through a protected space (FRR = 1 hr) of the East and West Exit Enclosures; see Figure 10. The Basement is also served by two exits; one which utilizes the West Exit Enclosure and a second leading to a grade level exit which discharges on the west side of the building; see Figure 11.

The Exit Stair Enclosures are constructed of concrete as shown in Figure 10. The interior walls and ceiling finish of the Exit Stair Enclosures are finished with paint only and meets the LSC requirements.

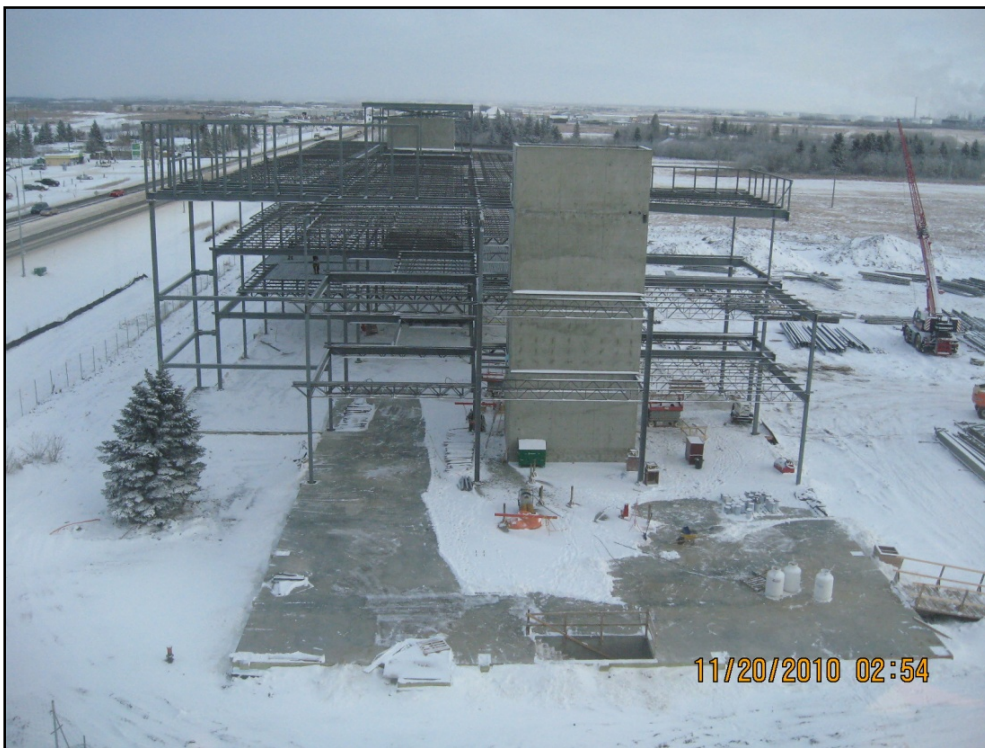
Figure 11: Egress from the basement is via the West Exit Stairway Enclosure or the exit stairs that can be seen passing through the basement roof slab in the foreground.

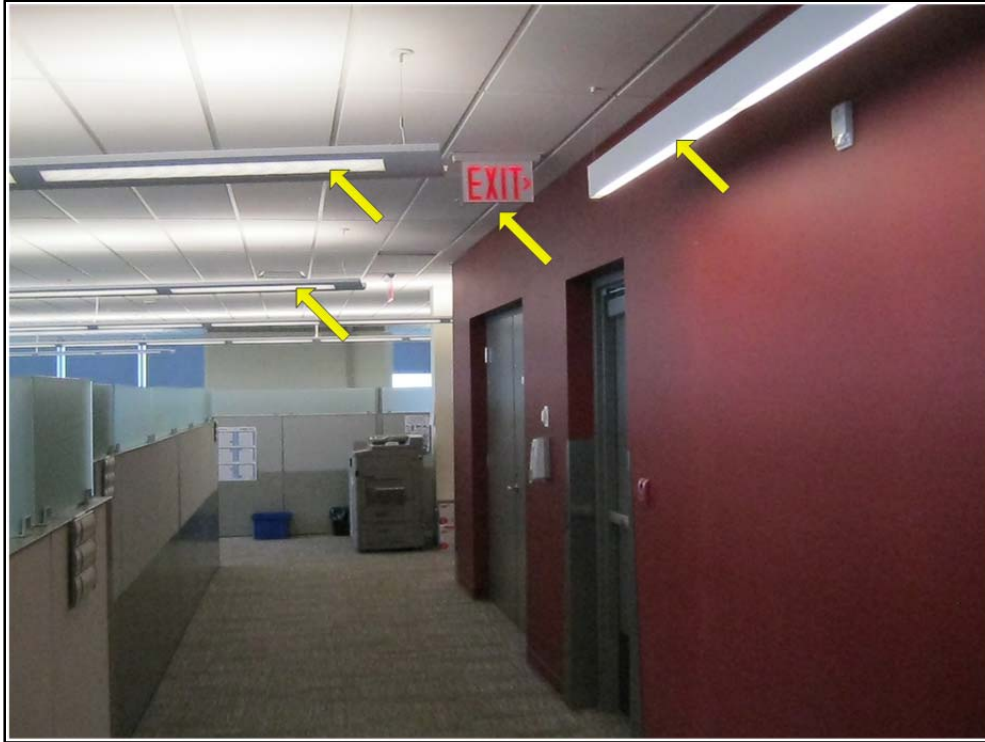
Emergency lighting is provided for all egress paths. The emergency lights are integrated to the rest of the building lighting system. On loss of main power, the end lamps which illuminate egress paths remain on drawing power from an Uninterrupted Power Supply (UPS) located in the Basement; see Figure 13. The UPS specifications and test report are in attached in Appendix 12. The building lighting system is also connected to a backup, diesel generator which starts automatically on loss of main power.

Figure 13: Emergency lighting and exit signs. The devices identified by the arrows remain illuminated following a main power loss by drawing on the building UPS. Only the end lamps above the corridor are on the UPS.

All exits are clearly identifiable as exits, and marked by an approved sign that is readily visible from any direction of exit access as shown in Figure 13. The emergency lighting UPS provides backup power to the exit signs. Horizontal components of the egress path within an exit enclosure are marked by approved exit signs.

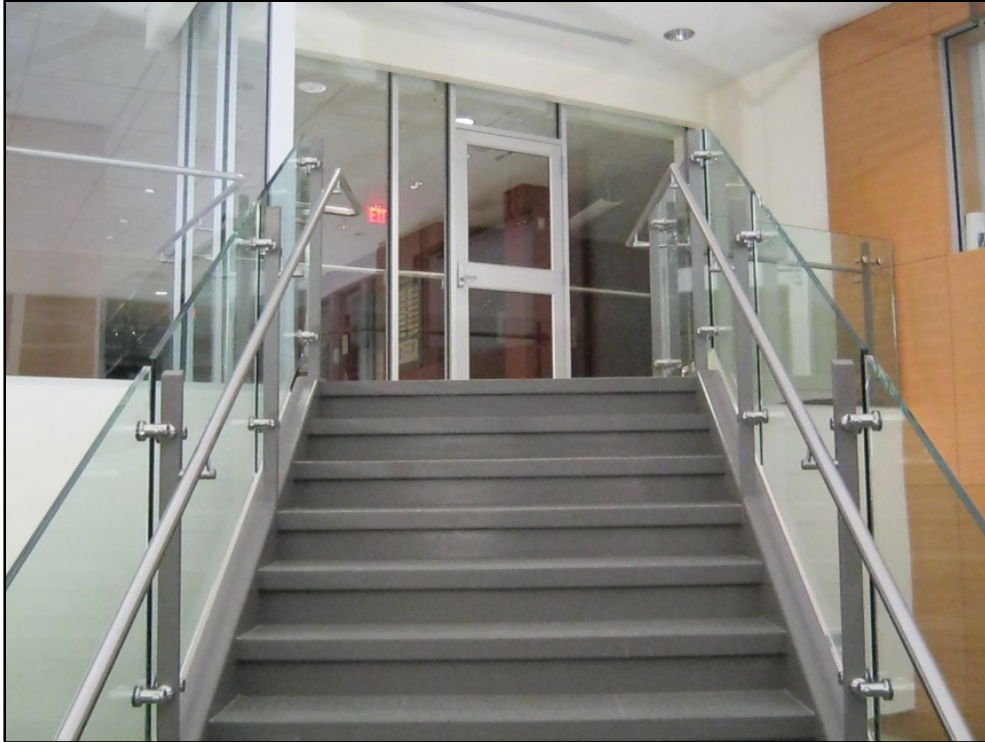
There are three paths by which occupants can leave the building from the third floor, including two fire rated stairway enclosures and atrium stairs. For smoke control purposes, the atrium is separated from the third floor by glass panels and doors as shown in Figure 15. The glass panels and doors are not fire rated however they are protected on both sides by automatic fire sprinklers. Only the east and west fire rated, Exit Stairway Enclosures are included in estimating movement time. The atrium stairs and the east and west elevators were excluded as exit paths.

Figure 15: Atrium stair showing separation between the atrium and third floor office space

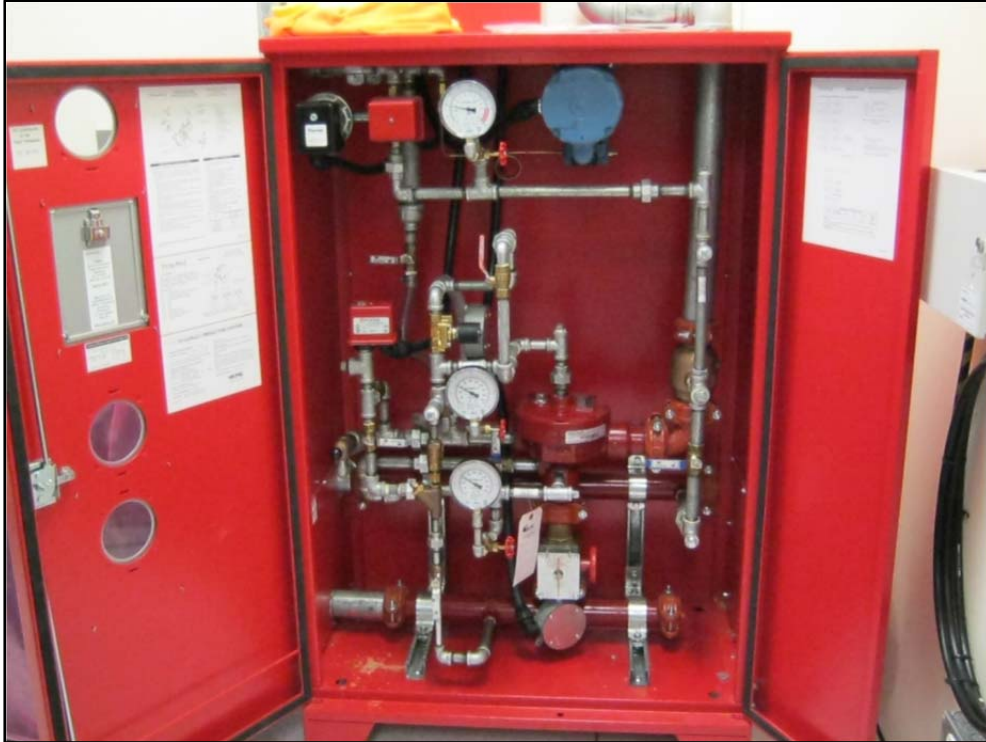
The pre-action system deluge valve, as shown in Figure 16, is controlled by a pneumatic actuator which is normally held in the closed position by system air pressure and a normally closed, electric solenoid. Both the supervisory pressure and the smoke detection system must be relieved before the deluge valve will allow water to fill the sprinkler system.

Figure 16: Preaction deluge valve located in the POP room

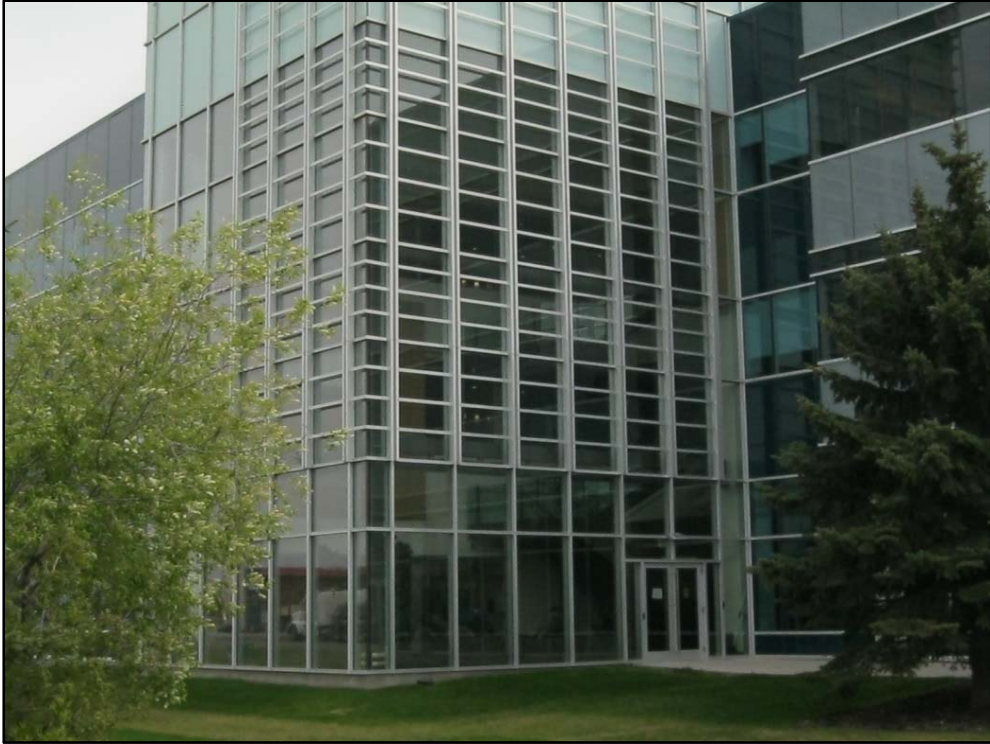
The building includes an Atrium which extends the entire height of the building as shown in Figure 17. The area is protected by special application window sprinklers installed on both sides of the glass panes as shown in Figure 18. The window sprinklers provide fire separation between the Atrium and the offices.

Figure 17: Atrium which extends from the main floor to the full height of the building

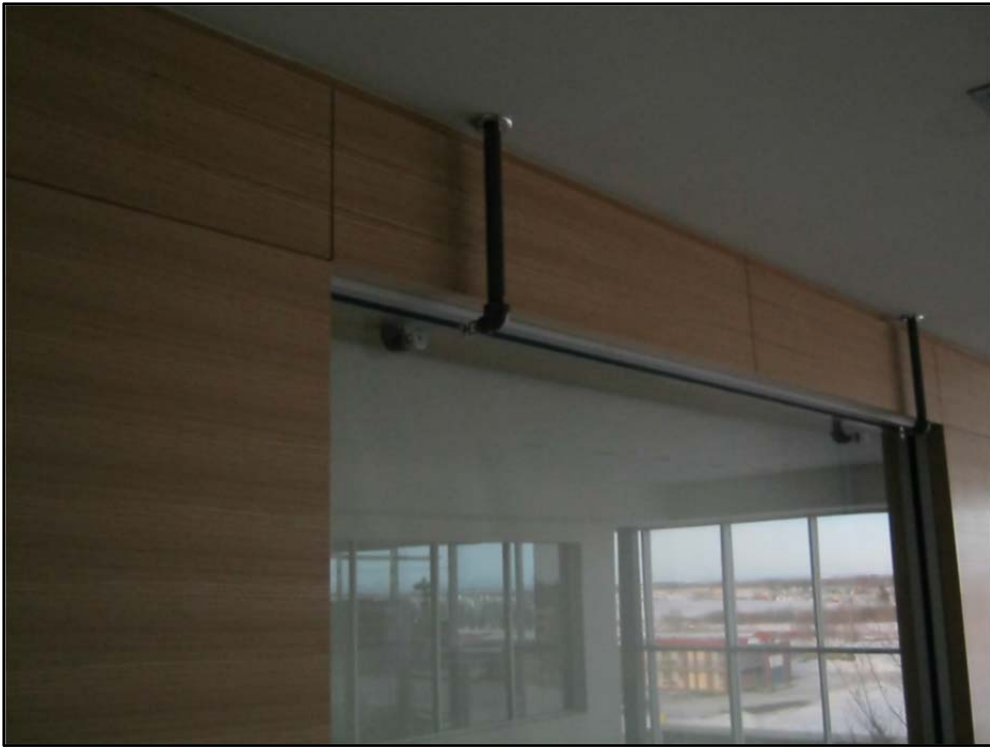
Figure 18: Gazing protection in the atrium space

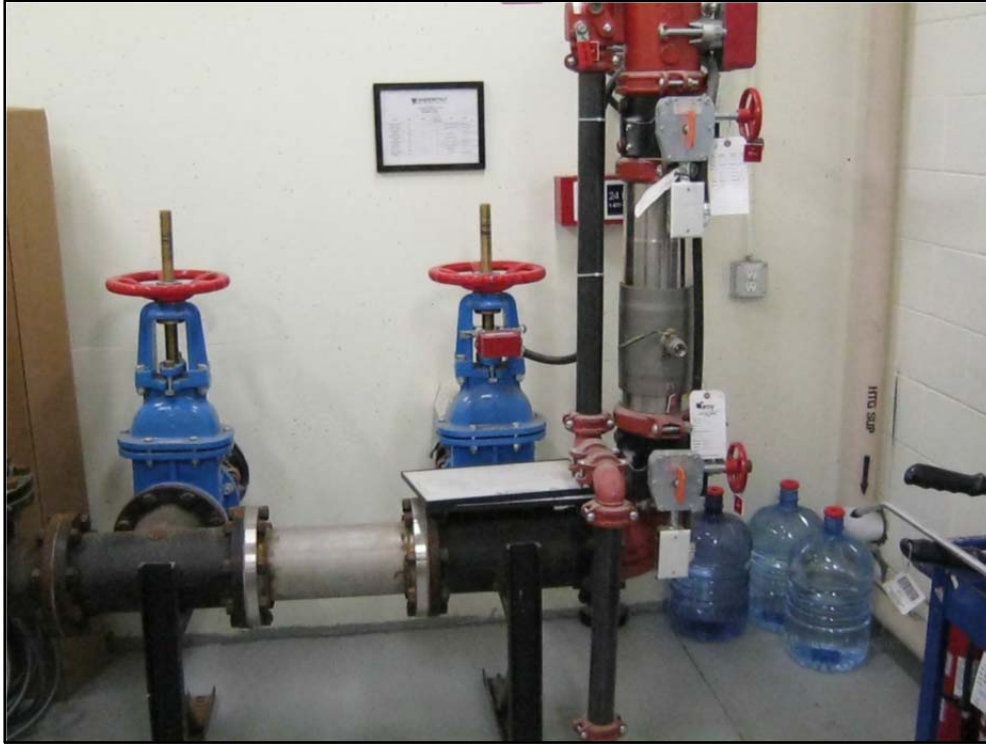
The arrangement of valves and fittings on the main riser is shown in Figure 24. The actual arrangement is shown in Figure 25.

Figure 25: Main water supply arrangement

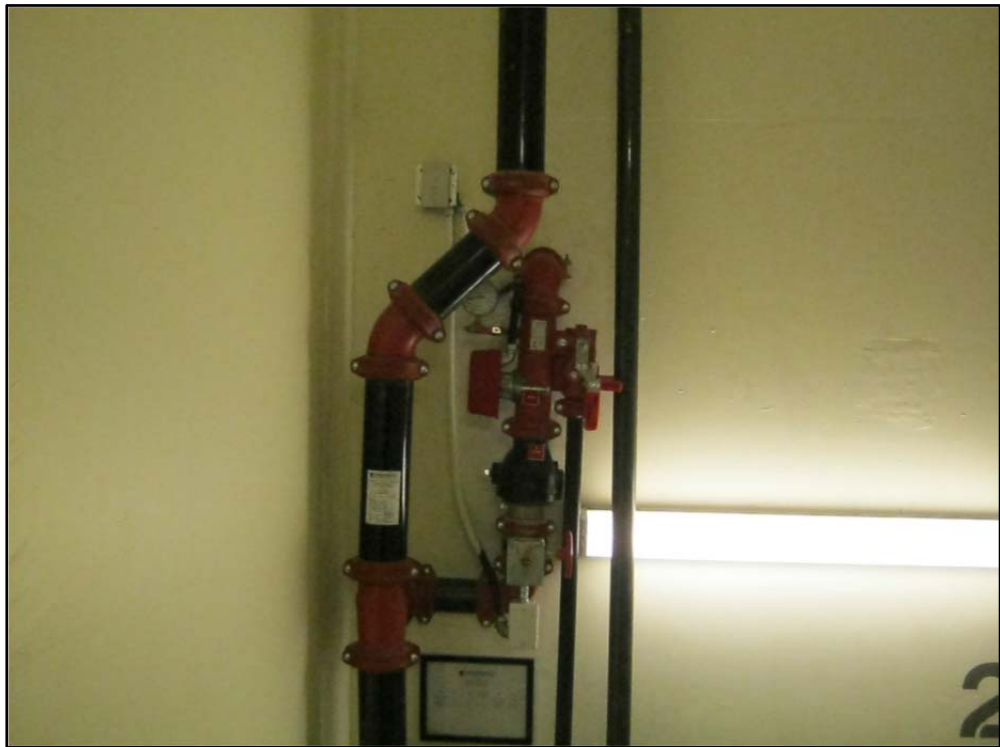
A typical floor control valve arrangement is shown in Figure 26. The actual arrangement is shown in Figure 27.

Figure 27: A typical floor control valve arrangement

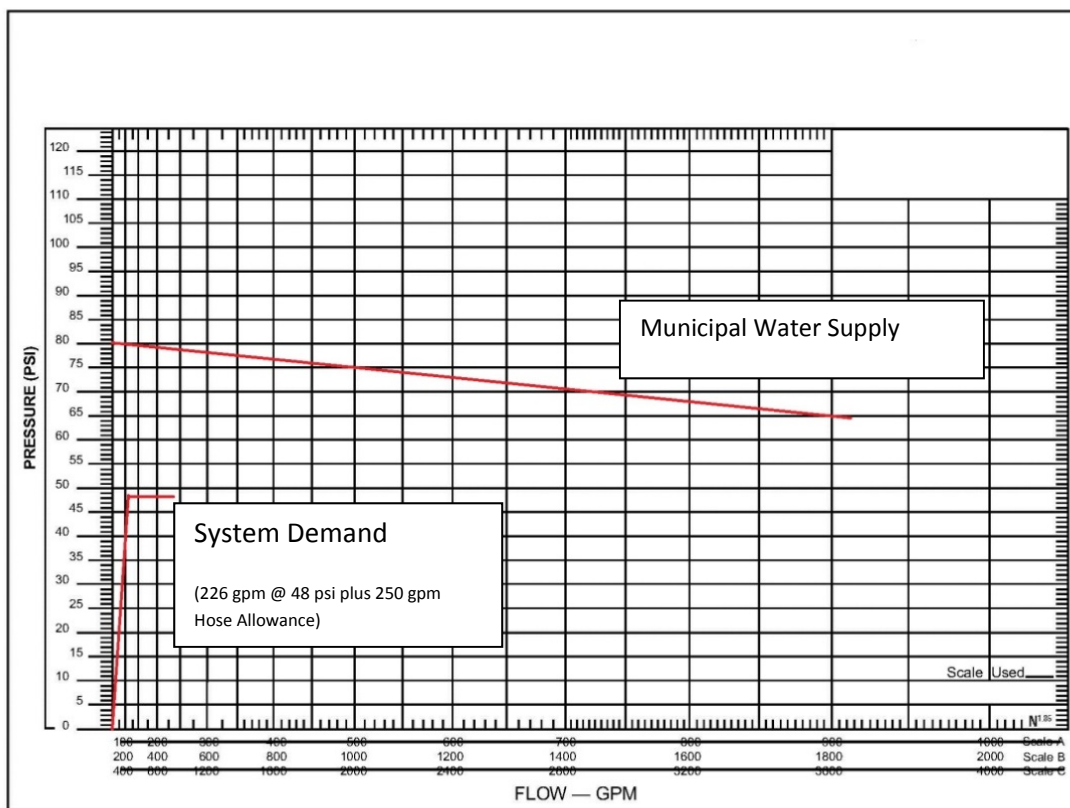
Figure 29: The system demand compared to the available municipal water supply

The area selected for analysis included Sprinklers 1 through 13 as shown in Figure 28. The demand was calculated starting with Sprinkler 1 on Branch Line 1. The flow and pressure was calculated back to the zone control valve. The frictional losses associated with pipe and fitting, along with elevation changes, were taken into account and are summarized in Appendix 28. The analysis revealed that the municipal water supply can meet the system demand as shown in Figure 29.

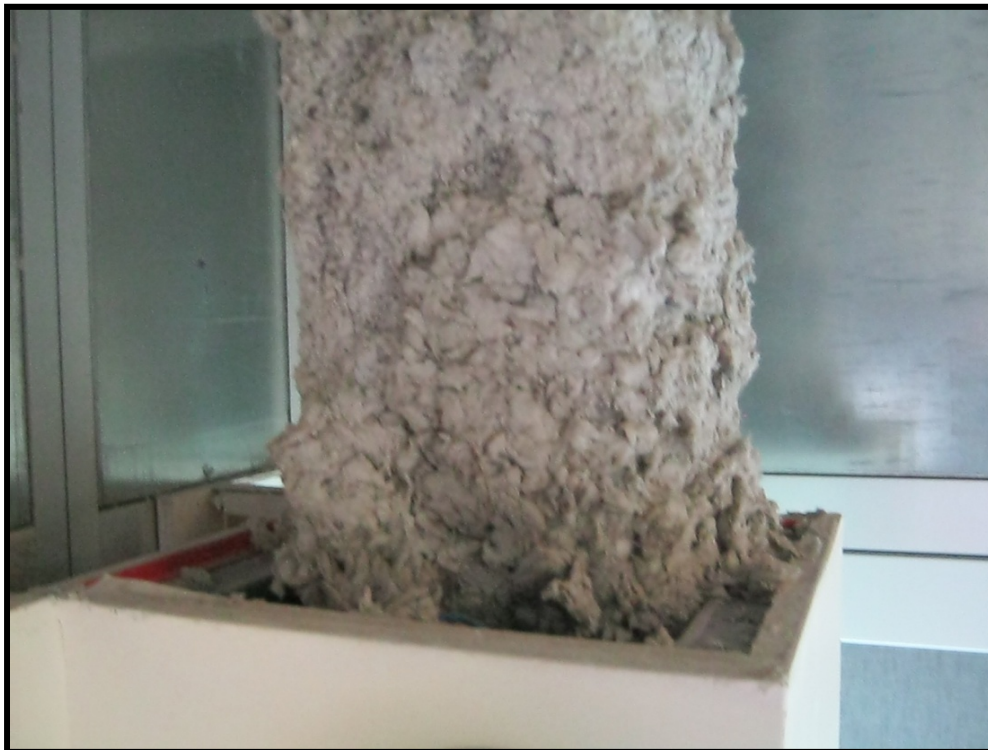
In most cases the fire proofing was not visible due to the installation of drop ceilings and other finishing materials. However the fire proofing was visible in the loading dock area as shown in Figures 37 and 38.

Figure 37: Fire proofing visible above the gypsum wall board applied for esthetic purposes.

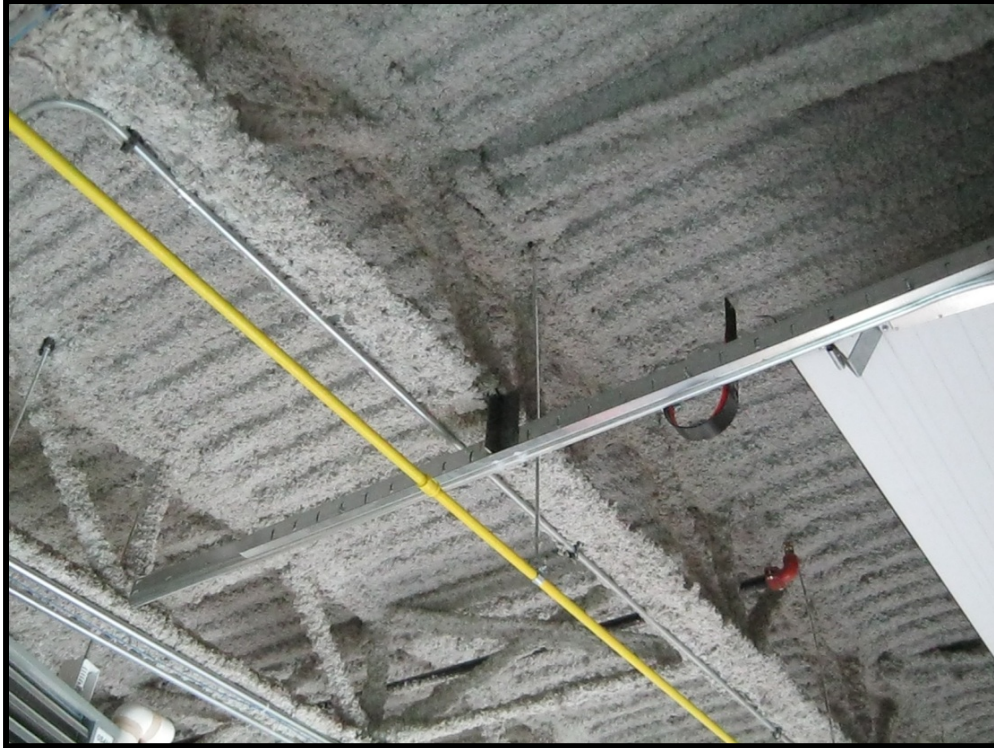
Figure 38: Fire proofing on joists and the underside of the floor assemblies

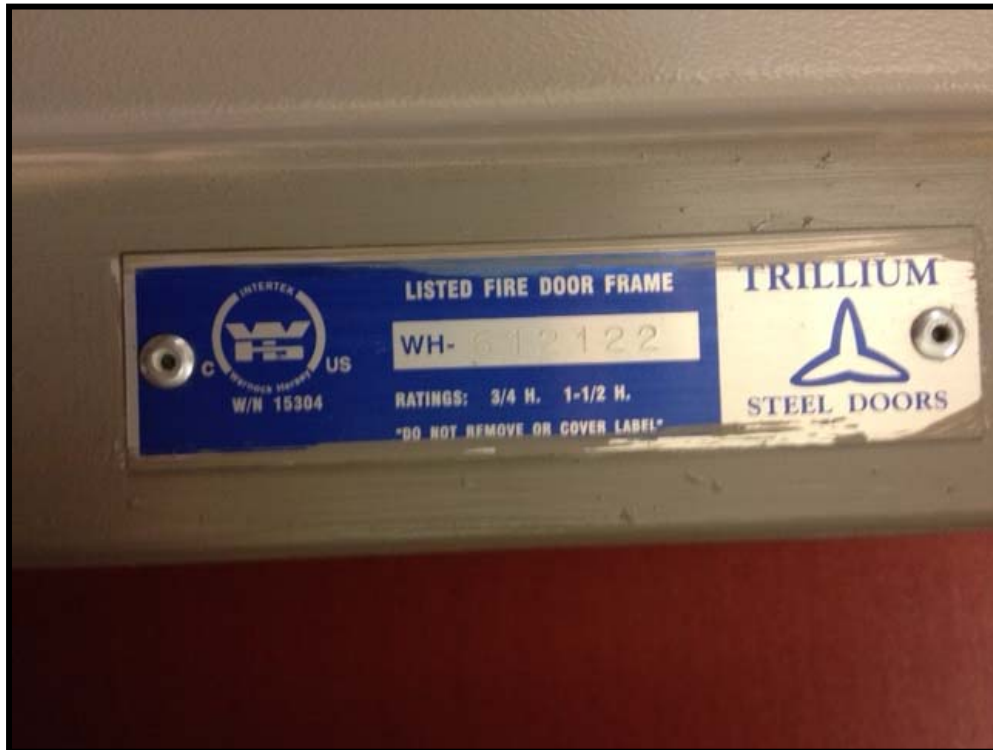
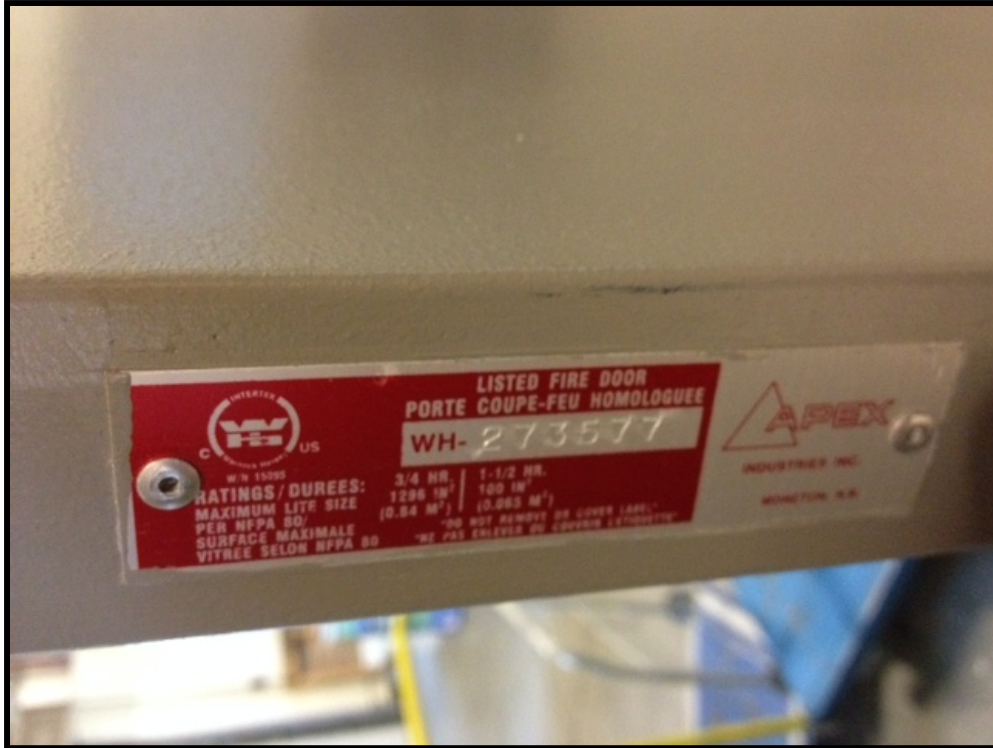
The building is equipped with fire rated, interior doors as required by Code. (LSC- 08-11.00); see Figures 40 and 41.

Figure 40: Fire rated door certification

Figure 41: Fire rated door certification

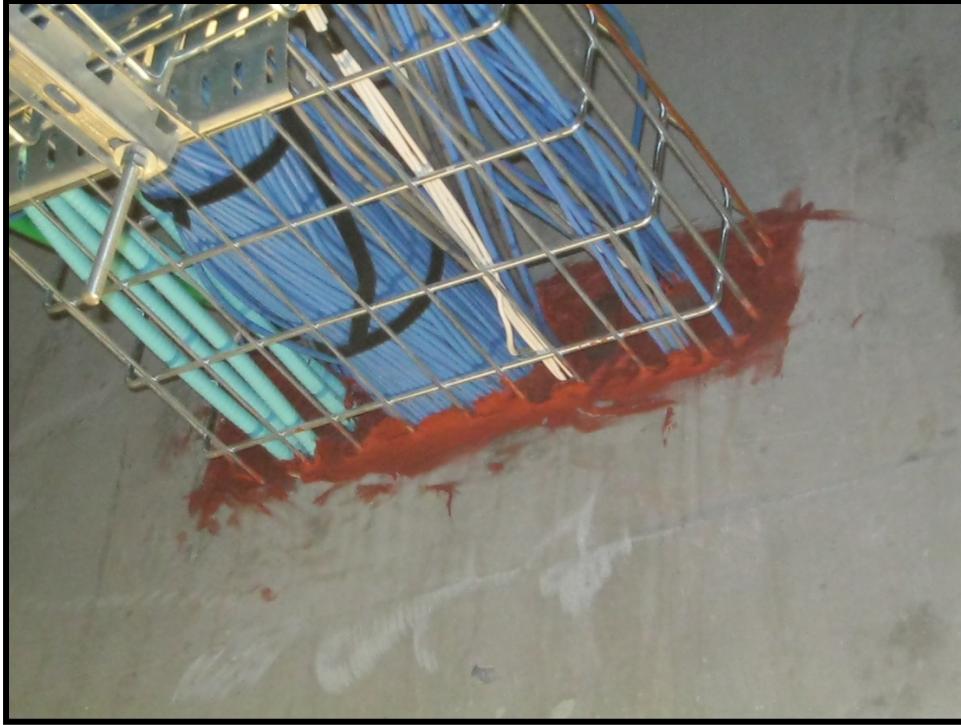
Various products were used to limit fire spread through penetrations as shown in Figures 43, 44 and 45. The fire stop used on the cable tray and piping penetrations was 3M Fire Barrier Sealant CP 25WB which is a latex based, intumescent sealant; see product specifications in Appendix 37. A self-leveling silicone sealant manufactured by Hilti was used on the floor penetrations as shown in Figure 45. The product specifications are included in Appendix 38.

Figure 43: Typical cable tray wall penetration showing typical application of fire-stop material.

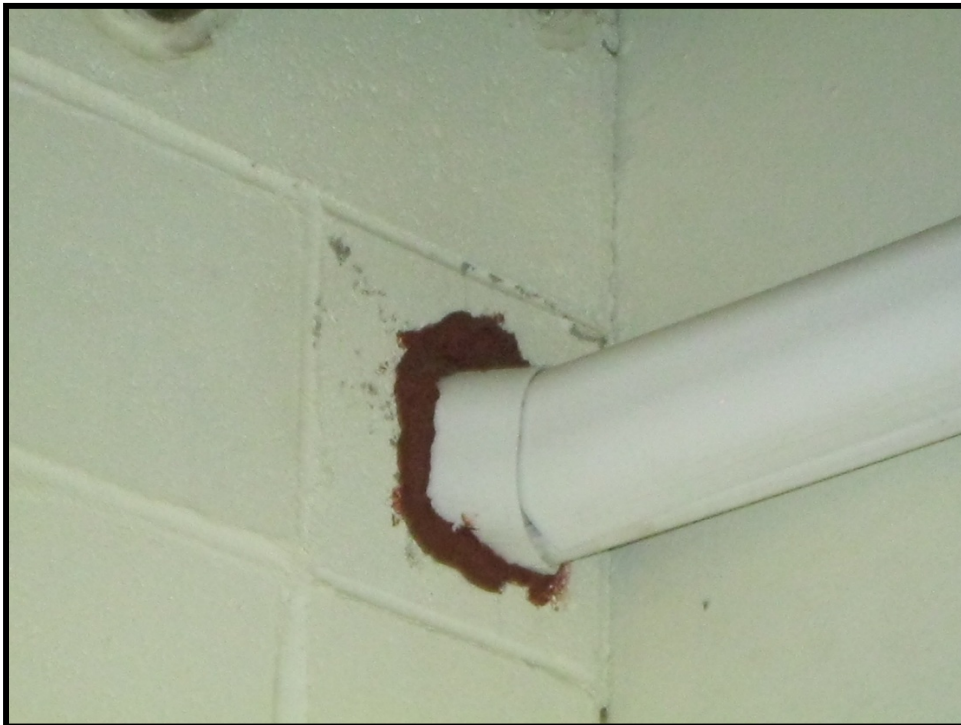
Figure 44: Typical wall penetration by pipe

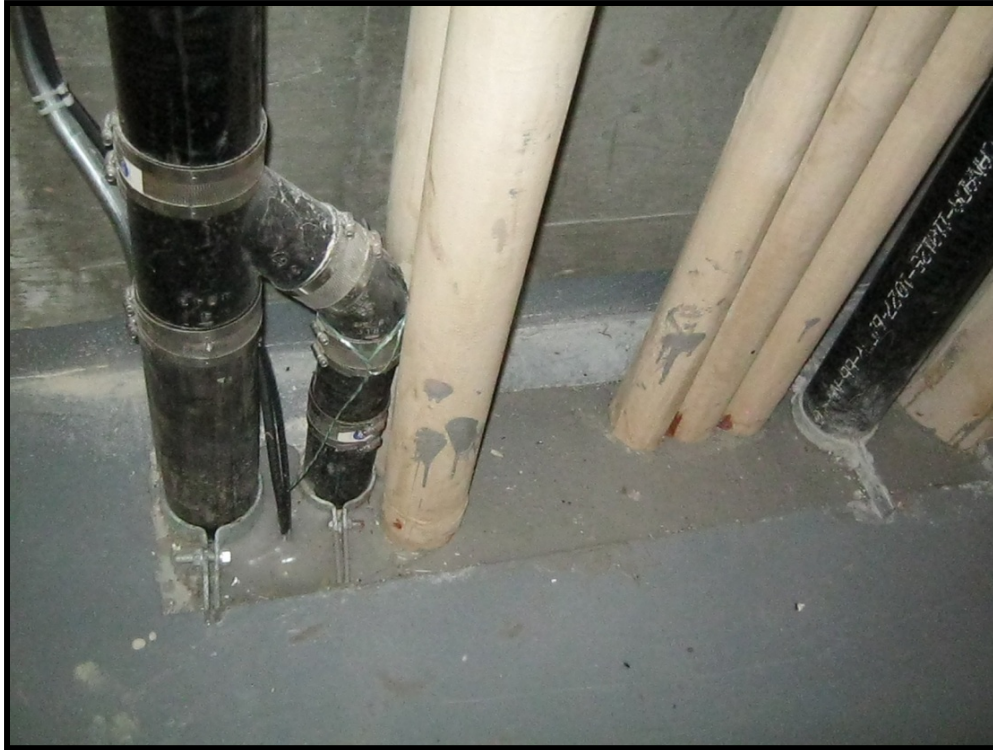
Figure 45: Typical floor penetration

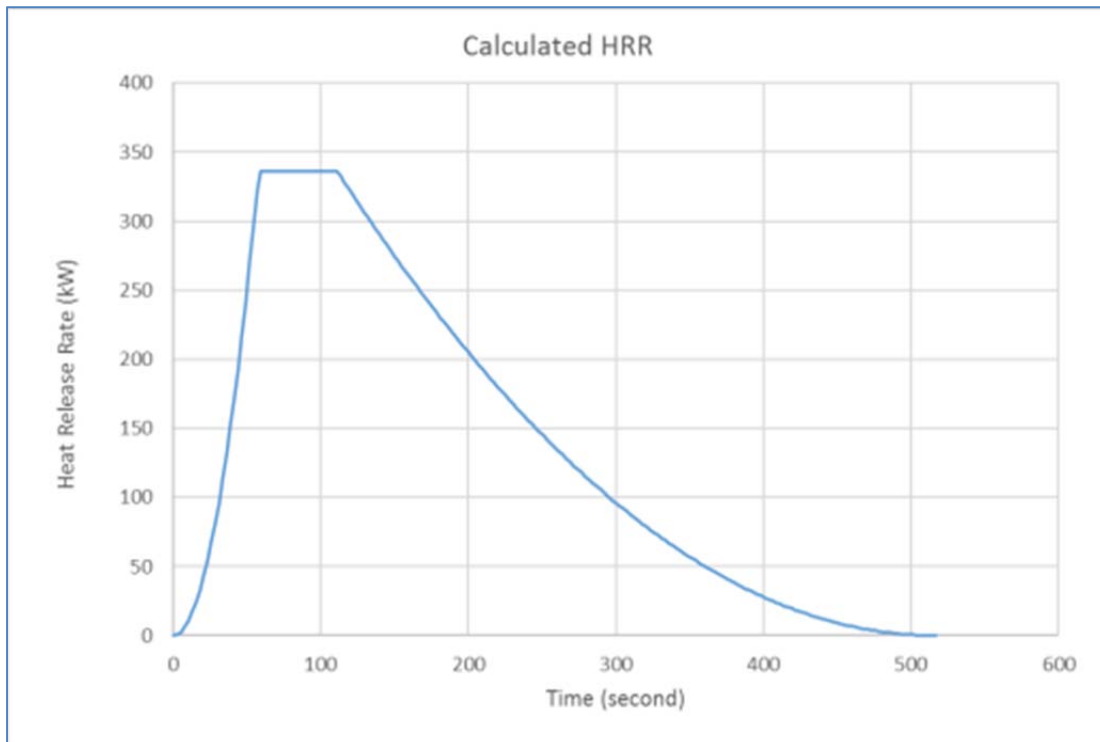
Figure 47: Heat release rate from trash bag fire.

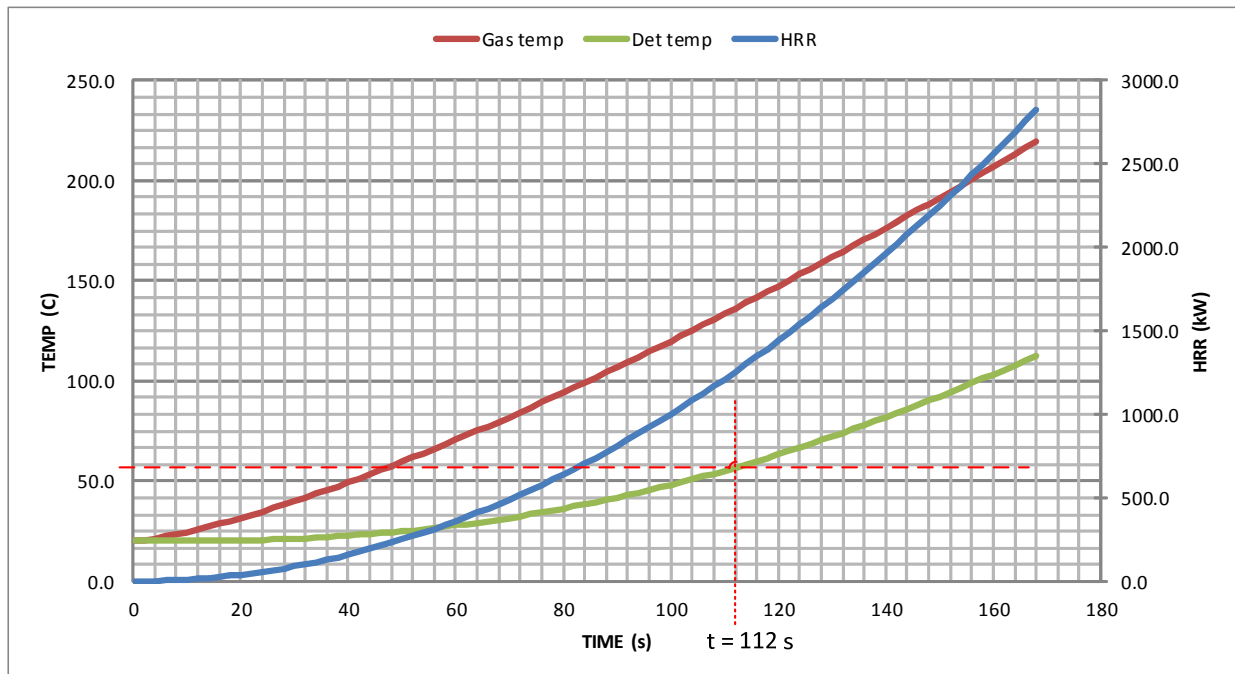
Figure 66: Output from the DETACT model indicating sprinkler head activation at approximately 112 s.
