Irrigation Efficiency of Santa Rosa Island Cloud Forest Restoration Project

Rebecca Bernard¹, Kathryn McEachern², Ken Niessen³

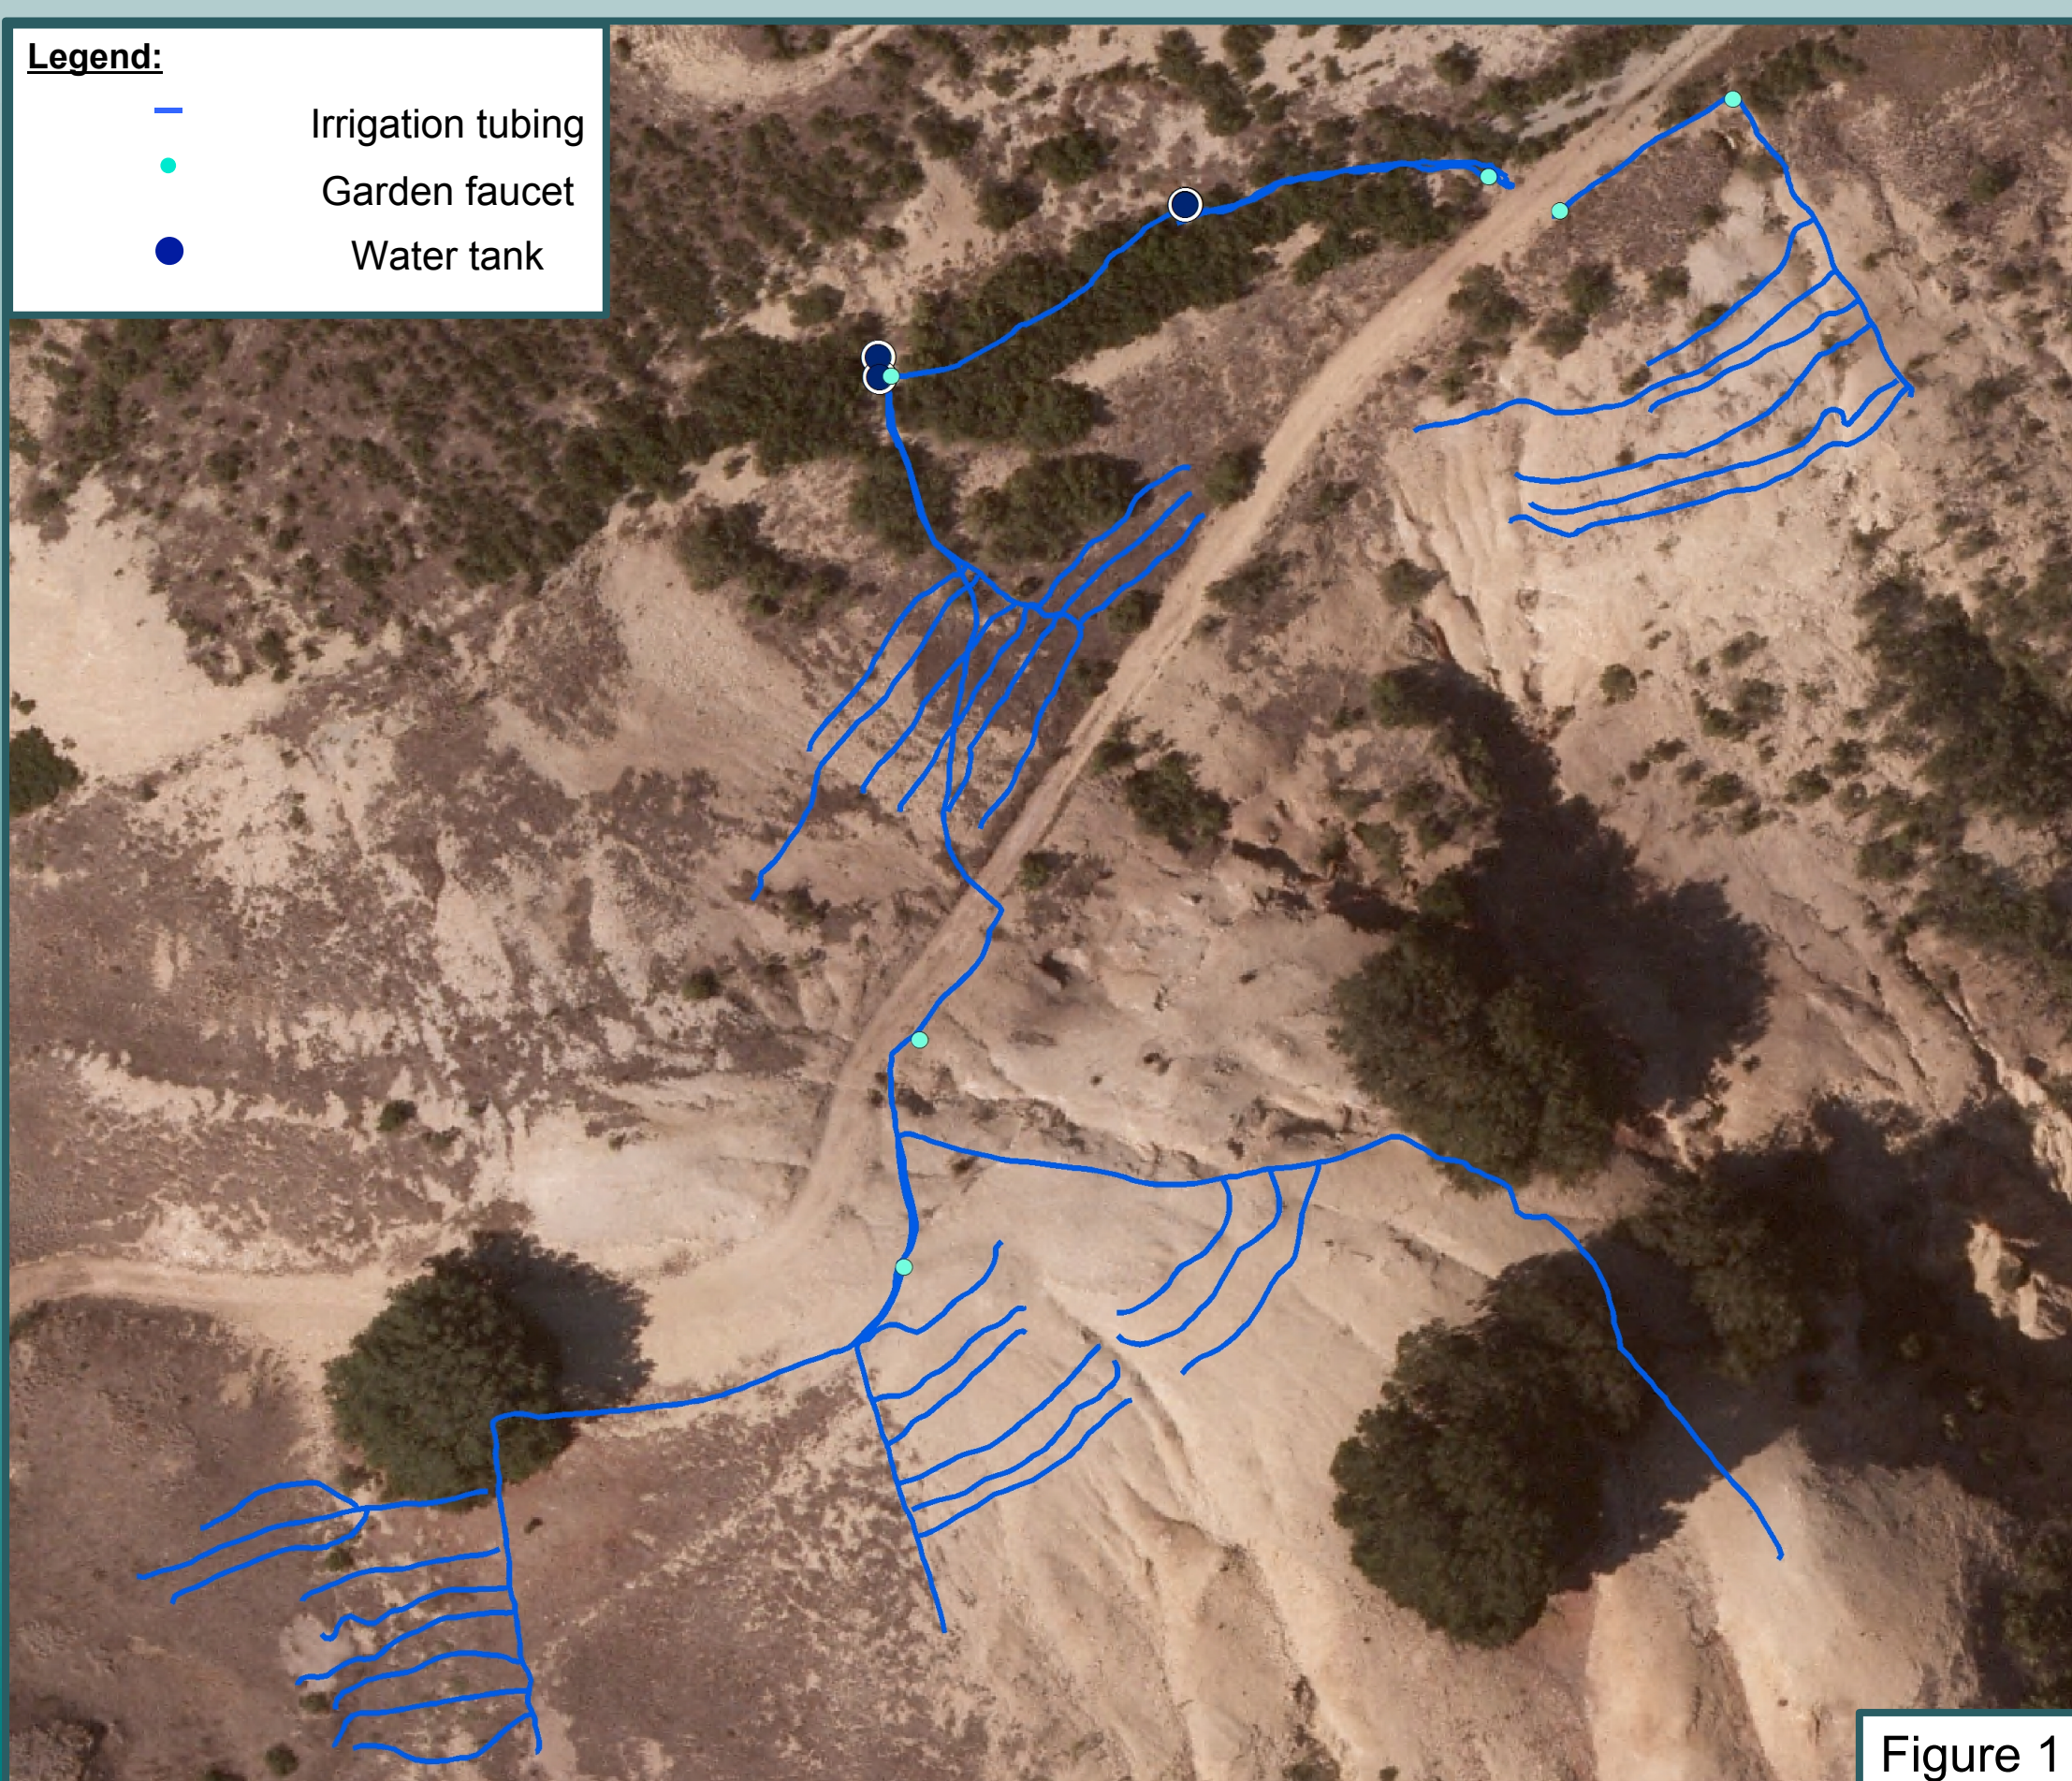
Figure 1

Legend:
— Irrigation tubing
● Garden faucet
● Water tank
