LOWER SCOTTS CREEK FLOODPLAIN AND
HABITAT ENHANCEMENT PROJECT

A Thesis
presented to
the Faculty of California Polytechnic State University,
San Luis Obispo

In Partial Fulfillment
of the Requirements for the Degree
Master of Science in Forestry Sciences

ABSTRACT

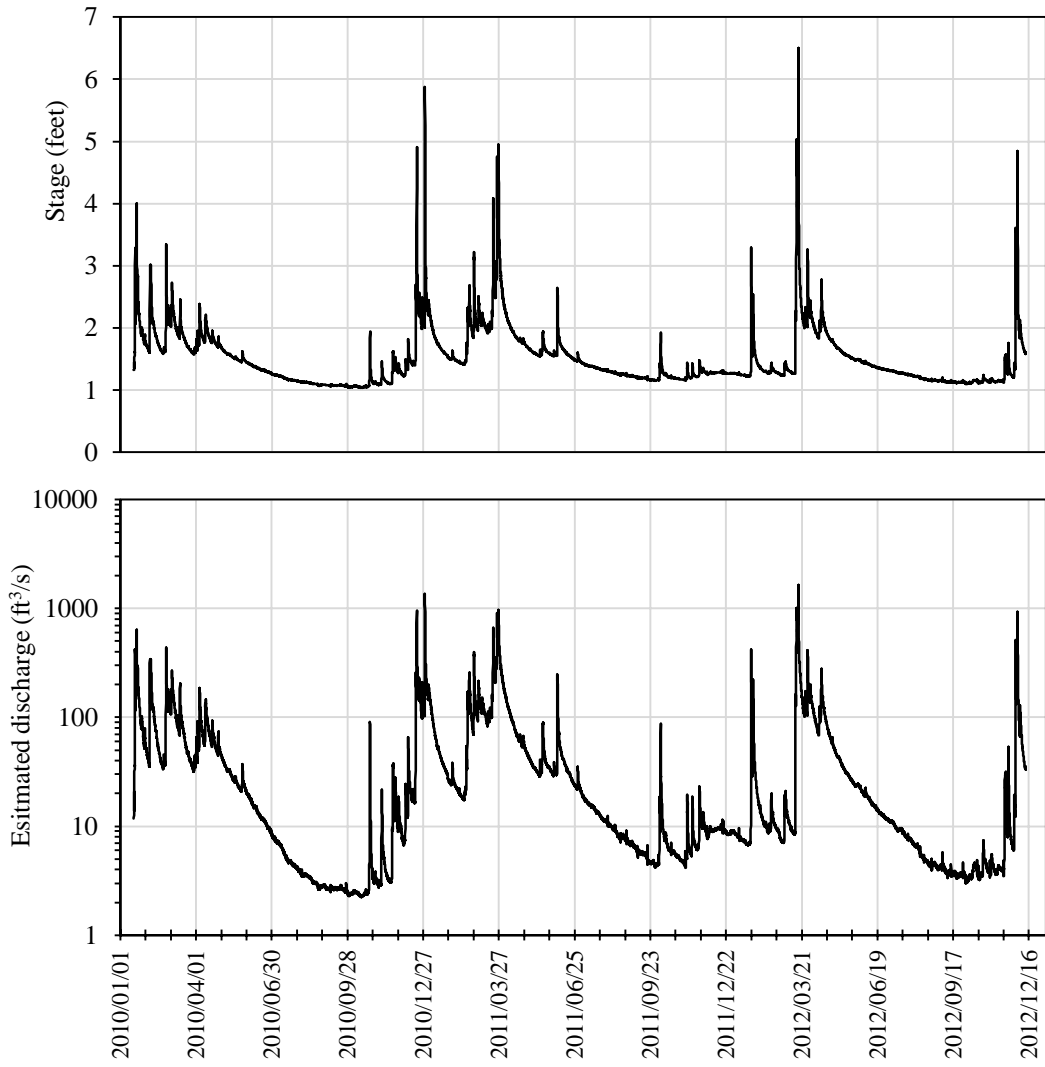
Figure 2. Stage (top) and estimated discharge (bottom) hydrographs for lower Scotts Creek below Archibald Creek from 1/17/2010-12/12/2012.

The bankfull discharge in lower Scotts Creek is estimated to be ~1000 ft³/s with a mean velocity of ~5 ft/s. Recent summer low-flow depths in riffles have been typically <0.5 ft with flow rates <10 ft³/s and velocities of ≤1 ft/s (J. Louen, personal communication, 3/27/2014). In addition to manual flow measurements, a stream gage records continuous stage data near the confluence with Archibald Creek at station 5700. A rating curve is used to estimate discharge on stage. Stage and discharge hydrographs for 2010-2012 show typical seasonal flow cycles (Figure 2). For the period of record represented below, Scotts Creek flowed at 0-20 ft³/s (summer low flow) for 58% of the time, from 20-200 ft³/s (winter base flow) for 38%, and above 200 ft³/s (high flow) for 4% of the time (Figure 3). Major flood events occurred recently in 1998, 1999, and late in December 2012.

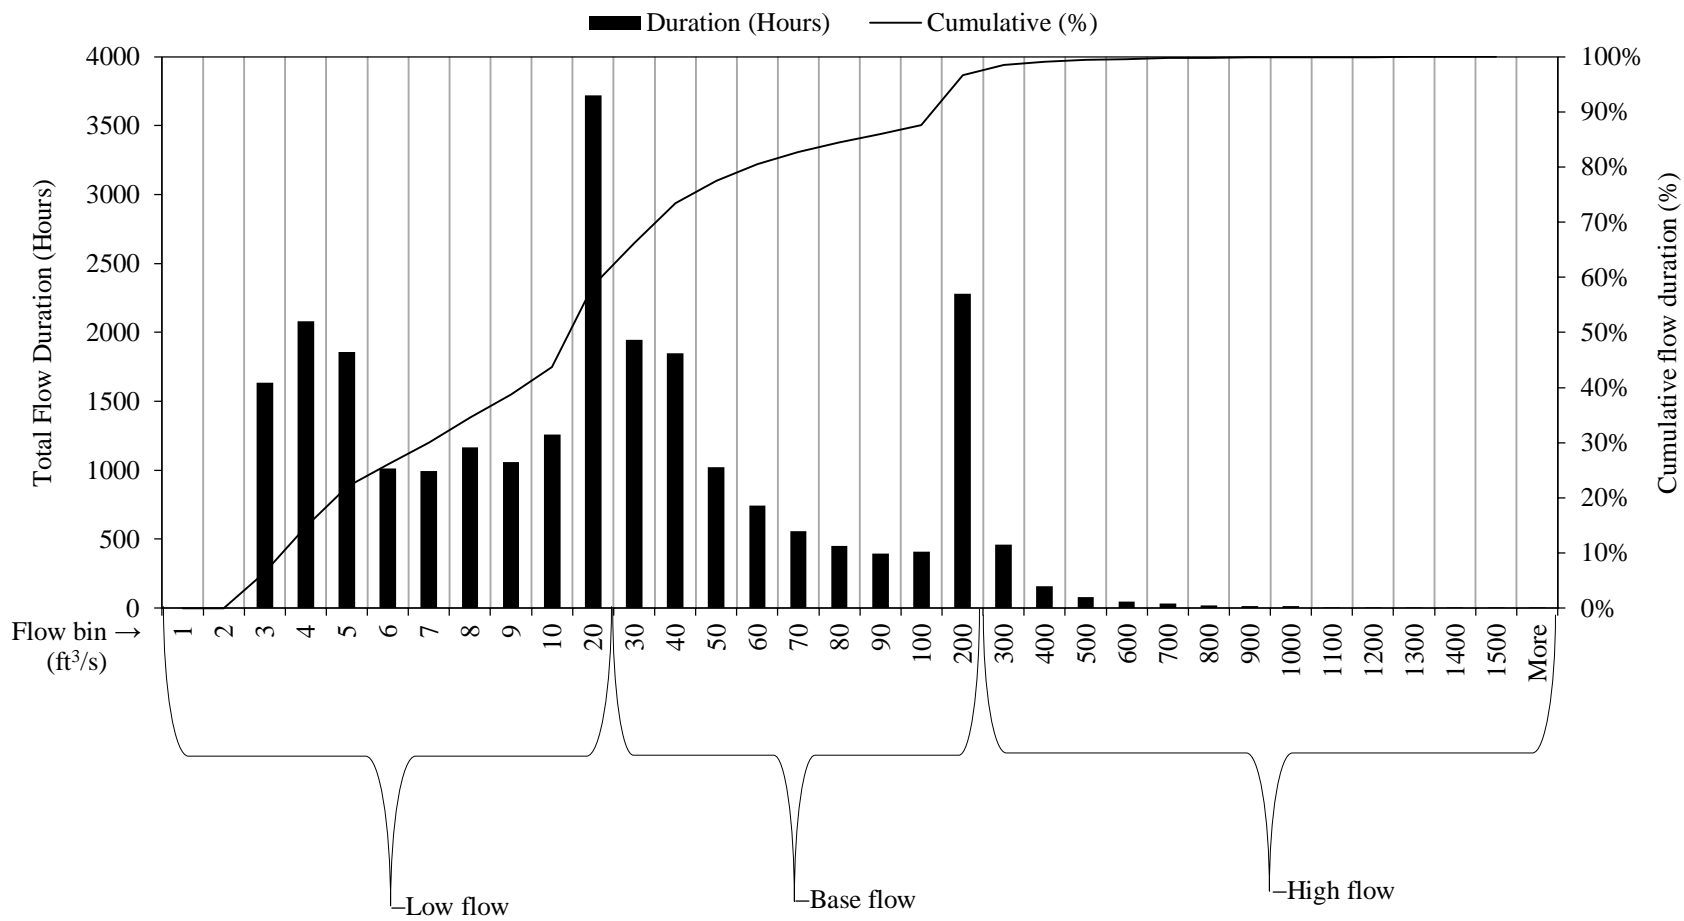
Figure 3. Flow histogram with flow regimes for the Scotts Creek stream gage below Archibald Creek for 1/17/2010-12/16/2012.

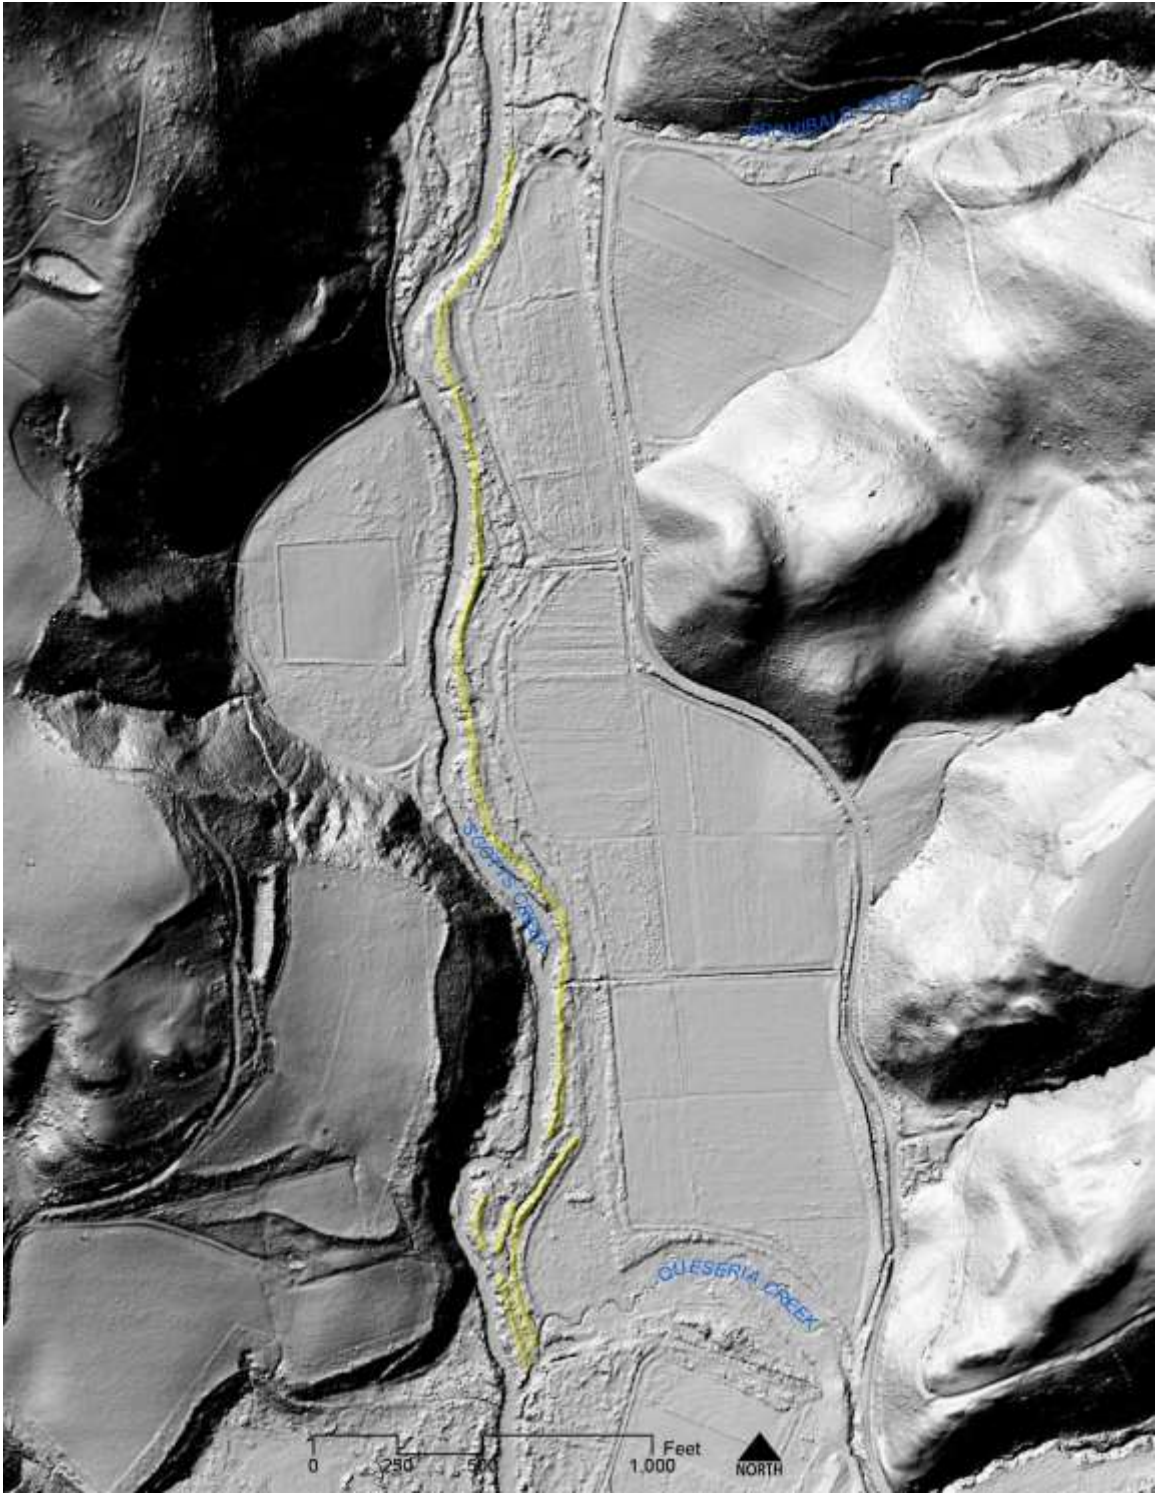
Figure 5. Hillshade view of lower Scotts Creek showing deteriorating levees (highlighted in yellow) along the left bank.

channel to maximize the area of crop fields (Rowley 2003). Scotts Creek was straightened and dredging was performed to maintain the straightened channel. Levees were constructed in the late 1938/9 on both sides of the stream to channel flow through the CA-1 Bridge opening. The United States Army Corps of Engineers (USACE) constructed additional levees and revetments along the lower crop fields beginning in 1956 (Figure 5). Portions of the streambanks were armored with steel vertical piles linked together with steel cable and welded wire fence. USACE continued to dredge the stream channel and maintain the levees through 1982 (Rowley 2003). Wood was historically removed from the lower Scotts Creek stream channel (County of Santa Cruz 1982).

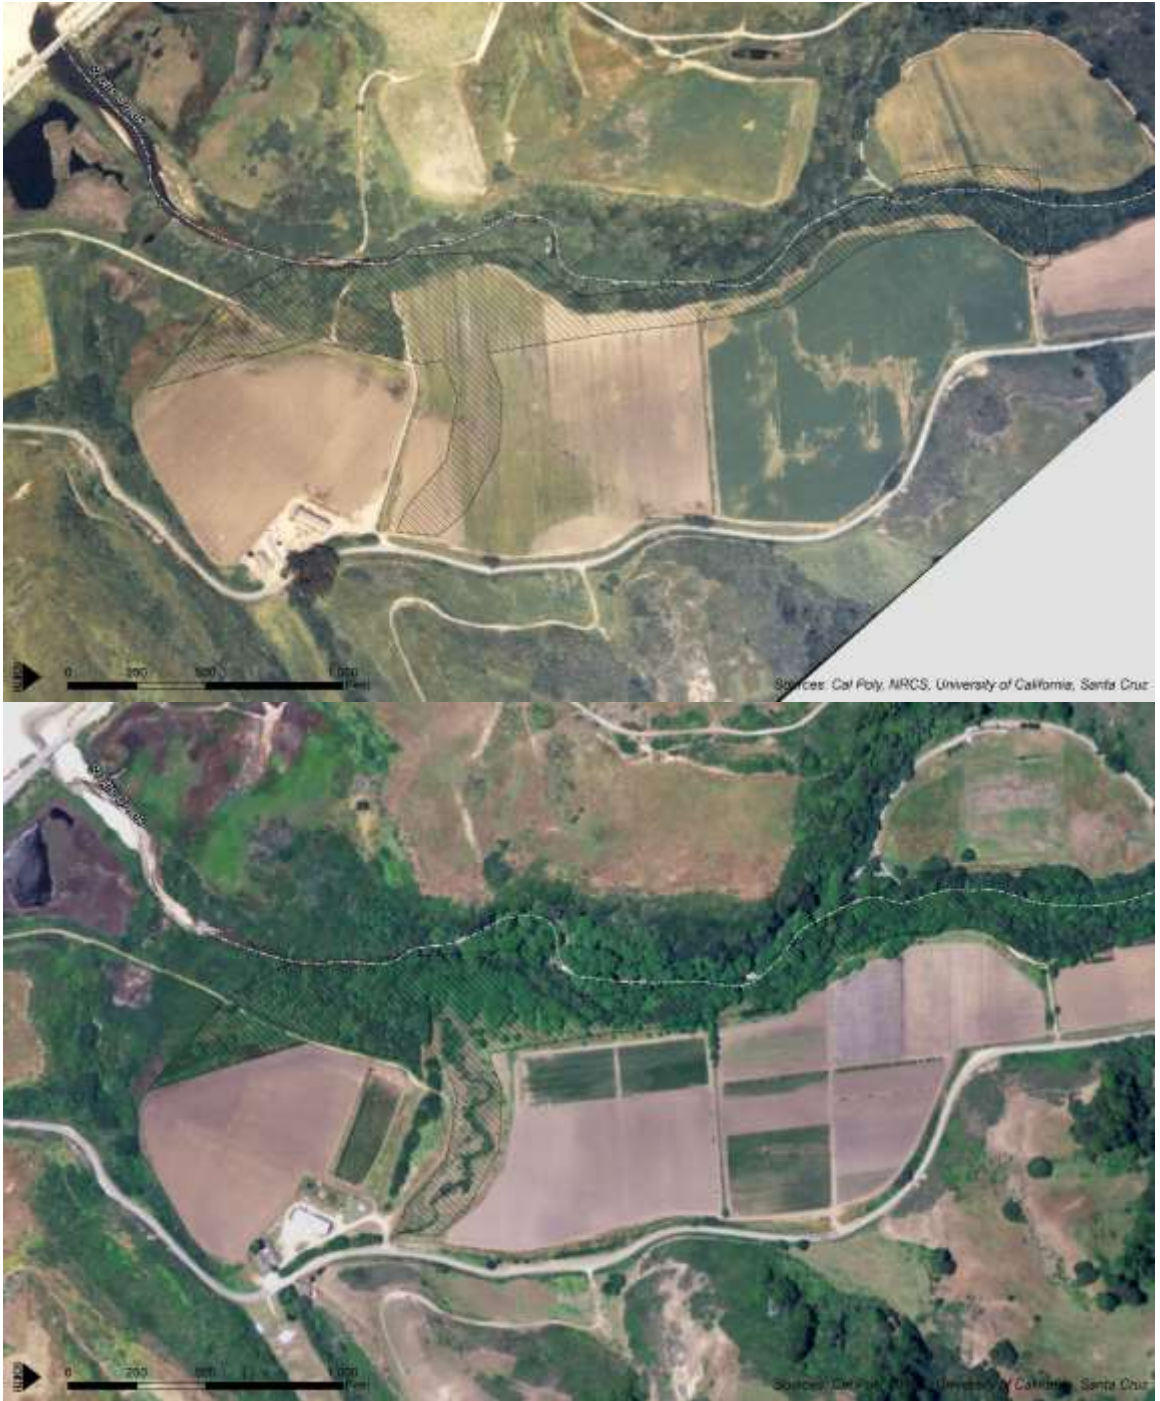
Figure 6. Orthographic aerial images of project reach showing regeneration of riparian vegetation from 1993 (above, representative of the vegetative condition that persisted until the establishment of the WRP) to 2012 (below), and approximate 2003 WRP boundary (hatched area). The CA-1 bridge is visible at top left.

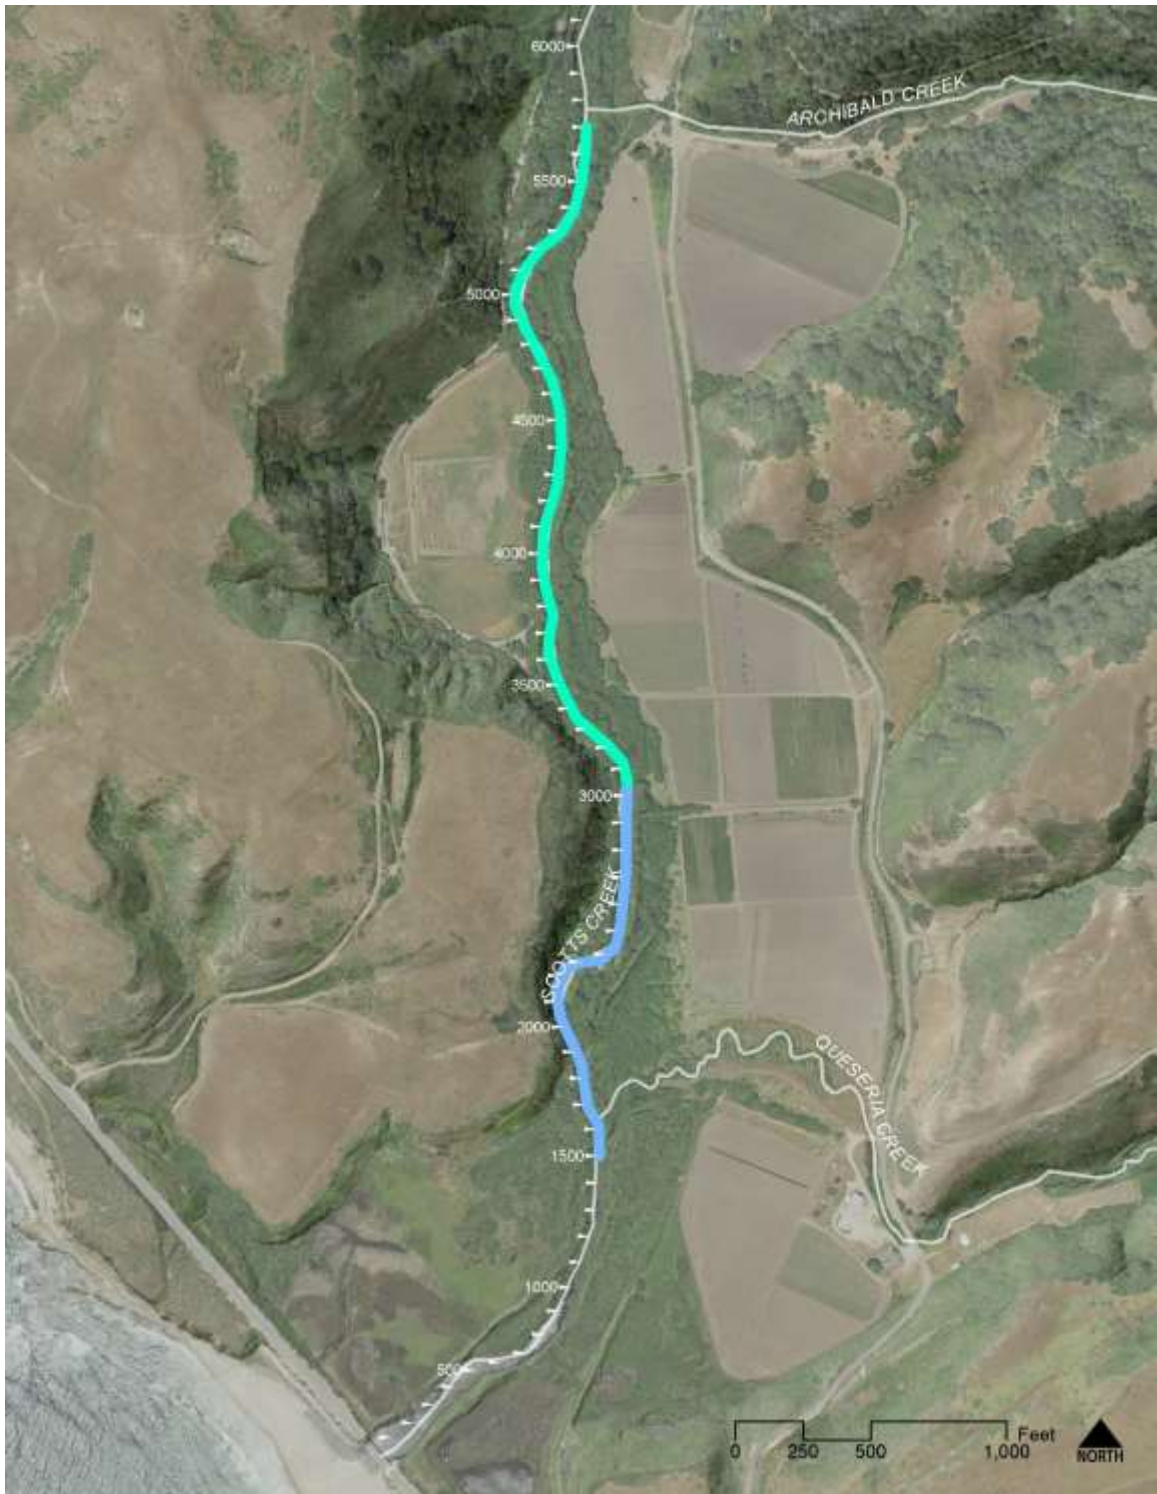
Figure 9. Project reaches with river stationing in feet upstream from the CA-1 bridge. Blue denotes Phase I, cyan Phase II. Stationing is offset by approximately -100 feet compared to stationing shown in the 100% design drawings.

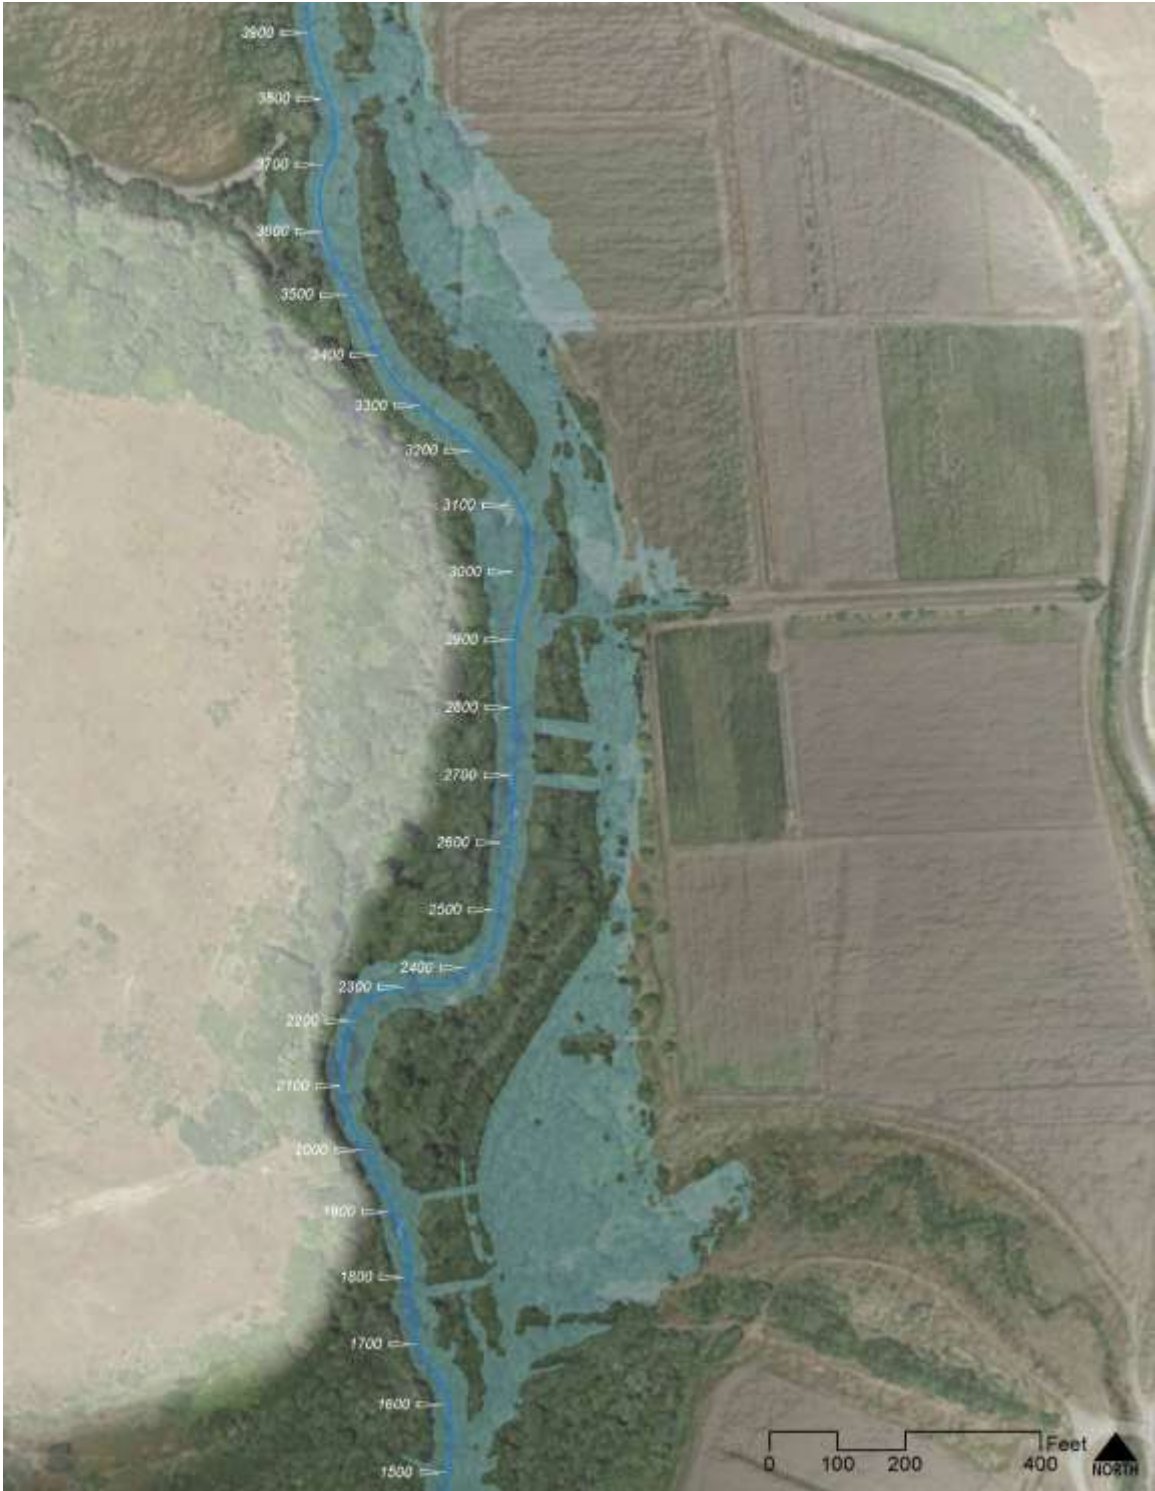
Figure 10. HEC RAS model results for the bankfull event showing potential inundation (shaded blue) through the proposed levee breaches.

HEC RAS 4.1.0 was used to check whether the levee breaches, and other features, would activate at the bankfull stage as designed. To accomplish this, AutoCAD Civil 3D 2014 Imperial was first used to create a DEM of a design iteration which included five levee breaches, 12 instream large wood complexes (modeled as prism-shaped obstructions in select main channel cross-sections), connections with two off-channel ponds, connections with two drainage ditches, and the enhancement of the Archibald Creek confluence. HEC RAS was used to model the bankfull discharge through the main channel on the design DEM. The results were analyzed with the HEC GeoRAS plugin for ArcMap 10.2 (Figure 10). While the one-dimensional HEC RAS model cannot accurately model overbank flow (Roni and Beechie 2012), the results were useful for comparing bankfull water surface elevations (WSEs) to the bottom elevations of the proposed features.

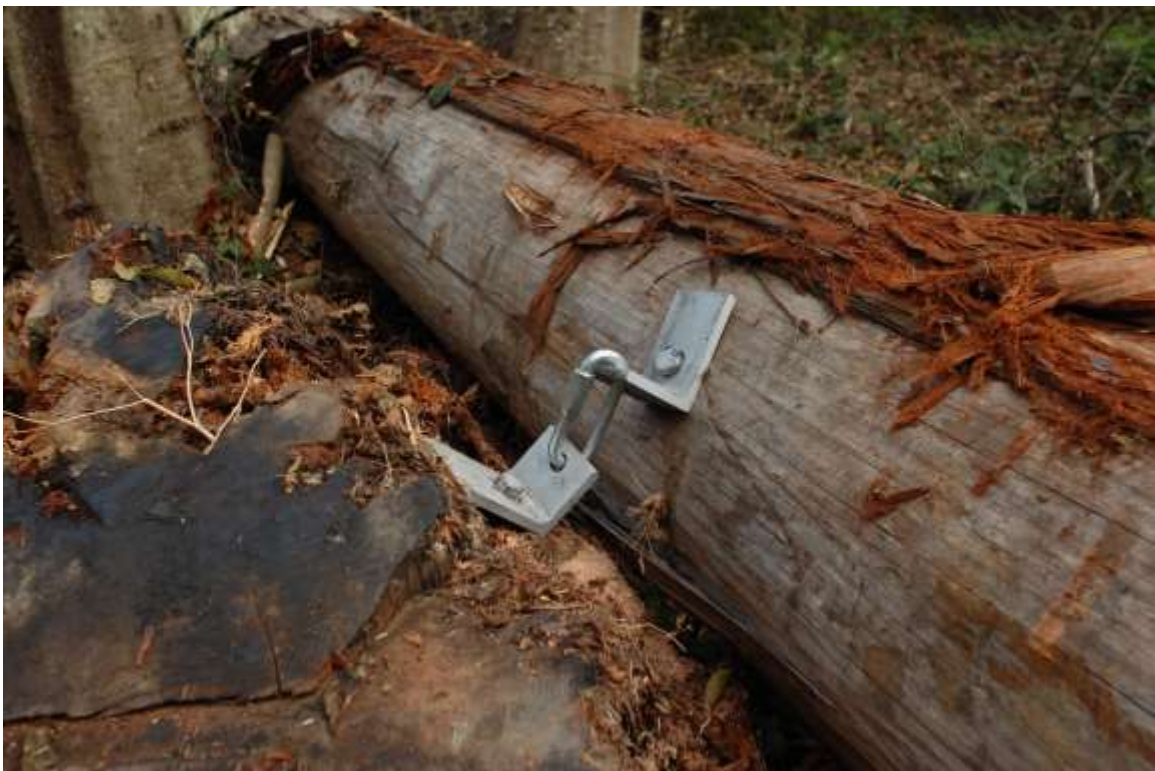
Figure 11. Log-rootwad coupler.

To create attachment points for the couplers in each of the LWC components, the design drawings called for the use of large-diameter eyeleted fasteners. Due to the difficulty and expense in sourcing large-diameter eyeleted bolts and lag screws, an alternative was devised by Jack Dietrich of Dietrich Ironworks (Santa Cruz). Steel angle brackets were coupled using a quick-link and then bolted to the boulder or log (Figure 11 and Figure 12). Go Native, Inc. alternatively used a pair of shackles instead of a single quick-link (see Figure 17 later in Chapter 5). An extra quick-link or shackle was added when it was necessary to extend the reach of the coupler.

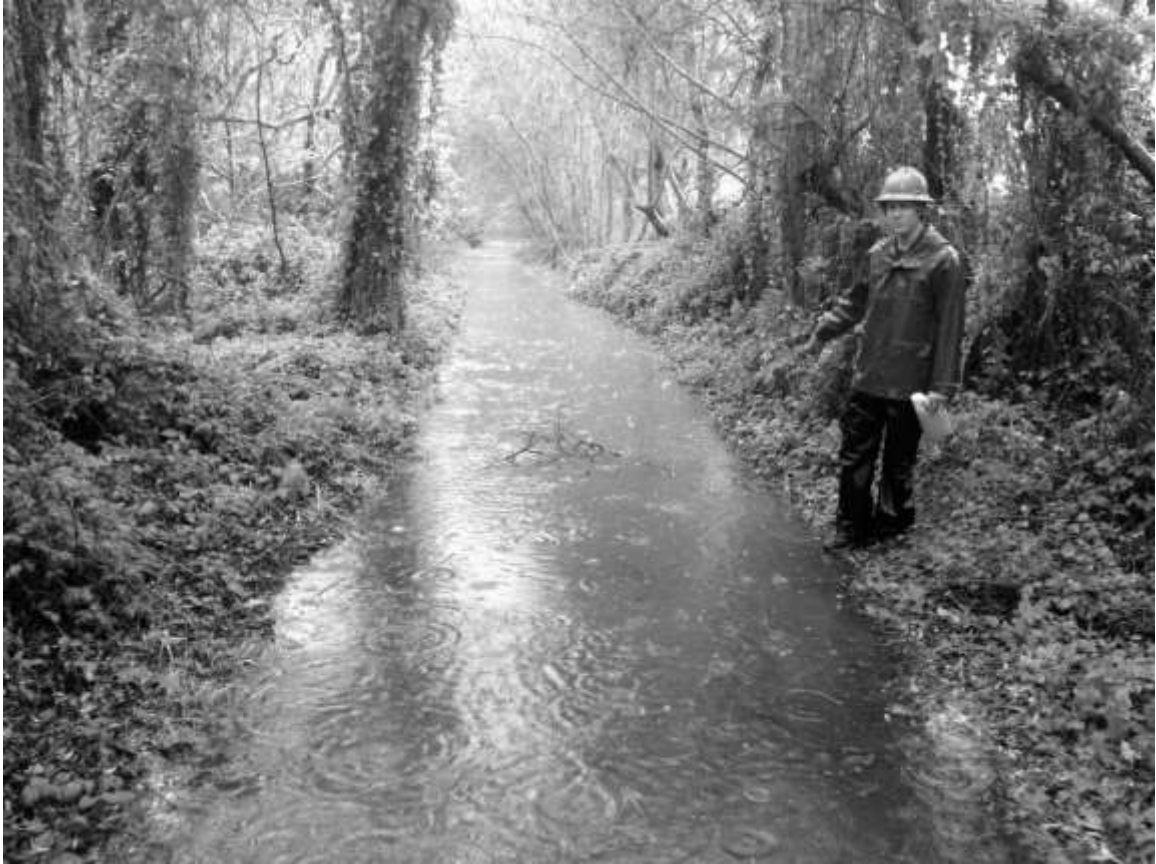
Figure 13. Photo taken during the 12/11/2014 storm of the access road segment that was to be decommissioned.

The road was replaced by a six-foot-wide sinuous trail located between the old road alignment and the streambank. The trail was placed on an elevated alignment and incorporated multiple grade reversals utilizing existing topographic features. The elevated alignment and grade reversals improved drainage of the trail surface and when combined with a sinuous alignment, should be effective at preventing unimpeded flow along the trail.

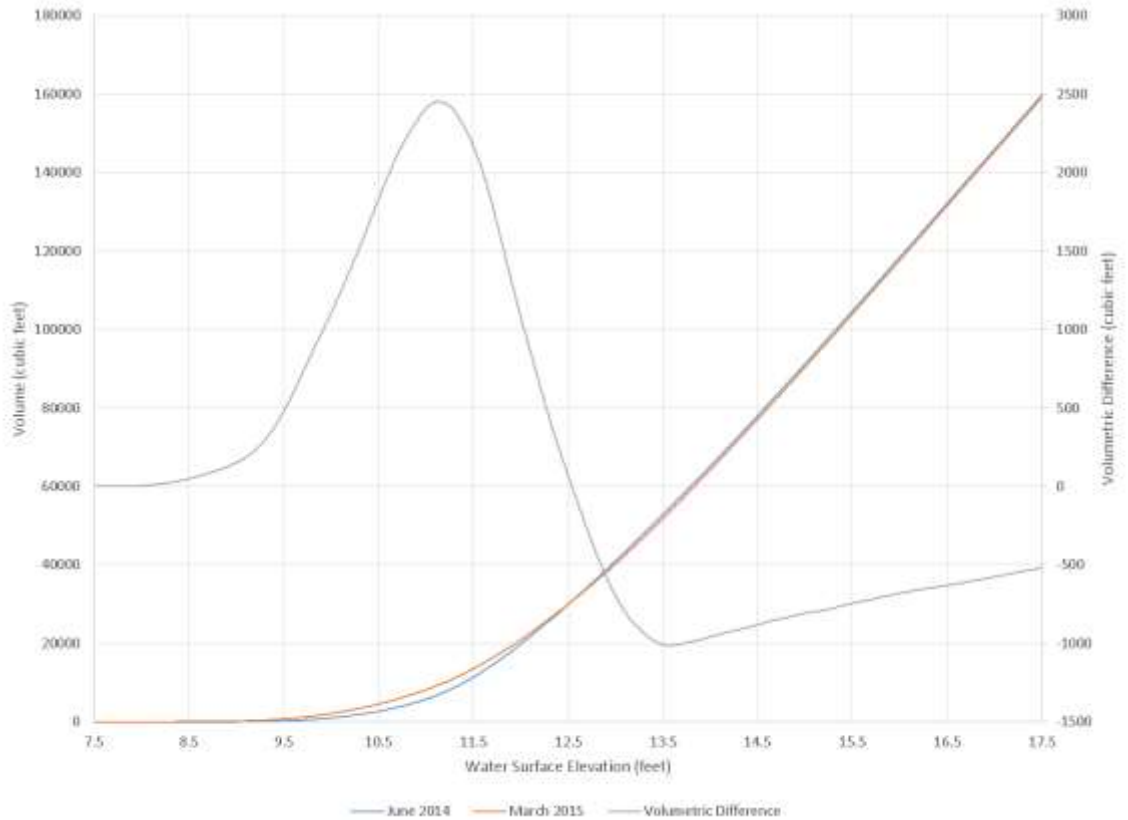
Figure 21. Habitat volumes at varying water surface elevations (primary axis), and volumetric differences (secondary axis) between June 2014 and March 2015.

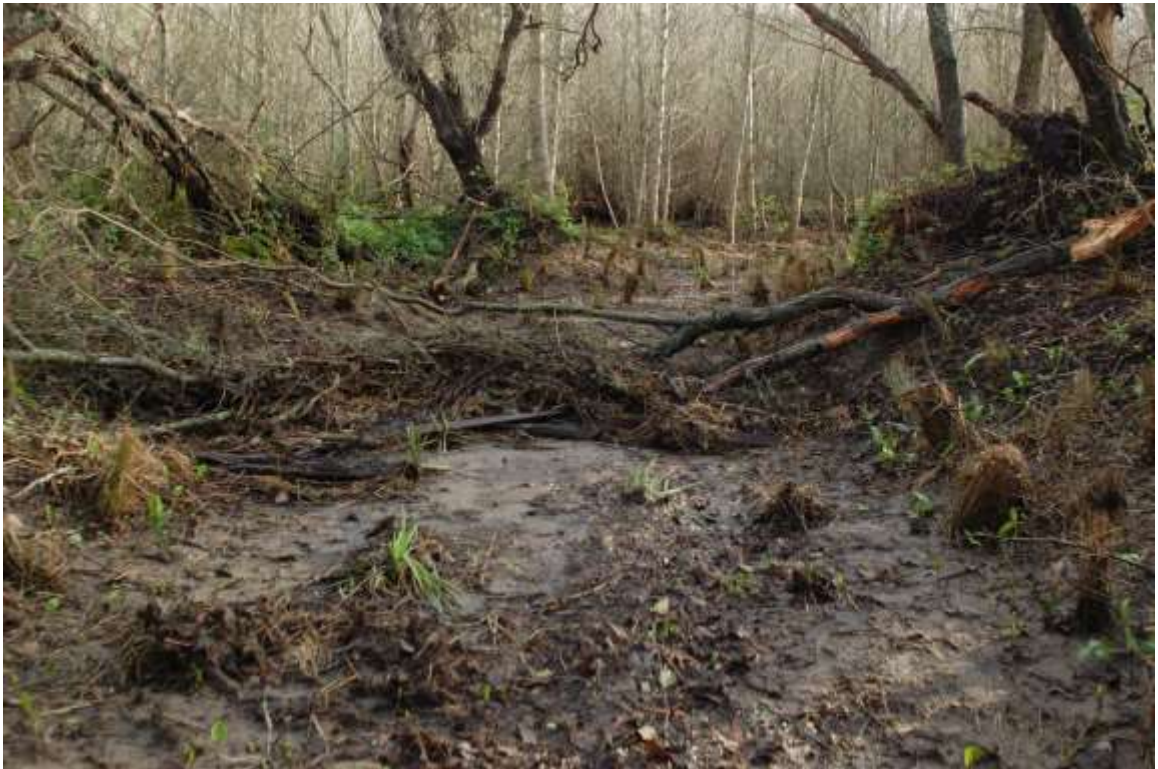
Figure 24. Looking east at debris racked across the throat of the breach at 2000 on 12/18/2014. Scotts Creek is directly behind the vantage point.

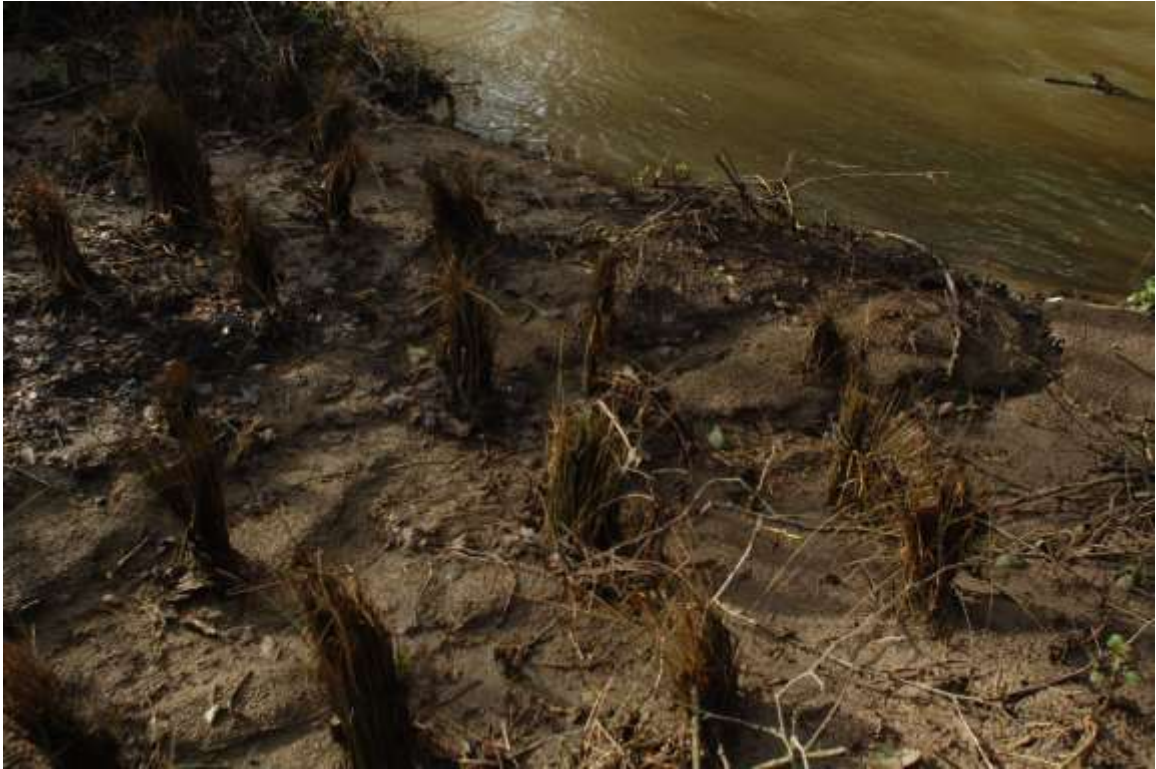
Figure 25. Rilling at the mouth of levee breach at 2000 on 12/18/2014

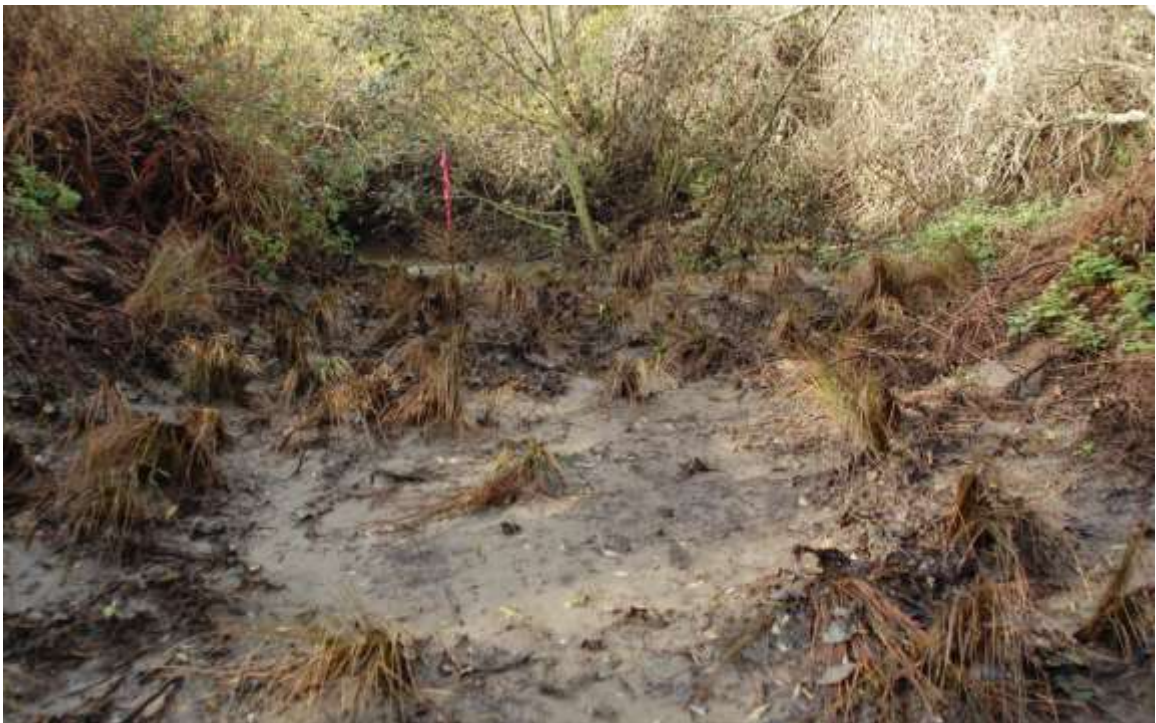
Figure 26. Standing in the breach channel at 1900 looking west at Scotts Creek on 12/18/2014. Vegetation is laid down in the outflow direction (towards camera).

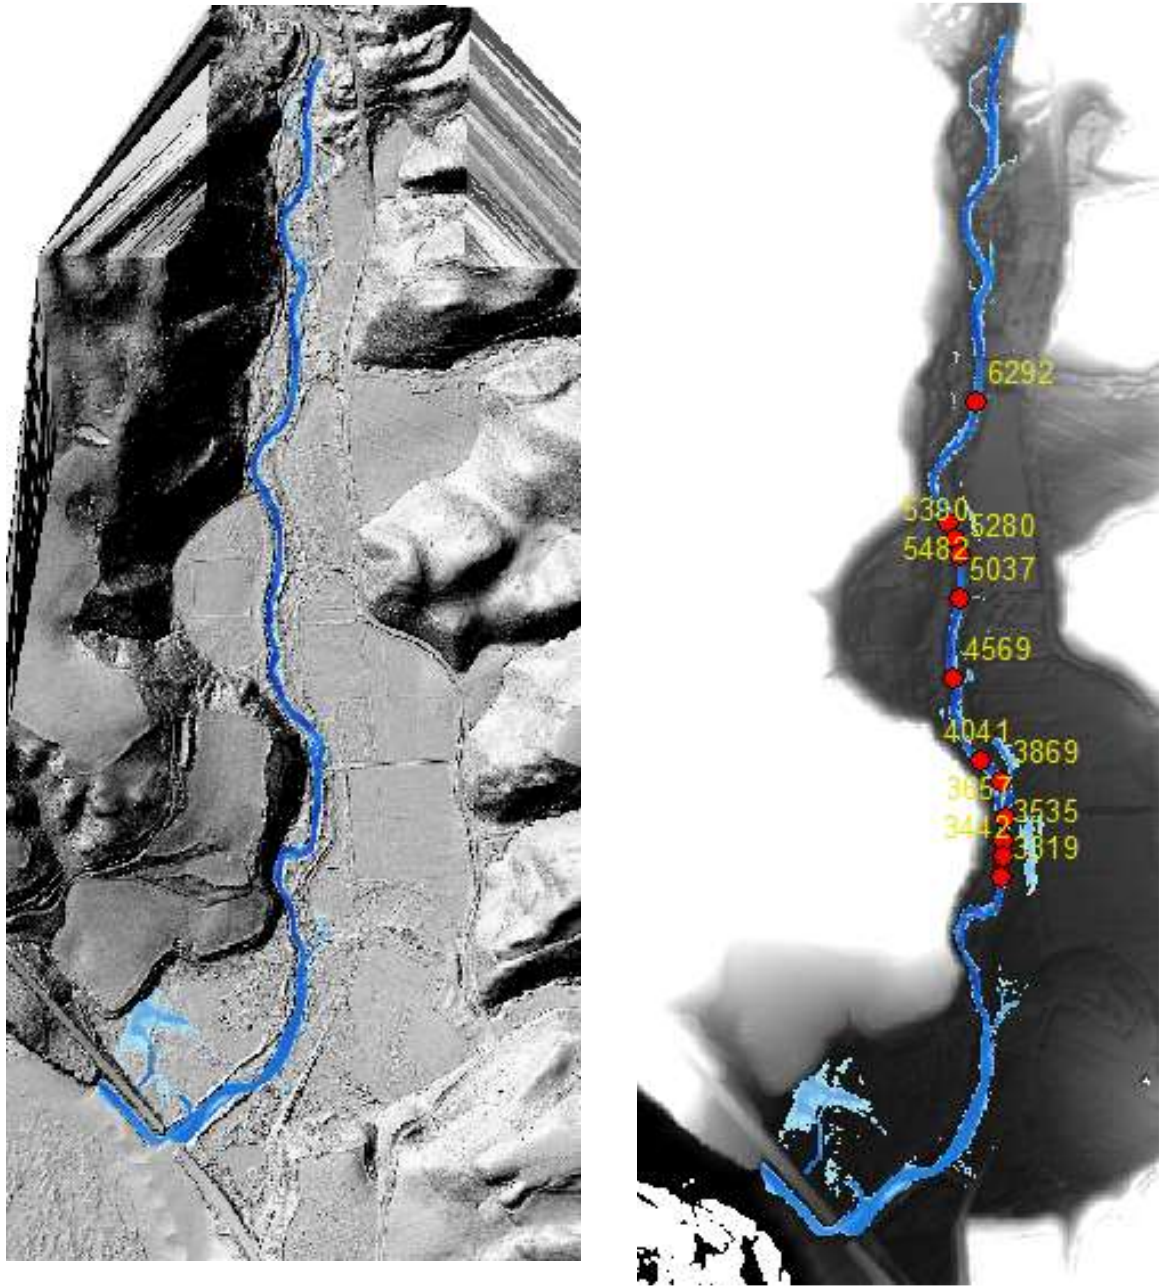
Figure 28. Pre- (left) and post-restoration (right) water surface extents and depths for the bankfull flow. Red dots represent wood habitat structures, with river stations labeled in yellow (Note: stations in this report do not correspond to stationing found elsewhere in the parent document).

The model results are presented in graphic format on the following pages (Figures 28–33).

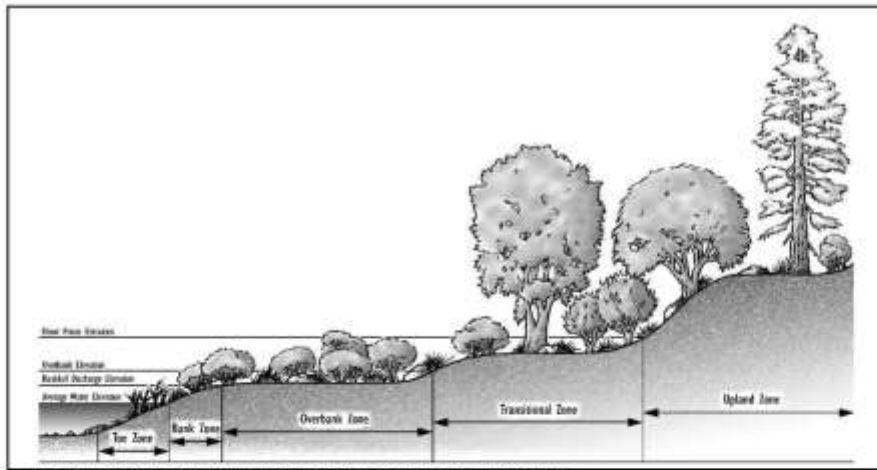
Figure 1. Location of hydrologic zones along a channel or shoreline.

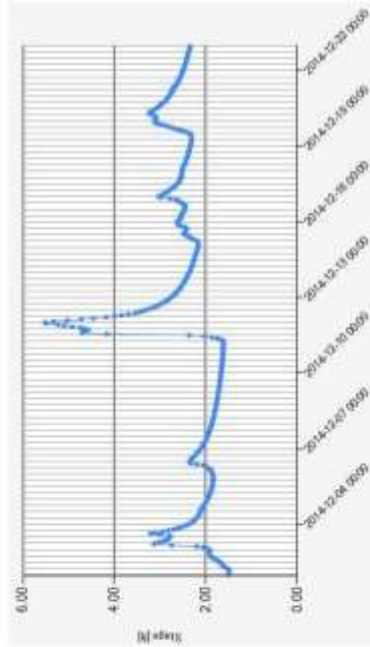
Figure 1. Hydrograph for Scotts Creek at the stream gage above Archibald Creek for December 2 – 22, 2014. Vertical grid lines represent 6-hour intervals.

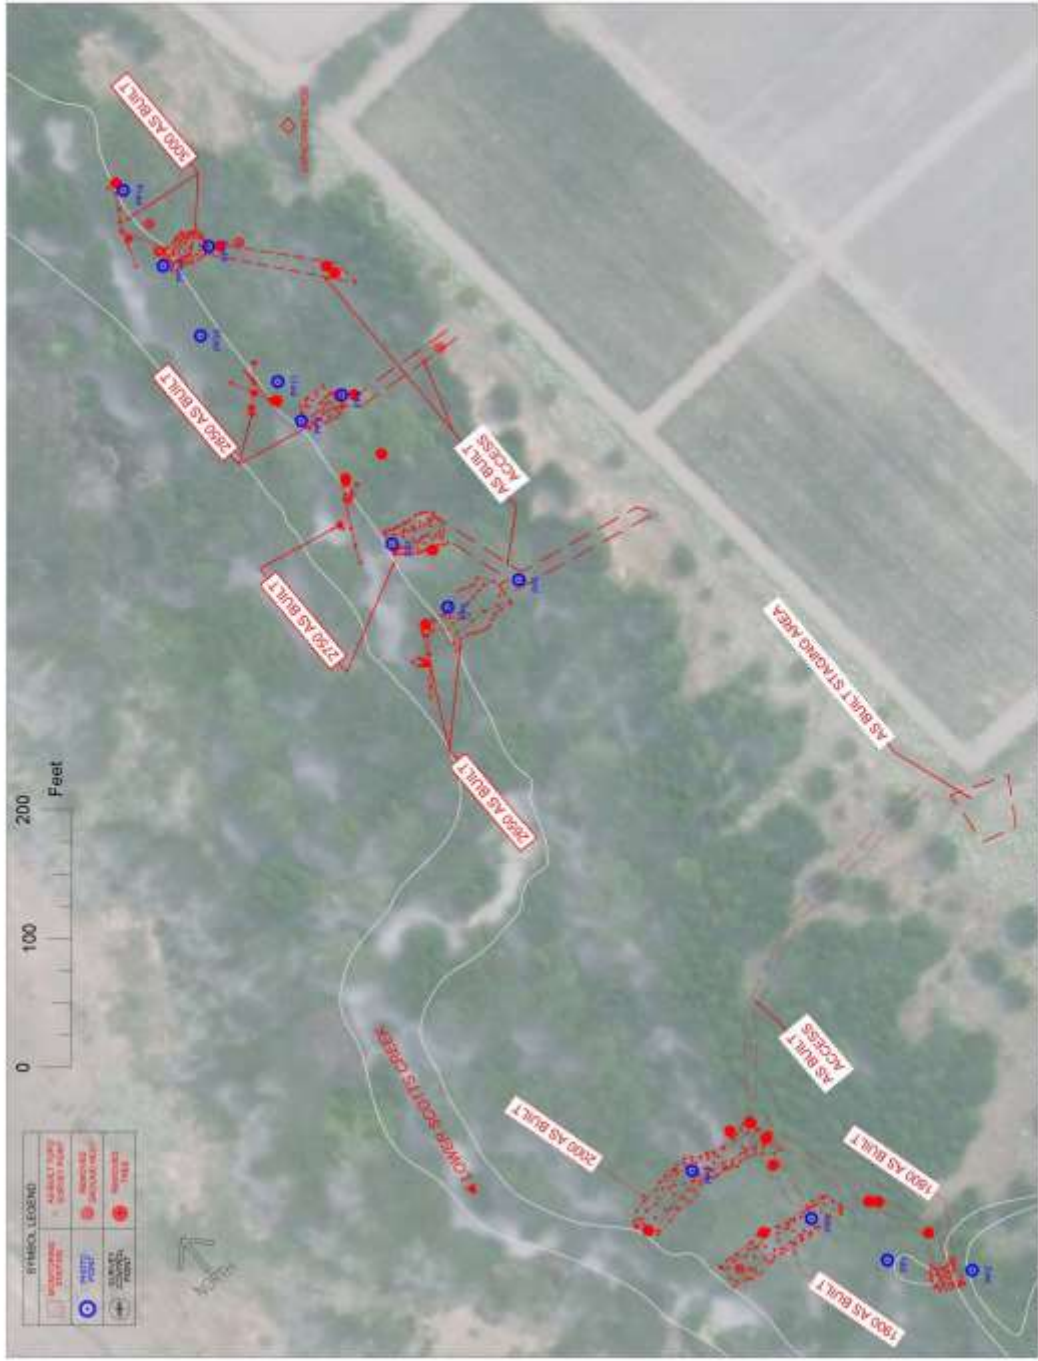
Figure 2. Map of the project reach showing photo points in blue. Scotts Creek, highlighted in grey, flows north to south.

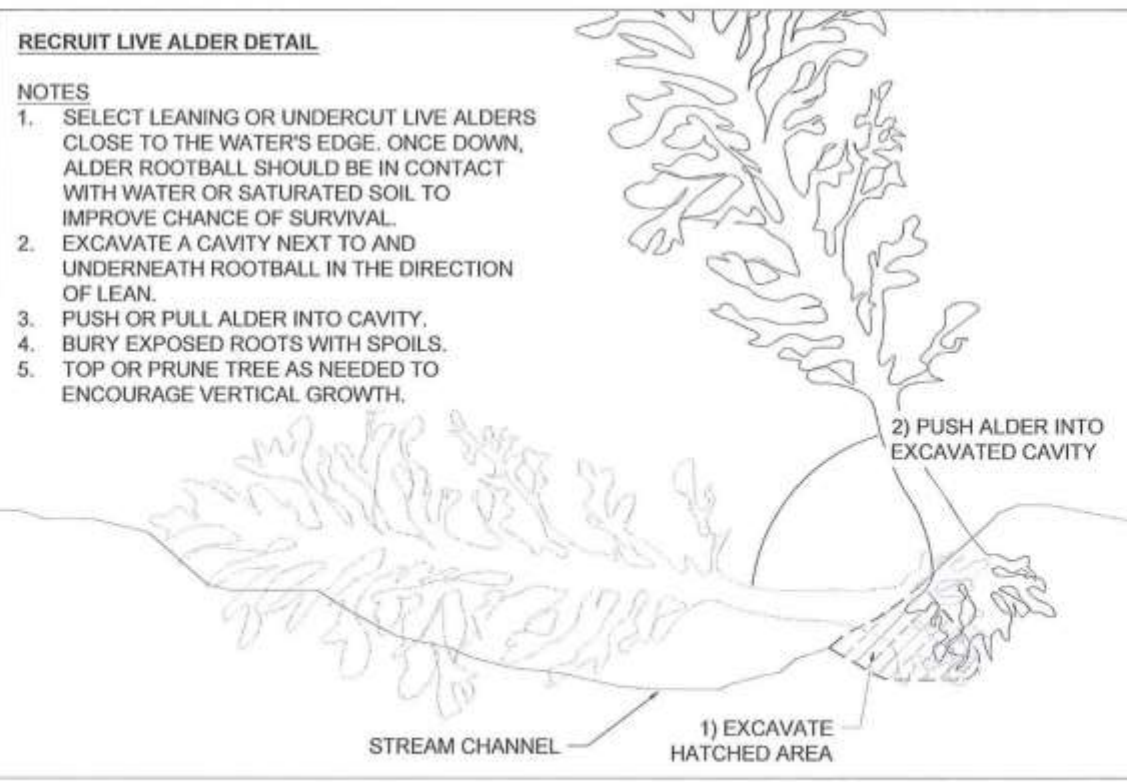
1. SELECT LEANING OR UNDERCUT LIVE ALDERS CLOSE TO THE WATER'S EDGE. ONCE DOWN, ALDER ROOTBALL SHOULD BE IN CONTACT WITH WATER OR SATURATED SOIL TO IMPROVE CHANCE OF SURVIVAL.
2. EXCAVATE A CAVITY NEXT TO AND UNDERNEATH ROOTBALL IN THE DIRECTION OF LEAN.
3. PUSH OR PULL ALDER INTO CAVITY.
4. BURY EXPOSED ROOTS WITH SPOILS.
5. TOP OR PRUNE TREE AS NEEDED TO ENCOURAGE VERTICAL GROWTH.
