**DETAILED STUDY OF INTEGRAL ABUTMENT BRIDGES AND PERFORMANCE
OF BRIDGE JOINTS IN TRADITIONAL BRIDGES**

September 2016

Civil and Environmental Engineering

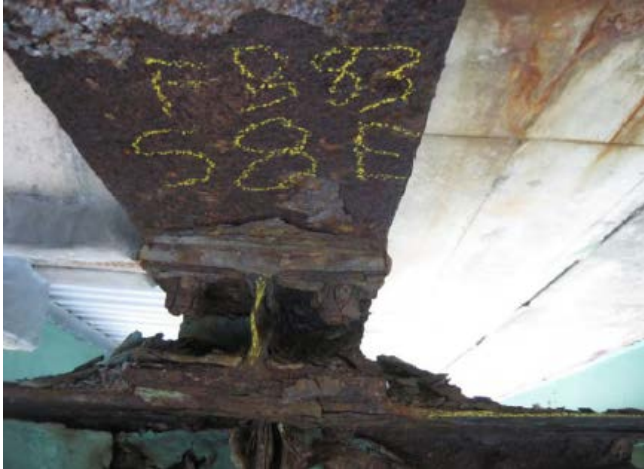
When joints stop performing correctly and allow salt water and anti-icing products to pass through to the substructure, they can cause expensive and extensive damage to the steel and concrete below. Joint failure can be costly in regards to repairing or replacing the joint, but the cost can extend far beyond the joint itself if it fails to protect the superstructure and substructure elements. The images shown in this section come from MassDOT inspection reports. Figure 2.1 shows substructure damage under a leaking deck joint where there has been section loss and web crippling.

Figure 2.1: Section Loss and Web Crippling at Deck Joint

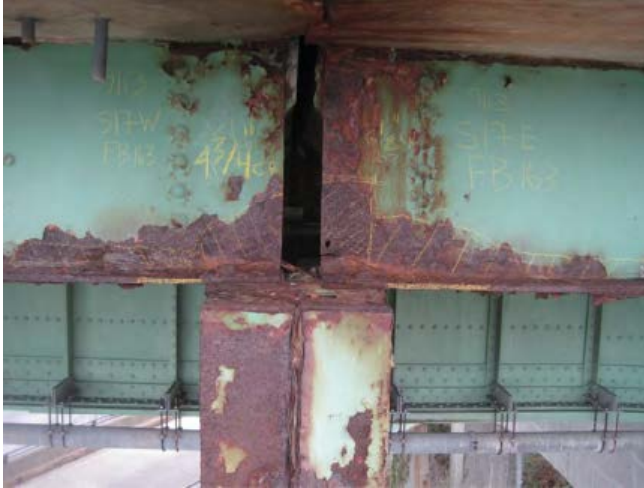
An example of superstructure damage is shown in Figure 2.2 where a leaking joint resulted in corrosion and other damage to the beam ends. A way to prevent leakage is to continue the deck over the backwall so that the joint does not leak here; beam end corrosion is a major issue from leaking joints. Figure 2.3 shows substructure damage where leaking joints lead to concrete damage beneath the bridge.

Figure 2.2: Section Loss, Rust Holes and Corrosion Cracks at Deck Joint

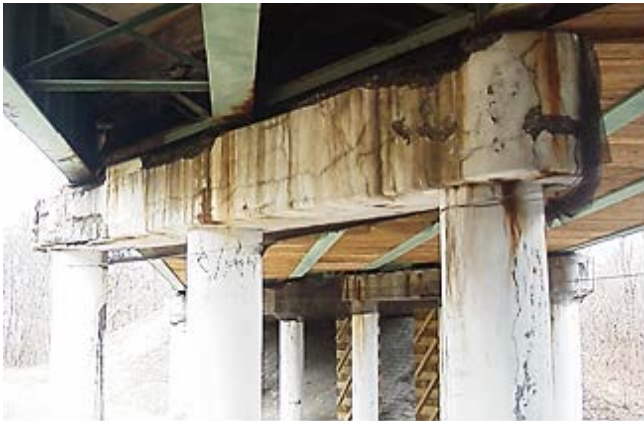
Figure 2.3: Substructure Damage to Concrete from Leaking Joint

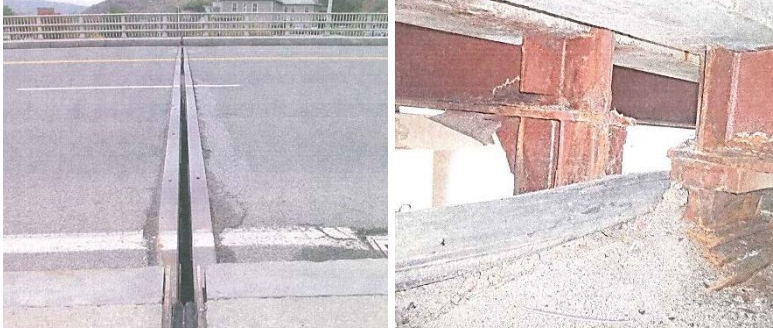
If the seal is improperly sized, or if the joint opening is not a uniform width, early failure can occur. Over time, compression seals have been reported to have decreased ability to stay in compression as a result of loss of resilience. This is even more prevalent if the movement is large. Compression seals should not be spliced. Compression seals can be made of closed cell foam or open cell foam. Figure 2.7 shows a failed compression seal from a MassDOT inspection report where 90% of the seal is displaced. The right side of the figure shows the picture of the same joint from below where the seal has fallen through and heavy debris build-up surrounds it.

Figure 2.7: Damaged Compression Seal

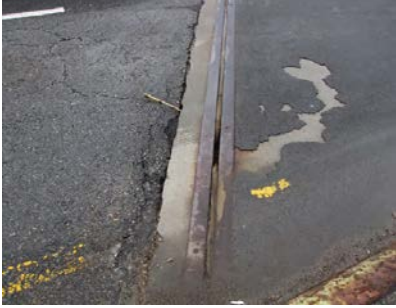
A picture of the failure of a strip seal from a MassDOT inspection report is shown in Figure 2.9. The figure shows where debris has built up and the seal has torn through in some locations allowing water to leak through.

Figure 2.9: Damaged Strip Seal

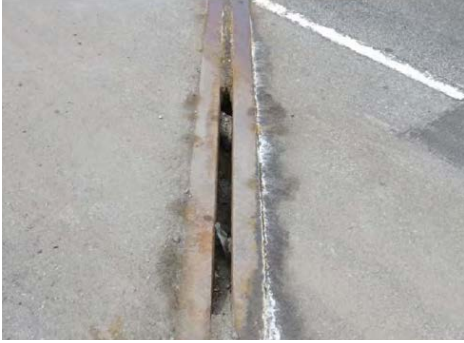
One benefit of pourable seals is that the performance is not affected if the joint walls are not perfectly parallel since it will mold into the shape of the irregular opening. The joint is generally easy to repair since just a portion of the seal can be repaired if needed which also minimizes traffic impact. Problems include: de-bonding, splitting, and damage from debris build-up. A picture of a damaged pourable seal from a MassDOT inspection report is presented in Figure 2.13. The seal has debonded and is missing from many areas of the joint, and is now filled up with debris.

Figure 2.13: Damaged Pourable Seal

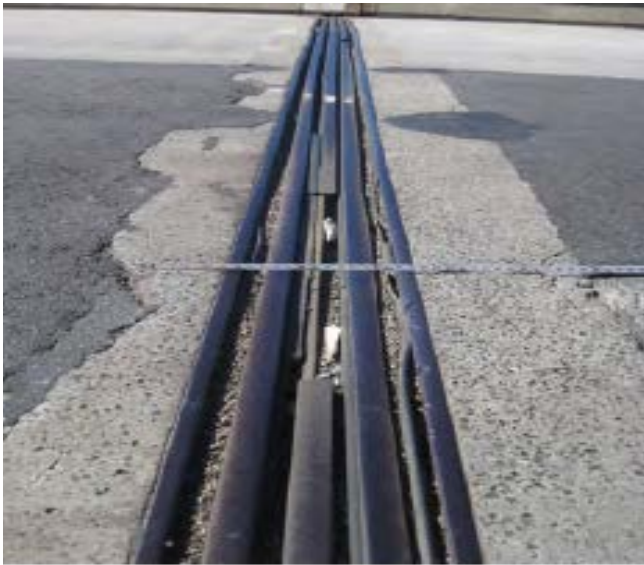
A schematic of a modular joint is presented in Figure 2.14. An image of a damaged modular joint from a MassDOT inspection report is presented in Figure 2.15. The inspection report noted that several support beams were cracked, loose, deflected upward (up to 1/2") and the joints were excessively moving under live load. Some steel beams were also missing, and others were broken.

Figure 2.15: Damaged Modular Joint

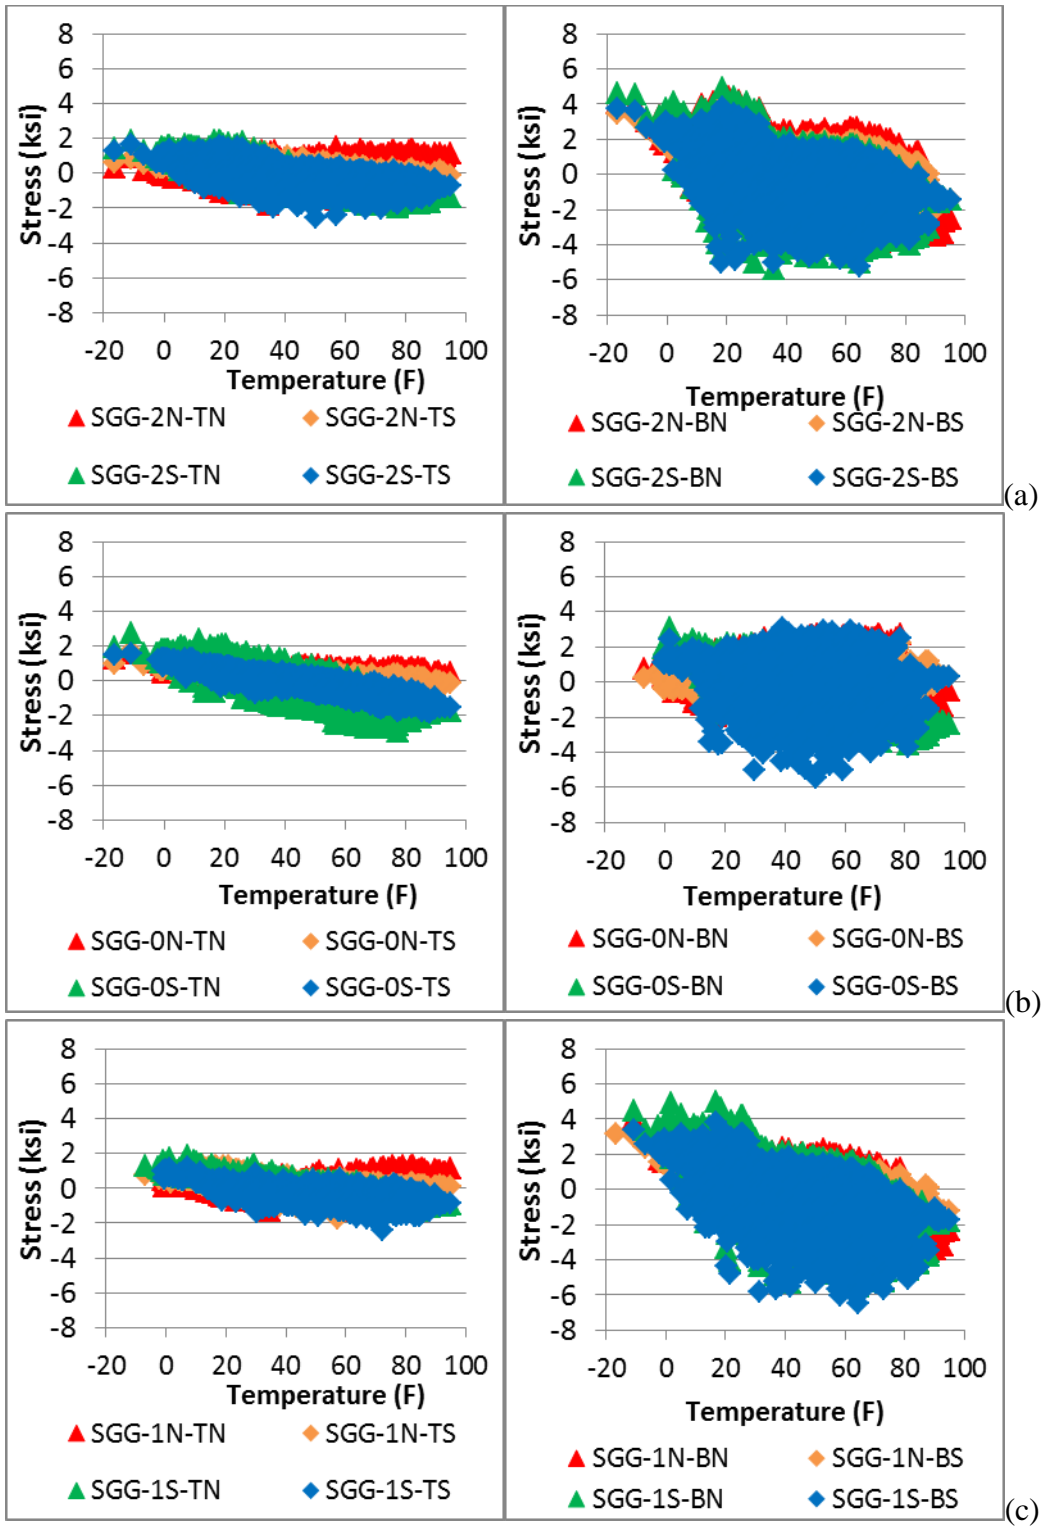
Figure 5.10: Stockbridge Girder Stresses vs. Temperature – (left) Top Flange Gages (right) Bottom Flange Gages -- (a) Abutment 1 (b) midspan and (c) Abutment 2

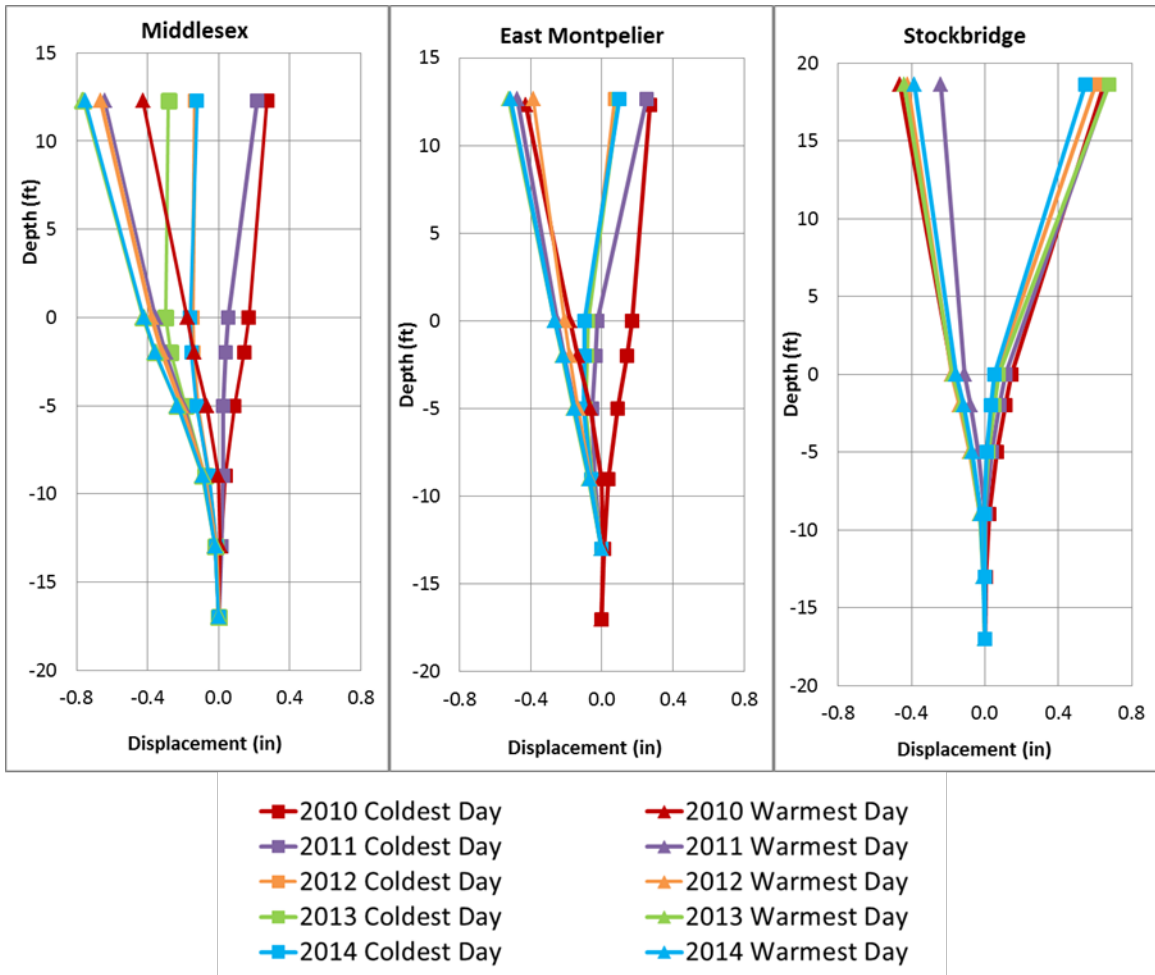
Figure 5.29 Substructure Displacement for Yearly Maximum and Minimum Temperatures (all three bridges)
