Lewis, S. orcid.org/0000-0003-2597-9625, Lewis, R., Goodwin, P.S. et al. (4 more authors) (2017) Full-scale testing of laser clad railway track; case study - testing for wear, bend fatigue and insulated block joint lipping integrity. *Wear*, 376 (Part B). pp. 1930-1937. ISSN 0043-1648

Full-Scale Testing of Laser Clad Railway Track; Case Study - Testing for Wear, Bend Fatigue and Insulated Block Joint Lipping Integrity

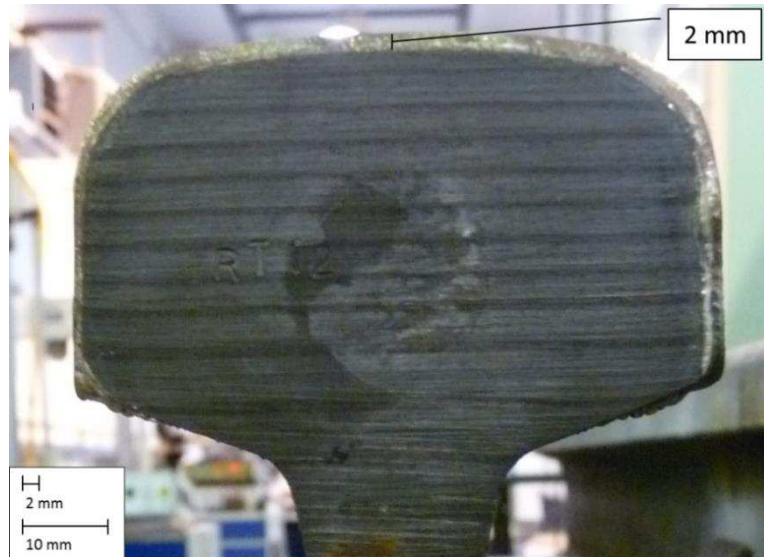
Figure 1: A section image of a R260 60-E2 rail clad to a depth of 2mm used in series 1 tests

For test series 1 both types of clad specimen were prepared for FSTF testing starting from a standard R260 grade one metre long section with 60-E2 profile. The crown radius and the gauge corners of the rails were machined away to a depth of 2mm. The profiles of the rails were then restored by cladding the deposit materials in two layers which were then ground to restore the original profile and achieve a good surface finish leaving a 2mm thick layer of clad at the surface as shown in Figure 1. Only part of the rail head comes into contact with the wheel, however, the full profile of the rail head was clad to show that the technology is capable of cladding any area of the railhead.

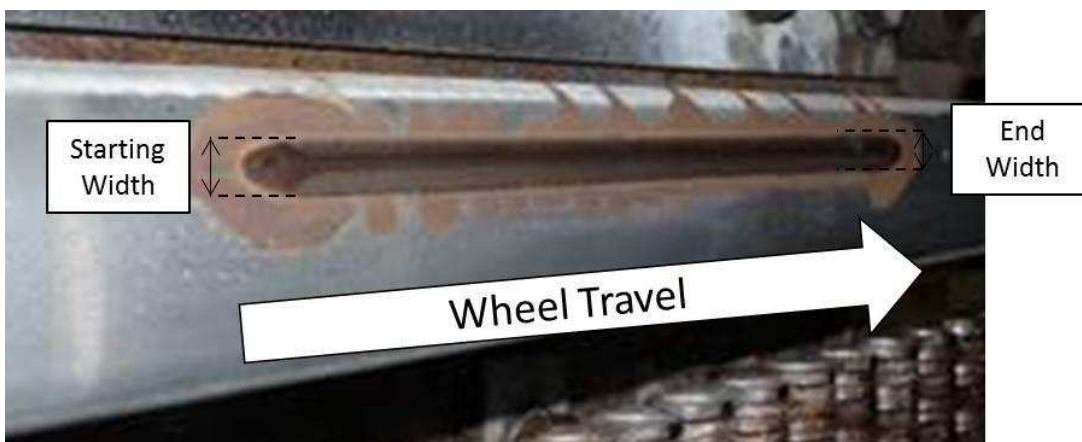
Figure 8: Illustration of how the wear band taper is measured

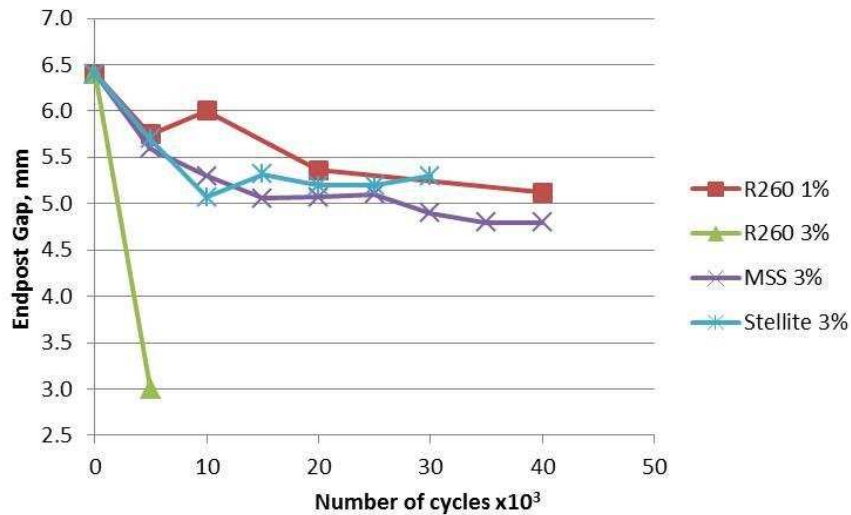
Figure 9: Evolution of the endpost gap with the number of test cycles (R260 3% test stopped early due to large scale deformation)

It can be seen from Figure 9 that the gap on the R260 sample tested at 3% slip more than halves in 5,000 cycles reducing to 3.4mm. For the same number of cycles, the MSS sample only sees a reduction of 0.8mm and the Stellite only 0.7mm. A second R260 sample tested at a reduced slip of only 1% showed a reduction of 0.6mm. This is quite a significant result as it shows that an endpost between two clad rails can resist almost 3 times the energy input into the contact (i.e. 3% slip compared to 1% slip) as a standard unclad IBJ. This is reinforced by the fact that the R260 sample tested at 1% tends to follow the same trend as the two clad specimens tested at 3% slip throughout the whole 40,000 cycle duration as seen in Figure 9.

Beyond 5,000 cycles of testing the endpost gaps in the Stellite and MSS samples continue to reduce until they reach approximately 5.3 and 5.1mm at 10,000 and 15,000 cycles respectively.

It can be noted from Figure 9 that the R260-1% and the Stellite-3% samples exhibit fluctuating behaviour where the gap reduces, increases and is then reduced again. This phenomenon is caused when metal flows across the endpost gap initially reducing it. Then a part of the deformed metal breaks away increasing the gap again. With more test cycles the material flows across the gap reducing it once more. This is quite clearly seen for the Stellite sample between 10,000 and 20,000 cycles. It is also quite possible that this is what is happening when the gap appears to increase for this sample at 30,000 cycles. A similar variation is seen in rail wear rate during twin – disc testing [13]. It is attributed to the accumulation of strain varying with depth, (driven by varying contact stress with depth) and the strain history of the material wearing away and reaching the rail surface. It is possible a similar mechanism is behind the fluctuation in gap size observed here.
