Stability evaluation and prediction of the Dongla reactivated ancient landslide as well as  
emergency mitigation for the Dongla Bridge

**Abstract:** The Dongla Bridge, Muli County, China, is a key access road between counties in Sichuan province and the only traffic facility for an important 500 kV **electricity** substation which provides power to nearby counties. In June 2011, during the bridge construction, an unknown landslide, subsequently named the Dongla Ancient Landslide (DAL), was encountered. Local reactivation of a portion of the DAL, termed the Dongla Reactivated Landslide (DRL), was indicated by evident **ground** deformation at the Dongla Bridge. In spite of this, transportation of **some** heavy electrical equipment to the substation was scheduled on 9 May 2013. So **to guarantee** the stability and security of the bridge became a primary emergency task. Detailed field investigations of the landslide occurrence, monitoring and emergency mitigation construction were carried out in the period between 2011 and 2014. This resulted in a temporary stabilization of the **revived** landslide **and ensured** the timely transportation of the heavy electrical equipment. It is

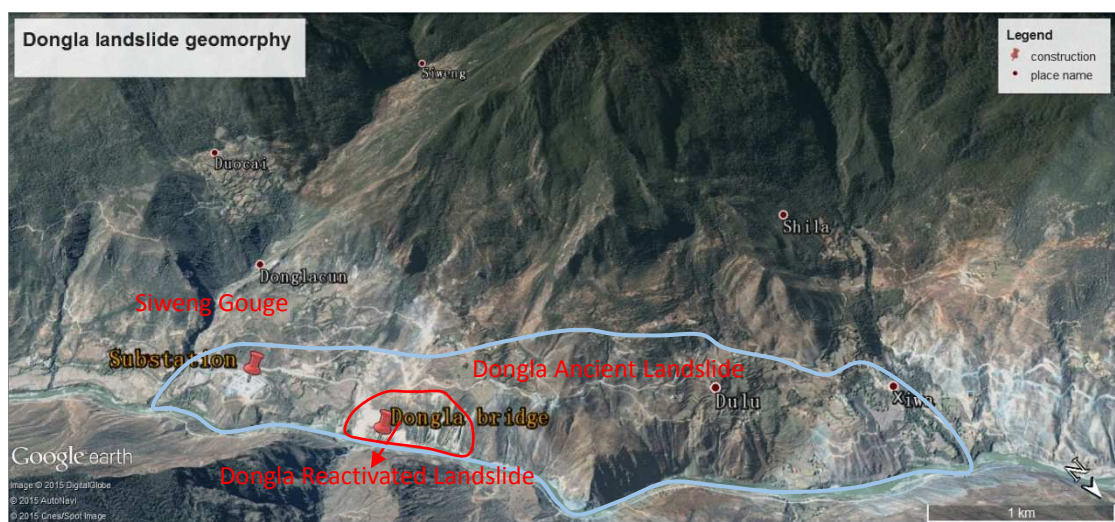
Fig. 2. Delineation of the Dongla Ancient Landslide and Dongla Reactivated Landslide.

The Dongla Reactivated Landslide (DRL) is located in the Shuiluo River, 10 km upstream from Shuiluo village, and 100 km upstream from Muli county of Sichuan province, China. It is located within an impoverished and sparsely populated mountainous region, connected previously by only poor-quality roads (Figure 1). Hydropower has recently been developed in this area and in order to provide a vital road link to a 500kV electricity substation as well as access to other counties, the 134 m long Dongla Bridge which crosses the Shuilou River, was completed in 2011 at the cost of 8 million Yuan. Unfortunately, due to inadequate geological exploration, the bridge abutment was located within a pre-existing ancient landslide (Figure 2), known here as the Dongla Ancient Landslide (DAL).

The drainage basin of the Shuiluo River is located at the transition area between the Qinghai-Tibet and Yunnan-Guizhou Plateaus, in the eastern Hengduan Mountains. The geomorphological pattern is an erosion terrain inclining from north to south with complicated geomorphic types. Due to deep incision cut by the river, the stretch where the DRL developed is 50 m - 60 m wide with a characteristic "V" shaped valley and 40° ~ 50° bank slopes (Figure 2).

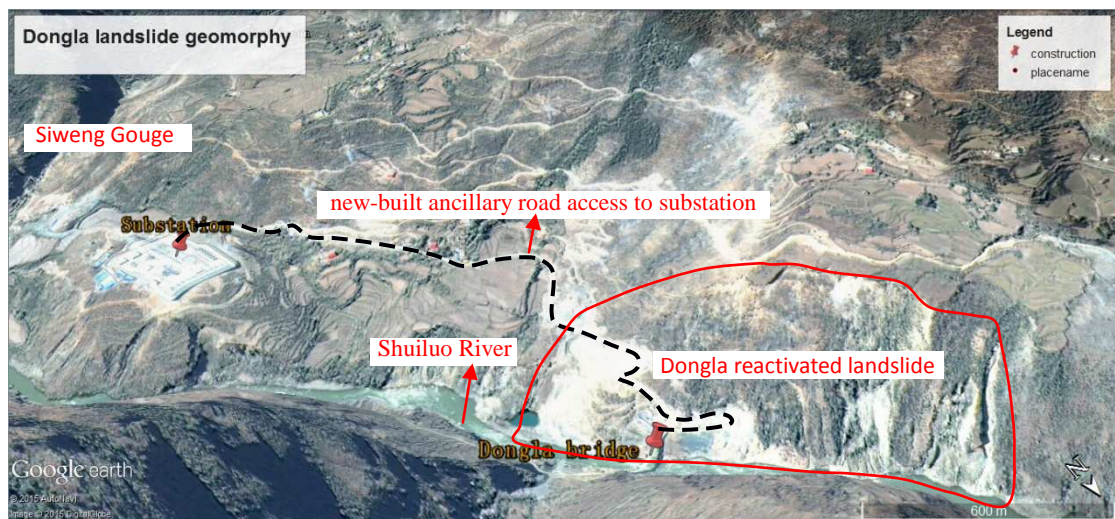
Fig. 3. Location of the Dongla Bridge and Dongla Reactivated Landslide. The construction of the Dongla Bridge and the new ancillary road (black line), as well as the gold mining pits and the gold washing pond destabilized the slope.

In addition, the engineering excavation for the new-built ancillary road and bridge construction (Figures 3 - 5) undercut the toe of slope, resulting in a reduction in the stabilizing force. The influence of this excavation is discussed in detail in Section 7 and 8.

Within the DAL, the width of the DRL source zone along the river is 1200 m, the length is 420 m, the area is 300,000 m<sup>2</sup> and the estimated volume is 6 million m<sup>3</sup> (Figure 3 and Figure 4). The head scarp is at 2310 m asl. and toe at 2115 m asl., resulting in 195 m elevation difference and an average gradient of 28° for this near-planar, translational slide. The chair-shaped rear scarp subsidence is approximately 40 m - 60 m (Figure 3 and Figure 6). As shown in Figure 6, the long tensile cracks at the rear and the shear cracks at the lateral boundary make the surface water and rainfall easily infiltrate into the slope.

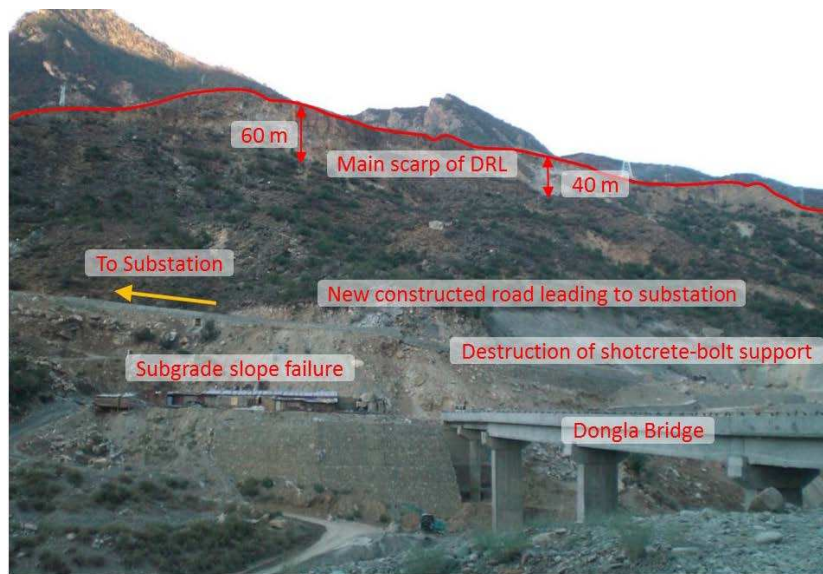
Fig. 6. Main scarp and local deformation features of the DRL. Viewing towards southwest.

Between the years 2011 and 2012, tension and shear cracks appeared and developed near the headscarp and the lateral boundary, respectively. Furthermore, bulging of a retaining wall at the toe of the DRL, collapse of the ancillary road slope and small brittle fractures on the bridge were observed (Figure 6).

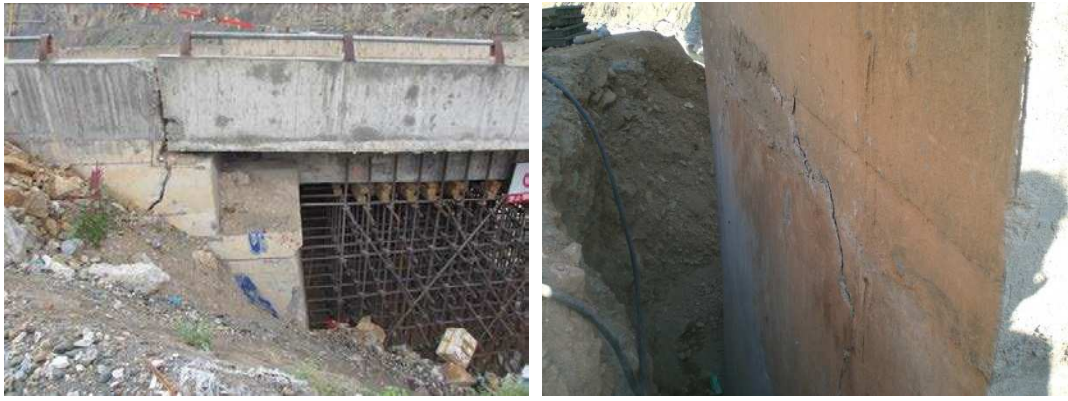
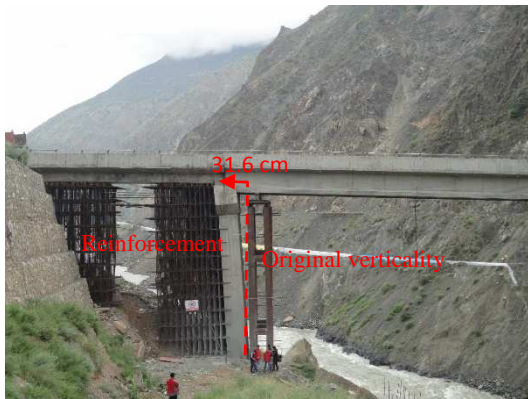
Fig. 9. Damage to bridge abutment and dislocation of bridge deck slab (a) Crack of west abutment. (b)

burial cracks on the back surface of Pier 2. (c) deformation of Pier 3.

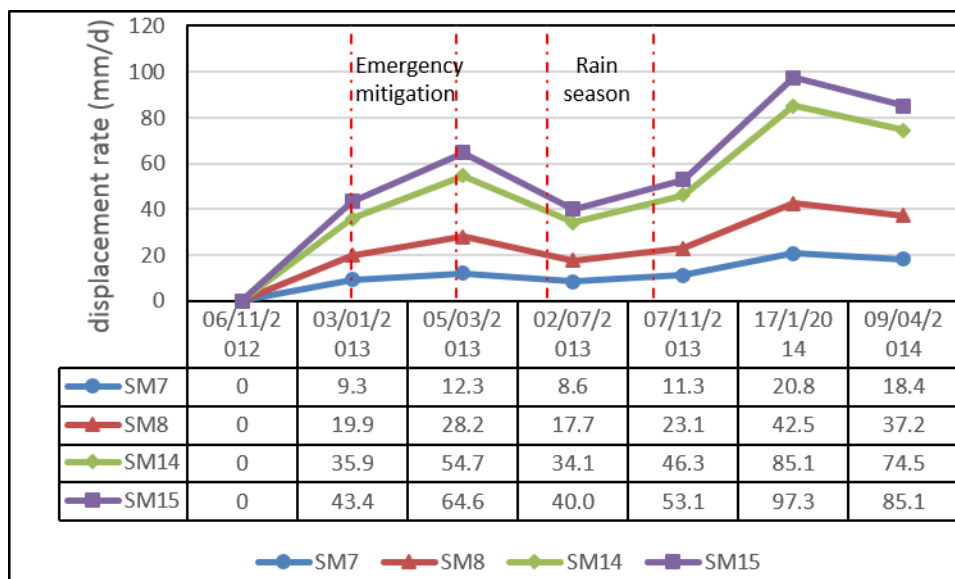
Fig. 10. The displacement rate of four surface monitoring points along the center cross section B-B.

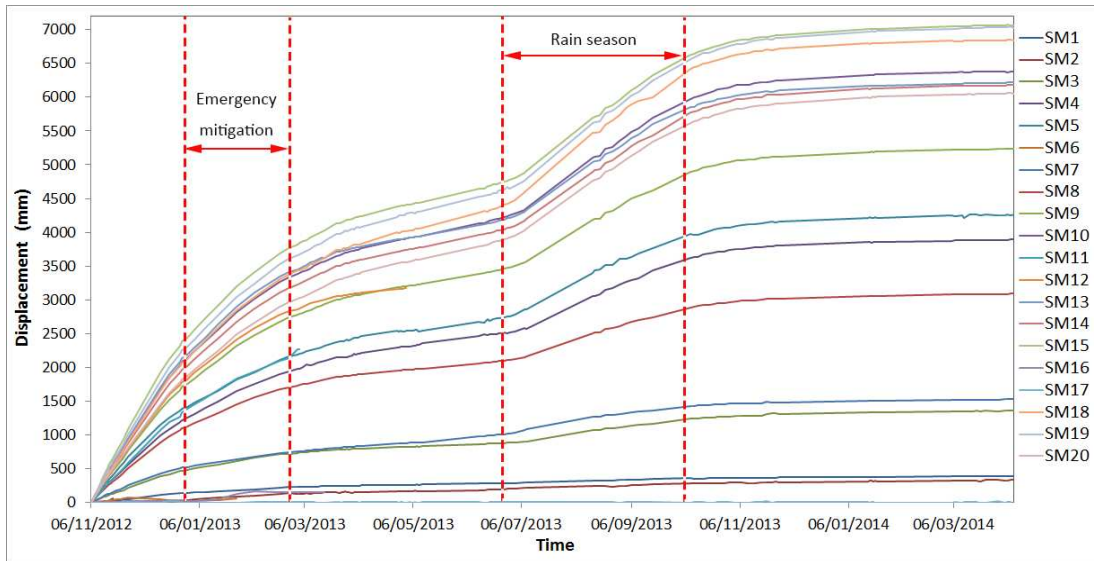
Fig. 11. The surface movement monitoring result. The displacement vector is consistent with the sliding direction.

The artificial slope was constructed between 4<sup>th</sup> and 20<sup>th</sup> February, 2013, resulting in a satisfactory reduction in the sliding rate (Figure 11), such that the cracks in soil stopped widening, as inspected visually. On 9<sup>th</sup> May 2013, nine vehicles carrying the heavy electrical equipment with a total load of

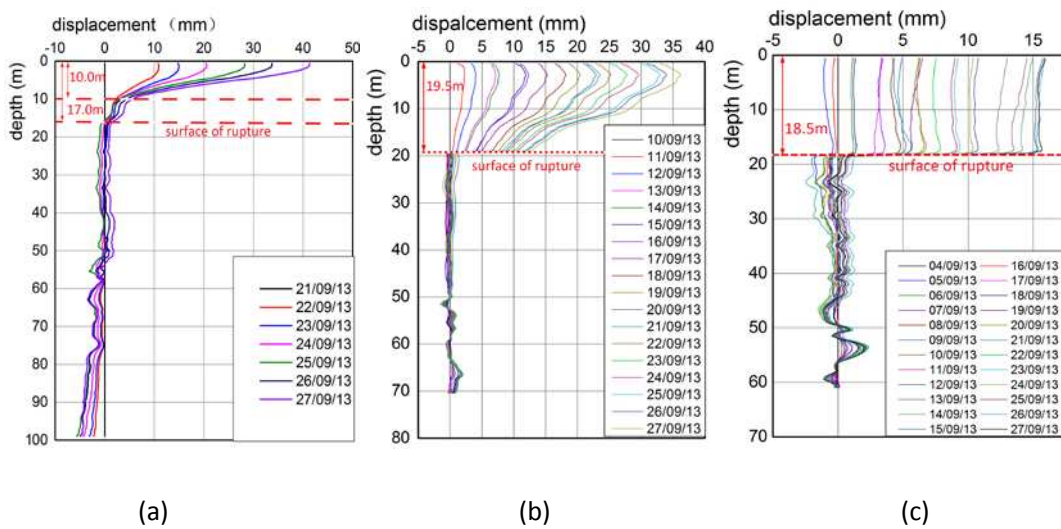
Fig. 12. Cumulative horizontal displacement vs the depth of inclinometers along the sliding vector (a) IN1 (b) IN2 (c) IN3 from 1<sup>st</sup> to 27<sup>th</sup> September 2013.

Figure 12 shows that: (1) the cumulative displacement and displacement rate at the top of IN3 is larger than at the other two inclinometers; whereas (2) the cumulative displacement and rate of the major sliding plane at IN1 is larger than other two inclinometers. These two observations suggest that: the external factor which triggered the DRL was erosion or degeneration of the toe of slope, resulting in translational movement at the toe, and the overall geomechanical movement mode is “creep - translational sliding”, resulting in additional shearing within the landslide mass above the toe (Stead et al. 2006; Zhao et al. 2015). This meant that, even though the emergency mitigation at the toe of the landslide did reduce the surficial deformation to some degree, via the reduction in translational movement, the sliding still went on due to shearing. These phenomena illustrate why movements were constantly active and could easily be accelerated.

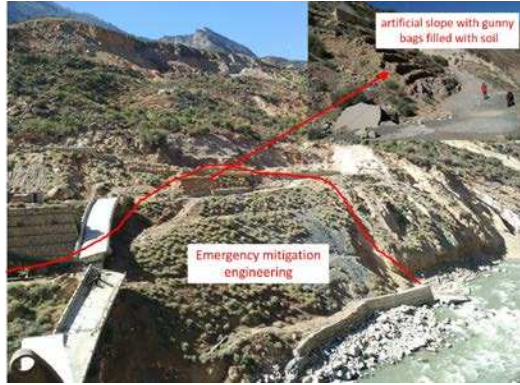
Fig. 15. Artificial slope (photograph taken 12<sup>th</sup> December 2015).

Mitigation of hazards of large, deep, and relatively fast-moving landslides is a difficult engineering task, which requires a good understanding of the causes and mechanisms that lead to slope failure (Pulko et al. 2012). In China, applying a surcharge to the toe of the landslide had previously successfully prevented similarly reactivated fossil landslides induced by manmade excavation (Popescu 2001; Li et al. 2006; Picarelli 2011; Chen et al. 2015). Here this method was applied to decrease the sliding rate of the DRL to guarantee the transportation of the heavy electrical equipment and the electric power delivery work as scheduled. 80000 m<sup>3</sup> gunny bags filled with soil were placed at the toe of the DRL, and an artificial slope of 200 m length was thereafter constructed along the Shuiluo River (Figures 13 - 15).

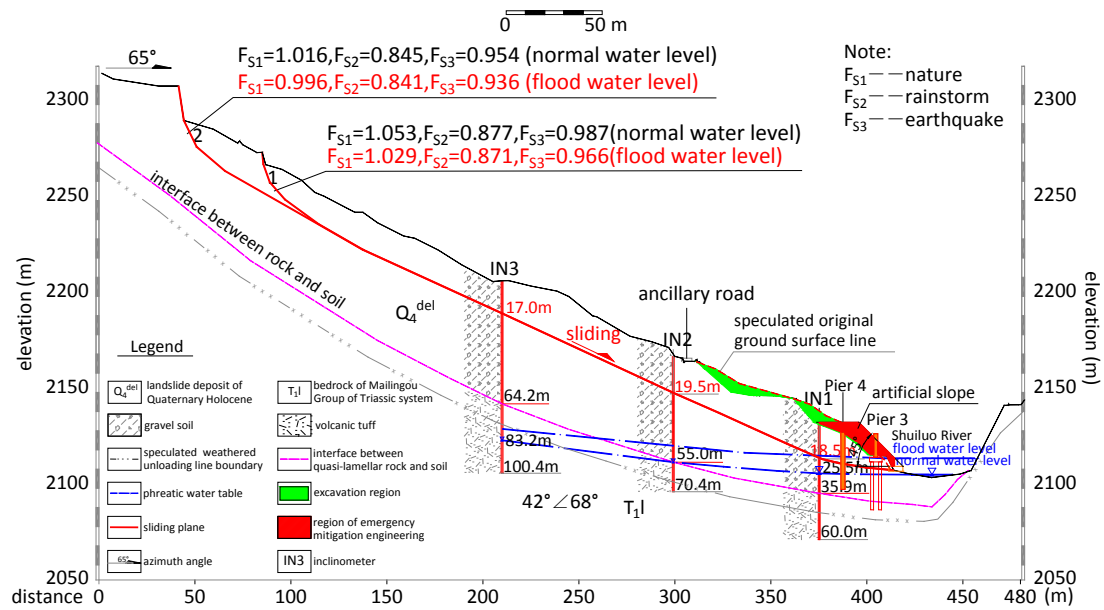
Fig. 16. Stability coefficients of the DRL under different scenarios (cross-section B-B).

The integral stability coefficients of the DRL were calculated under three scenarios with two water levels (Table 6 and Figure 16), which shows that the DRL would be unstable under both rainfall and earthquake conditions.

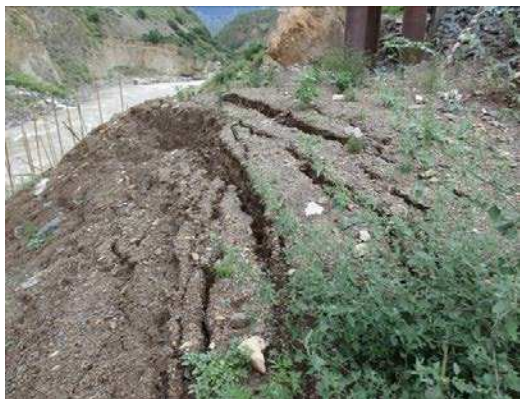
Fig. 17. New emerging arc tensile cracks on the artificial slope (photo taken February 2014)

Although the sliding rate of the DRL was decreased by the emergency mitigation, the displacement still increased slowly. In February 2014, a number of tensile cracks emerged on the artificial slope, presenting a potential risk to the stability of the bridge (Figure 17). Although the landslide would not be expected catastrophically accelerate under the state of low-speed deformation (Picarelli 2011), a sudden increase of the driving force (due to an inundation, heavy precipitation, or earthquake, etc.) could still lead to the destruction of the bridge. In the worst case scenario, river blockage or surge generation could happen because of the volume, location and activity of the DRL (Macfarlane 2009). Considering the volumes involved, in the worst case scenario where the moving mass slid coherently in wholly translational sliding, it could block the Shuiluo River and form a landslide dam with a

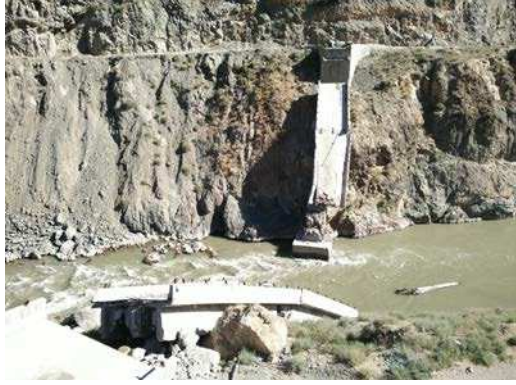
Fig. 18. Dongla Bridge was dismantled by bomb explosion on 12<sup>th</sup> July 2015.

Large ancient landslides in mountainous regions are vulnerable and liable to be reactivated by environmental changes such as changes of hydrologic balance and climate (Panek 2009). It is of utmost importance that any active mitigation measures are designed not only to efficiently restrain the sliding mass, but also to guarantee safe construction, with the likelihood of damage reduced to an acceptable level during the construction process (Pulko et al. 2012). Based on this consideration, several permanent treatment solutions for the DRL were proposed. However, to simply stabilize the sliding zone at the ancillary road section would cost nearly 100 million yuan, which would be unrealistic. In fact, the proprietor was in the dilemma of whether sustaining the existing Dongla Bridge with stabilization construction, which would be expensive and probably useless in the long term under the complex geological condition, or establishing a new bridge instead. After comprehensive comparison, the second plan was adopted. Thus the old bridge was dismantled via a controlled explosion (Figure 18), and a site to build the new bridge was chosen downstream outside the DAL. In the meantime, the
