Spillway Rock Scour Analysis - Composite of Physical & Numerical Modelling, Paradise Dam, Australia

E J Lesleighter¹, E F R Bollaert², B L McPherson³ and D C Scriven⁴

ABSTRACT

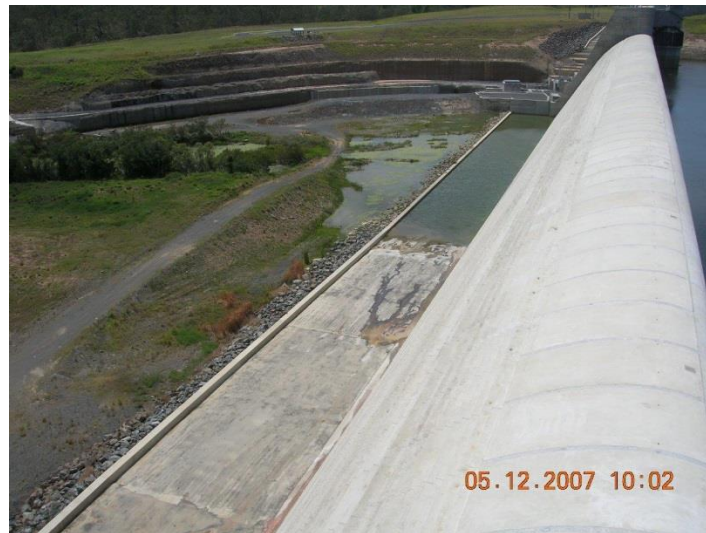
Figure 1. Paradise Dam primary spillway (2007)

The primary spillway is 315 m long with an ogee crest at EL 67.6 m and maximum height of 36.1 m. The crest is constructed in conventional reinforced concrete, and the downstream stepped face is capped with reinforced concrete anchored into 620 mm tall RCC steps. At the base of the steps, spillway flows meet a horizontal apron approximately 20 m in length with a vertical end sill 1 m in height. At the left end of the spillway, the original apron was at a level of EL 37.6 m, and at the right end, the apron was at EL 30.9 m. Figure 1 is a photograph of the dam and spillway. Figure 2 shows some detail of the primary spillway.

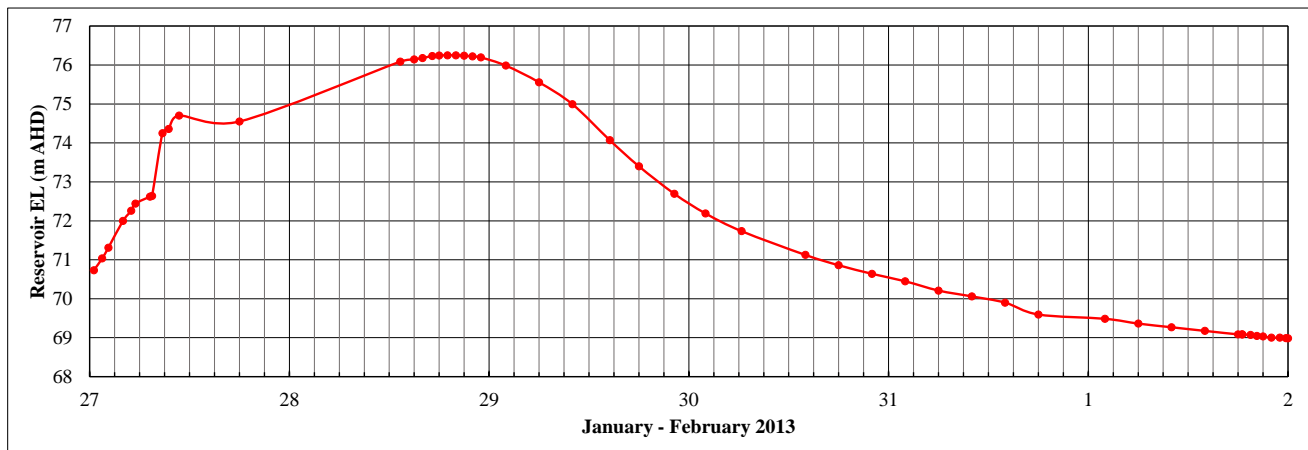
Figure 3. Paradise primary spillway stage hydrograph January 2013

The primary spillway was overtopped by 6 m on 29 December 2010. The reservoir level peaking at EL 73.6 m and remained above the crest level for more than three weeks. The peak discharge was equivalent to approximately 9,600 m³/s, or a unit discharge, q , of 30.48 m²/s. Table 1 presents the AEP discharges up to the AEP 1 in 10,000. Of much more consequence was a flood in January 2013. The peak reservoir level was EL 76.2 m, 8.6 m above the crest, and the corresponding discharge was 17,090 m³/s, a unit discharge of 54.3 m²/s. The Paradise outflow hydrograph is shown in Figure 3.

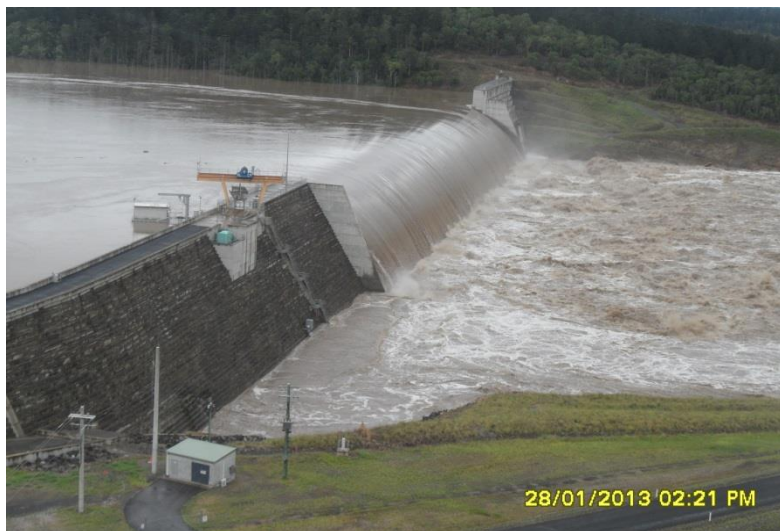
Figure 4. Flood behaviour January 2013

primary spillway, some deep scour adjacent to the apron, and removal of the end sill. Figure 4 is a photograph of the flood behavior, and Figure 5 illustrates the scoured surface over the area downstream of the spillway.

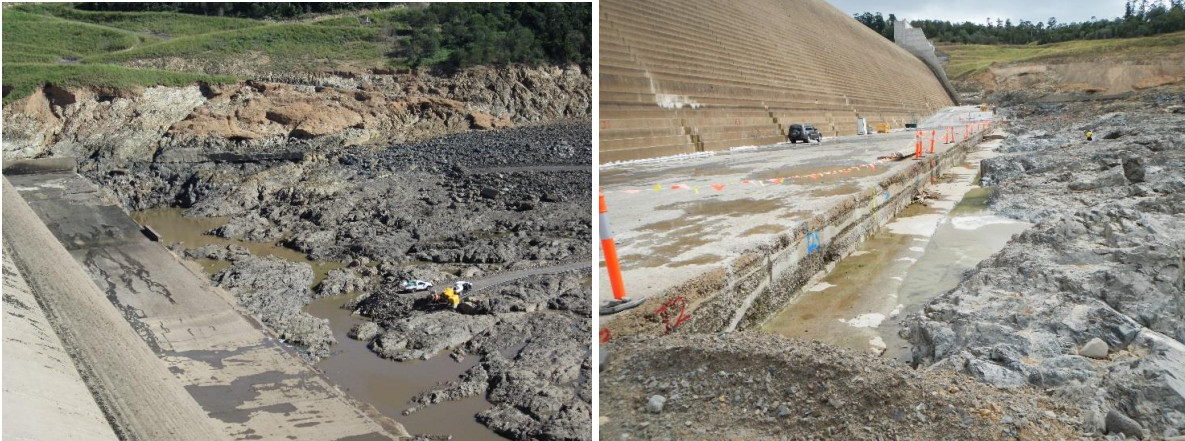
Figure 5. 2013 flood scour downstream of the primary spillway

The earlier flood produced some scour of material downstream of the spillway – mainly removal of alluvium and some movement of loose rock and rip rap. The 2013 flood, however, produced scour right across the length of the

The scour from the 2013 flood (Figure 5) demonstrated a geologic condition that provided scant resistance to the energy dissipated during the four-to-five day 2013 flood event. The dam is generally founded on metasediments known as the “Goodnight Beds” except on the right side where it is founded on basalt. Following the flood of 2013 and subsequent scour, further geotechnical investigations were undertaken. Features of particular note are faults, termed the “Paradise Fault” and the apron faults.

The deep scour that occurred in the 2013 flood, relatively close to the apron, including the removal of the vertical end sill, led to a series of investigations and analyses related to dam stability and the part that the geologic conditions played in the dam's integrity. It was necessary to augment the geologic knowledge of the site by extensive site investigations and mapping.

The safety evaluations included not only the depth of scour that had occurred – up to 13 m below apron level in one location – and the geologic investigations, but also investigation of the integrity of the concrete in the spillway apron. At an early stage following the 2013 flood, concrete works were implemented immediately downstream of the apron and included a capping slab on the apron itself. These measures were simply a precaution while the more detailed studies were being carried out.

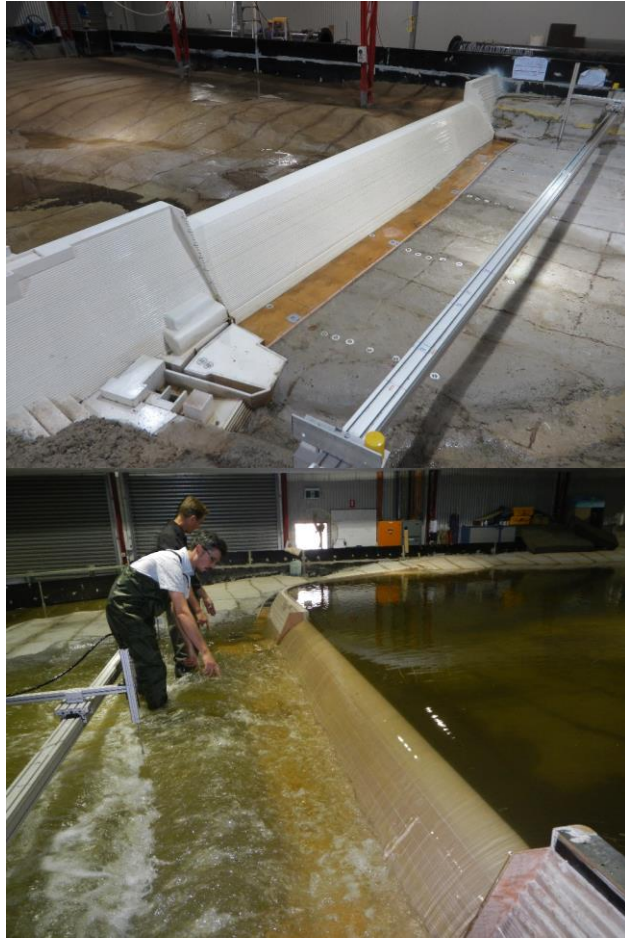
Figure 6. Model showing pressure transducer lines

The model was built to a scale of 1:70, with the ability to test for discharges up to the AEP 1 in 10,000. It was set up to investigate the spillway's as-built condition, the post-2011 flood condition, the post-2013 flood condition including interim works mentioned above, and studies of the secondary spillway overflow of the right abutment of the dam. Figure 6 provides a general view of a portion of the model with some of the flush-diaphragm transducers. Figure 7 shows the model operating at a mid-range discharge. Model instrumentation included more than 60 pressure transducers, a large number of piezometers, and an Acoustic Doppler Velocimeter (ADV) with electromagnetic flow metering up to model discharges of 1,200 L/s. Figure 8 illustrates the pressure transducer coverage on several lines.

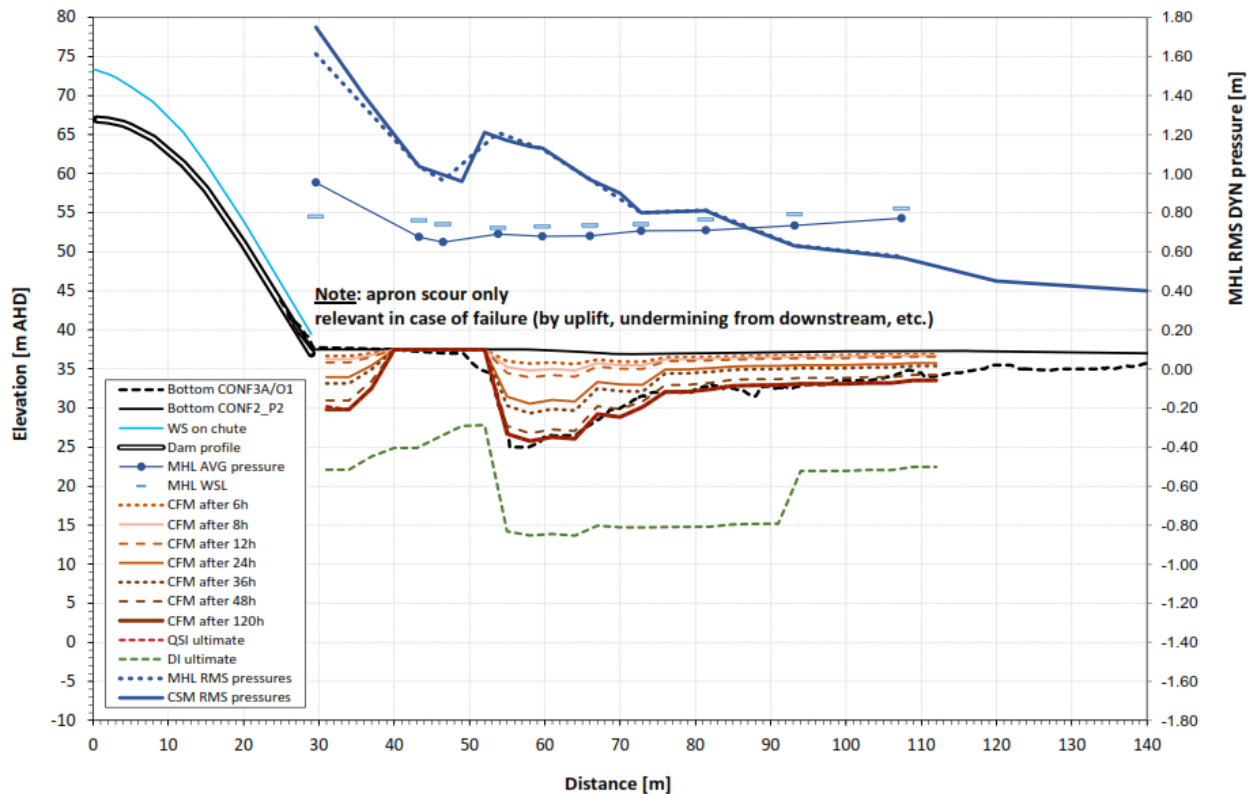
Figure 9. CSM calibration for the 2013 flood hydrograph

The detailed analyses that have applied the CSM procedures passed through two stages of calibration using the actual flood hydrograph in histogram format and use of the calibrated model to estimate various scour flood discharge scenarios. The calibration, for the most part, used the actual hydrographs of the 2013 flood. The calibration analyses for one of the profiles downstream of the spillway, Line 2 (see Figure 8), are shown in Figure 9.

The profiles show the analysis of scour for the three modules described above (CFM, QSI, and DI). In this flood, the rock scour was extensive. There are some key profiles to note. In light blue, the average of the dynamic pressures elevation from the transducers is shown. In heavy blue, the standard deviation of the measured and CSM calculated fluctuations is shown (read right). Other key profiles are in brown and show the estimate of progressive scour with exposure times for 6 to 120 hours. These may be compared to the black dashed profile, which is the surveyed profile following the 2013 flood.

On the basis of a successful calibration, as adjudged from the profiles exemplified in Figure 9, the CSM procedure was in a position to proceed to analysis of future scour. For those procedures, it was necessary to determine a long-term series of flood discharges that could be applied to determine on a time or year basis the expected scour that could occur downstream of the primary spillway. Using the selected discharge scenarios and the dynamic pressures and flow velocities as measured on the physical model, the CSM was set up also to investigate possible works if they were determined to be required.

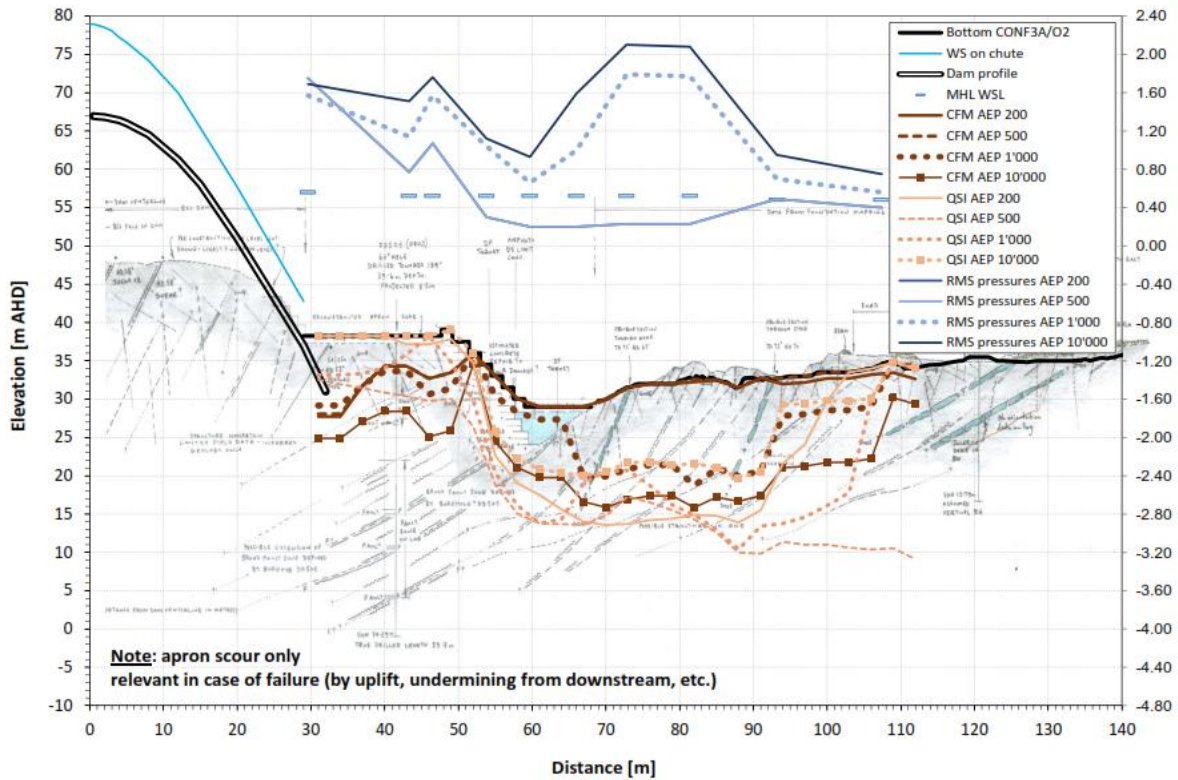
Figure 10. Estimate of future scour progress for a range of large flood discharges

Figure 10 is an example of the estimated potential scour downstream of the existing apron for a range of discharges devised to represent a scenario of six floods with discharges ranging from an AEP of 100 to and AEP of 1 in 10,000. While each module of the CSM procedure is shown (brown, red dashed, and green dashed), the time estimate of

scour using the Comprehensive Fracture Mechanics module, shown in brown, is deemed to represent the possible scour progress for the selected hypothetical range of floods and discharges. As noted on the figure, the scour profiles “under” the apron (distance 30m to 50m) apply to the possible scour in the event that the apron was actually removed.
