International Symposium on Hydraulic Structures

Nappe Vibration Mitigation Techniques for Free-overfall Structures

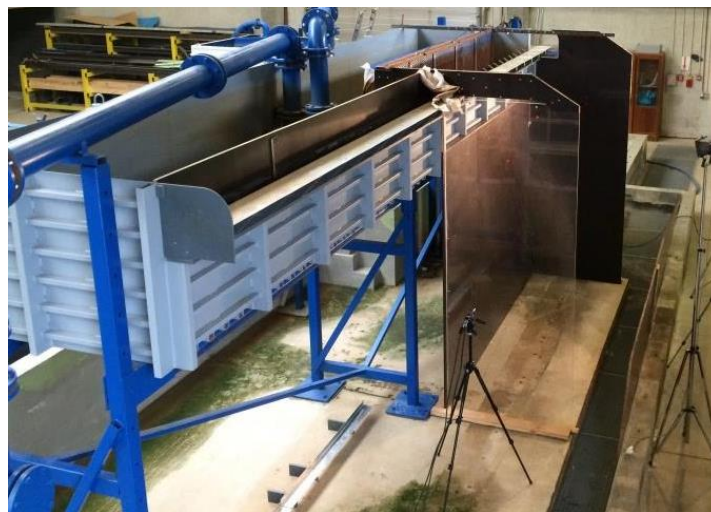
The experimental apparatus used in this study is located at the Engineering Hydraulics laboratory of the Université de Liège. It is illustrated in Figure 1. This large-scale model is a confined prototype-scale linear weir with a 3.46-m long crest and a 3.04-m high chute. The fall of water from the weir is confined between two lateral walls and a back wall, one lateral confinement wall being transparent (Plexiglas) and the others black multiplex panels.

Figure 1. Prototype-scale model

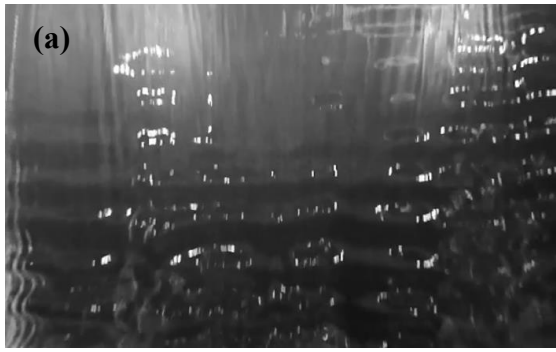
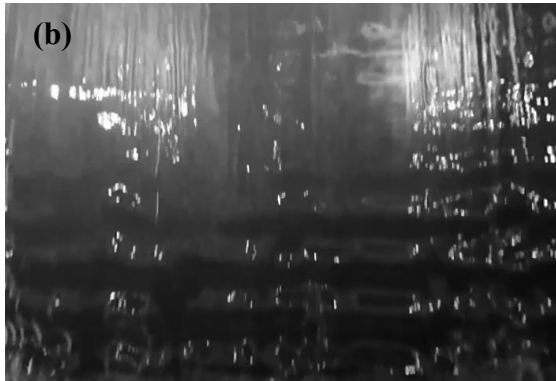
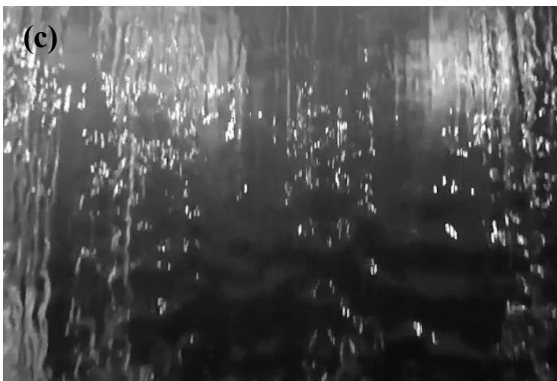
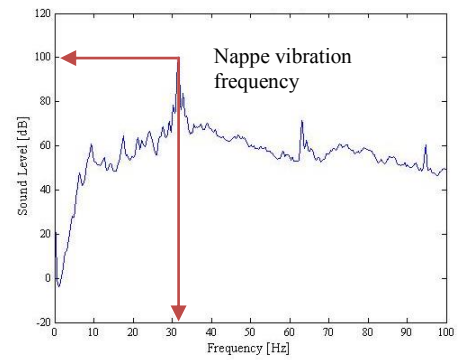
A preliminary study has been conducted on the non-modified quarter-round crest to establish the flow range that induces nappe vibrations and to characterize nappe vibration acoustics. This characterization is based on acoustic measurements and flow visualization. Audio and image recordings with a microphone and a high-speed camera (240 fps) have been made for various flow rates. A Fourier transform has been applied to the acoustic signal in order to isolate the dominant frequencies, and the lens distortion of the extracted images has been corrected. High-speed camera images in combination with Fourier transform of sound recording are illustrated in Figure 3 for a range of unit discharges.

Figure 3. Nappe vibration visualization and associated Fourier transform of sound recording for (a) $0.015 \text{ m}^2/\text{s}$, (b) $0.03 \text{ m}^2/\text{s}$, (c) $0.045 \text{ m}^2/\text{s}$ and (d) $0.06 \text{ m}^2/\text{s}$

For unit discharges between $0.01 \text{ m}^2/\text{s}$ and $0.07 \text{ m}^2/\text{s}$, measurements give a dominant frequency that varies between 30.75 Hz and 35.5 Hz. The associated sound level reported as a function of the discharge in Figure 4, combined with the visualization of nodal lines, allowed researchers to detect nappe vibration regions. Three distinct areas can be observed and distinguished from a hypothetical behavior without vibration (dashed line). Indeed, a significant increase of the sound level that exceeds 80 decibels (the mean sound level) occurs as the discharge increases up to $0.025 \text{ m}^2/\text{s}$. Then, the sound level remains steady in the range of 100 dB for discharges ranging from $0.025 \text{ m}^2/\text{s}$ to $0.045 \text{ m}^2/\text{s}$. Finally, as the nappe oscillation visually disappears, the sound level decreases and tends to stabilize at 80 dB. This base configuration analysis documents a baseline range of nappe vibration for unit discharges between $0.015 \text{ m}^2/\text{s}$ to $0.05 \text{ m}^2/\text{s}$.

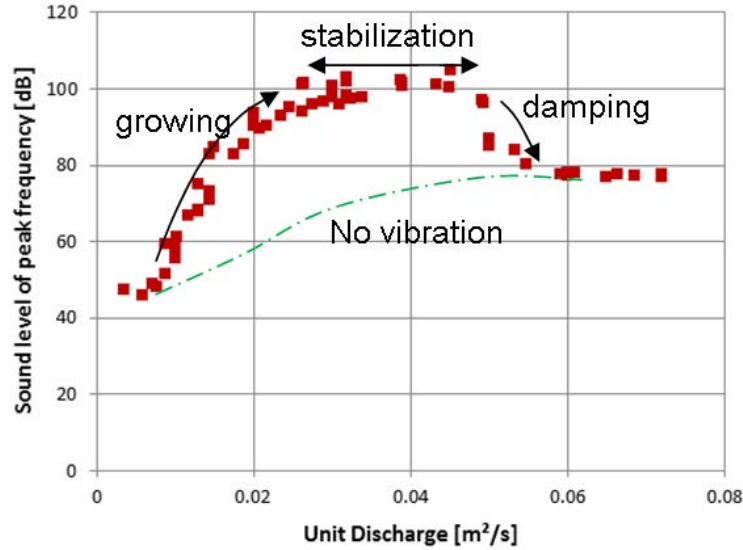
Figure 4. Detection of nappe vibration region using Fourier transform of sound recording

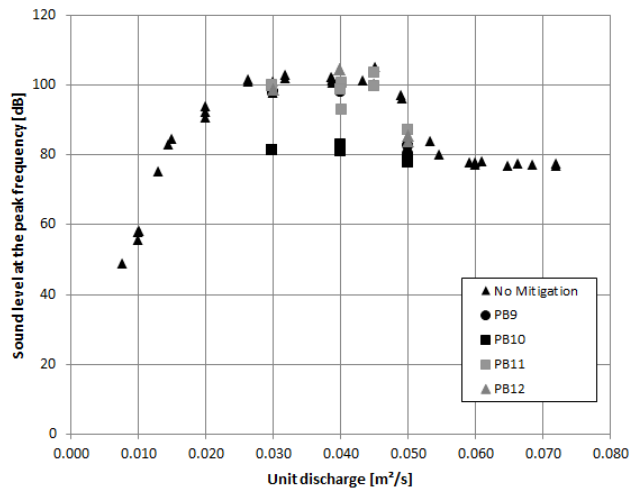
For projecting bolts, the first stage was research into the minimum bolt height required for a specific spacing and position, e.g., 10 cm and position 1 (configurations PB1 to PB4). Then, the bolt spacing was optimized for a fixed bolt height (configurations PB4 to PB8). The results of this first stage of experiments are illustrated in Figure 5 and show that the optimal configuration of projecting bolts is the configuration PB 6. Finally, in order to reduce the potential for debris collection, two additional positions (2 and 3) have been tested and optimized (configurations PB9 to PB12). The results of this second stage of experiments is illustrated in Figure 6; unfortunately, neither position was very effective.

Figure 6. Evolution of sound level at the peak frequency with unit discharge: configurations PB9 to PB12 (projecting bolts mitigation technique)
