## Emerging Technology to Exclude Wildlife from Roads: Electrified Pavement and Deer Guards in Utah, USA

EMERGING TECHNOLOGY TO EXCLUDE WILDLIFE FROM ROADS:  
ELECTRIFIED PAVEMENT AND DEER GUARDS IN UTAH, USA

A thesis submitted in partial fulfillment  
of the requirements for the degree

Wildlife Ecology

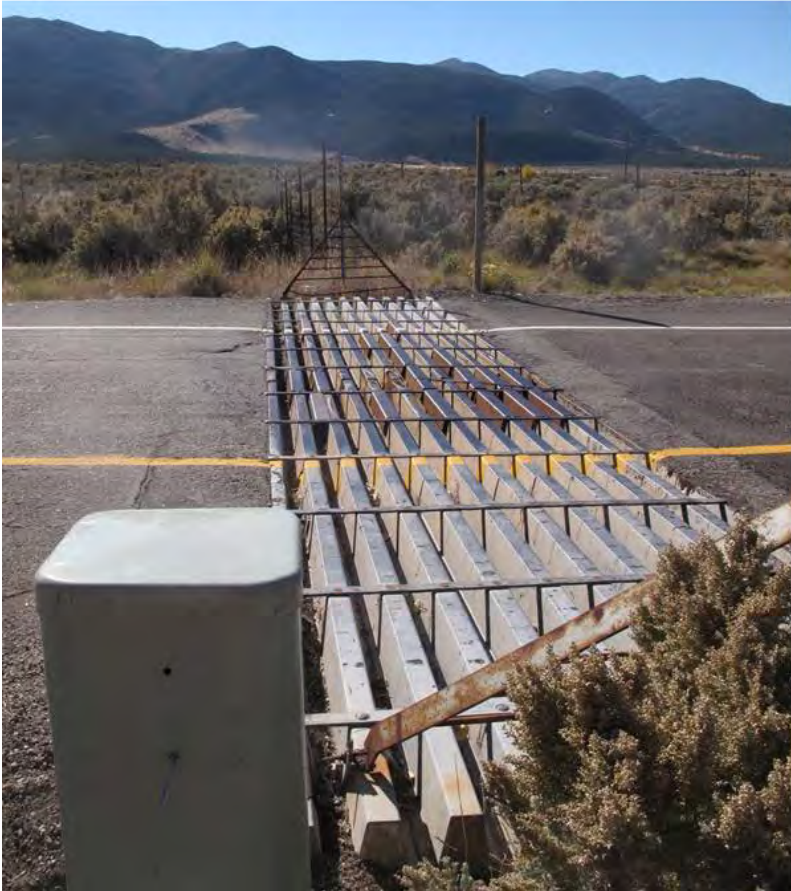
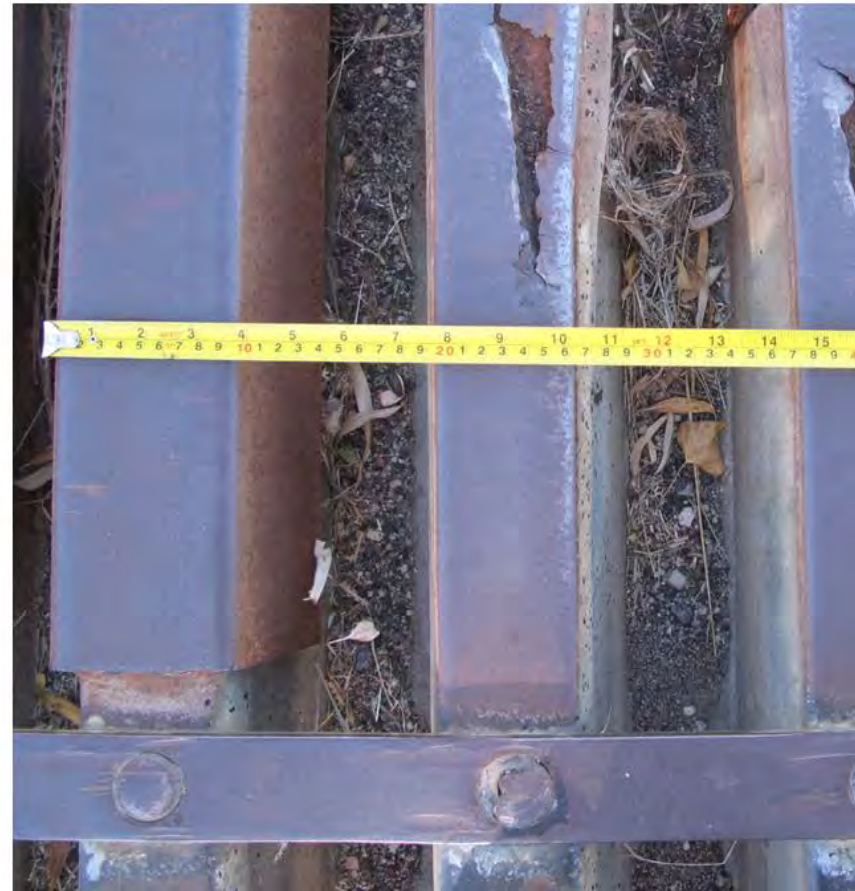
**Figure 2.** Cattle guard (1.9-m  $\times$  9.7-m) not constructed over excavation (A) and close view of cattle guard rails (B) on an access road to Interstate 15, near Summit, Utah, USA.

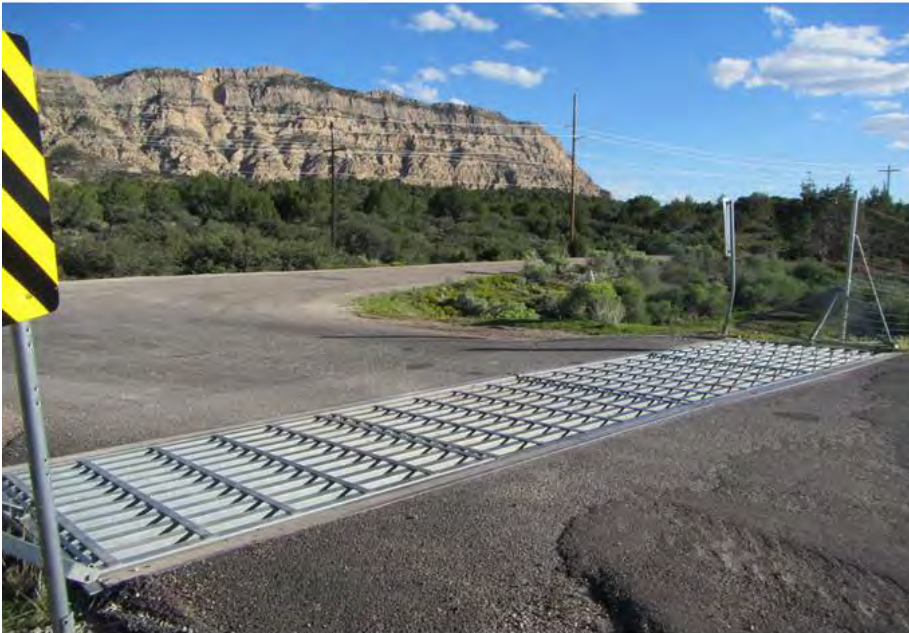
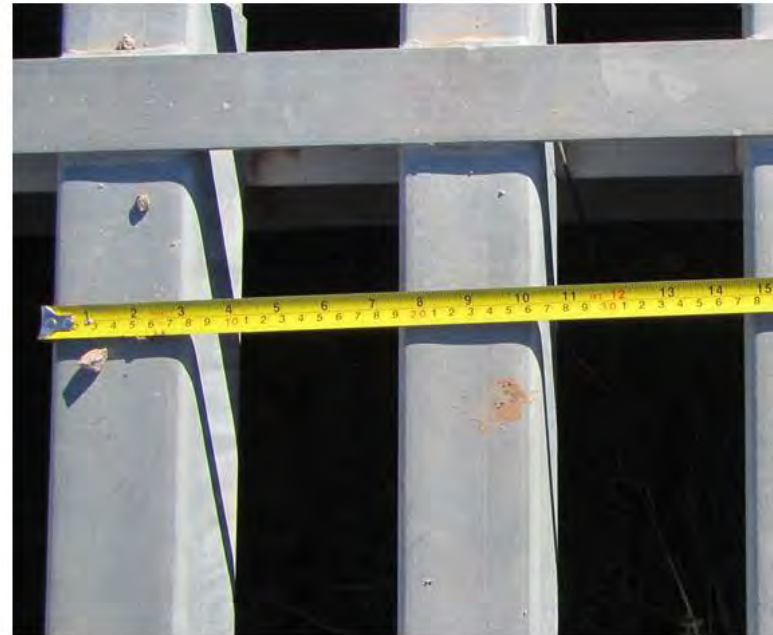
**Figure 3.** Standard cattle guard (2.1-m × 11-m) suspended over excavation (A) and close view of cattle guard rails (B) on an access road to Interstate 15, near Pintura, Utah, USA.

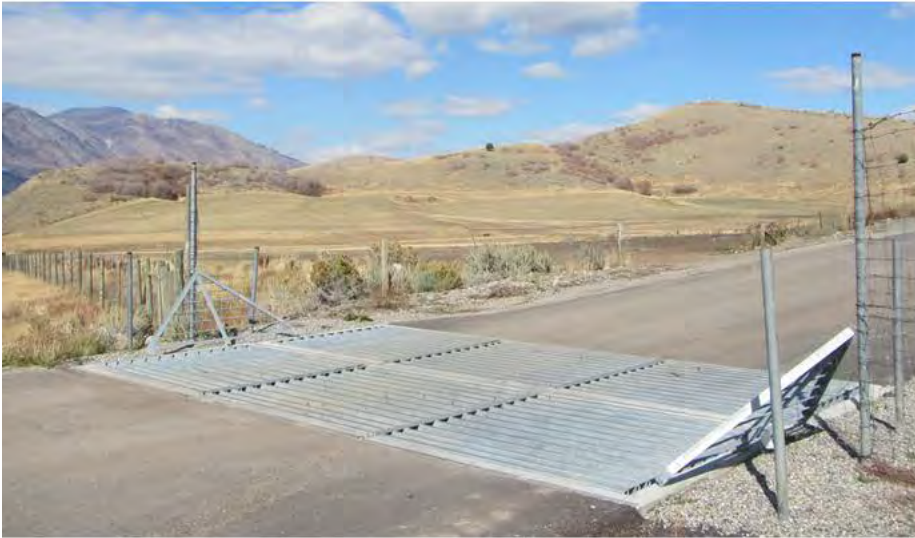
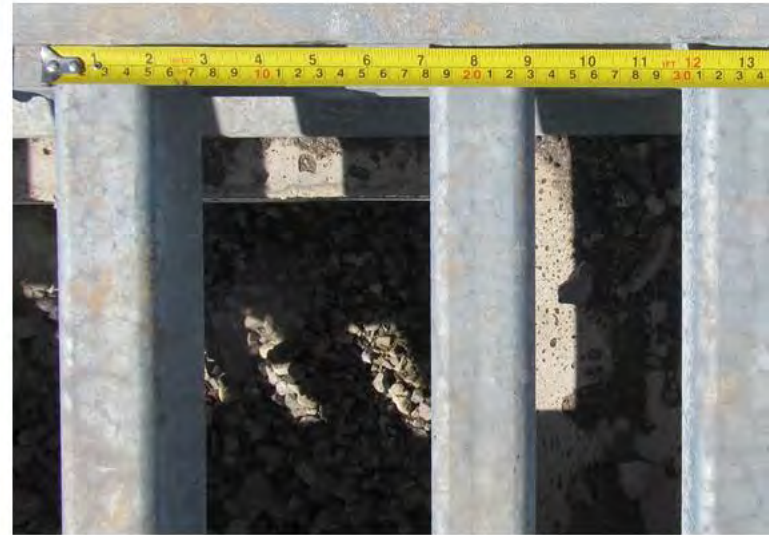
**Figure 4.** Double cattle guard (4.6-m × 7-m) suspended over excavation (A) and close view of cattle guard rails (B) on an access road to U.S. Highway 91, north of Mantua, Utah, USA.

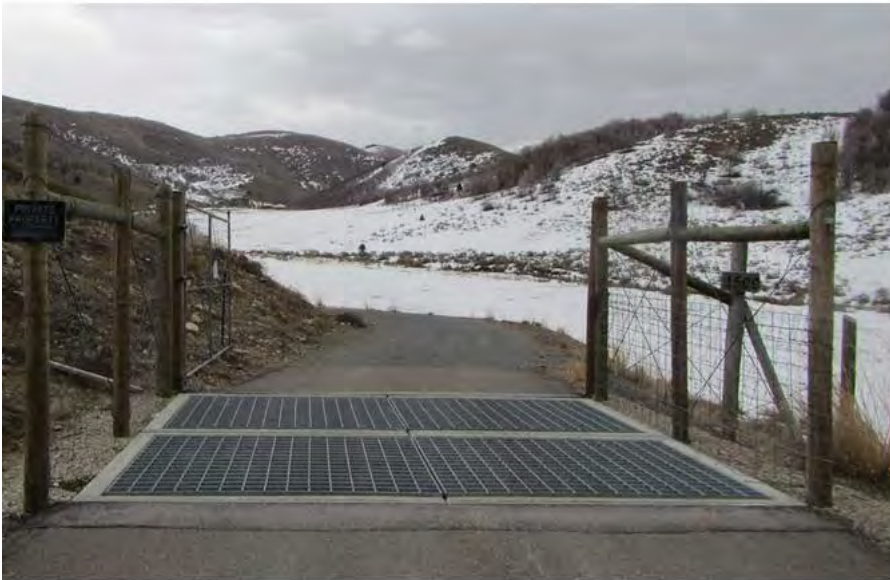
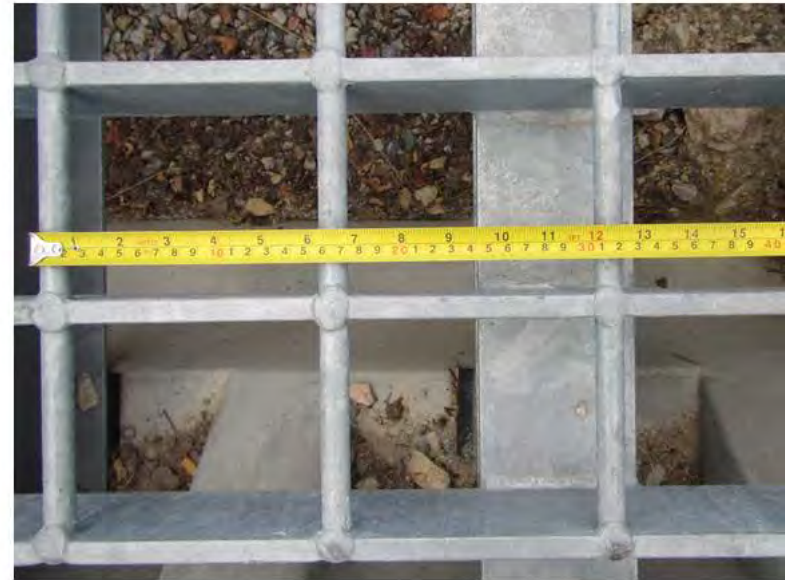
**Figure 5.** Wildlife guard (4.9-m × 4.9-m) suspended over excavation (A) and close view of steel grating (B) on an access road to U.S. Highway 91, near Mantua, Utah, USA.

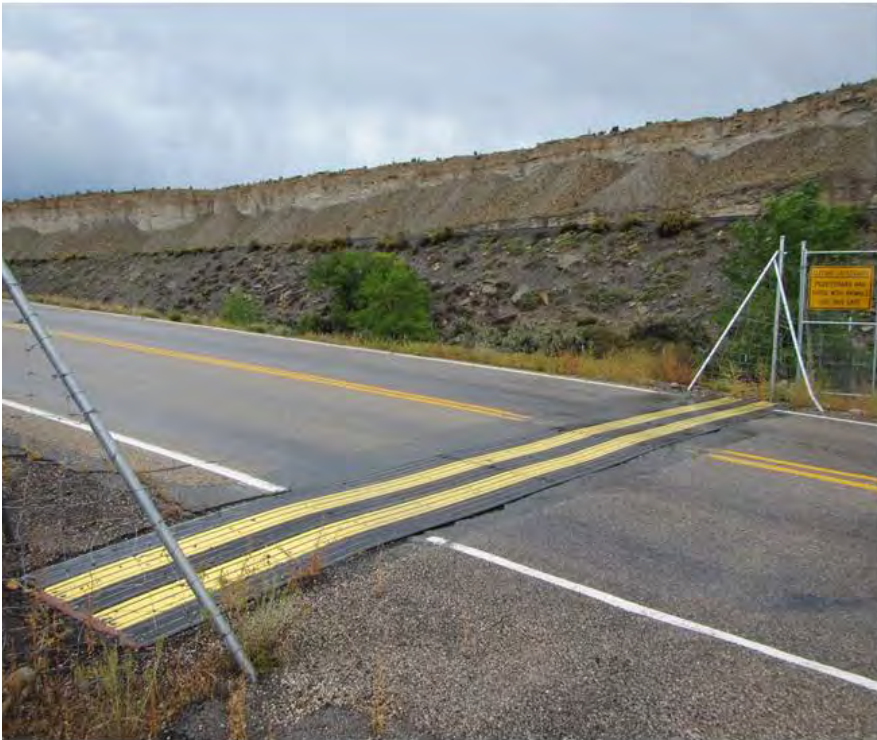
**Figure 6.** Electrified mat (1.2-m × 11-m, A) and close view of composite planks with embedded metal electrodes (B) on an access road to U.S. Highway 6, near Helper, Utah, USA.

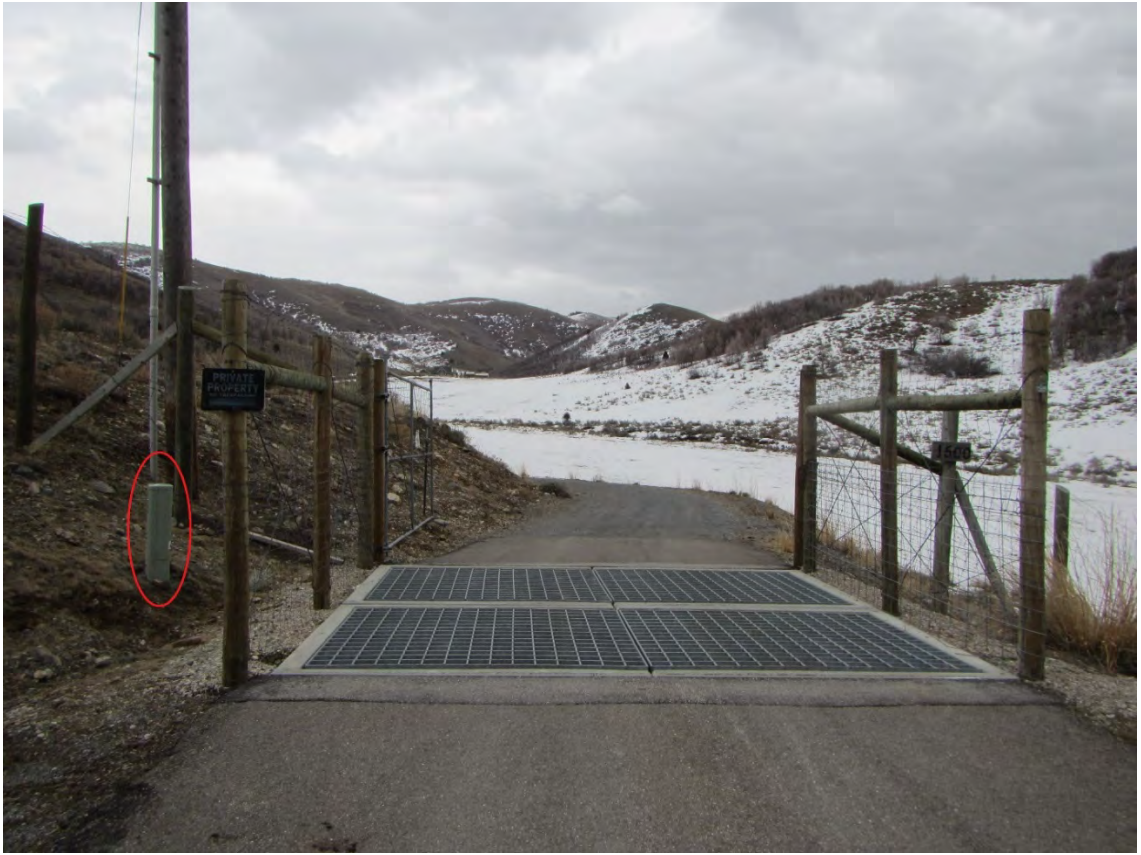
**Figure 7.** Motion activated wildlife camera (circled) used to monitor wildlife approaches to a wildlife guard on an access road to U.S. Highway 91, near Mantua, Utah, USA.

At each site, we deployed one motion activated wildlife camera on the highway entry side of each barrier to continuously monitor wildlife approaches. We mounted cameras within steel utility boxes to deter theft (Fig. 7 and Fig. 8). With the exception of one camera that was in place prior to the study, all cameras were deployed beginning in September 2013 and most were maintained continuously until late April 2015 (Table 1). We visited monitoring locations on a monthly basis to download images, replace batteries, and ensure proper camera function. We programmed cameras to take 1 to 5 images as fast as possible for each motion trigger. To prevent rapid power loss from repeated vehicle detections, we programmed most cameras to detect motion only during crepuscular and nighttime periods when wildlife were most active.

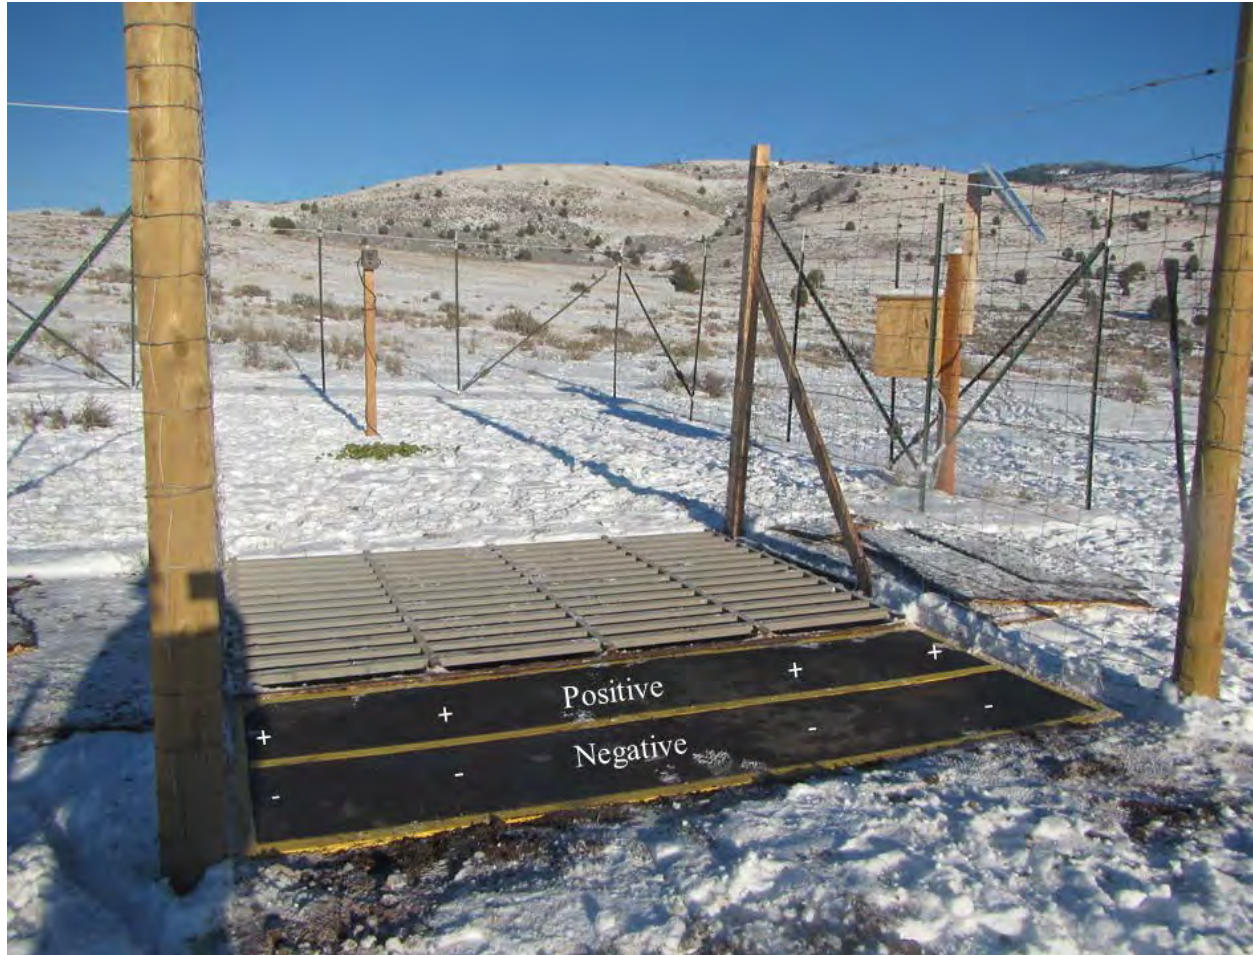
**Figure 11.** Close view of a 10 × 10-m wildlife enclosure used to test efficacy of 3 × 2.1-m cattle guards augmented with either 3 × 1.2-m (n = 2; pictured) or 3 × 0.91-m (n = 2) electrified pavement as an ungulate barrier at Hardware Ranch Wildlife Management Area, Utah, from mid-Oct 2014 to mid-March 2015. Positive and negative symbols added to indicate polarity of electrified pavement.

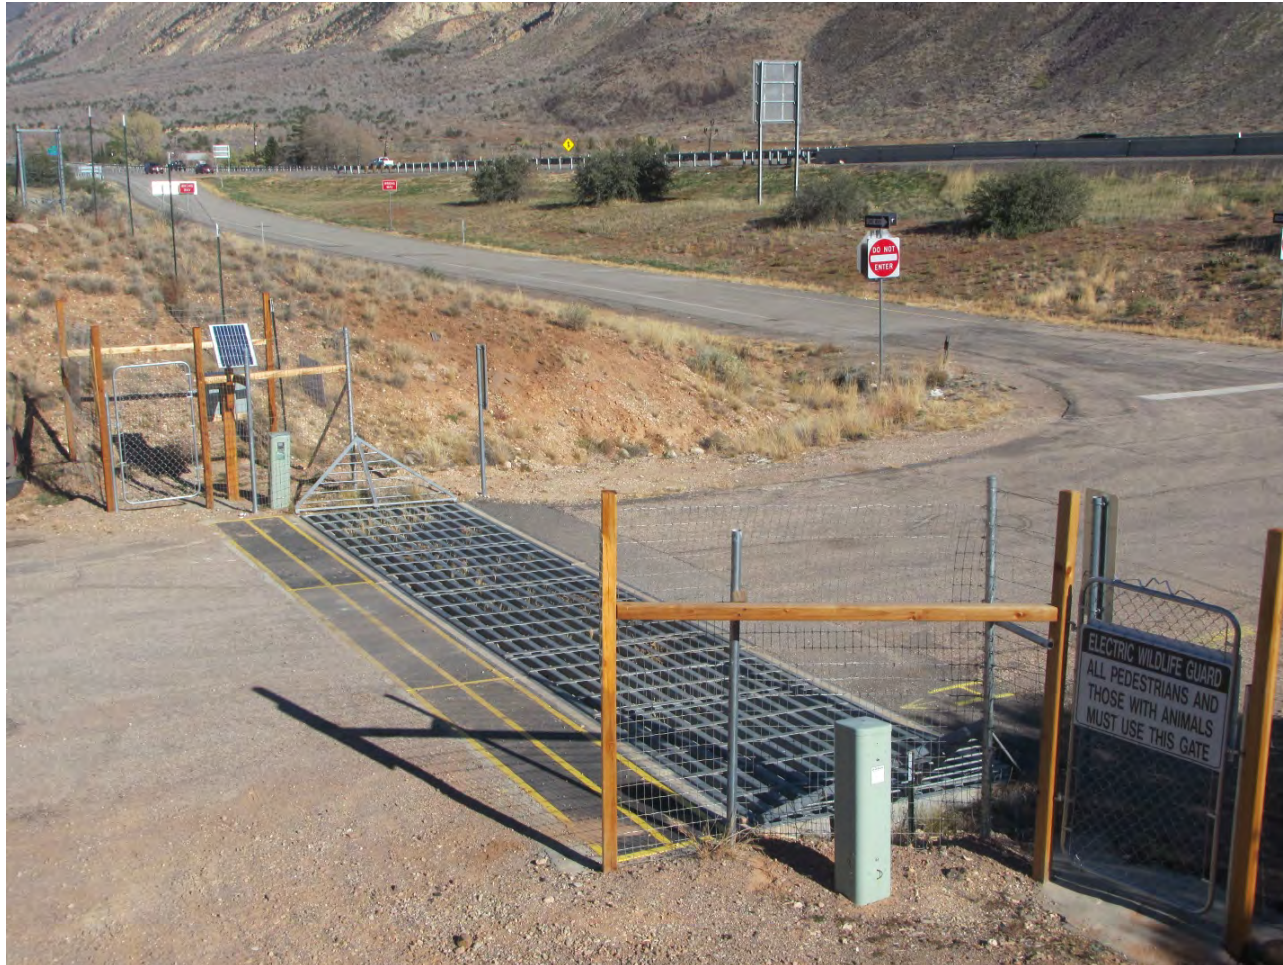
**Figure 13.** Cattle guard (2.1-m  $\times$  11-m) augmented with electrified pavement (0.91-m  $\times$  11-m) on access road to Interstate 15 (background), near Pintura, Utah, USA.

I observed 61 independent events in which mule deer approached within 2-m of the cattle guard augmented with a strip of 0.91-m-wide electrified pavement. Of these, 37 events (60.7%) resulted in a crossing event, in which one or more mule deer completely breached the guard and gained access to the fenced highway segment (Table 19). However, 31 of 37 (83.7%) crossing events occurred when deer breached through a 20-cm-wide gap between edge of the electrified pavement and the fence that was left unmitigated when the deterrent was installed. Further, I was unable to decipher whether deer crossed, or did not cross, in 24.6% of the events. I incorporated uncertainty from

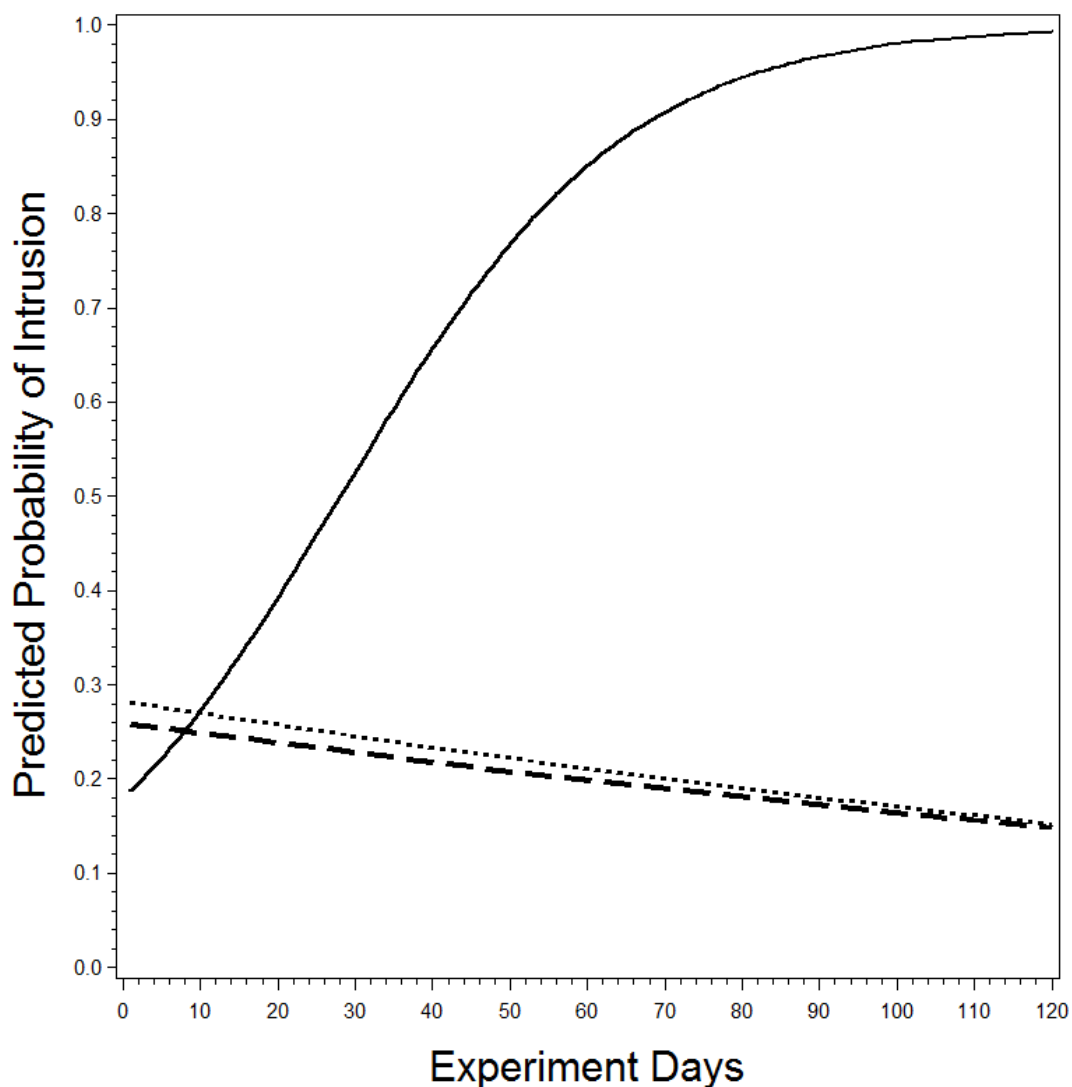
**Figure 16.** Effect of experiment day on the predicted probability of mule deer intrusion over the 17-week treatment period (mid-Nov 2014-mid-Mar 2015) at Hardware Ranch Wildlife Management Area, Utah, USA. Results from logistic model using observations from exclosures within block 1 during snow and snow-free conditions. As the feeding trial progressed, the likelihood of deer intrusion into exclosures treated with cattle guards increased significantly (control, solid line). Intrusion likelihood declined, though not significantly, at exclosures treated with cattle guards augmented with 0.91-m-wide electric pavement (treatment 1, dotted line) or 1.2-m-wide electric pavement (treatment 2, dashed line). The likelihood of deer intrusion did not differ among treatments 1 and 2, but was significantly higher at controls when compared with either treatments.
