## The Effect of Polymethylmethacrylate Bone Cement Vibration on the Bone-Cement Interface

Thomas, A. M. C.; McMinn, D. J. W.; Haddaway, M.; and McCall, I. W. (1992) "The Effect of Polymethylmethacrylate Bone Cement Vibration on the Bone-Cement Interface," *Cells and Materials*: Vol. 2 : No. 2 , Article 7.

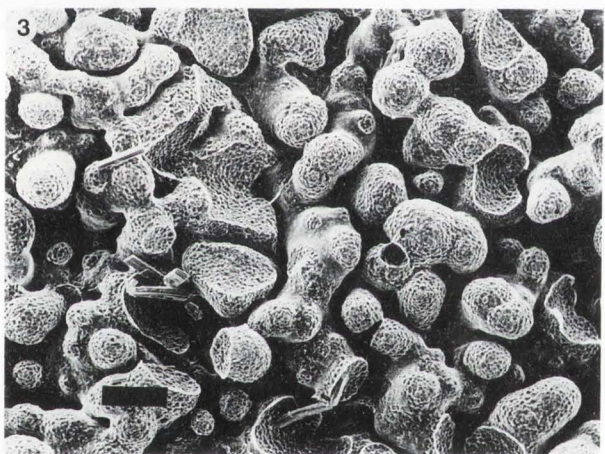
**Figure 3:** Scanning electron micrograph of cement surface in *in-vitro* control sample, after removal of bone using EDTA. The ends of the streams of PMMA are seen end on, from the direction of the bone. Scale 1 mm.

The scanning electron micrographs show that in control samples, the PMMA flows into the interstices of the cancellous bone (Fig. 3). The individual streams of PMMA are easy to recognize and the ends of the PMMA streams have rounded heads to them. The ends of the PMMA streams do not coat the cancellous bone very well. In the vibrated samples (Fig. 4), there is more bone material left adherent to the PMMA, the ends of the PMMA streams are more sharply cut off, and the PMMA appears to coat the bone trabeculae more effectively.

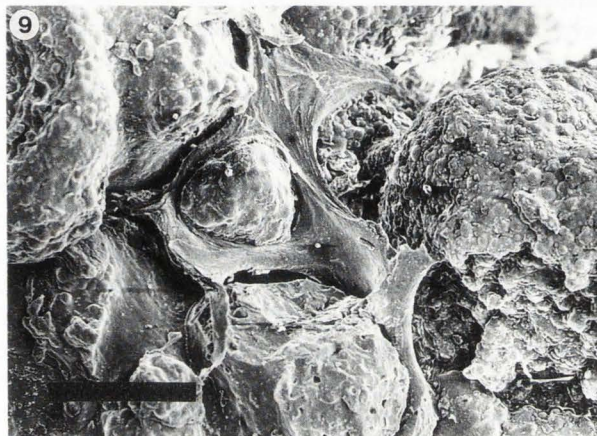
**Figure 9:** Scanning electron micrograph of cement surface following high pressure injection *in-vivo*. The cement streams are well moulded onto the bone trabeculae, and there is some residual bone material remaining after removal of bone mineral using EDTA. Scale 500  $\mu\text{m}$ .

SEM of the bone-cement interface *in-vivo* shows a featureless surface reflecting minimal cement penetration following the low pressure injection (Fig. 8). Following high pressure injection, there is a marked improvement in the bone-cement interlock with cement well moulded to the trabecular structure of the bone (Fig. 9). With vibration there is a similar marked improvement but due to differences in the structure of the cancellous bone, it is difficult to distinguish the effect from the high pressure injection (Fig. 10).
