21st European Conference on Fracture, ECF21, 20-24 June 2016, Catania, Italy

Applications of Residual Stress in Combatting Fatigue and Fracture

M N James ^{a, b*}, D G Hattingh ^b, D Asquith ^c, M Newby ^d and P Doubell ^d

Keywords: residual stresses; steam turbine blade and disc; friction taper hydro-pillar processing; weld repair; cracking

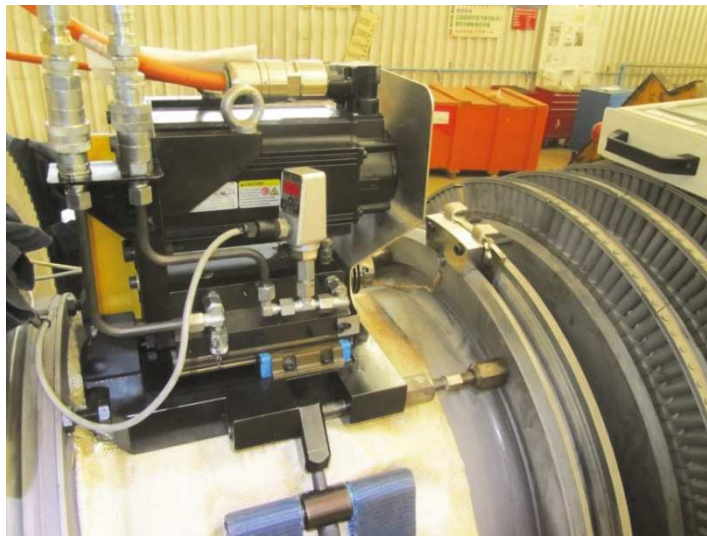
Figure 1. Illustration of the bespoke FTHP platform in position on a stream turbine rotor. It uses the registered WeldCore® process and is capable of extracting an annular metallurgical sample through the thickness of the blade attachment t-slot wall, repairing and re-drilling the hole in a single sequence of operations.

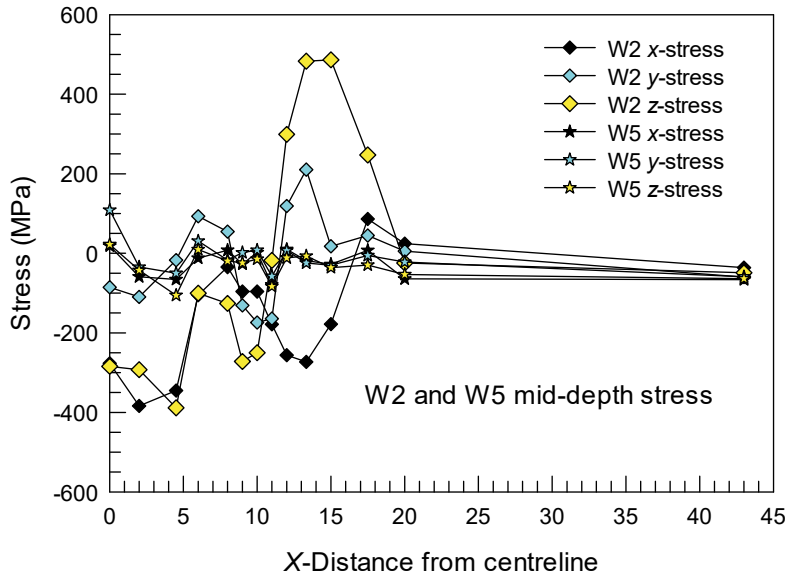
Figure 4. Comparison between the mid-depth values of residual stress in all three coordinate directions for specimens W2 (as-welded and undrilled) and W5. The edge of the original hole in the blade would have been at the x = 4 mm position.

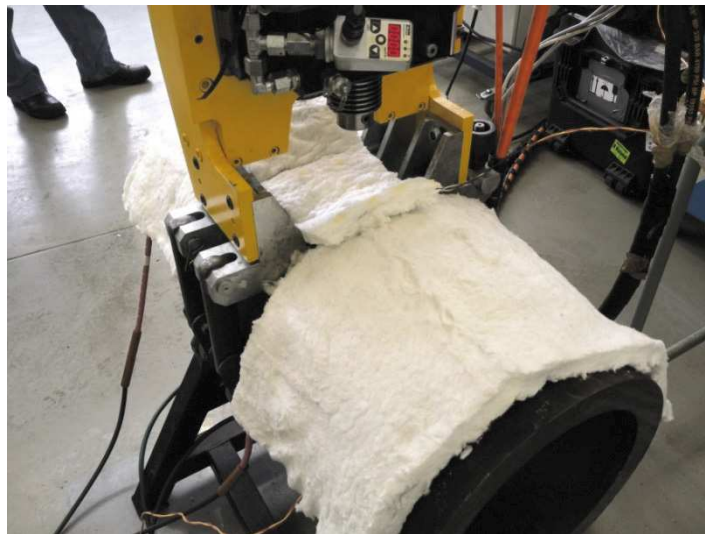
Figure 6. FTHP processing platform in-situ on a section of thick walled steam pipe. The pads are for preheating the pipe to approximately 200°C prior to commencing the WeldCore® process.

The sequence of events in the WeldCore® creep sampling process is shown in Figure 5 and the FTHP platform is shown in position attached to a piece of steam pipe in Figure 6. In the original planning for this experiment, specimens were prepared from two locations spaced at 90° intervals around the circumference of the pipe. At each position one as-welded specimen and one specimen that had been subjected to localised post-weld induction heat treatment were prepared. In the beamtime available in Experiment 1-02-128 it became necessary to concentrate the residual stress measurement effort on a single as-welded specimen (1A) and on a single specimen (2B) that had been welded and subjected to in-situ PWHT by induction heating (see Figure 7); these specimens were cut from circumferential positions 90° apart and a direct point-based comparison between the residual stresses before and after PWHT is therefore not possible. Nonetheless the residual stresses in the pipe would be expected to be similar

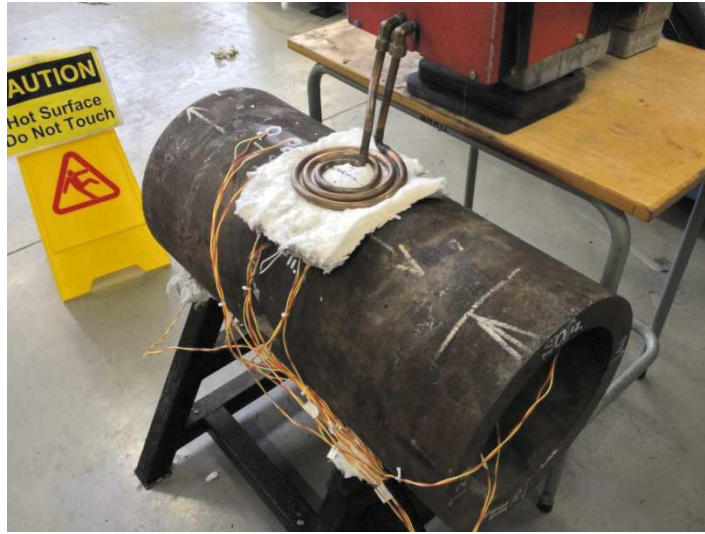
Figure 7. Induction heat treatment of the pipe after completion of the WeldCore® process.

at the two circumferential positions. Full details of the FTHP process are given in Table 1 and the consumable tool was manufactured from BS EN 10216 Grade 10CrMo9-10 (Material number 1.7380). The PWHT was limited to a maximum surface temperature of 800°C and induction heating was continued until the inner surface of the pipe reached 650°C which was then maintained for a minimum of 15 minutes. Cooling took place in still air conditions in the laboratory.

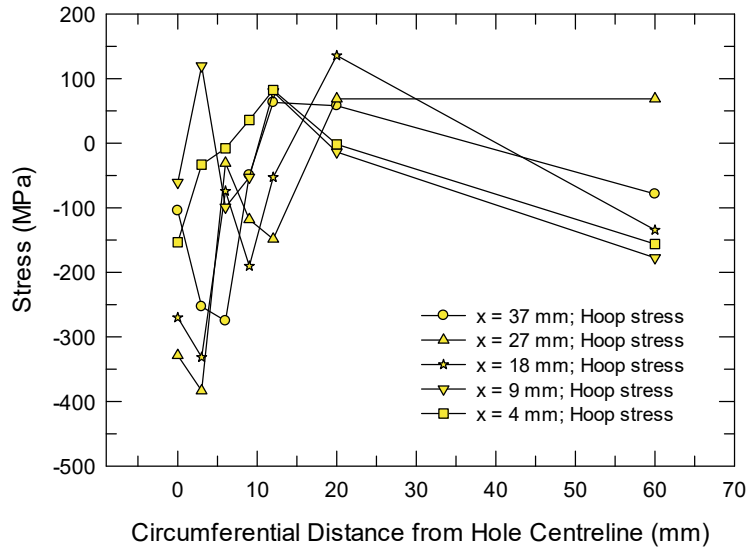
Figure 8b. Residual hoop stresses in specimen 2B after local PWHT by inductive coil.

Nonetheless, certain observations can be made from these hoop stress data; firstly, that at depths of 18 mm, 27 mm and 37 mm below the surface of the pipe, the large negative peaks that occur around the edge of the weld metal are reduced from peak values of 380 MPa to 450 MPa in the as-welded state, to values of around 275 MPa to 380 MPa. Secondly, the values of peak tensile hoop stress are also reduced at equivalent depths and, thirdly, the stress distribution moves in the tensile direction the closer to the outer surface the measurements are made (e.g. Figure 8b,

$x = 9$ mm and $x = 4$ mm). In all cases where data was obtained, the level of peak tensile hoop residual stress is < 120 MPa.

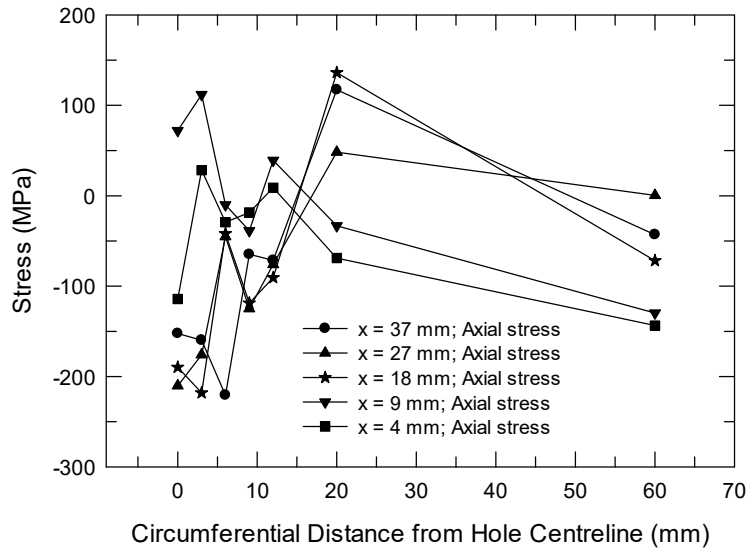
Figure 9b. Residual axial stresses in specimen 2B after local PWHT by inductive coil.

The same general observations are true of the axial stress measurements, although there is a significant difference in that the PWHT appears to sharply increase the stress variation across the heat-affected zone (HAZ) of the weld, between distances of 9 mm and 20 mm from the weld centreline. Peak values of tensile axial stress in all cases are < 140 MPa. Although experimental difficulties led to a smaller set of residual stress measurements than had been planned, it is clear that the FTTHP technique can be usefully employed for in-situ through-thickness creep sampling and that the level of tensile residual stress in the pipe wall is $< 50\%$ of the lower yield strength of the steel. Localised PWHT reduces the peak negative stresses by some 16% in the hoop direction in the pipe and by up to 38% in the axial direction.

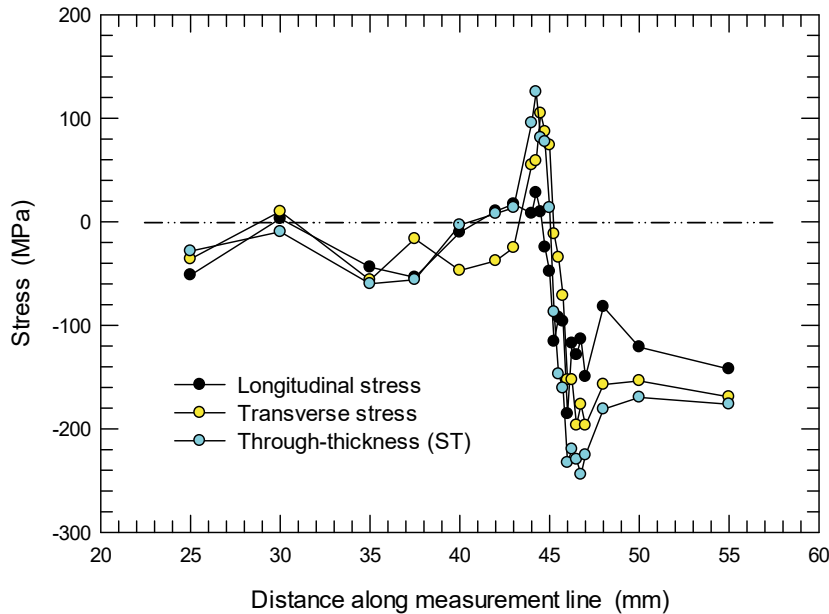
Figure 12b. Residual stress data measured in the PWHT tenon sample.

cases, and the resulting 3D residual stress data are shown in Figure 12a (as-welded) and Figure 12b (PWHT). The zero point for the x -axis of Figure 12 is the bottom surface of the test coupon, so the original fusion boundary is at $x = 45$ mm. It is clear that a substantial level of triaxial tensile stress exists on either side of the fusion boundary with peak values of circa 600 MPa. At the fusion boundary the peak stresses have reduced in value with the values in the T and ST directions tending to be negative, while the longitudinal stress remains tensile. It is clear that turbine blade tenons would have a significant risk of experiencing SCC, hydrogen-assisted cracking or fatigue.

In contrast after PWHT, the residual stress peaks are more localised to the fusion boundary transition and the peak tensile values are reduced to 100 – 120 MPa. A small region (≈ 2 mm wide) of triaxial tension still remains associated with the fusion boundary zone.
