# Evaluation of the Use of Lithium Compounds in Controlling Alkali-Silica Reactivity in Concrete Pavement

Nebraska Department of Roads  
Project Number RDT-QX5(1)

**October 2005**

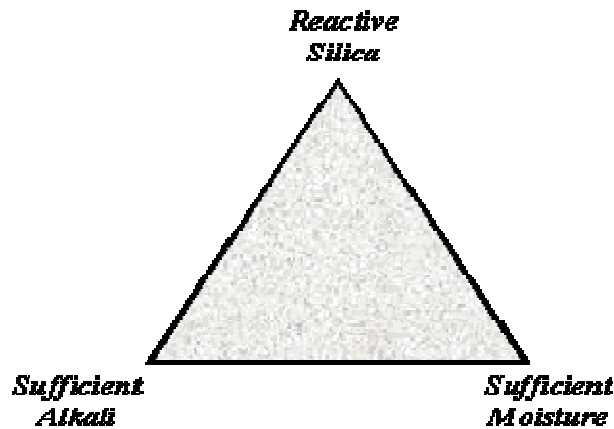
ASR Triangle

For ASR to occur, three essential components must be present as shown in the following diagram: (1) reactive forms of silica in the aggregate, (2) sufficient alkalis primarily from the cement, and (3) sufficient moisture.

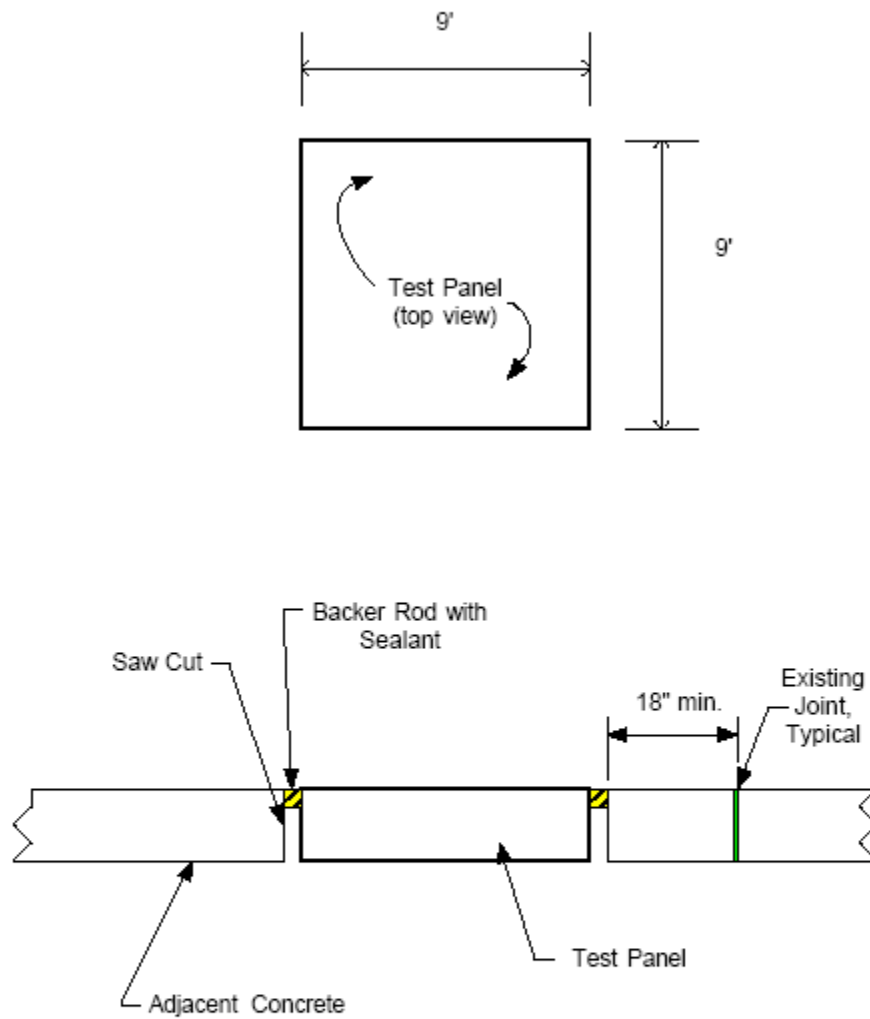
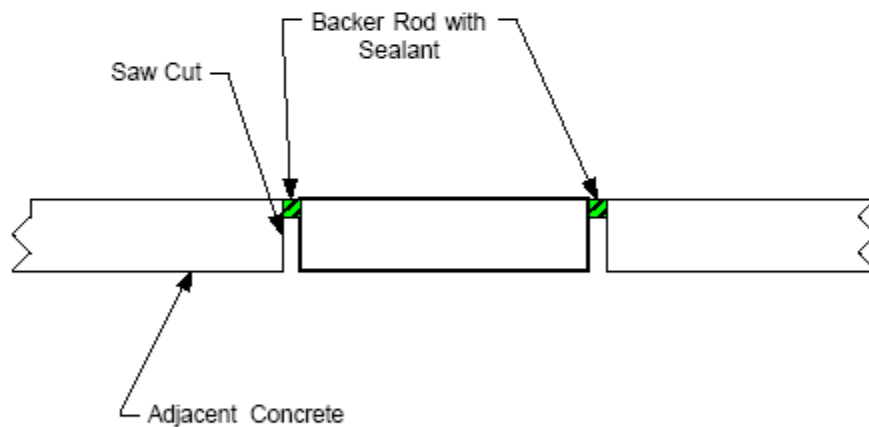
Figure No. 3

- Map Cracking & Photographic Documentation
- - - Impact Echo
- ▨ Schmidt Hammer & V-Meter
- ⊗ Demac Points

Various non-destructive evaluation (NDE) techniques were utilized to evaluate the pavement condition prior to and following the lithium treatments. These techniques included impact echo testing, Schmidt Hammer, V-meter testing, crack mapping, photographic survey, and expansion and contraction measurements. The locations of all the nondestructive tests conducted on a typical concrete panel are presented in Figure 3, Appendix I.

placed under the frame, and cracks, holes and other apparent surface defects were then traced onto the plastic sheets. Each one of the five (5) areas was tied to specific reference point locations for future repeatability. The locations of cracking mapping locations on the concrete panels are shown in Figure 3, Appendix I.

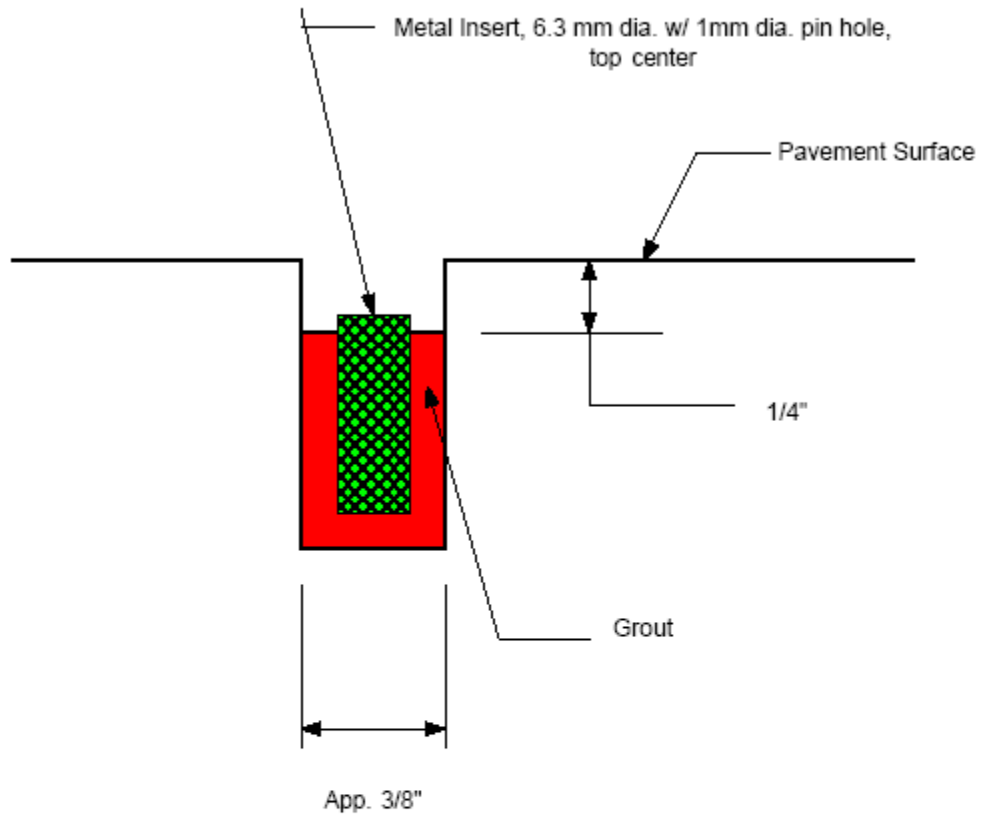
Figure No. 4

**Pavement Insert (DeMac Point) Detail**  
(no scale)

As a means to physically measure expansion and contraction of the concrete pavement, stainless steel knurled pins (or Demac points) having 1-mm diameter pin hole on the top, were inserted and grouted into pre-drilled holes in the pavement, as shown on Figure No. 4, Appendix I and in Photo Nos. 23 & 24. The depth of the drilled holes was such that the top of the pins were located approximately 0.25” below the pavement surface. There were nine (9) Demac points installed in each panel as previously shown in Photo No. 24. A four (4)-ft long, digital caliper with an accuracy of 0.001 inch was used to measure the distances between adjacent Demac points, as shown in Photo No. 25. All distances were read twice (i.e., in both directions) and then averaged to ensure data accuracy. Initial measurements along with ambient temperature readings were recorded before lithium treatment for a baseline reference. Following the initial measurements, the drilled holes were sealed with a flexible sealant that could be removed at a later time for subsequent

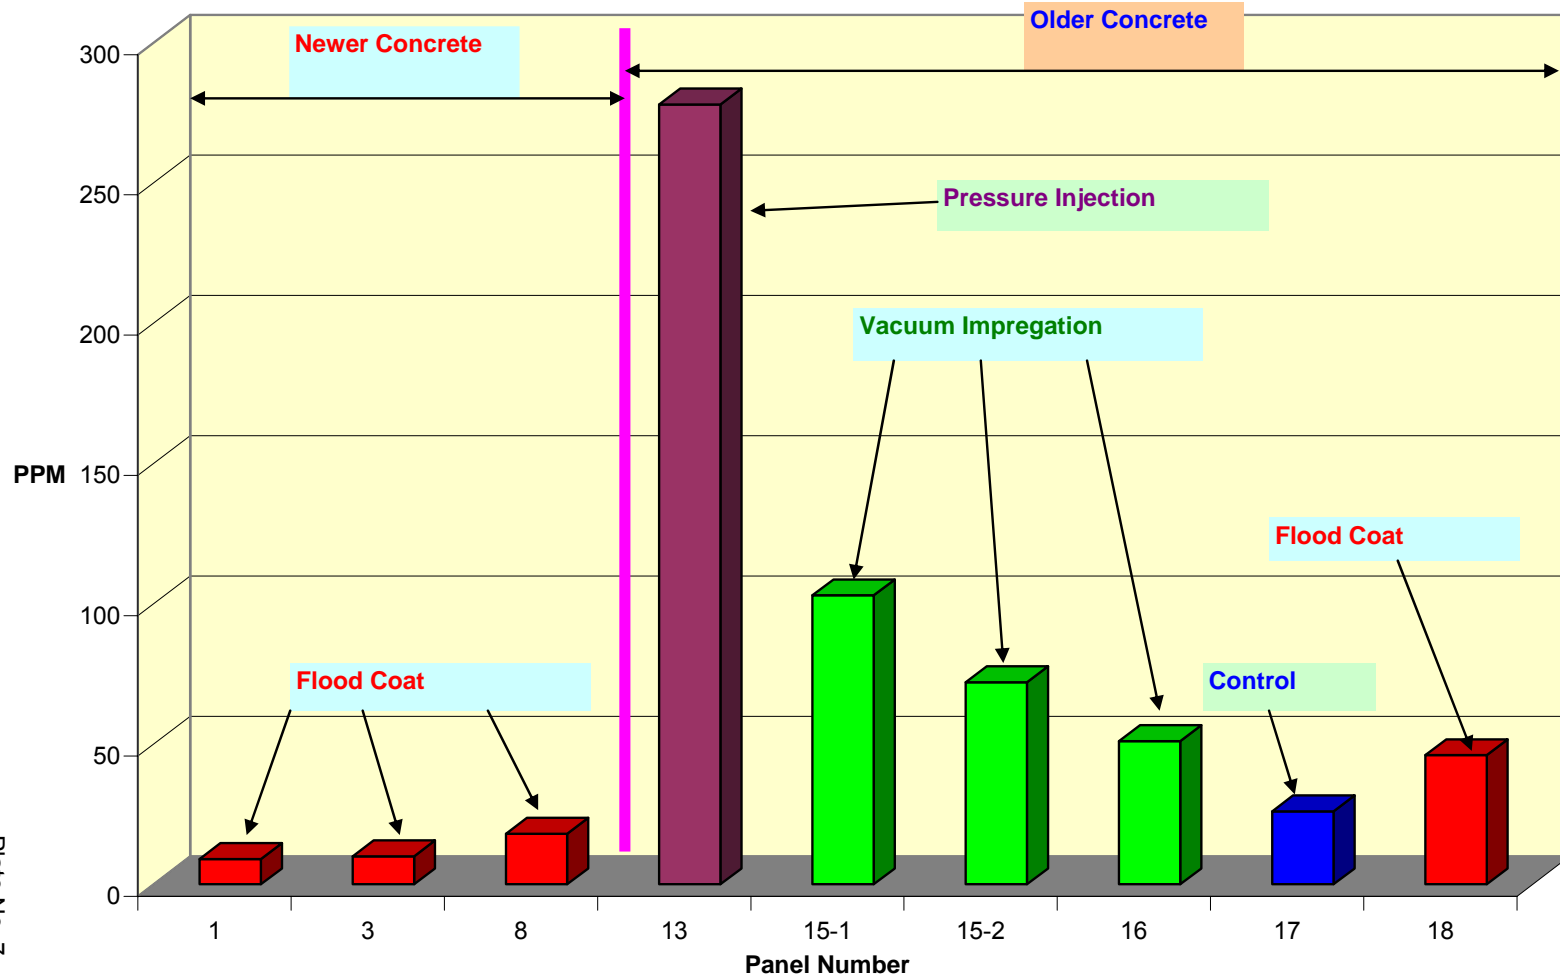
Plate No. 7

### Maximum Lithium Content

Overall summaries of lithium contents using various application methods are presented on Plate Nos. 7 & 8, Exhibit No. 6, Appendix III. As can be observed, greater lithium contents were achieved using the vacuum impregnation method as compared to simply a flood coat application. The pressure injection method achieved even a higher content.

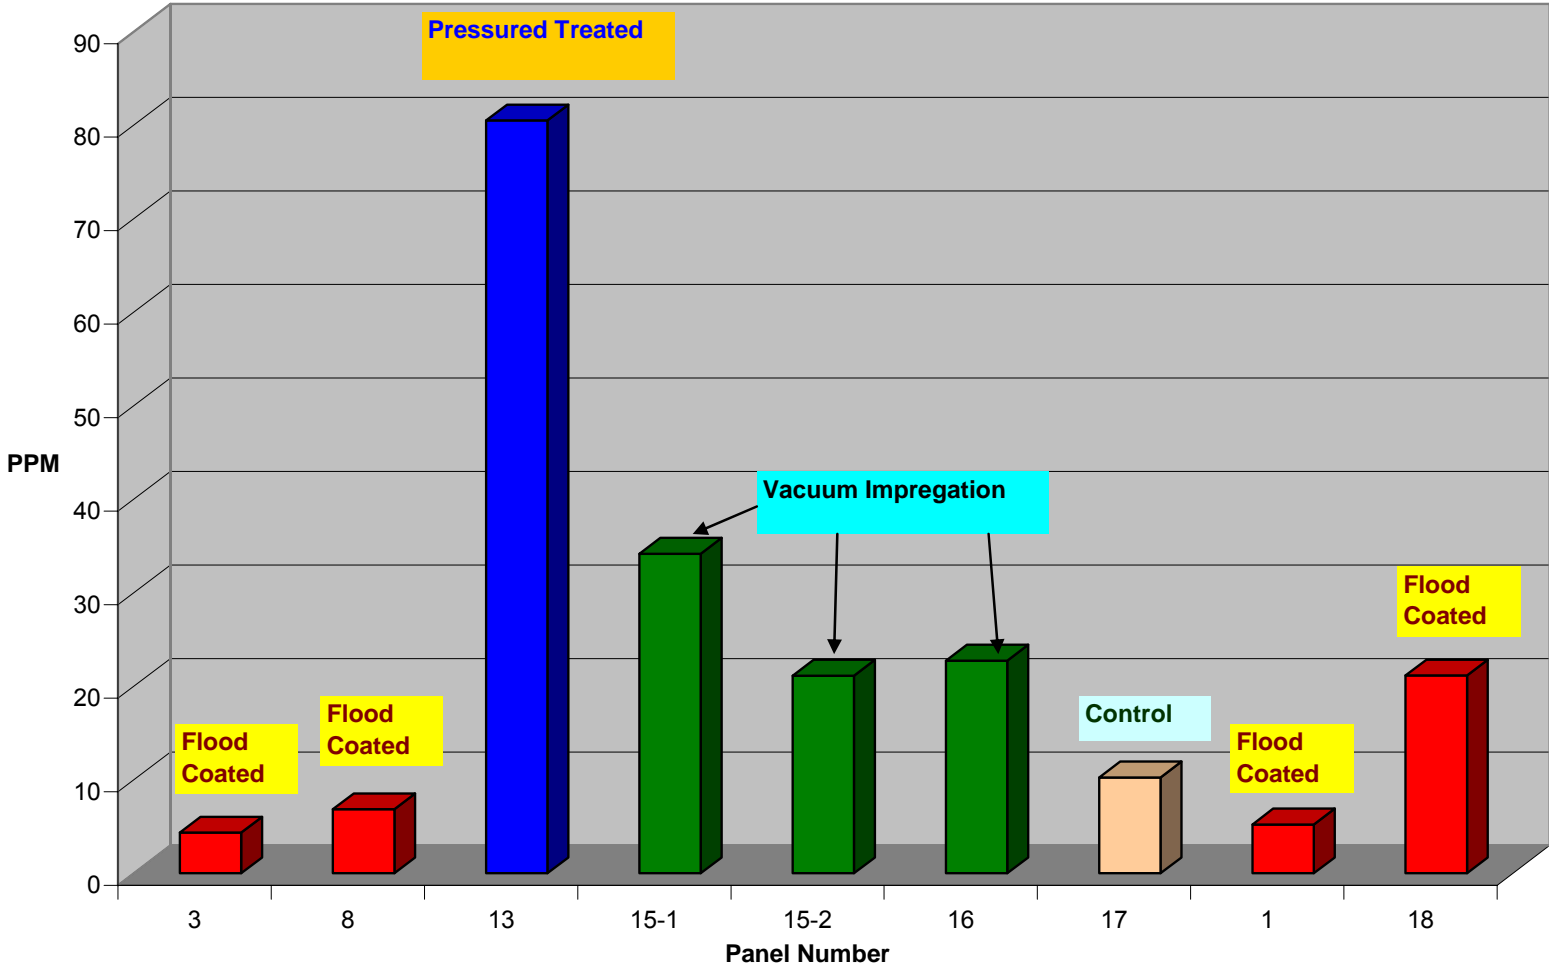
Plate No. 8

Average Lithium Content in Upper 4 Inches
