Steel Bridge System with Delayed Composite Action

NDOR Research Project Number SPR-PL-1(037) P529

Atorod Azizinamini, Ph.D., P.E.
Aaron J. Yakel

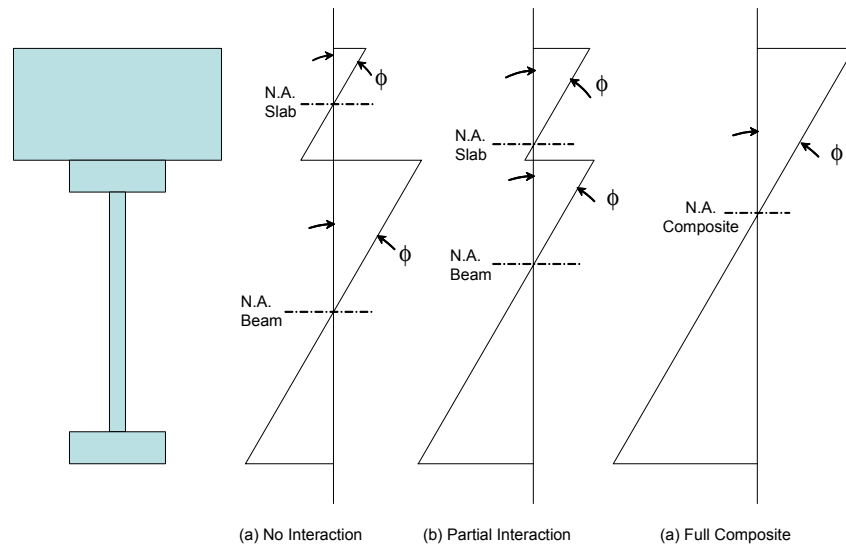
Figure 2-2: Conventional Two-Span Continuous Steel Girder

mechanism produces a compressive force on the bottom fiber of the concrete slab while an equal and opposite tensile reaction is imposed on the top fiber of the steel joist. Again, since the components are in contact the curvature within each component is the same. As seen in Figure 2-2b, these forces, or shear force, cause the neutral axis in the slab to shift downwards while the neutral axis in the joist is shifted upwards.

In the extreme case, the shear transfer mechanism is infinitely rigid and the strain in the bottom fiber of the concrete deck is the same as the strain in the top fiber of the steel joist. This condition is referred to as full composite action and the strain distribution under this condition is depicted in Figure 2-2c. Under this condition, a single neutral axis is located between

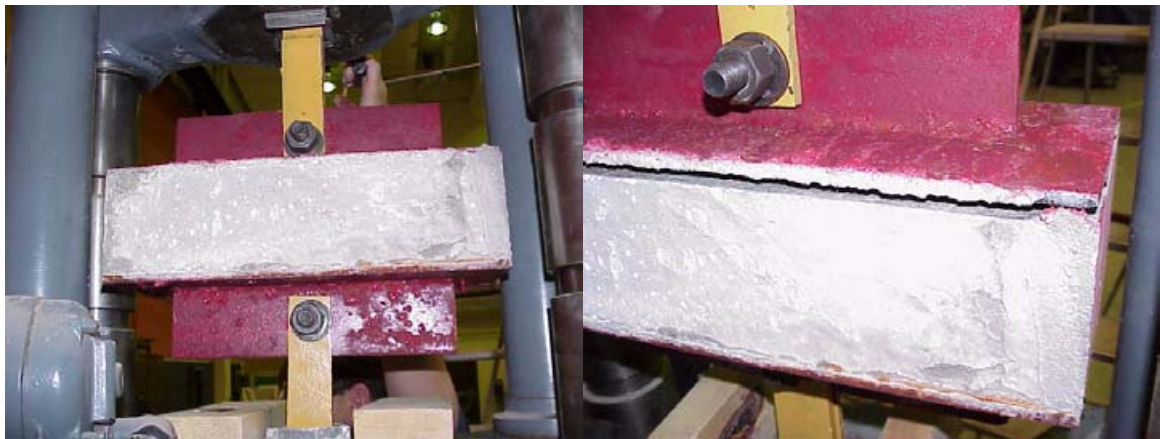
Figure 3-2: Photo of Specimen

Figure 3-2 shows a test specimen placed in the universal testing machine. Special handling care was taken to avoid stressing the concrete bond which may cause premature de-bond at the interface. Also, the tension splices were carefully aligned to avoid any eccentricity resulting in bending stresses induced at the interface.

The first specimen was tested at 7 days after the concrete pour and the second specimen was tested after 13 days. Bond strength in the early days is of most importance because injection of epoxy would normally have to take place during this period of time.

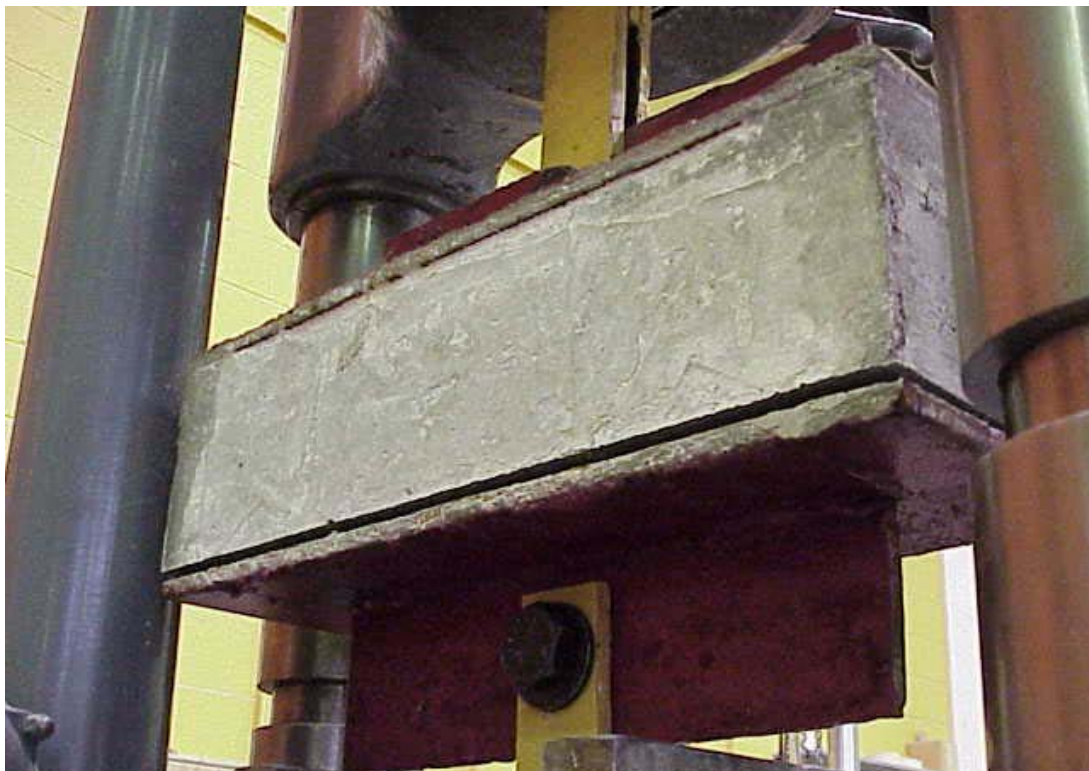
Figure 3-4: Specimen after failure

Since only one side of each contact surface failed during test #1, an upper bound for the tension bond between steel and cast-in place concrete could be measured by repairing and re-testing the failed specimens. Epoxy was applied to the failed surface of the specimens to connect the steel to the failed concrete surface and allow the failure to take place in the sound contact surface of the specimen. Figure 3-4 shows one of the failed specimens.

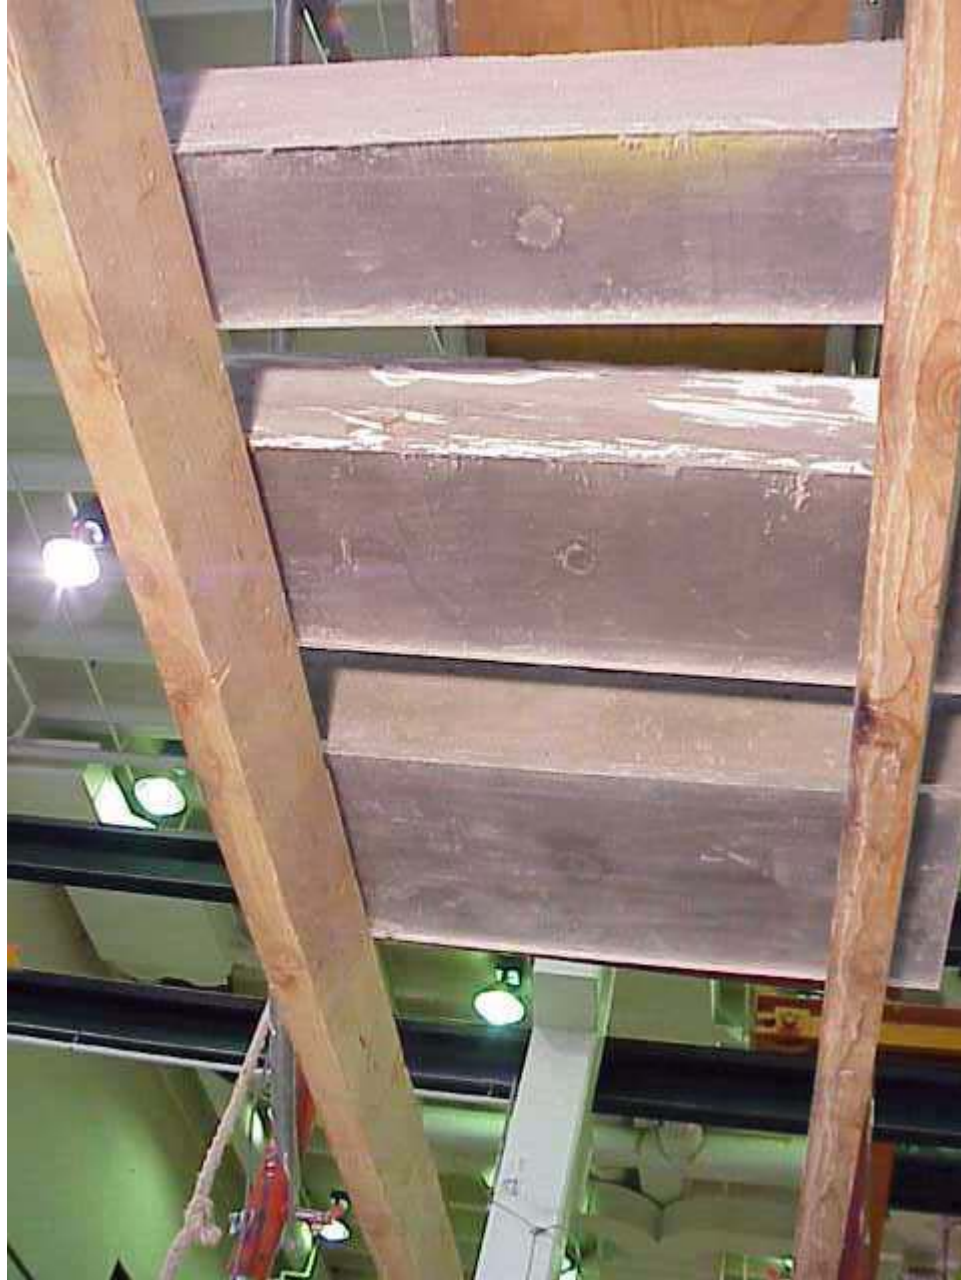
Figure 3-6: Underside of all 3 specimens

Low pressure epoxy (200 PSI) was injected through the holes and caused separation of the concrete from the poly-glass sheets. Figure 3-6 shows the photo taken from underneath the specimens before injecting epoxy and Figures 3-7 through 3-10 show the progression of epoxy dispersion. As can be noted, dispersion takes place in a perfectly radial fashion. It reaches the

long edges of poly-glass interface and leakage starts along these edges before the epoxy can completely spread out toward the short edges.

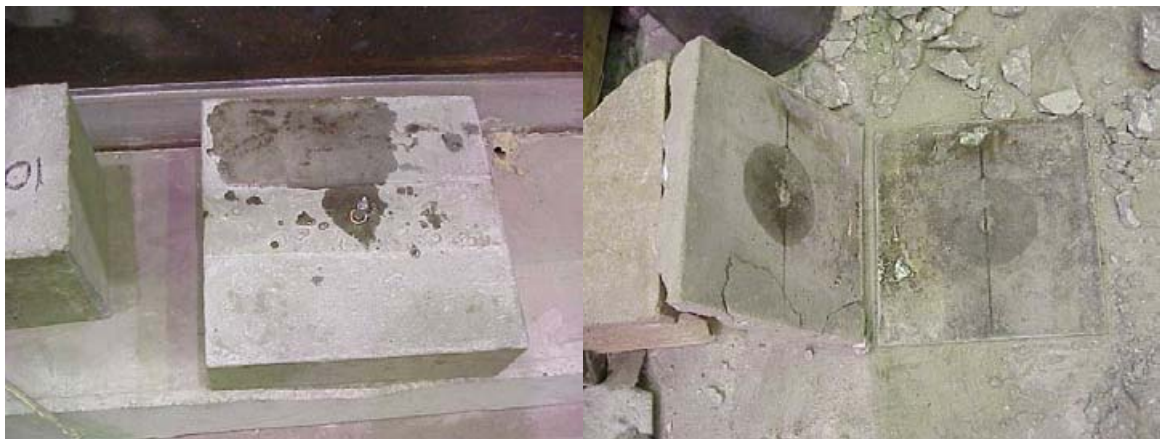
Figure 3-11: Specimen after injection

The epoxy pressure was increased to 500 PSI. However, leakage from couplers and packers was observed during the test. At this pressure, de-bond between steel and concrete did not take place. However, some amount of epoxy was able to find its way through the interface. Therefore, the pattern of dispersion could be observed. After two days, the concrete slab was separated from the steel plate. Great care was exercised during the separation process in order to preserve the integrity of the interface. It was observed that the epoxy spread uniformly over a circular area. Figures 3-11 and 3-12 show the specimen after injecting the epoxy and after the specimen had been dismantled, respectively.

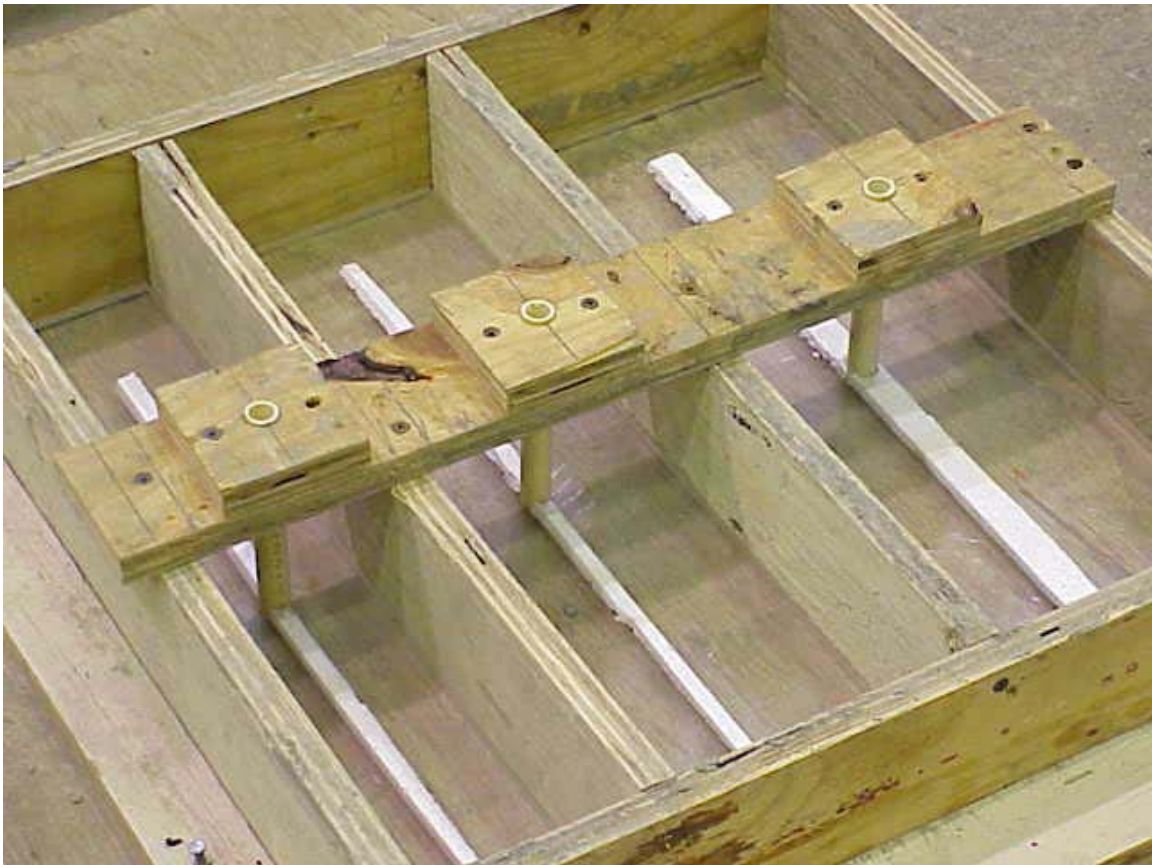
Figure 3-13: Setup showing Styrofoam guides

specimens identical to those used in Test #3 were prepared, however a narrow strip of Styrofoam was placed at the bottom end of the PVC pipe in each specimen. Different joint configurations were used to see the effectiveness of the epoxy transfer from the pipe to the Styrofoam strip. For the 4"×20" and the 6" ×20" specimens, a pair of notches was introduced at the bottom end of the pipe along the Styrofoam strip, while no modification was made to the pipe in the large specimen. Figure 3-13 shows the arrangement of the Styrofoam strips and the end condition of the pipes before casting the concrete.

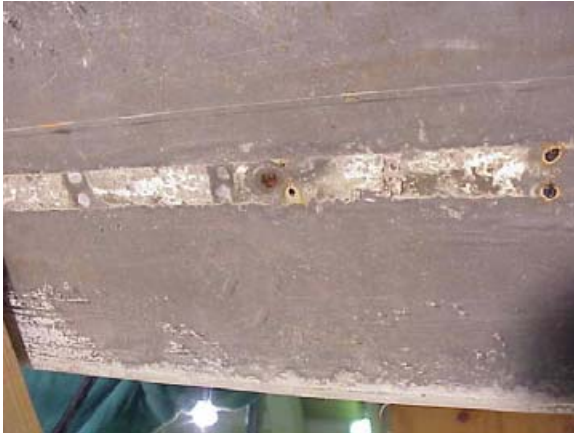
Figure 3-14: Underside of specimen

spreading. It was observed that dispersion takes place in a radial fashion and is not affected by the presence of the Styrofoam strips, or the presence of a notch at the pipe. Also, the flow of epoxy between the Styrofoam and poly-glass progressed at the same rate as in other areas of the interface.

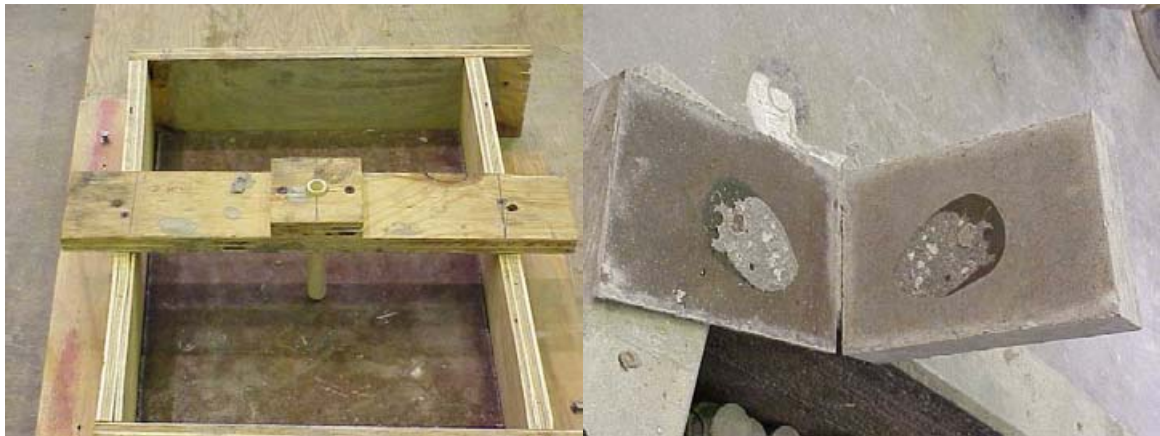
Figure 3-17: Form with injection tube in place

As in Test #4, high epoxy pressure could not be maintained due to leakage. Another cast-in-place specimen of the same size was prepared to examine the de-bond between the concrete and steel and find the dispersion pattern. No specific means of channeling epoxy was provided and no notches were made at the bottom end of the pipe. Figure 3-17 shows the specimen before casting concrete.

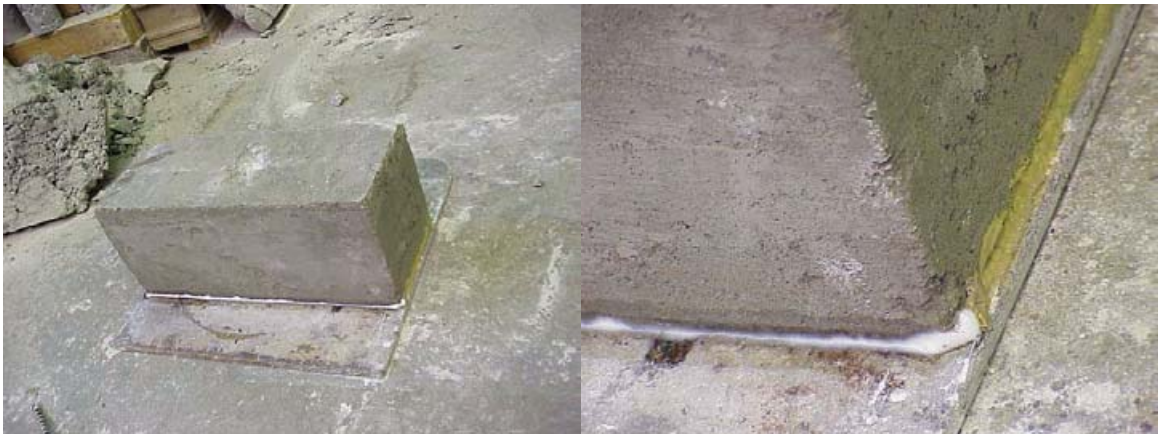
Figure 3-19: Test Setup after caulking

This test was aimed at experimentation and examining the ability of two different types of sealant in preventing leakage at the boundary of the interface. For expedience, a precast 6"×16"×8" concrete block was drilled through at the center. The concrete block was placed on a steel plate and two different types of caulking (MD Structural Adhesive and MD Silicon-Based Caulk) were applied along two edges for comparison. Small openings were left at the corners to allow passage of air pockets. Figures 3-19 and 3-20, respectively, show the specimen and close-up shot of the caulking agents. The Silicon-Based product is white (front edge) and the Structural Adhesive is yellow (side).

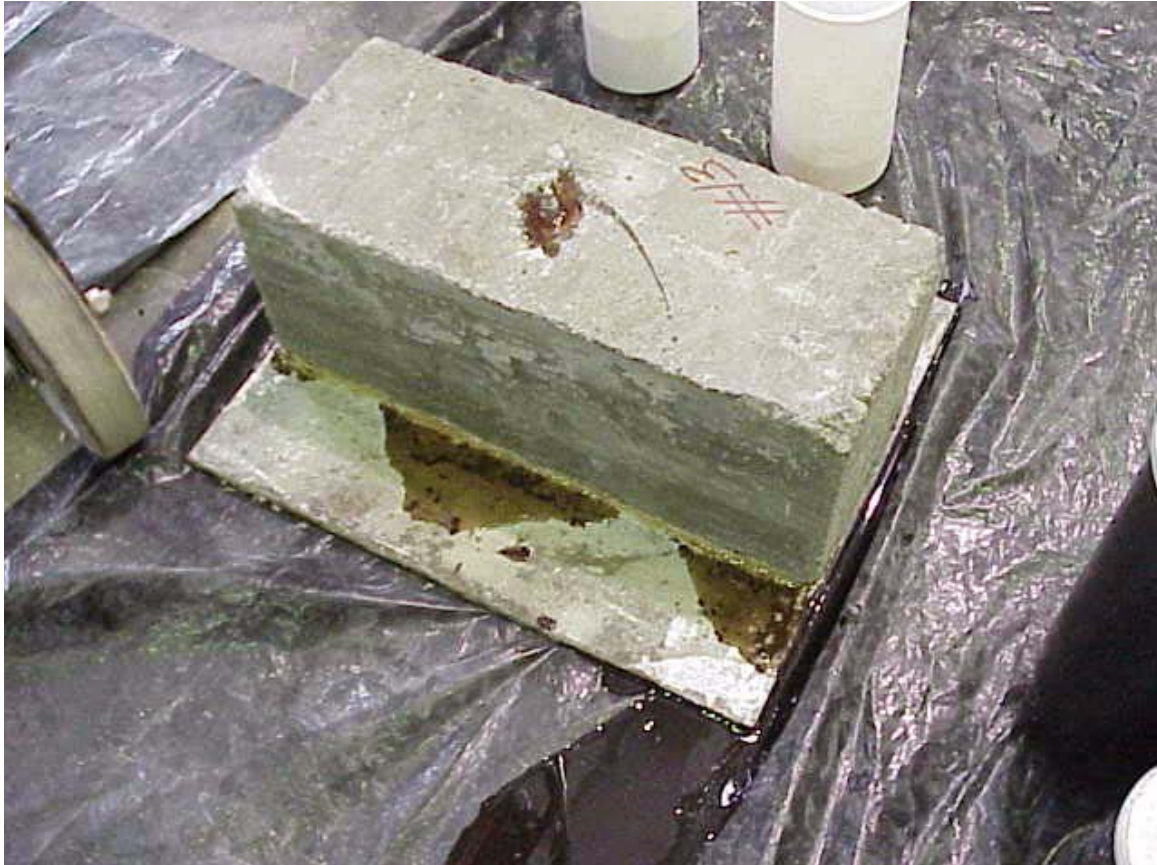
Figure 3-21: Specimen after injection

allowed to flow throughout the interface and break the seals. The MD Silicon-Based Caulk performed better than the Structural Adhesive by exhibiting more flexibility and better containment of the epoxy under higher pressure. Figure 3-21 shows the leakage along the boundary.

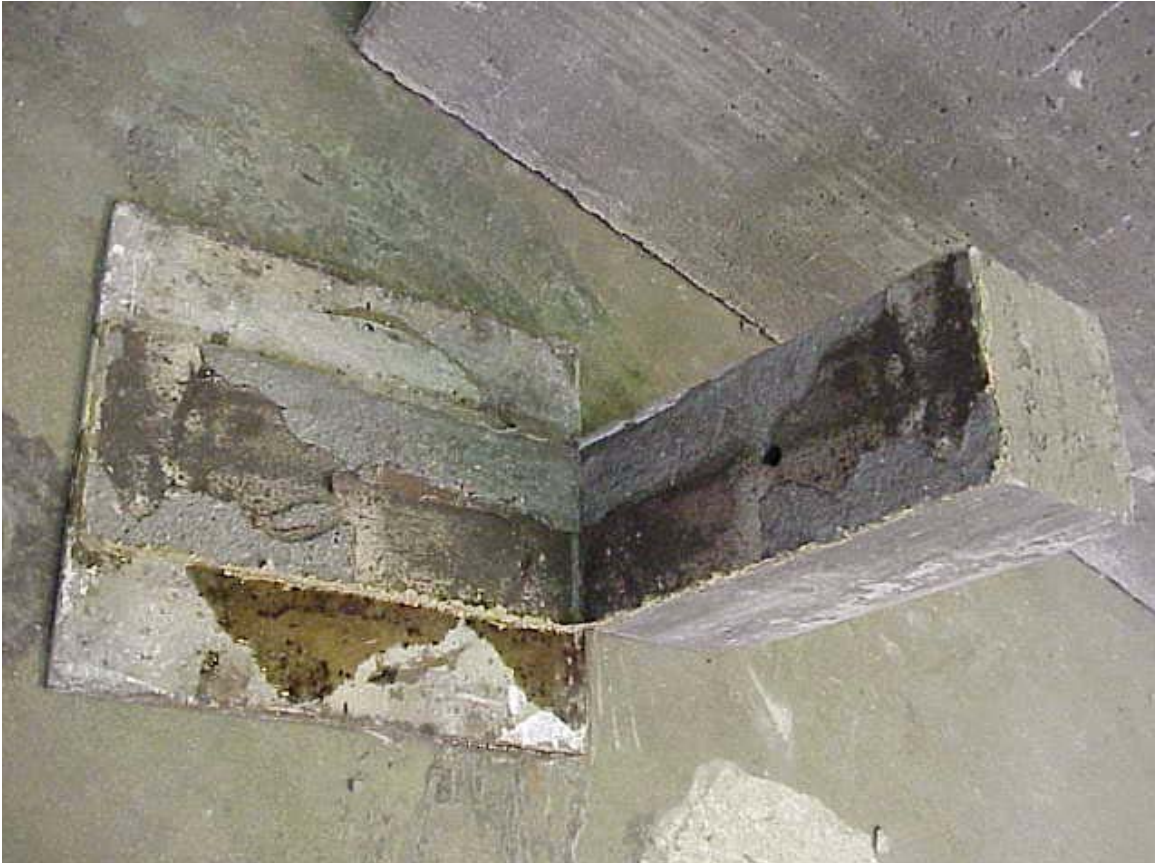
Figure 3-22: Specimen showing spread of epoxy

face. Figure 3-22 shows the epoxy bonded surface after the removal of the concrete.

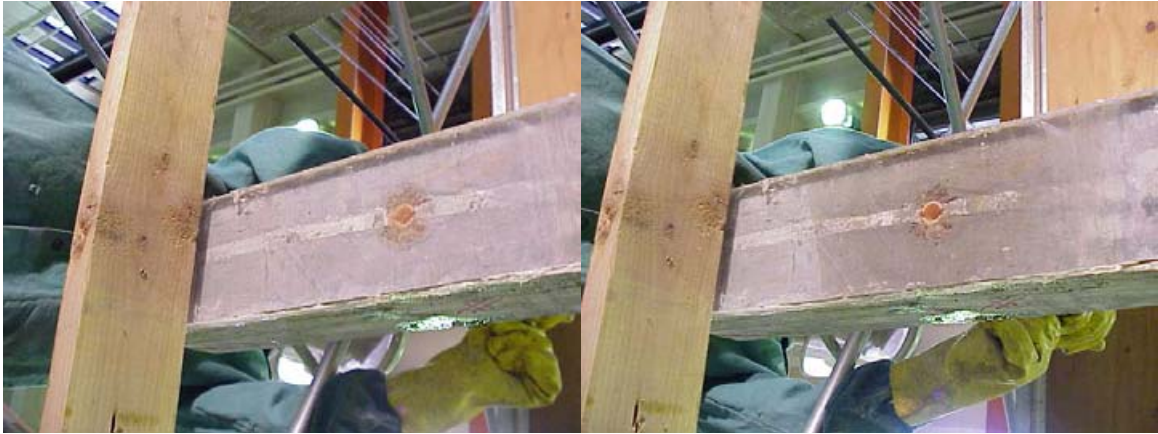
Figure 3-23: Underside of Specimen

This test was conducted in continuation of Test#5, again with the objective of improving epoxy flow throughout the interface before leakage starts at the boundary. However, in this test, in addition to caulking agents, Styro-foam strips were used to guide the epoxy. Three specimens of size 4×20, 6×20 and 8×20 were prepared. Figure 3-23 shows the underside of the

specimen prior to pumping the epoxy. BD Silicon-Based Caulking agent was used to seal along the boundary of the interface.

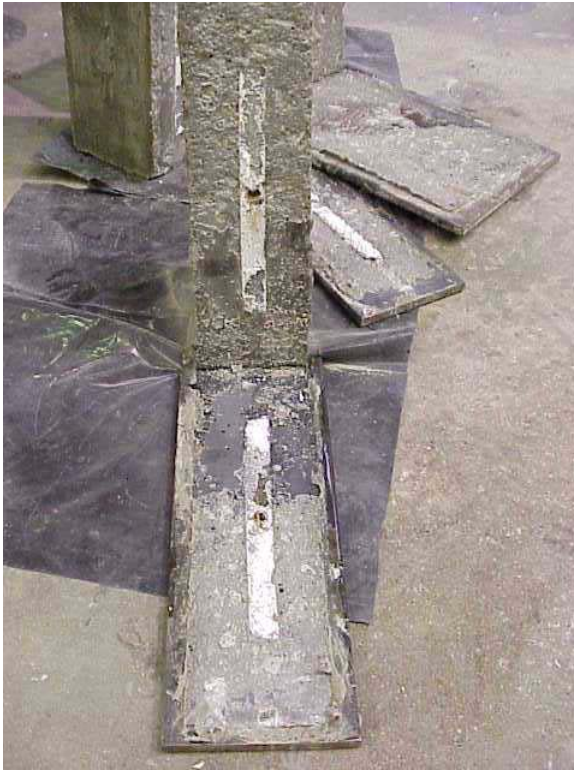
Figure 3-27: Specimen Dismantled showing spread of epoxy

of the epoxy throughout the interface. This can be seen in Figures 3-27 and 3-28. Also the embedded Styrofoam strip did not seem to guide the epoxy in the longitudinal direction.

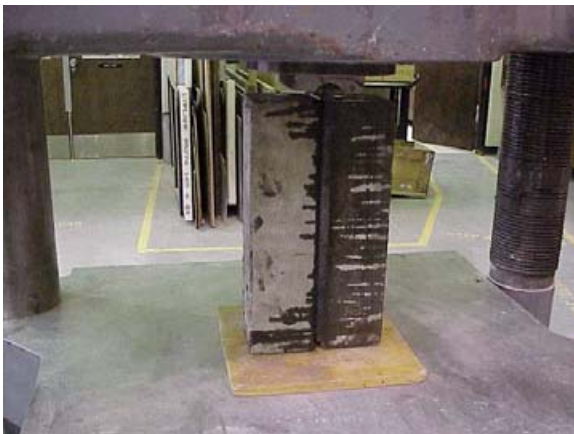
Figure 3-29: Specimen being tested

In both specimens, the failure occurred after a layer of epoxy on one side delaminated from the steel, followed by a diagonal tension failure as well as delaminating of the epoxy on the other side of the steel plate.

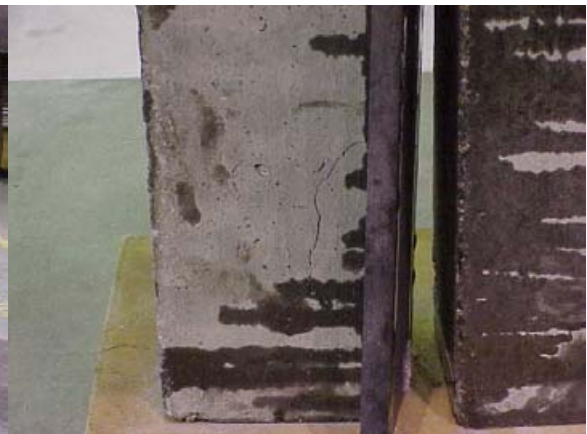
Figure 3-30: Pumping Epoxy (1)

On both concrete blocks, the surface layer of epoxy bonded to the concrete appeared intact. Other than the diagonal tension failure in the concrete which had resulted from unbalanced loading, no other plane of failure in the concrete, particularly near the epoxy layer, was observed. Figure 3-30 shows the failed bonded side of the steel plate, and Figure 3-31 shows the condition of the epoxy layer after removing the specimen from the testing machine.

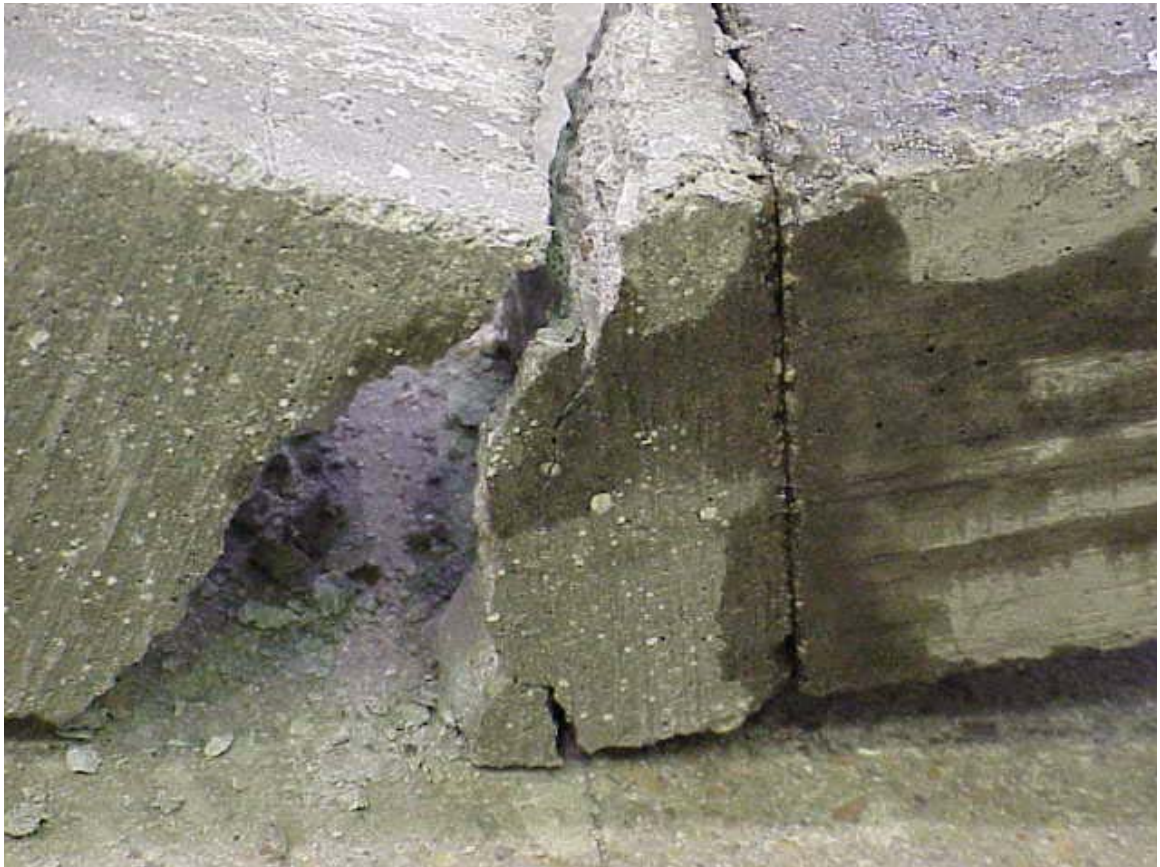
Figure 3-34: Close-up of failure

Under 452 lbs of load, tension failure occurred. Given the dimensions of the cross section, this value of the load corresponds to 216 PSI tensile stress. As Figure 3-34 shows, the plane of fracture was in the concrete at mid-span and not in the interface. This indicates that the strength of the tensile bond between the epoxy and the concrete as well as the tensile strength of the epoxy itself are both greater than the tensile strength of the concrete.

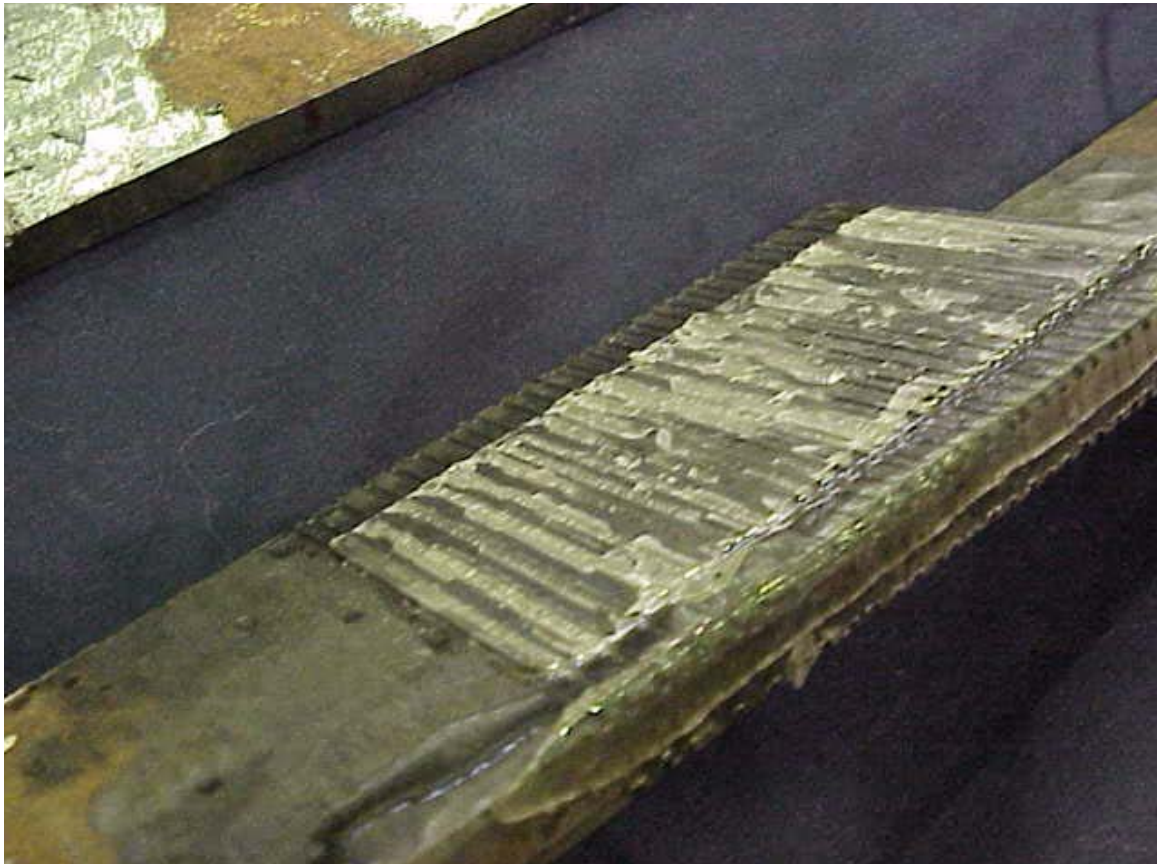
Figure 3-38: Close-up of failure

The epoxy failure occurred as result of partial de-bonding of steel from steel and partial fracture within the epoxy. The failure load was measured 15,792 lbs, corresponding to 987 PSI. Figure 3-38 shows the failure surface.

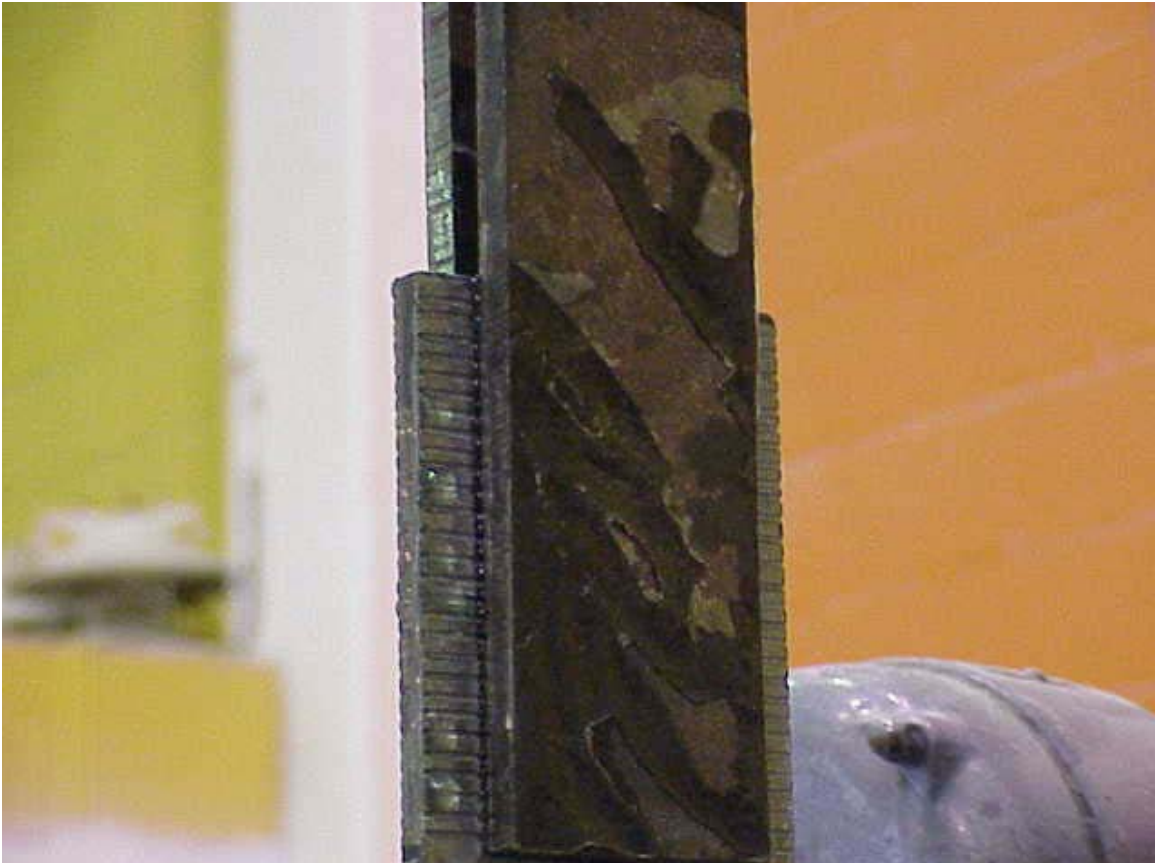
Figure 3-39: Close-up of lap specimen

This test was aimed at measuring the shear bond strength of the epoxy on a machine-grooved surface. 1/32" deep grooves were used on all contact surfaces. Also, a de-greaser was used to clean the machine-groove surfaces before applying the epoxy. The specimen was tested after 7 days. Figure 3-39 shows the photo of the specimen during the test.

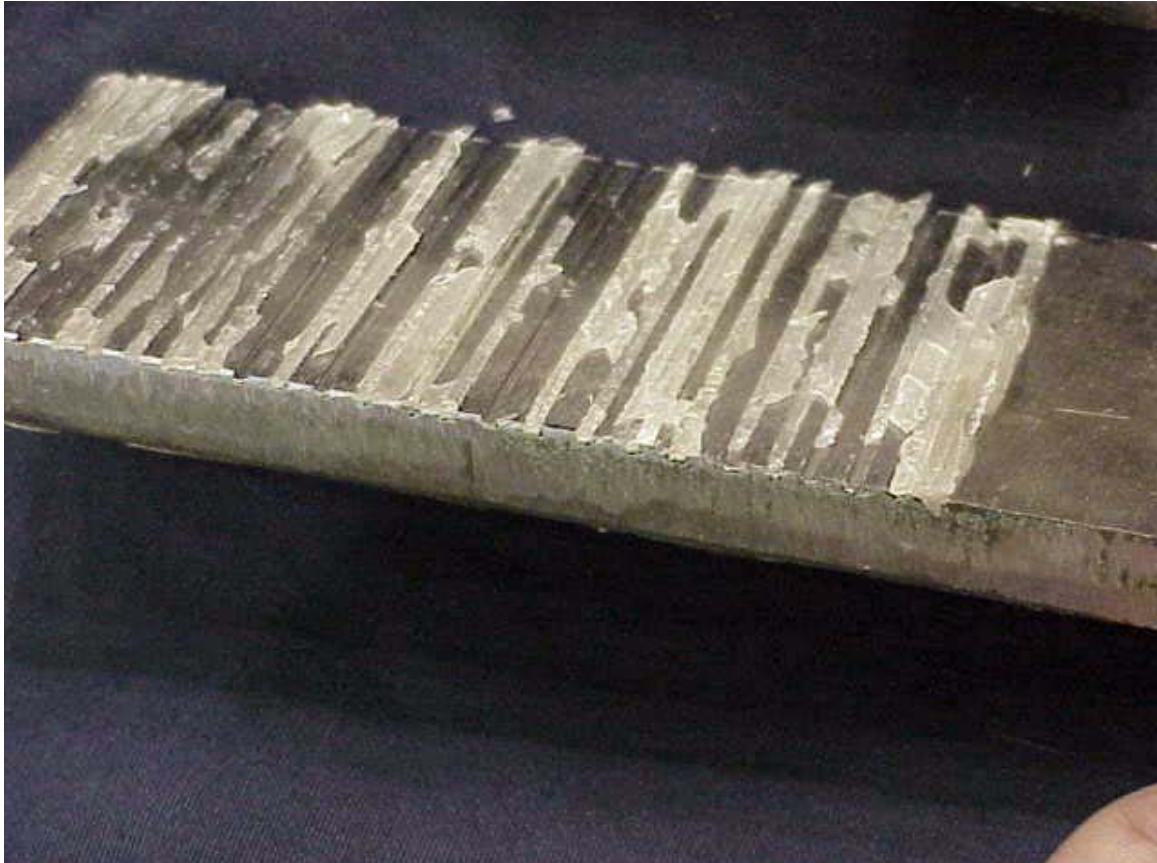
Figure 3-40: Close-up of failed surface

was mostly within the epoxy. Figure 3-40 shows the photo of the failed epoxy surface.

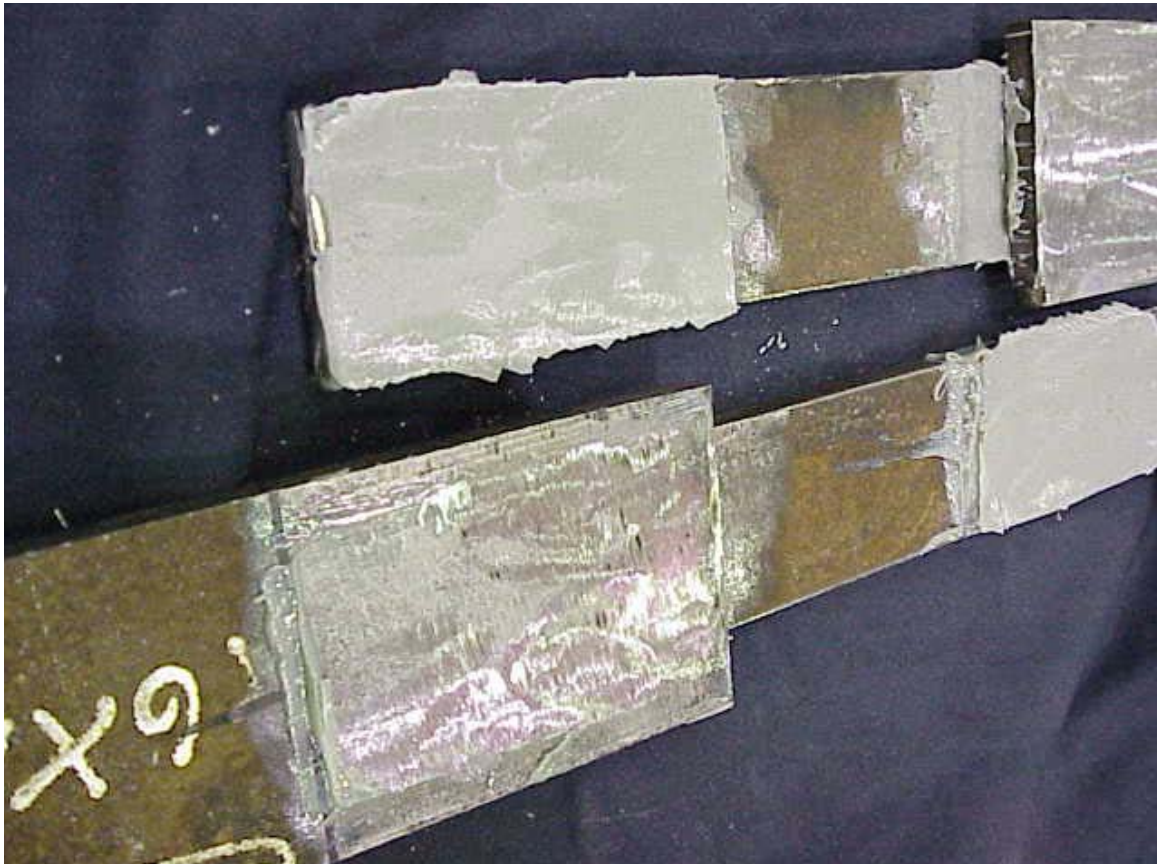
Figure 3-41: Close-up of failure

The specimen failure load was measured at 6,344 lbs, corresponding to a shear strength of 397 PSI. The failure was sudden, and resulted from debonding of the gel adhesive from the steel. Figure 3-41 shows the failed specimen.

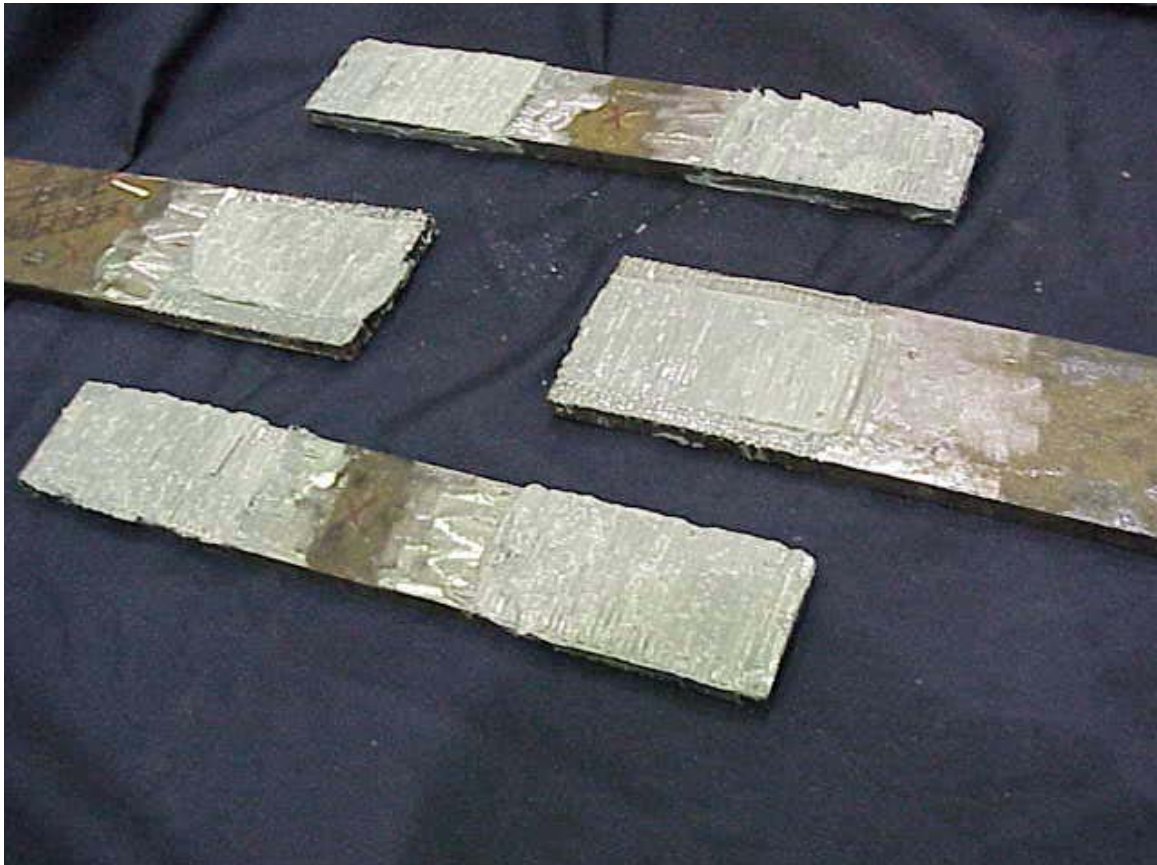
Figure 3-43: Specimen after failure

of the gel adhesive revealed that part of the area was not completely cured. The failure surface is shown in Figure 3-43.

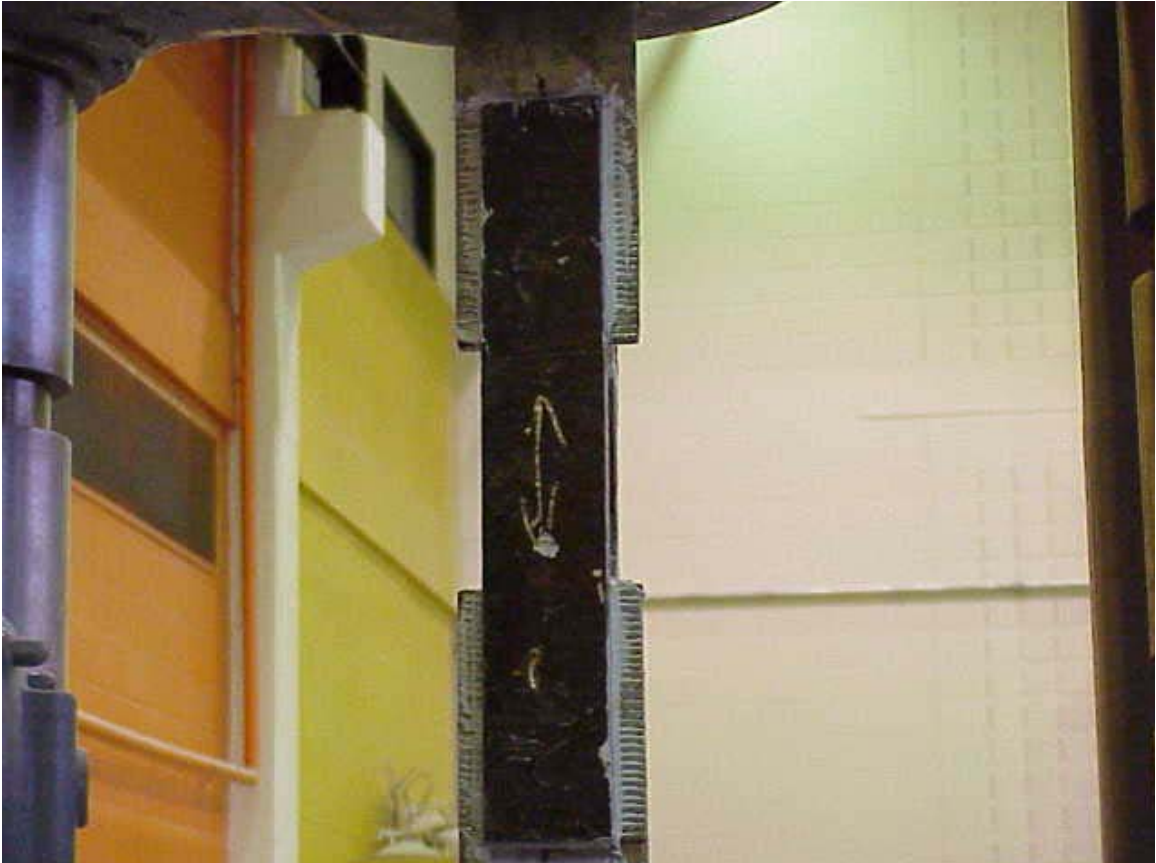
Figure 3-45: Test setup

This test was to determine the shear bond strength of Prime Resins - Prime Gel 2000 applied over a machine-grooved surface. The same mix ratio and specimen dimensions were used as in Test #19. The steel surface was machined to make 1/32" deep grooves with 1/8" spacing. The specimen

was tested after 5 days. Figure 3-45 shows the picture of the specimen during the test.

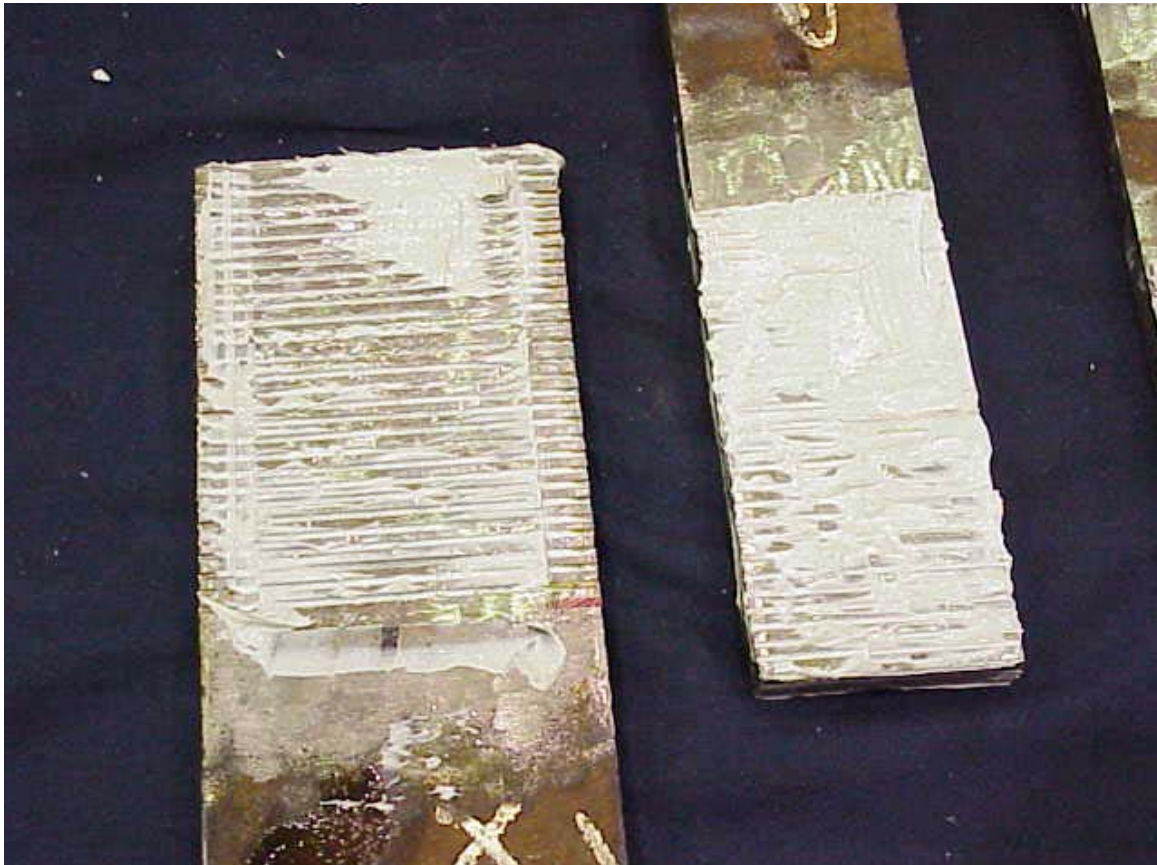
Figure 3-46: Close-up of failure

that gel debonding from the steel was also responsible for the failure. Figure 3-46 shows a close-up of the failure surface.

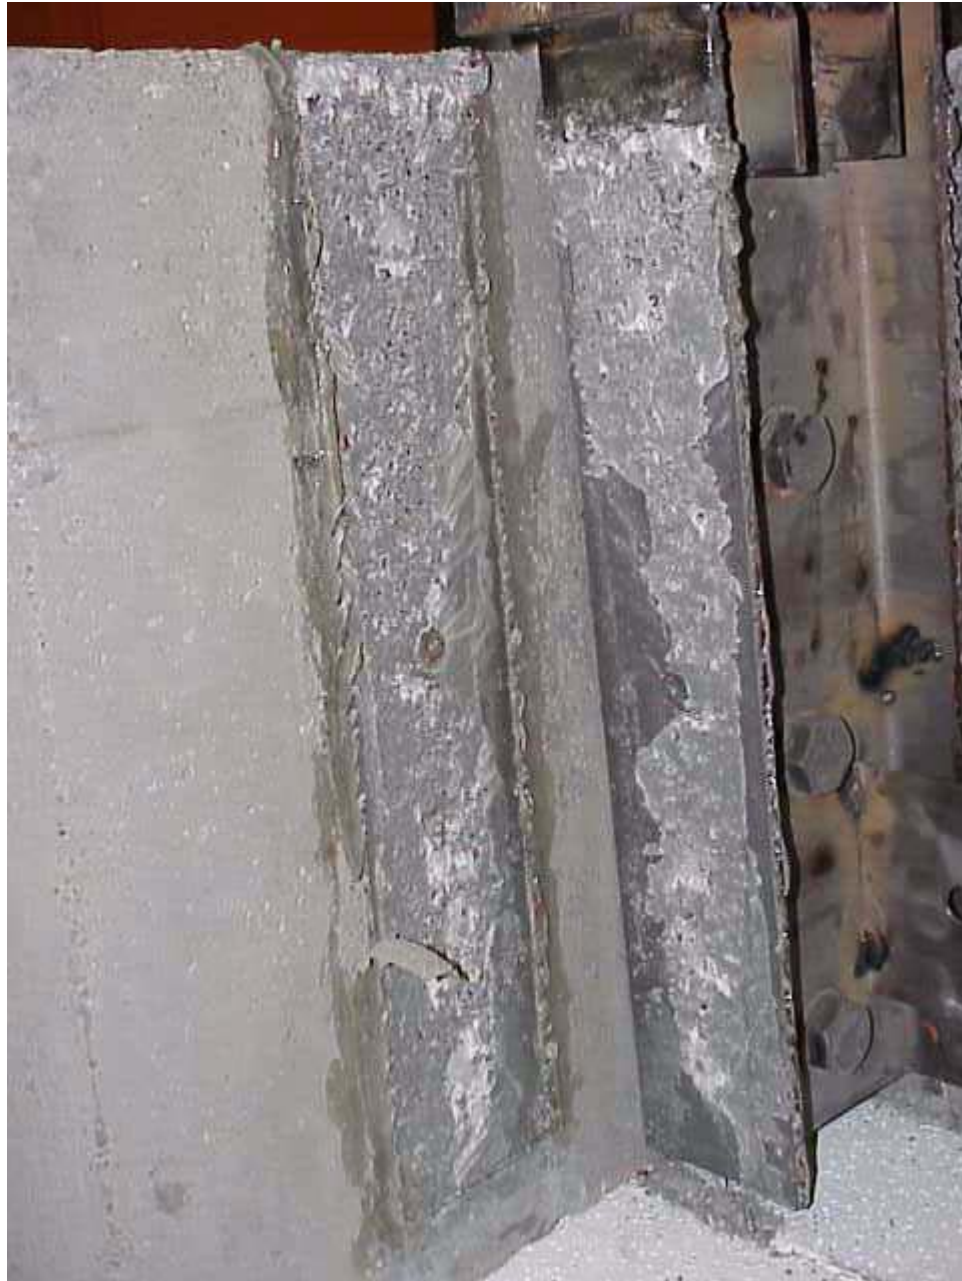
Figure 3-49: Specimen after failure

The first specimen exhibited a high initial stiffness and the load increased up to 35,000 lbs. This was followed by a substantial load reduction and increased displacement, indicating distress and failure of the specimen. The second specimen exhibited very similar behavior and failed at 30,000 lbs.

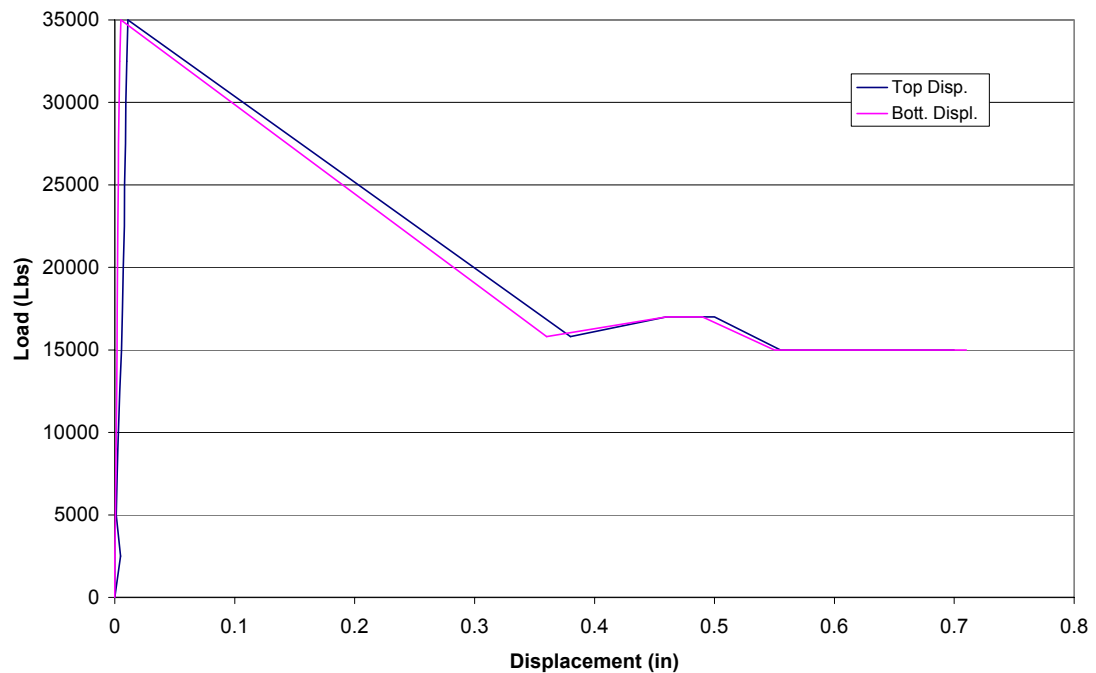
Figure 3-50: Load Deflection Push Out Specimen 1

Figures 3-50 and 3-51 show the force-displacement plots for the tested specimens. Given that the area of shear interface = $2 (20" \times 4") = 160 \text{ in}^2$, the shear strength of Specimen #1 = 218.8 PSI and Specimen #2 = 187.5 PSI.
