Steel Bridge System with Delayed Composite Action

NDOR Research Project Number SPR-PL-1(037) P529

Atorod Azizinamini, Ph.D., P.E.
Aaron J. Yakel

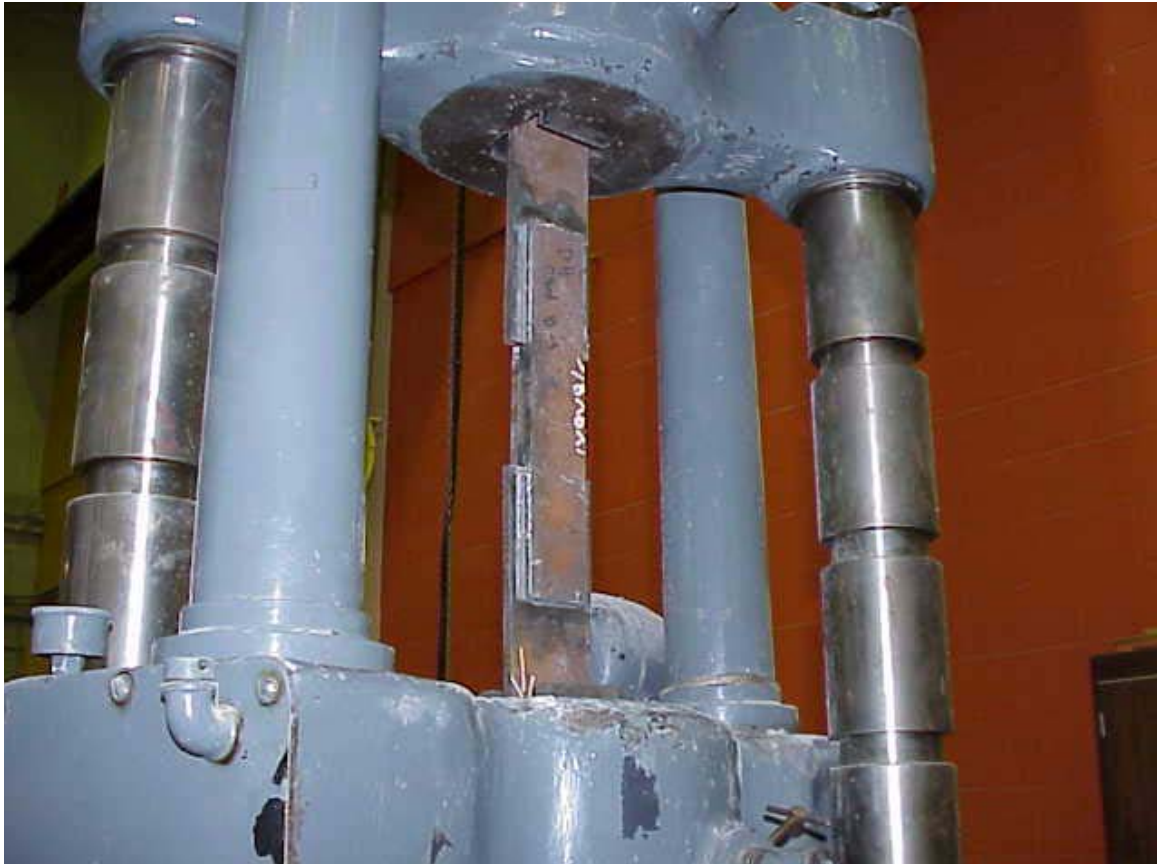
Figure 3-55: Test Setup

The goal of this test was to evaluate the adhesion of the epoxy to steel. Two specimens were tested with a contact area of 2"×4" per lap. One of these specimens can be seen mounted in the test frame in Figure 3-55.

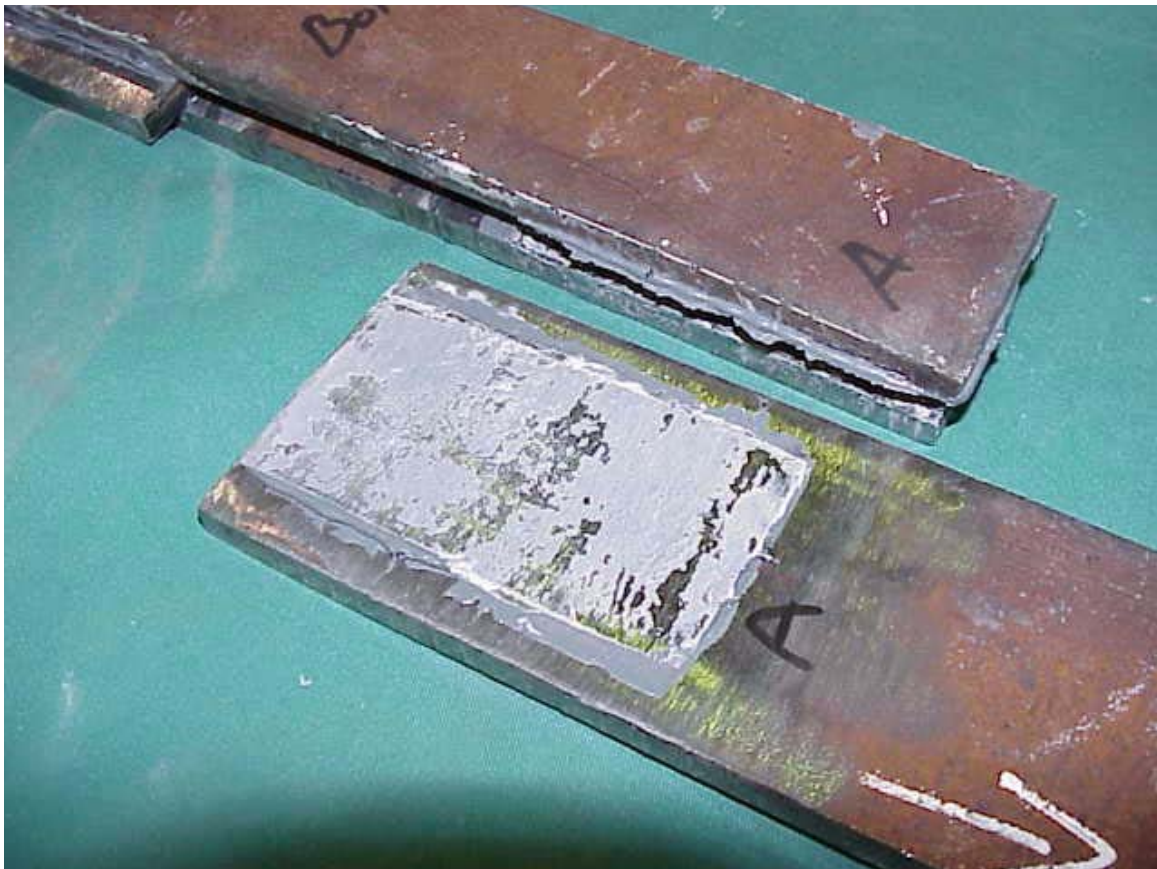
Figure 3-56: Close-up of failure

The results of the test were quite positive. The failure loads were 33.5 kips and 22.2 kips. Figure 3-56 shows the failure surface after testing. The average shear strength obtained from the testing of the two specimens was 3469 psi. This compares well with the published expected value of 3200 psi. The strength is 3.7 times that obtained from bare steel on steel tests utilizing the WEBAC epoxy. It is also 2.3 times the maximum value obtained using the WEBAC epoxy when the surface had been milled which was the preparation resulting in the highest strength for the WEBAC epoxy.

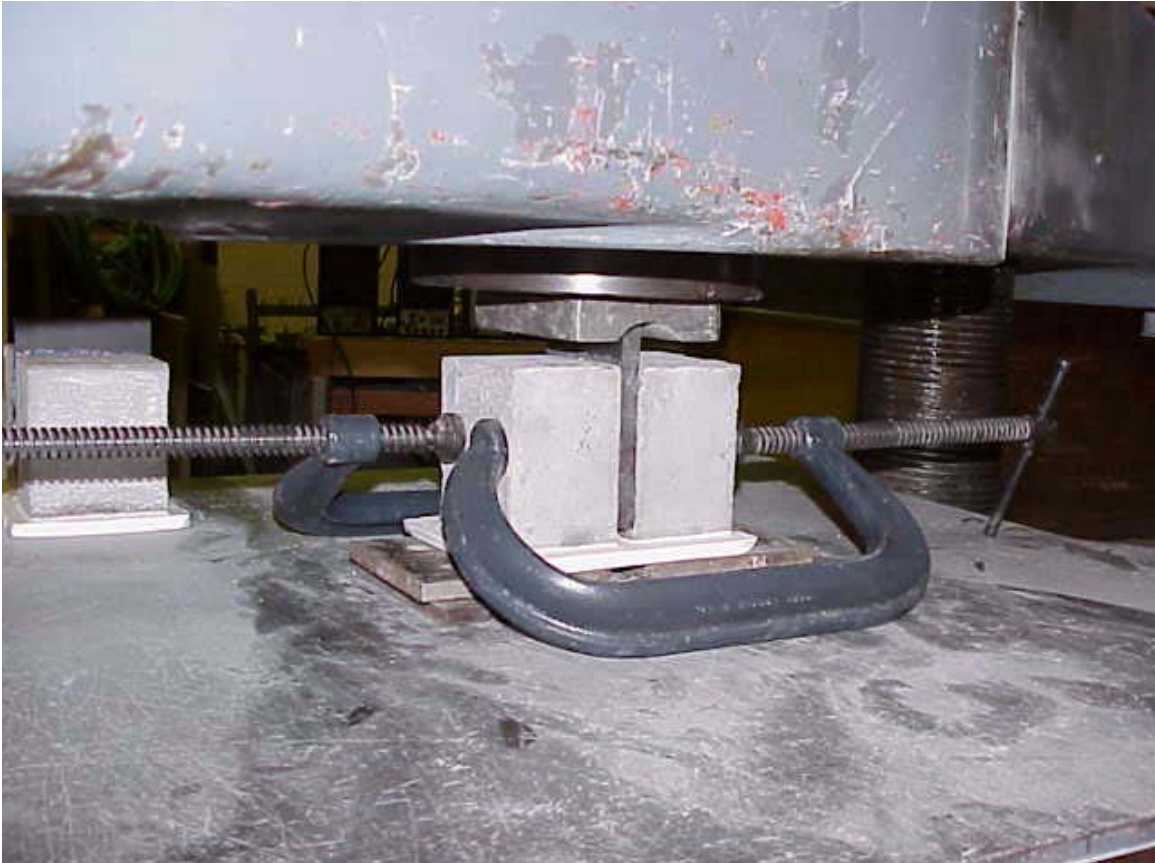
Figure 3-58: Test Setup with C-Clamps

tion of the failure indicated the failure was not due entirely to shear. It was determined the C-clamp was not stiff enough to prevent movement.

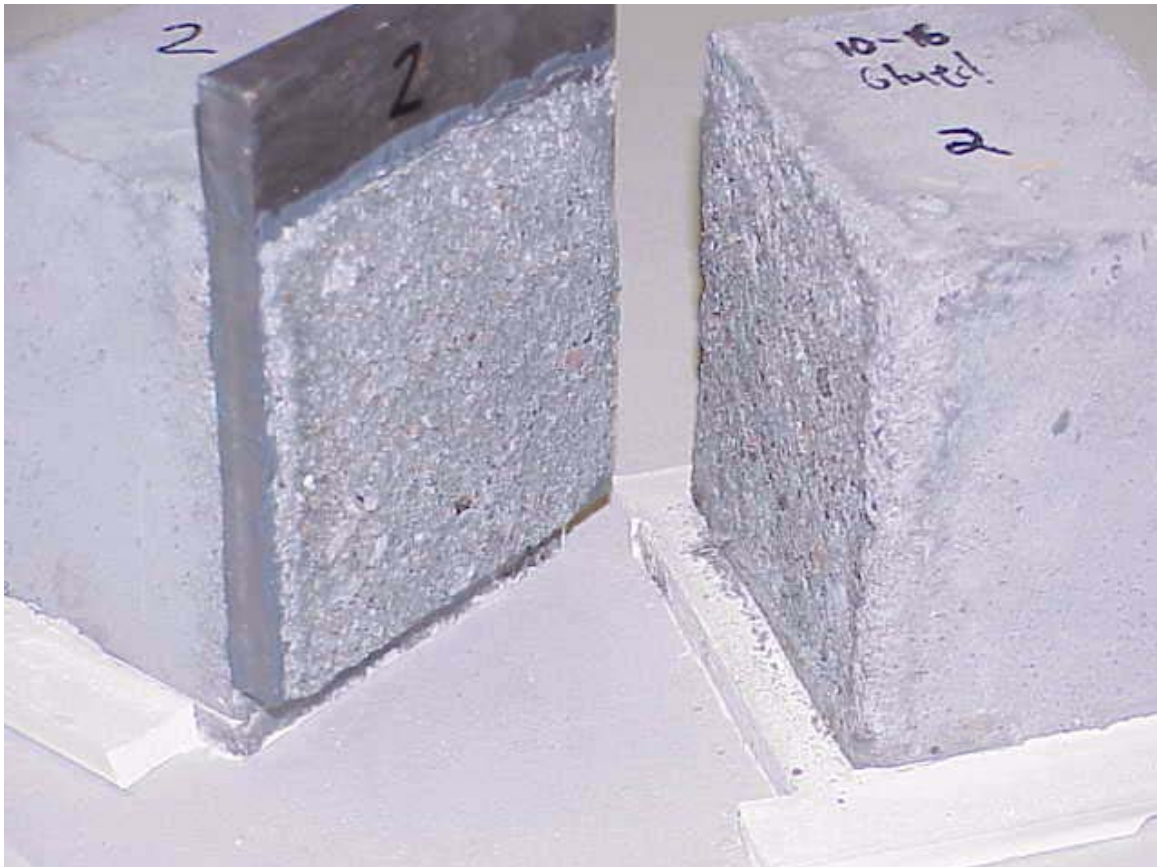
Figure 3-61: Close-up of failure second specimen

Figure 3-61 shows the second specimen which used a C-clamp to provide lateral restraint. Here, one can see there is much less concrete left on the steel.

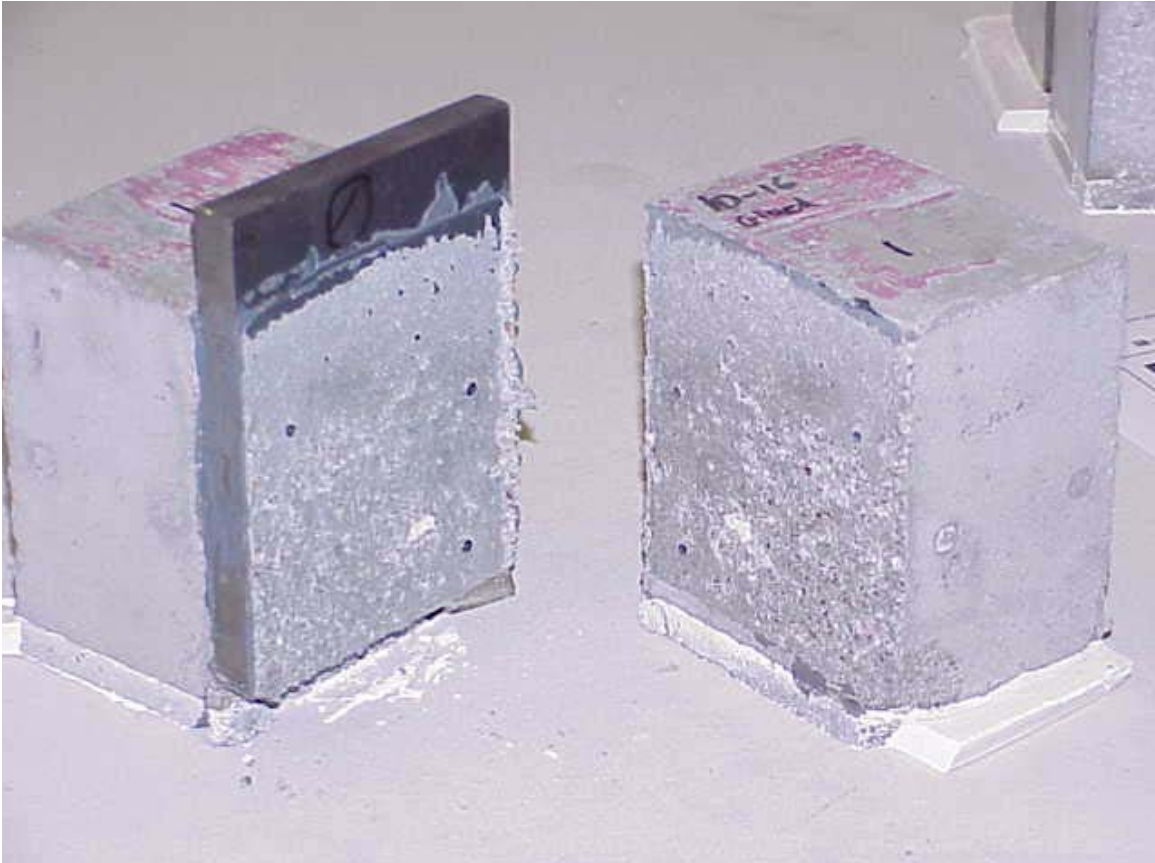
Figure 3-62: Close-up of failure third specimen

primary failure element. There are a few locations where the epoxy debonded from the steel.

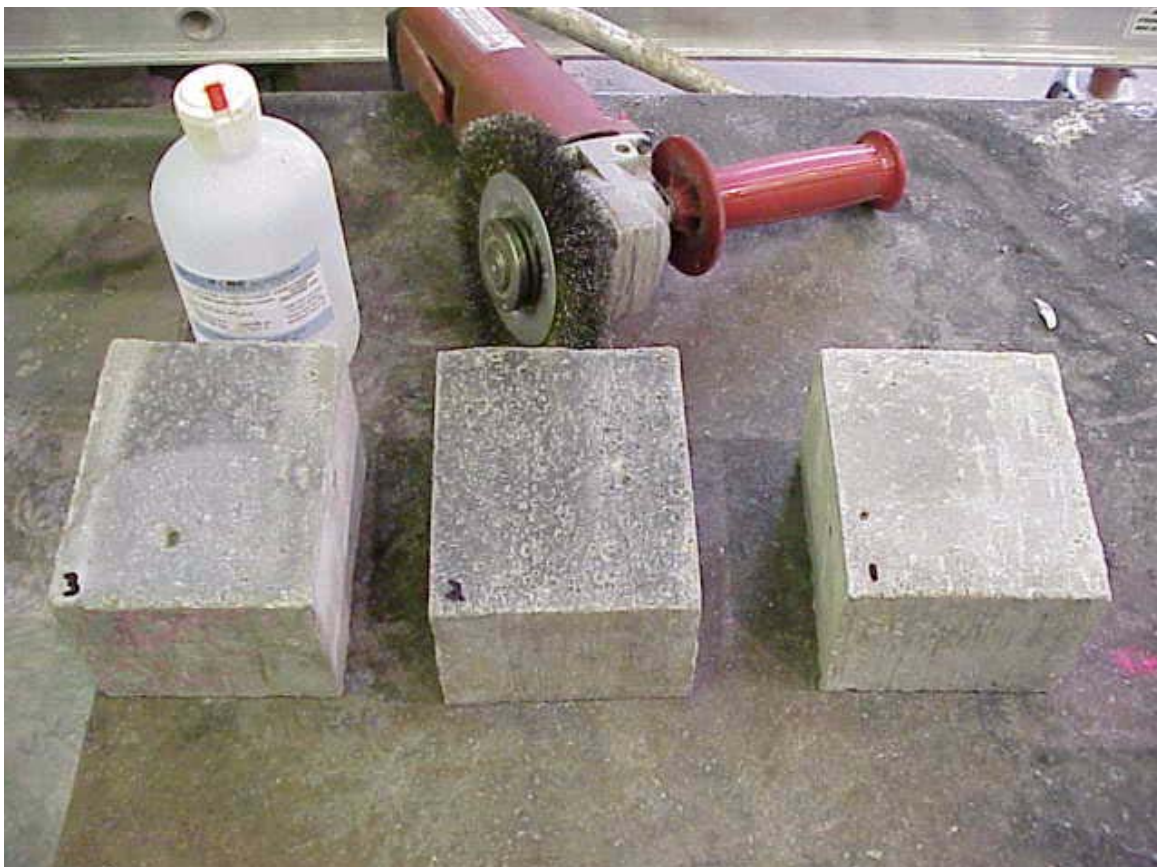
Figure 3-63: Surface preparation steps

Three specimens were tested with a contact area of 2"×4". The first was prepared by removing the fines from the surface of the specimen with grinder fitted with a wire wheel brush. Unfortunately, use of the wire brush appeared to leave a residue on the concrete. This residue was then removed using an acid wash process similar to the preparation used on the steel. Figure 3-63 shows the results of each step. The block on the right has not been touched. The middle block shows the residue after brushing. The block on the left shows the removal of the residue.

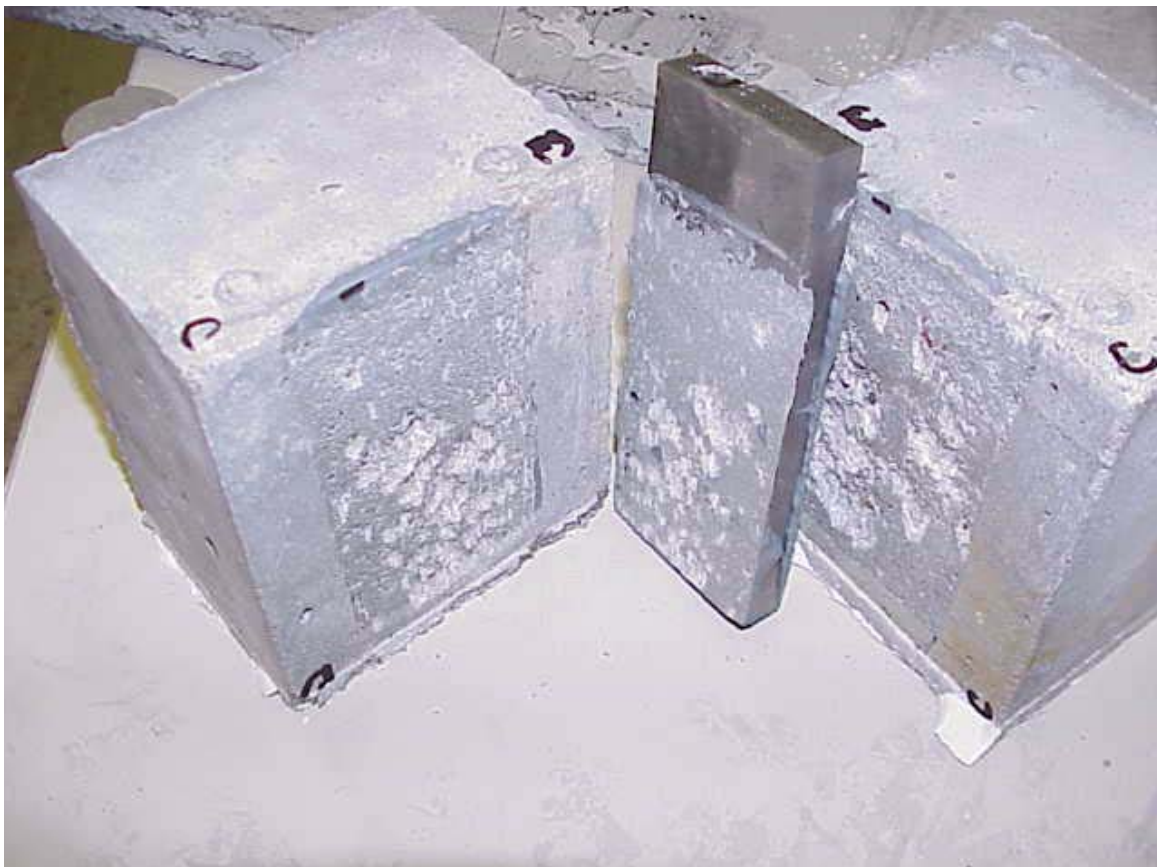
Figure 3-64: Close-up of failure control specimen

Figure 3-64 shows the control block after testing. The failure is similar to the third specimen from test #2.

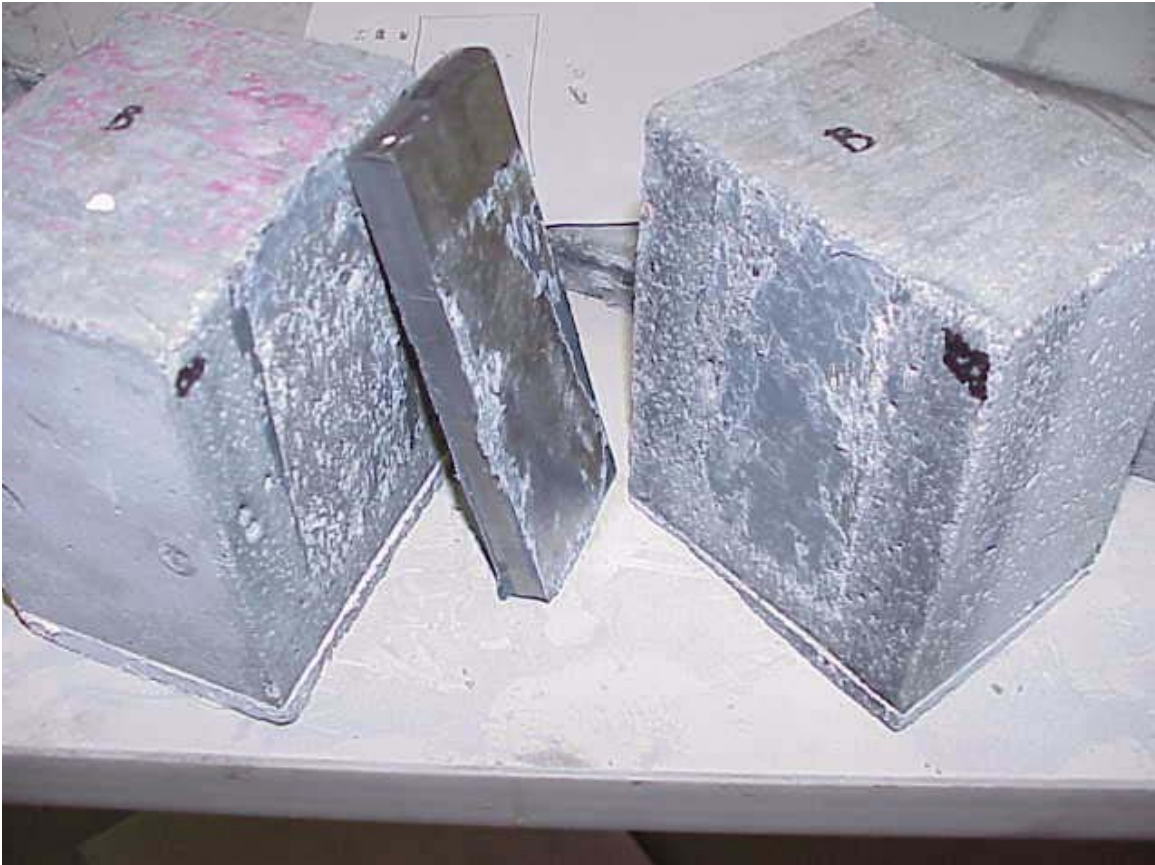
Figure 3-65: Close-up of failure wire prepped specimen

Figure 3-65 shows the block which had been prepared with the wire wheel after testing. This specimen did not perform as well as the control. This is most likely due to the presence of the residue on the concrete.

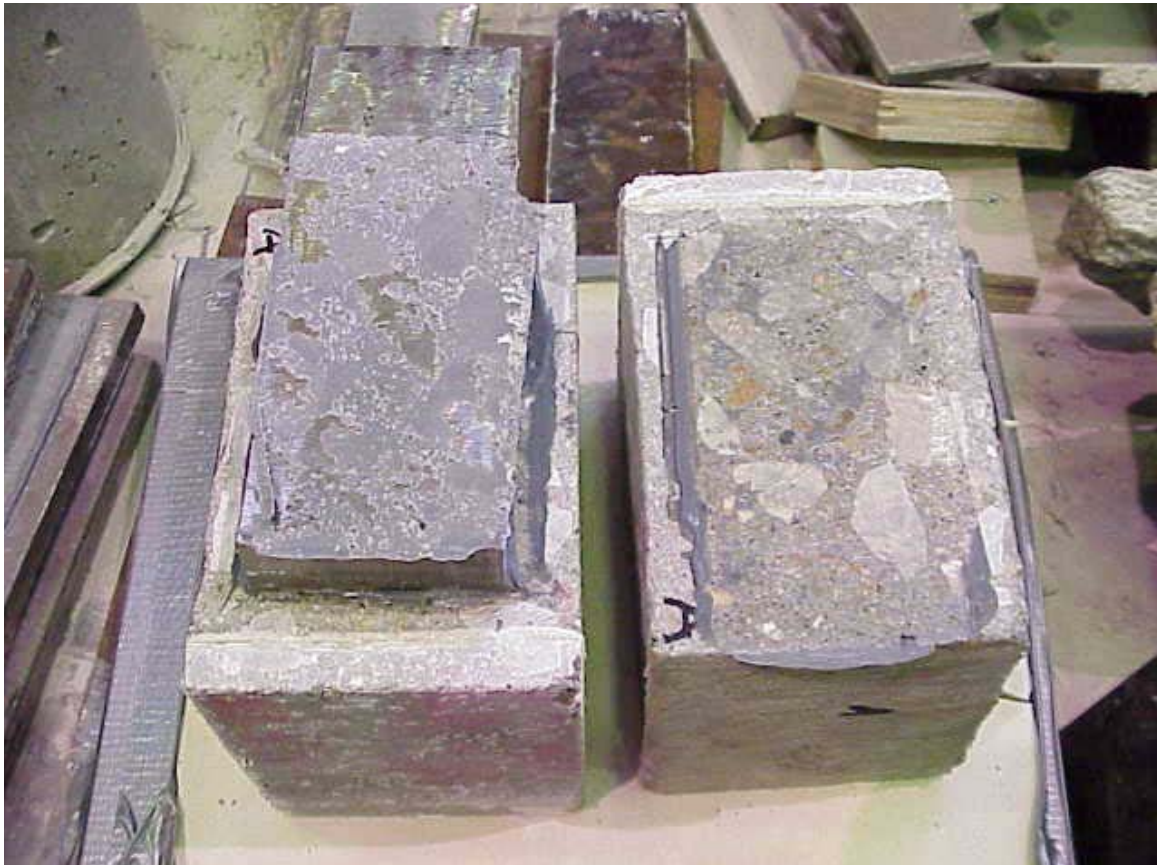
Figure 3-66: Close-up of failure cut specimen

The cut block is shown in Figure 3-66. The resulting strength from this specimen was 2038 psi. This is an 23% increase over the control specimen.

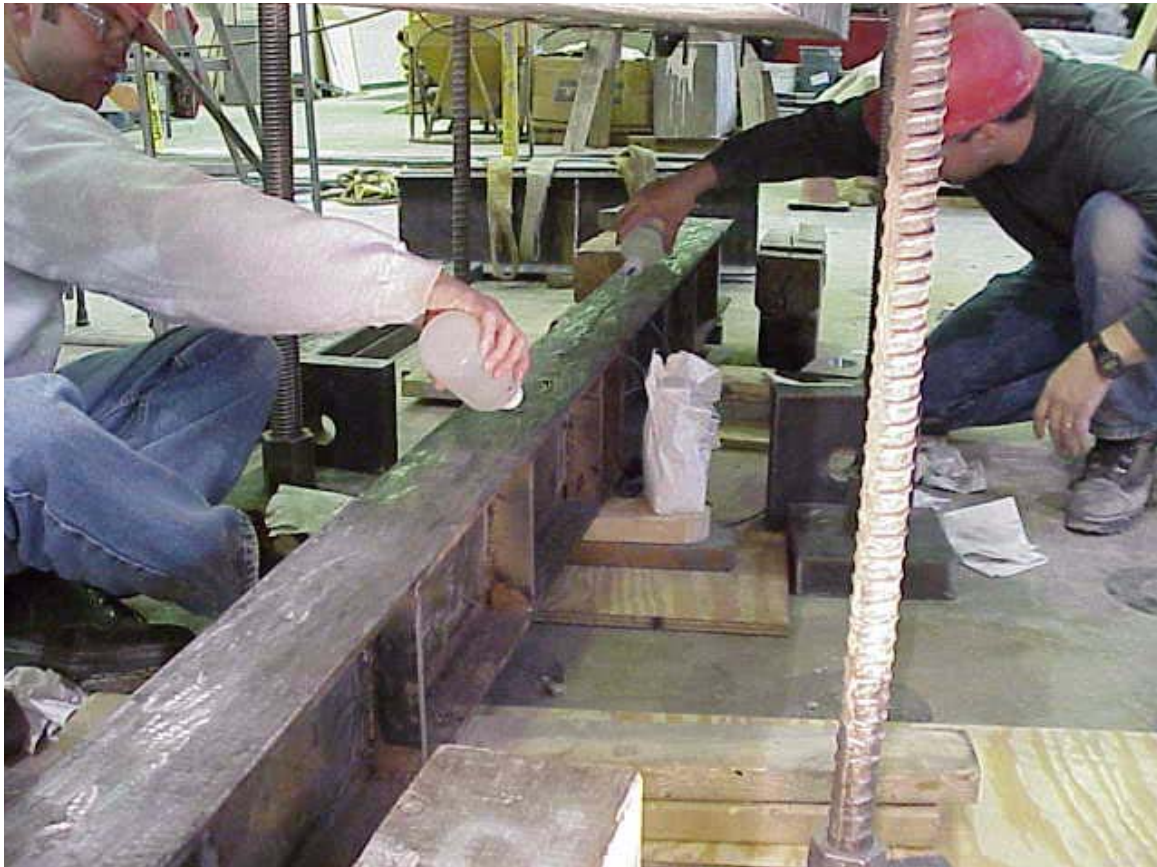
Figure 3-68: Preparation of Steel Surface

The steel surface was prepared by grinding to bare steel and then degreasing. A mild acid etch was then applied to further clean the surface. The

acid was then neutralized with a base wash. Figure 3-68 shows the preparation process.

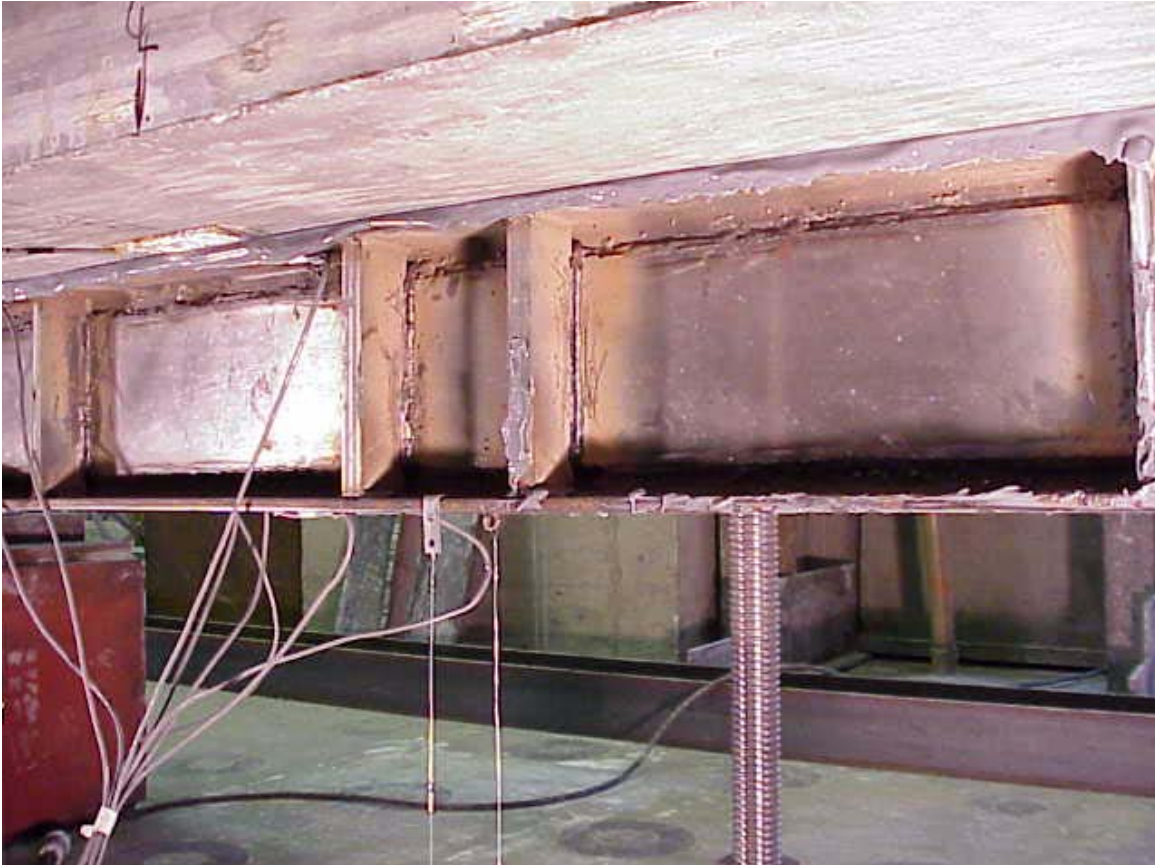
Figure 3-69: Assembled Epoxy Beam Specimen

The epoxy was then mixed and applied generously to the steel surface. After the slab had been lowered on the steel, the slab was clamped to the beam. This clamping squeezed out the excess epoxy, leaving a minimal

glue line. This excess epoxy can be seen in Figure 3-69 of the assembled system.

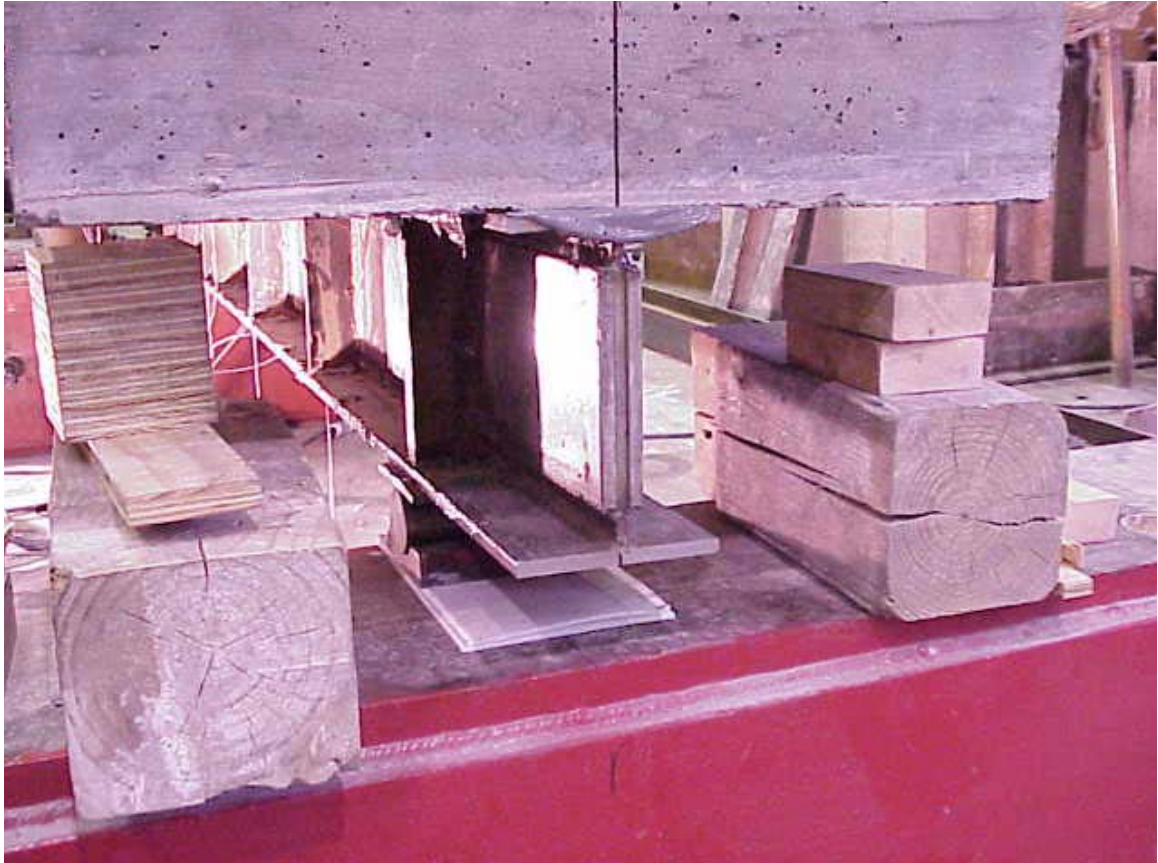
Figure 3-70: Close-up of Epoxy Beam Specimen End Support

The beam was tested in three-point bending with a concentrated load at midspan. The specimen was supported by rollers at the ends to allow free rotation. The roller base at one end was placed on Teflon to allow free longitudinal translation. The end detail can be seen in Figure 3-70. Load was

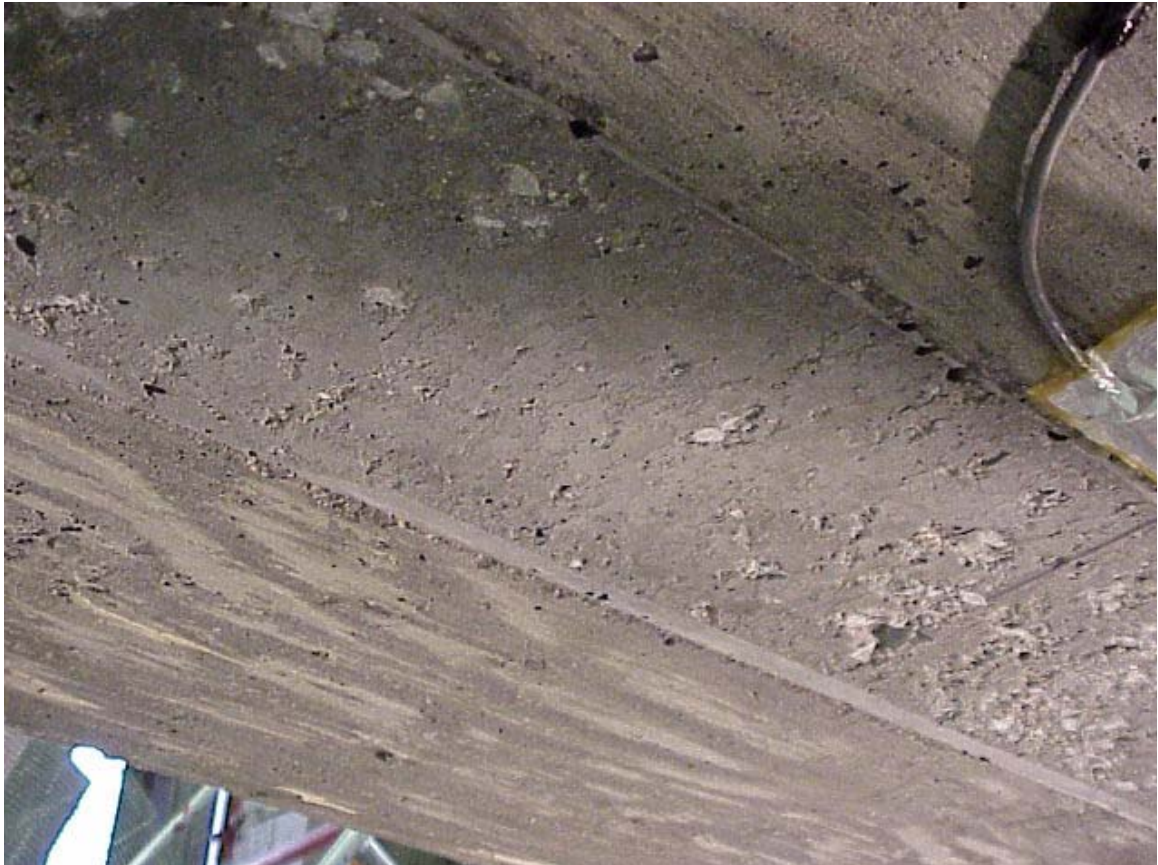
Figure 3-73: Underside of Deck after removal

After the load was removed, it was discovered that the entire slab was completely separated from the steel beam and could be simply lifted away. The underside of the concrete slab can be seen in Figure 3-73.

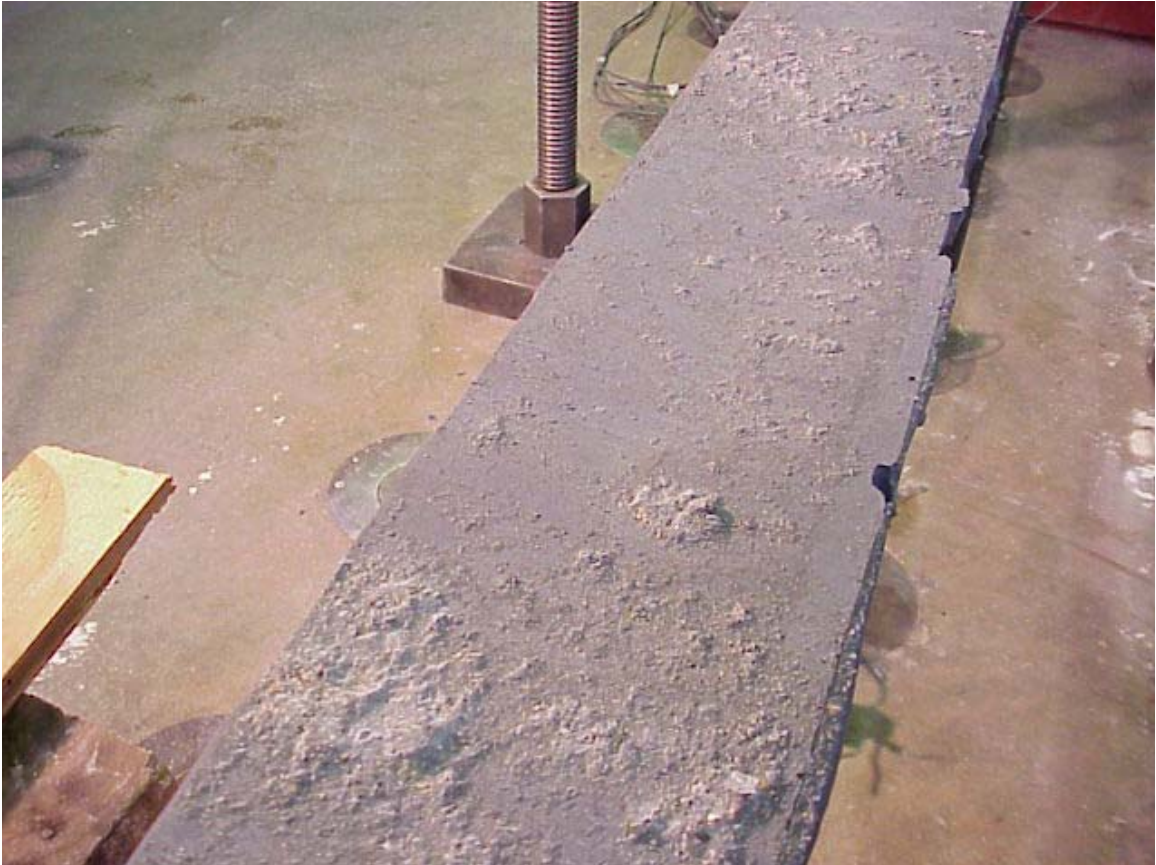
Figure 3-74: Exposed Epoxy Surface

Examination of the beam revealed that the concrete to epoxy bond had been the weak link as indicated by the fact that all of the epoxy remained on the steel. Figure 3-74 shows a close up of this surface. Although it may not be clear from the figure, it was quite evident that a fine residue of

cement was embedded in the epoxy. Therefore, it does not appear as though the epoxy failed, but rather the face of the concrete pulled away.

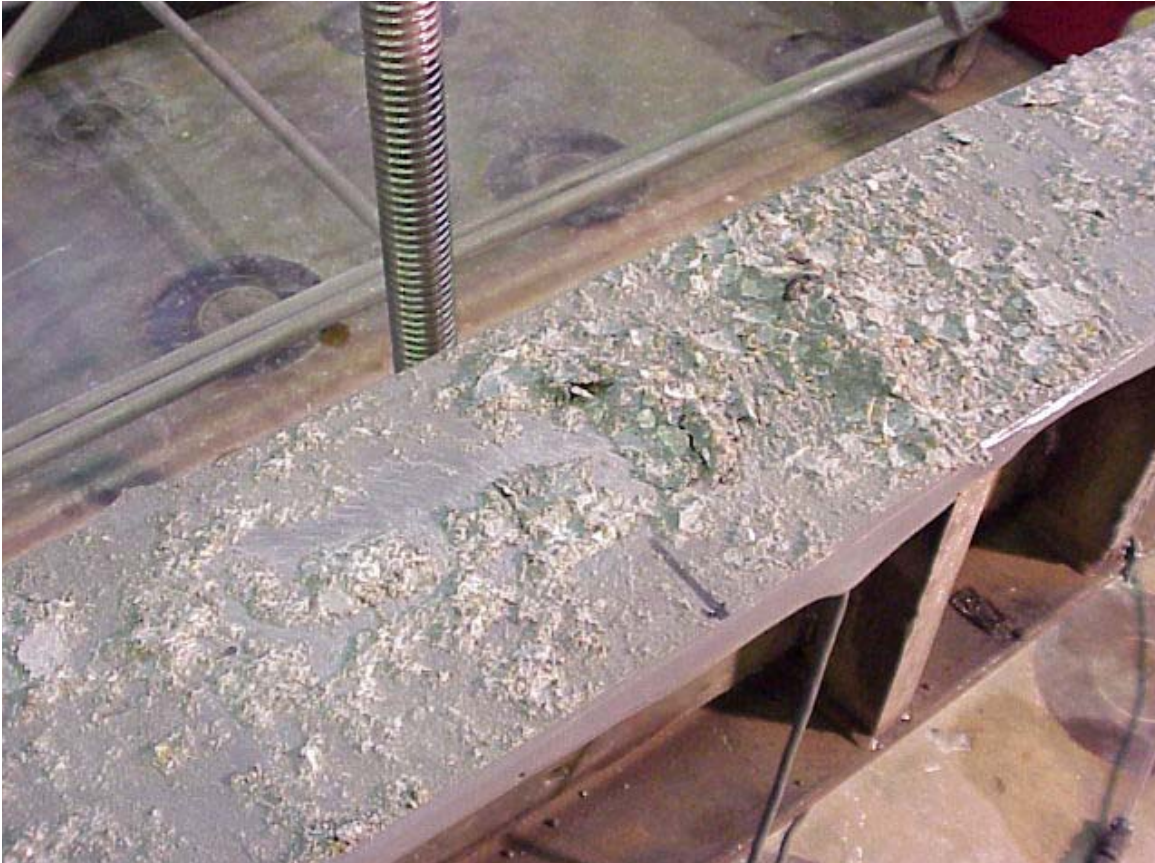
Figure 3-75: Failure Surface Near Mid-Span

from the epoxy and there was some localized shear failure of the epoxy itself.

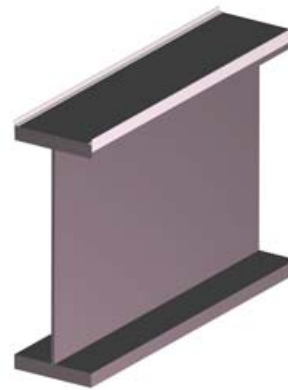
Figure 3-79: Coping Applied

An extruded plastic coping is applied to the sides of the flange as shown in Figure 3-79. Figure 3-80 shows a close up of the coping. The vertical projection, when embedded in the concrete deck, will act as a bead of caulking in preventing the epoxy (to be injected later) from seeping out from the sides of the flange. Since the effectiveness of the coping comes from its embedment into the concrete, the coping can be attached in whatever manner is simplest, such as contact cement or other adhesive.

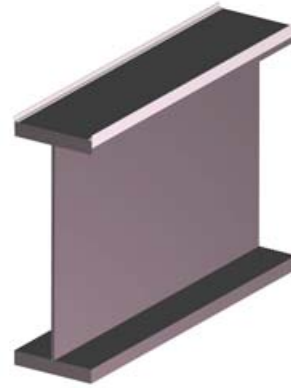
Figure 3-100: Coping Applied

The process begins similar to that used in the stud strip alternative. Plastic coping is placed on the bare steel beam as shown in figures 3-99 through

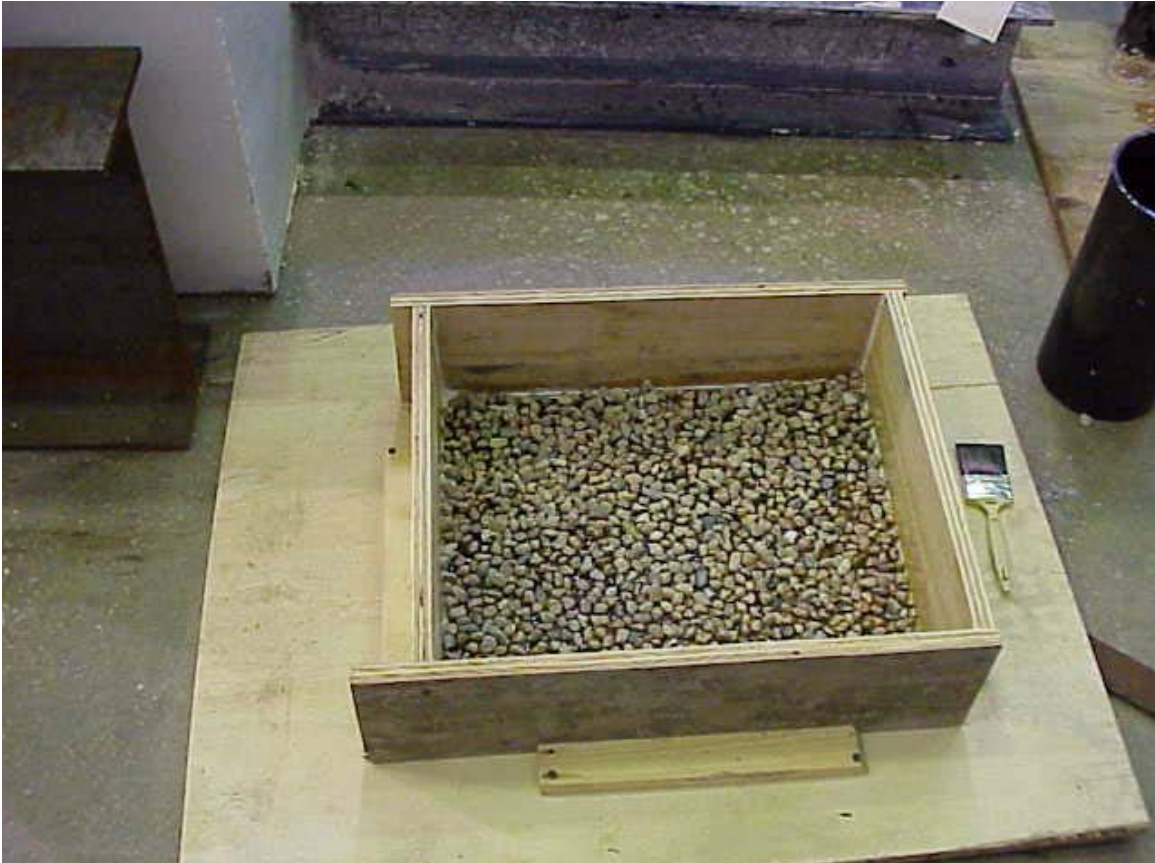
Figure 3-109: Pebbles bonded to steel

A modification has also been suggested expands on the layer of sand which utilizing larger aggregate. A layer of large pebbles is glued to the top of the

flange in the shop prior to shipment. An example of this can be seen in Figures 3-109 and 3-110.

From this point, the alternative would proceed similar to the previous utilizing a layer of sand followed by pumped epoxy after the deck had cured and shrunk. The irregular surface presented by the pebbles would increase the surface area for the epoxy to adhere to and also provide a degree of mechanical interlock.

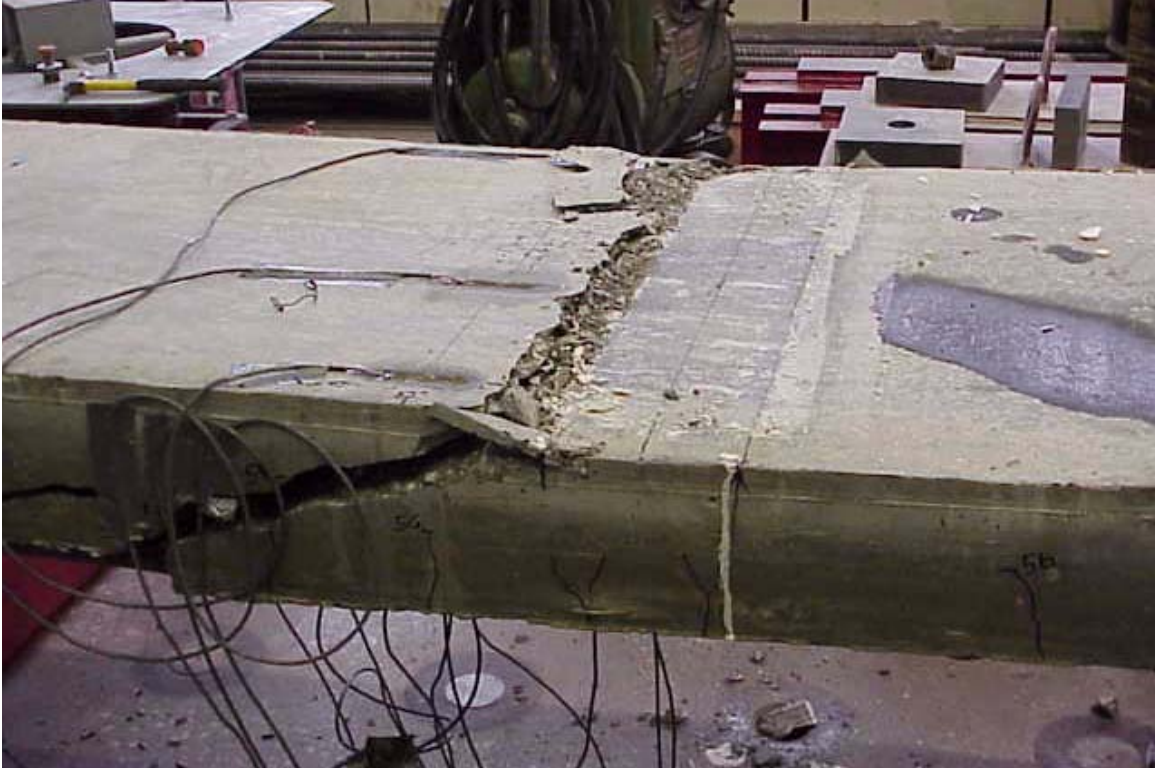
Figure 3-117: Specimen after Failure

Figure 3-117 shows a photo of the test specimen after the test conclusion. The specimen failed by crushing of the concrete slab, as indicated in Figure 3-1177. There was some relative slip between the slab and the steel as shown in Figure 3-118. Figure 3-119 shows the photo of the specimen after removal of the damaged concrete. There was no damage to the longitudinal plate or drop bars. The holes that were used to pass the transverse reinforcement and drop bars did show signs of inelastic deformations as shown in Figure 3-120. This indicates that, in designing the longitudinal plate, the bearing capacity of the holes should be a design item.
