Safety and Driver Behavior Studies at Multiple Lane Approaches to Stop-Controlled Intersections

*NDOR Research Project Number SPR-P1(05) P574
Transportation Research Studies*

Final Report

**Nebraska Transportation Center
Department of Civil Engineering
College of Engineering
University of Nebraska-Lincoln**

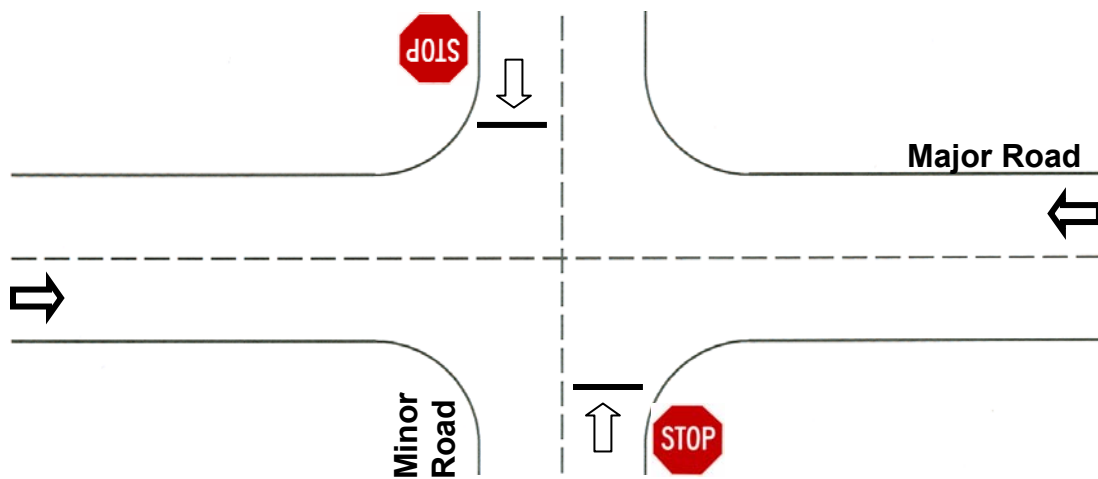
A two-way stop-controlled intersection is the most common type of intersection in the United States (2, Bared, 2000). In general, it involves a minor roadway with a stop-controlled approach intersecting a major roadway with no control as shown in FIGURE 1.

FIGURE 1 Generic Diagram of 2-Way Stop-Controlled Intersection

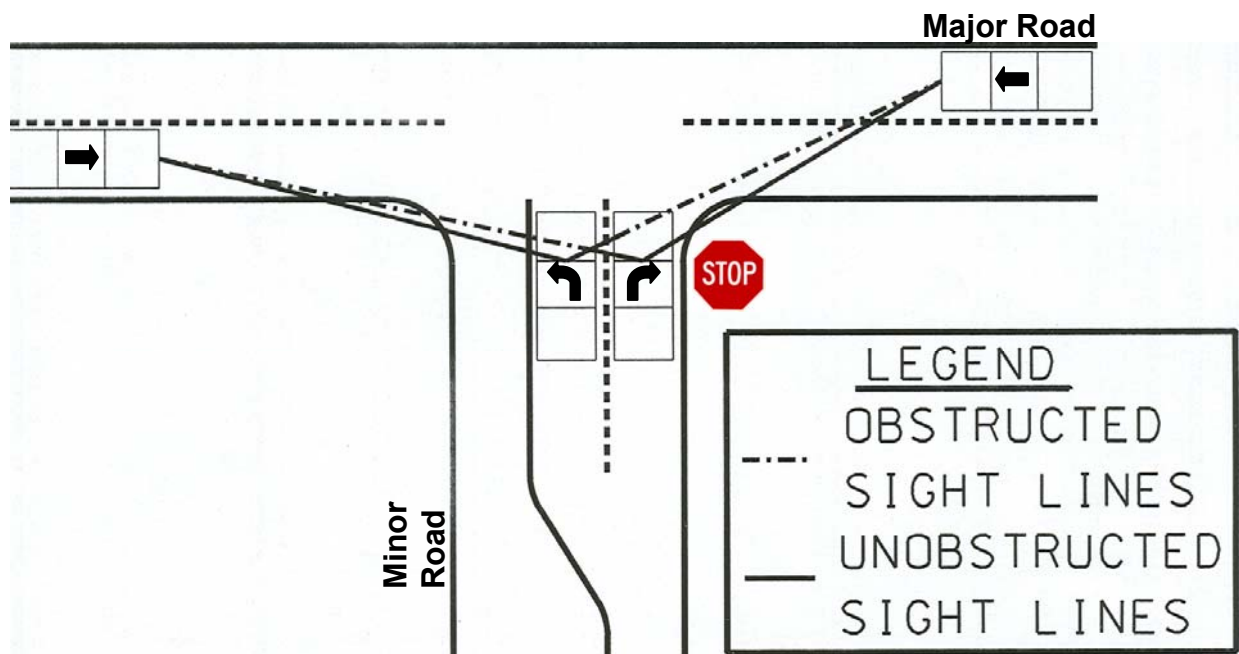
Conversion of single lane approaches of two-way stop-controlled intersections to multiple-lane approach (MLA) stop-controlled intersections may result in unsafe traffic conditions if the three-dimensional geometric features of the stopped approach aren't appropriately designed. FIGURE 2 shows a sketch illustrating reasons for concern. Drivers stopped adjacent to each other on multiple-lane approaches at a stop sign can obstruct one another's view of approaching traffic on the major road with their vehicles, which can potentially lead to unsafe driving conditions. This occurrence is even more of a problem if a combination of large and small vehicles is involved. An assessment of driver behavior, driver expectancy, traffic operations, and safety at MLA stop-controlled intersections is needed. Currently no information is available for intersection design guidelines that take traffic safety and driver behavior at MLAs under consideration. Appropriate intersection sight distance is further discussed in Chapter 2.

FIGURE 2 Sight Distance Obstructions at MLA Stop-Controlled Intersections Caused by Adjacent Stopped Vehicles

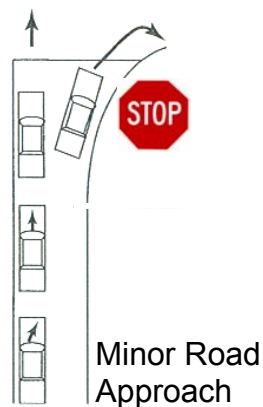
Many MLA intersections will remain in use or be built in the future to reduce driver delay regardless of the outcome of the safety studies outlined above, since these locations will not meet warrants for signalization and/or will be in remote areas of Nebraska where installation of a signal for operational purposes will have negative safety impacts for other reasons. Wide-throated SLA intersections that have been constructed to accommodate large trucks can also function as MLA intersections when two vehicles on the stopped approach are small, relative to the paved surfacing available to queue adjacent to major road. FIGURE 3 shows an example of such a “flared” intersection approach throat.

FIGURE 3 Illustration of a Flared Intersection Approach that Functions as an MLA-Type Intersection (12, Highway Capacity Manual, Exhibit 17-18, pg. 17-21)

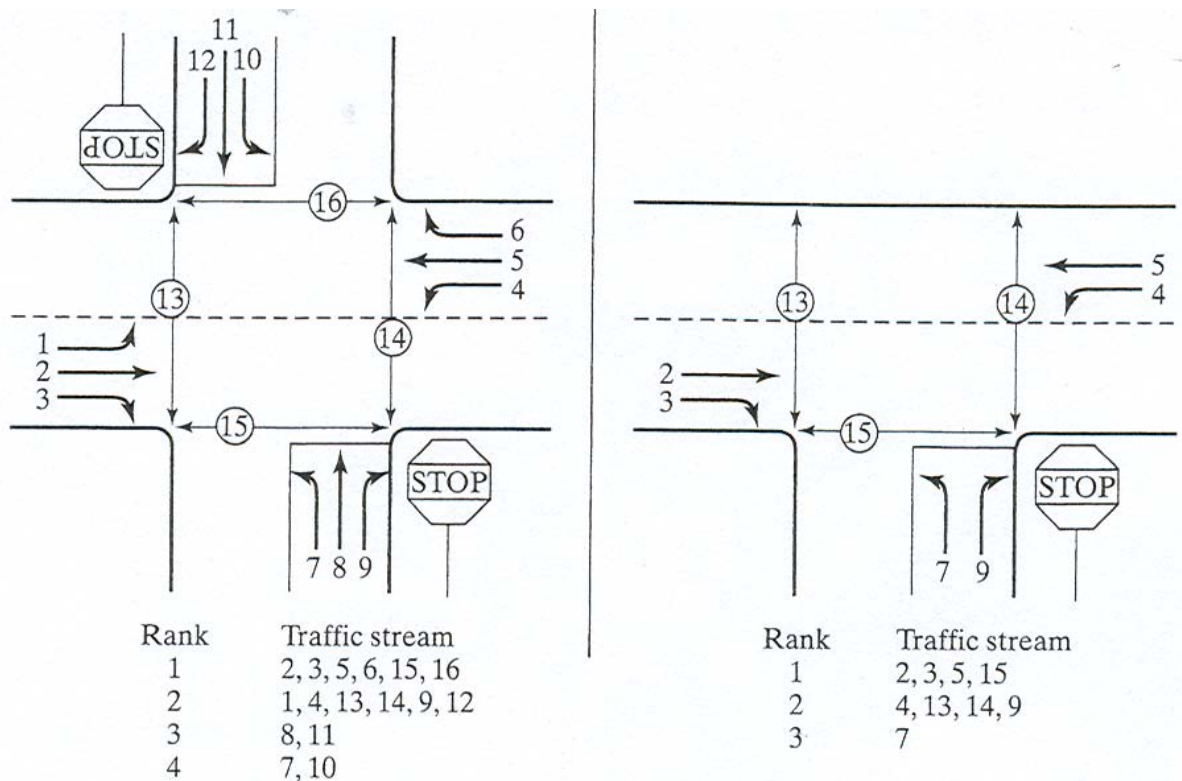
FIGURE 4 shows the hierarchy of movements at a two-way stop-controlled intersection. Traffic streams 13, 14, 15 and 16 refer to pedestrians, if they are a consideration. This study will not include consideration of pedestrians since those intersections under study did not exhibit significant if any pedestrian usage. According to these guidelines, if a left- and right-turning vehicle are stopped at the same time, the right-turning vehicle has priority over the left, since the driver only requires a suitable gap in traffic from the major road traffic approaching the intersection from the driver's left side.

FIGURE 4 Priority of Vehicle and Pedestrian Movements at a 2-Way Stop-Controlled Intersection (12, Highway Capacity Manual, Exhibit 17-3, pg. 17-4)

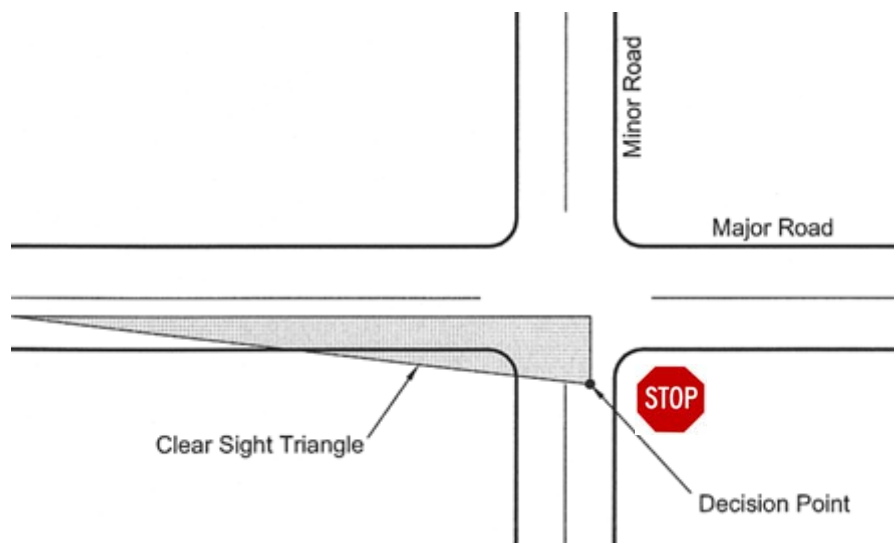
Intersection sight distance (ISD) is of concern for every roadway design engineer, as lack of proper ISD can lead to unsafe driving conditions. The American Association of State and Highway Transportation Officials (AASHTO) has detailed a sight triangle that is relevant at a stop-controlled intersection (18, NCHRP, 1986). Intersection sight triangles are imaginary lines formed by a driver's sight line to an object, usually an approaching vehicle. The driver's sight line forms the hypotenuse, while each leg is formed by perpendicular distances from the driver's eye to the center of the major roadway driving lane and driver's eye to the oncoming vehicle, as shown in FIGURE 5.

FIGURE 5 Example of Departure Sight Triangle (19, FHWA, 2004)

The relevant sight triangle when a driver is departing after coming to a stop at an intersection with two-way stop-control is called a departure sight triangle. When two vehicles are stopped next to each other at an MLA stop-controlled intersection, the departure sight triangle can be obstructed. Khattak and Gopalakrishna (20, 2003) found that rectifying sight distance obstructions could improve safety at intersections, at least concerning older drivers with slower reaction times.

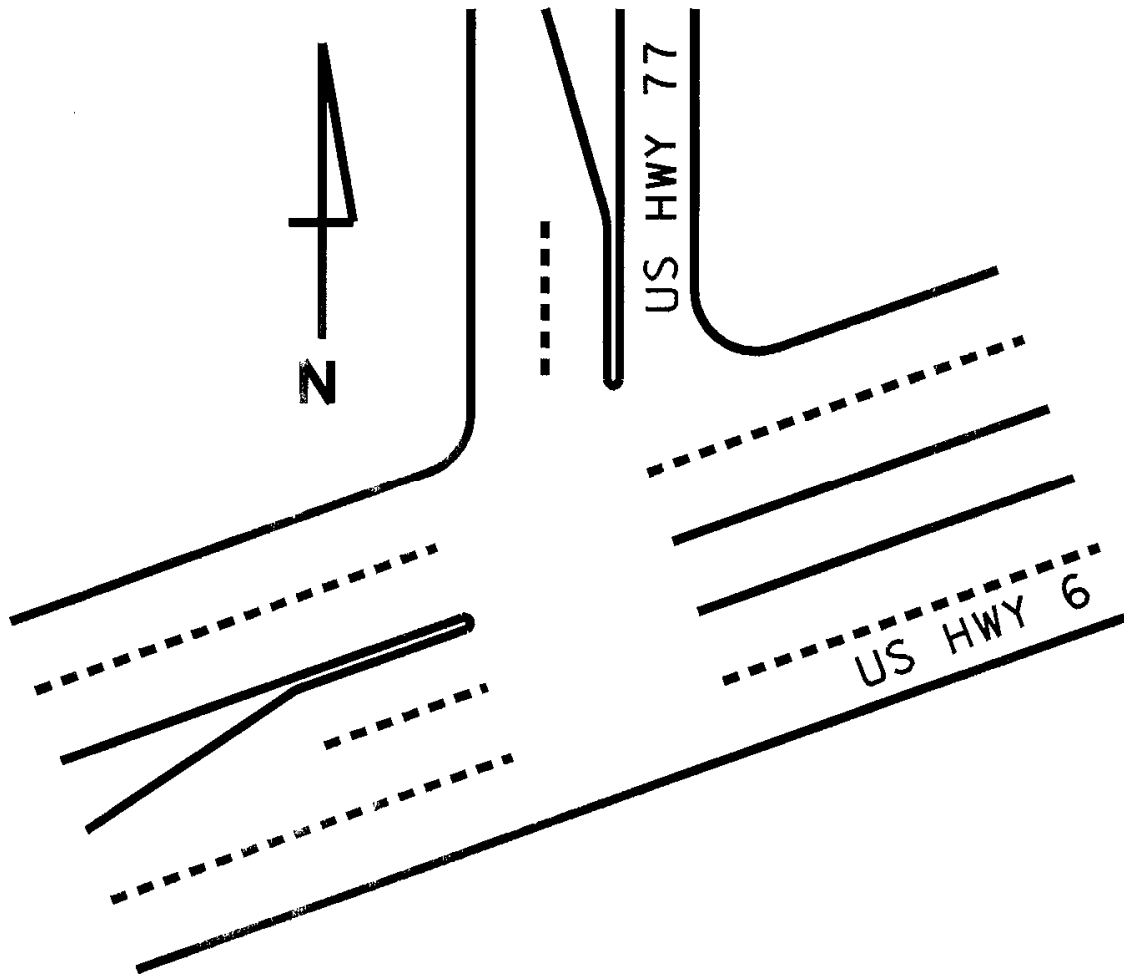
Intersection 1, shown in FIGURE 7, is the intersection of US Highway 6 and 56th Street in Lincoln, Nebraska. At this location, US Highway 77 is also known as 56th St within the community of Lincoln. Since US Highway 77 and US Highway 6 are two major routes used for entering and exiting the northeast portion of Lincoln from Interstate 80, this intersection receives a relatively large traffic volume of 10,000 vehicles per day on average. This intersection was stop-controlled until 1999, when it was signalized by the City of Lincoln Public Works and Utilities Department. This intersection was used as part of the before-after comparison group study on signalization as a treatment to improve safety at MLA stop-controlled intersections.

FIGURE 7 US Highway 6 & US-77/56th St, Intersection 1

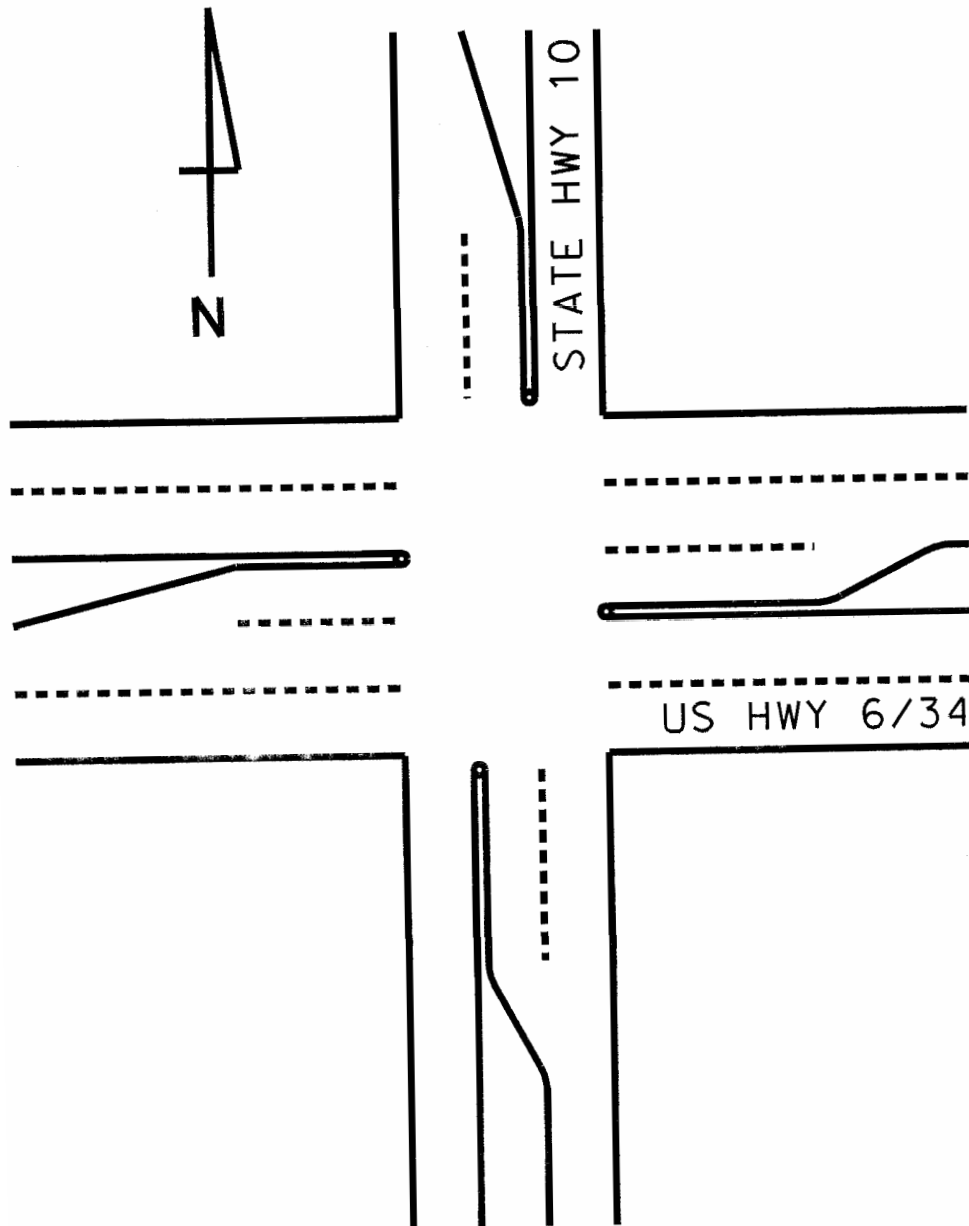
Intersection 2, also investigated using the Empirical Bayes method is the intersection of US Highway 6 and Nebraska Highway 10 in Minden, a town in central Nebraska with a population of approximately 3,000. This intersection represents the main intersection in the city of Minden, and experiences an AADT of approximately 6,000 vehicles per day. In FIGURE 8, Nebraska Highway 10 runs north-south and US Highway 6 runs east-west. This intersection, which was signalized in 1994, was used as part of the before-after comparison group study on signalization as a treatment to improve safety at MLA stop-controlled intersections.

FIGURE 8 US Highway 6 & Nebraska Highway 10, Intersection 2

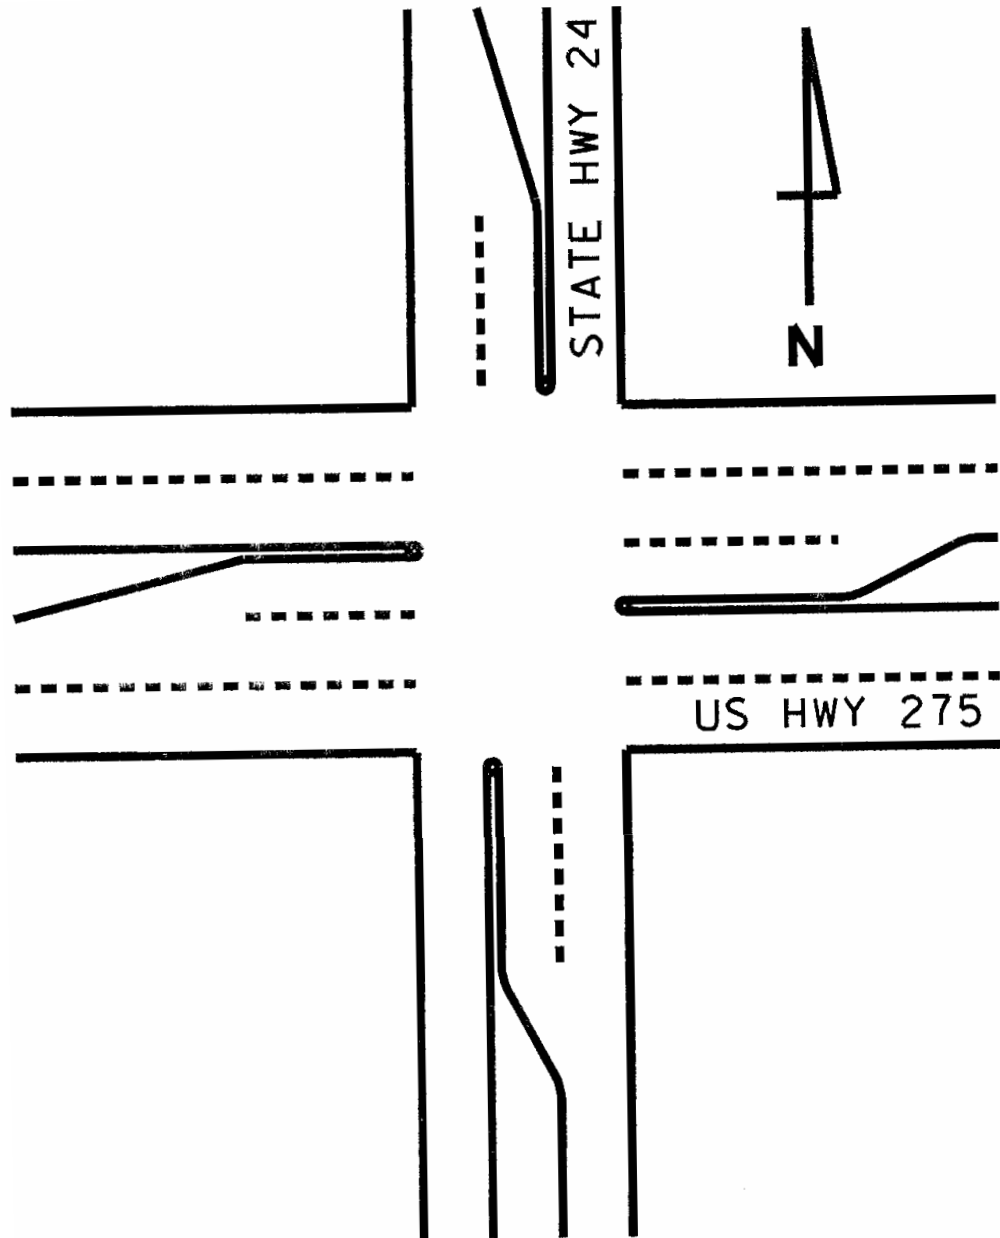
Intersection 3, the intersection of US Highway 275 and Nebraska Highway 24, lies on the eastern edge of Norfolk, a city with population approximately 24,000 in northeastern Nebraska. This intersection experiences an AADT of 6,500 vehicles per day and was signalized in 1997. In FIGURE 9, US Highway 275 runs east-west and Nebraska Highway 24 runs north-south. This intersection was used as part of the before-after comparison group study on signalization as a treatment to improve safety at MLA stop-controlled intersections.

FIGURE 9 US Highway 275 & Nebraska Highway 24, Intersection 3

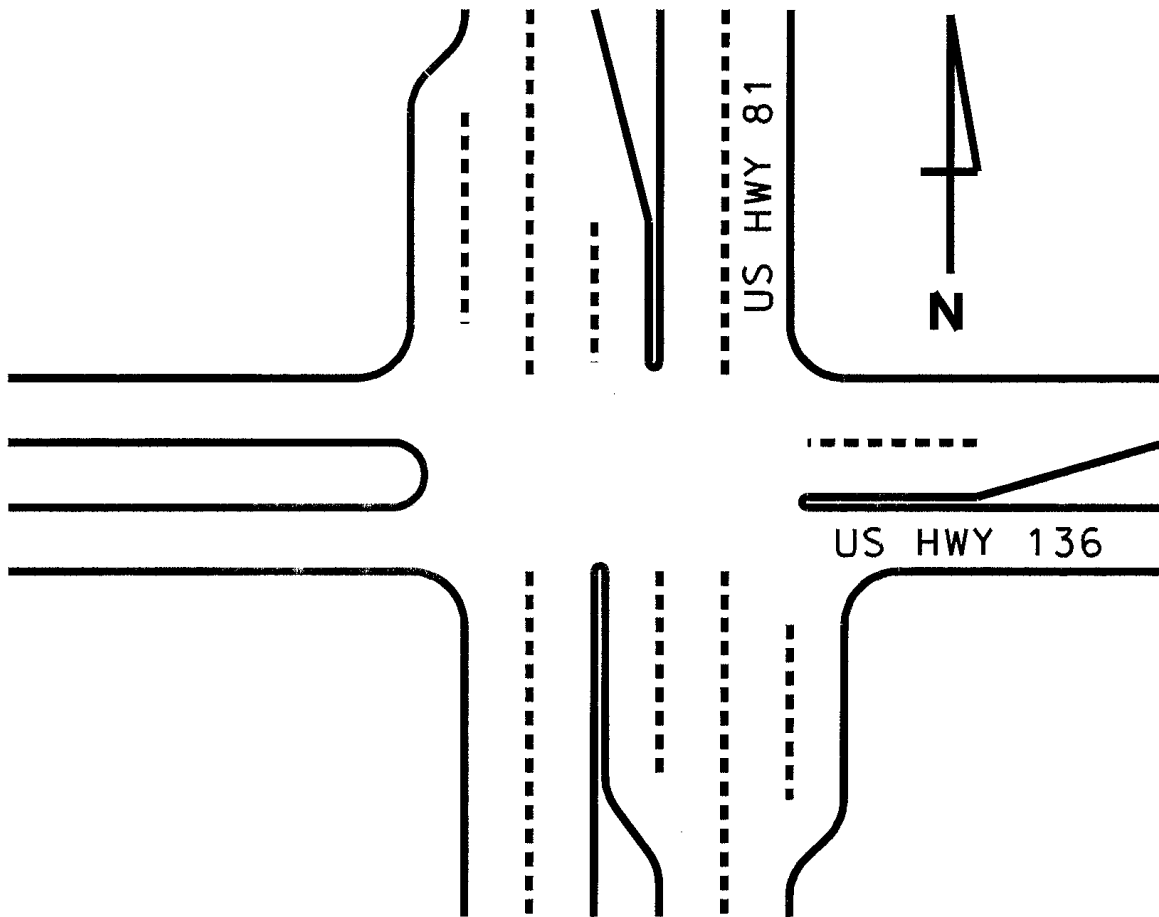
The intersection of US Highway 81 and US Highway 136, shown in FIGURE 10, is located in a rural area near the town of Hebron (population 1,500) in south-central Nebraska. The intersection experiences an AADT of 2,700 vehicles per day. Following a fatal crash involving a teen-aged girl, the left-turn lane on US Highway 136 was removed in 2000 to change this intersection to single lane intersection with two-way stop-control. This intersection was used as part of the before-after comparison group study investigating lane removal as a treatment to improve safety at MLA stop-controlled intersections.

FIGURE 10 US Highway 81 & US Highway 136, Intersection 4

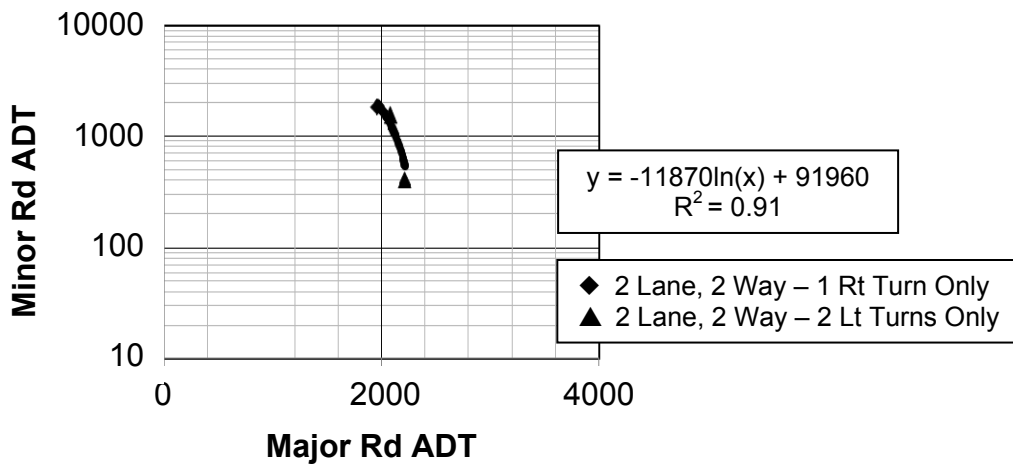
FIGURE 12 Results of Major ADT vs Minor ADT Relationship at Intersections of 2-Lane, 2-Way Roadways with Below Average 3-Yr Accident Rates, Major Rd Speed Limit = 65 mph

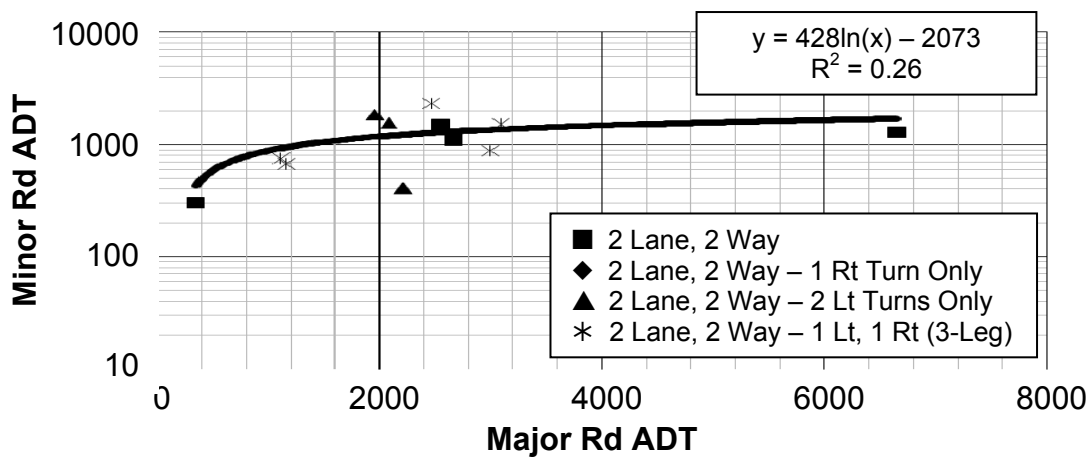
FIGURE 13 Results of Major ADT vs Minor ADT Relationship at Intersections of 2-Lane, 2-Way Roadways with Below Average 3-Yr Accident Rates, Major Rd Speed Limits = 60 and 65 mph

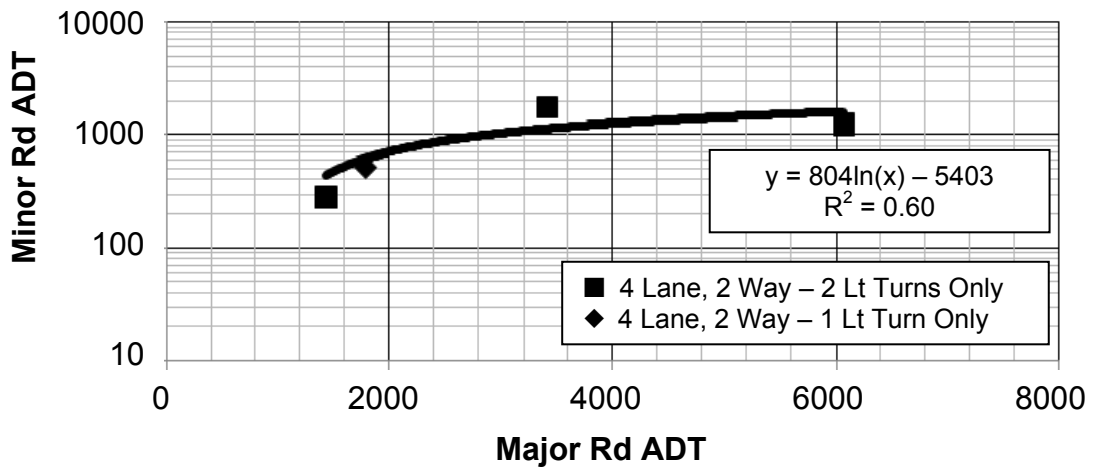
FIGURE 14 Results of Major ADT vs Minor ADT Relationship at Intersections of 4-Lane, 2-Way Roadways with Below Average 3-Yr Accident Rates, Major Road Speed Limit = 60 and 65 mph

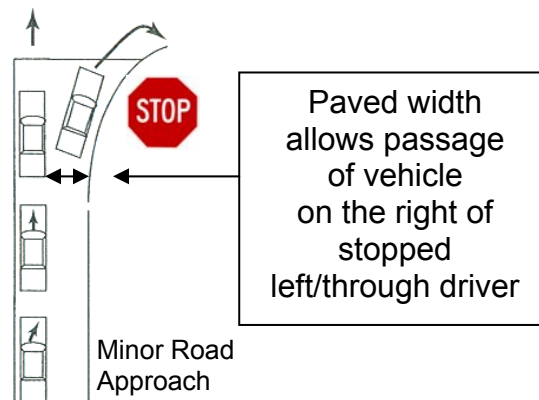
As outlined in Chapter 1, many MLA intersections will remain in use or be built in the future to reduce driver delay regardless of the outcome of the safety studies discussed in the previous chapters. These locations will not meet warrants for signalization and/or will be in remote areas of Nebraska where installation of a signal for operational purposes will have negative safety impacts for other reasons. Wide-throated single-lane approach (SLA) intersections that have been constructed to accommodate the turning footprint of large trucks can also function as MLA intersections when two vehicles on the stopped approach are small relative to the paved surfacing available. This results in drivers lining up adjacent to each other as shown in FIGURE 3, repeated below for convenience. If the paved area to the right of a stopped left/through vehicle is wide enough to safely pass, a right-turning driver will generally do so, pull forward of the left/through vehicle to view non-stopping traffic on the major road, and choose an acceptable gap to make a right turn and enter the major road traffic stream.

FIGURE 3 Illustration of a Flared Intersection Approach that Functions as an MLA-Type Intersection (12, Highway Capacity Manual, Exhibit 17-18, pg. 17-21)

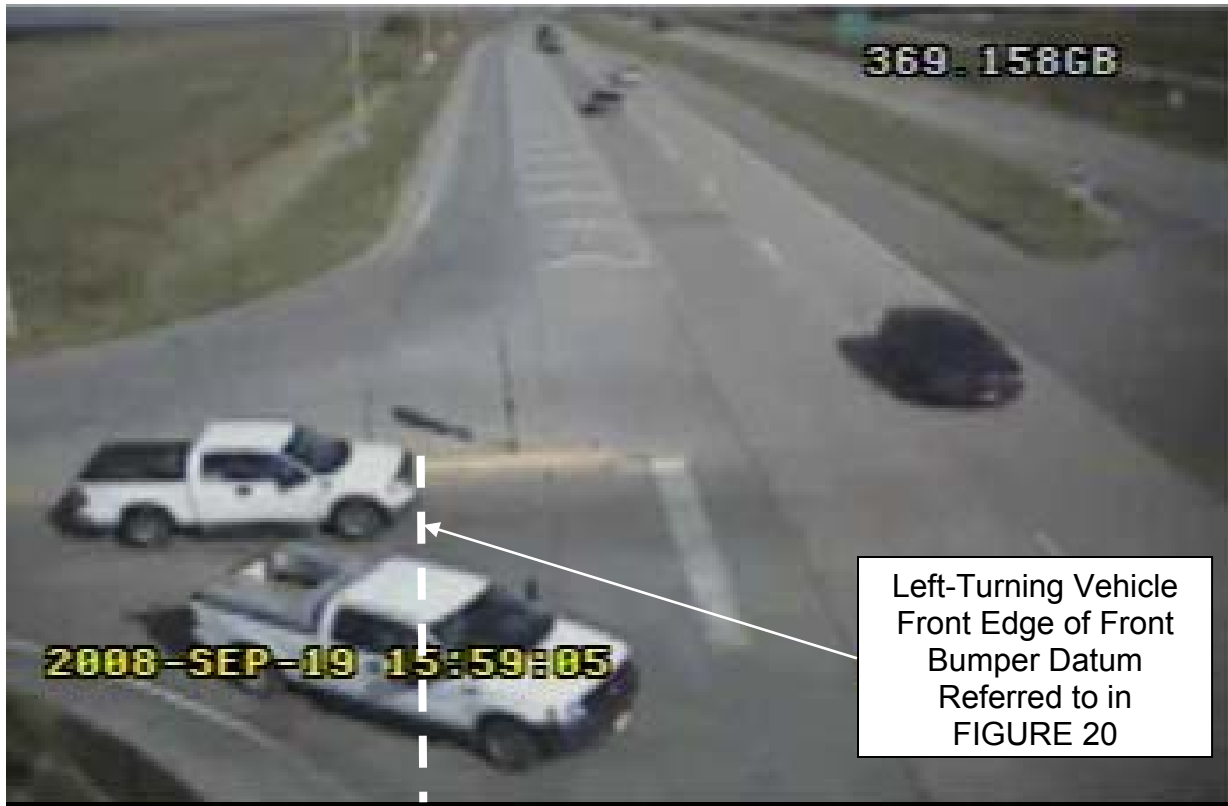
with sufficient paved surface that they may pull forward of a left/through stopped vehicle on the same approach, look for an appropriate gap in through traffic approaching from their left and enter the flow of traffic safely. Therefore, any three-dimensional features or traffic control device cues that reinforce that conviction should be used to encourage right-turn drivers to perform that behavior in this situation. If the position of the right-turning driver can be accurately estimated, an optimal position for the left/through driver can be encouraged as well, resulting in the optimal condition for vehicles within a less-than-desirable intersection sight distance situation. FIGURE 15 shows an example of such a situation at a stopped-control intersection south of Lincoln, NE at the easternmost junction of US Hwy 77 (expressway) and Nebraska Hwy 41 (two-lane two-way highway). The photograph was taken from a pole-mounted camera as part of a current NDOR research study on offset right-turn lanes (ORTLs) titled "Conditions Warranting Offset Right-Turn Lanes (ORTL) for Improved Intersection Sight Distance", (NDOR Project SPR-P1(06)P592).

FIGURE 15 Photograph of Typical Driver Behavior at MLA Intersection, US Hwy 77 & East Junction N-41

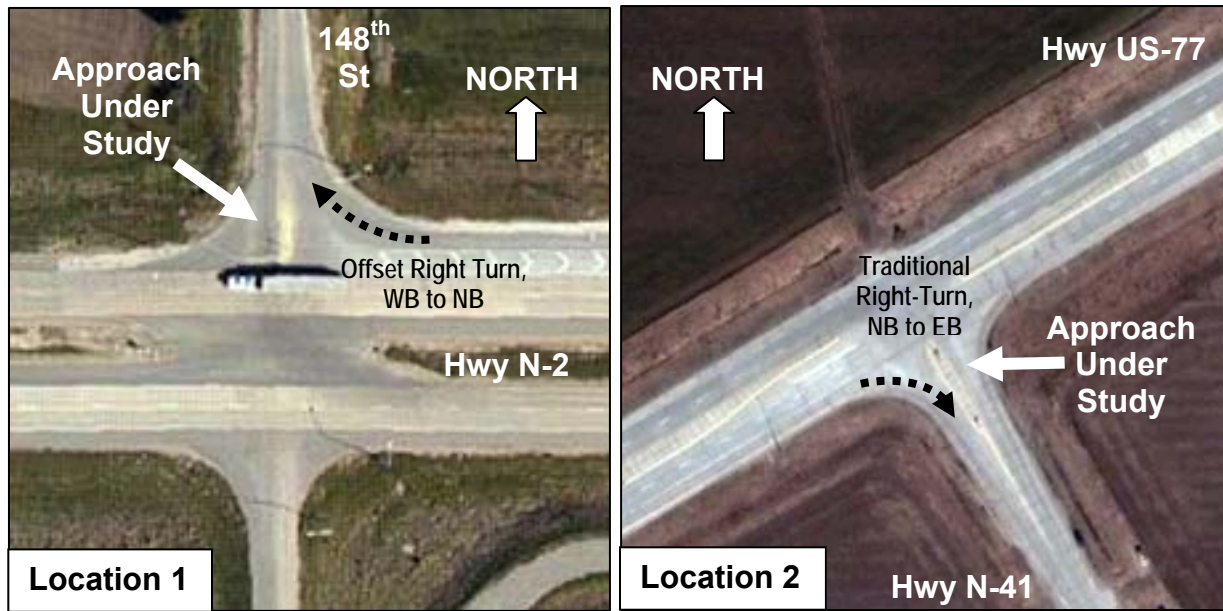
As part of the ORTL research project, the effectiveness of adding a “Stop at Line” sign on a 2-way stop-controlled approach was studied. Two stopped approach locations were chosen for data collection, both of which had raised center medians with a STOP sign within the raised median and a STOP sign on the right side of the approach as well. Vehicle stopping positions were recorded at both locations under varying conditions. Location 1 was at the intersection of 148th Street and Hwy N-2 to the southeast of Lincoln, NE. Location 2 was at the easternmost intersection of Hwy US-77 and Hwy N-41 between Lincoln and Beatrice. Both N-2 and US-77 are 4-lane divided expressways and both 148th St and N-41 are 2-lane roadways. Location 1 has an offset right-turn lane to the left of the 148th St stop-controlled approach (for the WB to NB right-turn movement) and Location 2 has a traditional right-turn lane to the left of the N-41 stop-controlled approach (NB to EB right-turn movement). Aerial views of both locations are shown in FIGURE 16.

FIGURE 16 Study Locations 1 and 2 from Offset Right-Turn Lane (ORTL) Project

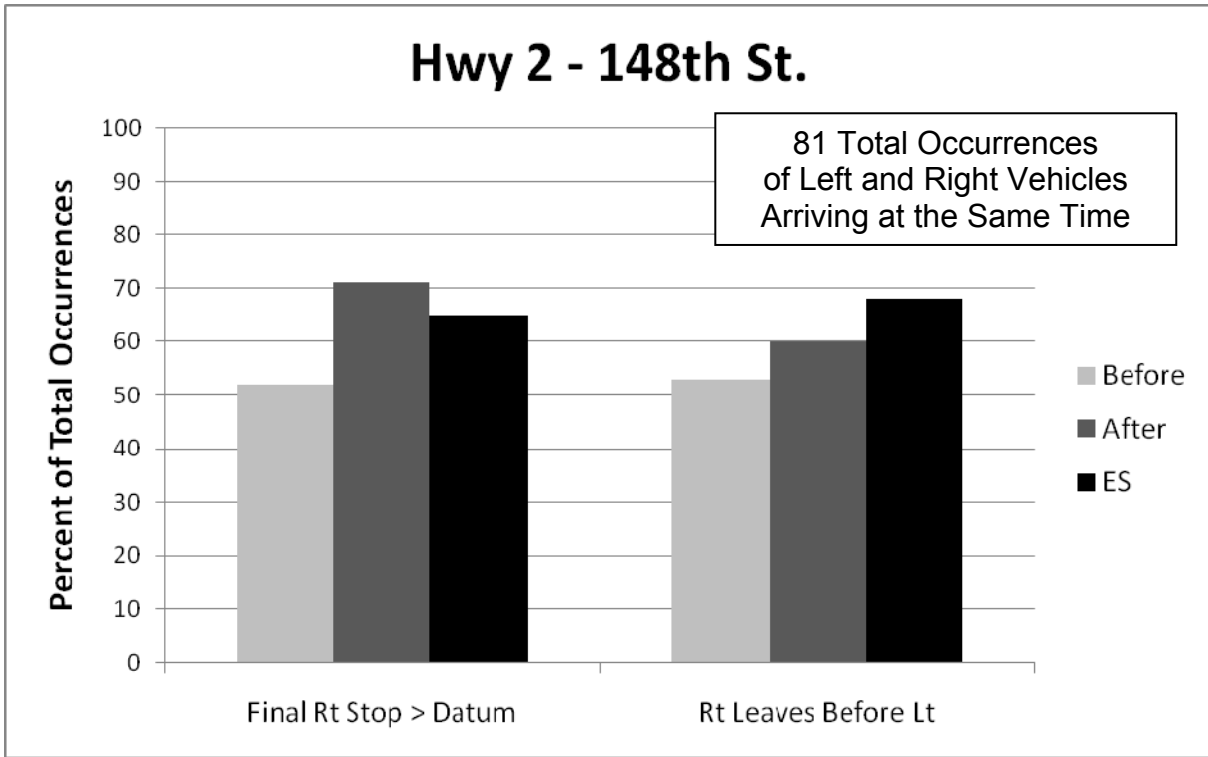
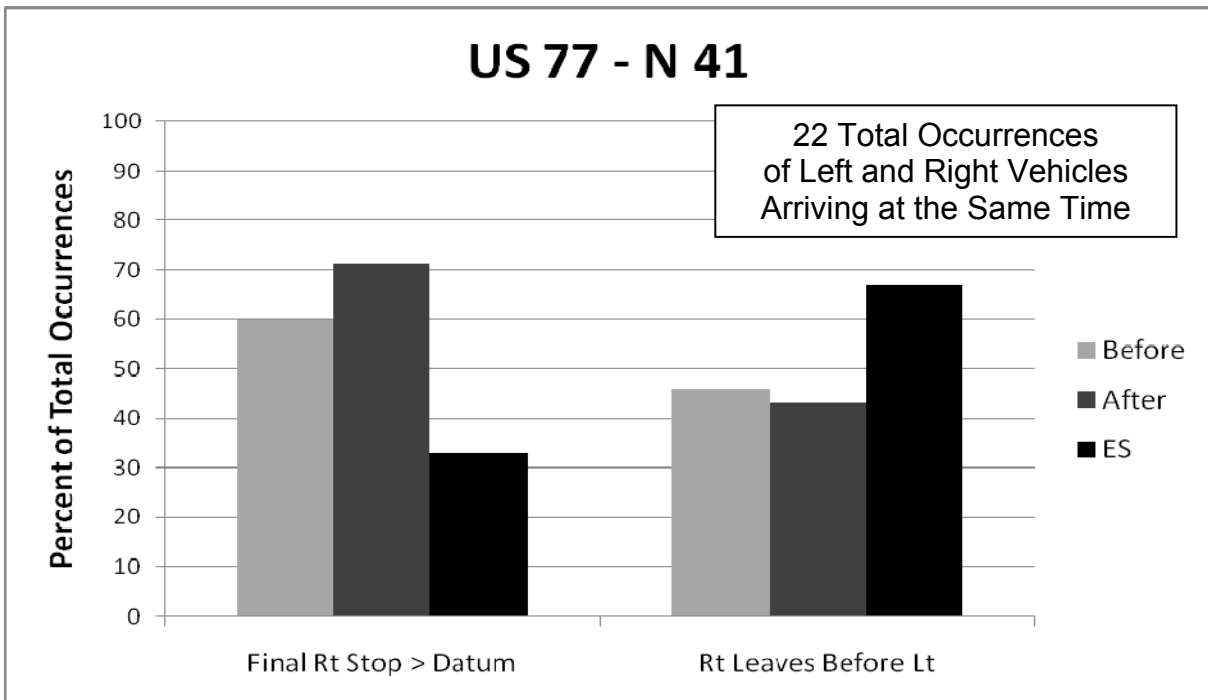
All occurrences of left-right vehicle conflicts on the ORTL video were viewed to determine the likelihood of the behavior described above. Results are shown in FIGURE 17 which indicates that right-turning drivers pull forward of view-blocking left-turning vehicles and leave before the left-turning drivers the majority of the time.

FIGURE 17 Results of Right-Turning Driver Behavior at MLA Type Intersections at Location 1, 148th St and Hwy 2 and Location 2, US Hwy 77 and Hwy N-41

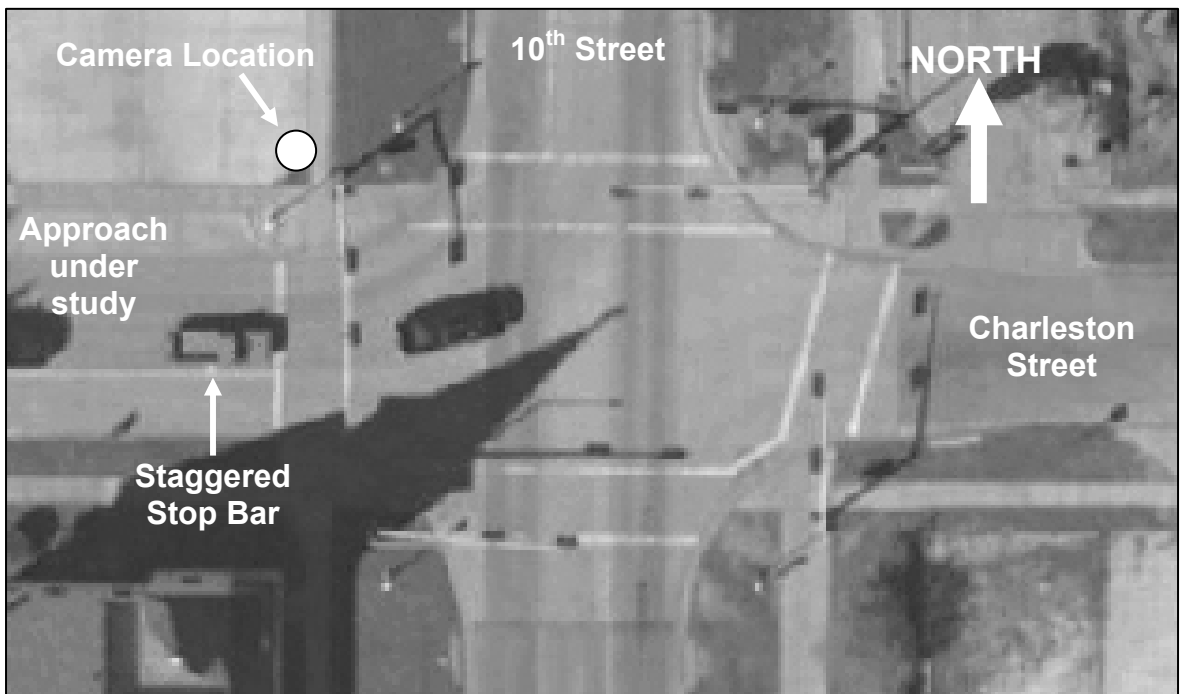
The intersection of 10th and Charleston Streets in Lincoln, NE shown in FIGURE 19 was selected as an appropriate study site for an accurate assessment of driver behavior at a signalized intersection with a staggered stop bar. At this intersection, the left-turn lane stop line for the eastbound to northbound movement is set back 10 feet from the straight/right-turn stop line which also serves as the near boundary for the crosswalk striping. Another view of the study intersection approach is shown in FIGURE 20. After review of the MUTCD guidelines (7, MUTCD, 2003) and discussions with Traffic Division authorities at NDOR, the desirable position for stopping at the stop bar was considered to be with the front edge of the front bumper of a stopped vehicle at the near edge of the stop bar, as shown in FIGURE 21.

FIGURE 19 Aerial View of Staggered Stop Bar Study Site at 10th and Charleston Sts in Lincoln, NE.

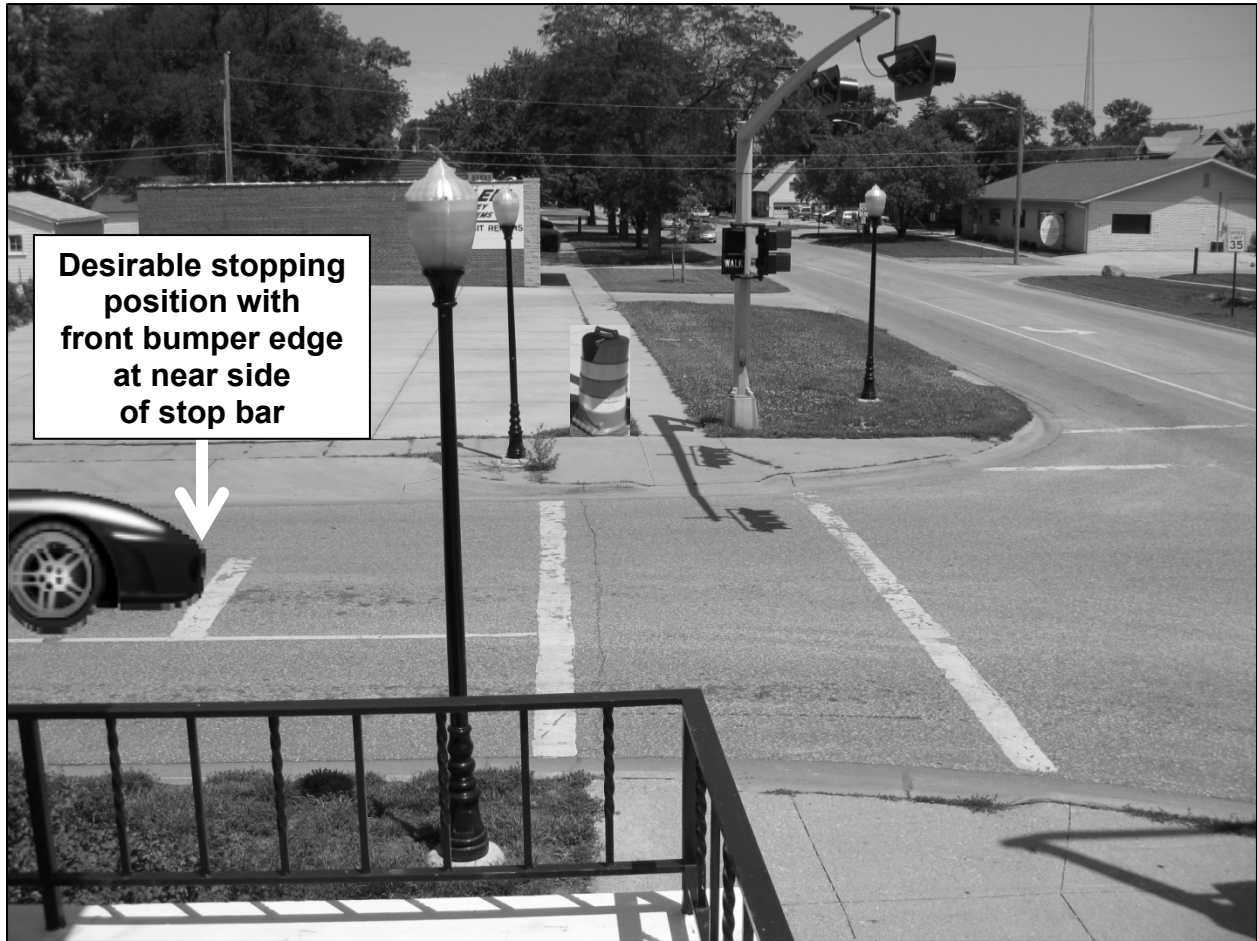
FIGURE 20 View of Staggered Stop Bar on Eastbound Approach to 10th and Charleston Sts, Lincoln, NE.

Driver behavior on the eastbound approach was videotaped from a location within the public right-of-way, adjacent to the stop bar. Since the filming location was so close to the drivers being studied, a video camera tripod was set within a plastic construction barrel modified with an opening at the top to allow unobstructed filming and to prevent drivers from modifying their behavior due to video surveillance. A camcorder on the tripod within the barrel was used for filming with power supplied from a deep cycle battery. The battery was connected to a power inverter which was attached to a surge protector. The camera was then powered through the surge protector with an AC power cable. A view of the camera location from the traffic barrel is superimposed in FIGURE 20 and shown in more detail in FIGURE 21.

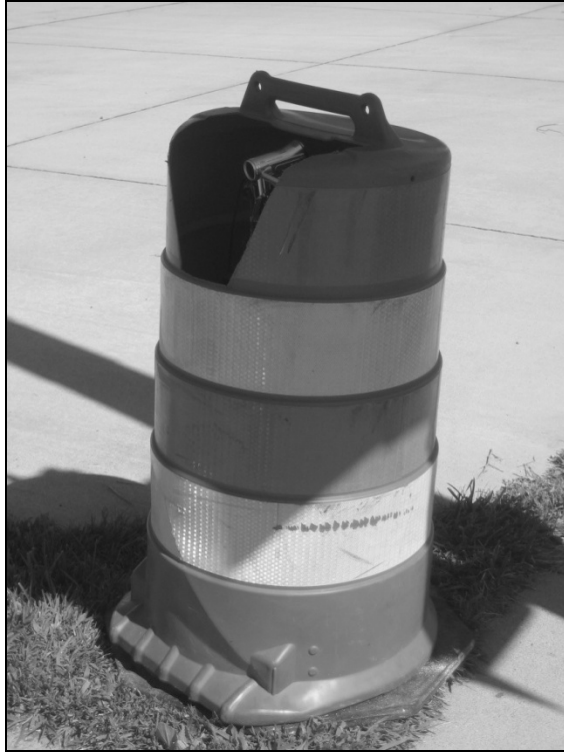
FIGURE 21 “Barrel Camera” Setup.

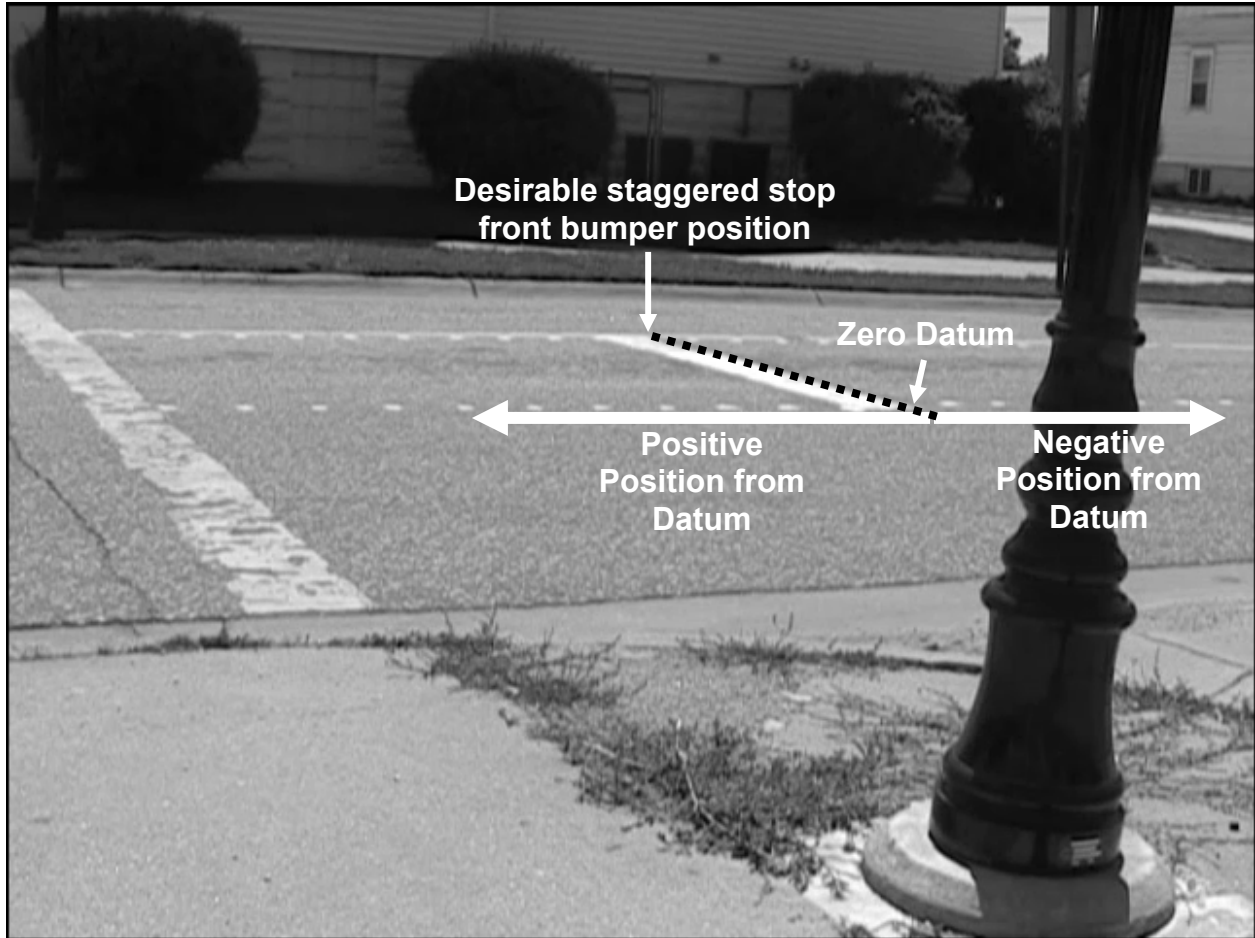
To record stopping distances accurately, reference dots were painted along the left-turn lane under study. These dots were placed at 1 ft increments from the boundary of the eastbound approach crosswalk to 10 ft beyond the staggered stop line. When analyzing the video, the zero-datum point was the desired stop position, shown in FIGURE 22. The stop line for the left-turning vehicles was faded and worn in places so the line was repainted immediately before beginning the study.

FIGURE 22 Screenshot from Camera Viewpoint with Datum and 1-ft Increment Spaced Reference Dots.

To quantify the stop position, a screenshot was taken from the video for each stopped left-turn vehicle occurrence. This screenshot was then placed into MicroStation V8 software. The reference dots served as a guideline to place graphics to record the vehicle stop location more accurately. Once finished, the MicroStation V8 drawing was printed out on a transparency without the screenshot. Since the drawing was sized one-to-one, the transparency was placed on the computer monitor with the video playing, and accurate stop positions were compiled.

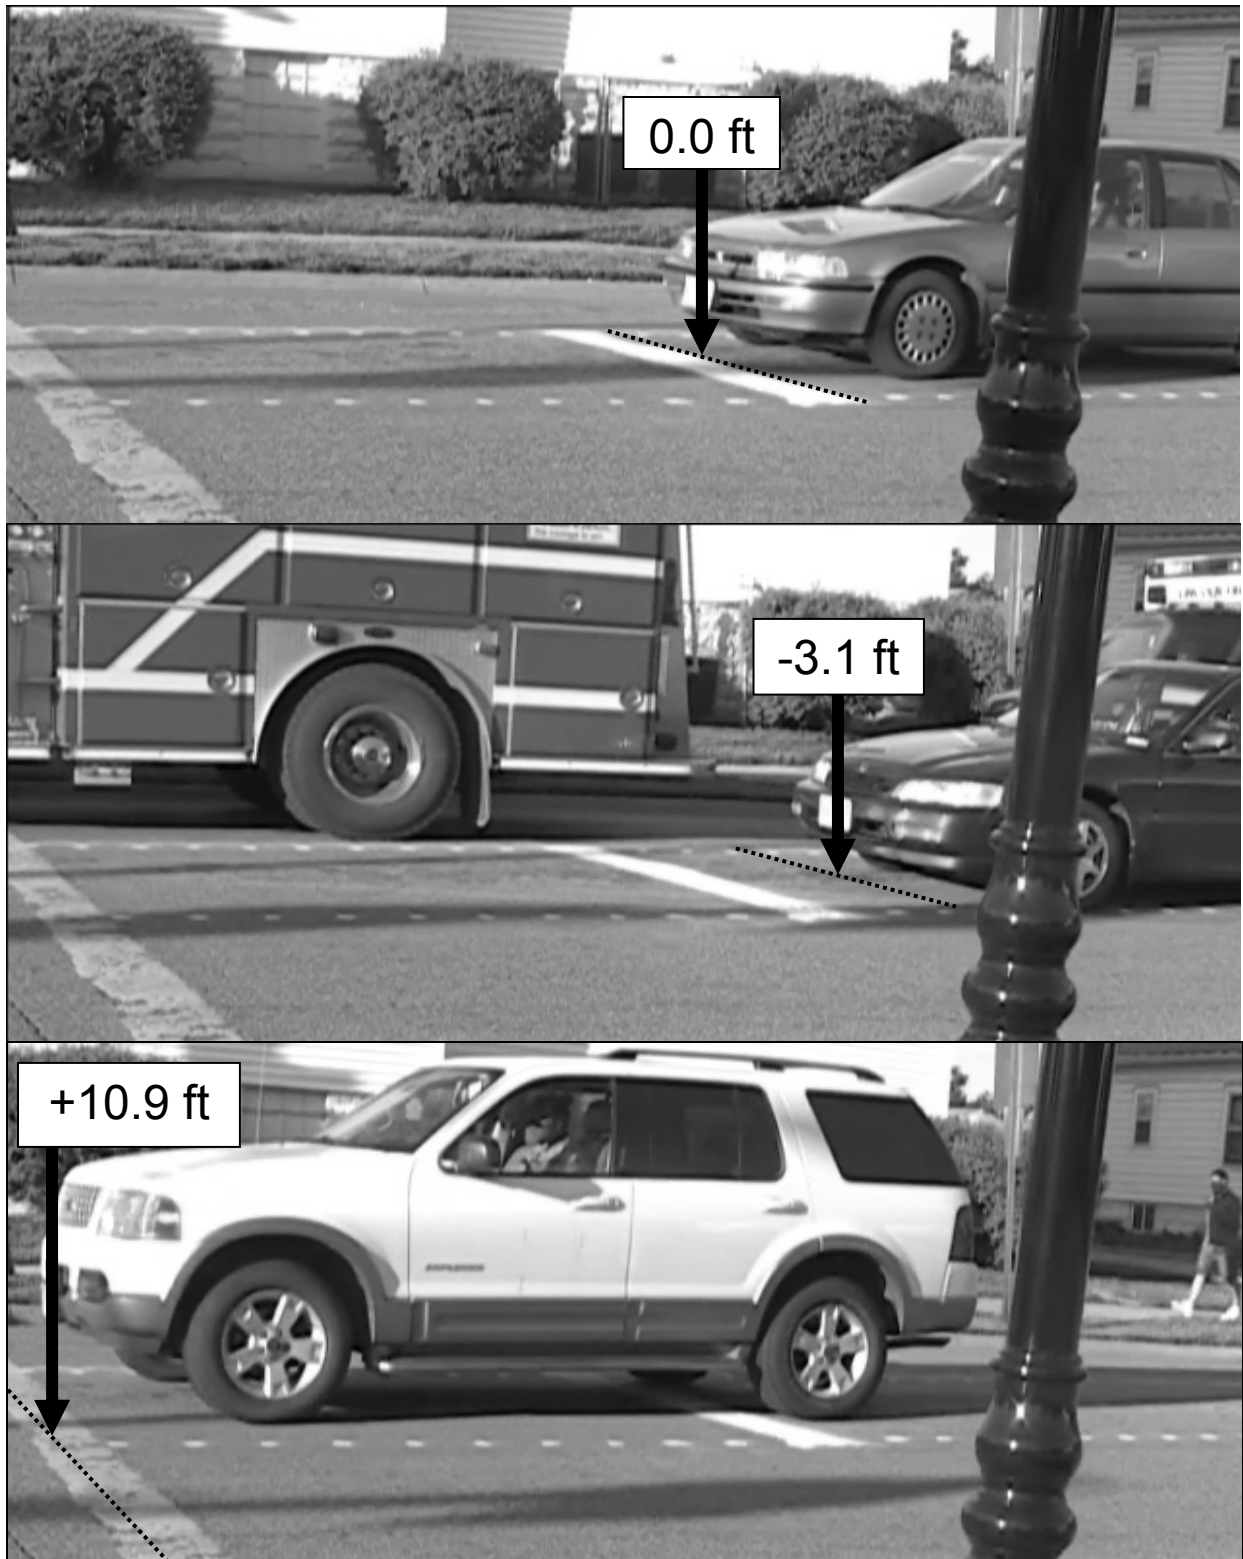
Stops made before the datum line were recorded as negative values, while stops beyond the datum line were recorded as positive values as shown in FIGURE 25. The boundaries of the stop positions were 10 ft before the staggered stop line and 12 ft beyond the staggered stop line. These were chosen due to the width of the camera view from its field position. Values outside these limits were recorded as “-10+” and “12+,” respectively. Pictures of vehicles stopped at different points along the studied approach are shown in FIGURE 25.

FIGURE 25 Video Screenshots with Stops at 0.0, -3.1, and +10.9 ft from the Datum.
