Safety and Driver Behavior Studies at Multiple Lane Approaches to Stop-Controlled Intersections

*NDOR Research Project Number SPR-P1(05) P574
Transportation Research Studies*

Final Report

**Nebraska Transportation Center
Department of Civil Engineering
College of Engineering
University of Nebraska-Lincoln**

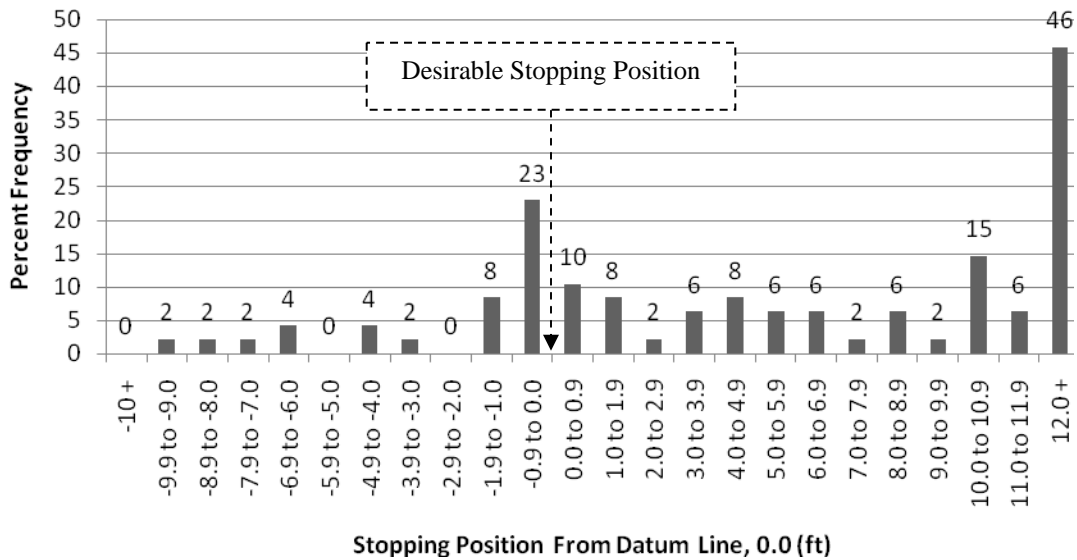
FIGURE 26 shows the percent occurrence frequency of the location of the front edge of the front bumper of the stopped vehicles recorded. After viewing the results, it was apparent that once drivers got beyond a certain point, their view of the staggered stop bar would not be possible and their positioning would then be influenced by the near edge of the crosswalk instead (essentially a second stop-bar location). Recognizing this effect, an assumption was made that the eye of the driver was 8 ft behind the front edge of the front bumper of the vehicle (as used in the intersection sight distance model of the AASHTO Green Book (28, page 657)). Once the bumper was 8 ft beyond the datum line (a recording of +8.0 ft), the staggered stop line was assumed to have no influence (i.e. the driver could no longer see the staggered stop bar without turning his/her head 90 degrees and looking down at the pavement).

FIGURE 26 Percent Occurrence Frequency of Front Bumper Position Under Condition 1 with Total Number of Vehicle Occurrences from Study.

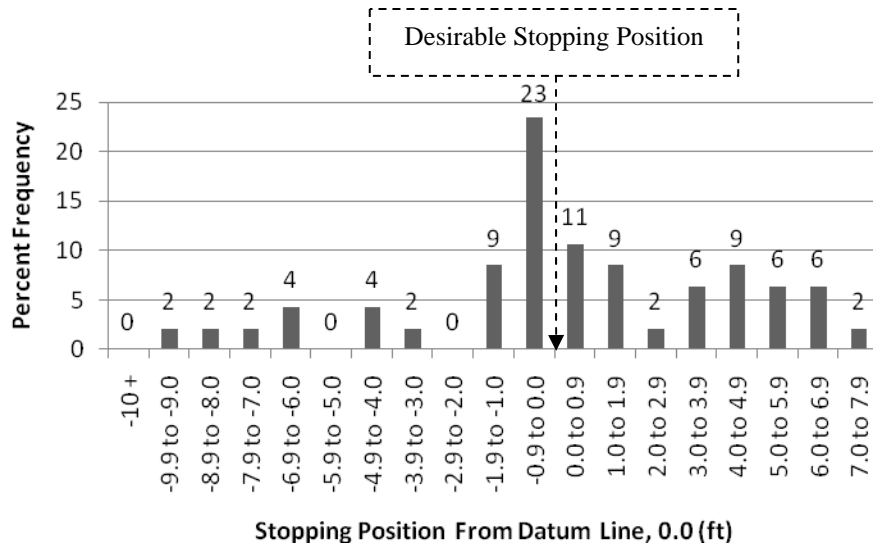
FIGURE 27 shows the percent occurrence frequency of this subgroup of vehicles under Condition 1. Conditions 2 and 3 are shown in FIGURES 28 and 29 respectively. FIGURE 30 shows the percent occurrence frequency for all conditions combined. TABLE 22 shows a summary of statistics for the data along with sample size error estimates.

FIGURE 27 Percent Frequency of Positioning, Condition 1.

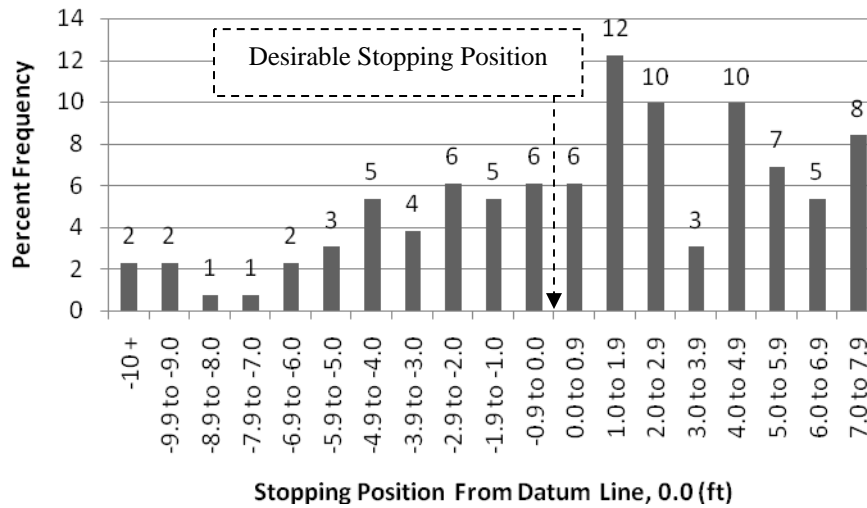
FIGURE 28 Percent Frequency of Positioning, Condition 2.

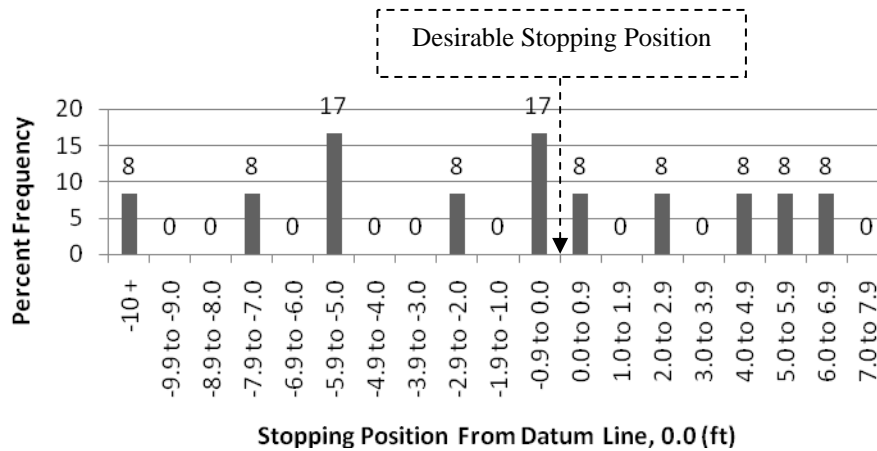
FIGURE 29 Percent Frequency of Positioning, Condition 3.

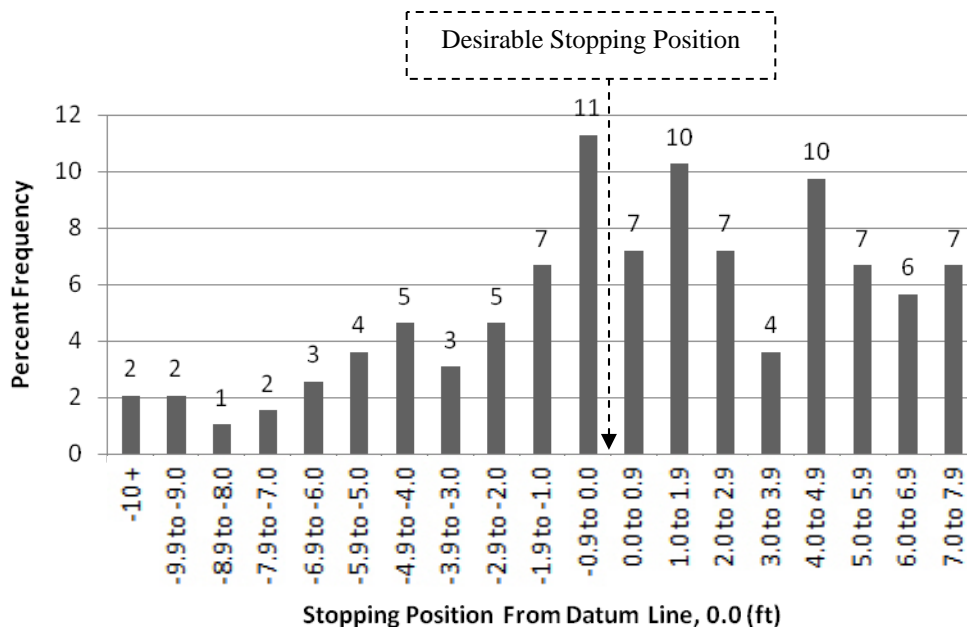
FIGURE 30 Percent Frequency of Positioning, Conditions 1, 2, and 3 Combined.

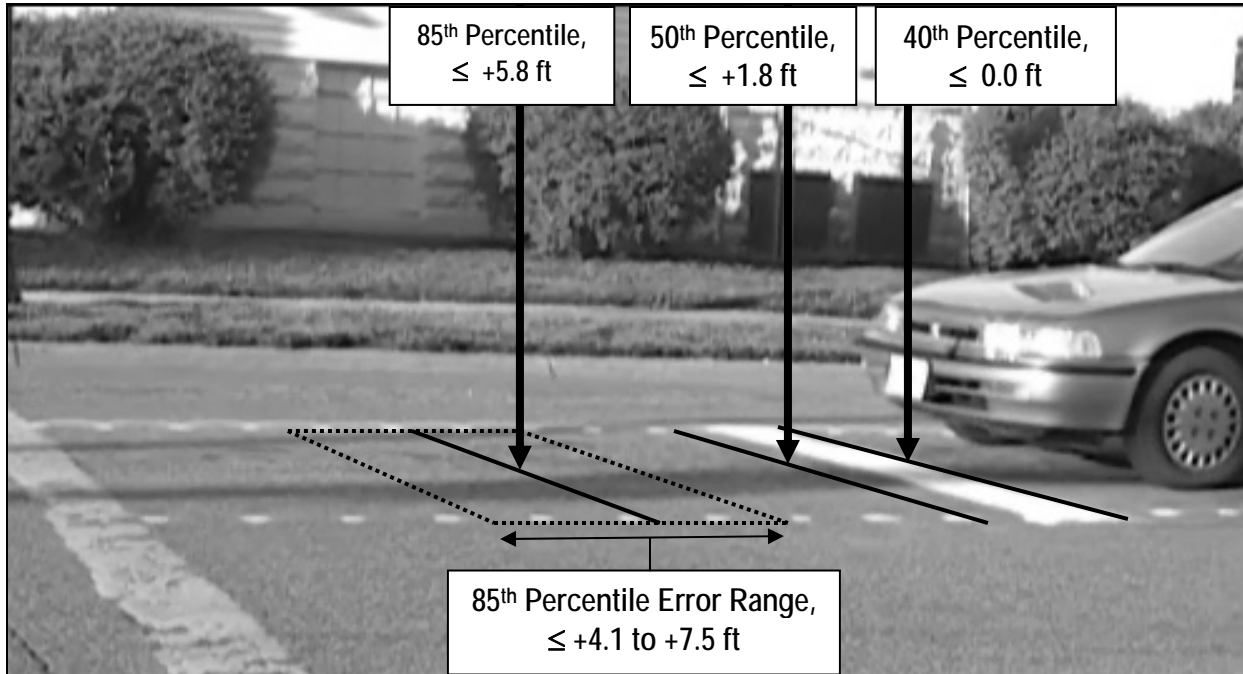
FIGURE 31 shows a visual interpretation of the confidence range of the 85-percentile position of vehicles for Condition 2 (shaded values in TABLE 22). This means that considering the least error, 85 percent of stopping drivers under Condition 2 positioned their vehicles at +4.1 ft or less from the desired position. Considering the most error, 85 percent of stopping drivers under Condition 2 positioned their vehicles at +7.5 ft or less from the desired position. FIGURE 28 also shows that 40 percent of the stopped drivers studied under Condition 2 did so at or before the desired location. Half of the stopped drivers (the median value shaded in TABLE 23) positioned their vehicles +1.8 ft or before the desired position.

FIGURE 31 Visual Interpretation of Staggered Stop Bar Driver Behavior Results

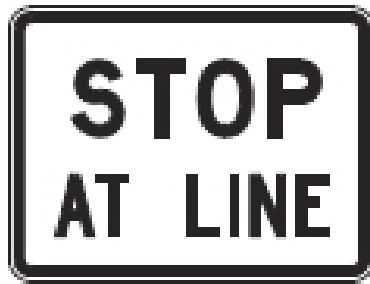
The State of Nebraska currently has a special placard designed which is to be placed immediately above or below the stop sign at a stop-controlled intersection to encourage drivers to recognize the desirable position for them to stop their vehicles. FIGURE 33 shows an example of the “STOP AT LINE” placard (NDOR Sign R1-5C-24).

FIGURE 33 Example of NDOR Sign R1-5C-24.

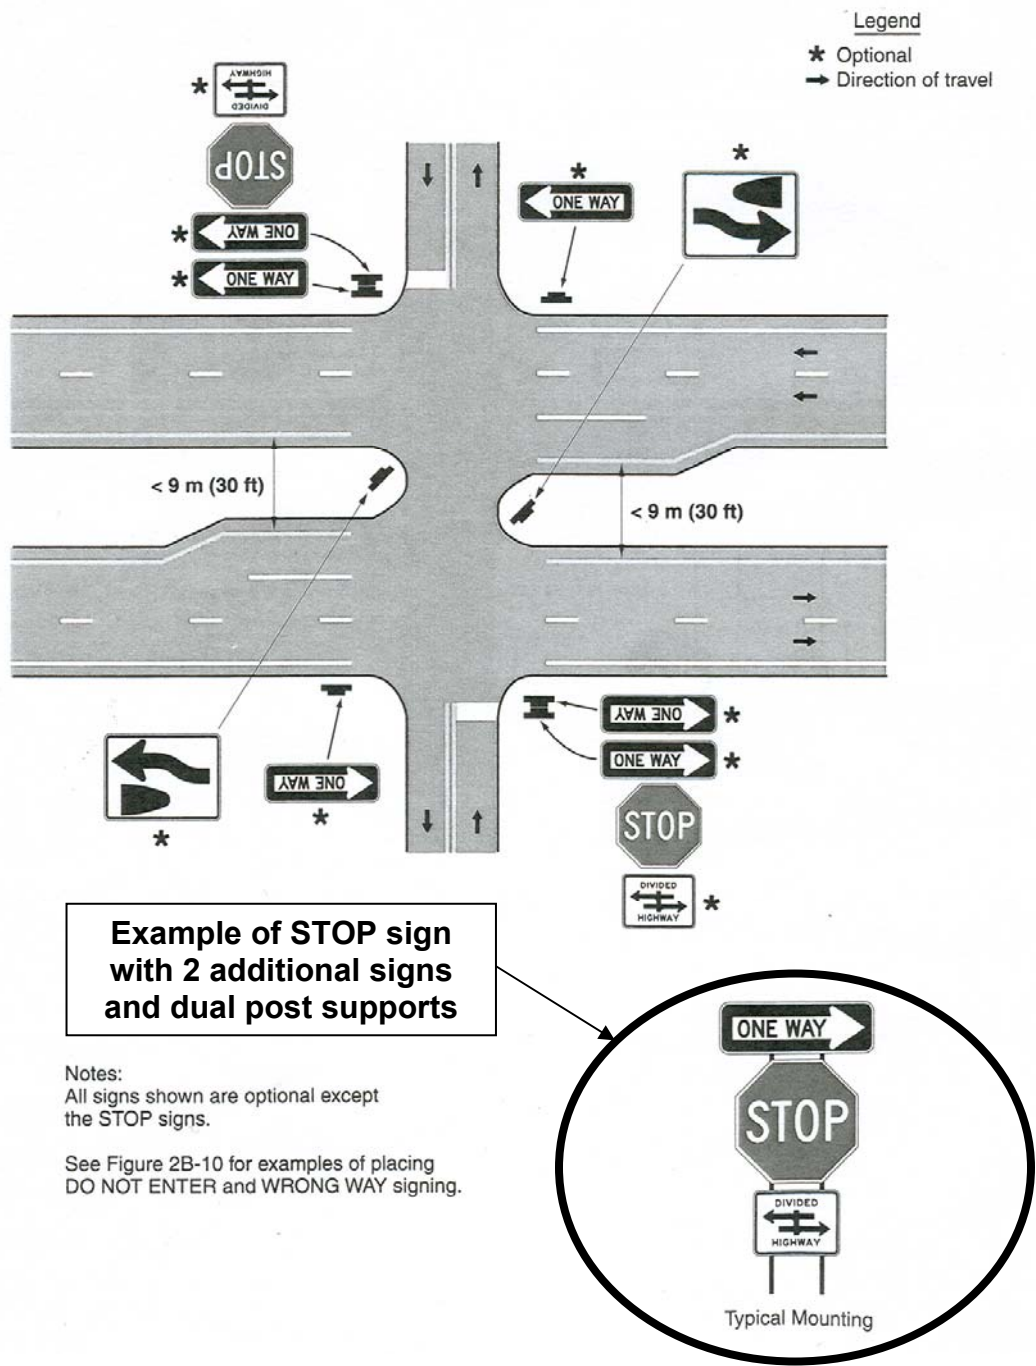
“signs should be individually installed on separate posts or mountings except where one sign supplements another” (7, 2003, Section 2A.16.A). Three signs may require two mounting posts rather than one as shown in the circled area within FIGURE 37 which is a reproduction of the STOP sign installation in Figure 2B-14 of the MUTCD (7, 2003, page 2B-34).

FIGURE 34 Reproduction of Figure 2B-14 of the MUTCD

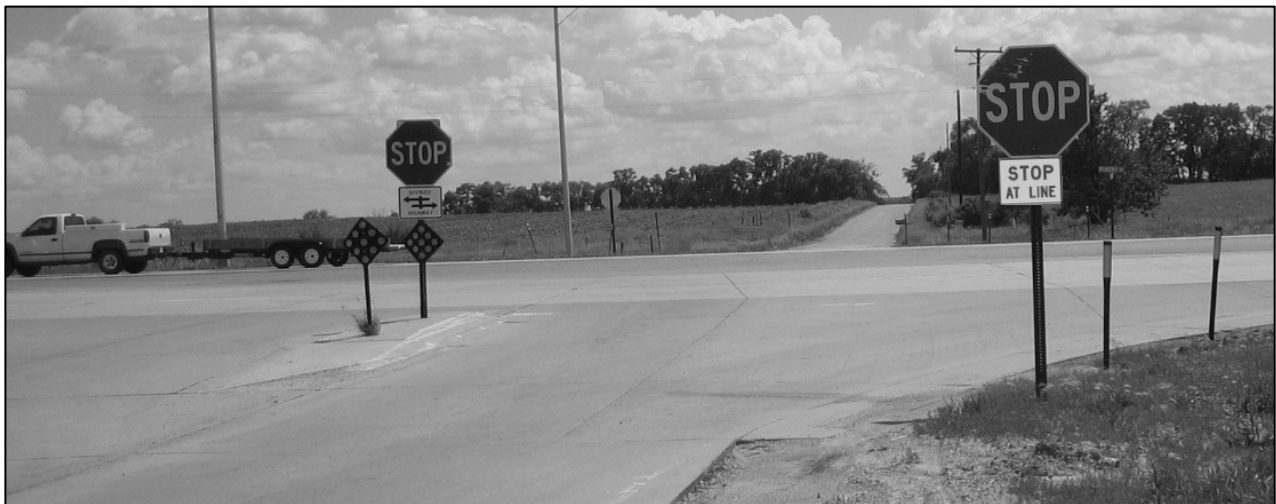
In the ORTL study “*Conditions Warranting Offset Right-Turn Lanes (ORTL) for Improved Intersection Sight Distance*”, (NDOR Project SPR-P1(06)P592), the “Stop at Line” sign was added only to the STOP sign on the right side of the approach, instead of on both STOP signs. This was due to the fact that the center median STOP sign already had a divided median sign (required) and a diamond-shaped delineator sign (optional) on a single post. NDOR signing authorities felt adding another sign to this existing combination would violate engineering judgment principles based on minimizing the number of sign messages per installation. A photograph of the final study sign installation is shown in FIGURE 35.

FIGURE 35 Example of Placement of STOP AT LINE Sign Only on Right STOP Sign on ORTL Project

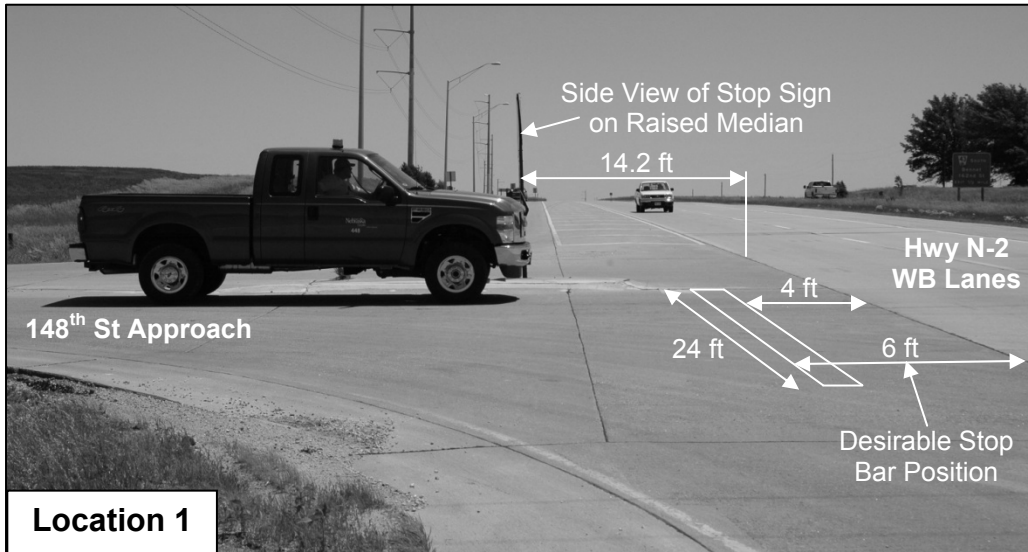
Both locations exhibited driver stopping behavior that was not conducive for optimal intersection sight distance, given the fact that right-turning traffic within either style of right-turn lane would temporarily block the view of drivers judging suitable gaps in cross traffic for a safe entry into the intersection. Stopping position data was collected to see if adding the “STOP AT LINE” sign under the STOP sign on the right side of the approach would encourage drivers to locate their vehicles at the desirable position where stop bars were positioned, which is 6 ft from the edge of the cross traffic lane, as shown in FIGURES 36 and 37.

FIGURE 36 Painted Stop Bar at Desirable Location for Optimal Intersection Sight Distance for Stopped Driver at 148th and Hwy N-2 Intersection

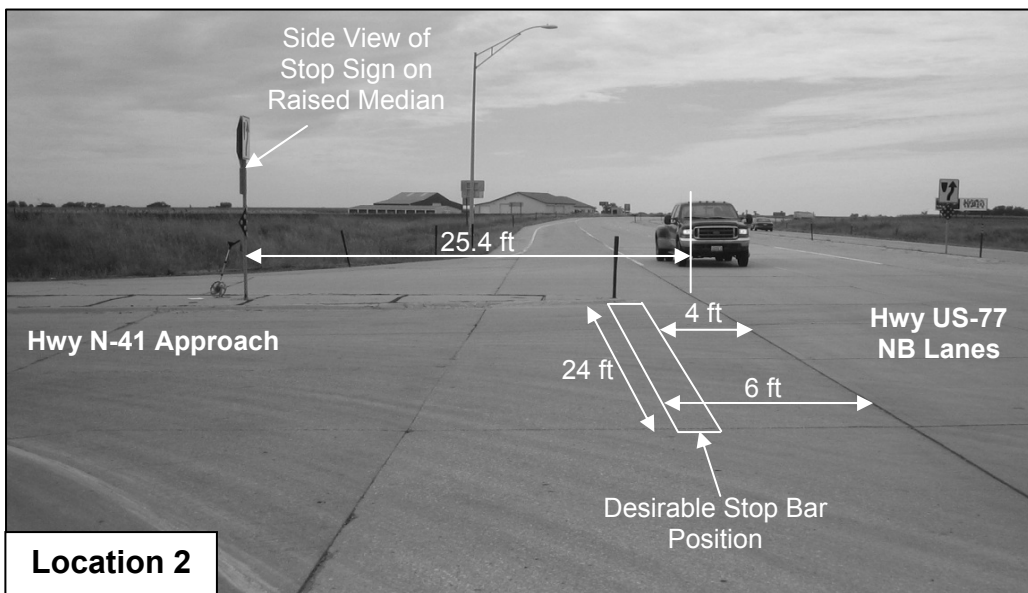
FIGURE 37 Painted Stop Bar at Desirable Location for Optimal Intersection Sight Distance for Stopped Driver at Hwy US-77 and N-41 Intersection

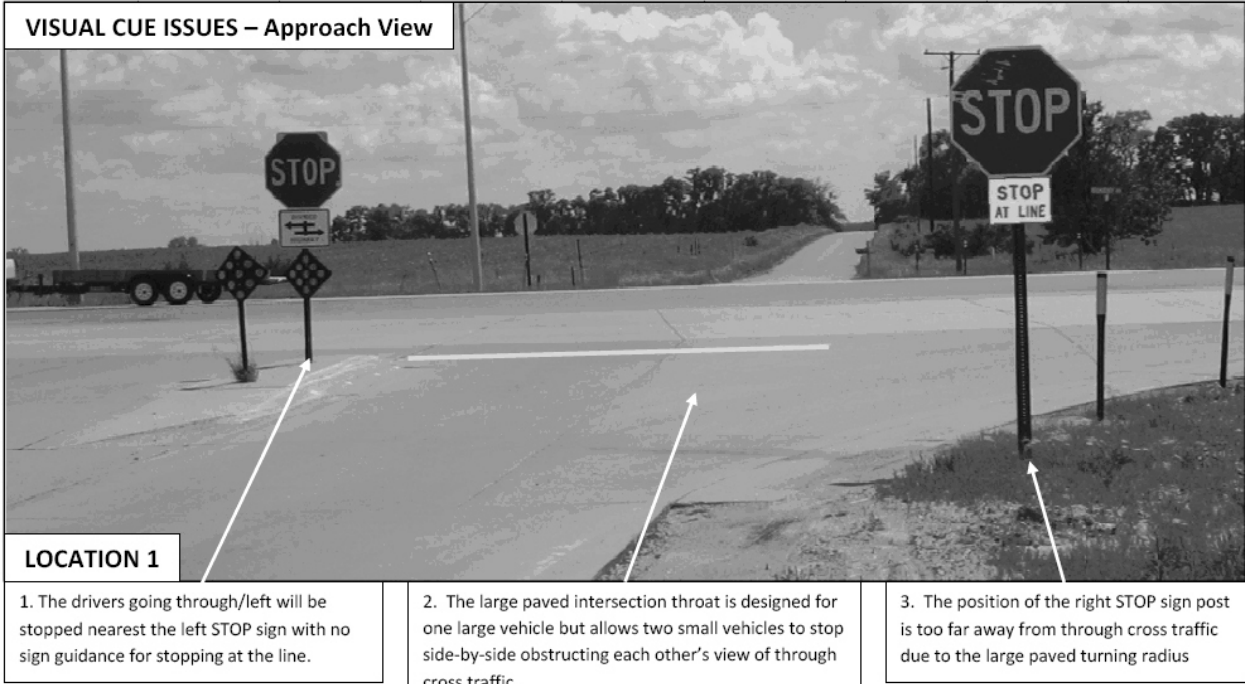
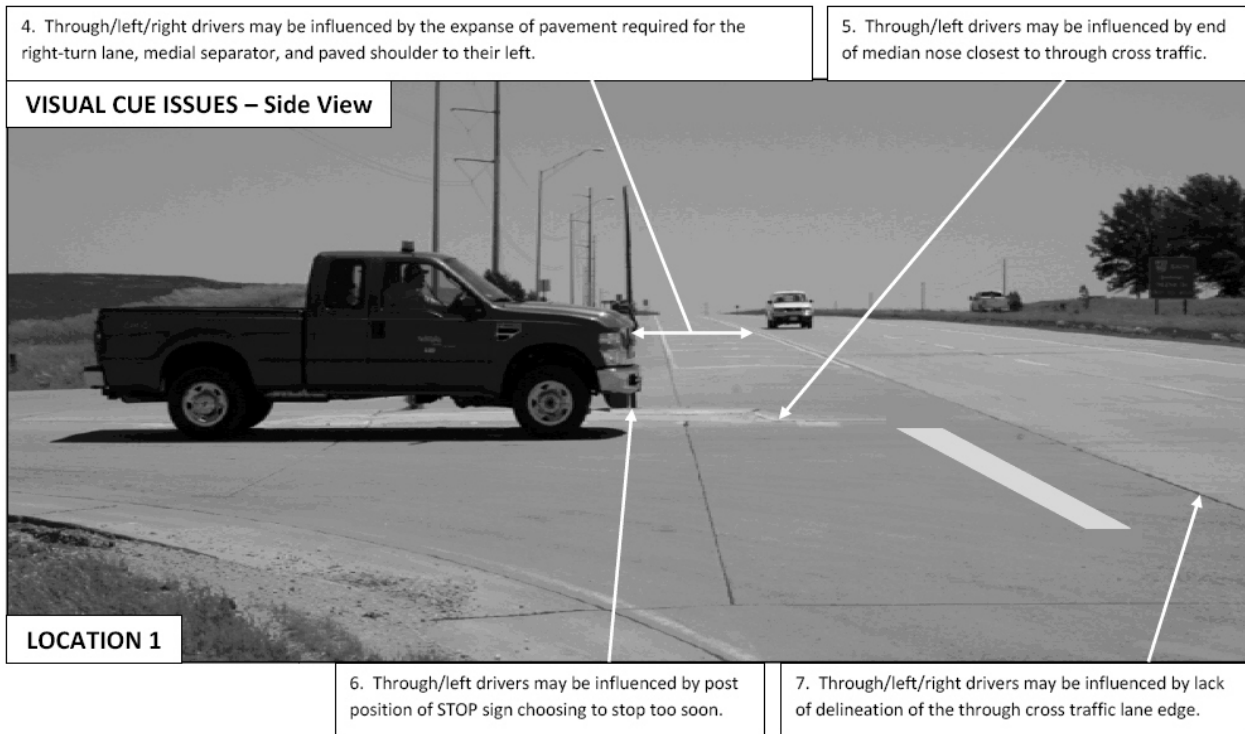
Although Location 1 showed a slight improvement in driver stopping behavior over the extended period of time for Scenario 3, it was only about 1 ft in magnitude which would not generally improve the driver’s intersection sight distance if a right-turning vehicle were in the right-turn lane. Looking at FIGURES 36, 37 and 38 allows one to speculate on reasons for the relative failure of the “STOP AT LINE” sign to make a difference in driver positioning behavior. FIGURE 38 shows examples of visual cues the minor road approach driver may be receiving from the three-dimensional features and traffic control devices at the intersection which may be resulting in inappropriate choices for optimal safety. Recommendations for improving the misleading visual cues are shown in FIGURE 39. Each visual cue issue, recommendation for improvement, explanation of recommendation and official guideline resource is summarized following FIGURES 38 and 39 in TABLE 22. FIGURE 40 shows a plan view of the proposed recommendations.

FIGURE 38 Counter-productive Visual Cue Issues at Location 1, ORTL Study

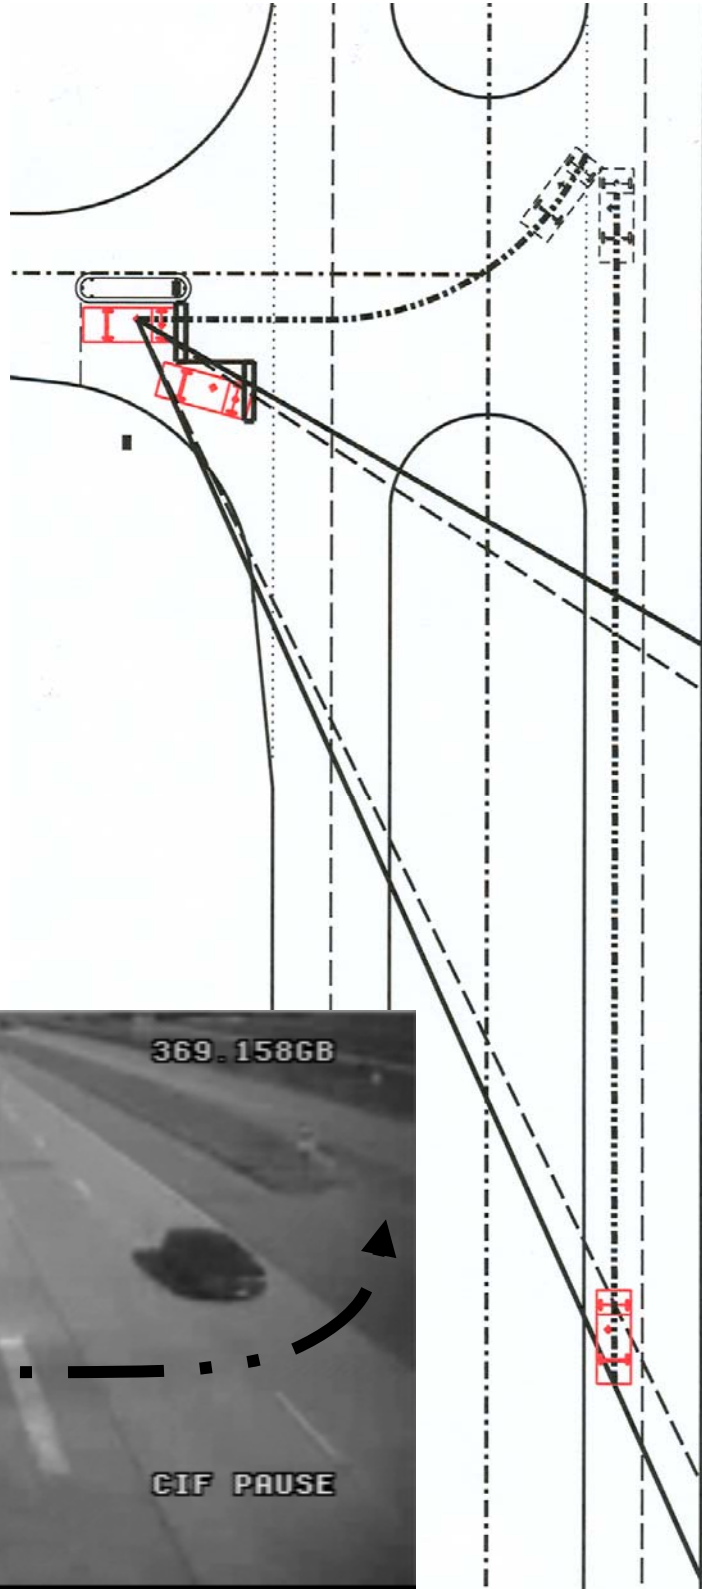
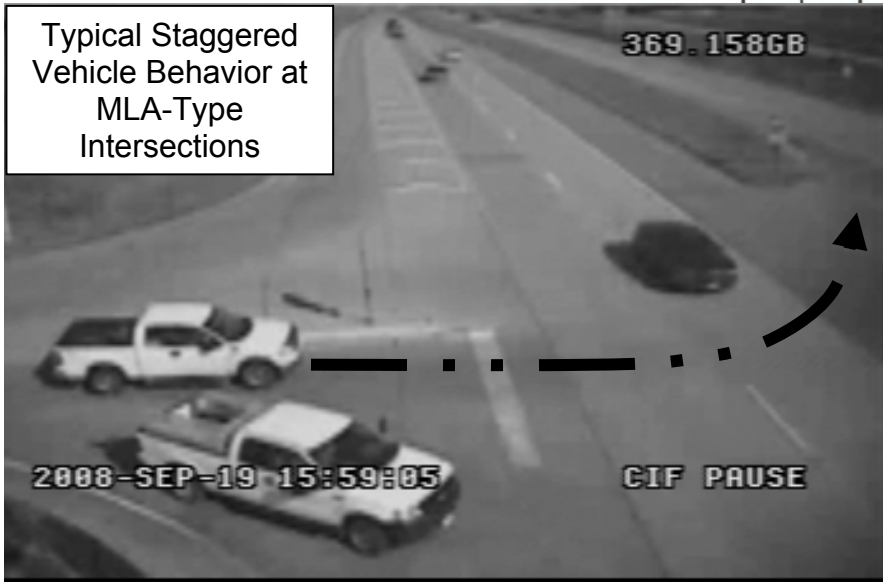
FIGURE 40 Plan View of Proposed Staggered Stop Bar Pavement Marking to Better Fit Driver Behavior at MLA-Type Intersections

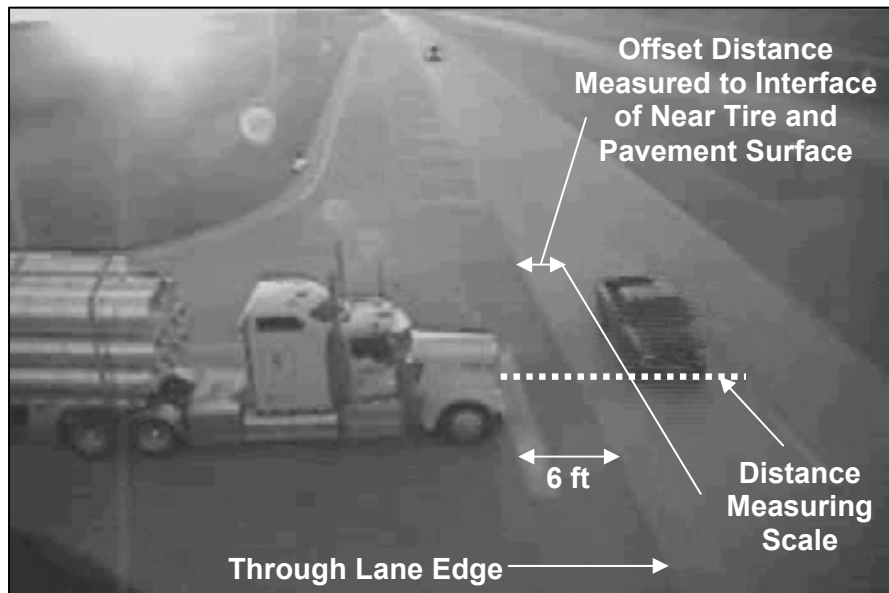
FIGURE 41 Example of Determination of Through Vehicle Positioning at US 77 and N-41 Intersection

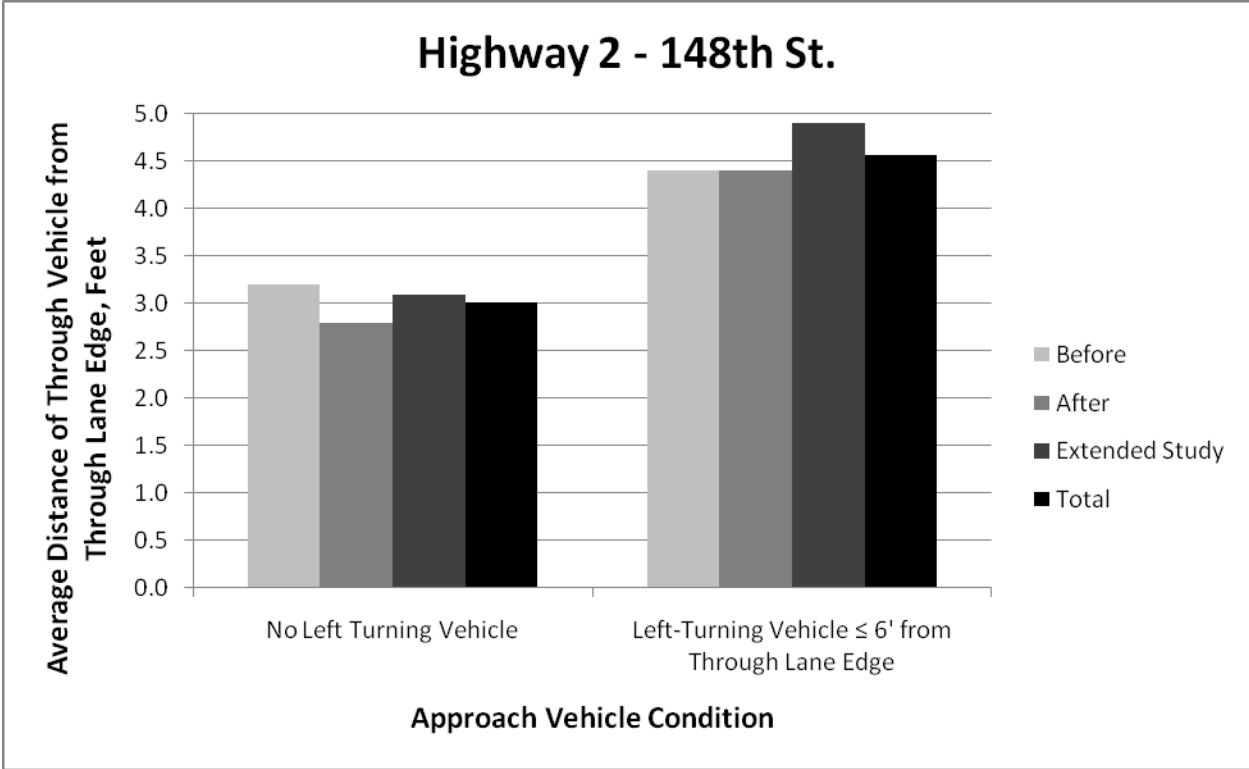
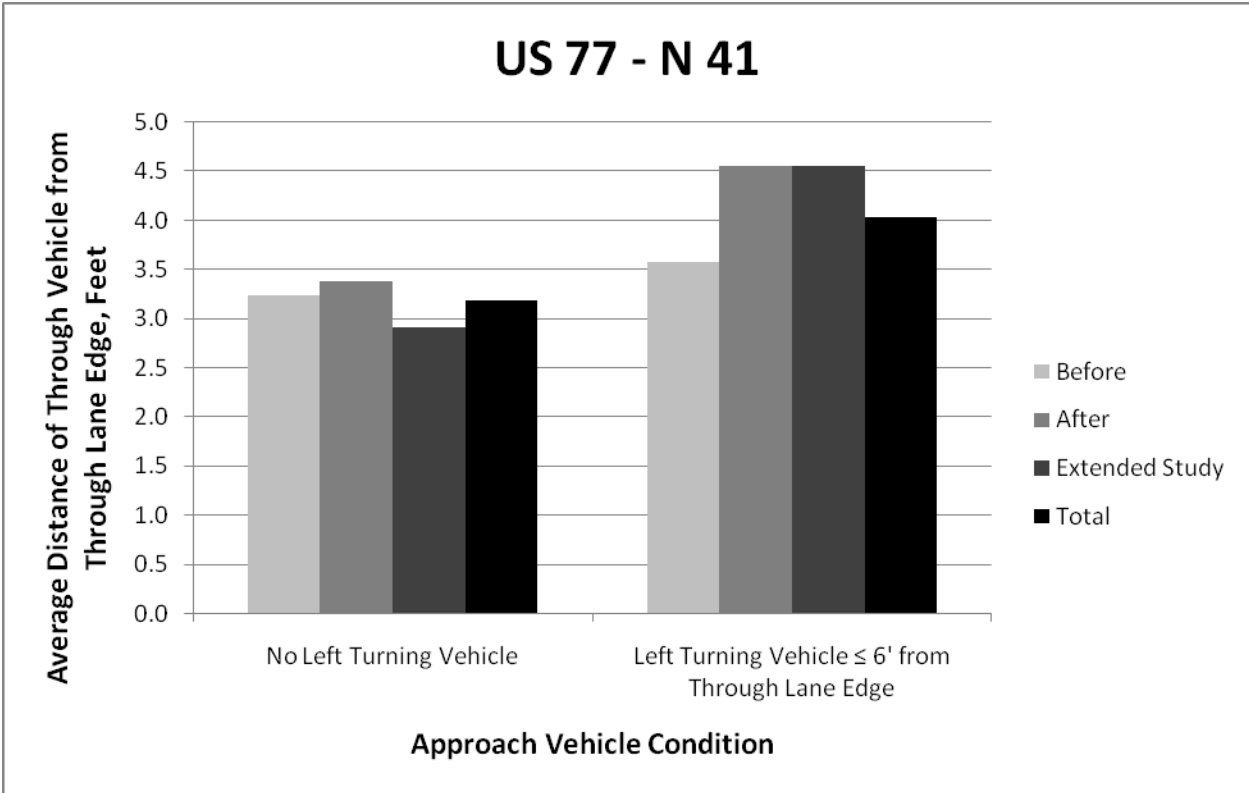
FIGURE 42 Comparison of Through Vehicle Lane Positioning When Stop-Controlled Approach Vehicles At or Within 6 ft of Through Lane Edge and When No Approach Vehicles are Present

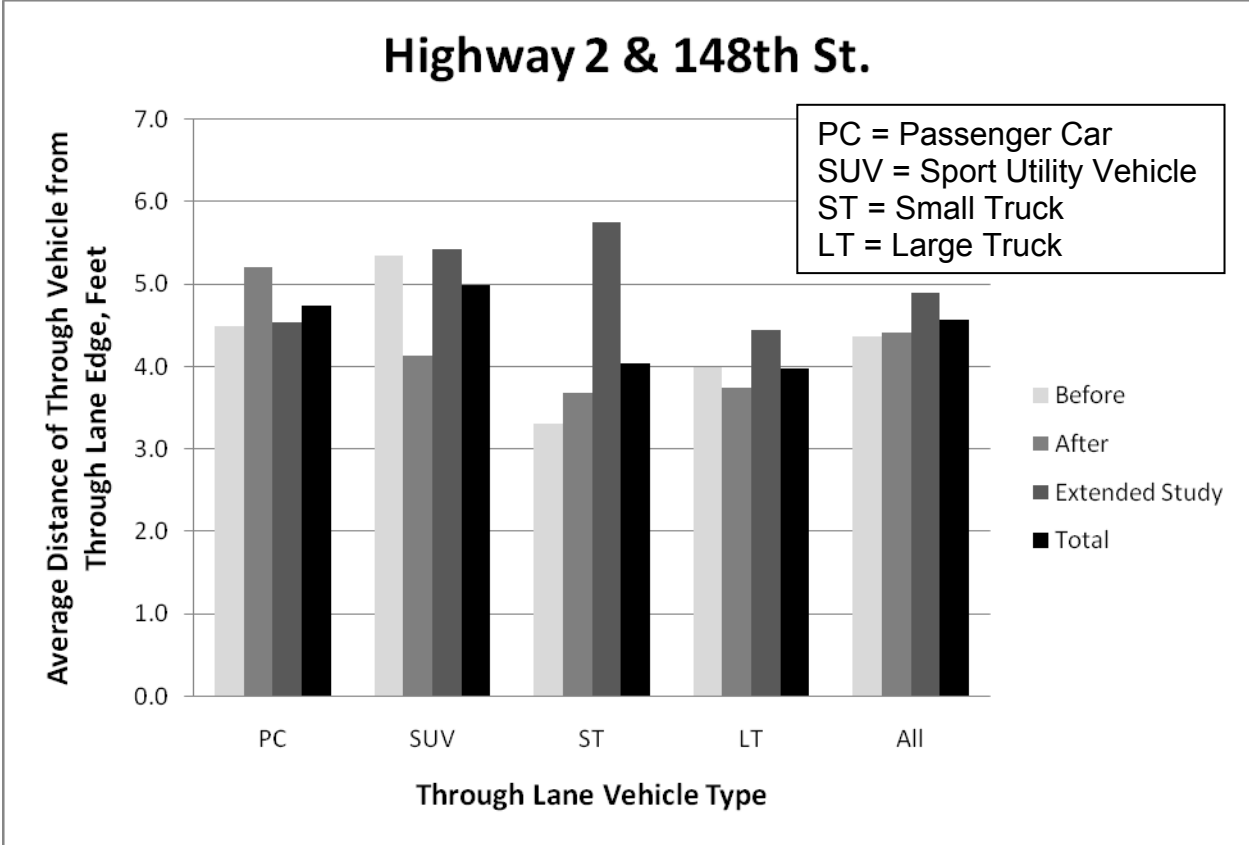
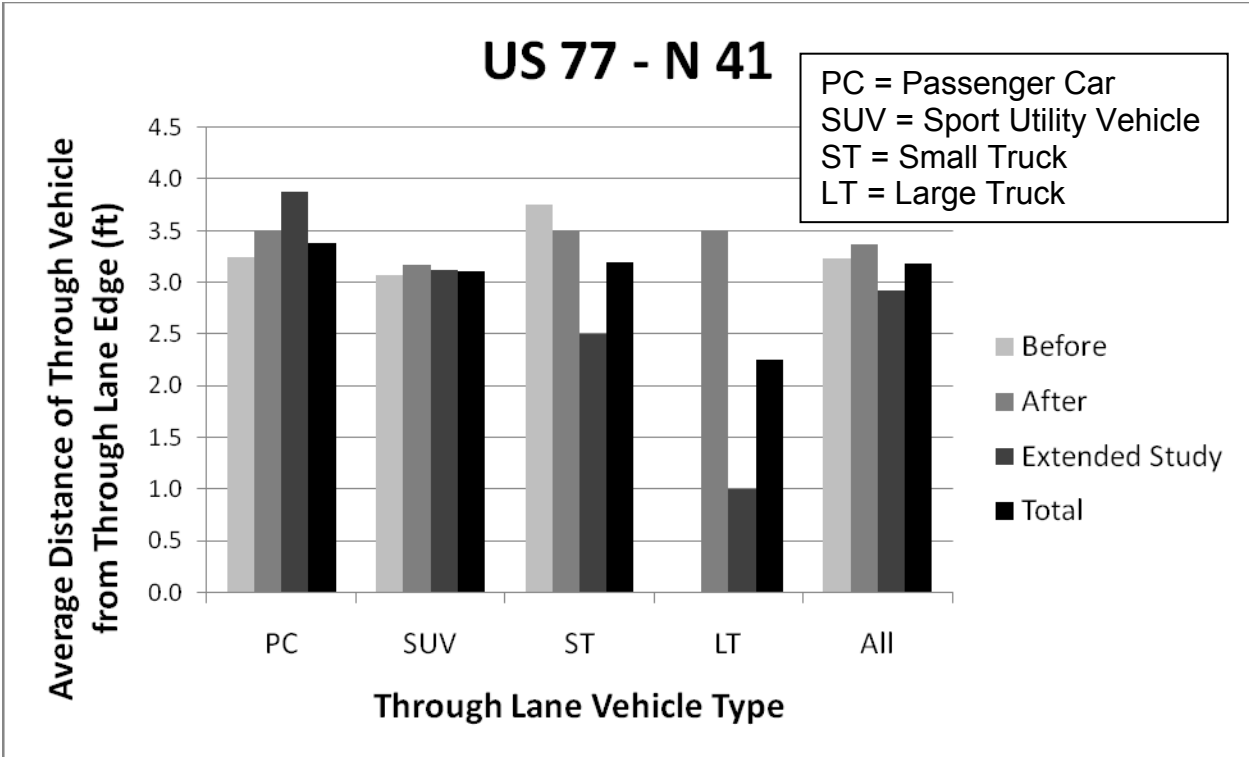
FIGURE 43 Comparison of Through Lane Vehicle Type Positioning When Stop-Controlled Approach Vehicles At or Within 6 ft of Through Lane Edge

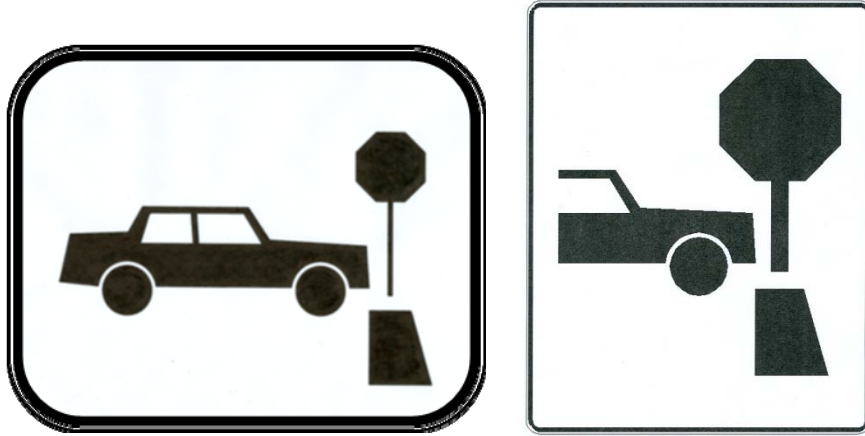
FIGURE 44 Examples of Iconic “STOP AT LINE” Placard

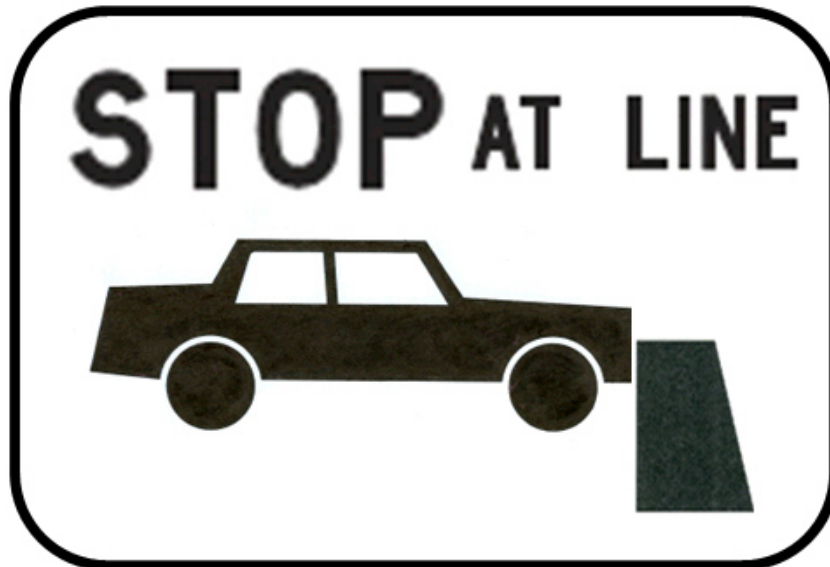
FIGURE 45 Example of “STOP AT LINE” Sign and Iconic Placard Combined

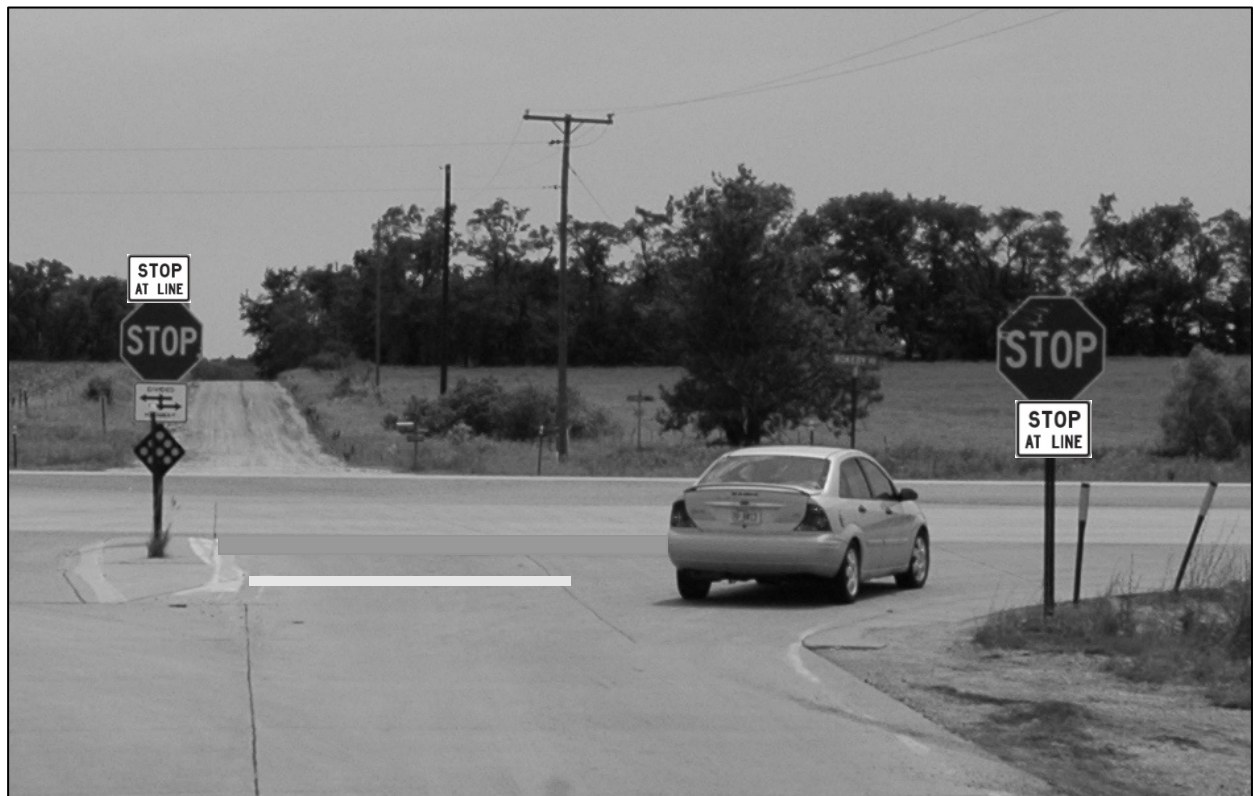
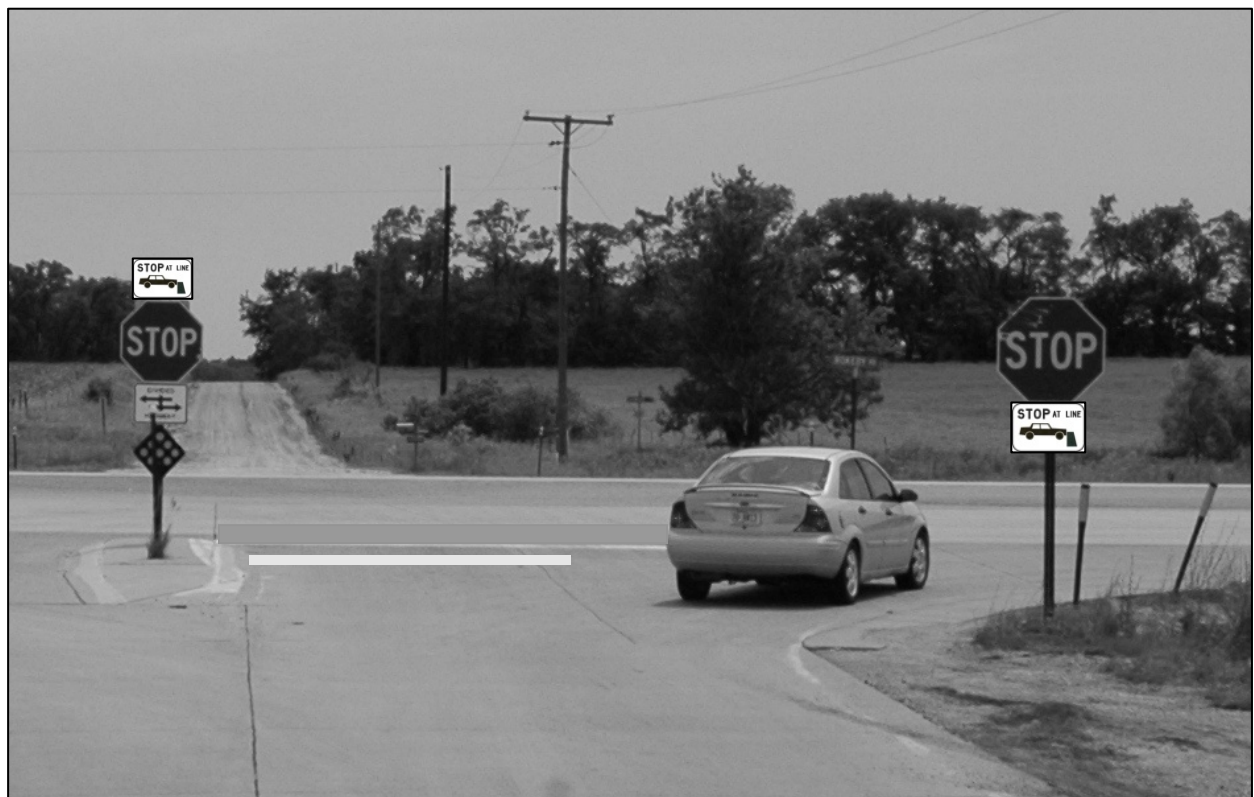
FIGURE 46 Simulation of Proposed Single-Signing Recommendation.

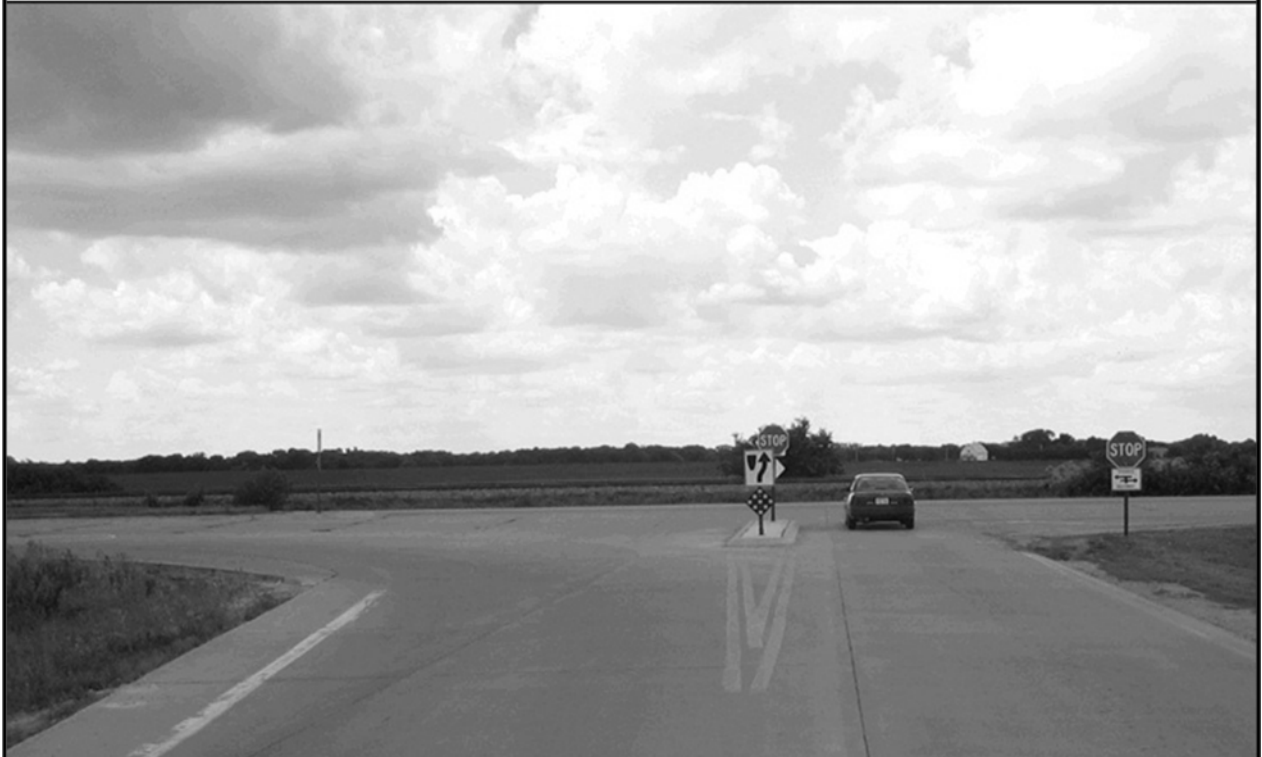
FIGURE 47 Page 1 of Student Survey Document

Imagine that you are the driver of this car, stopped at a three-legged intersection with stop signs on your approach indicating that you must make a complete stop before entering the main roadway upon which traffic does not stop.

An informal survey was given to 47 male civil engineering and construction management freshman-through-senior-level undergraduates on January 21st, 2009 to determine if they were aware of exactly where to place their vehicles when cued by a painted stop bar on the pavement at a stop-controlled intersection. Participants were told the purpose of the survey and given a two-page document with the information shown in FIGURES 47 and 48.

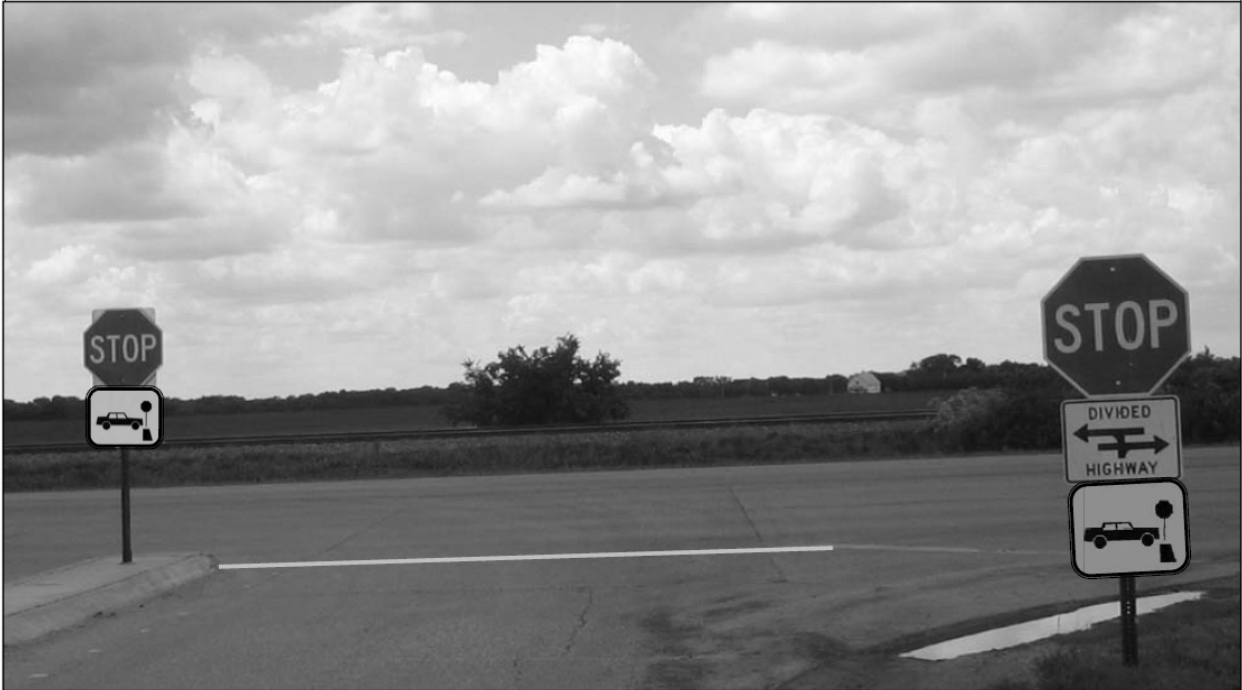
FIGURE 49 Page 1 of Second Survey

Imagine that you are the driver of this car, stopped at a three-legged intersection with stop signs on your approach indicating that you must make a complete stop before entering the main roadway upon which traffic does not stop.

In the following class period on January 26th, the students were told that the original surveys had been misplaced and that their responses were required again. The front page of the two-page survey was changed to show a closer view of the same intersection approach but this time with “STOP AT LINE” iconic signs under the stop signs, as shown in FIGURE 48. Page 2 of the second survey remained exactly the same as the first survey.
