Dynamic Impact Testing of Wood Posts for the Midwest Guardrail System Placed Adjacent to a 2H:1V Fill Slope

DYNAMIC IMPACT TESTING OF WOOD POSTS FOR THE MIDWEST GUARDRAIL SYSTEM (MGS) PLACED ADJACENT TO A 2H:1V FILL SLOPE

MwRSF Research Report No. TRP-03-234-10

December 16, 2010

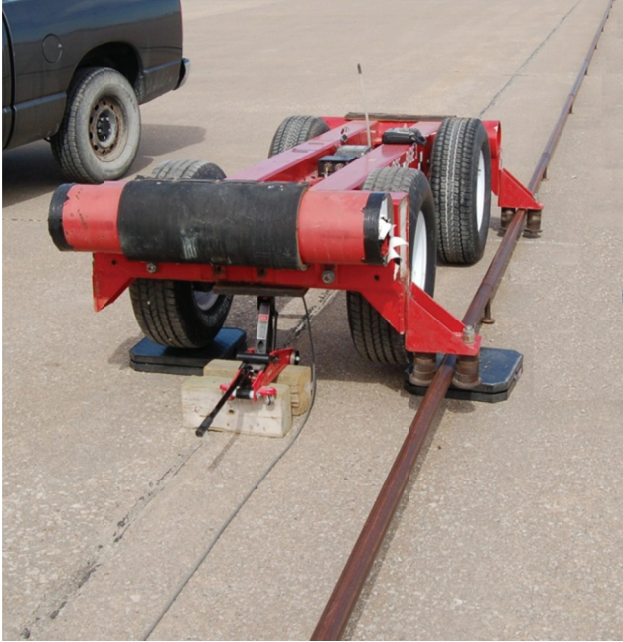
Figure 2. Rigid Frame Bogie on Guidance Track

A rigid frame bogie was used to impact the posts. A variable height, detachable impact head was used in the testing. The bogie head was constructed of 8-in. (203-mm) diameter, ½-in. (13-mm) thick standard steel pipe, with ¾-in. (19-mm) neoprene belting wrapped around the pipe to prevent local damage to the post from the impact. The impact head was bolted to the bogie vehicle, creating a rigid frame with an impact height of 24⁷/₈ in. (632 mm). The bogie with the impact head for test no. MGS221PT-22 is shown in Figure 2, and the bogie for test no. MGS221PT-23 and MGS221PT-24 through MGS221PT-28 is shown in Figure 3(a) and Figure 3(b), respectively. For test nos. MGS221PT-22, MGS221PT-23, and MGS221PT-24 through MGS221PT-28, the weight of the bogie with the addition of the mountable impact head and accelerometers was 1,815 lb, 1,845 lb, and 1,757 lb (823 kg, 837 kg, and 797 kg), respectively. The weight variance was due to the different accelerometers used during each crash test and for test nos. MGS221PT-24 through MGS221PT-28, the guidance track bearings were removed from the bogie.

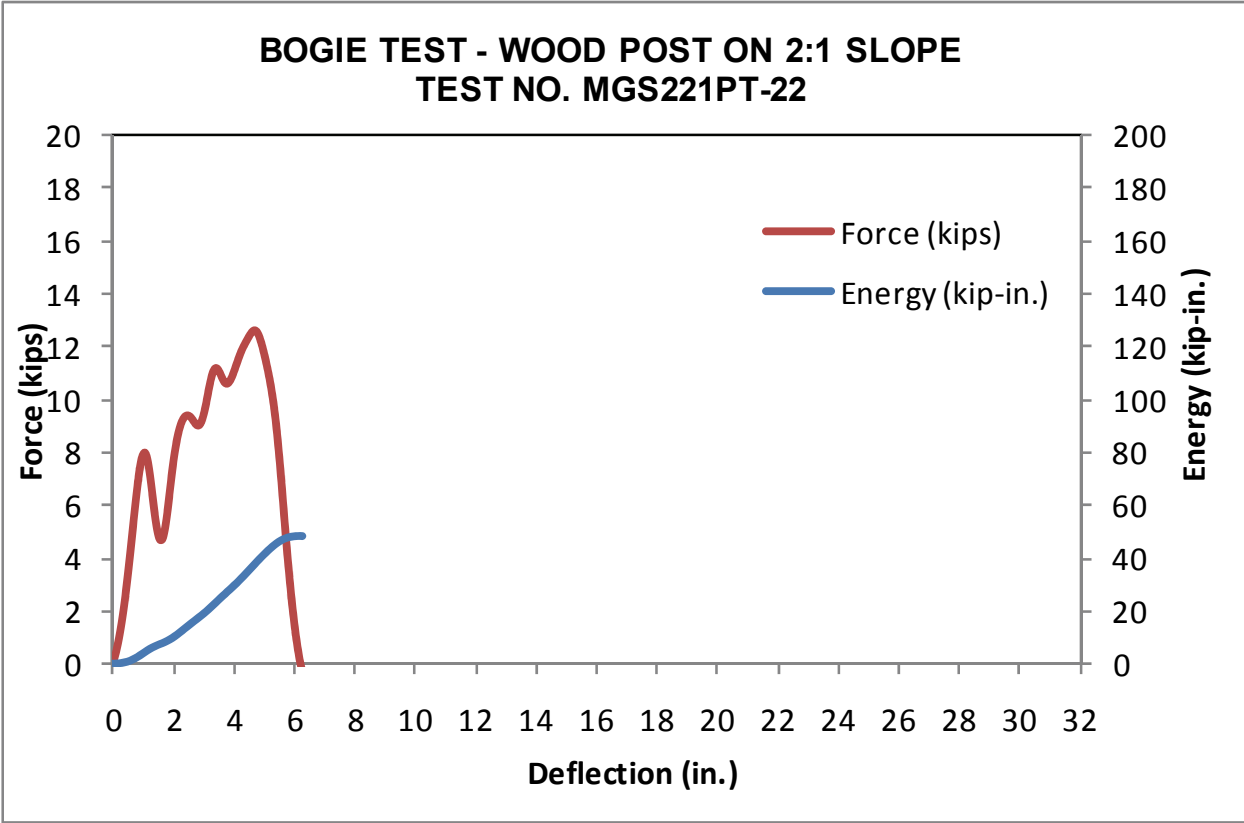
Figure 4. Force vs. Deflection and Energy vs. Deflection, Test No. MGS221PT-22

Force vs. deflection and energy vs. deflection curves were created from the accelerometer data and are shown in Figure 4. The force vs. deflection curve indicated an initial peak in the force level due to the inertial effects of the post and soil. After this inertial peak, there was a slight drop in load followed by an increase in load as the post rotated through the soil. The rotation of the post in the soil generated a peak force of 12.7 kips (56.3 kN) at 4.7 in. (119 mm) of deflection prior to fracture of the post. After this point, the force rapidly declined to zero as

the post fractured below grade with very little soil deformation. The post had a maximum deflection of 6.2 in (157 mm) and absorbed 48.8 kip-in. (5.5 kJ) of energy. Time-sequential photographs and post-impact photographs are shown in Figure 5.

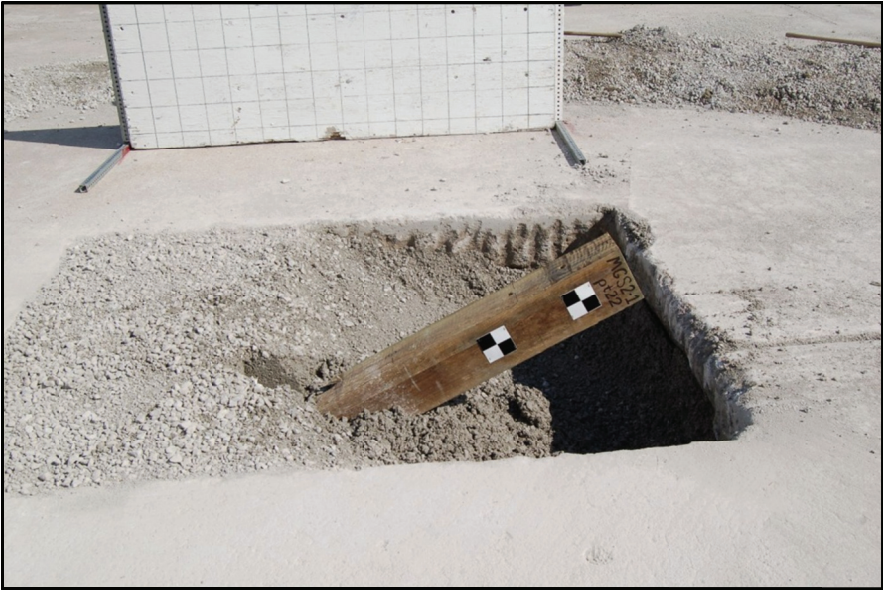
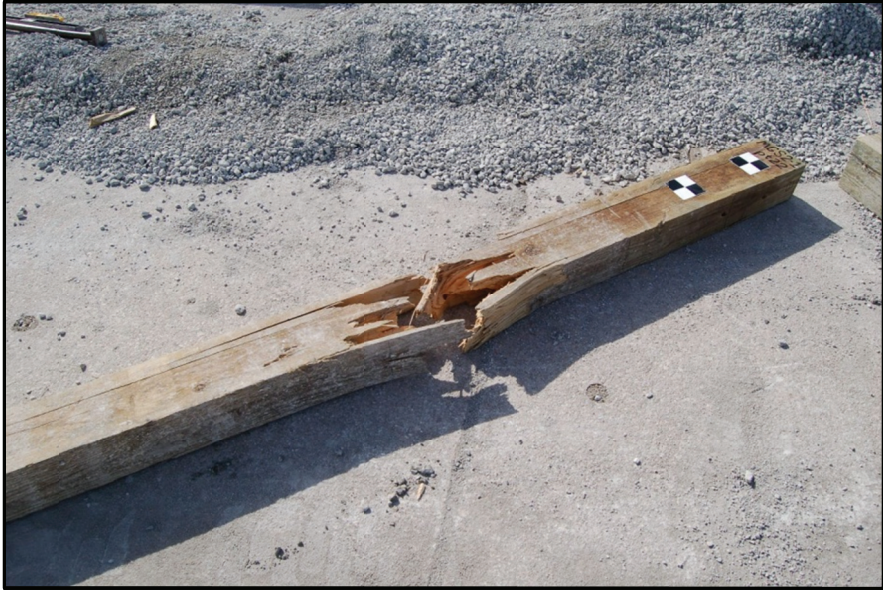
Figure 5. Time Sequential and Post-Impact Photographs, Test No. MGS221PT-22

Test no. MGS221PT-22 was an impact of the bogie on the strong axis of a 6-in. x 8-in. x 96-in. (152-mm x 203-mm x 2,438-mm) wood post at a speed of 15.1 mph (24.3 km/h). The post was installed in an 8-ft long by 5-ft wide (2.44-m long by 1.52-m wide) soil pit at the slope breakpoint of a 2H:1V slope with an embedment depth of 64 in. (1,626 mm). Upon impact, the post began to rotate through the soil. The post rotated through the soil 4.7 in. (119 mm) before fracture which initiated approximately 0.018 seconds after impact. Fracture occurred approximately 24 in. (610 mm) below ground level. The maximum deflection of the post was 6.2 in. (157 mm) at the time of complete fracture.

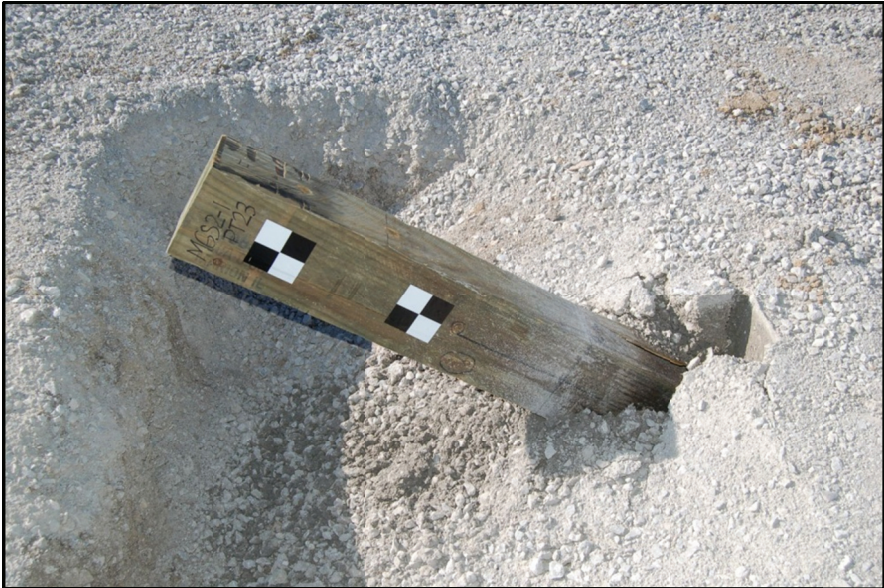
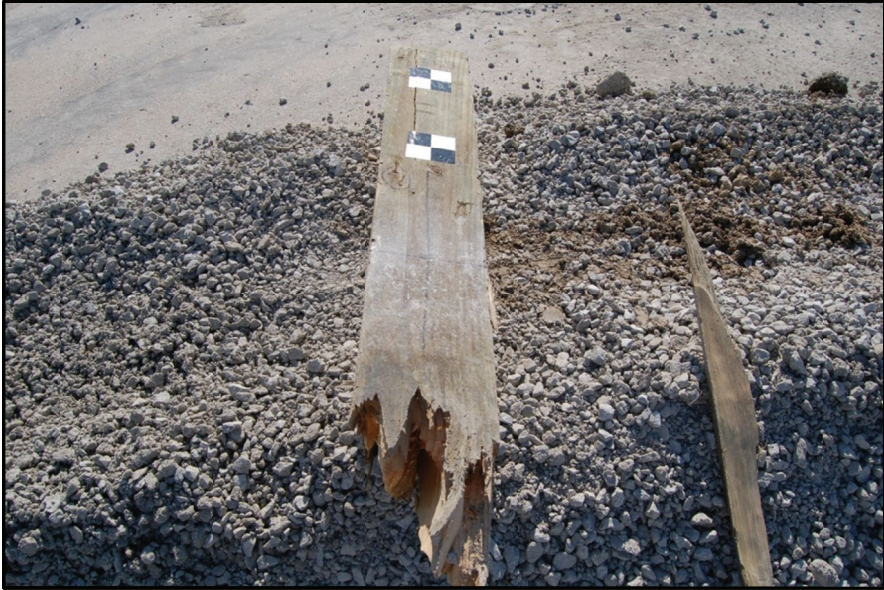
Figure 7. Time Sequential and Post-Impact Photographs, Test No. MGS221PT-23

Following test no. MGS221PT-22, the researchers were concerned that the limited size of the testing pit was adversely affecting the post-soil interaction forces. Consequently, the remaining tests were conducted in a standard guardrail testing pit that was modified in order to conduct the post testing. Test no. MGS221PT-23 was an impact of the bogie on the strong axis of a 6-in. x 8-in. x 96-in. (152-mm x 203-mm x 2,438-mm) wood post at a speed of 16.0 mph (25.7 km/h). The post was installed at the slope breakpoint of a 2H:1V slope with an embedment depth of 64 in. (1,626 mm). Upon impact, the post began to rotate through the soil. The post rotated through the soil 8.3 in. (211 mm) before fracture which initiated approximately 0.032 seconds after impact. Fracture occurred approximately 18 in. (457 mm) below ground level. The maximum deflection of the post was 9.8 in. (249 mm) at the time of complete fracture.

Force vs. deflection and energy vs. deflection curves were created from the accelerometer data and are shown in Figure 6. The force vs. deflection curve indicated an initial peak in the force level due to the inertial effects of the post and soil. After this inertial peak, there was a slight drop in load followed by an increase in load as the post rotated through the soil. The rotation of the post in the soil generated a peak force of 11.2 kips (49.8 kN) at 8.3 in. (211 mm) of deflection. After this point, the force rapidly declined to zero as the post fractured with very little soil deformation. The post had a maximum deflection of 9.8 in (249 mm) and absorbed 75.0 kip-in. (8.5 kJ) of energy. Time-sequential photographs and post-impact photographs are shown in Figure 7.

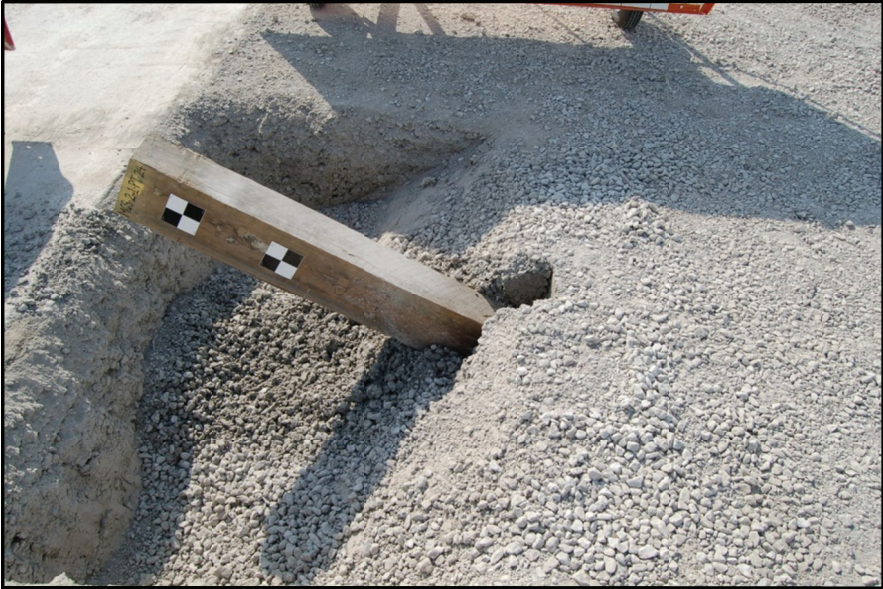
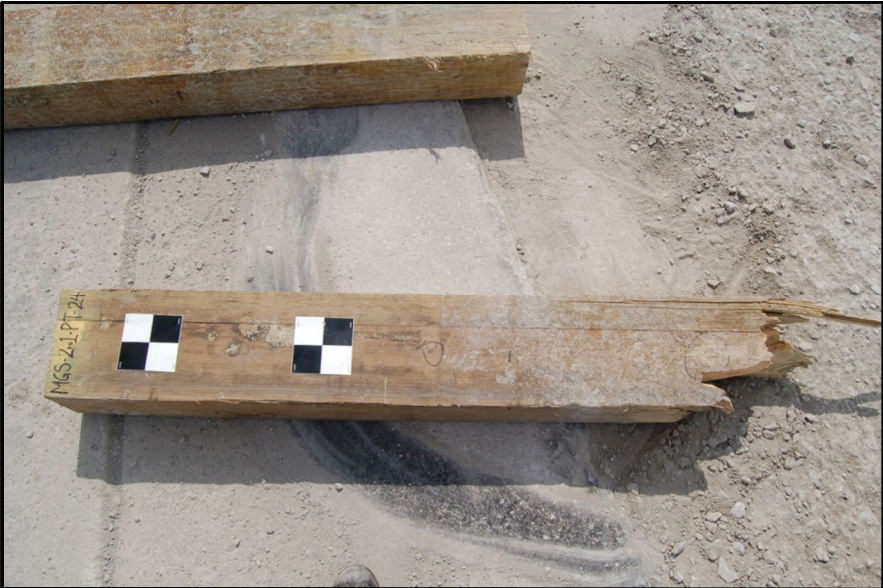
Figure 9. Time Sequential and Post-Impact Photographs, Test No. MGS221PT-24

Test no. MGS221PT-24 was an impact of the bogie on the strong axis of a 6-in. x 8-in. x 96-in. (152-mm x 203-mm x 2,438-mm) wood post at a speed of 18.4 mph (29.6 km/h). The post was installed at the slope breakpoint of a 2H:1V slope with an embedment depth of 64 in. (1,626 mm). Upon impact, the post began to rotate through the soil. The post rotated through the soil 7.3 in. (185 mm) before fracture which initiated approximately 0.024 seconds after impact. Fracture occurred 14 in. (356 mm) below ground level at a knot on a side face of the post. The maximum deflection of the post was 9 in. (229 mm) at the time of complete fracture.

Force vs. deflection and energy vs. deflection curves were created from the accelerometer data and are shown in Figure 8. The force vs. deflection curve indicated an initial peak in the force level due to the inertial effects of the post and soil. After this inertial peak, there was a slight drop in load followed by an increase in load as the post rotated through the soil. The rotation of the post in the soil generated a peak force of 17.4 kips (77.6 kN) at 7.3 in. (185 mm) of deflection. After this point, the force rapidly declined to zero as the post fractured with very little soil deformation. The post had a maximum deflection of 9.0 in (229 mm) and absorbed 103.4 kip-in. (11.7 kJ) of energy. Time-sequential photographs and post-impact photos are shown in Figure 9.

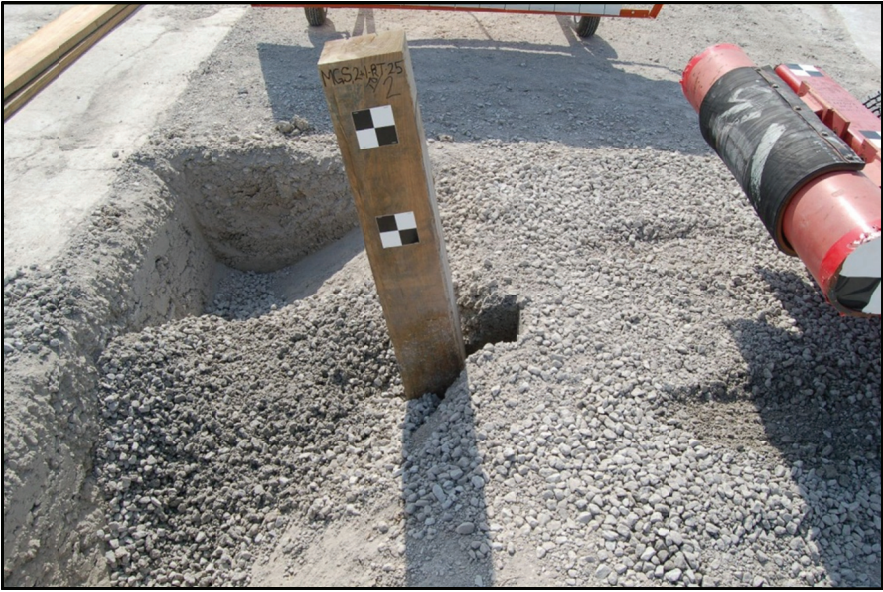
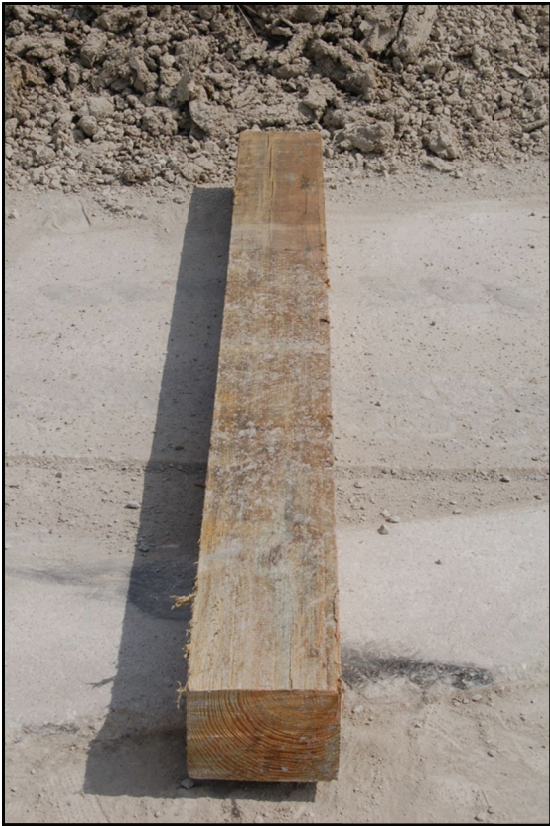
Figure 11. Time Sequential and Post-Impact Photographs, Test No. MGS221PT-25

Test no. MGS221PT-25 was an impact of the bogie on the strong axis of a 6-in. x 8-in. x 90-in. (152-mm x 203-mm x 2,286-mm) wood post at a speed of 15.1 mph (24.3 km/h). The post was installed at the slope breakpoint of a 2H:1V slope with an embedment depth of 58 in. (1,473 mm). Upon impact, the post began to rotate through the soil. The post rotated through the soil and showed no signs of fracturing. The bogie was brought to a stop and did not override the post. The maximum deflection of the post was 18.4 in. (467 mm).

Force vs. deflection and energy vs. deflection curves were created from the accelerometer data and are shown in Figure 10. The force vs. deflection curve indicated an initial peak in the force level due to the inertial effects of the post and soil. After this inertial peak, there was a slight drop in load followed by an increase in load as the post rotated through the soil. The rotation of the post in the soil generated a peak force of 12.1 kips (53.8 kN) at 4.9 in. (124 mm) of deflection. After the reaching the peak force level, the resistive force declined slightly through the maximum deflection of 18.4 in. (467 mm). The average force level for the test through 15 in. (381 mm) of deflection was 9.9 kips (44.1 kN). The post rotating in soil absorbed a total of 161.7 kip-in. (18.3 kJ) of energy. Time-sequential photographs and post-impact photographs are shown in Figure 11.

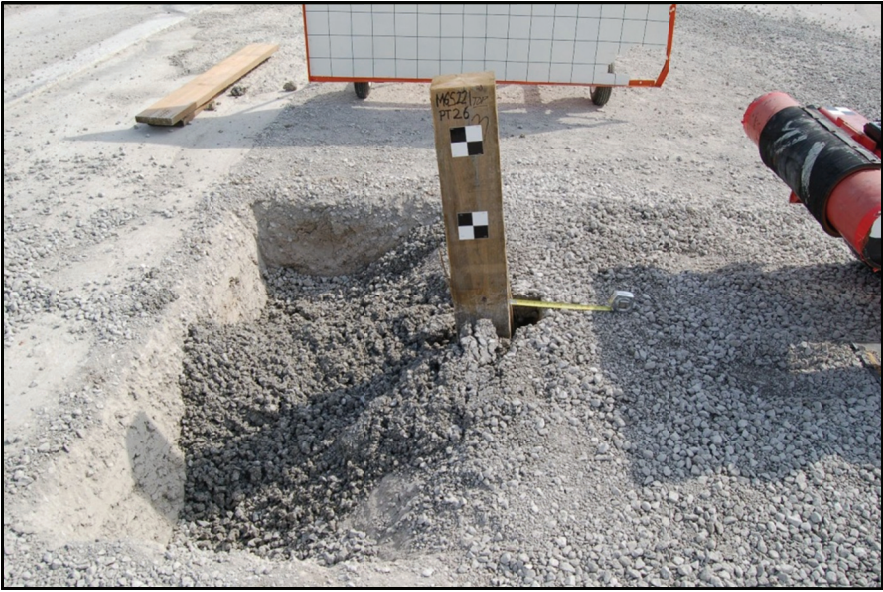
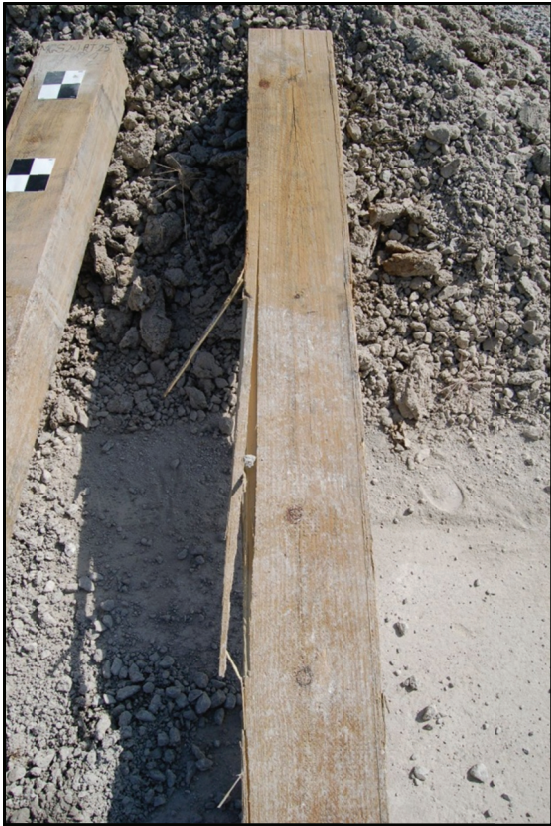
Figure 13. Time Sequential and Post-Impact Photographs, Test No. MGS221PT-26

Test no. MGS221PT-26 was an impact of the bogie on the strong axis of a 6-in. x 8-in. x 90-in. (152-mm x 203-mm x 2,286-mm) wood post at a speed of 16.0 mph (25.7 km/h). The post was installed at the slope breakpoint of a 2H:1V slope with an embedment depth of 58 in. (1,473 mm). Upon impact, the post began to rotate through the soil. The post rotated through the soil and the post did not fracture. Some splintering was observed along the edge of the post. The bogie was brought to a stop and did not override the post. The maximum deflection of the post was 15.1 in. (384 mm).

Force vs. deflection and energy vs. deflection curves were created from the accelerometer data and are shown in Figure 12. The force vs. deflection curve indicated an initial peak in the force level due to the inertial effects of the post and soil. After this inertial peak, there was a slight drop in load followed by an increase in load as the post rotated through the soil. The rotation of the post in the soil generated a peak force of 15.6 kips (69.4 kN) at 4.7 in. (119 mm) of deflection. After the reaching the peak force level, the resistive force declined slightly through the maximum deflection of 15.1 in. (384 mm). The average force level for the test through 15 in. (381 mm) of deflection was 11.3 kips (50.4 kN). The post rotating in soil absorbed a total of 180.9 kip-in. (20.4 kJ) of energy. Time-sequential photographs and post-impact photographs are shown in Figure 13.

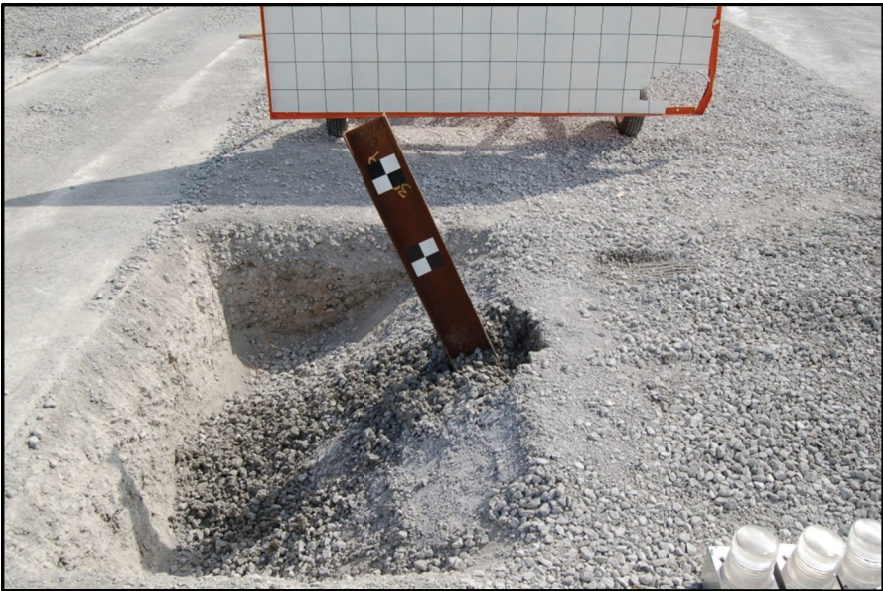
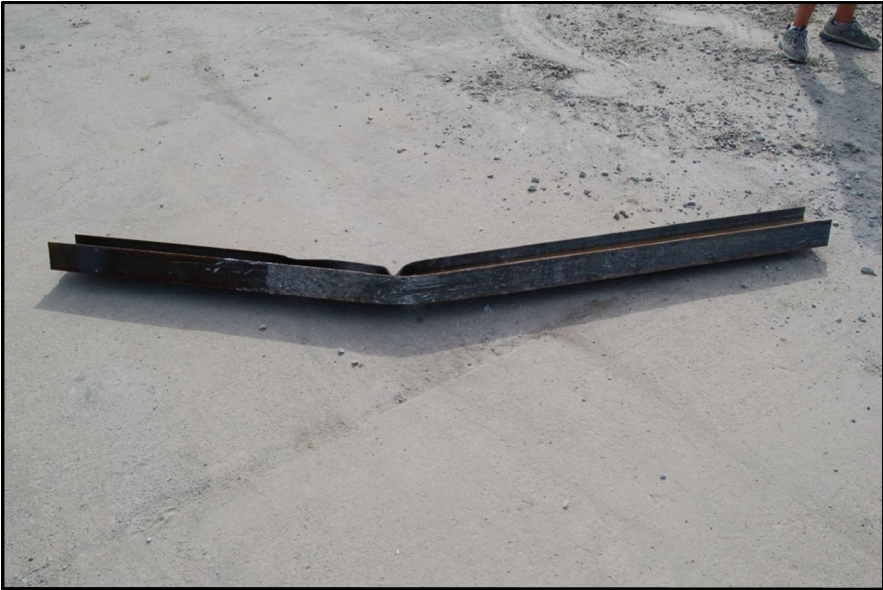
Figure 15. Time Sequential and Post-Impact Photographs, Test No. MGS221PT-27

Test no. MGS221PT-27 was an impact of the bogie on the strong axis of a W6x9 (W152x13.4) steel post at a speed of 13.7 mph (22.0 km/h). The 108-in. (2,743-mm) long post was installed at the slope breakpoint of a 2H:1V slope with an embedment depth of 76 in. (1,930 mm). Upon impact, the post began to rotate through the soil. As the post rotated through the soil, the post yielded about the strong axis. The bogie was brought to a stop and did not override the post. The maximum deflection of the post was 16.2 in. (411 mm).

Force vs. deflection and energy vs. deflection curves were created from the accelerometer data and are shown in Figure 14. The force vs. deflection curve indicated an initial peak in the force level due to the inertial effects of the post and soil. After this inertial peak, the load continued to increase as the post rotated through the soil. The rotation of the post in the soil generated a peak force of 13.2 kips (58.7 kN) at 2.4 in. (61 mm) of deflection. After the reaching the peak force level, the resistive force steadily declined through the maximum deflection of 16.2 in. (411 mm). The average force level for the test through 15 in. (381 mm) of deflection was 8.4 kips (37.2 kN). The post rotating in soil absorbed a total of 131.8 kip-in. (14.9 kJ) of energy. Time-sequential photographs and post-impact photographs are shown in Figure 15.

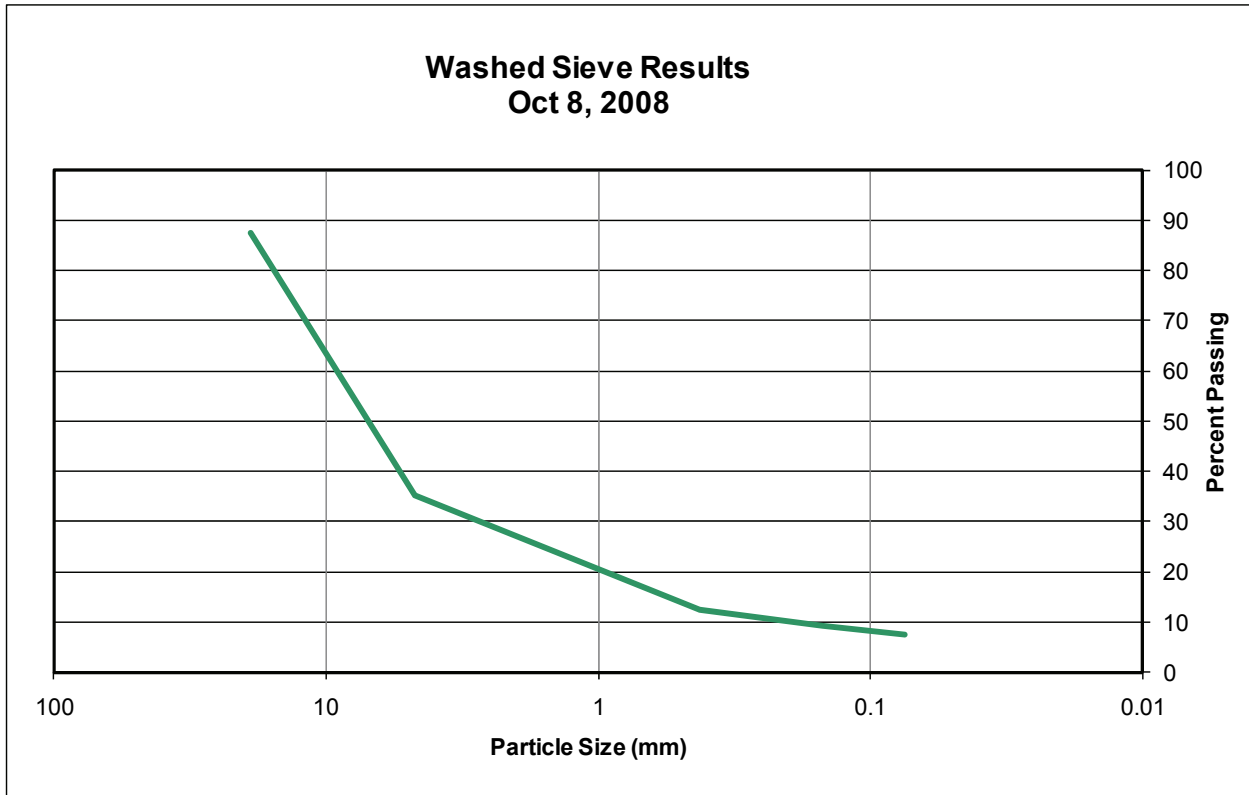
Figure A-1. Soil Characteristic Data, Test No. MGS221PT-22

Soil Test #	10082008	Moisture Content %	-55.853		
Wet Soil Test Weight (kg)	1.056				
Dry Soil Test Weight (kg)	2.392				
Date	10/8/2008				
Sieve Pan #	Sieve Opening (mm)	Pan Weight (kg)	Final Weight (kg)	Final Soil Weight (kg)	% passing
3 / 4	19.05	1.196	1.496	0.300	87.458
4	4.75	1.068	2.320	1.252	35.117
40	0.425	0.822	1.364	0.542	12.458
100	0.15	0.762	0.842	0.080	9.114
200	0.075	0.716	0.752	0.036	7.609
Loss				0.182

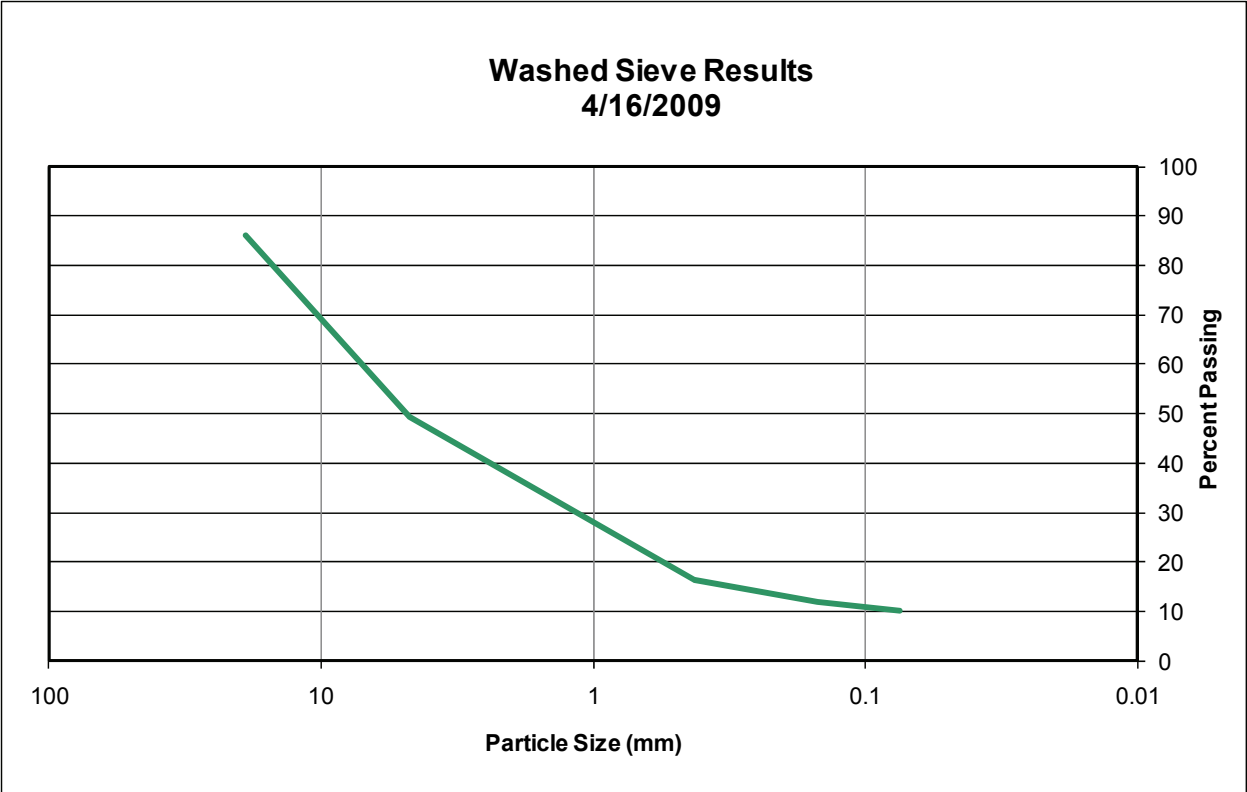
Figure A-2. Soil Characteristic Data, Test No. MGS221PT-23

Soil Test #		4162009	Moisture Content %	#DIV/0!	
Wet Soil Test Weight (kg)					
Dry Soil Test Weight (kg)		1.488			
Date		4/16/2009			
Sieve Pan #	Sieve Opening (mm)	Pan Weight (kg)	Final Weight (kg)	Final Soil Weight (kg)	% passing
3 / 4	19.05	1.196	1.402	0.206	86.156
4	4.75	1.068	1.618	0.550	49.194
40	0.425	0.822	1.310	0.488	16.398
100	0.15	0.762	0.826	0.064	12.097
200	0.075	0.716	0.744	0.028	10.215
Loss			0.152

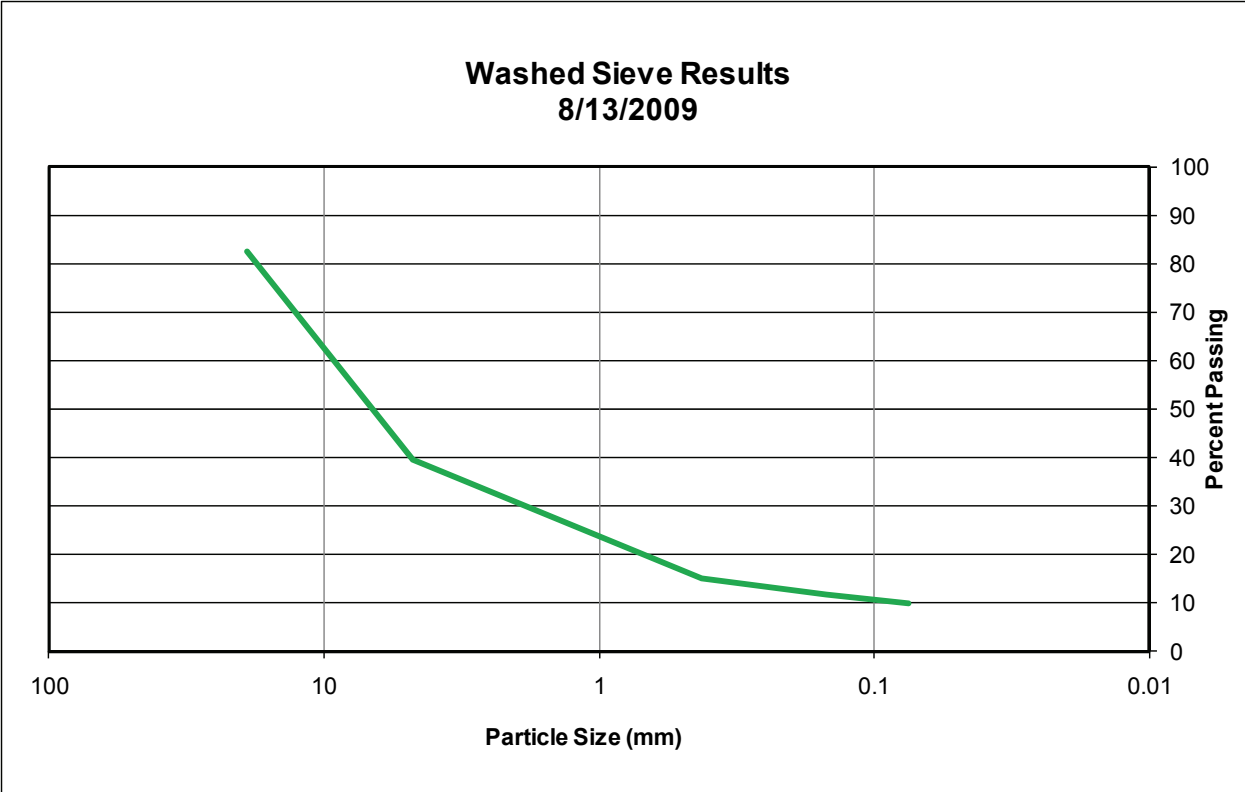
Figure A-3. Soil Characteristic Data, Test Nos. MGS221PT-24 through MGS221PT-28

Soil Test #		8132009		Moisture Content %	#VALUE!
Wet Soil Test Weight (kg)		N/A			
Dry Soil Test Weight (kg)		4.226			
Date		8/13/2009			
Sieve Pan #	Sieve Opening (mm)	Pan Weight (kg)	Final Weight (kg)	Final Soil Weight (kg)	% passing
3 / 4	19.05	1.196	1.938	0.742	82.442
4	4.75	1.068	2.876	1.808	39.659
40	0.425	0.822	1.866	1.044	14.955
100	0.15	0.762	0.904	0.142	11.595
200	0.075	0.716	0.790	0.074	9.844
Loss			0.416
