Performance Evaluation of Brass Breakaway Couplings

*Midwest States Regional Pooled Fund Research Program
Fiscal Year 2009-2010 (Year 20)
Research Project Number TPF-5(193)
NDOR Sponsoring Agency Code RFPF-10-POLE*

PERFORMANCE EVALUATION OF BRASS BREAKAWAY COUPLINGS

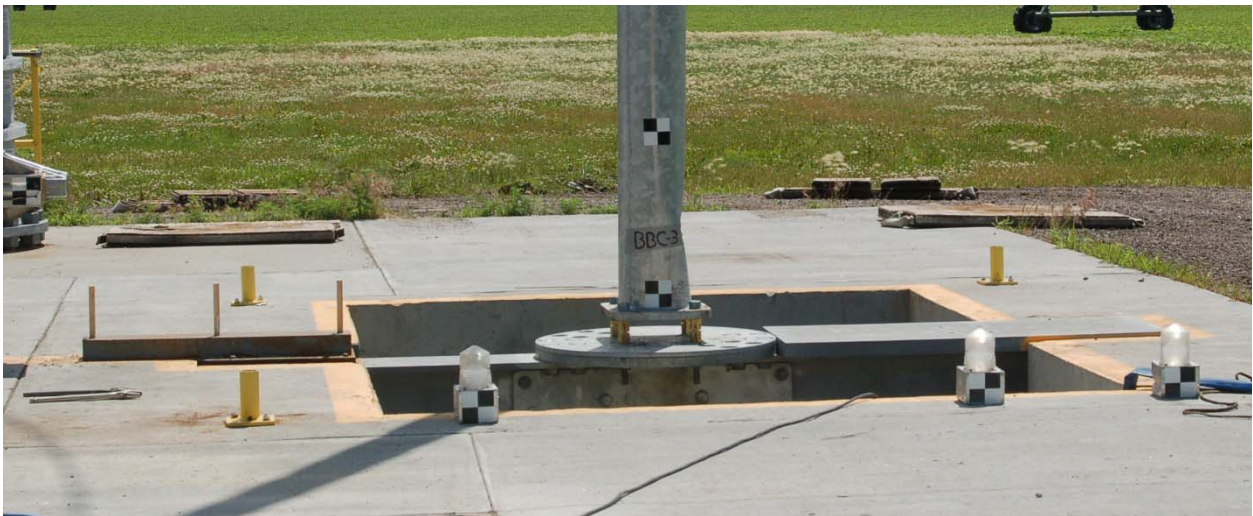
Figure 12. Wooden Dowel Setup

For all pendulum tests reported herein, three wooden dowels, spaced at 18-in. (457-mm) intervals, were used to determine the speed of the pendulum mass before impact. The dowels were mounted so that the undercarriage of the pendulum body would incrementally impact all three dowels just prior to impact with the pole system. The pendulum speed was then determined from the high-speed video (at 1000 frames/sec) by determining the times at which each dowel was impacted. A photograph of the speed trap setup is shown in Figure 12.

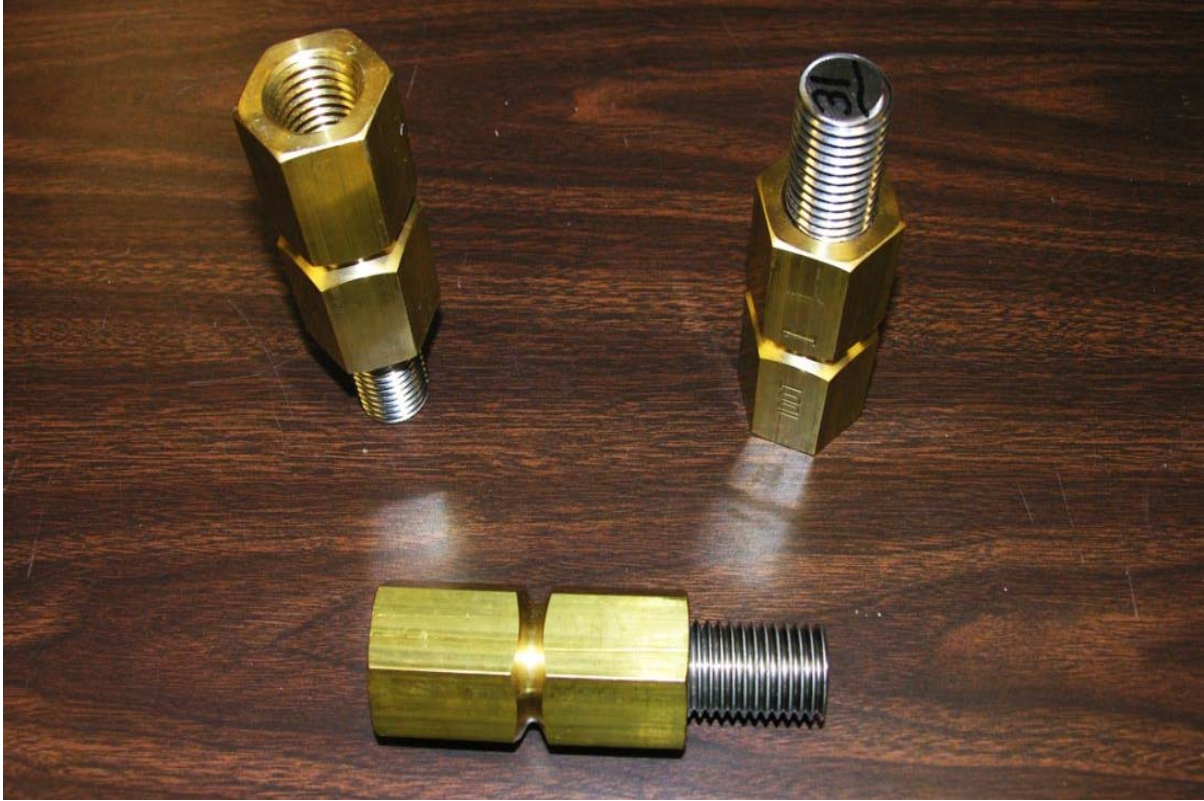
Figure 19. Brass Couplings (Version 1), Test Nos, BBC-1 and BBC-2

Four ASTM B16 brass breakaway couplings were used to fasten the poles to the foundation in test nos. BBC-1 and BBC-2, as shown in Figures 18 and 19. The 1½-in. (38-mm)

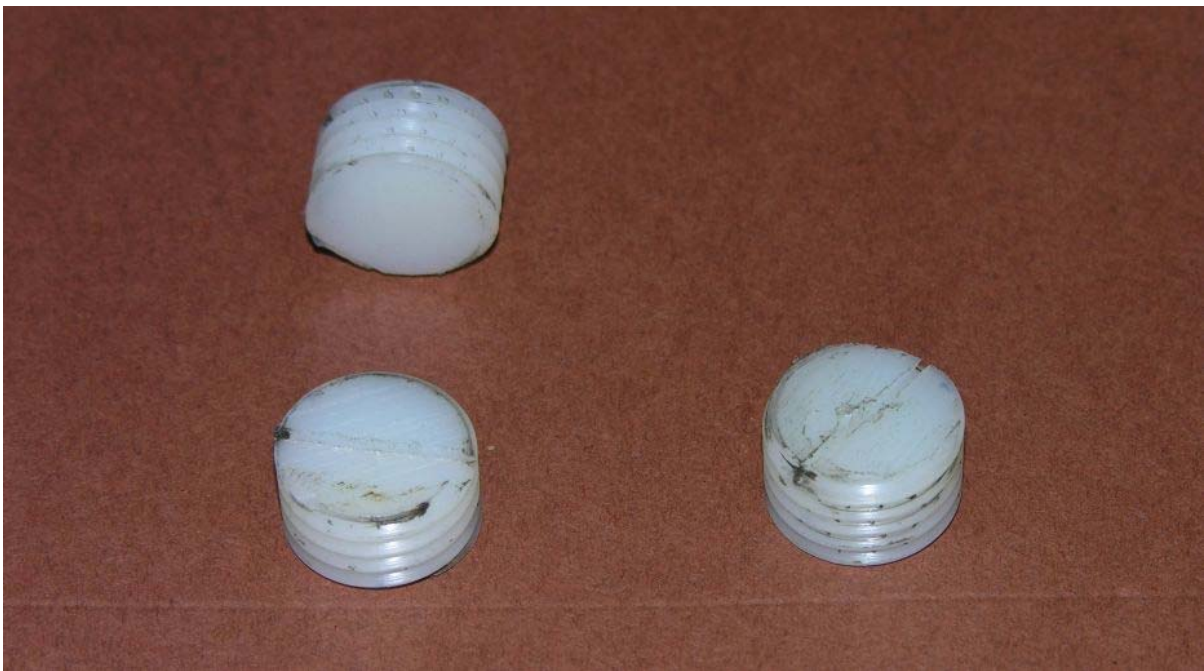
Figure 20. Nylon Inserts for Brass Couplings, Test No. BBC-1

To prevent the anchor bolts from extending through the critical notched area of the coupling, a nylon insert was inserted inside the coupling. The threaded nylon insert was ½ in. (13 mm) long by 1-in. (25-mm) diameter, as shown in Figure 20. A single groove was cut into one end of the insert so that it could be fastened into the coupling using a screwdriver. The nylon inserts were only used in test no. BBC-1.

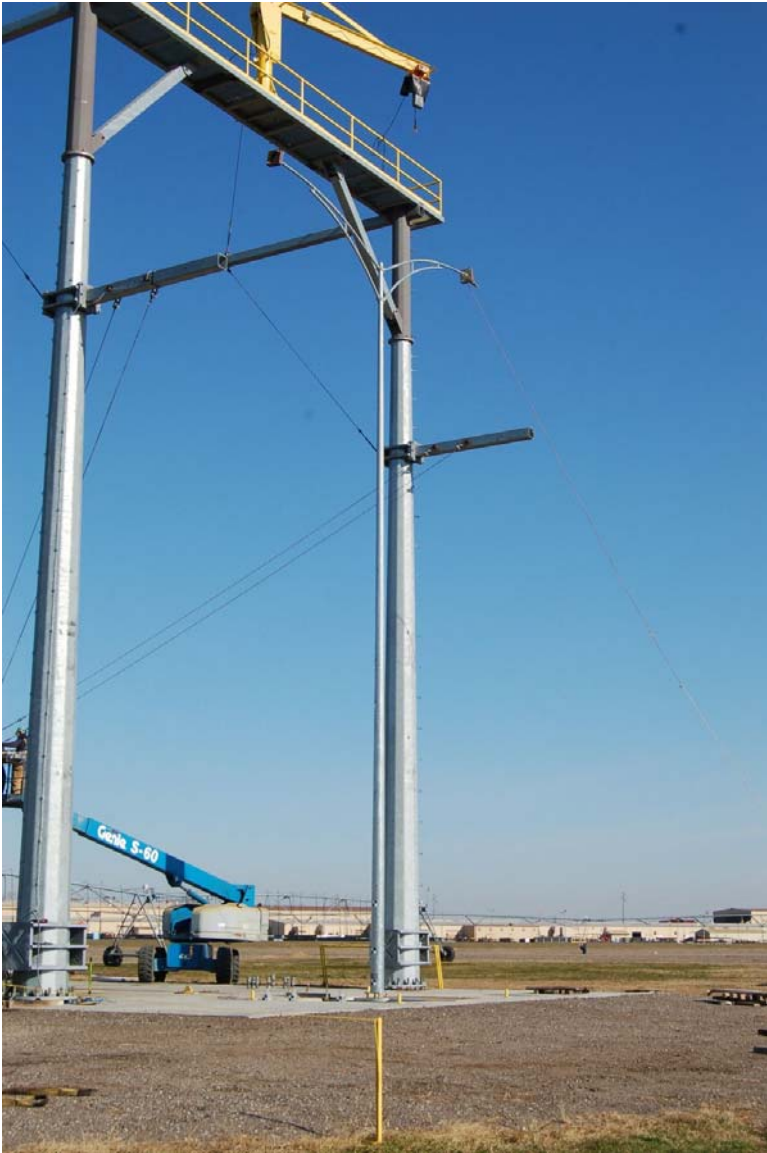
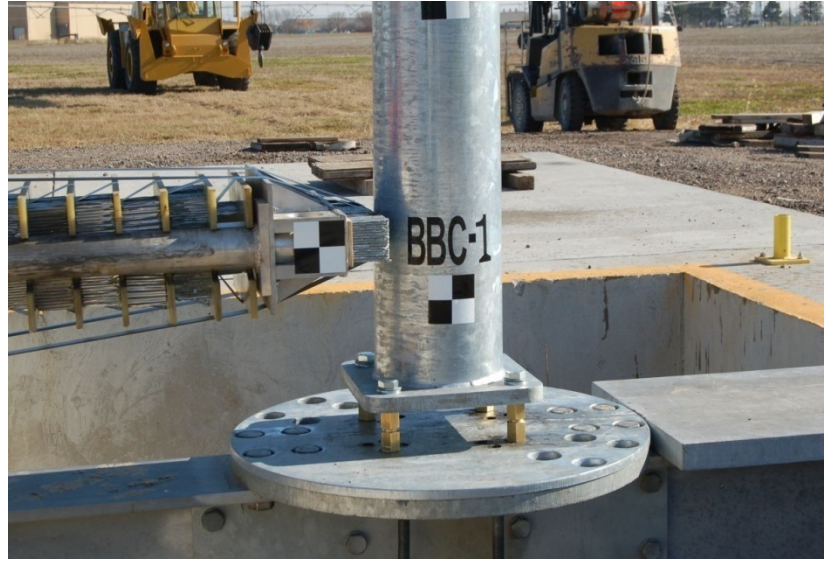
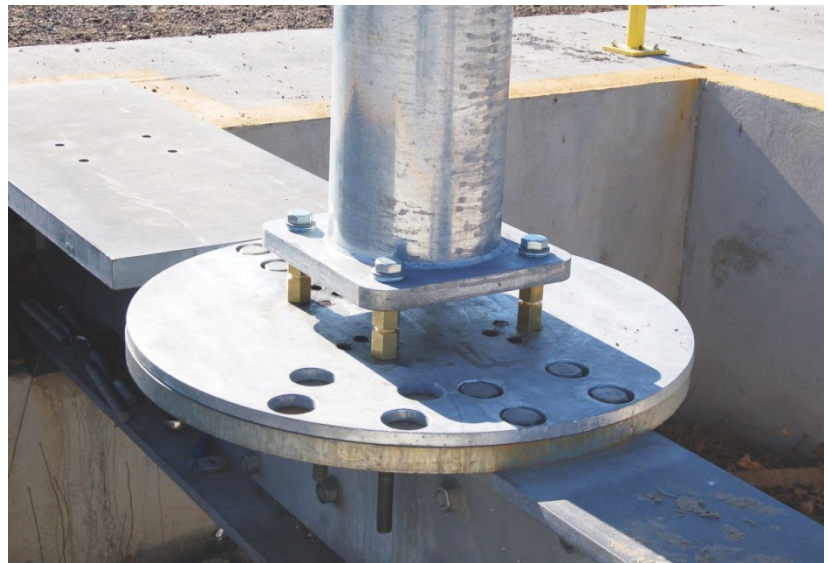
Figure 23. Assembled Test Installation, Test No. BBC-1

Two tests were performed in Round 1, test nos. BBC-1 and BBC-2. Each test installation was comprised of a luminaire pole, arms, simulated luminaires, breakaway couplings, and a simulated rigid foundation, as shown in Figures 13 through 22. Each component is described separately in the following sections. The fully assembled test installations for the Round 1 testing program are shown in Figures 23 and 24. Material specifications, mill certifications, and certificates of conforming are shown in Appendix A.

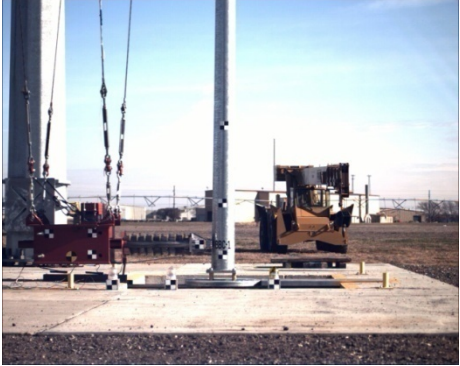
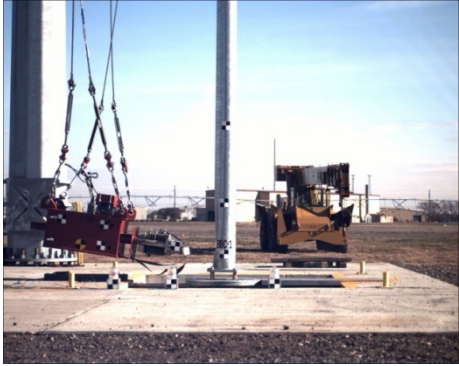
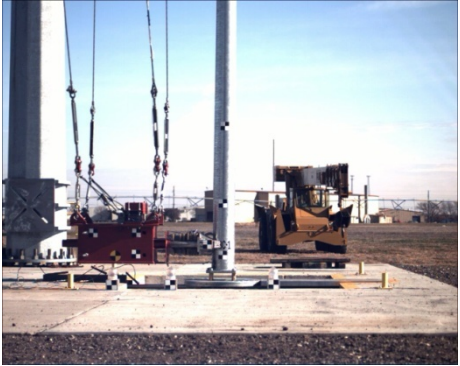
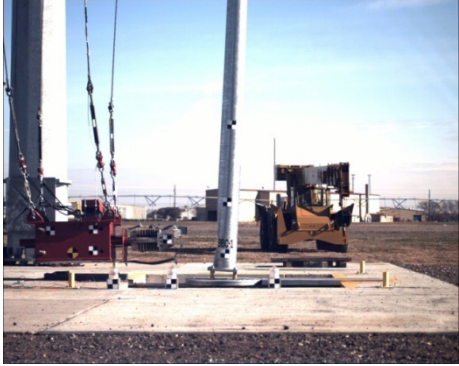
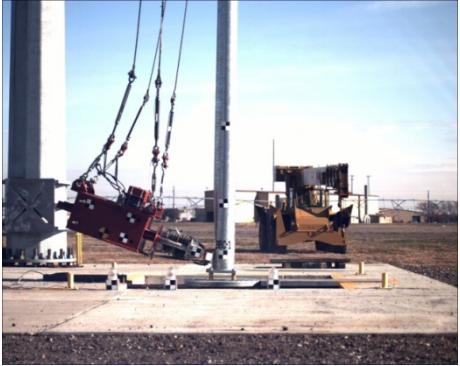
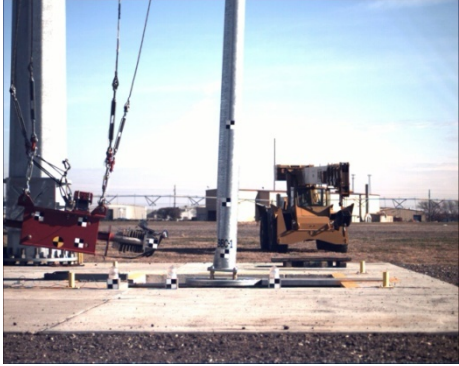
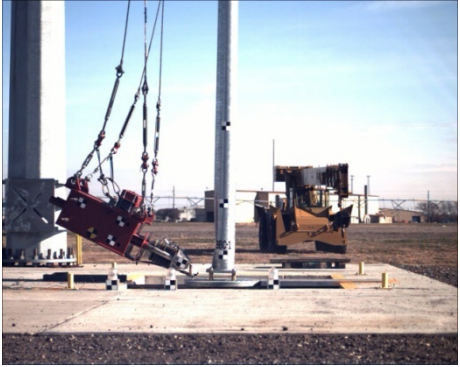
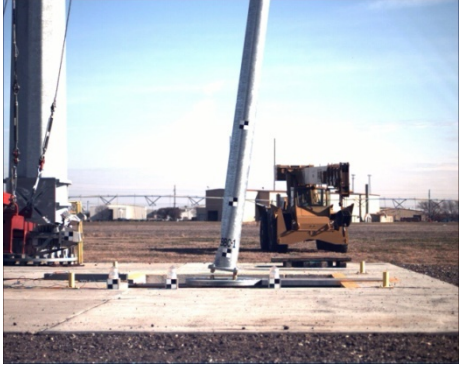
Figure 26. Additional Sequential Photographs, Test No. BBC-1

The 1,878-lb (852-kg) pendulum with crushable nose impacted the 53-ft (16.2-m) nominal height steel pole with brass couplings at a speed of 21.8 mph (35.1 km/h). A summary of the test results and sequential photographs are shown in Figure 25. Additional sequential photographs are shown in Figures 26 and 27.

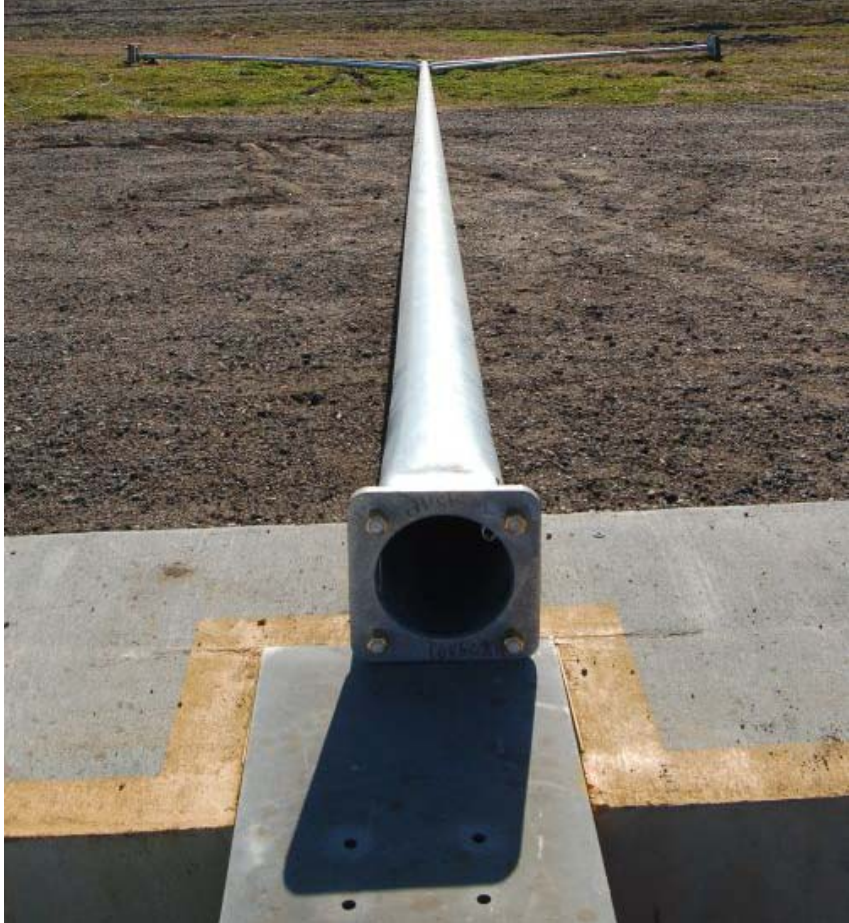
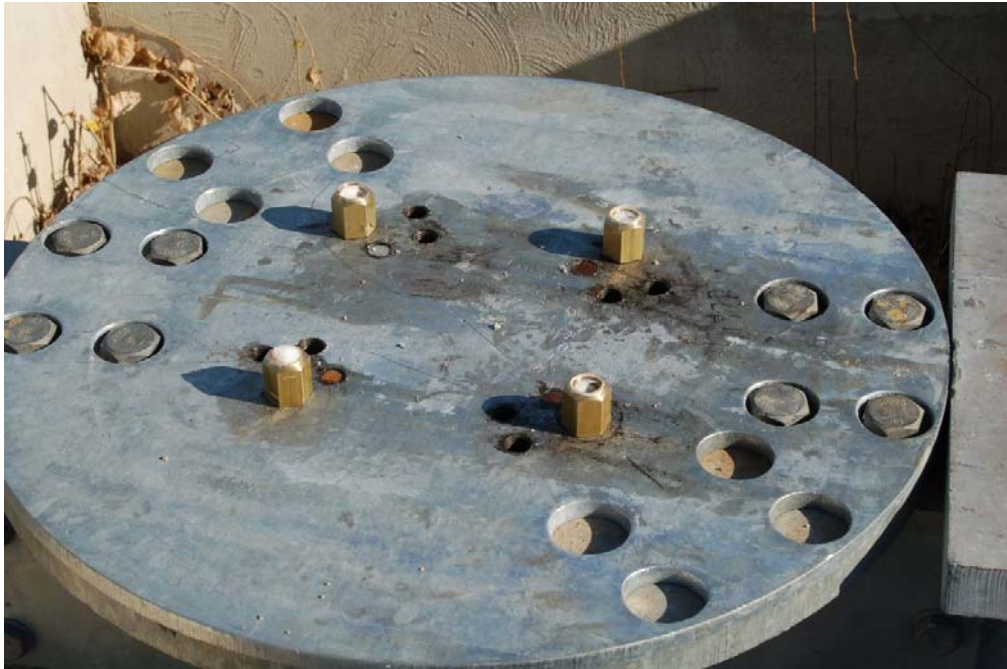
Figure 28. System Damage, Test No. BBC-1

Damage to the luminaire pole and brass couplings is shown in Figures 28 and 29. The steel pole was dented at the impact height. The steel pole and truss arms remained intact and

came to rest lying with the base 6 ft - 2 in. (1.8 m) downstream from impact. All four couplings fractured and left stub heights of 1¾ in. (44 mm), as shown in Figure 28. All four of the nylon inserts were also fractured into two pieces.

During test no. BBC-1, the 53-ft (16.2-m) nominal height steel luminaire pole with brass couplings did not break away in a controlled and predictable manner. The two front couplings fractured following impact, but the two rear couplings fractured much later due to the leaning of the pole. All four couplings had a stub height of 1¾ in. (44 mm), thus meeting the 4-in. (100-mm) maximum stub height requirement provided in AASHTO's *Standard Specifications for*

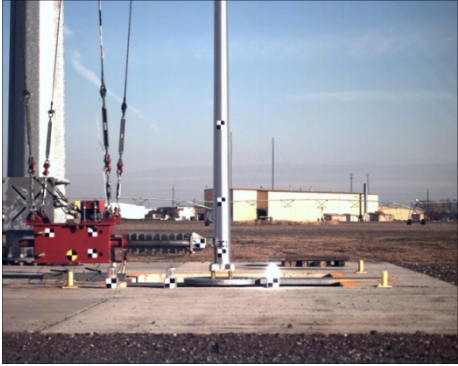
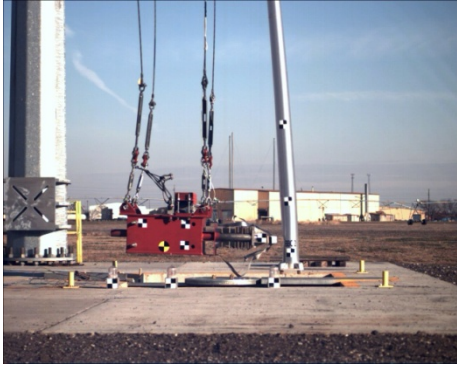
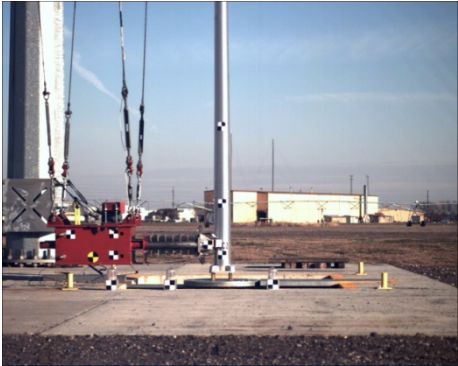
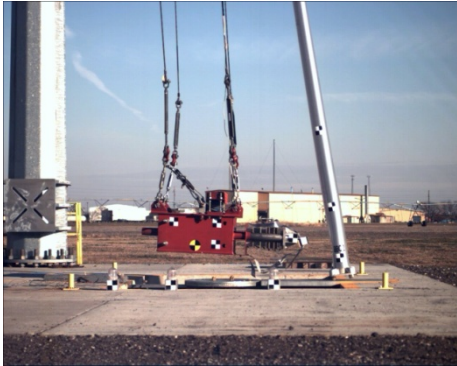
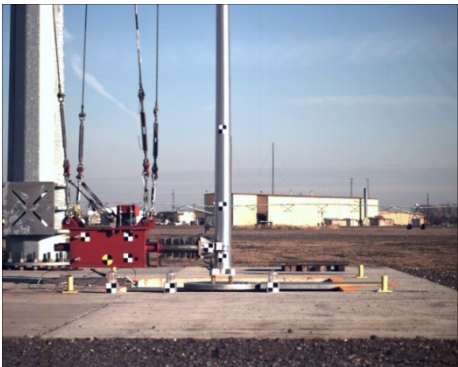
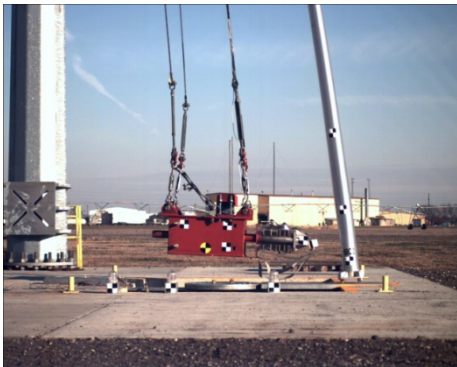
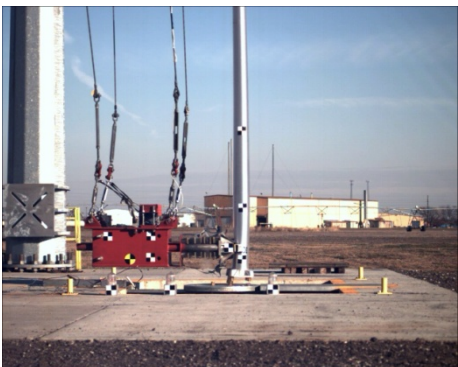
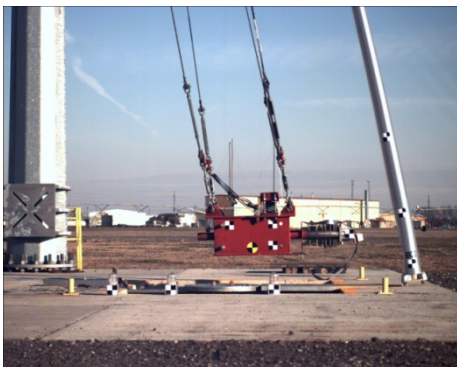
Figure 31. Additional Sequential Photographs, Test No. BBC-2

The 1,878-lb (852-kg) pendulum with crushable nose impacted the 30-ft (9.1-m) nominal height aluminum pole with brass couplings at a speed of 21.8 mph (35.1 km/h). A summary of the test results and sequential photographs are shown in Figure 30. Additional sequential photographs are shown in Figures 31 and 32.

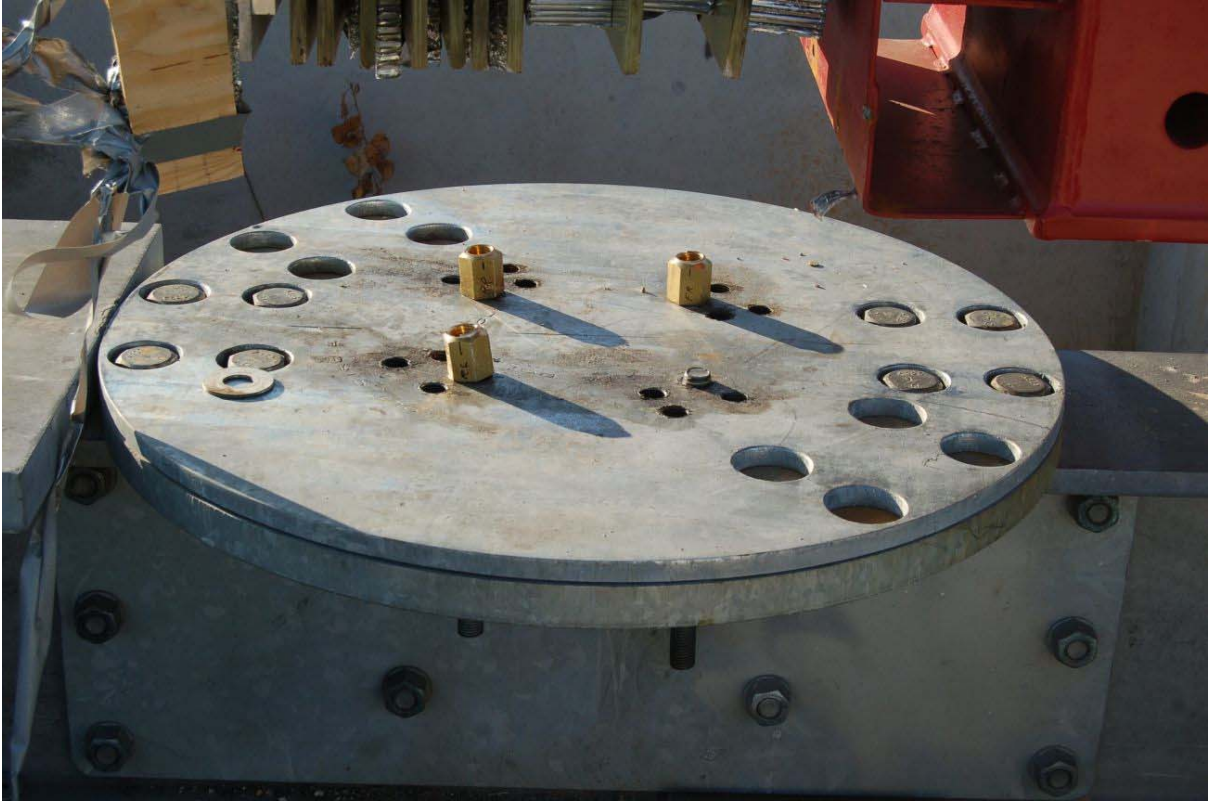
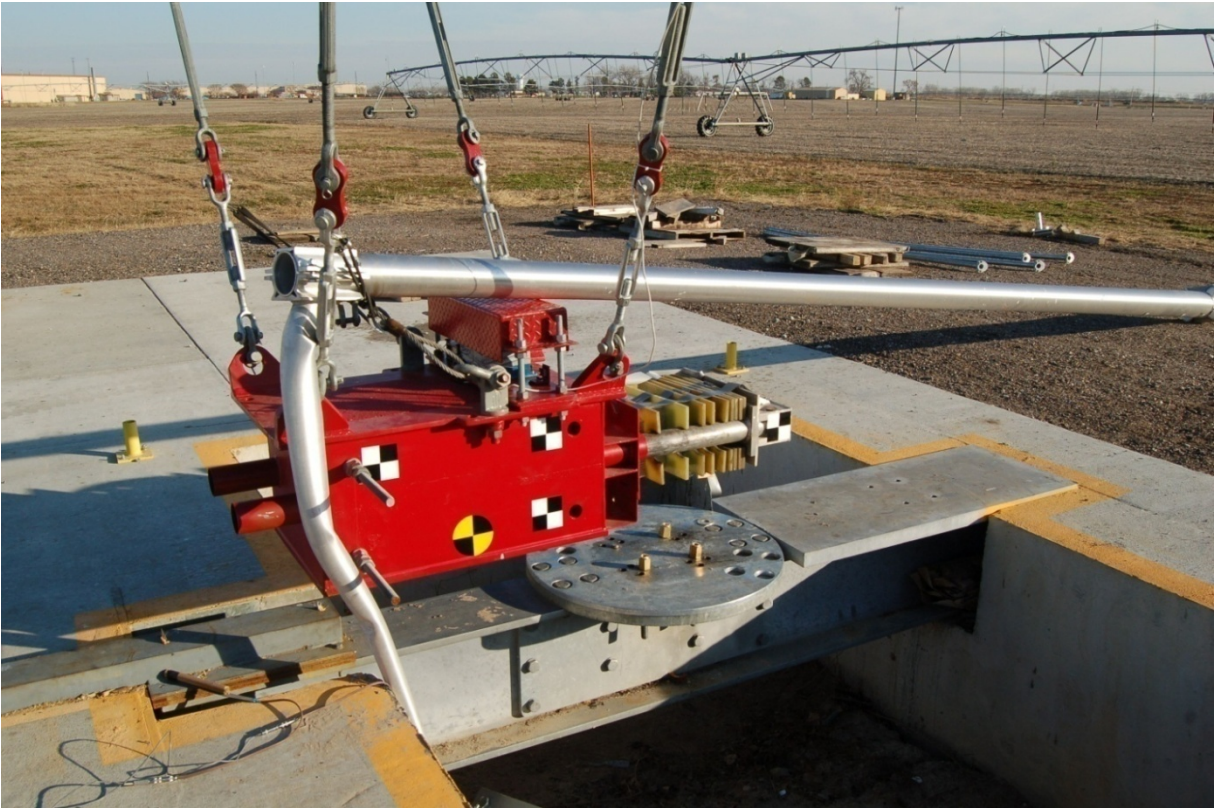
Figure 33. System Damage, Test No. BBC-2

Damage to the luminaire pole and brass couplings is shown in Figures 33 and 34. The aluminum pole was dented at the impact height. The luminaire arm was bent significantly from contact with the pendulum during its back swing. The pole and luminaire arm came to rest on top of the pendulum. Three brass couplings fractured as expected, resulting in a remaining stub height of 1¾ in. (44 mm). The other brass coupling was disengaged from its anchor bolt due to the improper installation of the coupling onto the anchor bolt.

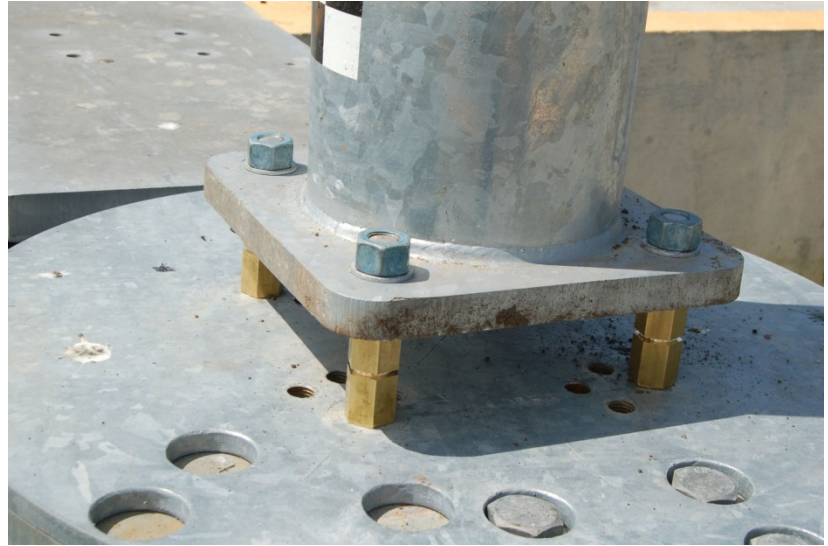
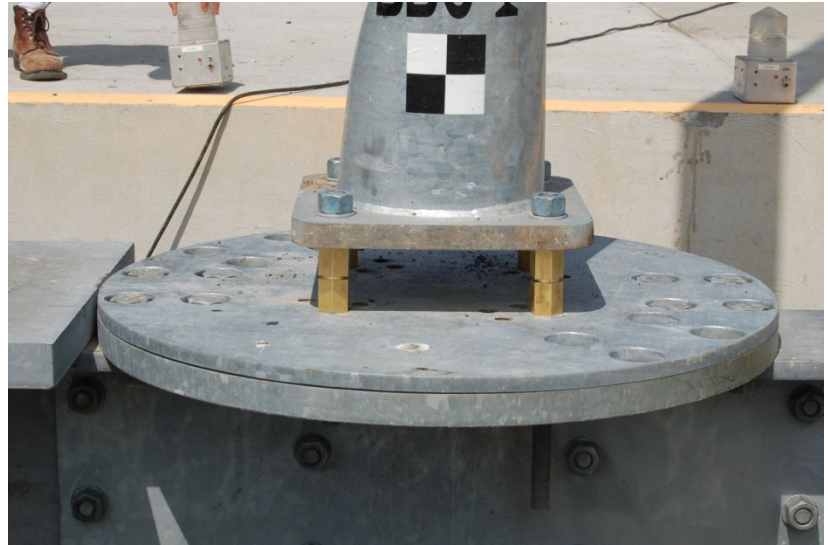
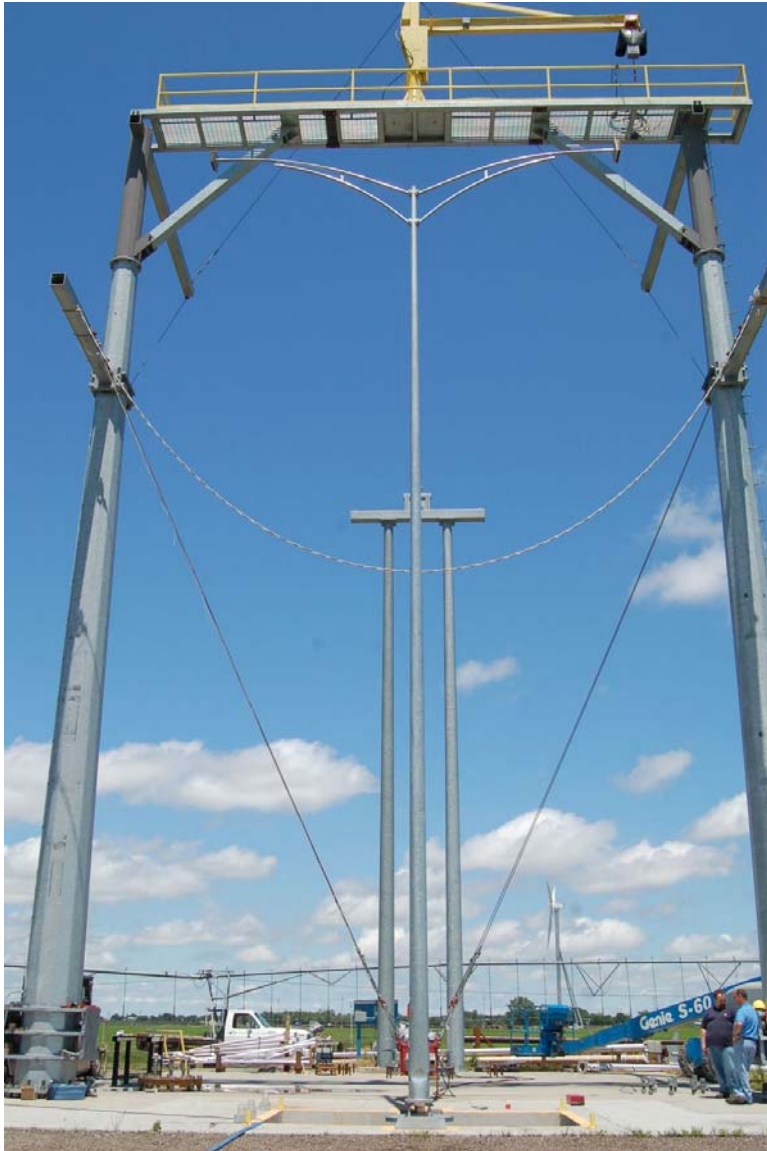
Figure 38. Assembled Test Installation, Test No. BBC-4

luminaire bulb. Photographs of the assembled systems for test nos. BBC-3 through BBC-5 are shown in Figures 37 through 39, respectively.

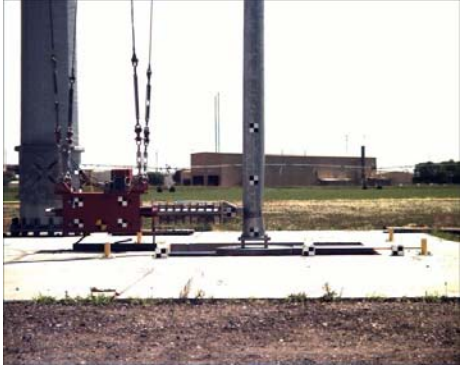
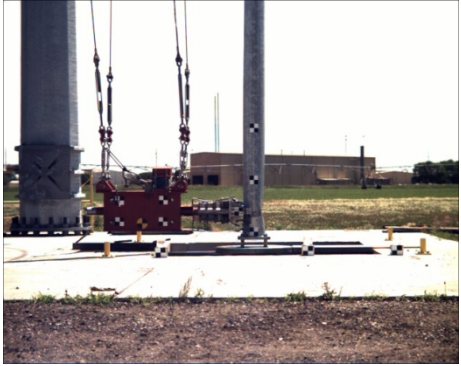
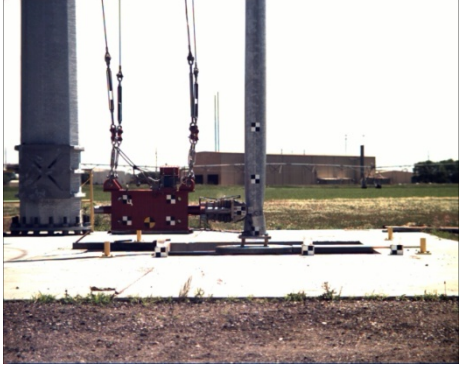
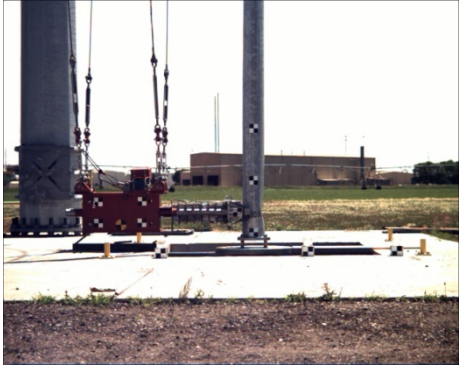
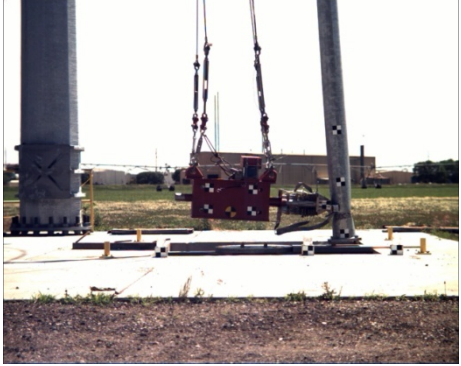
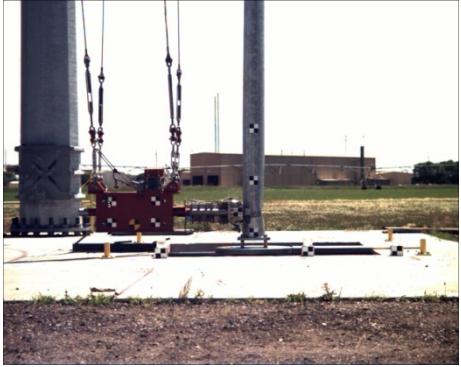
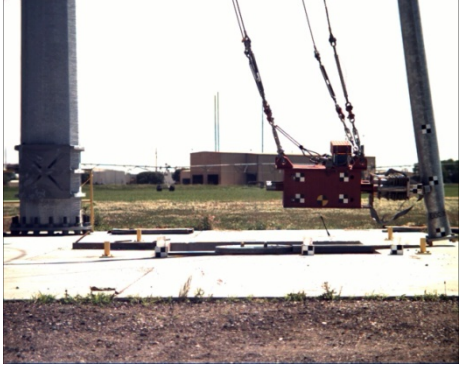
Figure 41. Additional Sequential Photographs, Test No. BBC-3

The 1,849-lb (839-kg) pendulum with crushable nose impacted the 53-ft (16.2-m) nominal height, steel luminaire pole with dual truss arms, simulated luminaire weights, and mounted on brass breakaway couplings (Version 2) at a speed of 21.8 mph (35.1 km/h). A summary of the test results and sequential photographs are shown in Figure 40. Additional sequential photographs are shown in Figures 41 and 42.

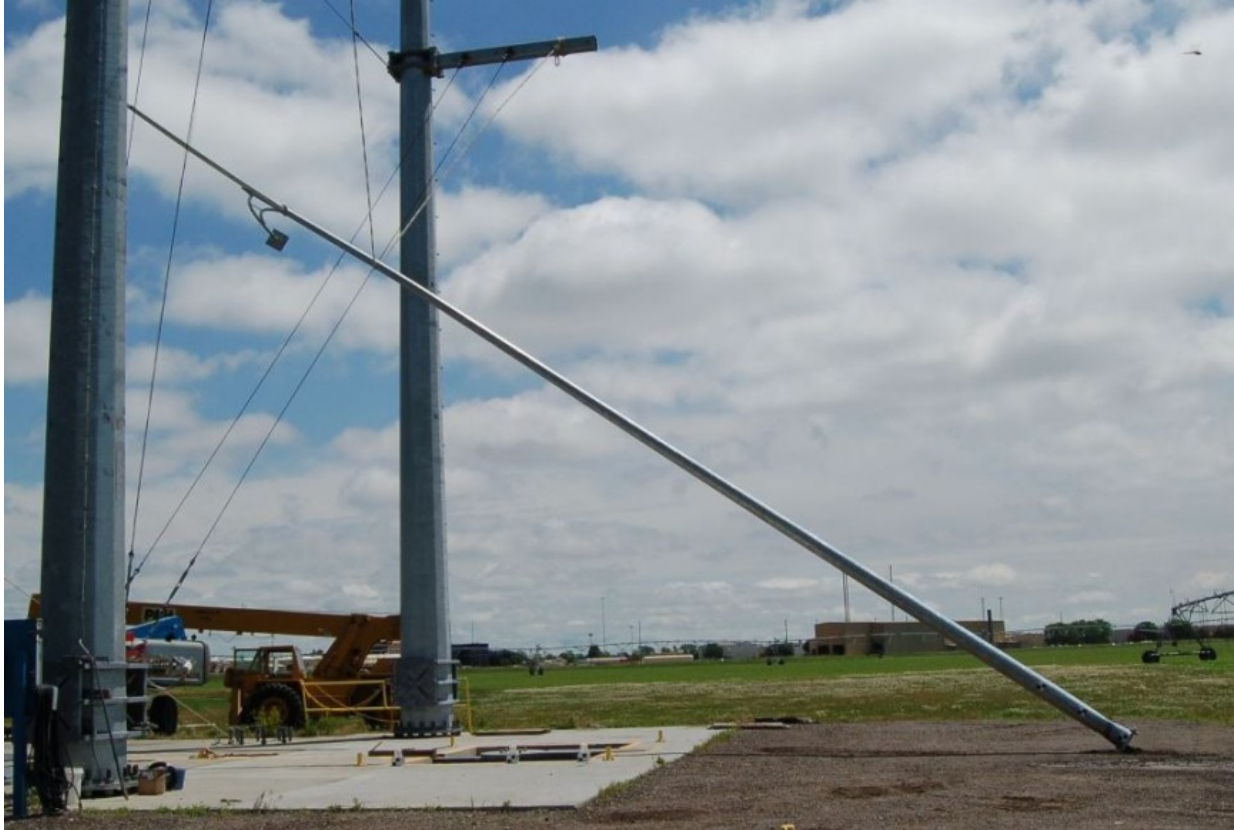
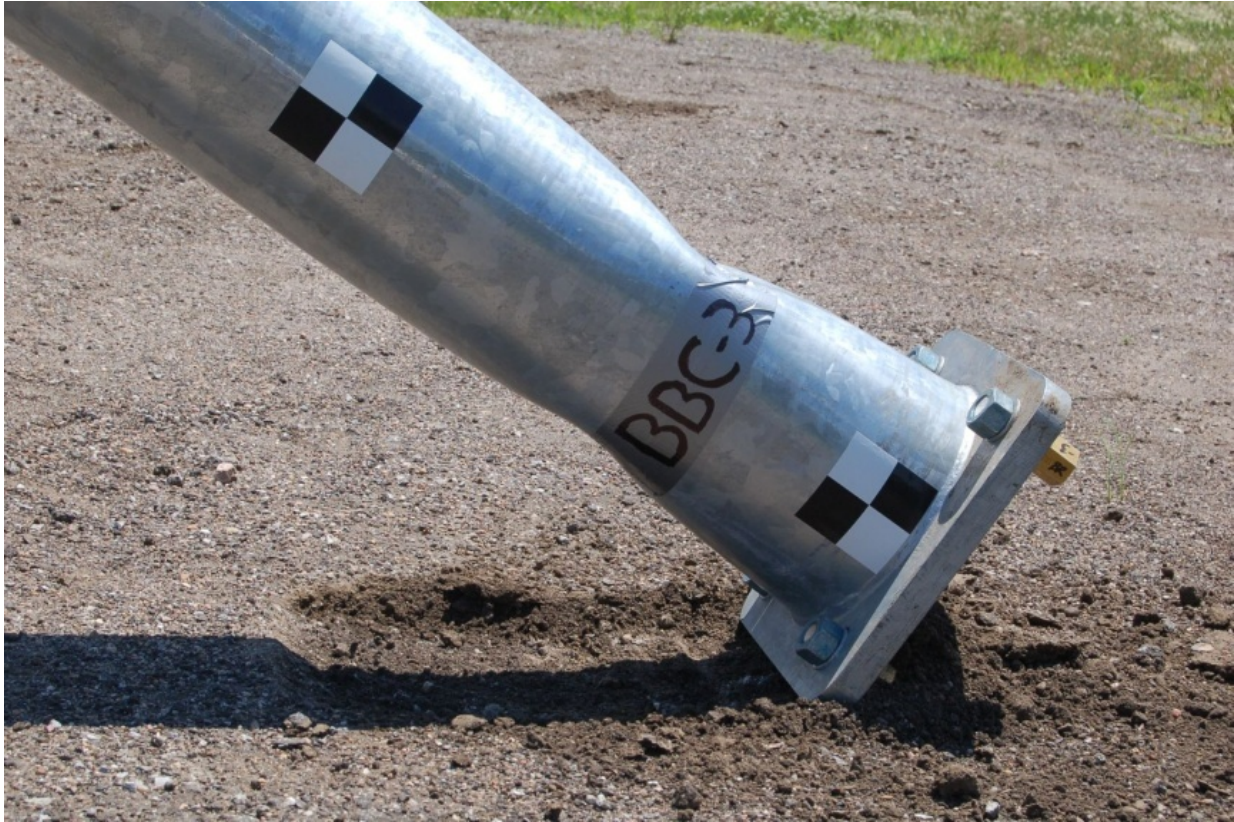
Figure 43. System Damage, Test No. BBC-3

Damage to the luminaire pole and brass couplings is shown in Figures 43 and 44. The steel pole was dented at the impact height. The base of the pole came to rest 26 ft (7.9 m) downstream from the initial attachment location with the top of the pole captured by the tether. The two mast arms were slightly bent due to the tether system catching the pole as it fell. All four brass couplings fractured through the center notch, resulting in stub heights of 1¼ in. (44 mm).

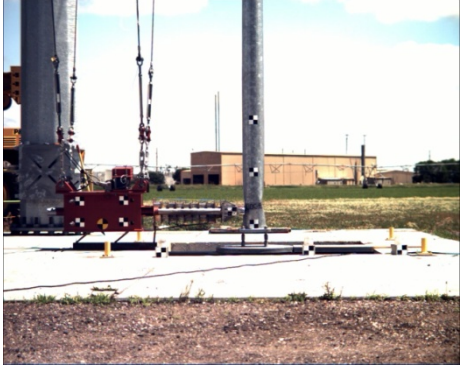
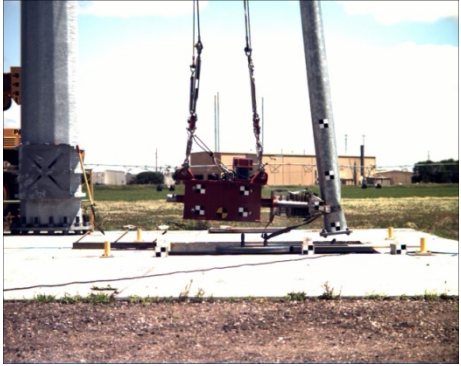
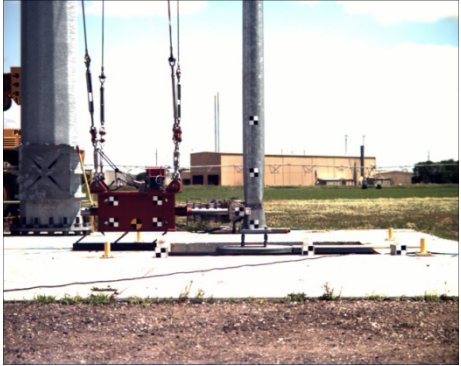
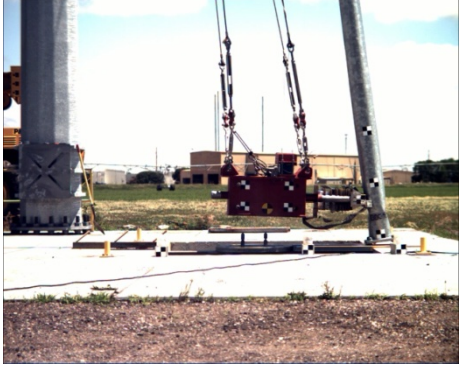
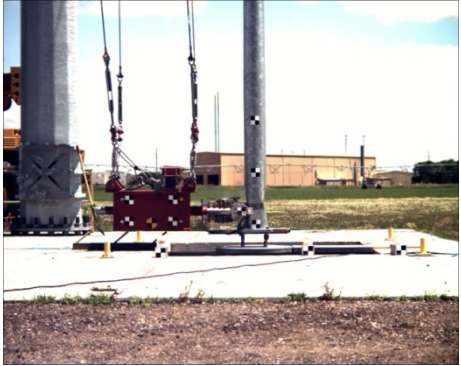
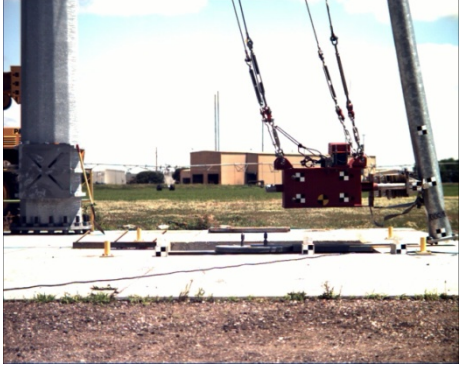
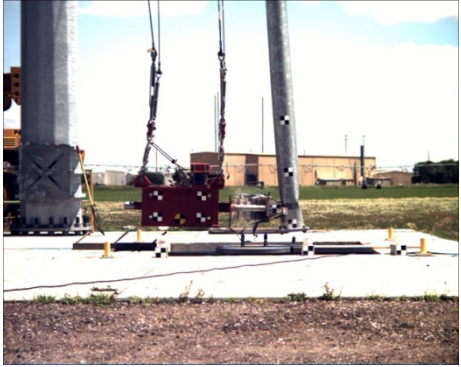
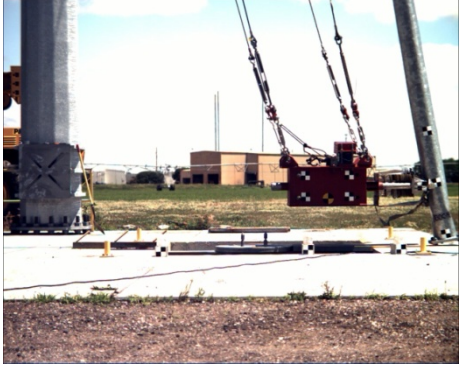
Figure 46. Additional Sequential Photographs, Test No. BBC-4

The 1,849-lb (839-kg) pendulum with crushable nose impacted the 53-ft (16.2-m) nominal height, steel luminaire pole with dual mast arms, simulated luminaire weights, and mounted in 1-in. (25-mm) diameter TRANSPO couplings at a speed of 23.3 mph (37.5 km/h). A summary of the test results and sequential photographs are shown in Figure 45. Additional sequential photographs are shown in Figures 46 and 47.

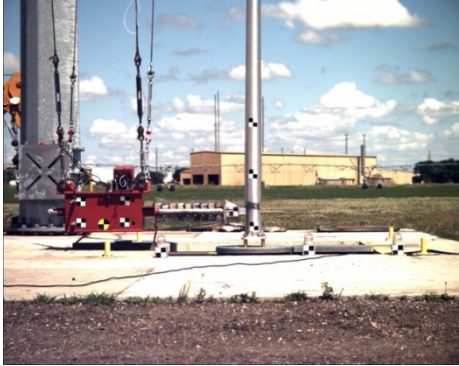
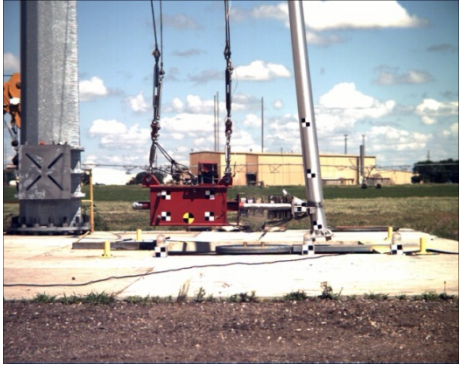
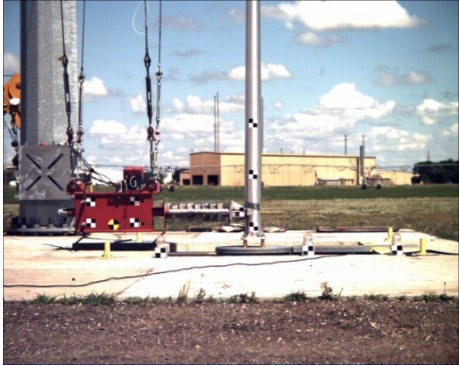
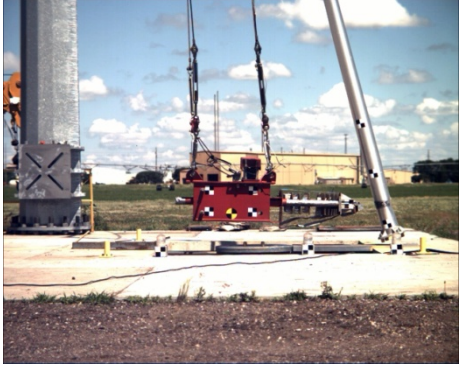
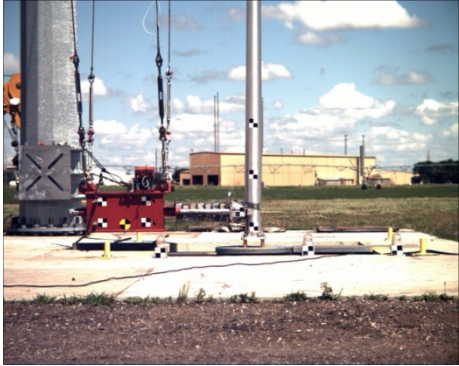
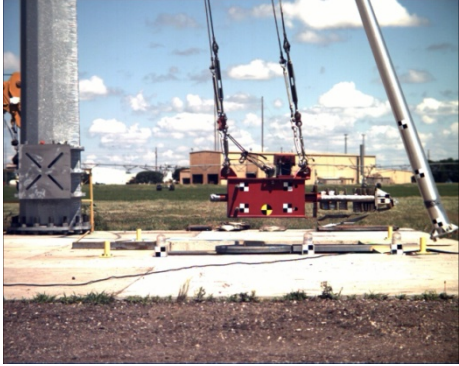
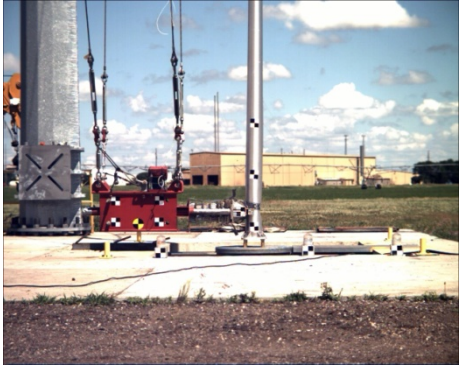
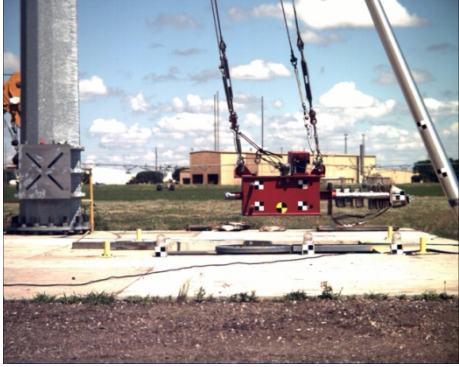
Figure 51. Additional Sequential Photographs, Test No. BBC-5

- Impact Conditions
 - Speed 21.8 mph (35.1 km/h)
 - Angle 0 deg
 - Impact Height 17½ in. (445 mm)
- Test Article Damage Moderate
- Stub Heights
 - Four Occurrences 1¼ in. (44 mm)
- Transducer Data

The 1,849-lb (839-kg) pendulum with crushable nose impacted the 30-ft (9.1-m) nominal height, aluminum luminaire pole with single mast arm, simulated luminaire weights, and mounted on brass breakaway couplings (Version 2) at a speed of 21.8 mph (35.1 km/h). A summary of the test results and sequential photographs are shown in Figure 50. Additional sequential photographs are shown in Figures 51 and 52.

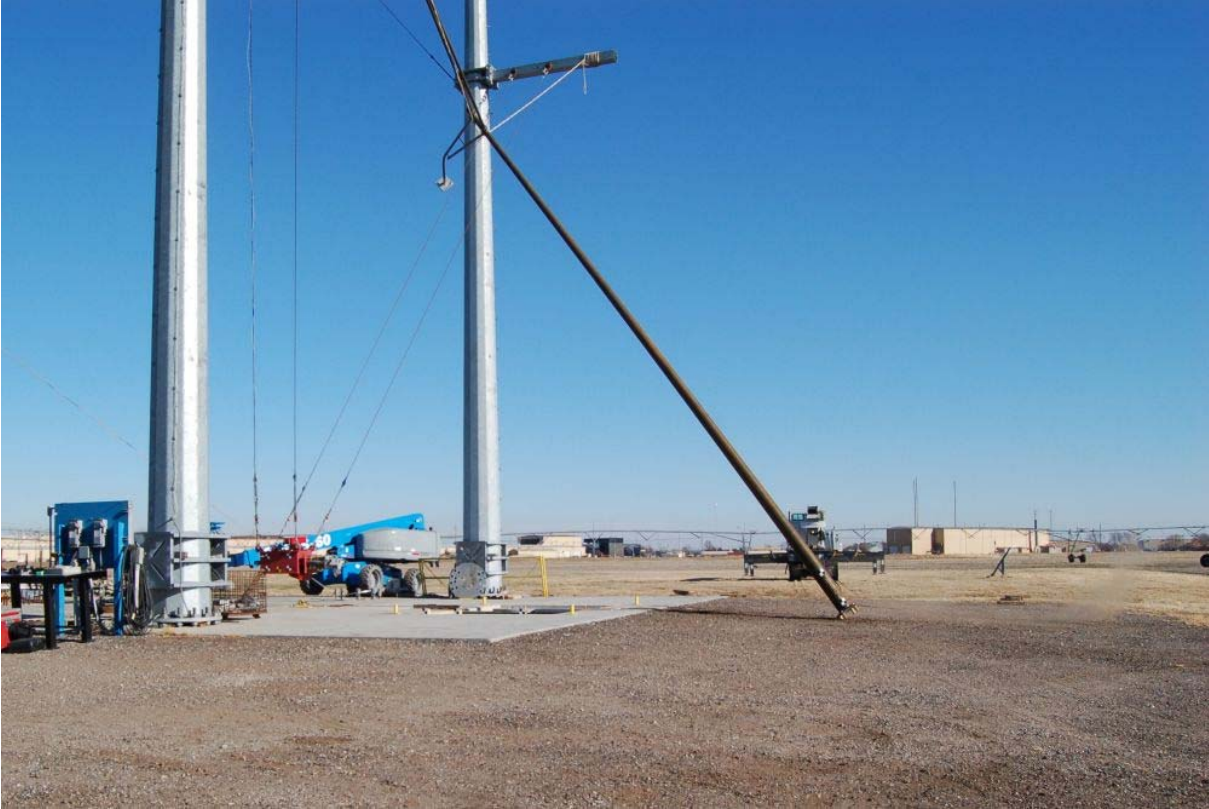
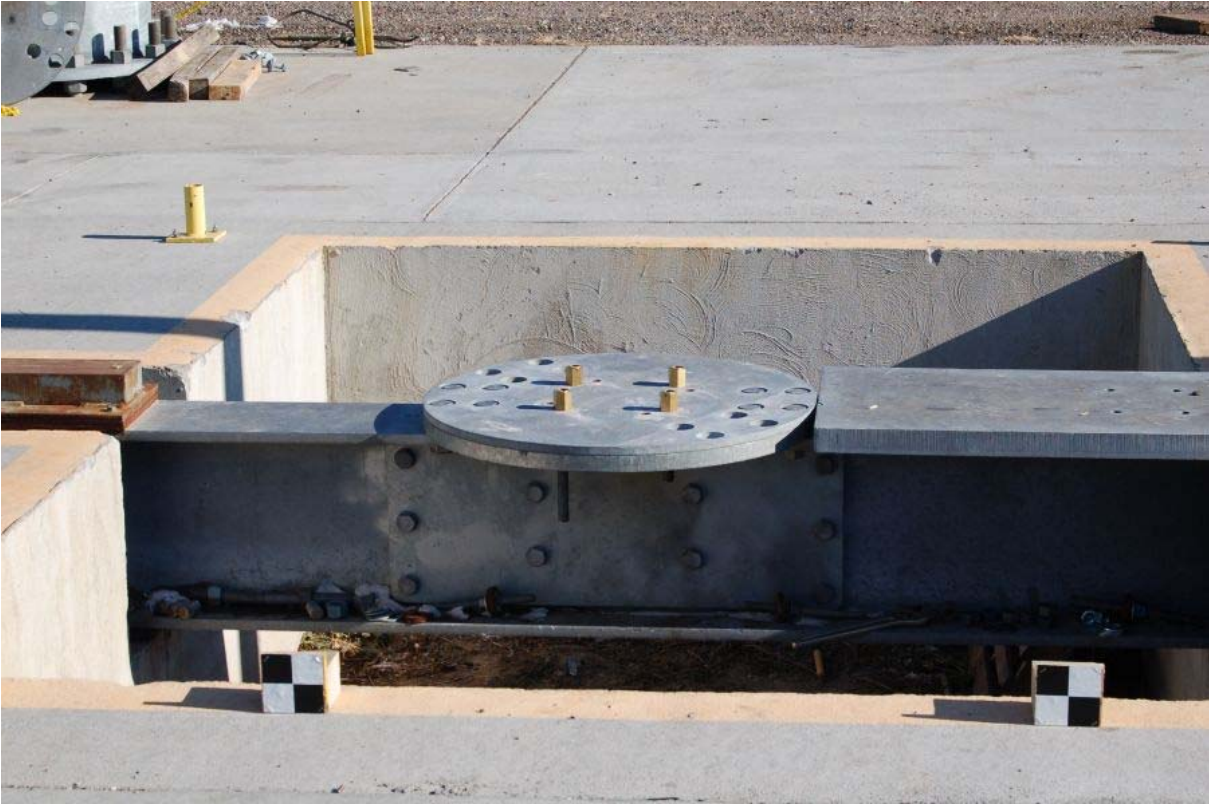
Figure 64. System Damage, Test No. BBC-6

Damage to the luminaire pole and brass couplings is shown in Figures 64 and 65. The luminaire arms were bent slightly forward from when the tethers caught the pole as it fell. The base of the pole came to rest 20 ft (6.1 m) downstream from the initial attachment location with the top of the pole captured by the tether system. All four brass couplings fractured through the notch, thus, leaving stub heights of 1³/₄ in. (44 mm).
