Performance Evaluation of Brass Breakaway Couplings

*Midwest States Regional Pooled Fund Research Program
Fiscal Year 2009-2010 (Year 20)
Research Project Number TPF-5(193)
NDOR Sponsoring Agency Code RFPF-10-POLE*

PERFORMANCE EVALUATION OF BRASS BREAKAWAY COUPLINGS

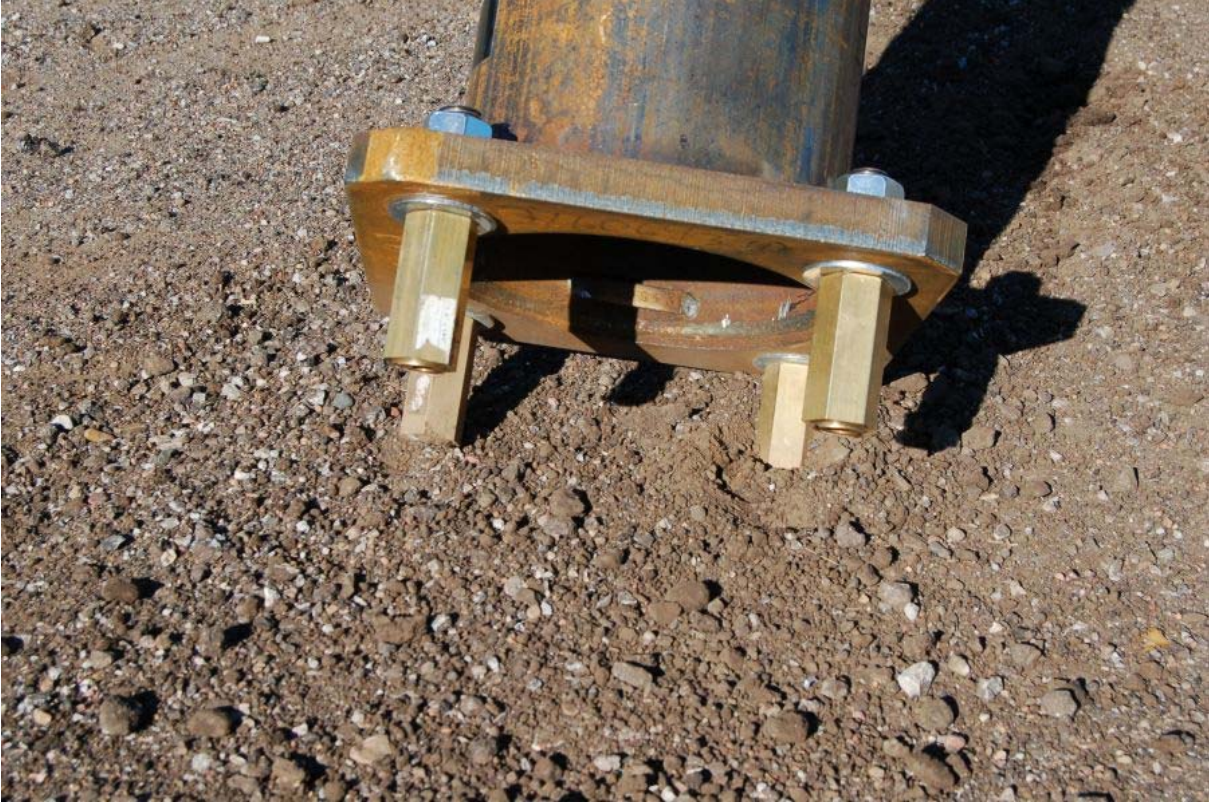
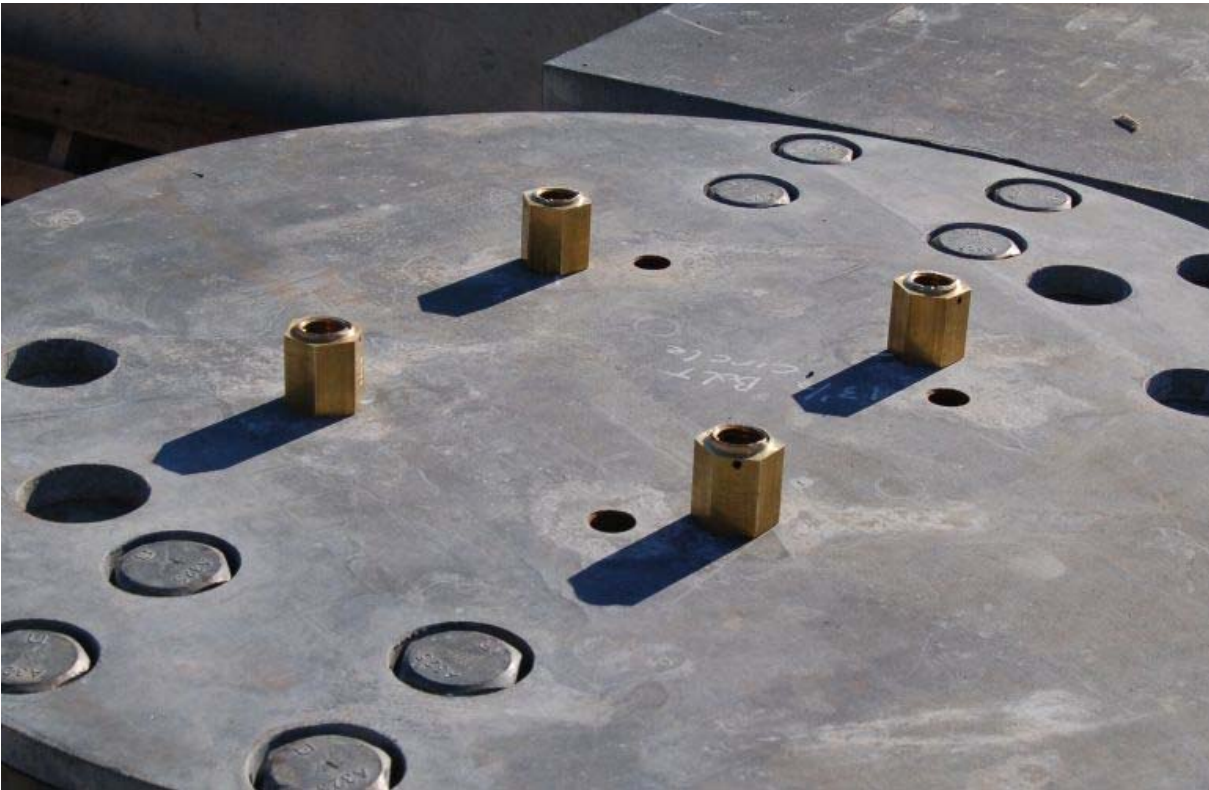
Figure 65. System Damage, Test No. BBC-6

Damage to the luminaire pole and brass couplings is shown in Figures 64 and 65. The luminaire arms were bent slightly forward from when the tethers caught the pole as it fell. The base of the pole came to rest 20 ft (6.1 m) downstream from the initial attachment location with the top of the pole captured by the tether system. All four brass couplings fractured through the notch, thus, leaving stub heights of 1³/₄ in. (44 mm).

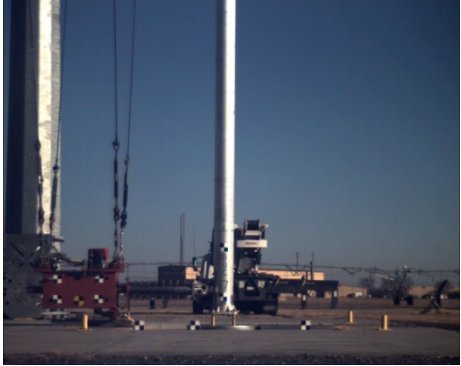
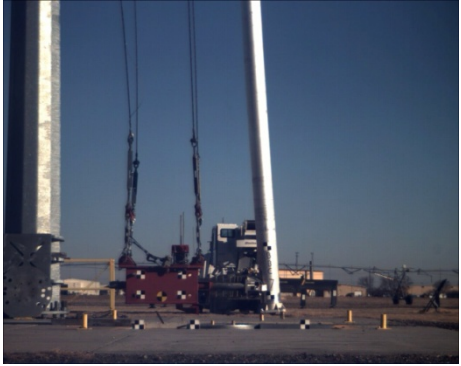
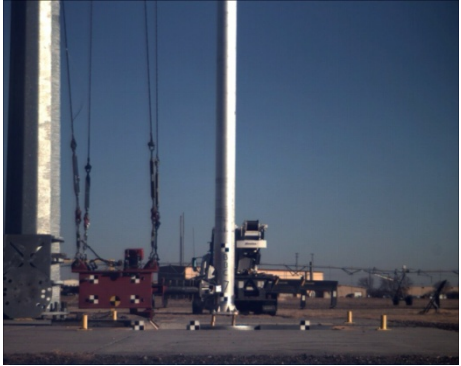
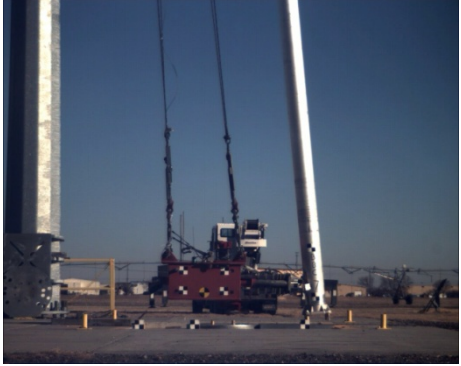
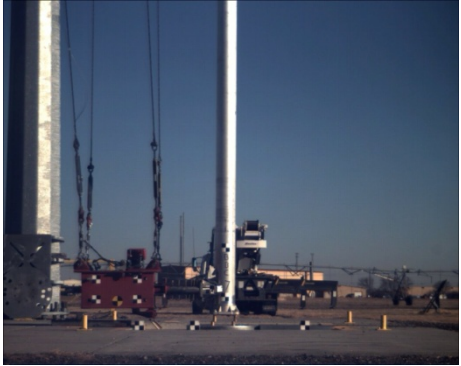
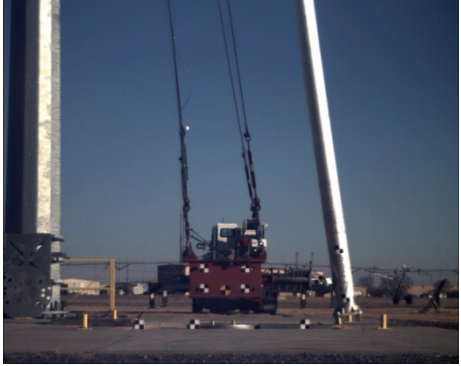
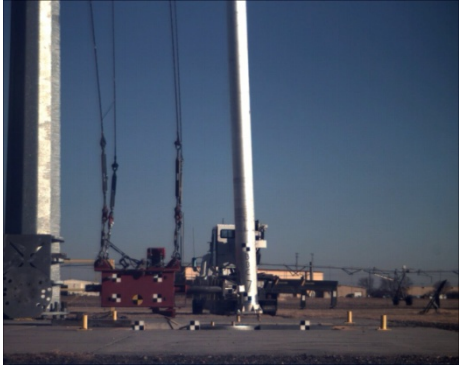
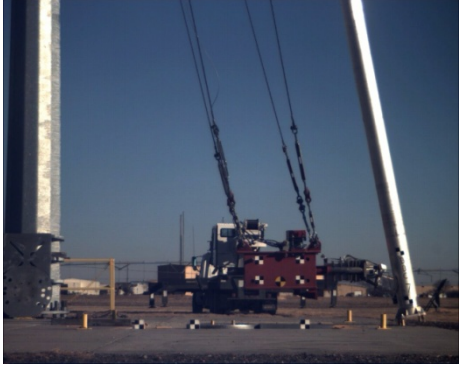
Figure 67. Additional Sequential Photographs, Test No. BBC-7
125

The 1,882-lb (854-kg) pendulum with crushable nose impacted the 55-ft (16.8-m) nominal height, aluminum luminaire pole with dual mast arms, simulated luminaire weights, and mounted on breakaway brass couplings (Version 3) at a speed of 21.8 mph (35.1 km/h). A summary of the test results and sequential photographs are shown in Figure 66. Additional sequential photographs are shown in Figures 67 and 68.

0.048	The left-front coupling fractured.
0.049	The right-front coupling fractured.
0.052	The right-rear coupling fractured.
0.053	The left-rear coupling fractured.

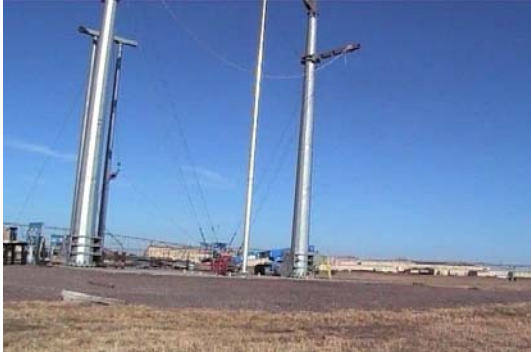
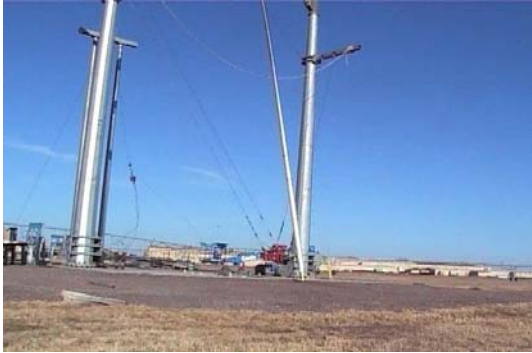
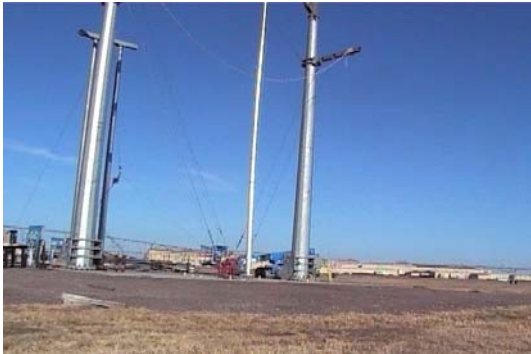
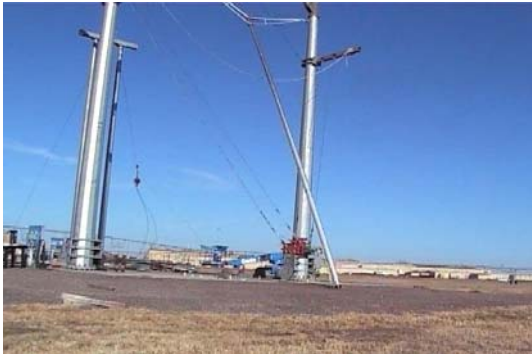
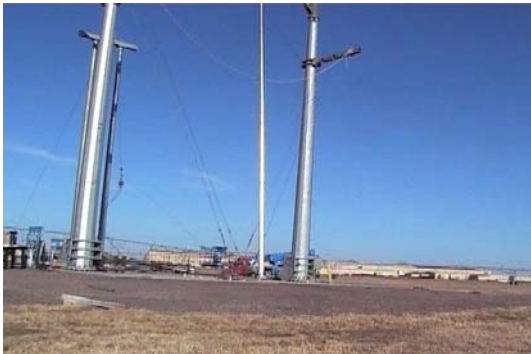
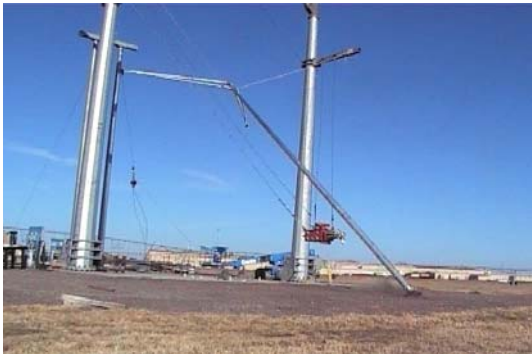
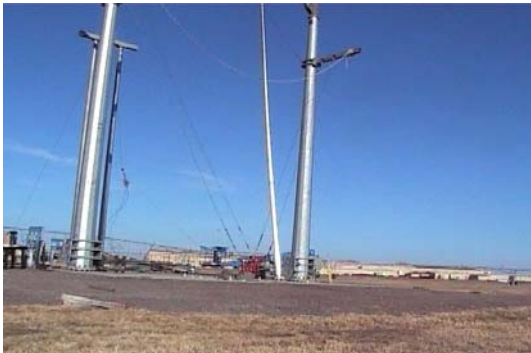
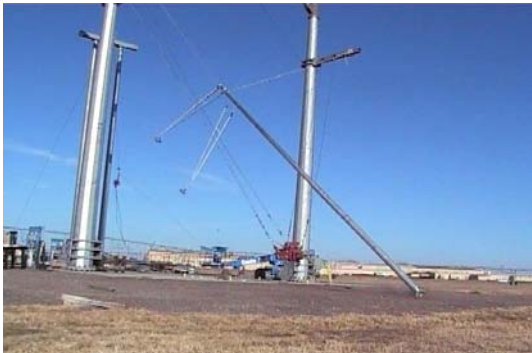
Figure 68. Additional Sequential Photographs, Test No. BBC-7

0.556	The pendulum impacted the pole for a second time on its upswing.
1.724	The top of the pole was caught by the tether ropes.
1.931	The left luminaire arm bent near the arm simplex due to the impact load caused by the tethers.

2.214	The left luminaire arm fractured away from the arm simplex.
3.034	The left luminaire arm contacted the ground after fracturing off the pole.

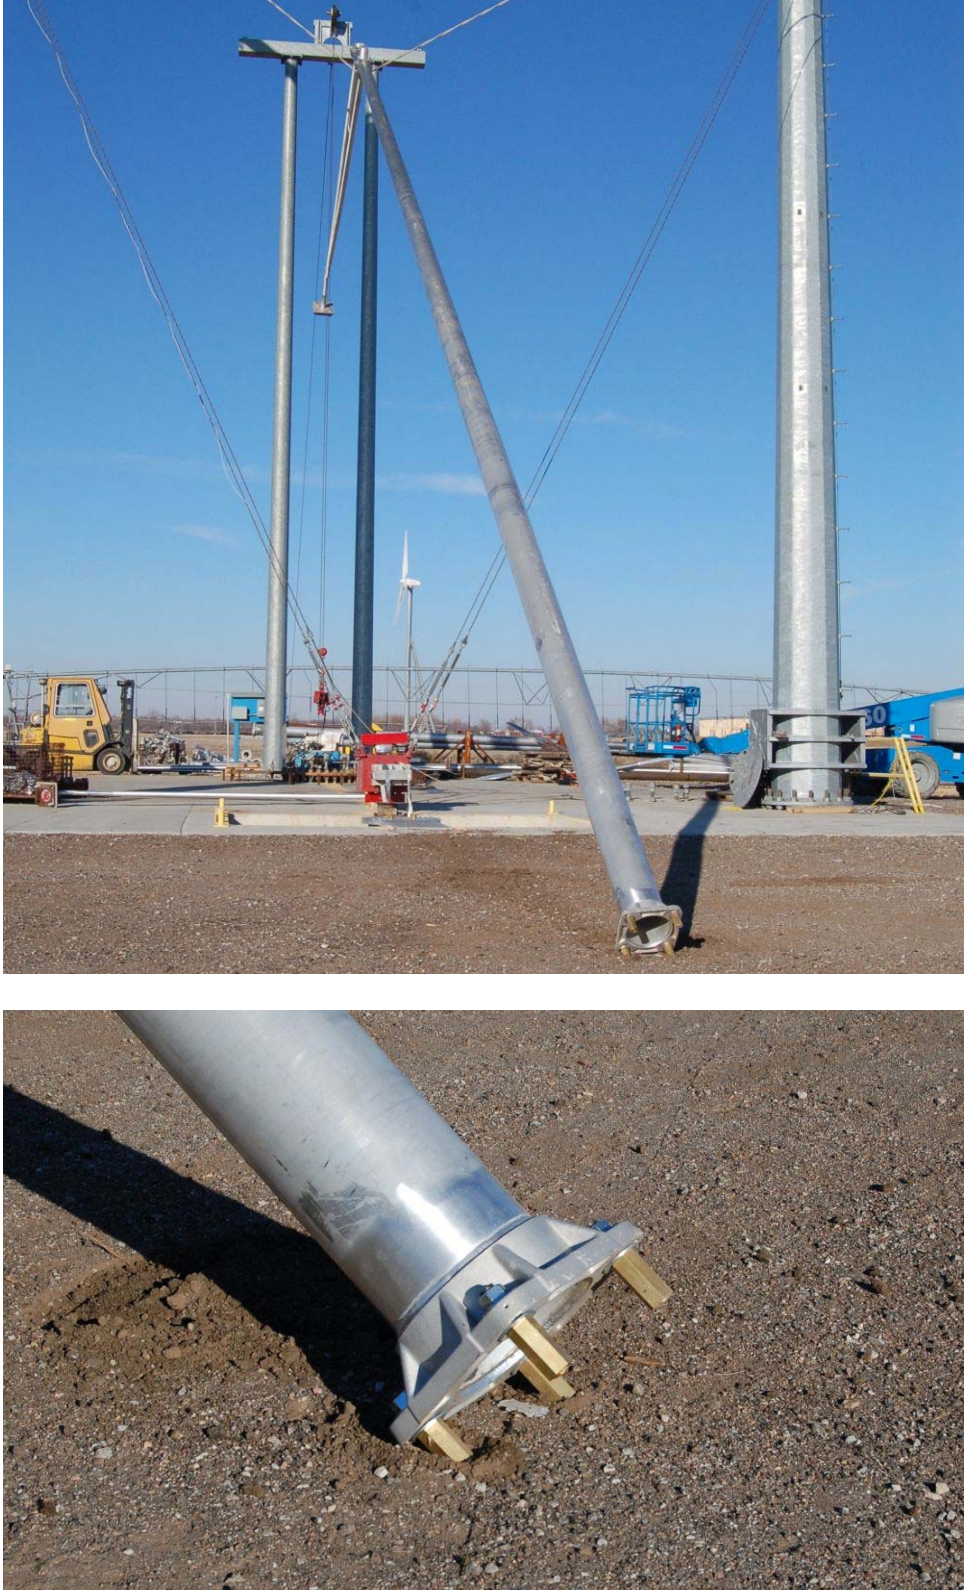
Figure 69. System Damage, Test No. BBC-7

Damage to the luminaire pole and brass couplings is shown in Figures 69 through 71. The pole came to rest with its base 31.5 ft (9.6 m) downstream from the initial impact location, while

the top of the pole was captured by the tether system. All four brass couplings fractured through the notch, resulting in stub heights of 1¾ in. (44 mm). The left luminaire arm fractured near the arm simplex due to the tether catching the pole as it fell. The left arm came to rest approximately 15 ft (4.6 m) upstream of impact.
