Development of Alternative Wood-Post MGS Approach Guardrail Transition

*Midwest States Regional Pooled Fund Research Program
Fiscal Year 2009 (Year 19)
Research Project Number TPF-5(193)
NDOR Sponsoring Agency Code RFP-09-03*

DEVELOPMENT OF ALTERNATIVE WOOD-POST MGS APPROACH GUARDRAIL TRANSITION

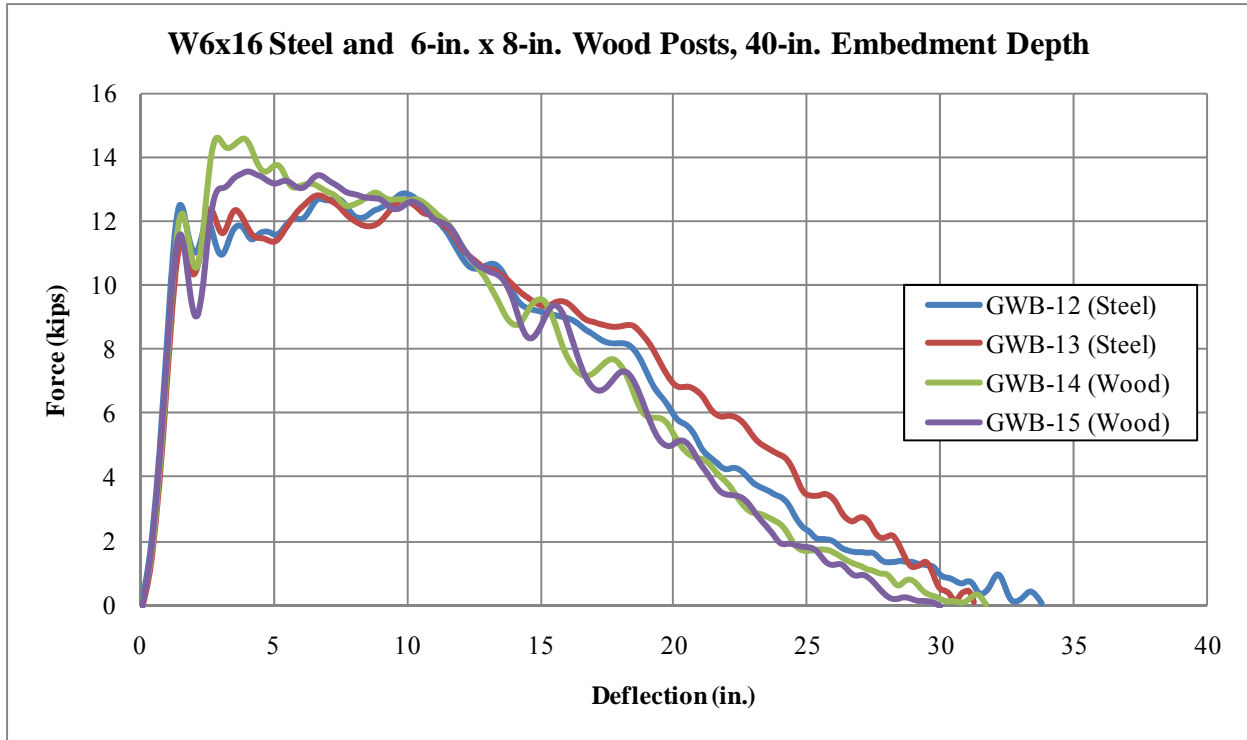
Figure 1. W6x16 (W152x23.8) Steel and 6-in. x 8-in. (152-mmx203-mm) Wood Posts in Highly Compacted Soil

With the adoption of MASH in 2009, test facilities are now required to follow soil strength guidelines for test article installation in soil in order to ensure consistency among the test facilities. MASH adheres to the general philosophy that testing longitudinal barriers in stiff soil results in higher impact and barrier loads, increased occupant risk values, and increased propensity for rail rupture, pocketing, and snag. Therefore, MASH has established a minimum post-soil resistance force standard to ensure that systems are installed in strong, stiff soil. To satisfy these requirements, MwRSF began to use a high energy, soil compaction method when installing system components (e.g., posts) for compliance testing. As expected, recent bogie testing has shown increased post-soil interaction forces. However, the stiffer soil has not changed the similarity between force vs. deflection curves for the standard MGS guardrail posts. In a recent dynamic testing study, two 6-in. x 8-in. (152-mm x 203-mm) wood posts and two W6x16 (W152x23.8) steel posts were embedded 40 in. (1,016 mm) in a highly compacted soil and impacted at 20 mph (32 km/h) [8]. The W6x16 (W152x23.8) posts have the same flange width and overall depth as a W6x9 (W152x13.4) so the soil resistances for the two posts are the same. Wood and steel posts provided very similar resistances throughout the impact event, as shown by the force vs. deflection curves in Figure 1.

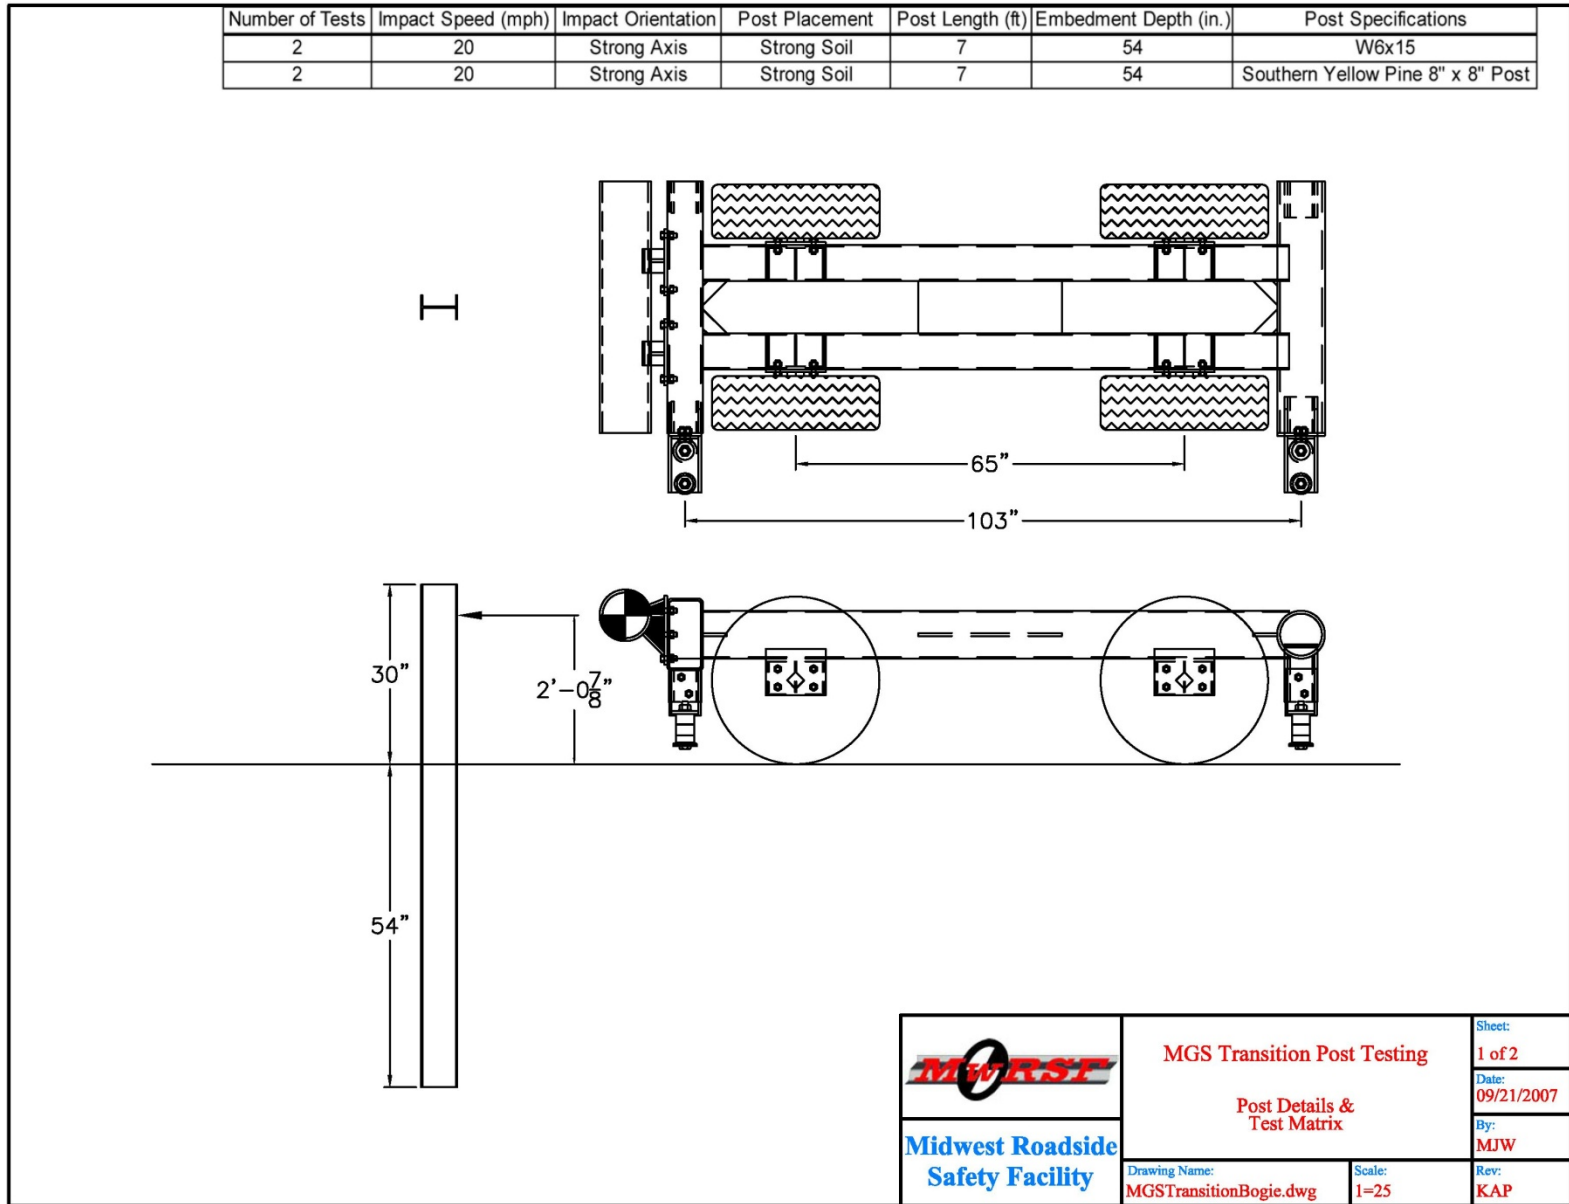
Figure 2. Bogie Testing Setup

Twenty dynamic component tests were conducted on W6x15 (W152x22.3) steel posts and various wood-post sizes in soil. The target impact conditions for all tests were 20 mph (32 km/h) at an angle of 0 degrees, creating a classical “head-on” or full-frontal impact and strong axis bending. The posts were impacted 24 $\frac{7}{8}$ in. (632 mm) above the ground line. The dynamic component test matrix and the test setup are shown in Table 3 and Figure 2, respectively.

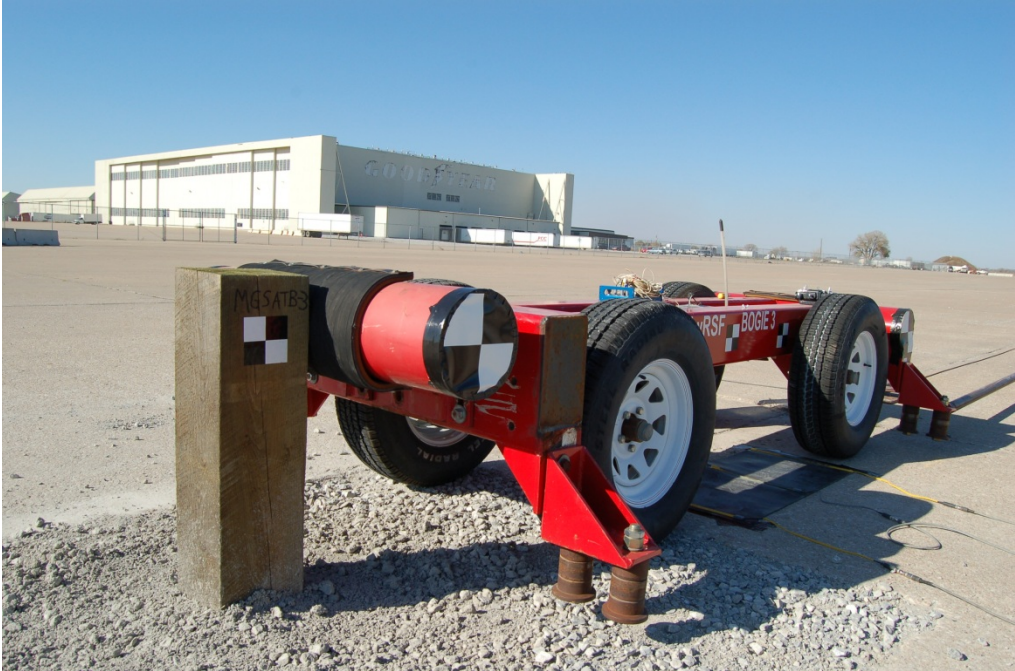
Figure 3. Rigid Frame Bogie on Pipe Guide Track System

A rigid frame bogie vehicle was used to impact the posts. A variable height, detachable impact head was used in the testing. The bogie head was constructed using 8-in. (203-mm) diameter, ½-in. (13-mm) thick standard steel pipe, with ¾-in. (19-mm) neoprene belting wrapped around the pipe. The neoprene material was used to prevent the impact head from causing local damage to the post and to prevent large spikes in acceleration. The impact head was bolted to the

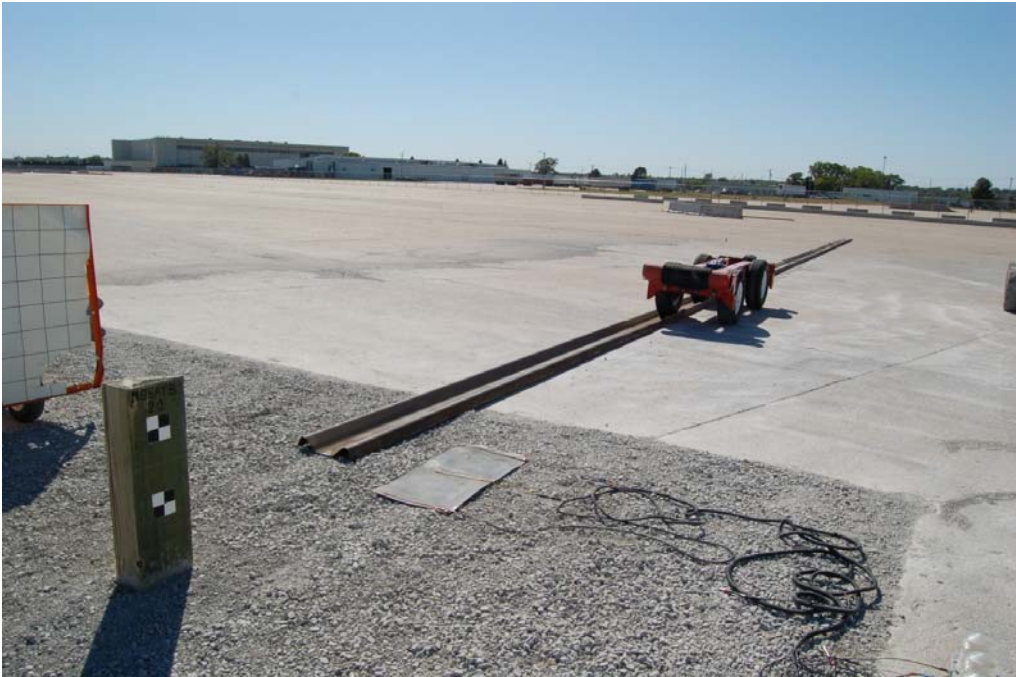
Figure 4. Rigid Frame Bogie on B-beam Guide Track System

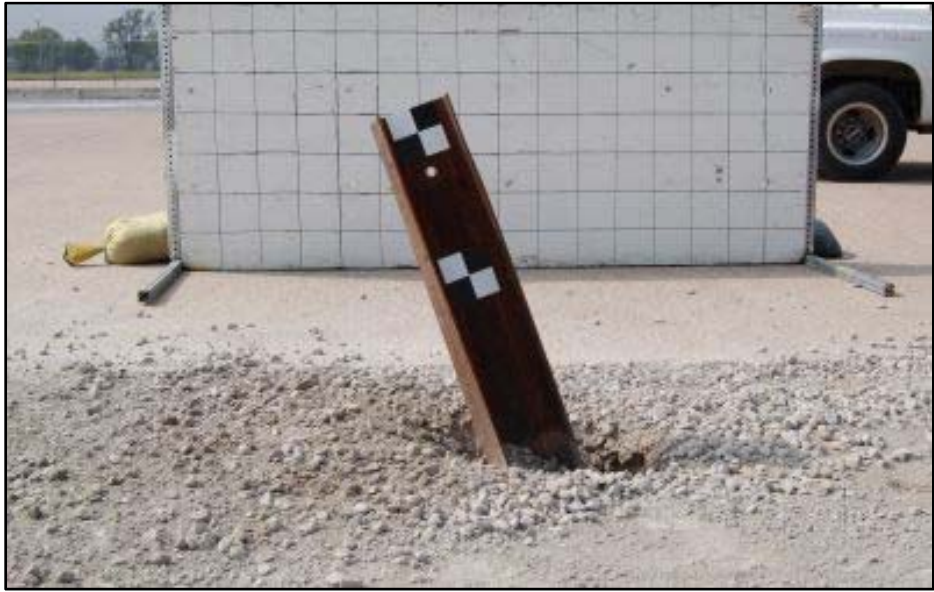
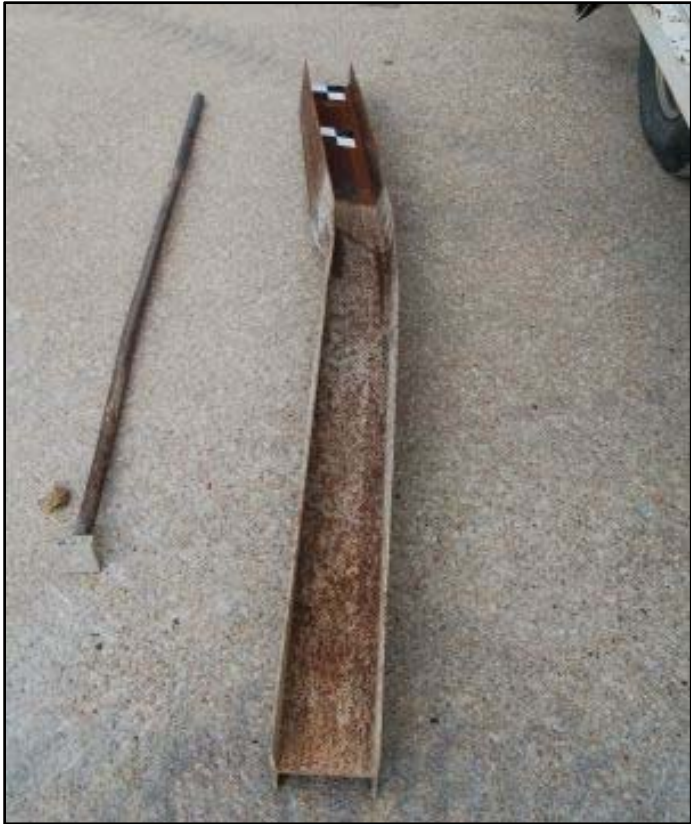
Figure 6. Time Sequential and Post-Impact Photographs, Test No. MGSATB-1

Force vs. deflection and energy vs. deflection curves created from the EDR-3 accelerometer data are shown in Figure 5. Initially, inertial effects resulted in a force spike of 13.6 kips (60.5 kN) over the first few inches of deflection. The post provided an average resistance force of 13.8 kips (61.4 kN) throughout the impact event, with a peak force of 20.1 kips (89.5 kN). At maximum deflection, the post absorbed 268.5 kip-in. (30.3 kJ) of energy. Time-sequential photographs and post-impact photographs are shown in Figure 6.

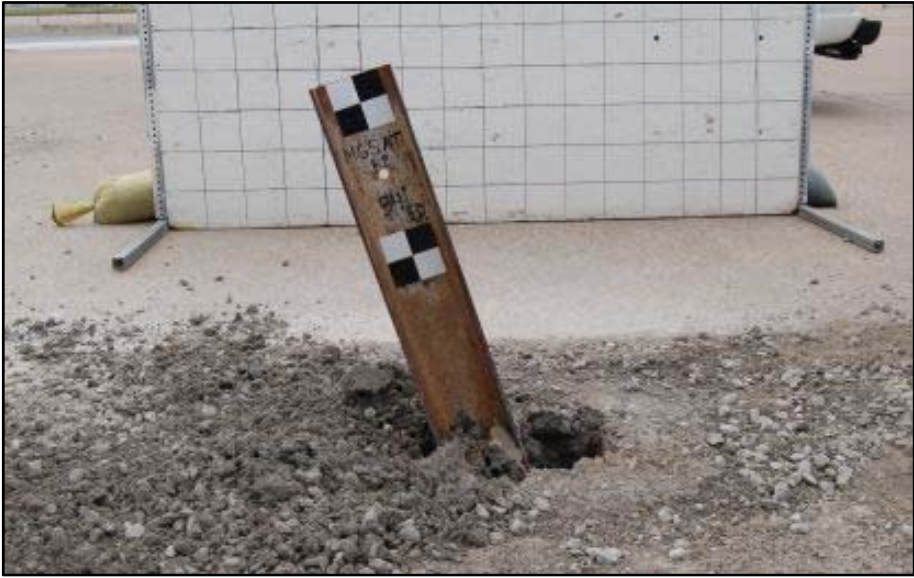
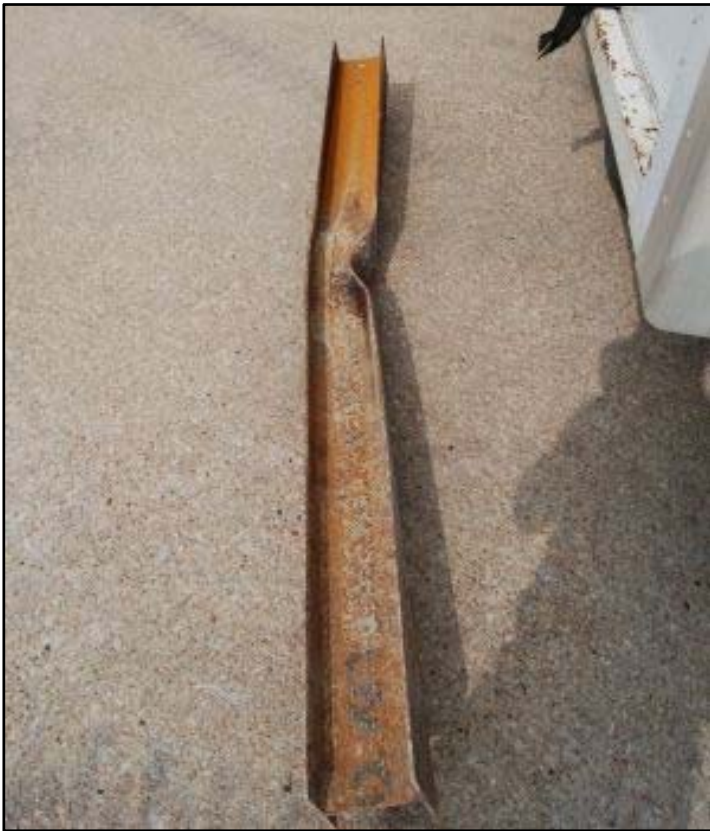
Figure 8. Time Sequential and Post-Impact Photographs, Test No. MGSATB-2

Force vs. deflection and energy vs. deflection curves created from the EDR-3 accelerometer data are shown in Figure 7. Initially, inertial effects resulted in a peak force of 14.2 kips (63.2 kN) over the first few inches of deflection. After a short drop in magnitude, the force increased and remained relatively constant near 19 kips (85 kN) between 10 in. and 18 in. (254 mm and 457 mm) of deflection. The peak force was 19.9 kips (88.5 kN). At the maximum deflection, the post absorbed 282.8 kip-in. (31.9 kJ) of energy. Time-sequential photographs and post-impact photographs are shown in Figure 8.

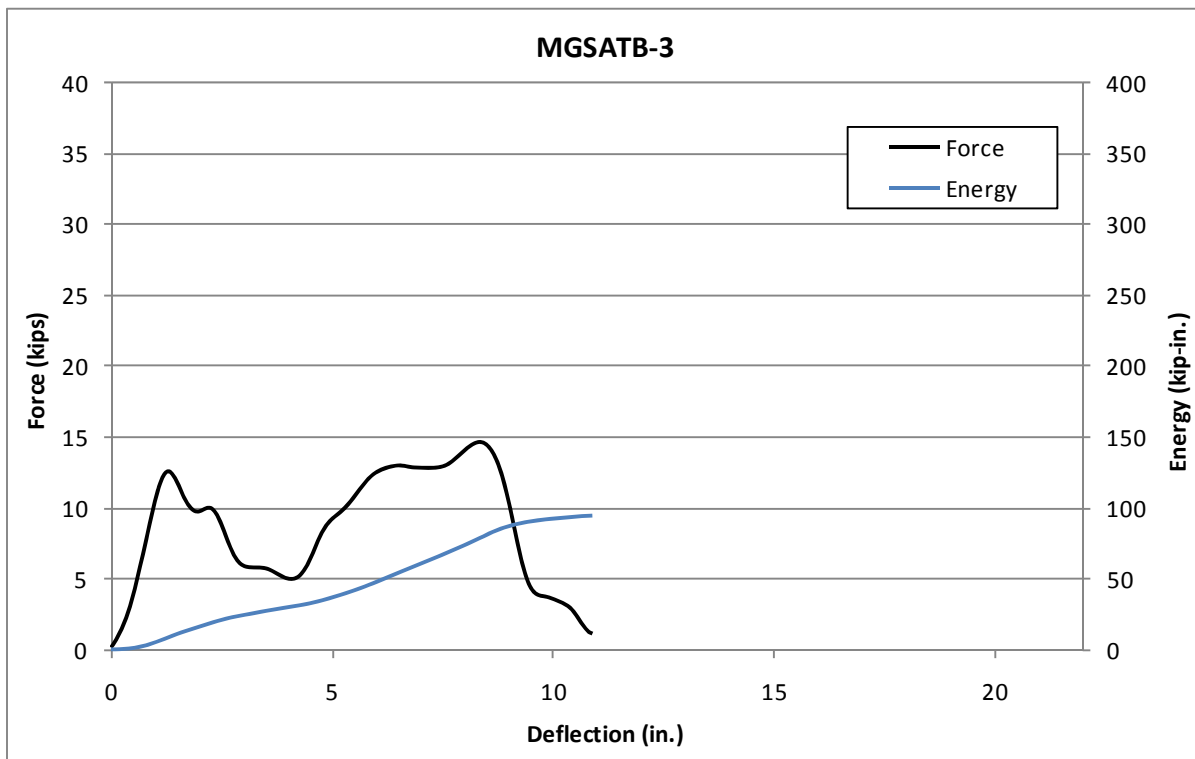
Figure 9. Force vs. Deflection and Energy vs. Deflection, Test No. MGSATB-3

During test no. MGSATB-3, the bogie impacted the post at a speed of 18.2 mph (29.3 km/h). The post fractured at a deflection of 10.9 in. (277 mm), and the bogie traveled over the broken post stub. The post fractured approximately 12 in. (305 mm) below the ground line.

Force vs. deflection and energy vs. deflection curves created from the EDR-3 accelerometer data are shown in Figure 9. Initially, inertial effects resulted in a force spike of 12.6 kips (56.0 kN) over the first few inches of deflection. The post began to fracture at a deflection of 8.3 in. (212 mm) and at a peak force of 14.7 kips (65.2 kN). At fracture, the post absorbed 94.6 kip-in. (10.7 kJ) of energy. Time-sequential photographs and post-impact photographs are shown in Figure 10.

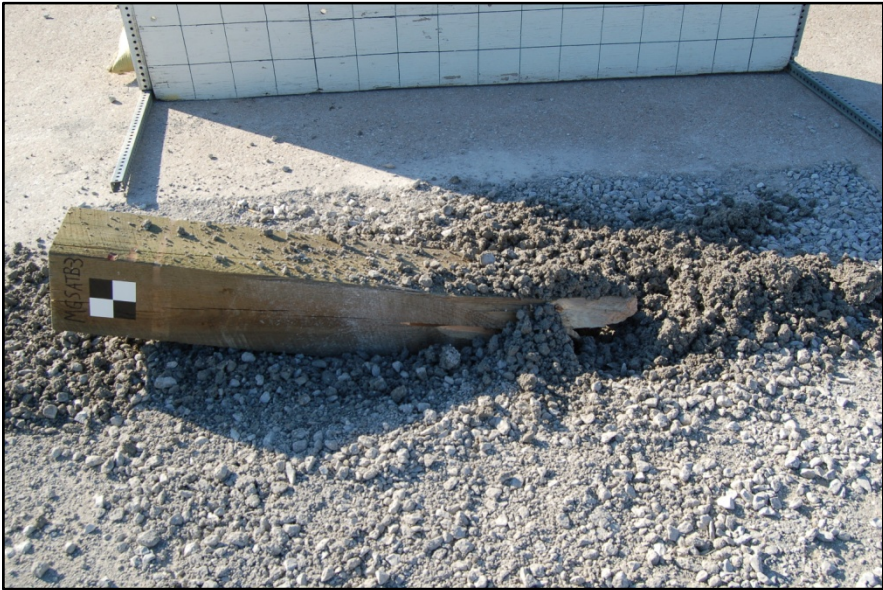
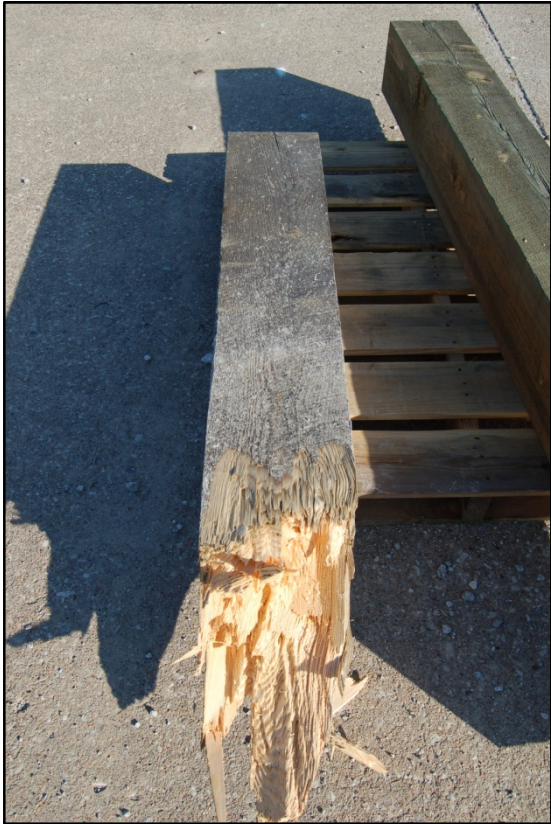
Figure 10. Time Sequential and Post-Impact Photographs, Test No. MGSATB-3

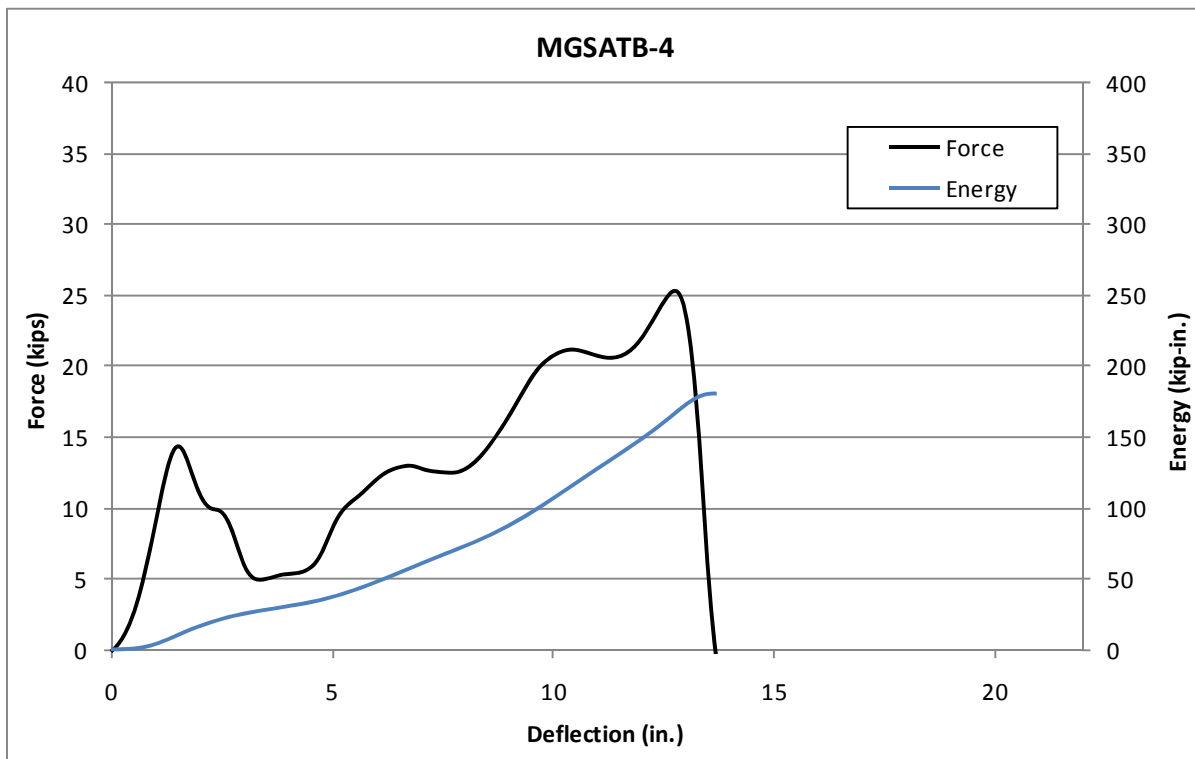
Figure 11. Force vs. Deflection and Energy vs. Deflection, Test No. MGSATB-4

During test no. MGSATB-4, the bogie impacted the post at a speed of 18.7 mph (30.1 km/h). The post fractured at a deflection of 13.7 in. (348 mm), and the bogie traveled over the broken post stub. The post fractured approximately 12 in. (305 mm) below the ground line.

Force vs. deflection and energy vs. deflection curves created from EDR-3 accelerometer data are shown in Figure 11. Initially, inertial effects resulted in a force spike of 14.4 kips (64.1 kN) over the first few inches of deflection. The post began to fracture at a deflection of 12.7 in. (323 mm) and a peak force of around 25.4 kips (113 kN). At fracture, the post absorbed 183.7 kip-in. (20.8 kJ) of energy. Time-sequential photographs and post-impact photographs are shown in Figure 12.

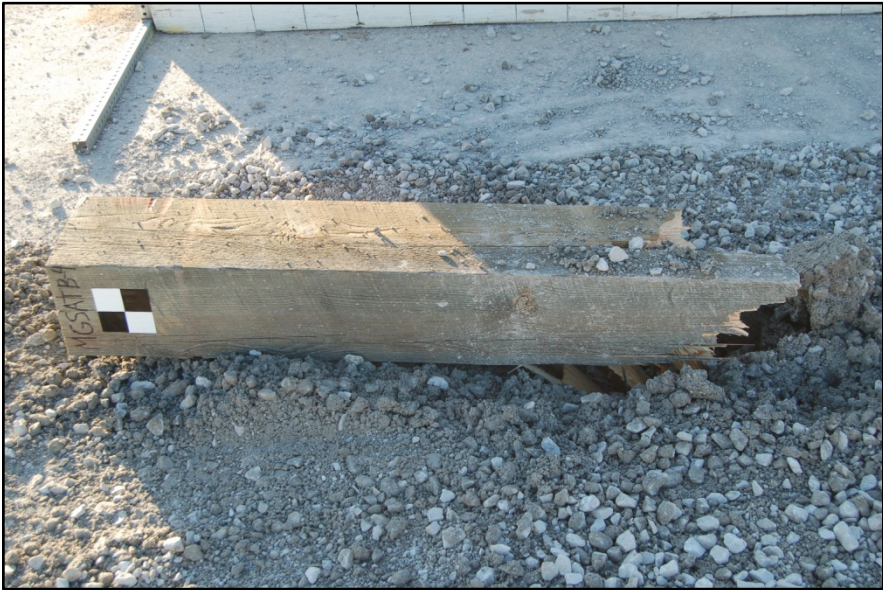
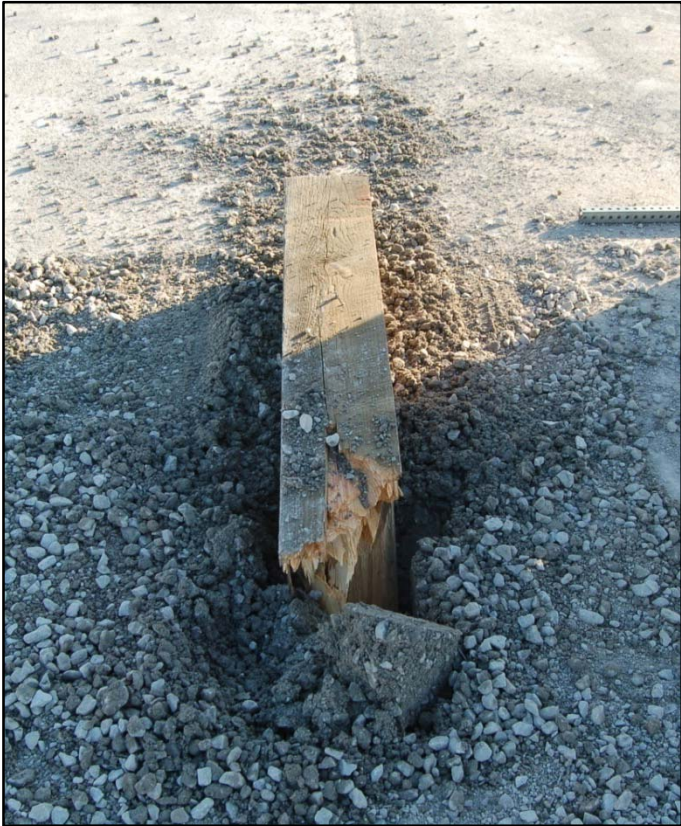
Figure 12. Time Sequential and Post-Impact Photographs, Test No. MGSATB-4

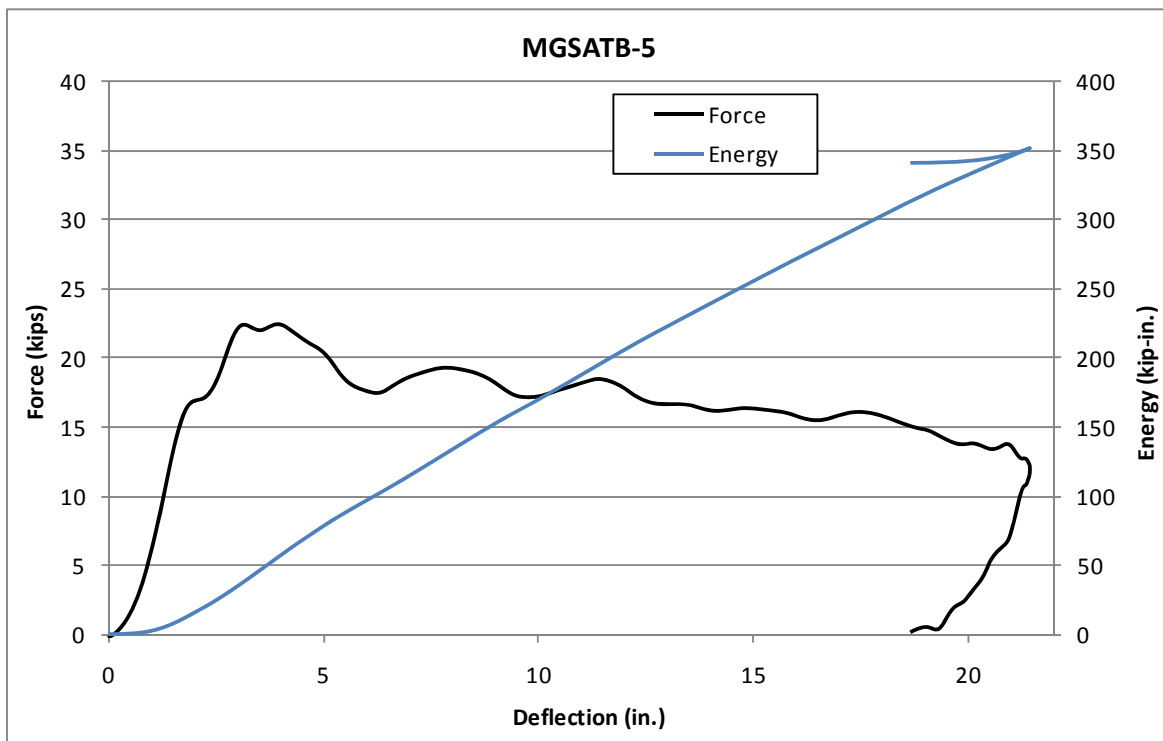
Figure 13. Force vs. Deflection and Energy vs. Deflection, Test No. MGSATB-5

Force vs. deflection and energy vs. deflection curves created from the EDR-3 accelerometer data are shown in Figure 13. A peak force of 22.4 kips (99.5 kN) was observed over the first few inches of deflection. The post provided a relatively constant resistance force of about 17 kips (76 kN) throughout the rest of the impact event. At the maximum deflection, the post absorbed 351.0 kip-in. (39.7 kJ) of energy. Time-sequential photographs and post-impact photographs are shown in Figure 14.

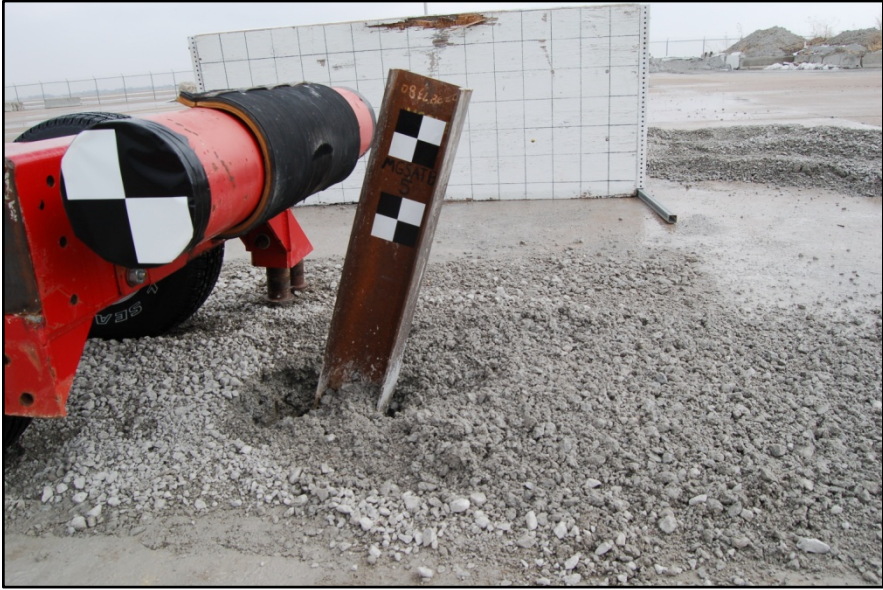
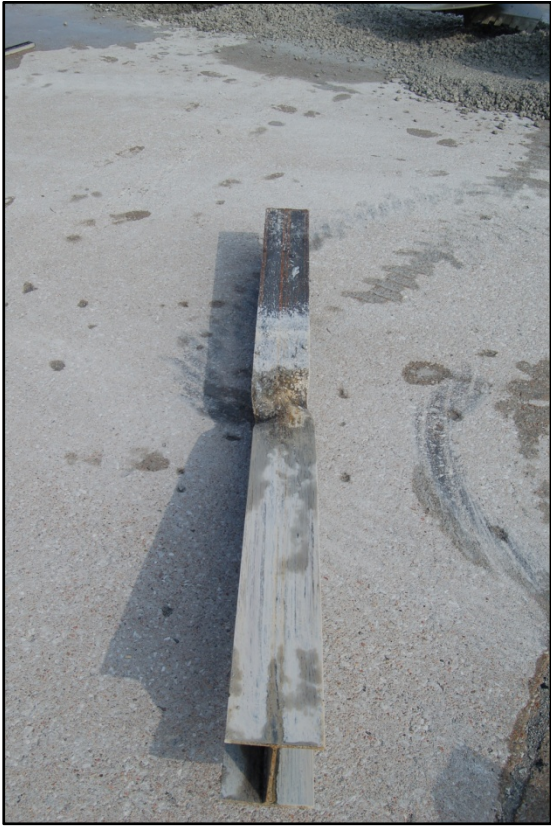
Figure 14. Time Sequential and Post-Impact Photographs, Test No. MGSATB-5

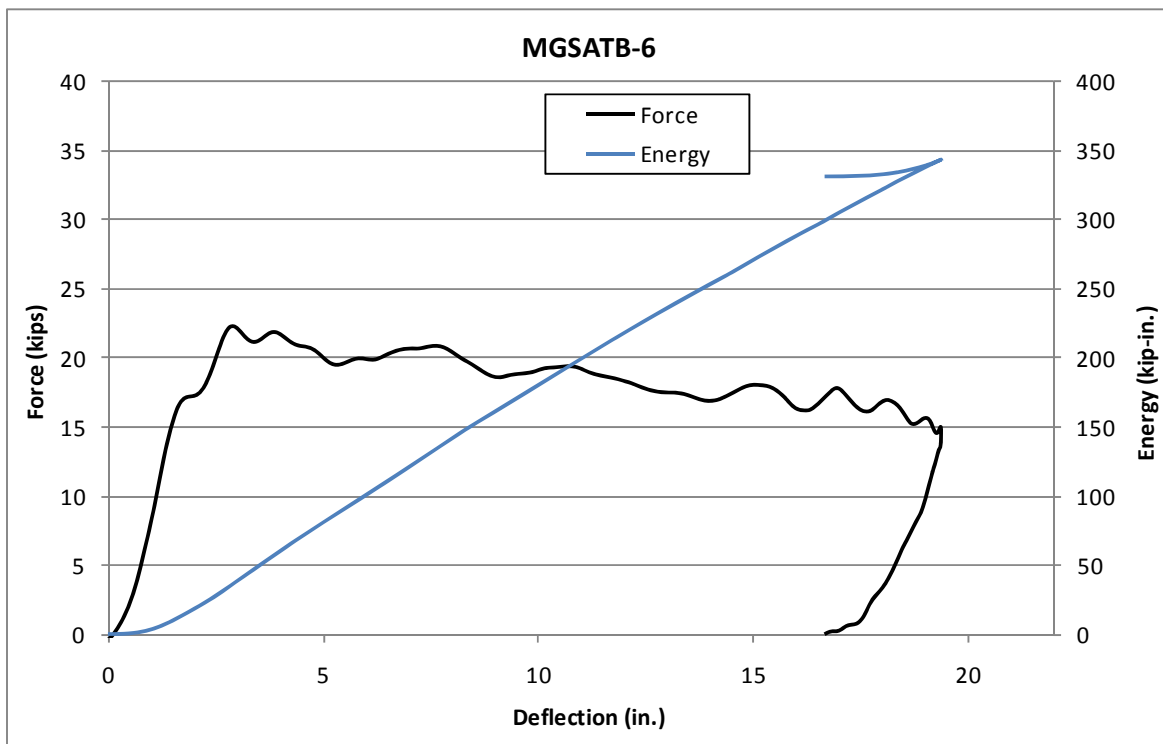
Figure 15. Force vs. Deflection and Energy vs. Deflection, Test No. MGSATB-6

Force vs. deflection and energy vs. deflection curves created from EDR-3 accelerometer data are shown in Figure 15. A peak force of 22.3 kips (99.3 kN) was observed over the first few inches of deflection. The post provided a relatively constant resistance force of around 18 kips (80 kN) throughout the rest of the impact event. At the maximum deflection, the post absorbed 343.9 kip-in. (38.9 kJ) of energy. Time-sequential photographs and post-impact photographs are shown in Figure 16.

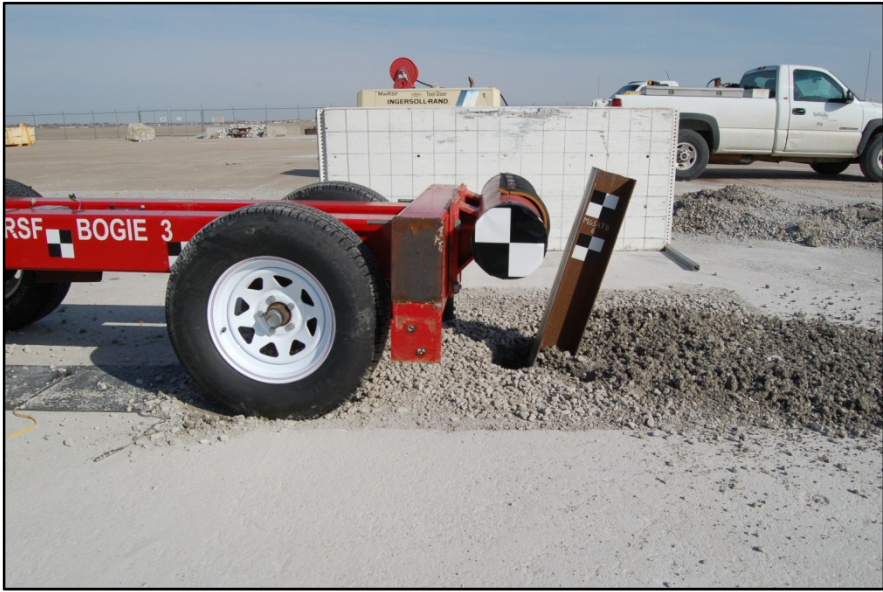
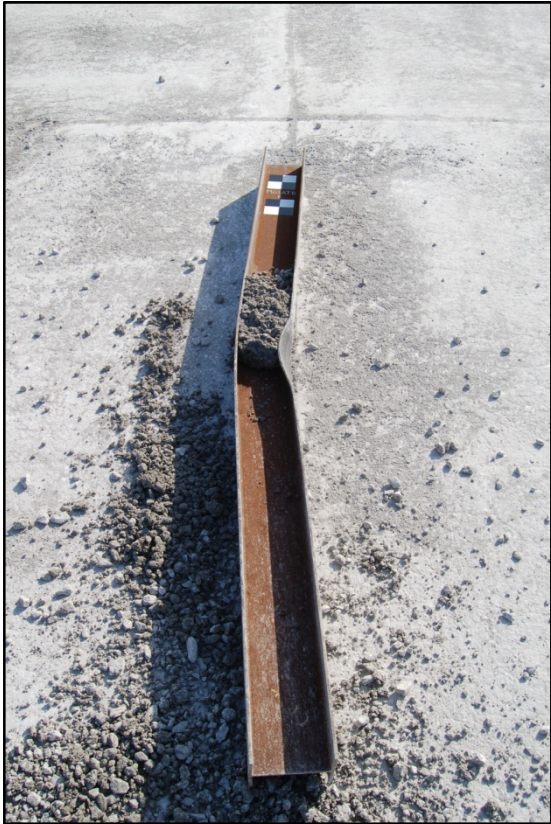
Figure 16. Time Sequential and Post-Impact Photographs, Test No. MGSATB-6

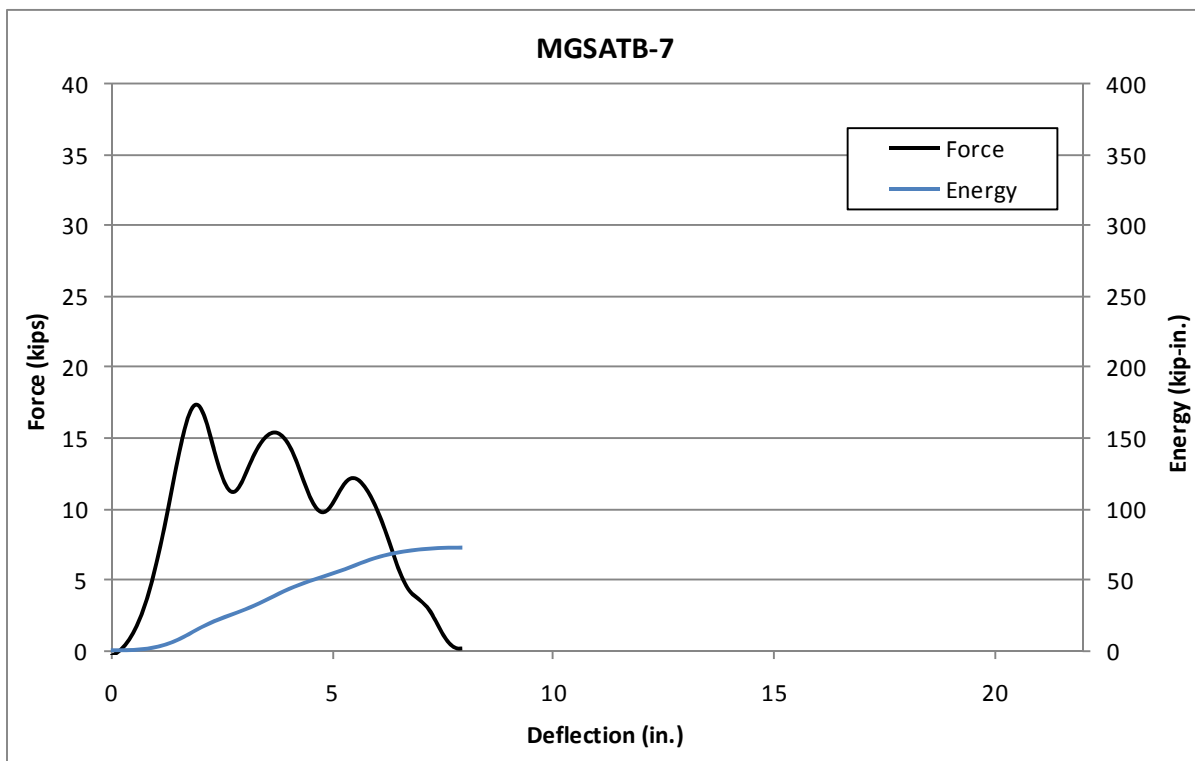
Figure 17. Force vs. Deflection and Energy vs. Deflection, Test No. MGSATB-7

During test no. MGSATB-7, the bogie impacted the post at a speed of 21.4 mph (34.4 km/h). As a result, the post fractured at a deflection of 7.9 in. (201 mm), and the bogie traveled over the post stub. The post fractured approximately 4 in. (102 mm) below the ground line. The upper portion of the post split into two pieces when a vertical crack originated at the fracture location and traveled up to the top of the post. This vertical cracking took place 14 msec after impact and at a deflection around 5 in. (127 mm).

Force vs. deflection and energy vs. deflection curves created from EDR-3 accelerometer data are shown in Figure 17. The three force spikes show a systematic fracture of the post throughout the impact event. The post began to fracture at a deflection of 2.0 in. (51 mm), and at a peak force of 17.3 kips (76.9 kN). At fracture, the post absorbed 73.0 kip-in. (8.3 kJ) of energy. Time-sequential photographs and post-impact photographs are shown in Figure 18.

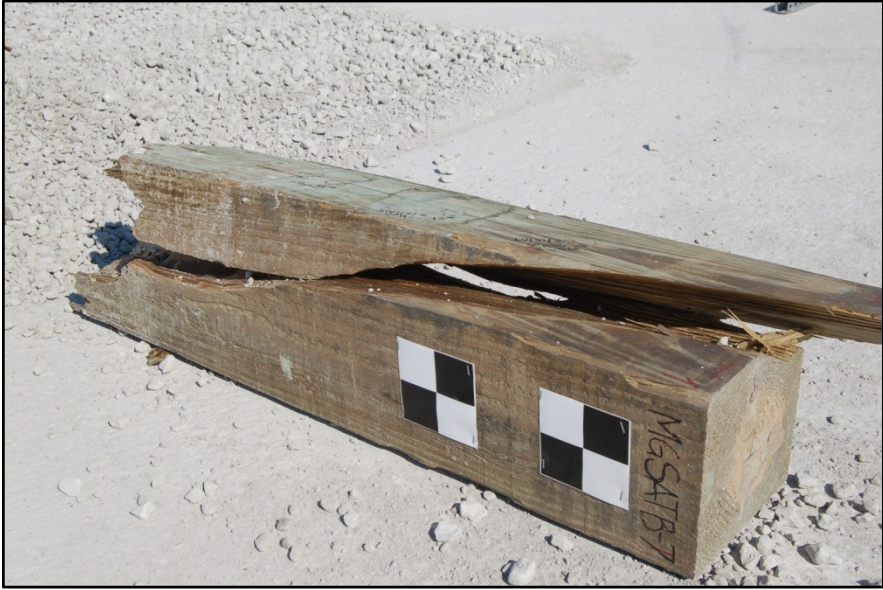
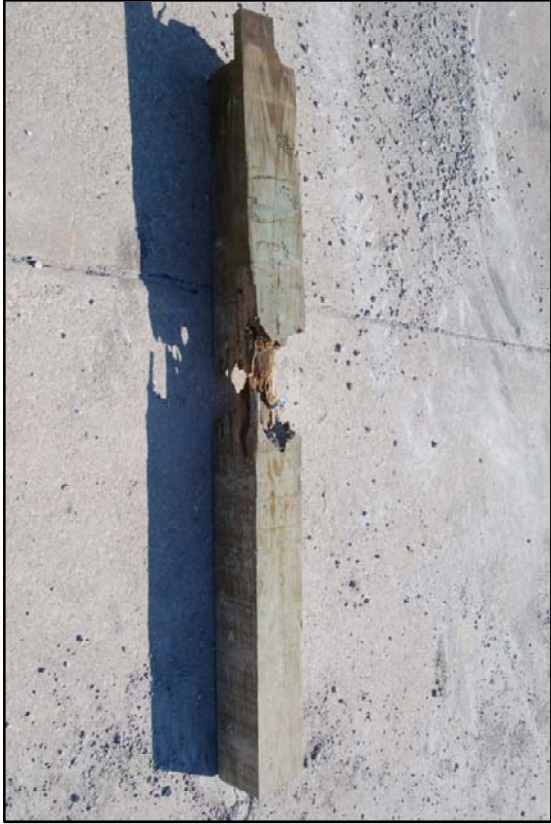
Figure 18. Time Sequential and Post-Impact Photographs, Test No. MGSATB-7

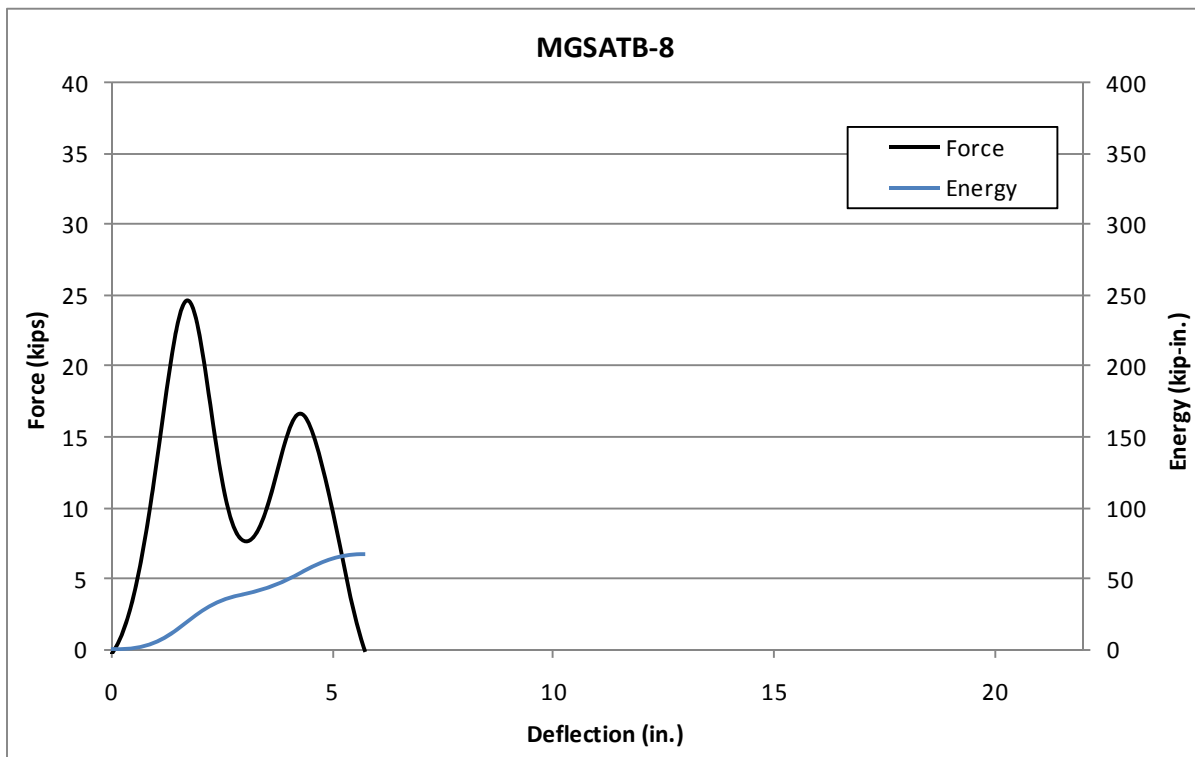
Figure 19. Force vs. Deflection and Energy vs. Deflection, Test No. MGSATB-8

During test no. MGSATB-8, the bogie impacted the post at a speed of 21.9 mph (35.2 km/h). As a result, the post experienced a progressive fracture which concluded at a deflection of 5.7 in. (145 mm) with the bogie traveling over the post stub. The post fractured approximately 8 in. (203 mm) below the ground line.

Force vs. deflection and energy vs. deflection curves created from EDR-4 accelerometer data are shown in Figure 19. The two force spikes show a systematic fracture of the post throughout the impact event. A peak force of 24.6 kips (109.3 kN) was observed over the first few inches of deflection. At fracture, the post absorbed 66.8 kip-in. (7.5 kJ) of energy at. Time-sequential photographs and post-impact photographs are shown in Figure 20.

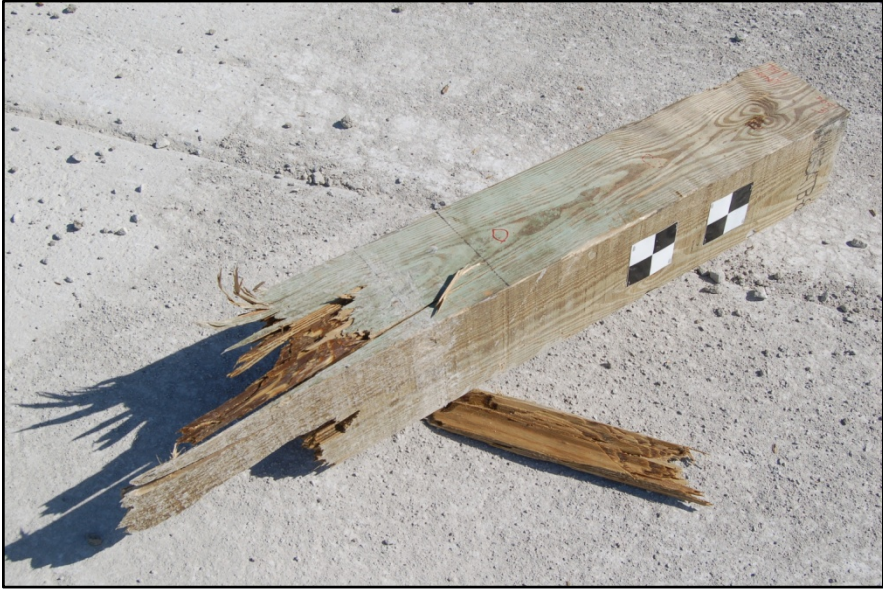
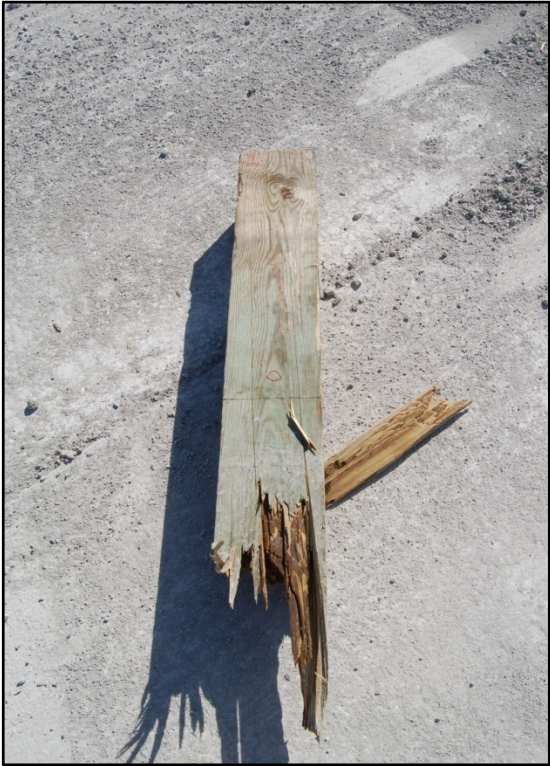
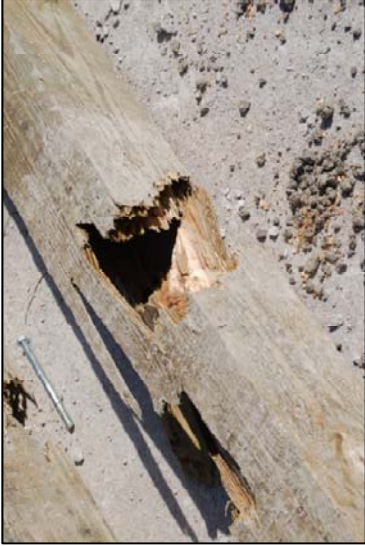
Figure 20. Time Sequential and Post-Impact Photographs, Test No. MGSATB-8

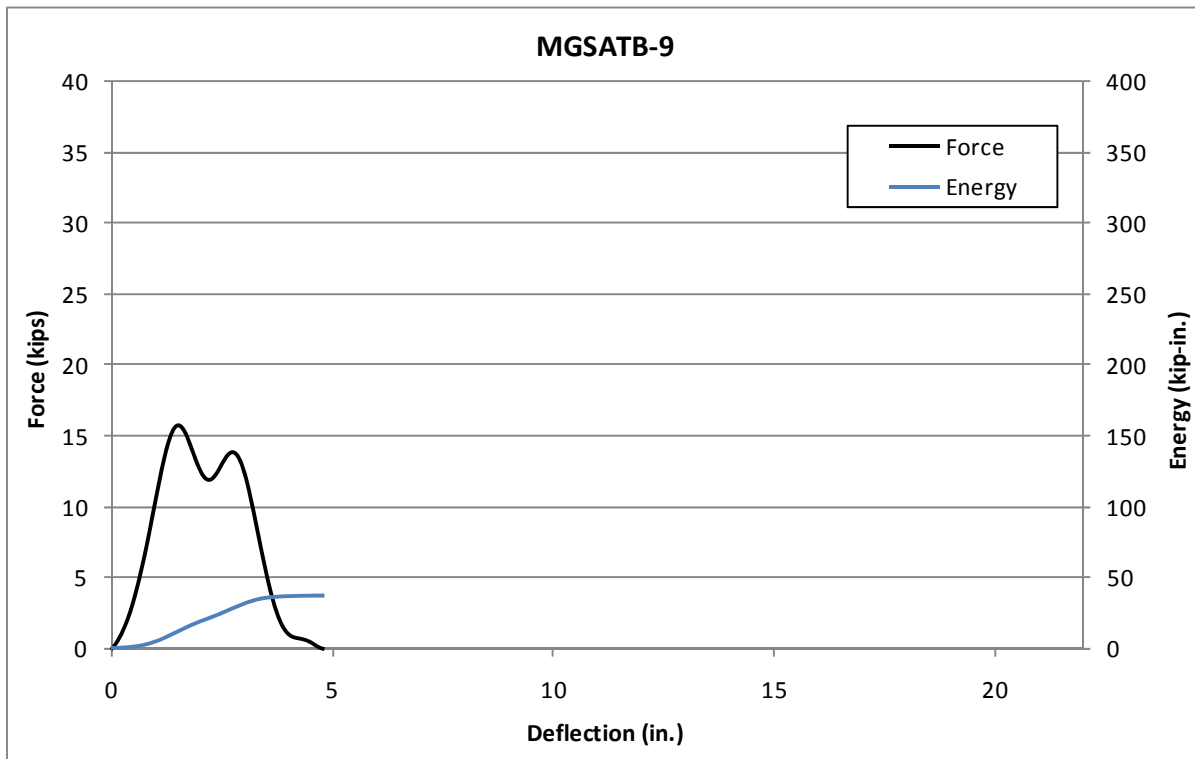
Figure 21. Force vs. Deflection and Energy vs. Deflection, Test No. MGSATB-9

During test no. MGSATB-9, the bogie impacted the post at a speed of 19.9 mph (32.0 km/h). As a result, the post fractured at a deflection of 4.8 in. (122 mm), and the bogie traveled over the post stub. The post fractured approximately 15 in. (381 mm) below the ground line.

Force vs. deflection and energy vs. deflection curves created from the EDR-3 accelerometer data are shown in Figure 21. A peak force of 15.7 kips (69.8 kN) was observed over the first few inches of deflection. At fracture, the post absorbed 37.3 kip-in. (4.2 kJ) of energy. Time-sequential photographs and post-impact photographs are shown in Figure 22.

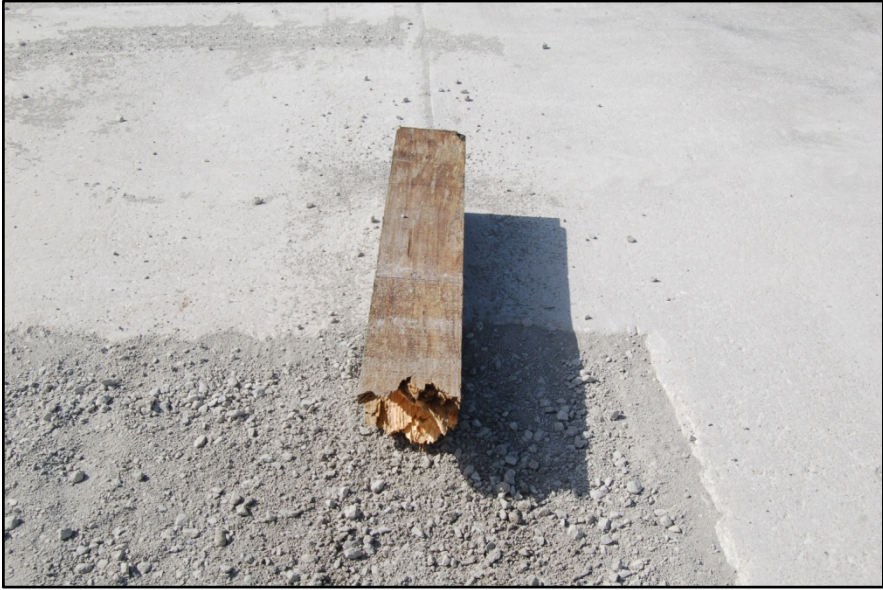
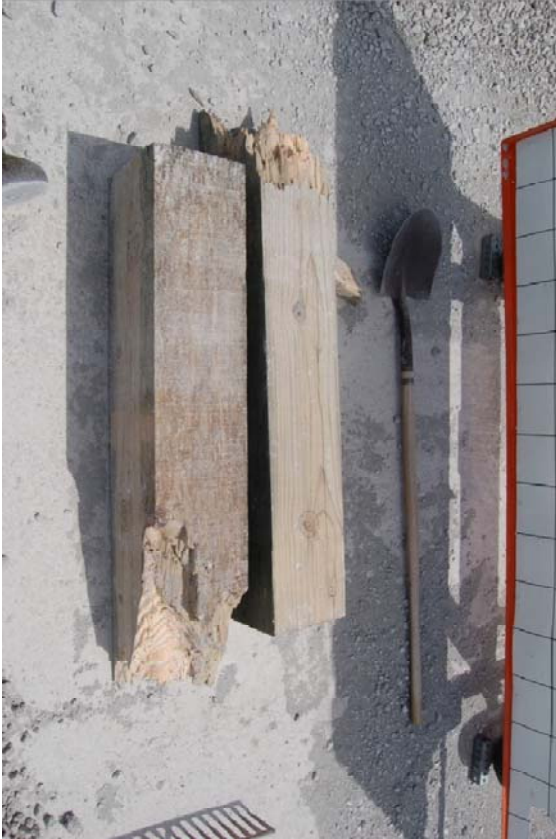
Figure 22. Time Sequential and Post-Impact Photographs, Test No. MGSATB-9
