Development of Alternative Wood-Post MGS Approach Guardrail Transition

*Midwest States Regional Pooled Fund Research Program
Fiscal Year 2009 (Year 19)
Research Project Number TPF-5(193)
NDOR Sponsoring Agency Code RFP-09-03*

DEVELOPMENT OF ALTERNATIVE WOOD-POST MGS APPROACH GUARDRAIL TRANSITION

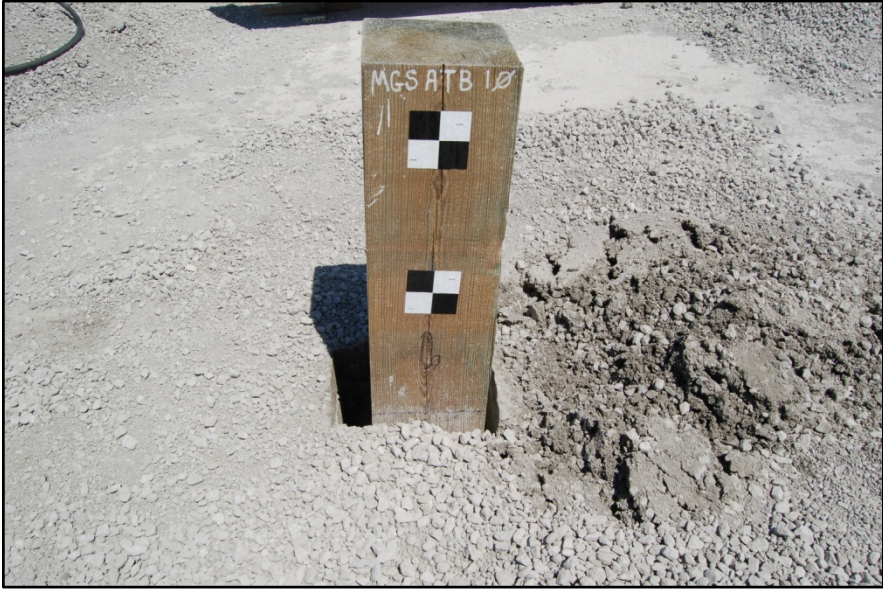
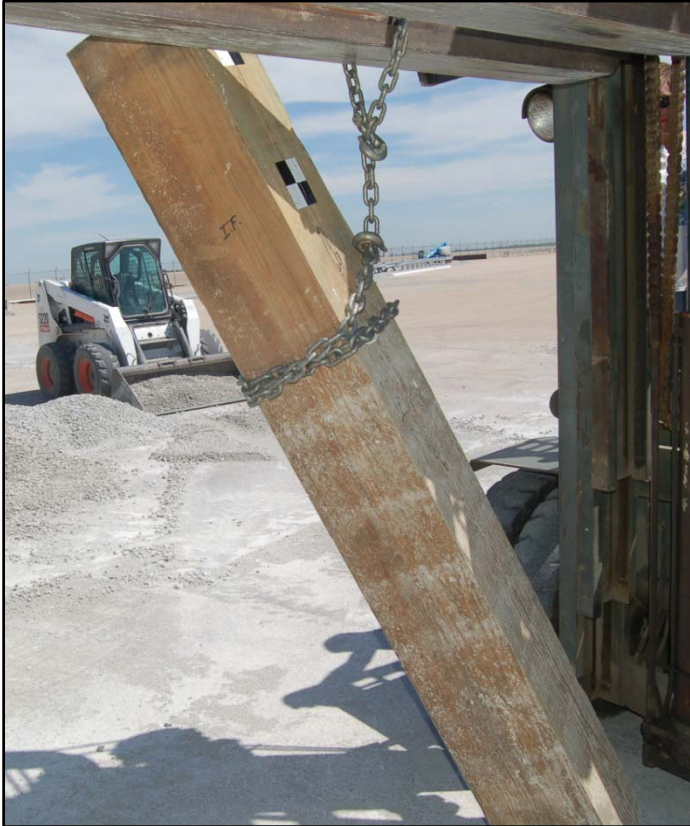
Figure 24. Time Sequential and Post-Impact Photographs, Test No. MGSATB-10

Force vs. deflection and energy vs. deflection curves created from the EDR-3 accelerometer data are shown in Figure 23. The forces quickly rose to a peak force of 36.7 kips (163.3 kN) over the first few inches of deflection. The post provided an average resistance force of 28 kips (120 kN) through 10 in. (254 mm) of deflection. The post absorbed 307.4 kip-in. (34.7 kJ) of energy. Time-sequential photographs and post-impact photographs are shown in Figure 24.

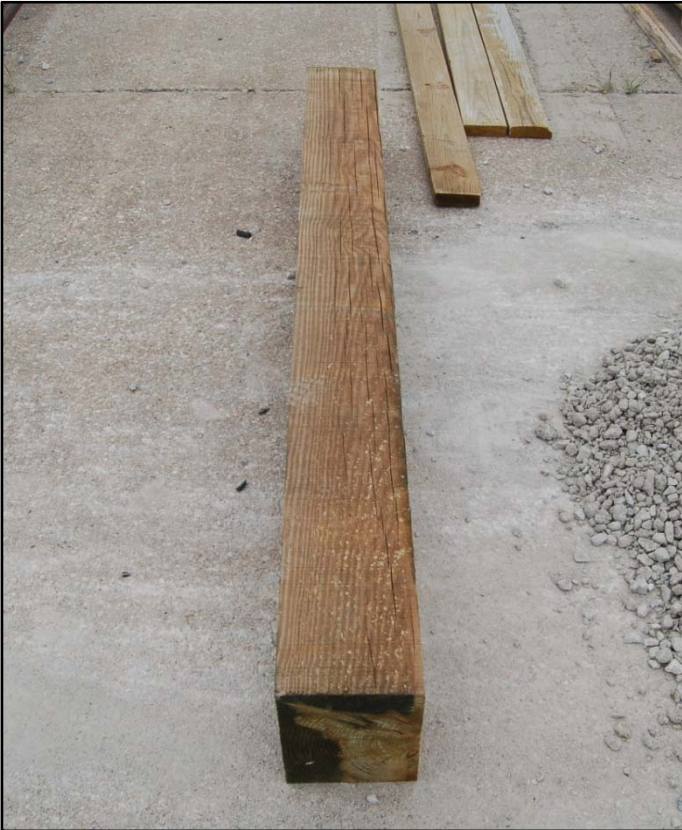
Figure 26. Time Sequential and Post-Impact Photographs, Test No. MGSATB-11

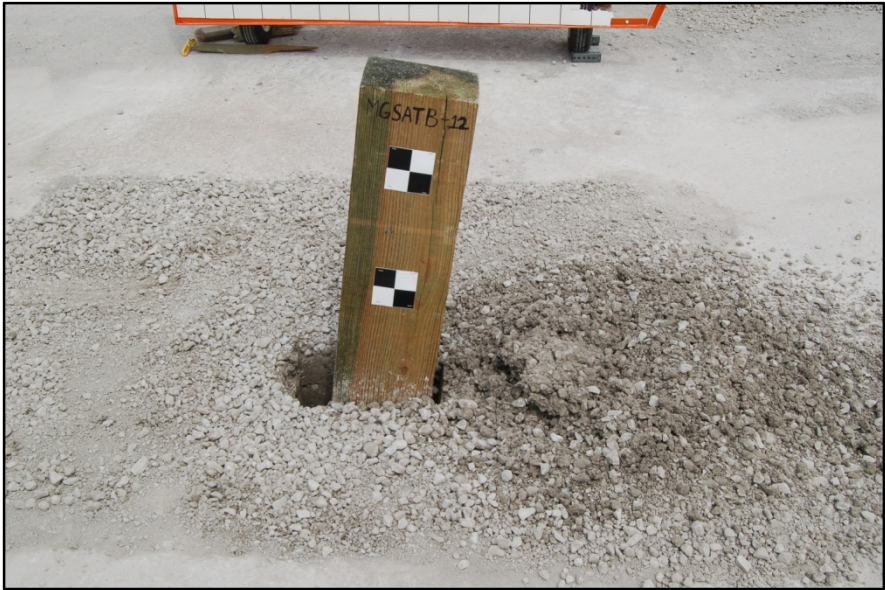
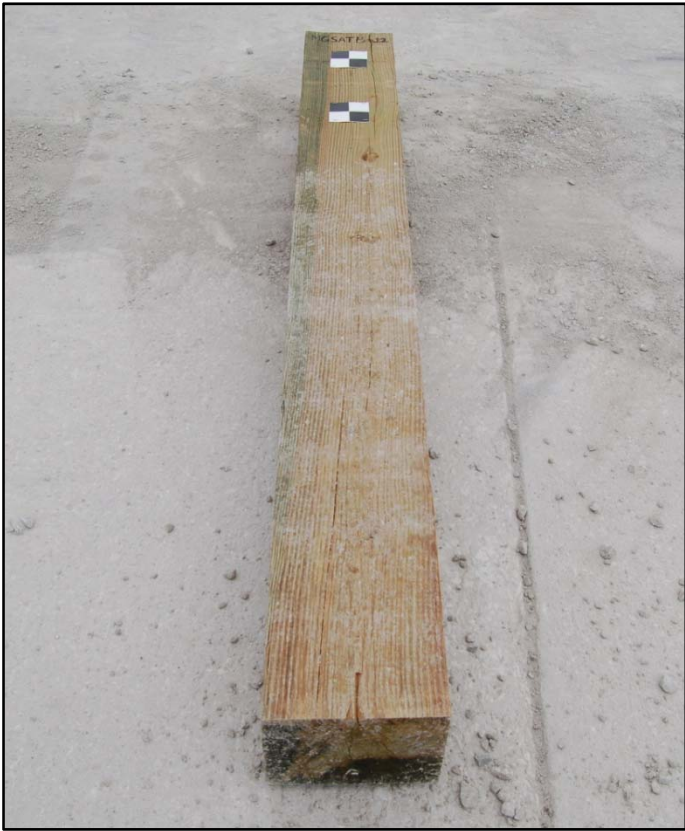
Figure 28. Time Sequential and Post-Impact Photographs, Test No. MGSATB-12

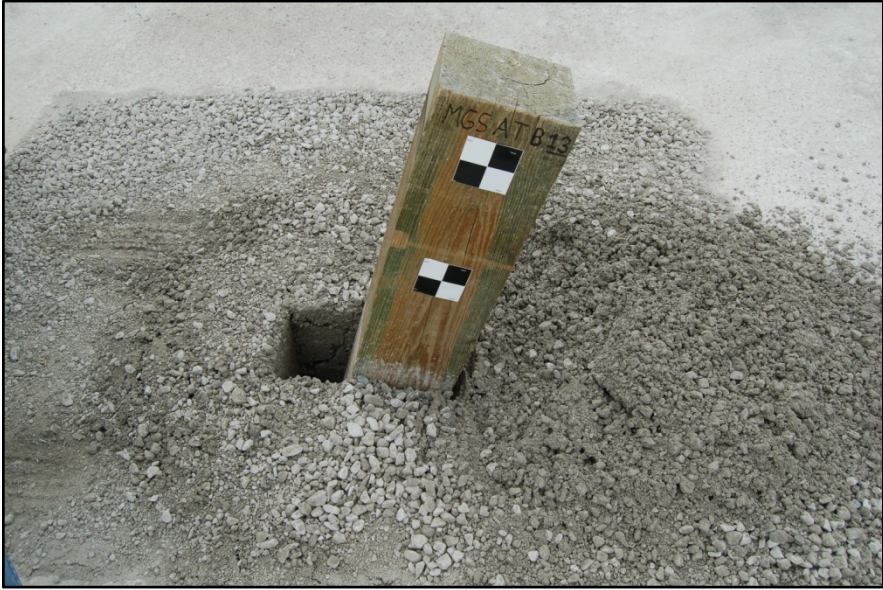
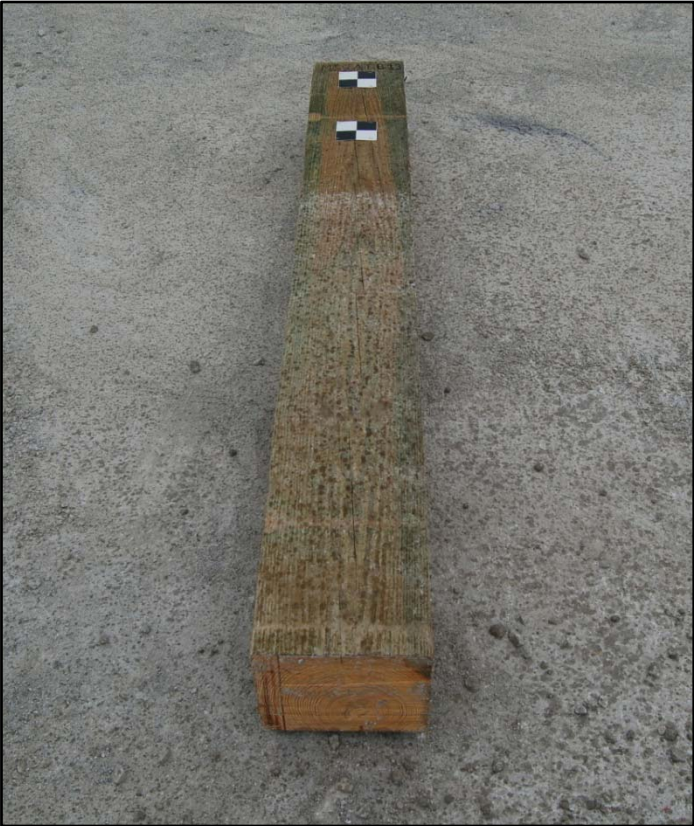
Figure 30. Time Sequential and Post-Impact Photographs, Test No. MGSATB-13

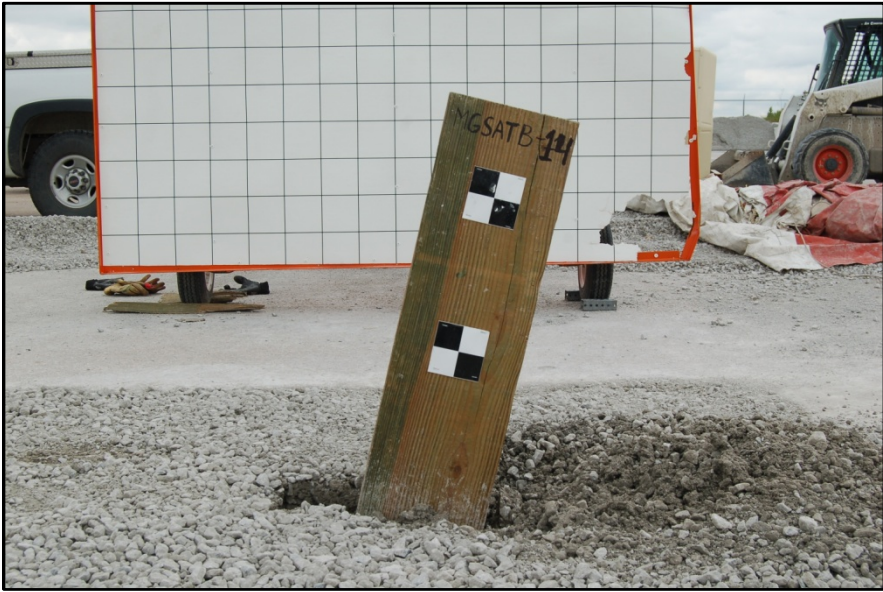
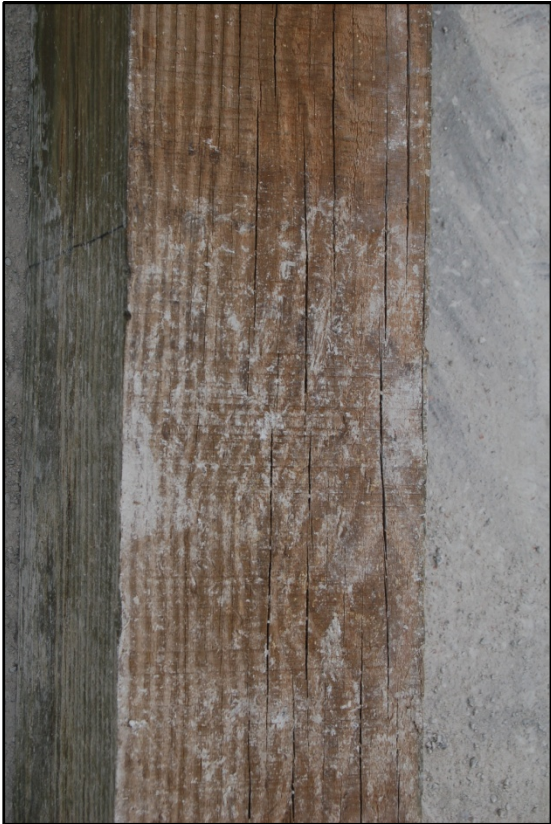
Figure 32. Time Sequential and Post-Impact Photographs, Test No. MGSATB-14

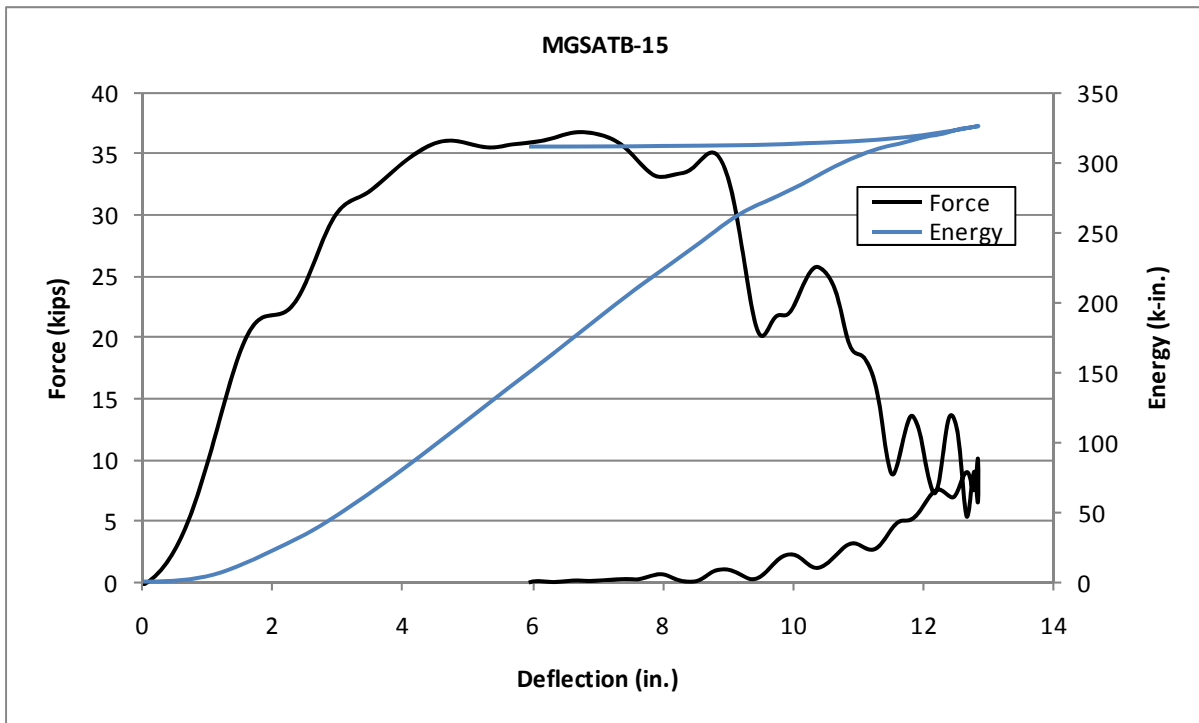
Figure 33. Force vs. Deflection and Energy vs. Deflection, Test No. MGSATB-15

During test no. MGSATB-15, the bogie impacted the post at a speed of 21.0 mph (33.8 km/h). As a result, the post rotated through the soil to a maximum deflection of 16.8 in. (427 mm), at which point, the bogie vehicle was brought to a stop and then rebounded backward. The post showed early signs of fracture as cracks were found on the tension side face of the post at 8 in. (203 mm) below the ground line. The post was also bent downstream at this same location.

Force vs. deflection and energy vs. deflection curves created from the EDR-3 accelerometer data are shown in Figure 33. Initially, the force rapidly increased to 35 kips (156 kN) and remained at this magnitude until 9 in. (229 mm) of deflection. The load decrease beyond this deflection was attributed to the cracks that formed on the tension side face of the post. The post absorbed 325.6 kip-in. (36.8 kJ) of energy. Time-sequential photographs and post-impact photographs are shown in Figure 34.

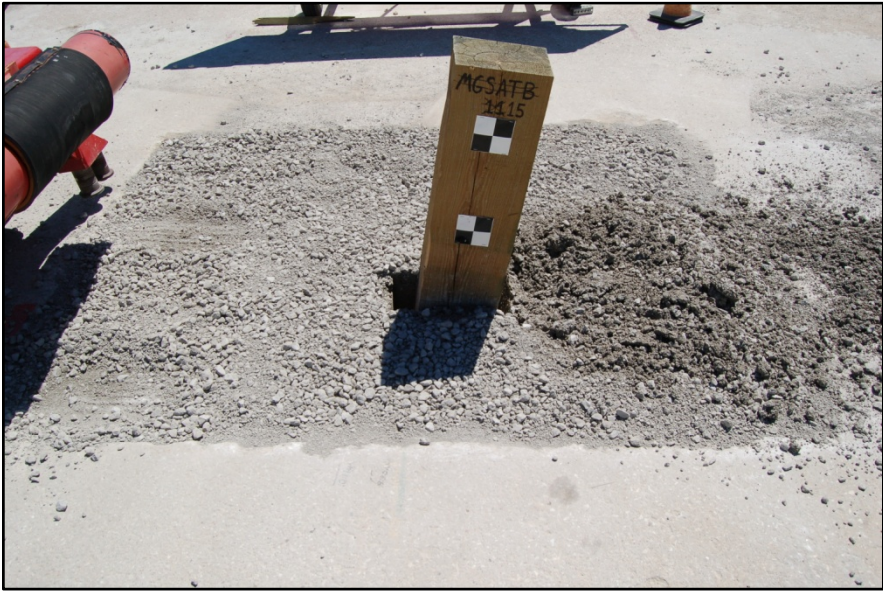
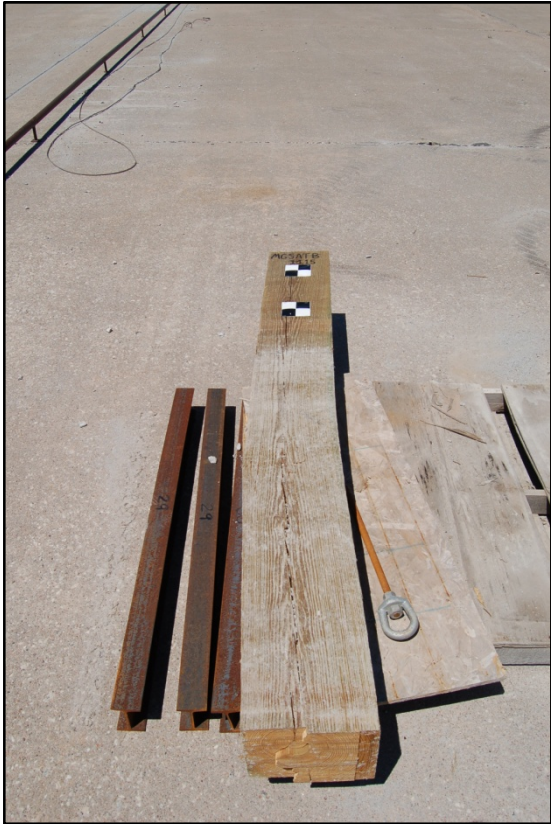
Figure 34. Time Sequential and Post-Impact Photographs, Test No. MGSATB-15

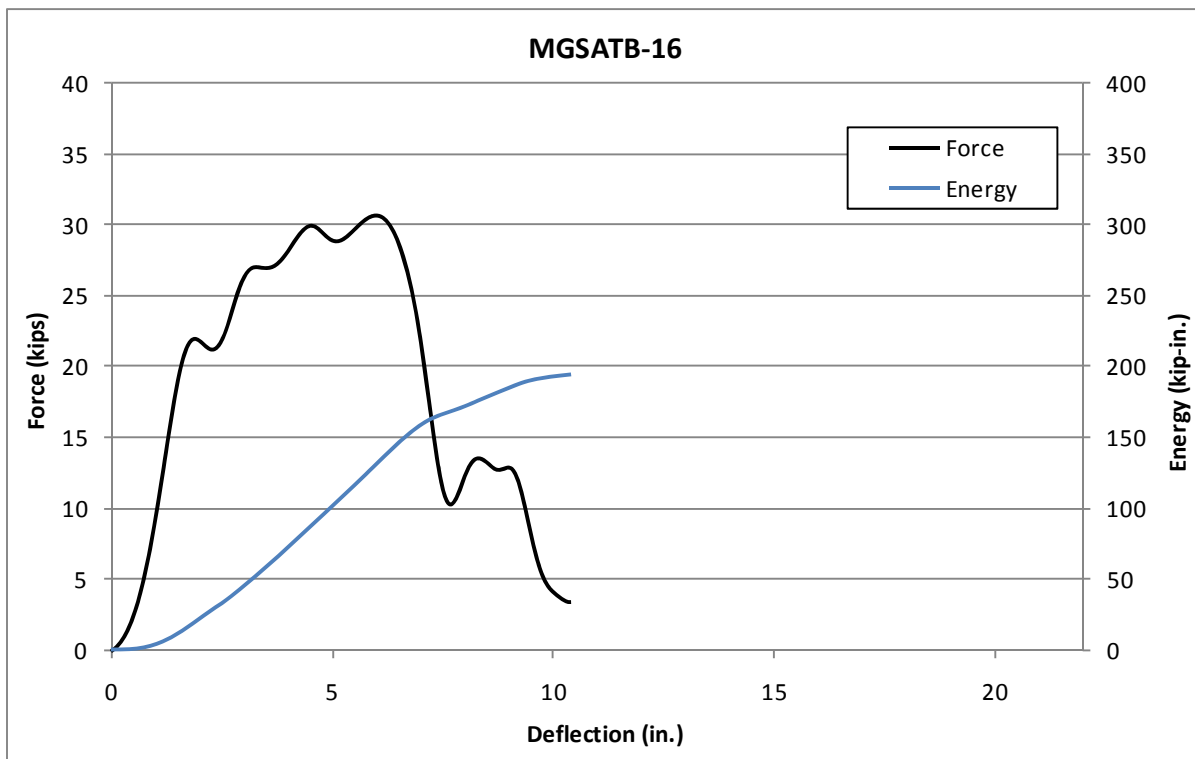
Figure 35. Force vs. Deflection and Energy vs. Deflection, Test No. MGSATB-16

During test no. MGSATB-16, the bogie impacted the post at a speed of 20.2 mph (32.5 km/h). As a result, the post began to rotate through the soil but fractured at a displacement of 10.4 in. (264 mm). The post fractured near ground line.

Force vs. deflection and energy vs. deflection curves created from the EDR-3 accelerometer data are shown in Figure 35. The resistance force steadily increased until it reached a peak force of 30.7 kips (136.5 kN) at 6 in. (152 mm) of deflection, when the post began to fracture. At fracture, the post absorbed 194.4 kip-in. (22.0 kJ) of energy. Time-sequential photographs and post-impact photographs are shown in Figure 36.

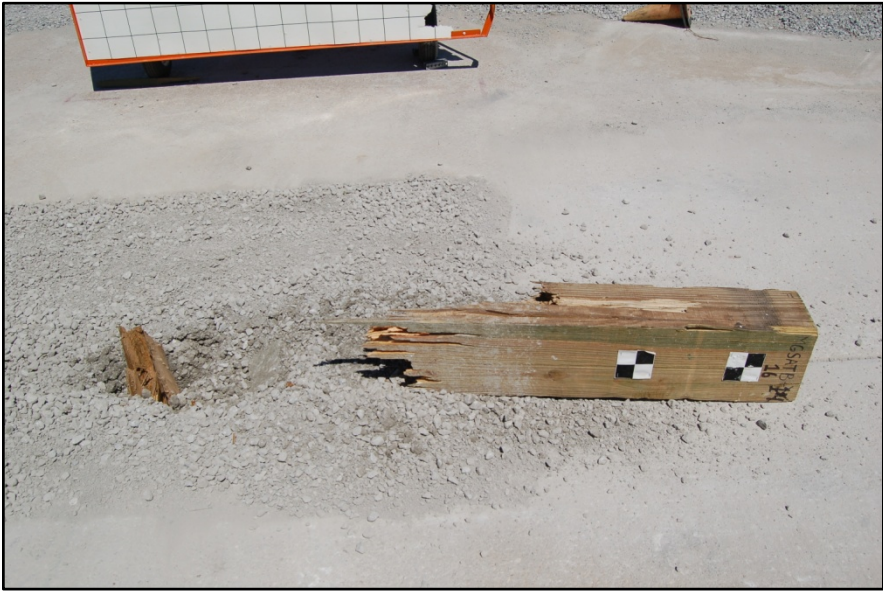
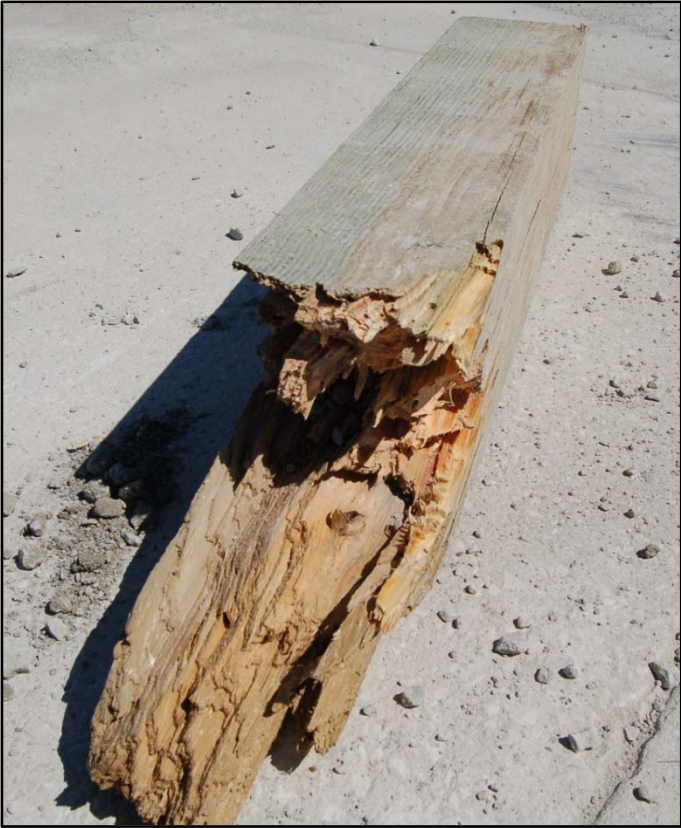
Figure 36. Time Sequential and Post-Impact Photographs, Test No. MGSATB-16

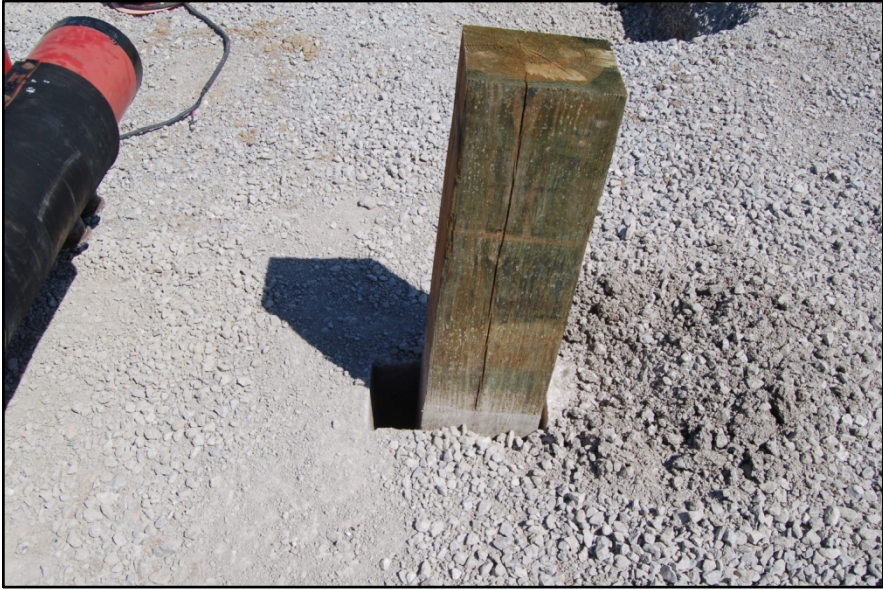
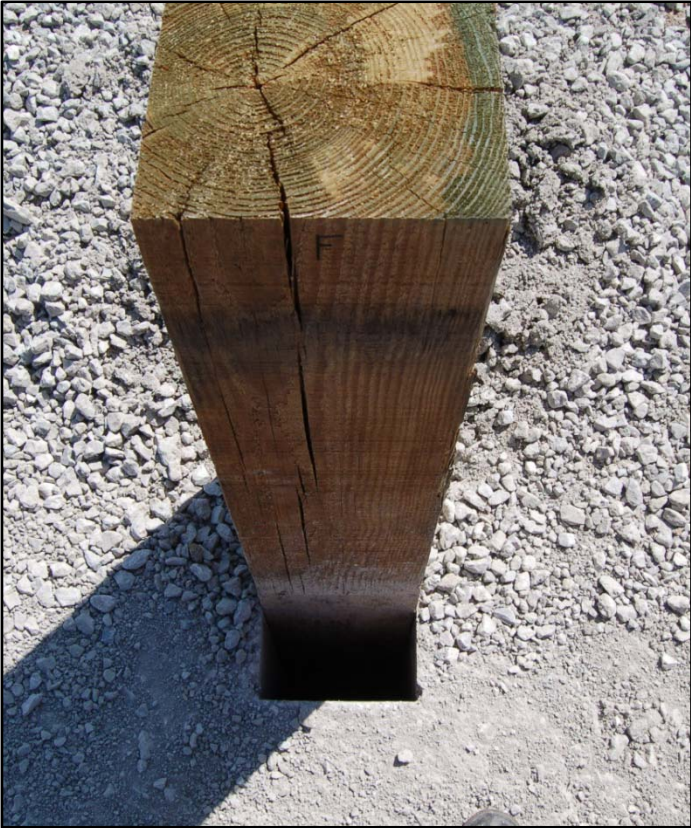
Figure 38. Time Sequential and Post-Impact Photographs, Test No. MGSATB-17

Force vs. deflection and energy vs. deflection curves created from the EDR-3 accelerometer data are shown in Figure 37. The resistance increased rapidly to a peak force of 34.8 kips (154.8 kN) over the first few inches of deflection. The post provided an average resistance force of 27.5 kips (122.3kN) through 10 in. (25.4 mm) of deflection. The post absorbed 286.5 kip-in. (32.4 kJ) of energy. Time-sequential photographs and post-impact photographs are shown in Figure 38.

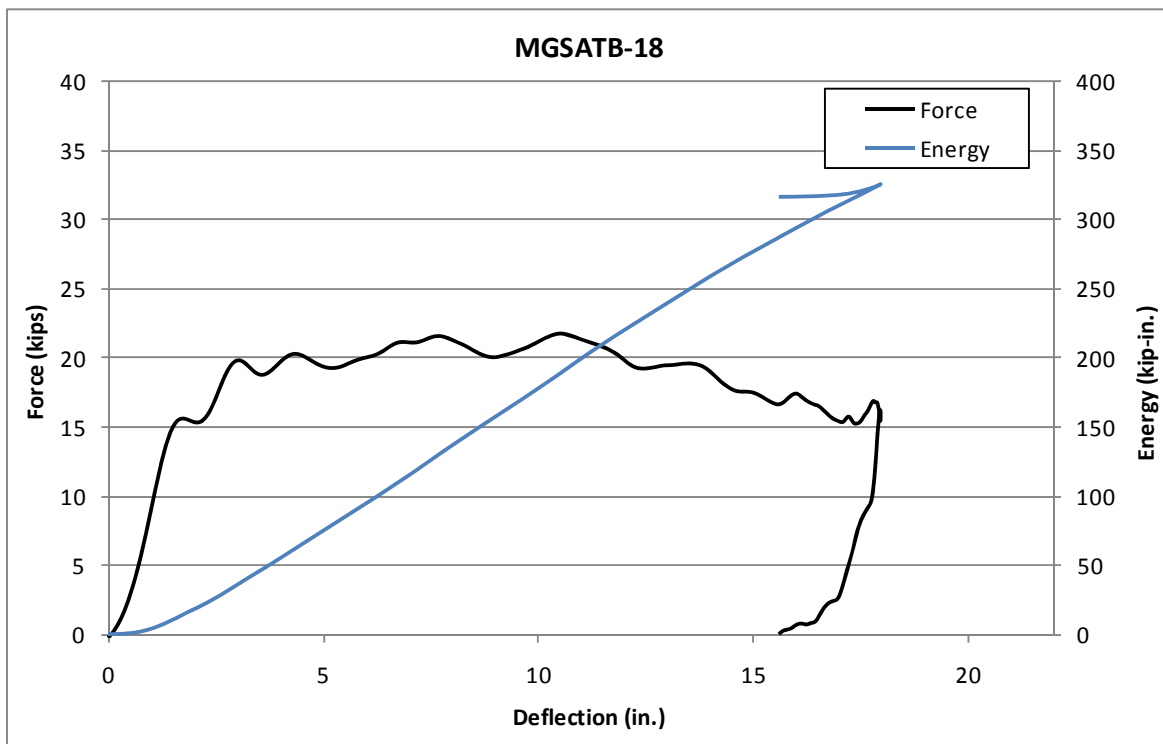
Figure 39. Force vs. Deflection and Energy vs. Deflection, Test No. MGSATB-18

Force vs. deflection and energy vs. deflection curves created from the EDR-3 accelerometer data are shown in Figure 39. After the initial stiffness increase over the first few inches of deflection, the post provided a relatively constant resistance force of around 20 kips (90 kN). A peak force of 21.8 kips (96.8 kN) was observed at 10 in. (25.4 mm) of deflection. The post absorbed 352.2 kip-in. (36.7 kJ) of energy. Time-sequential photographs and post-impact photographs are shown in Figure 40.

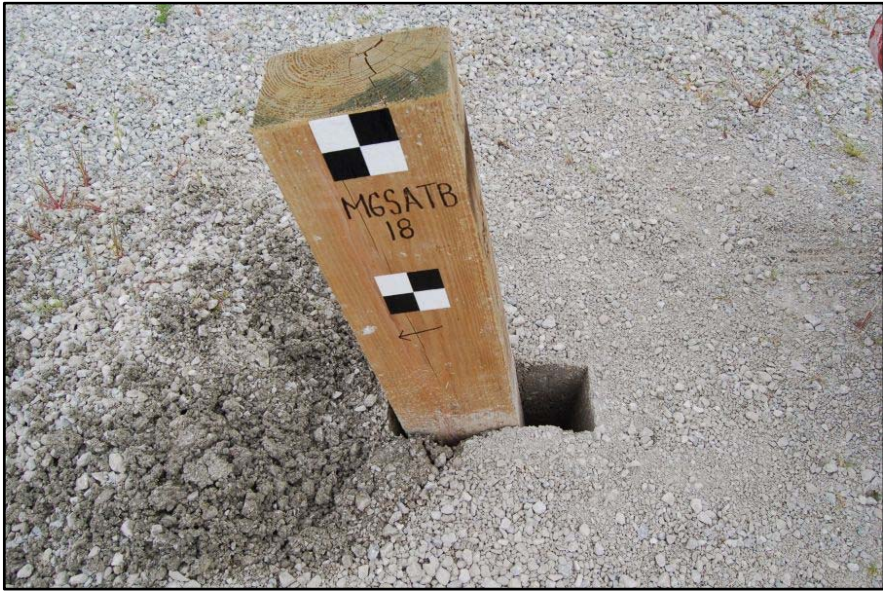
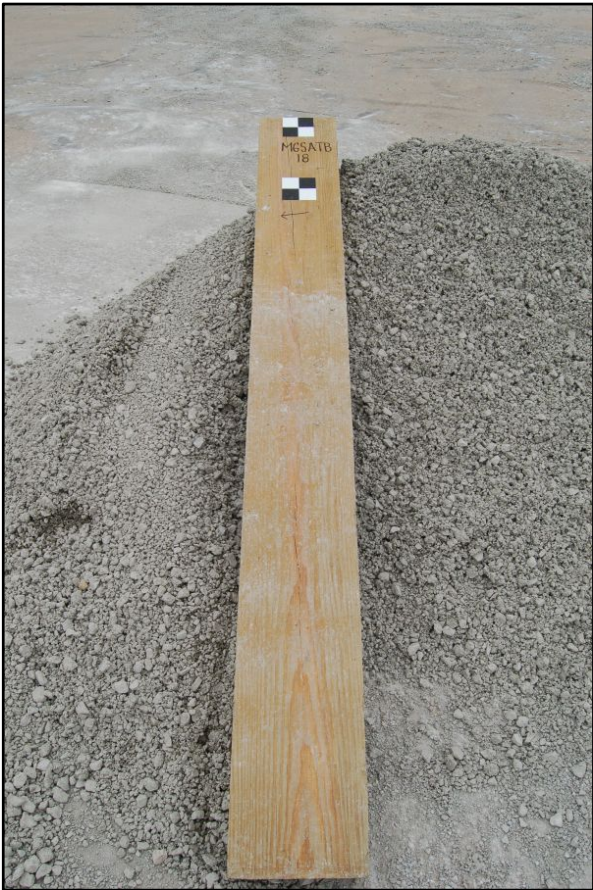
Figure 40. Time Sequential and Post-Impact Photographs, Test No. MGSATB-18

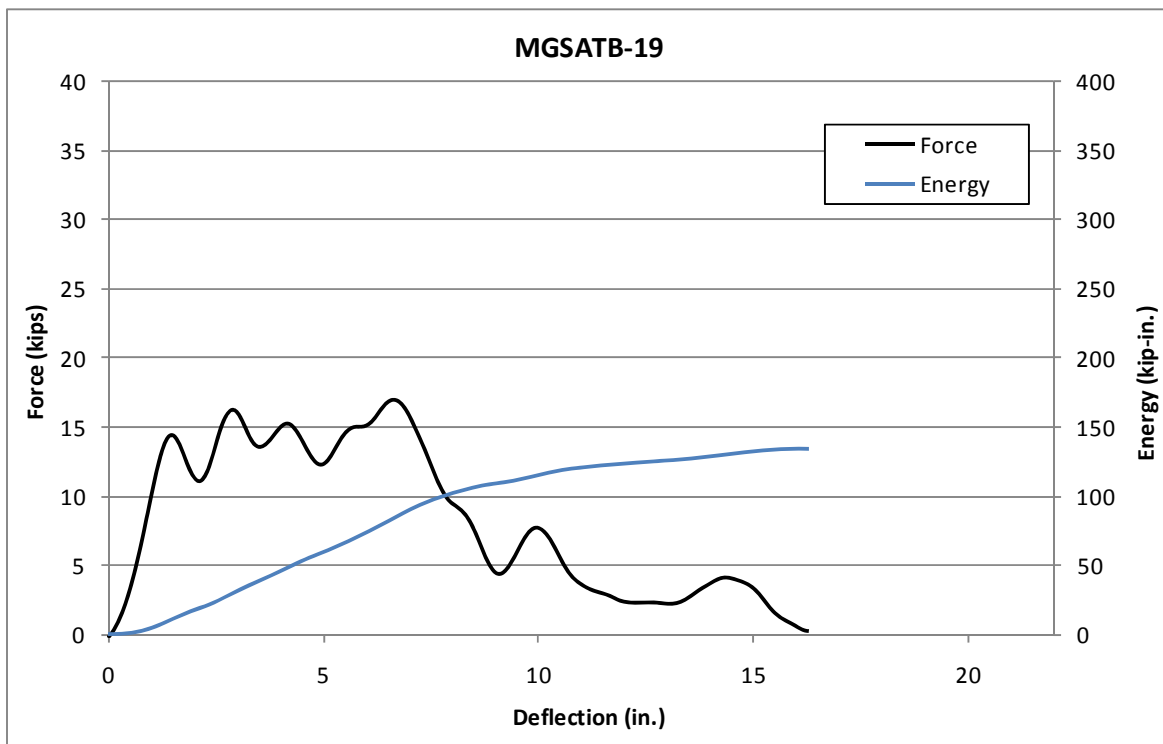
Figure 41. Force vs. Deflection and Energy vs. Deflection, Test No. MGSATB-19

During test no. MGSATB-19, the bogie impacted the post at a speed of 19.7 mph (31.7 km/h). As a result, the post fractured into three pieces, and the bogie traveled over the post stub. The upper portion of the post split in to two pieces through a preexisting vertical crack on the left side of the post. After splitting, the upper pieces fractured from the bottom portion of the post at approximately 8 in. (203 mm) below the ground line.

Force vs. deflection and energy vs. deflection curves created from the EDR-3 accelerometer data are shown in Figure 41. Before fracture, the post provided a resistance force of around 15 kips (65 kN) with a peak force of 17.0 kips (75.8 kN) at a deflection of 6.7 in. (170 mm). At fracture, the post absorbed 124.3 kip-in. (14.0 kJ) of energy. Time-sequential photographs and post-impact photographs are shown in Figure 42.

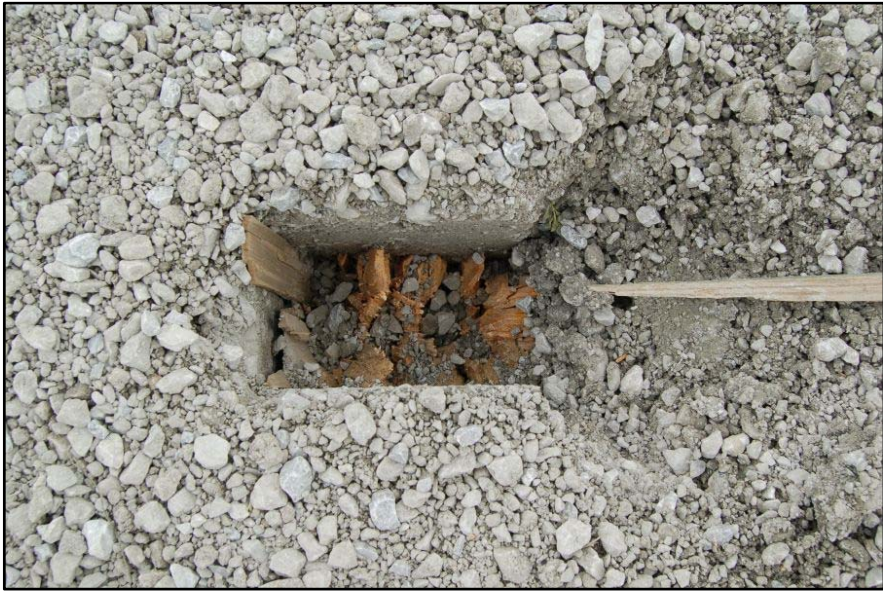
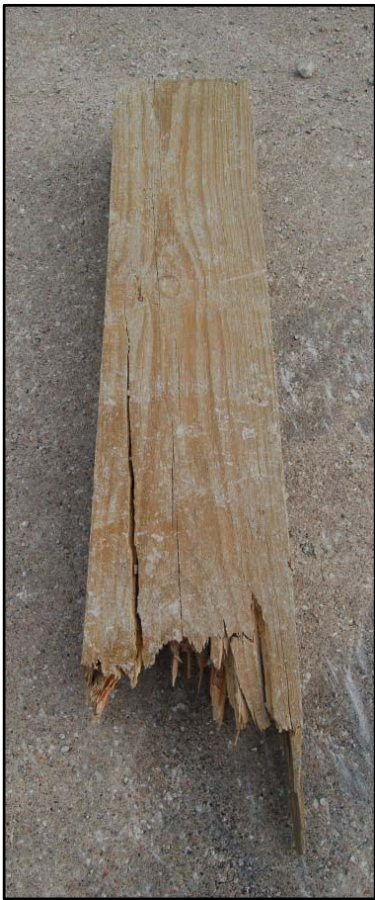
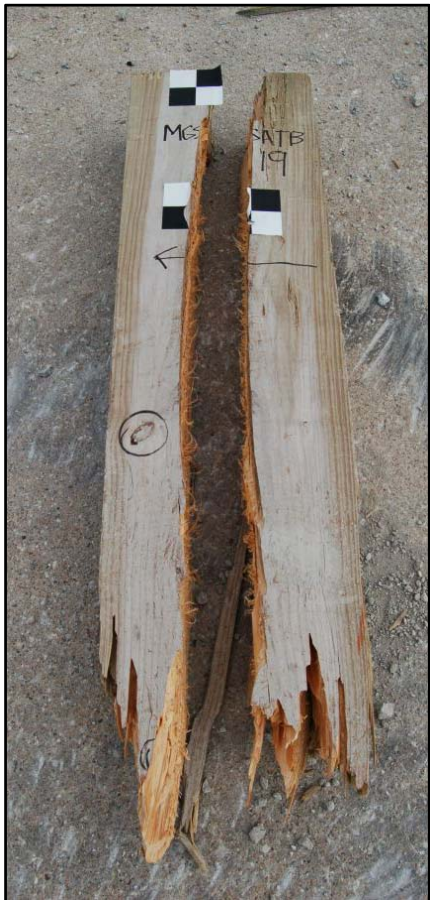
Figure 42. Time Sequential and Post-Impact Photographs, Test No. MGSATB-19

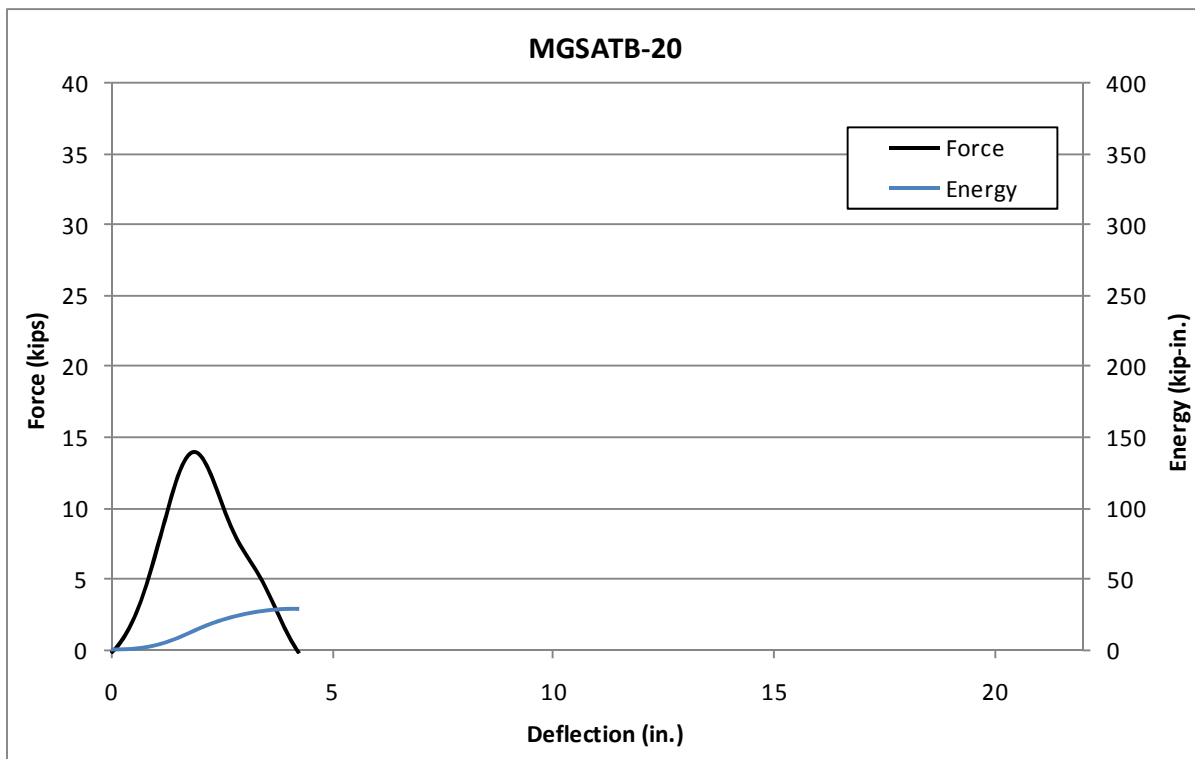
Figure 43. Force vs. Deflection and Energy vs. Deflection, Test No. MGSATB-20

During test no. MGSATB-20, the bogie impacted the post at a speed of 24.5 mph (39.5 km/h). As a result, the post fractured at a deflection of 4.2 in. (108 mm), and the bogie traveled over the post stub. The post fractured at approximately 8 in. (20 cm) below the ground line.

Force vs. deflection and energy vs. deflection curves created from the EDR-3 accelerometer data are shown in Figure 43. Due to early post failure, only a single force spike was recorded. The peak force was 13.9 kips (61.9 kN) at a deflection of 1.9 in. (48 kN). The post absorbed 28.5 kip-in. (3.2 kJ) of energy at the time of fracture. Time-sequential photographs and post-impact photographs are shown in Figure 44.

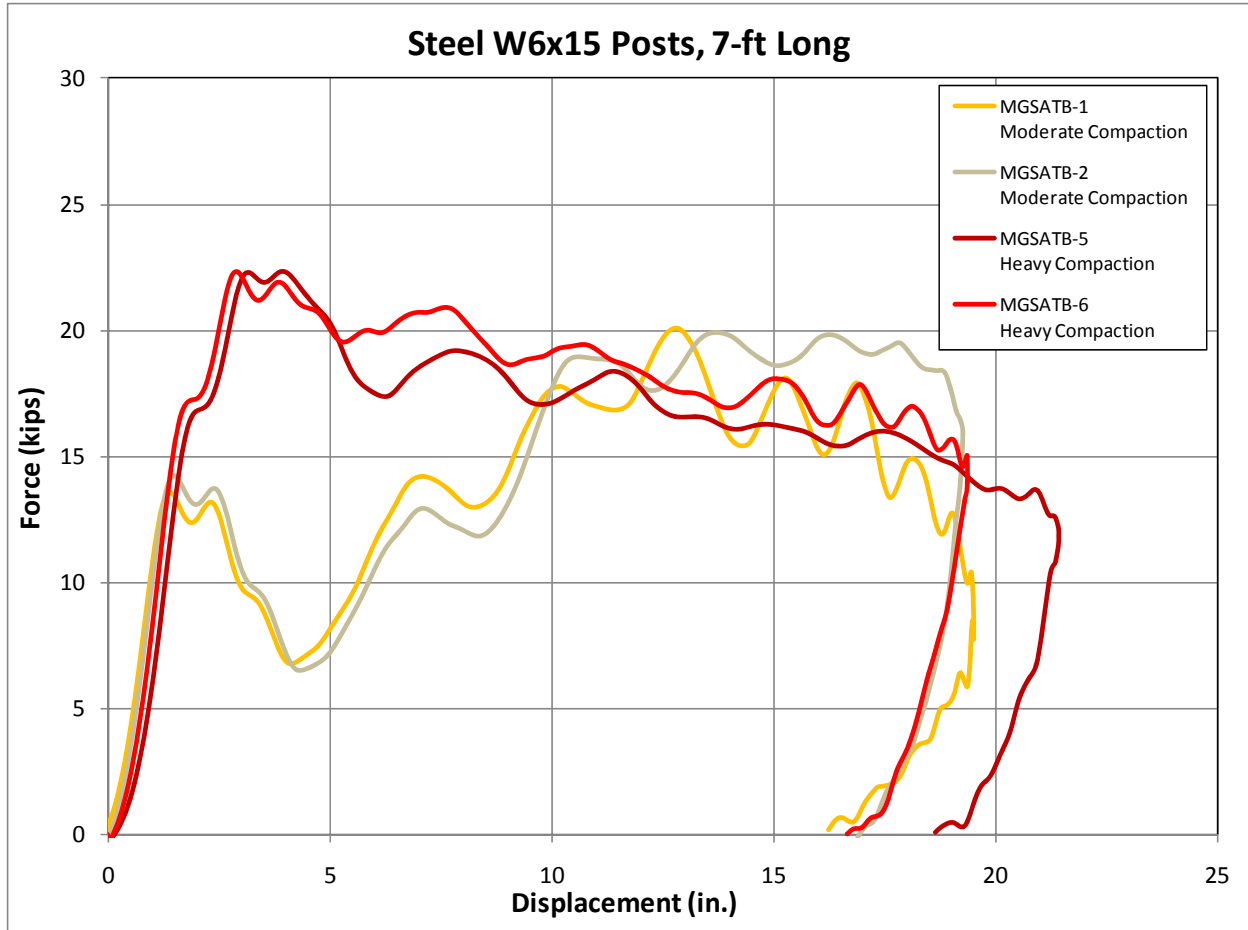
Figure 45. Force vs. Deflection Comparison, 7-ft (2.1-m) Long W6x15 (W152x22.3) Steel Posts

The plastic deformation observed in all four steel posts was significant when searching for an equivalent wood post. Since wood posts lack this ductility, the wood posts should have a larger/stronger cross section to reduce the risk of fracture. Further, it was recognized that the embedment depth of an equivalent wood post may vary from that of the steel post due to changes in the post cross section. Therefore, multiple post sections and lengths were tested in an attempt to determine an equivalent wood post.

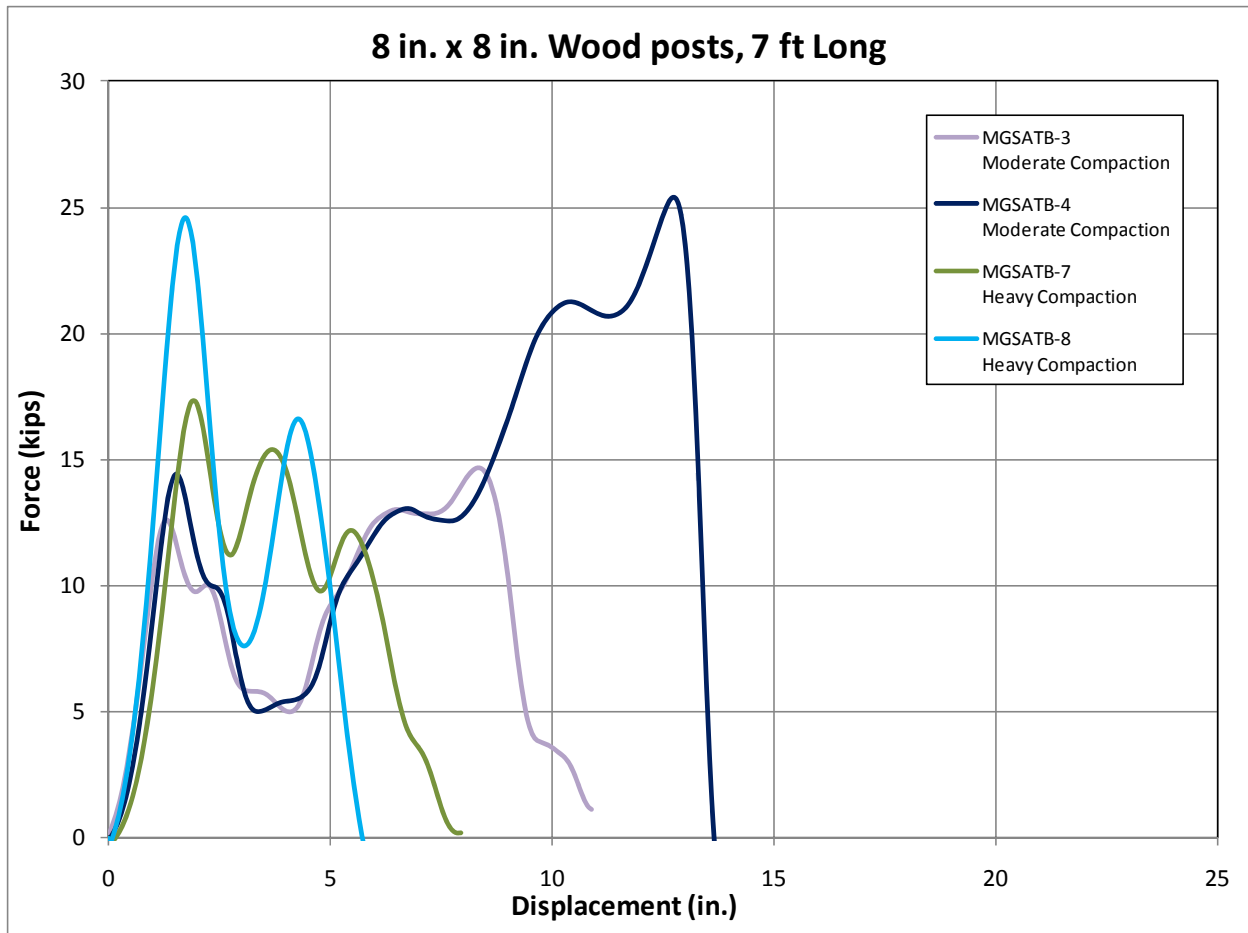
Figure 46. Force vs. Deflection Comparison, 7-ft (2.1-m) Long 8-in. x 8-in. (203-mm x 203-mm) Wood Posts

Four tests were conducted on 7-ft (2.1-m) long, 8-in. x 8-in. (203-mm x 203-mm) wood posts. Two posts were installed in moderately compacted soil, while the other two were installed in heavily compacted soil. Regardless of soil compaction, each test resulted in post fracture. Although the individual deflections at time of fracture varied, three out of four posts had fractured prior to 10 in. (254 mm) of deflection, thus restricting the total energy absorption of the post. As a result, the 8 in. x 8 in. (203 mm x 203 mm) cross section was determined to be too weak to provide equivalent resistance to the steel post when used as a 7-ft (2.1-m) long wood post.

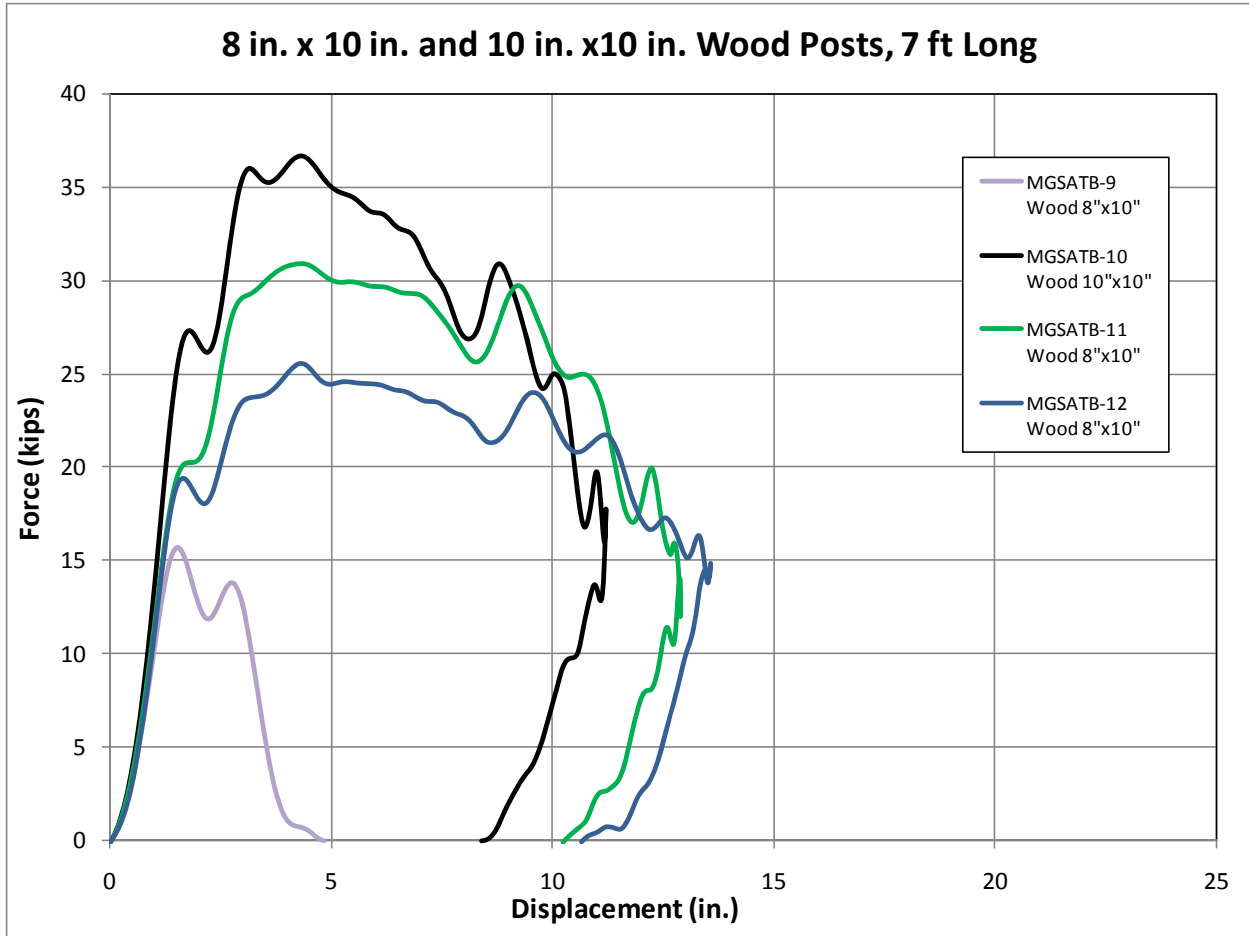
Figure 47. Force vs. Deflection Comparison, 7-ft (2.1-m) 8-in. x 10-in (203-mm x 254-mm). and 10-in. x 10-in. (254-mm x 254-mm) Wood Posts

These 8-in. (203-mm) and 10-in. (254-mm) wide posts displaced more soil than the W6x15 (W152x22.3) steel post. This was the result of two main factors. First, the wood posts were wider than the steel posts, which meant more soil would be involved in the inertial resistance at the onset of post rotation. This created higher resistance forces at the beginning of the impact event. Second, the steel posts bent after impact which indicated the soil resistance to rotation was greater than the bending strength of the W6x15 (W152x22.3) cross section. Wood posts cannot yield in the same manner as steel posts; thus, the energy had to be absorbed by soil displacement. To minimize the amount of soil displacement/resistance, either the embedment depth or the post width had to be reduced.

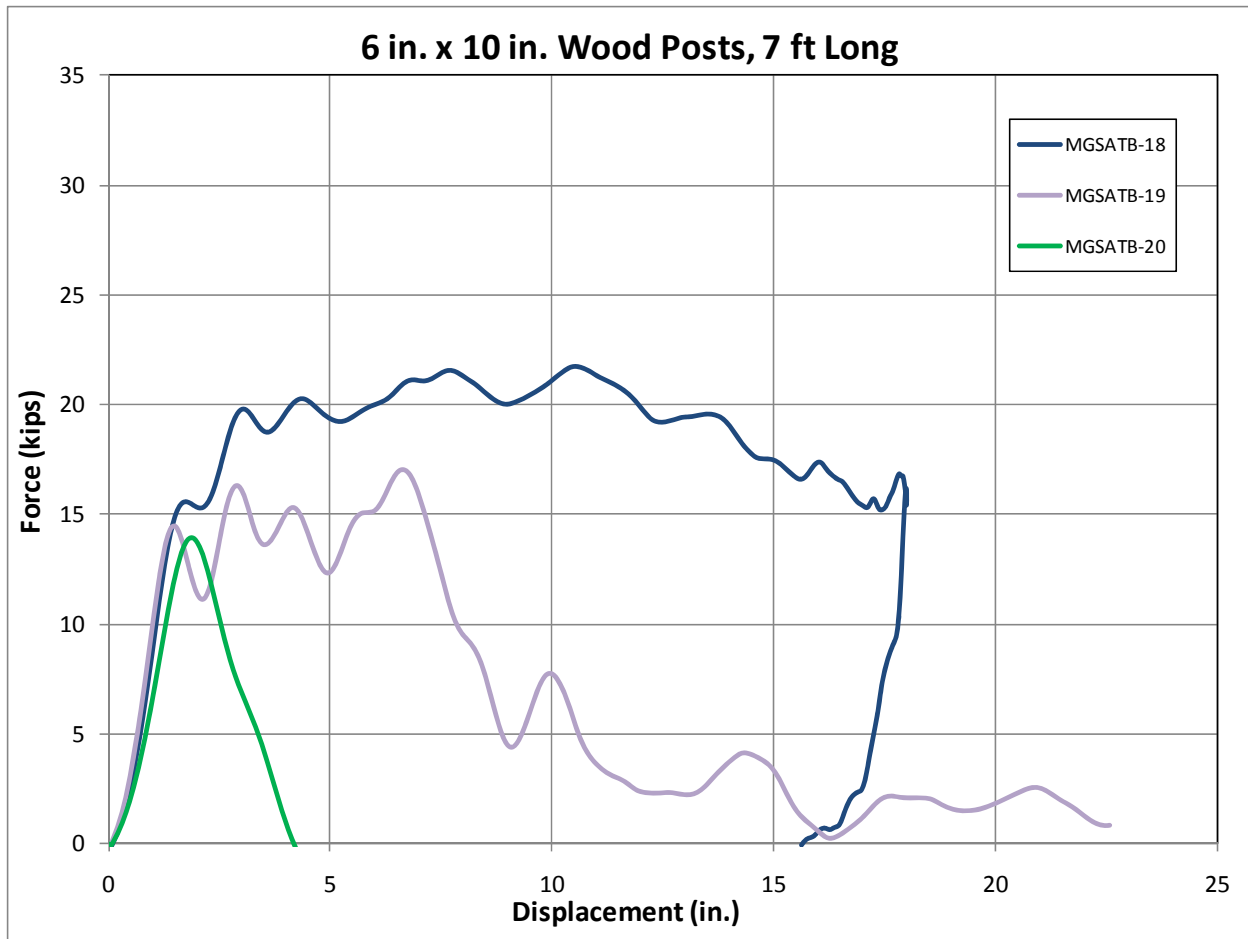
Figure 48. Force vs. Deflection Comparison, 7-ft (2.1-m) Long 6-in. x 10-in. (152-mm x 254-mm) Wood Posts

Three tests were conducted on 6-in. x 10-in. (152-mm x 254-mm) wood posts with 52 in. (1,321 mm) embedment. Test no. MGSATB-18 provided favorable results as the resistance force remained relatively constant ranging from 17 to 21 kips (76 to 93 kN) throughout the test, as shown in Figure 48. The average force over 15 in. (381 mm) of deflection was 18.4 kip (81.9 kN), which closely resembled the average force for the W6x15 (W152x22.3) steel posts of 17.5 kips (77.7 kN). However, the next two bogie tests resulted in post fracture. Therefore, the 6-in. x 10-in. (152-mm x 254-mm) wood posts were determined to have inadequate bending strength to transfer the required forces.
