Development of Alternative Wood-Post MGS Approach Guardrail Transition

*Midwest States Regional Pooled Fund Research Program
Fiscal Year 2009 (Year 19)
Research Project Number TPF-5(193)
NDOR Sponsoring Agency Code RFP-09-03*

DEVELOPMENT OF ALTERNATIVE WOOD-POST MGS APPROACH GUARDRAIL TRANSITION

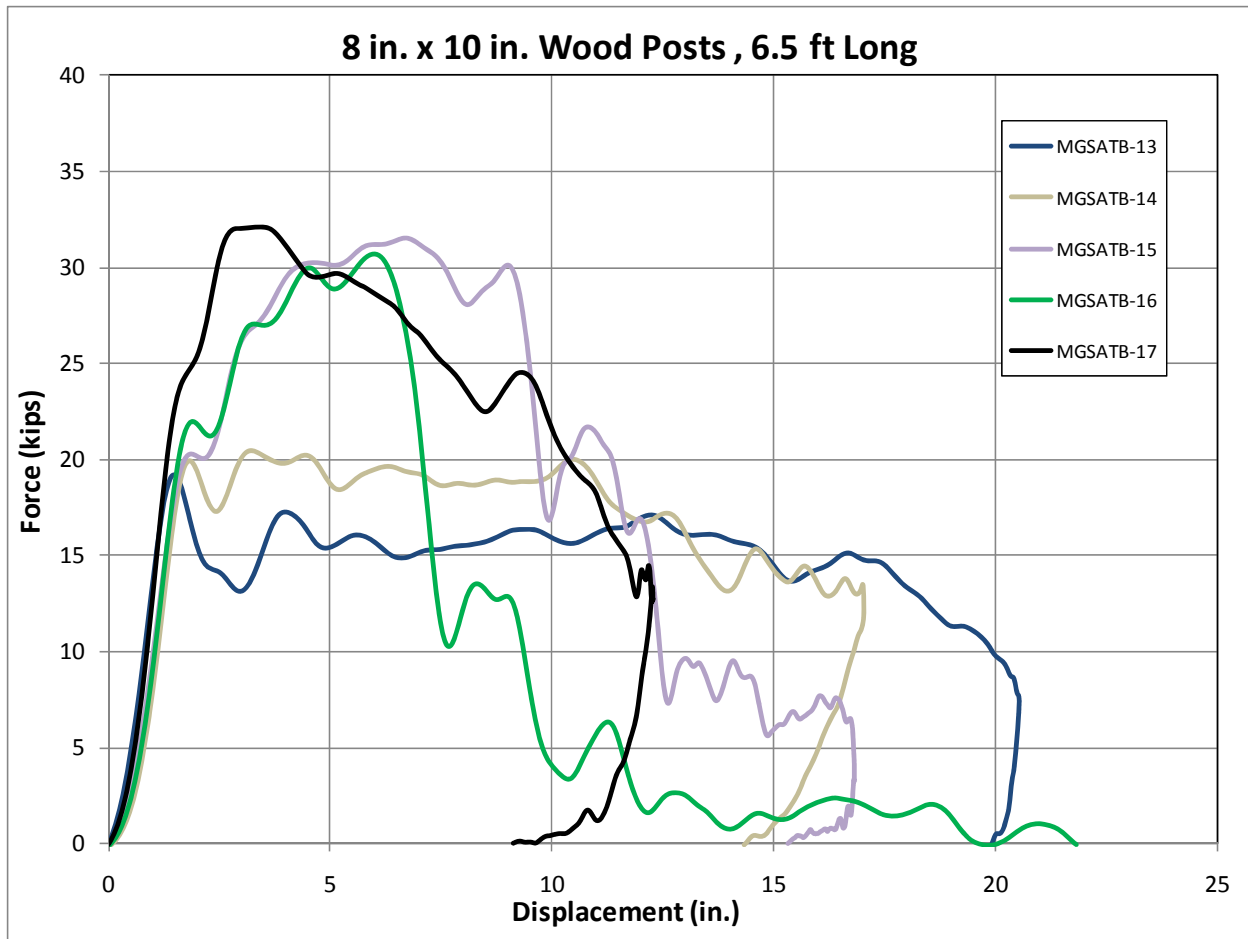
Figure 49. Force vs. Deflection Comparison, 6.5-ft (2.0-m) Long 8-in. x 10-in. (203-mm x 254-mm) Wood Posts

Five tests were conducted on 8-in. x 10-in. (203-mm x 254-mm) wood posts with 48 in. (1,219 mm) embedment. Only one post fractured, although another one showed the early stages of fracture and was slightly bent. Not including the results from test no. MGSATB-16 in which the post fractured, the average force over 15 in. (381 mm) of deflection 17.7 kips (78.6 kN). This value was very similar to the targeted design load of 17.5 kips (77.7 kN) over 15 in. (381 mm) of deflection.

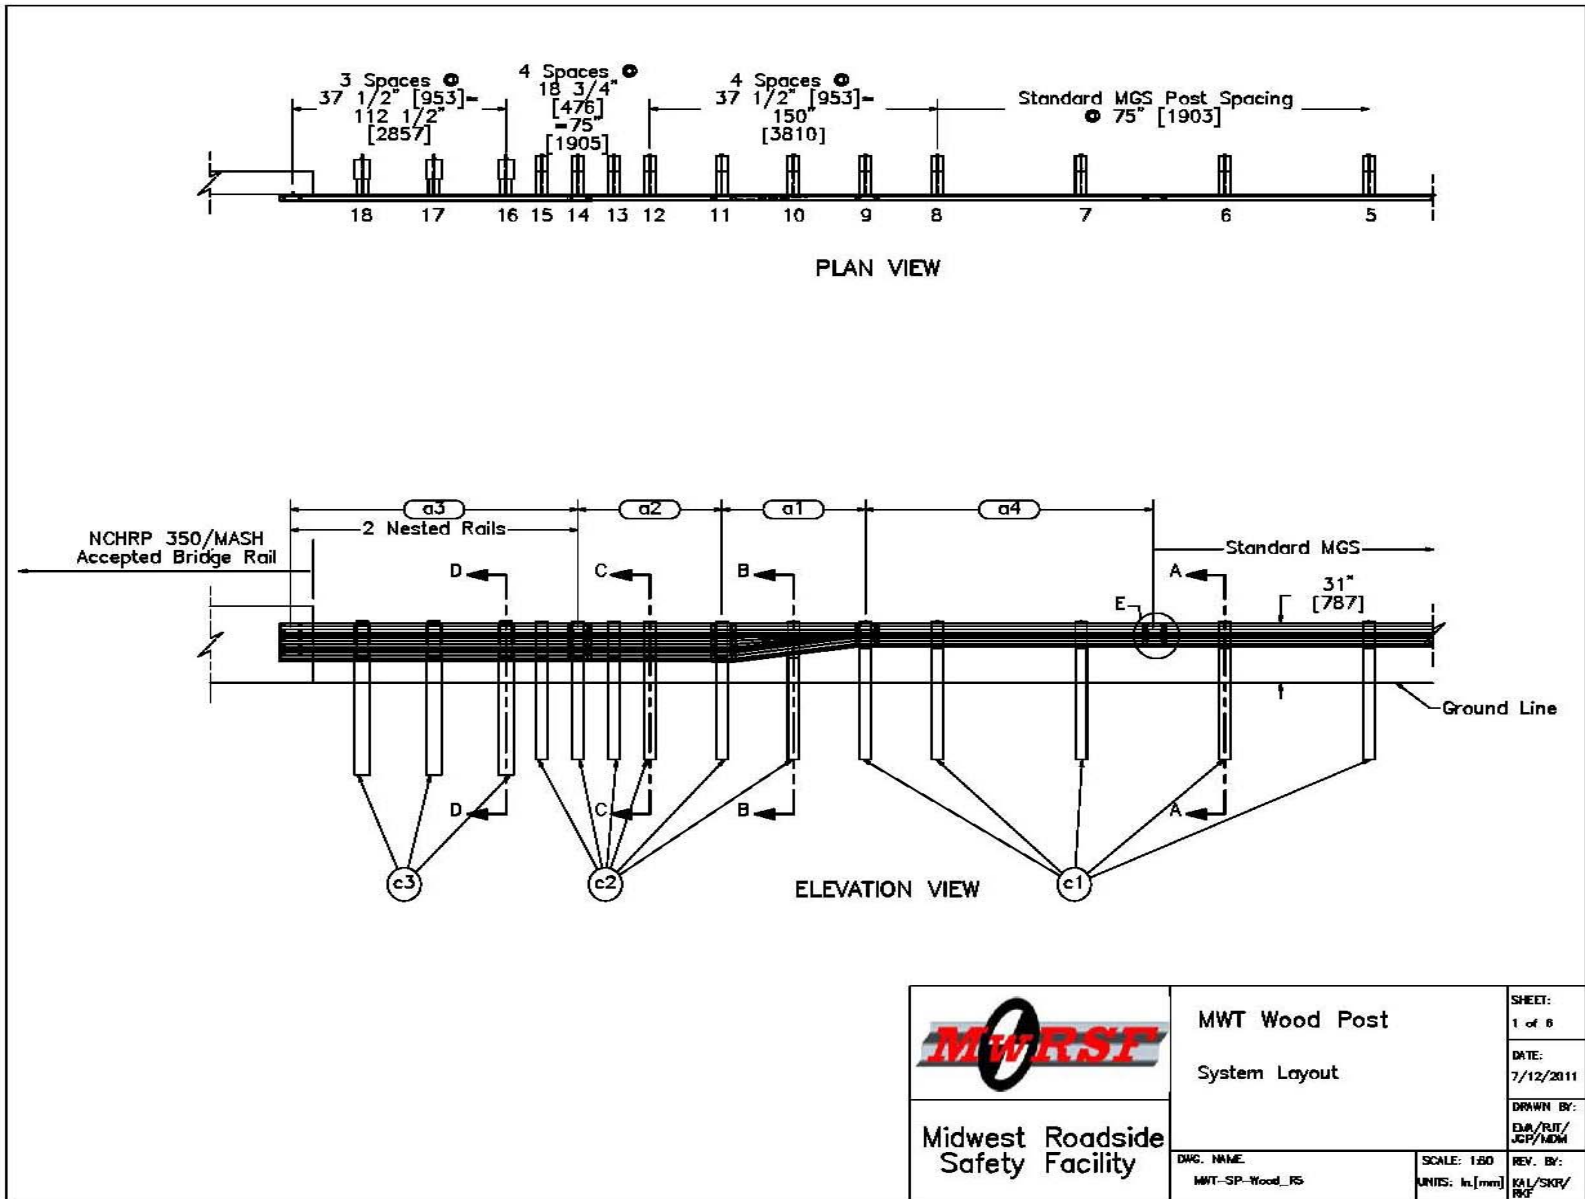
Figure 50. Design Details, Wood Post MGS Stiffness Transition System Layout

The rail elements utilized in the wood post MGS stiffness transition remained unchanged from the steel post version of the system. Standard 12 gauge (2.66-mm thick) W-beam guardrail was used upstream of post no. 9. A 75-in. (1,903-mm) long, 10 gauge (3.42-mm thick) asymmetrical W-beam to thrie beam transition element spanned between post nos. 9 and 11. A 75-in. (1,903-mm) long, 12 gauge (2.66-mm thick) section of thrie beam spanned between post nos. 11 and 14. Finally, nested 12 gauge (2.66-mm thick) thrie beam was utilized between post no 14 and the bridge rail.

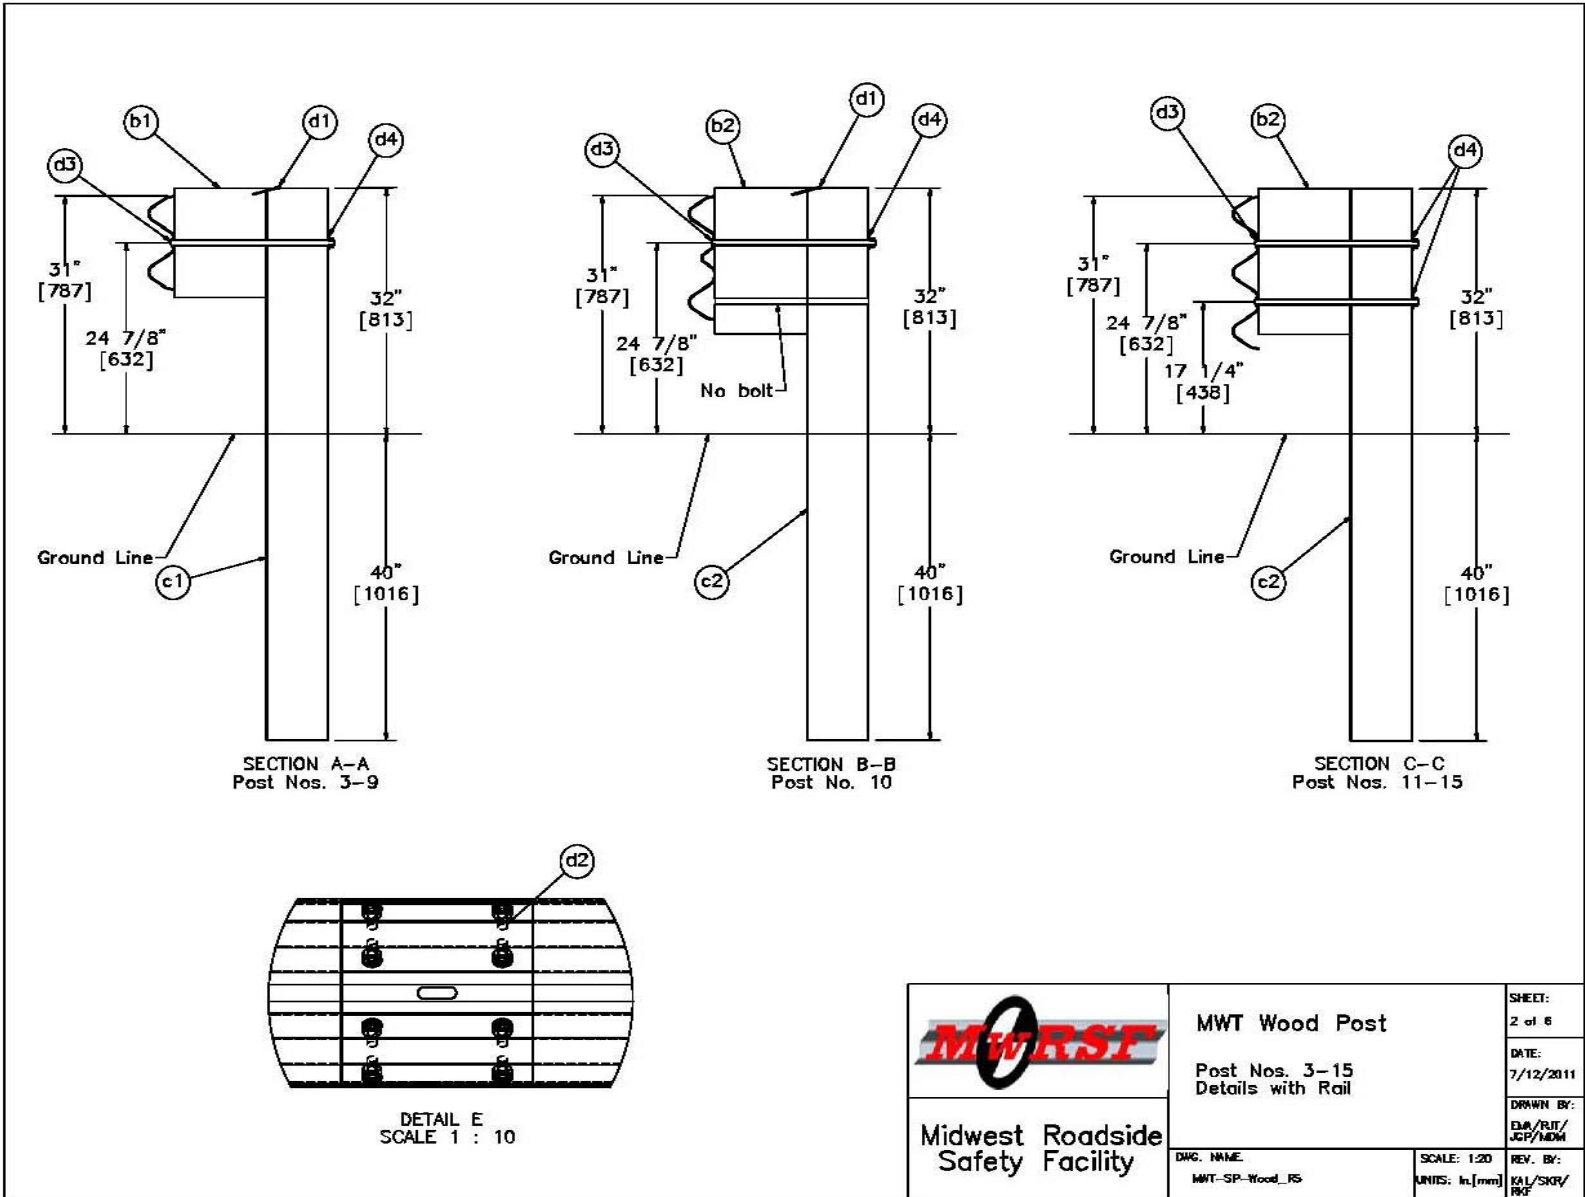
Figure 51. Post Nos. 3 through 15 Rail Attachment Details

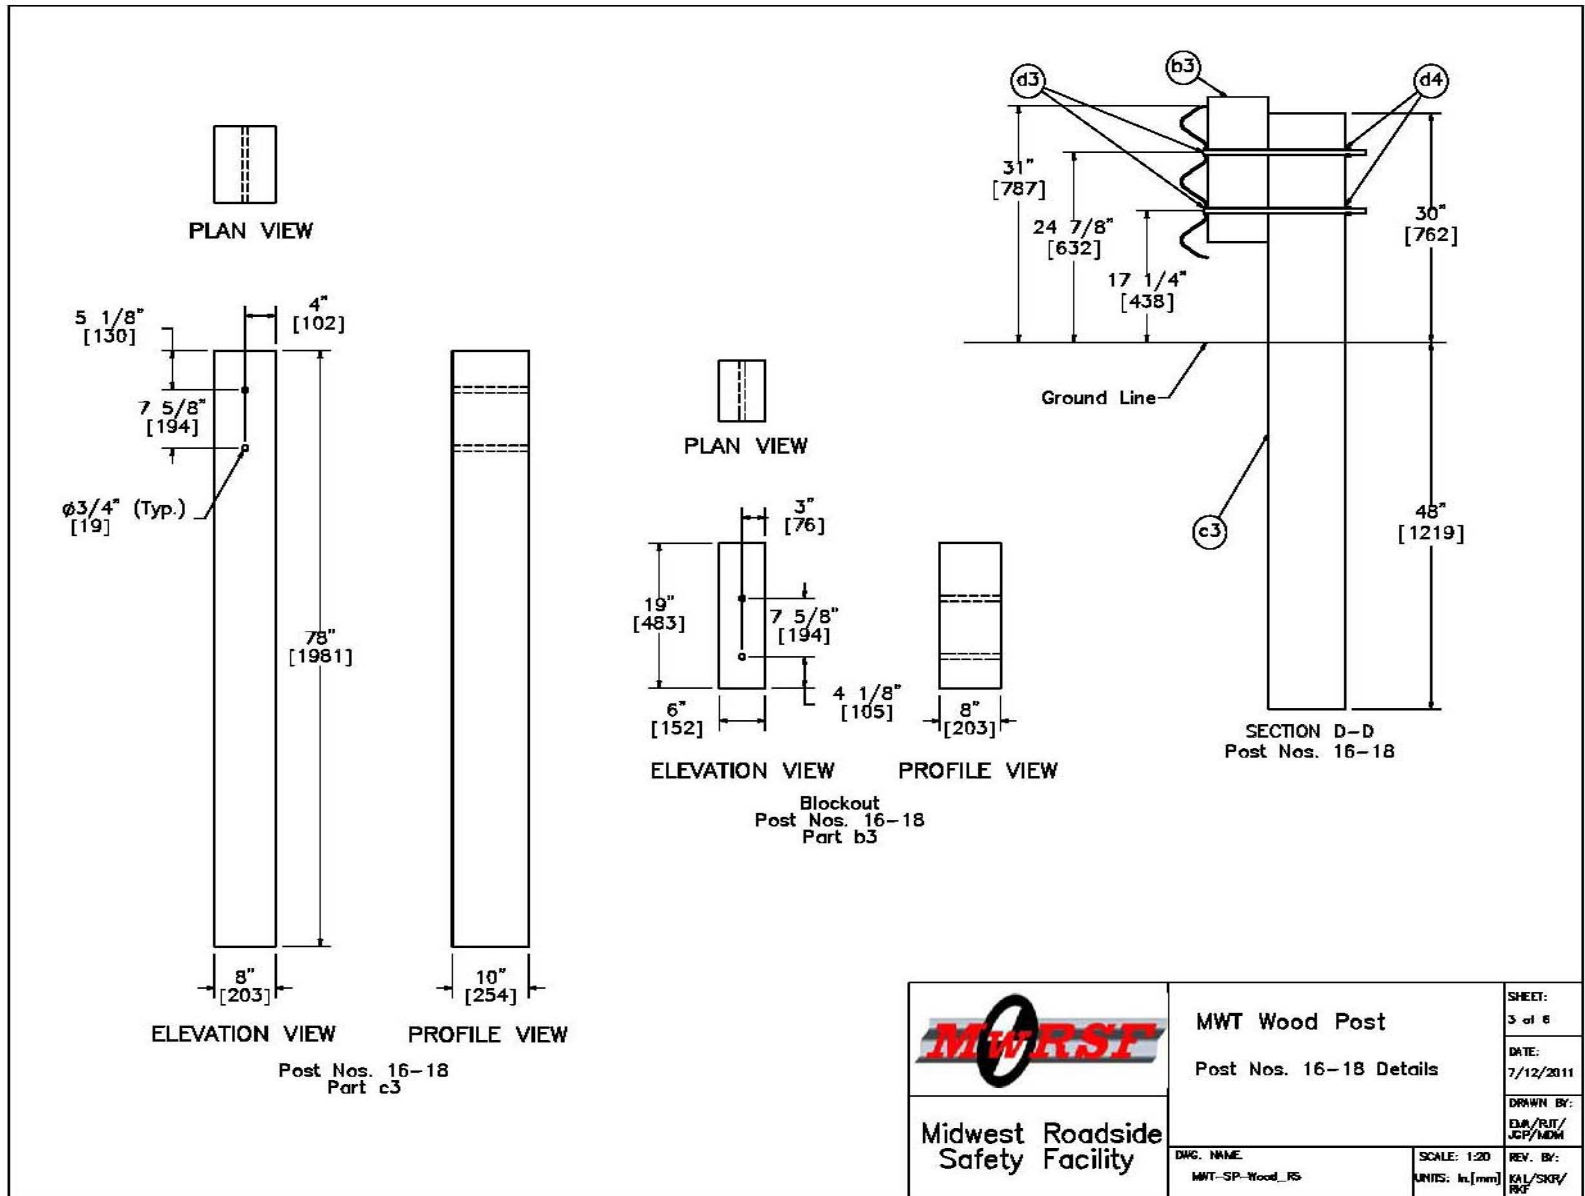
Figure 52. Post Nos. 16 through 18 Design Details

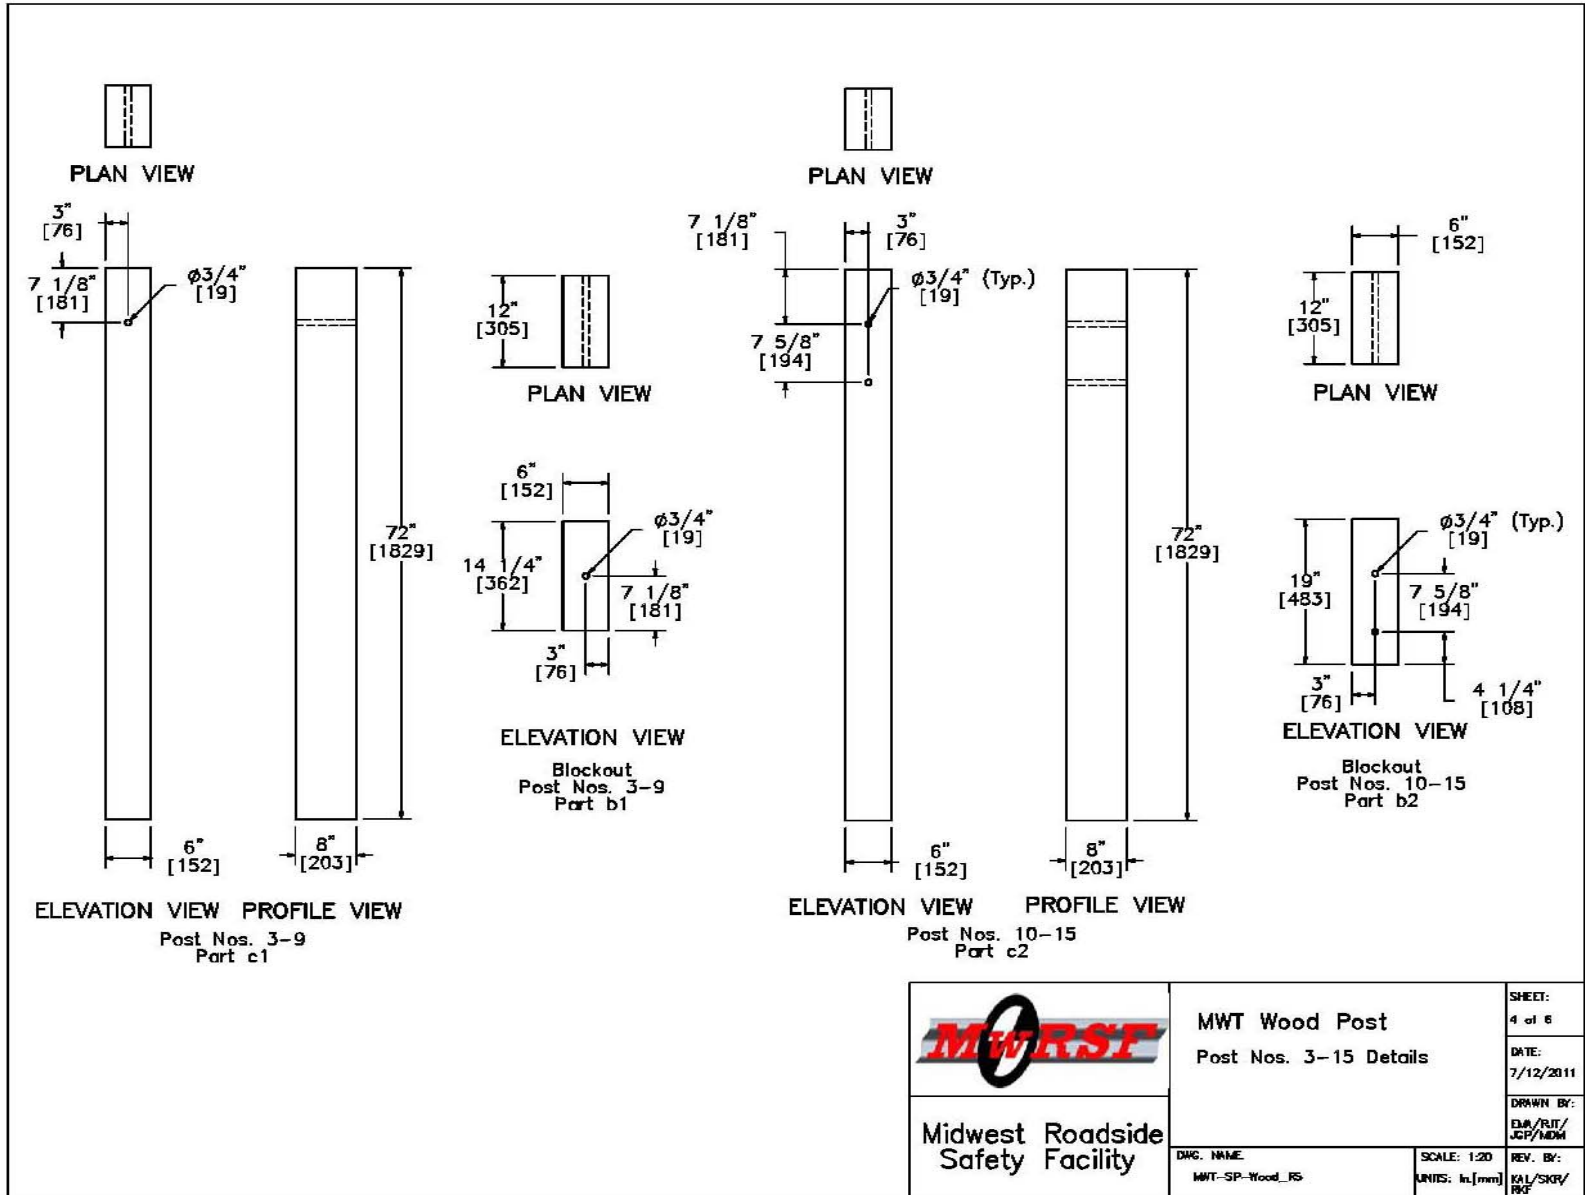
Figure 53. Post Nos. 3-15 Design Details

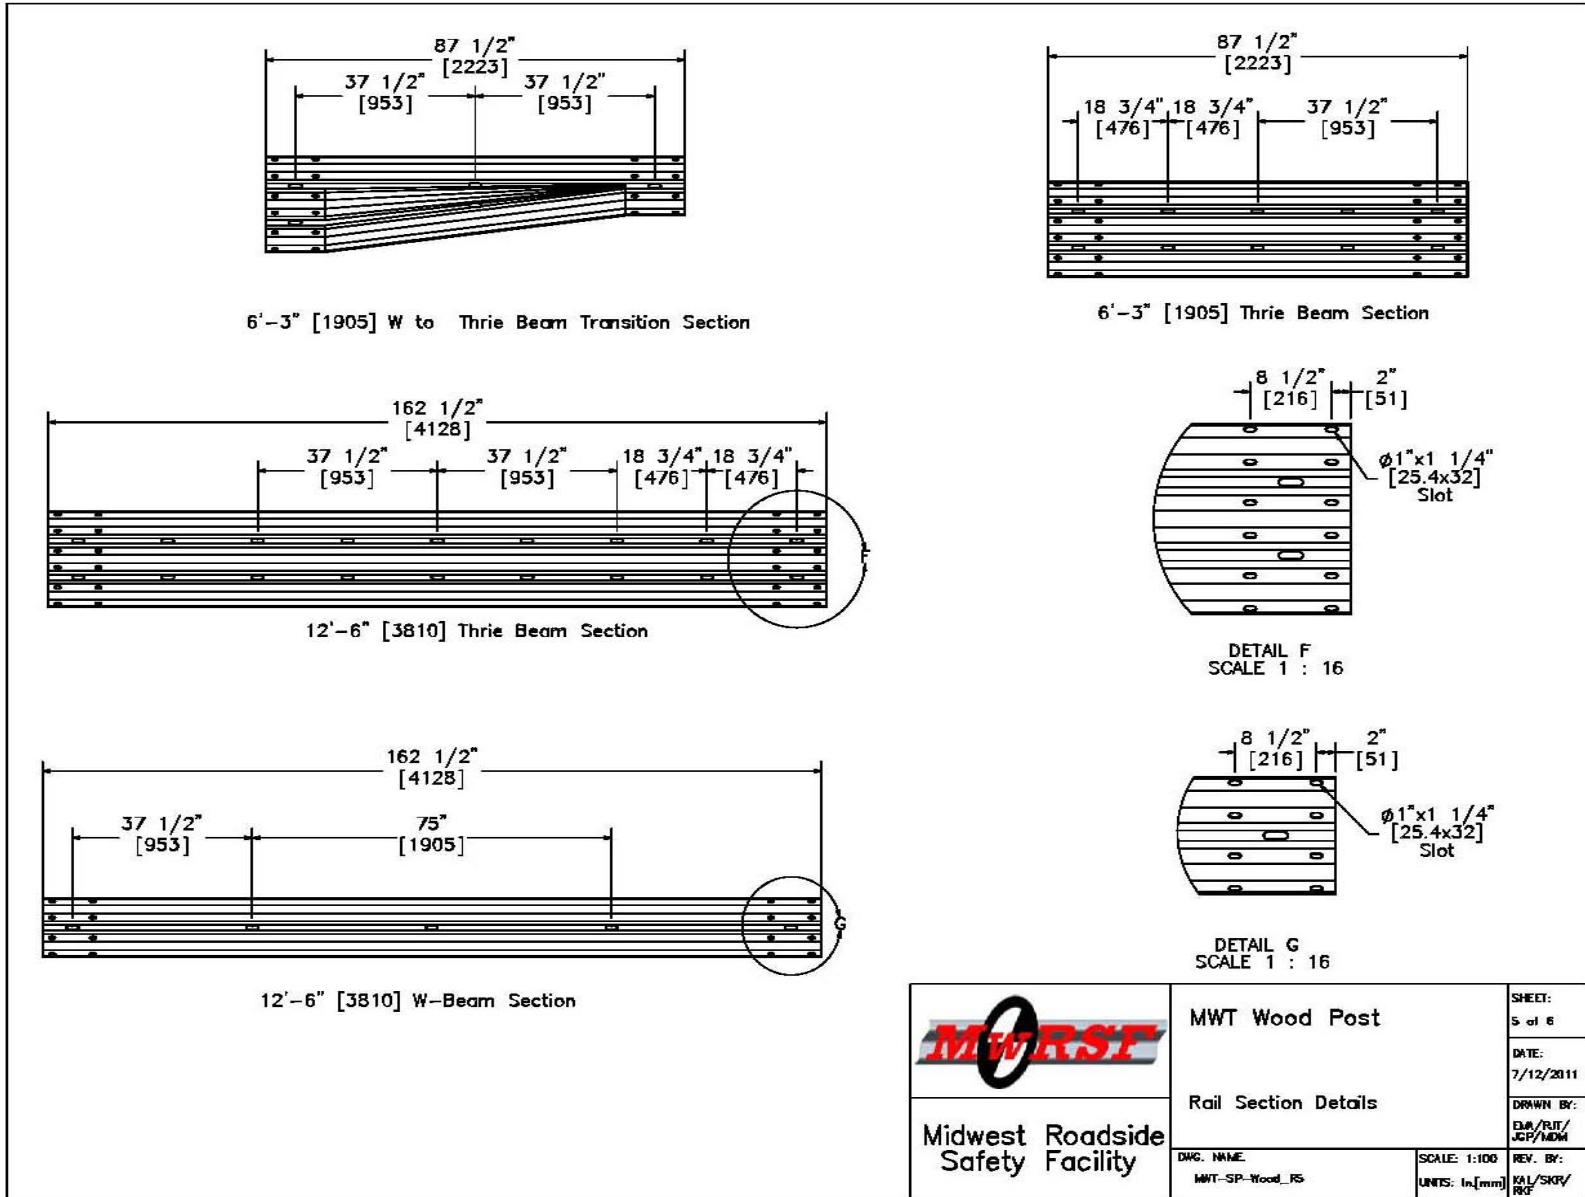
Figure 54. Rail Sections Details

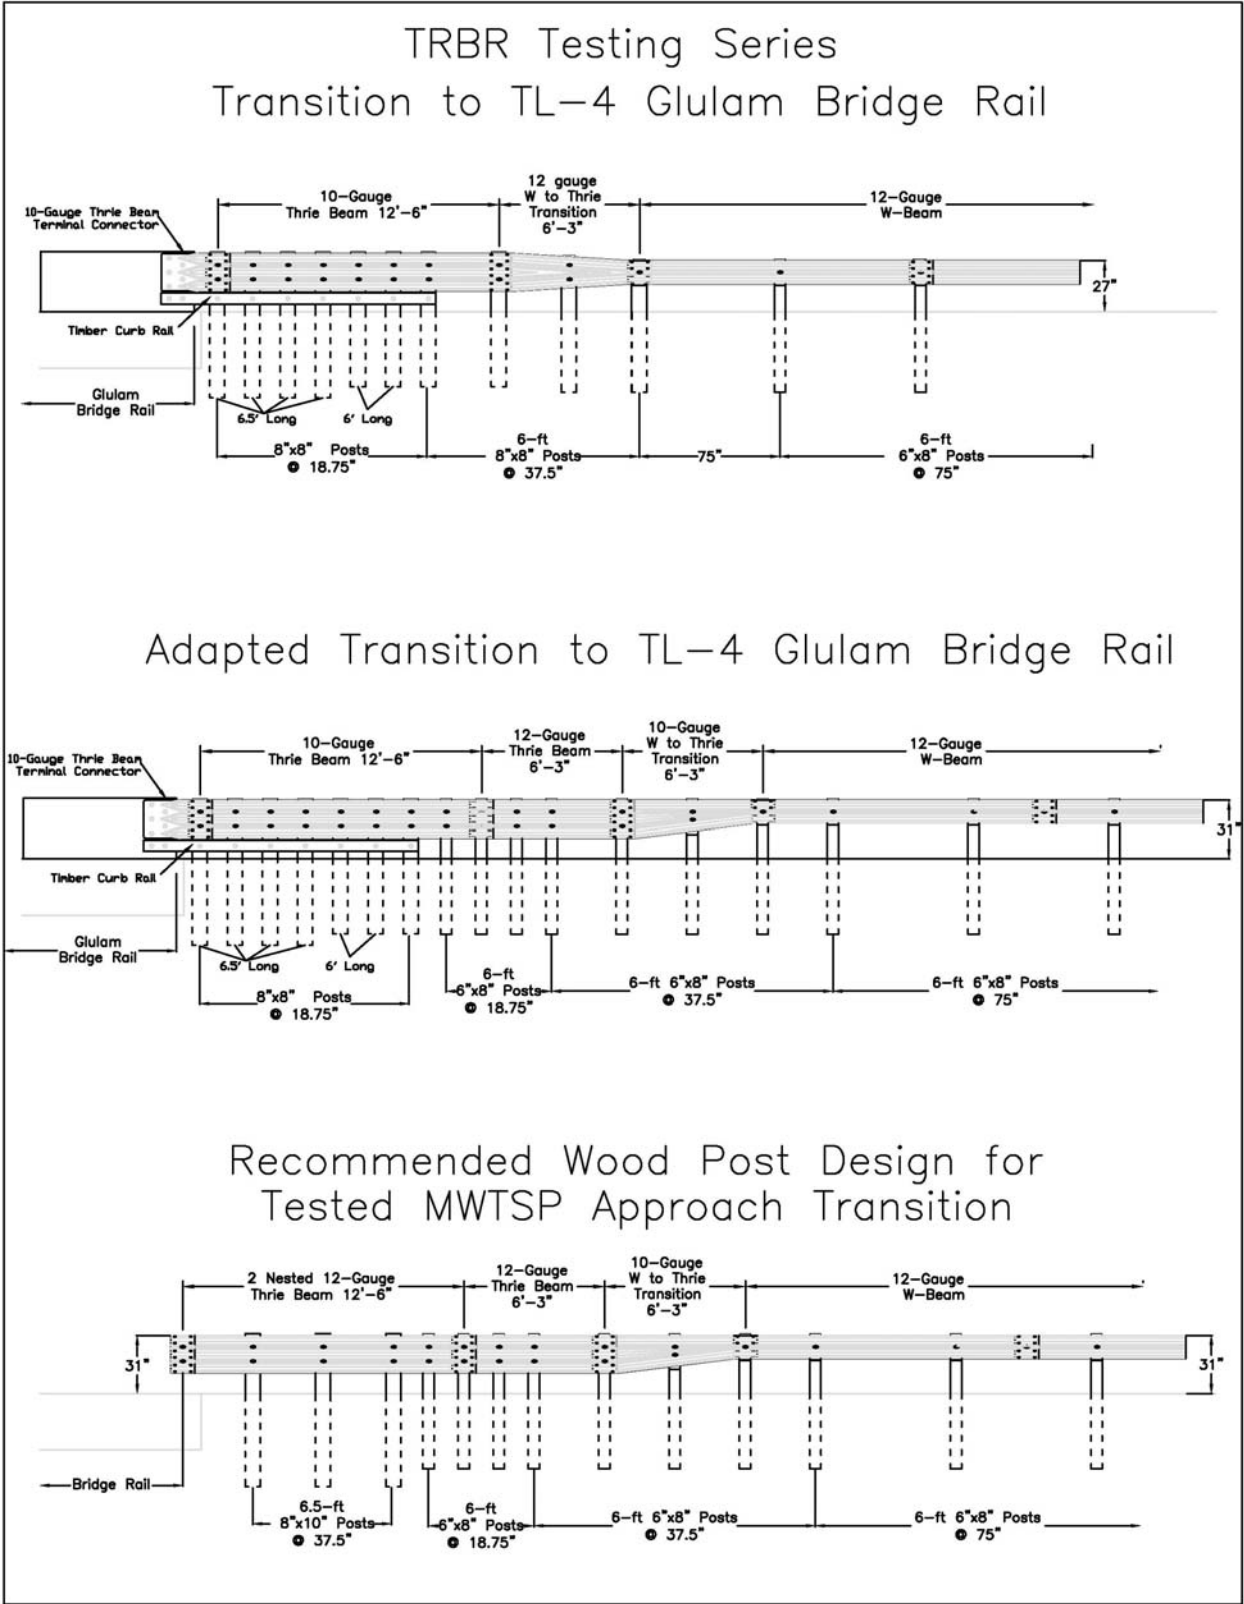
Figure 56. Approach Transition to TL-4 Glulam Bridge Rail [13-16]

Although not specifically shown, the new wood post stiffness transition described herein can be adapted to other thrie beam approach guardrail transitions. Small adjustments in rail height for the upstream stiffness transition may be necessary to match previously-approved approach guardrail transitions, such as those with heights of 31⅝ in. (803 mm).

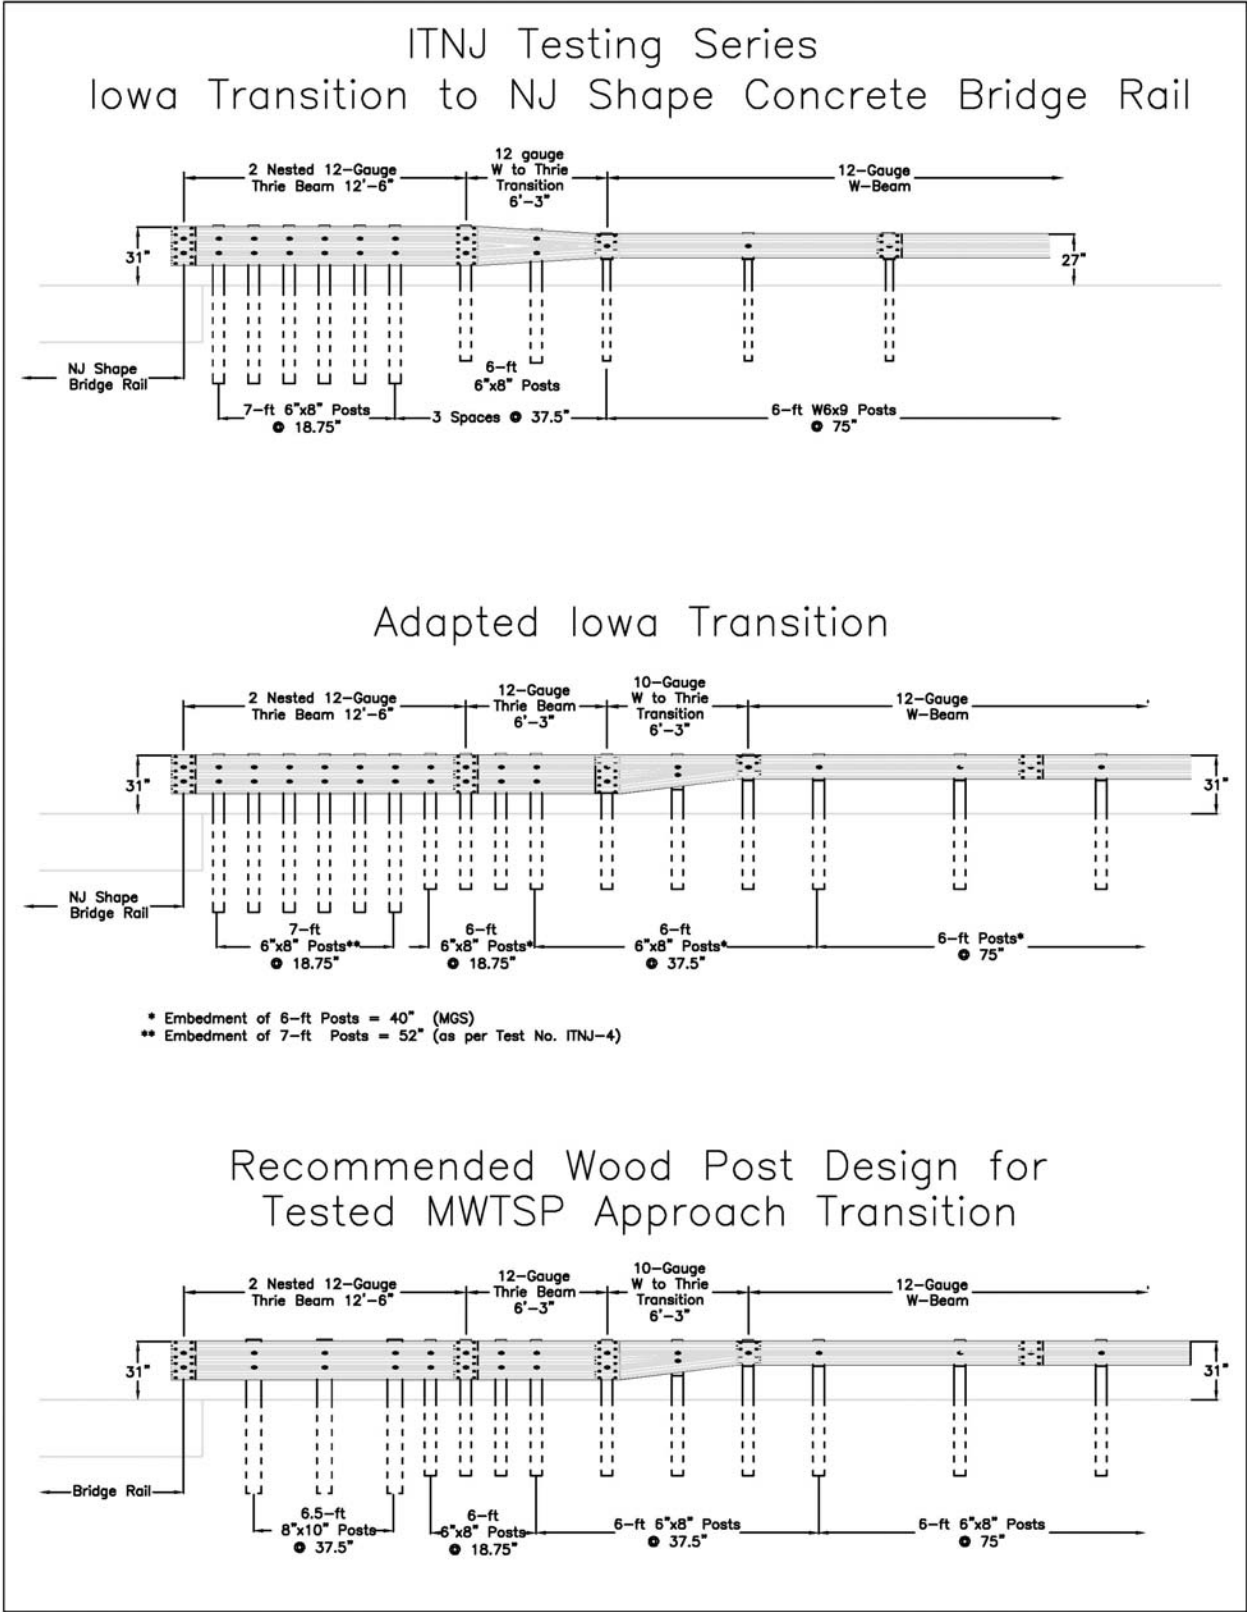
Figure 57. Approach Iowa Transition to NJ Shape Concrete Parapet [17-20]

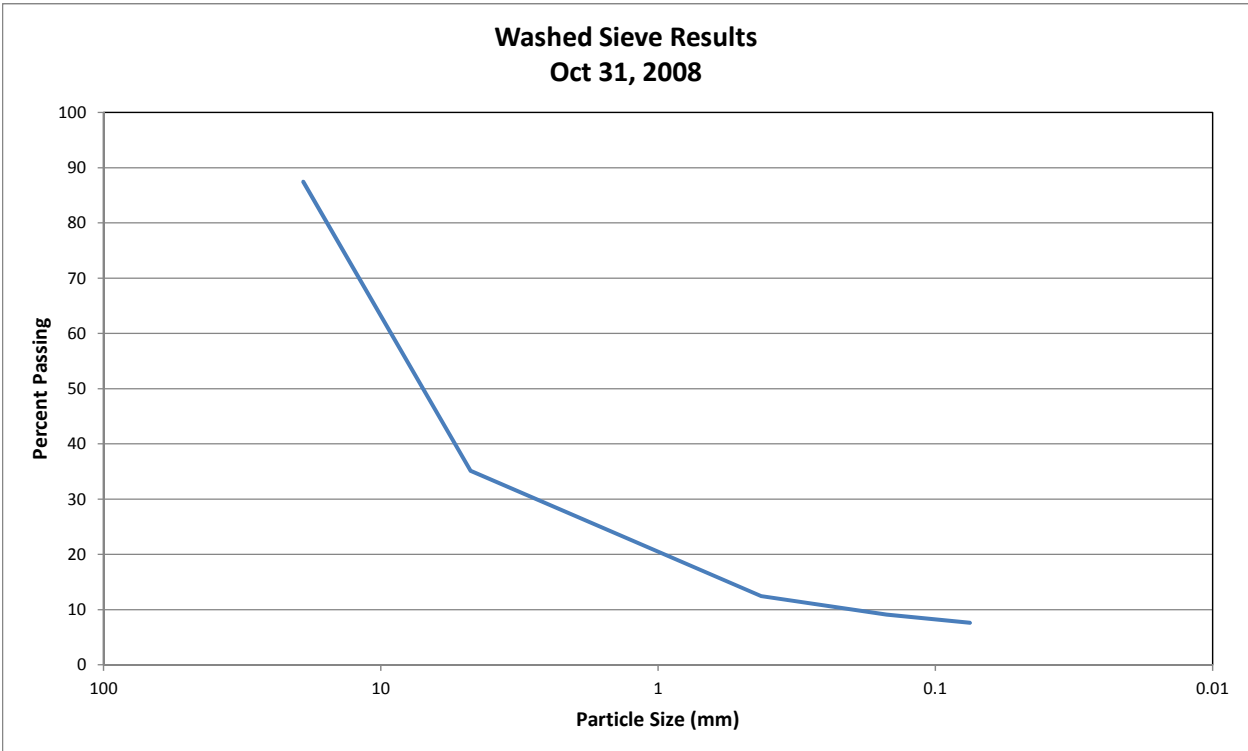
Figure A-2. Sieve Analysis for MGSATB-5 through MGSATB-8

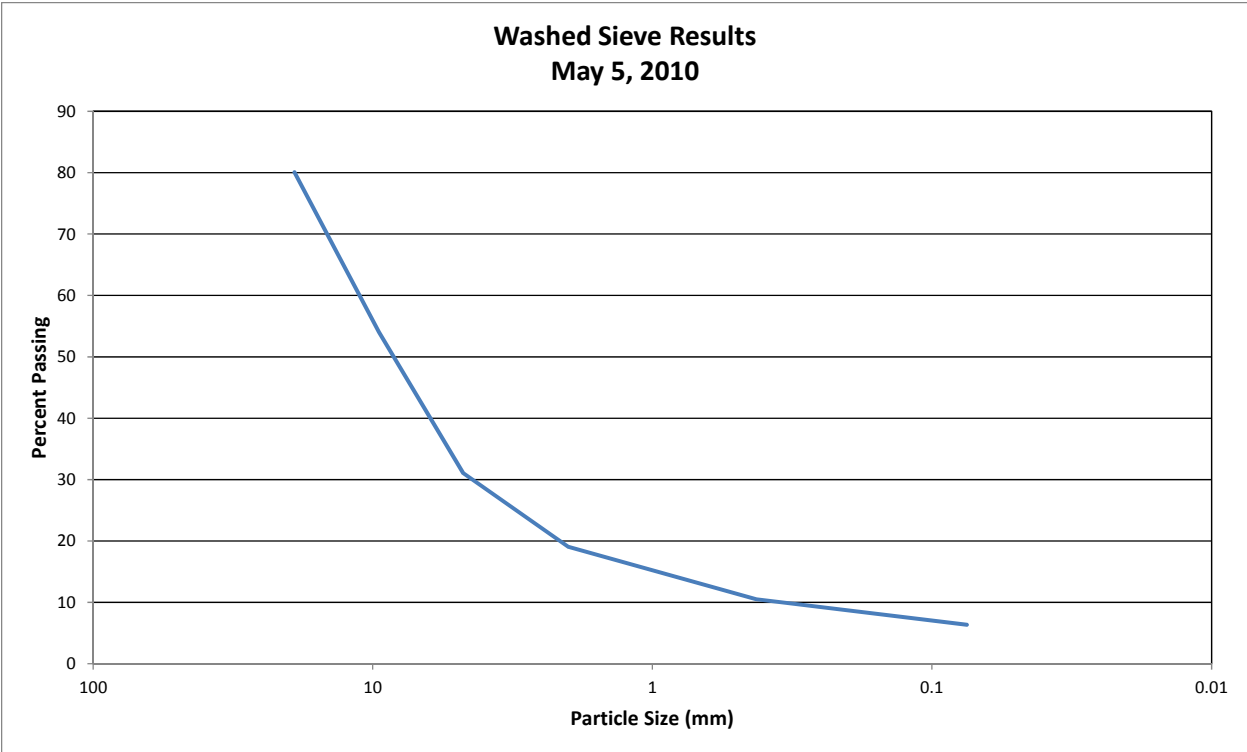
Figure A-4. Sieve Analysis for MGSATB-18 Through MGSATB-20.

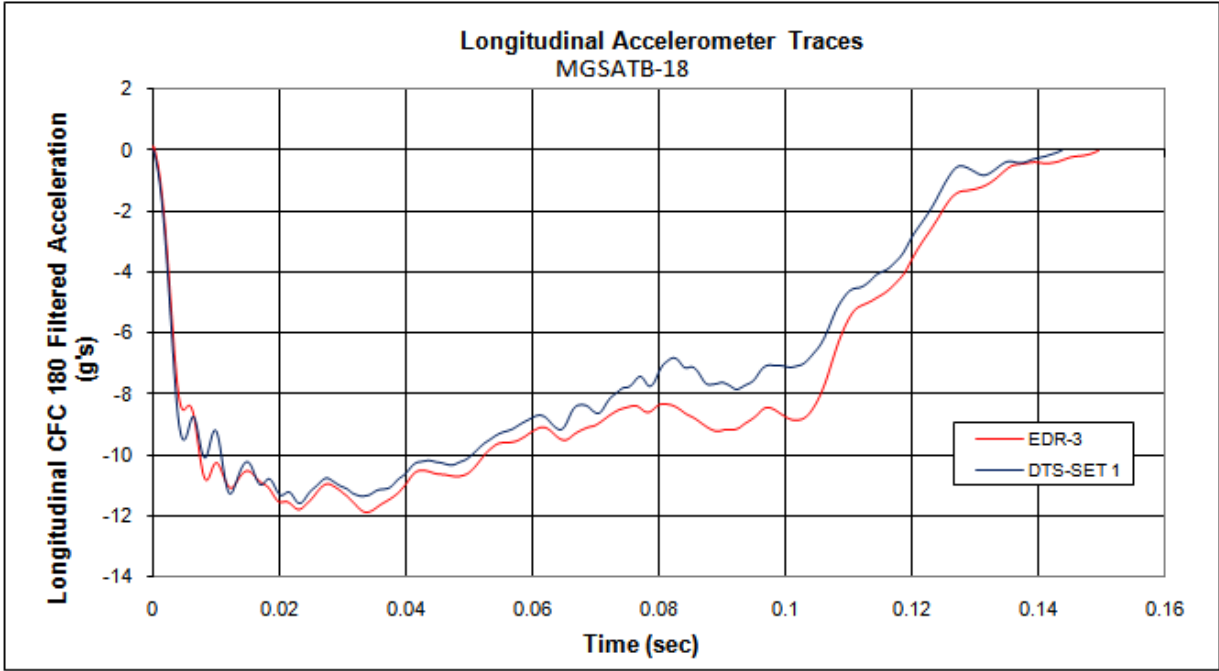
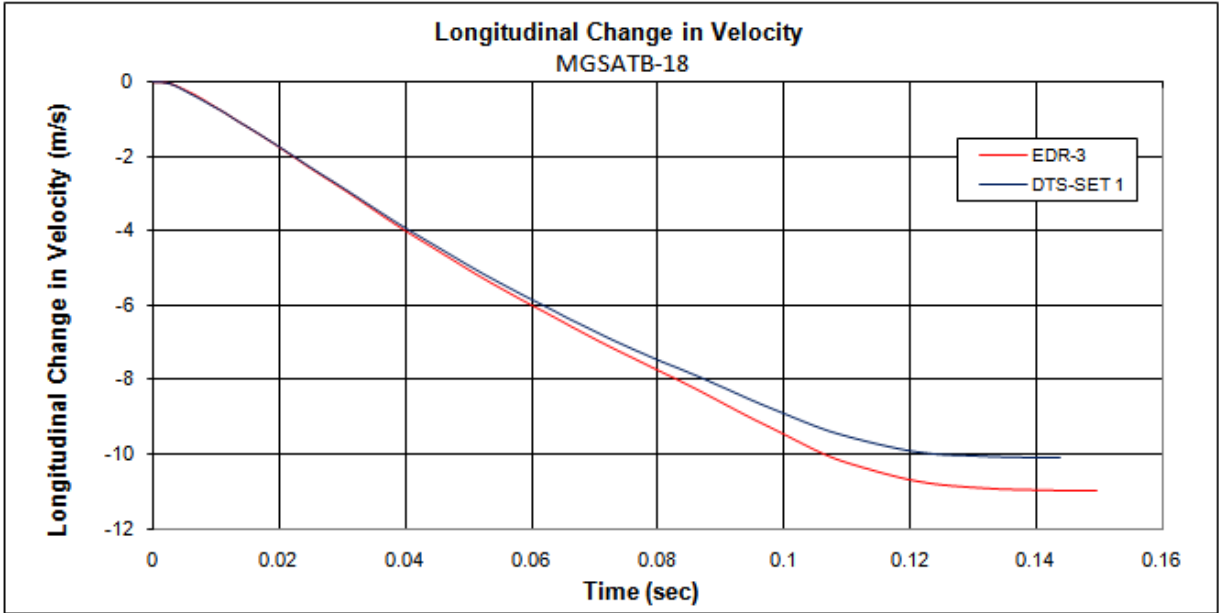
DTS	EDR-3	% Difference
Final ΔV :	10.12	10.97	8.40%

Figure B-1. EDR-3 and DTS Equivalency Comparisons, Test No. MGSATB-18

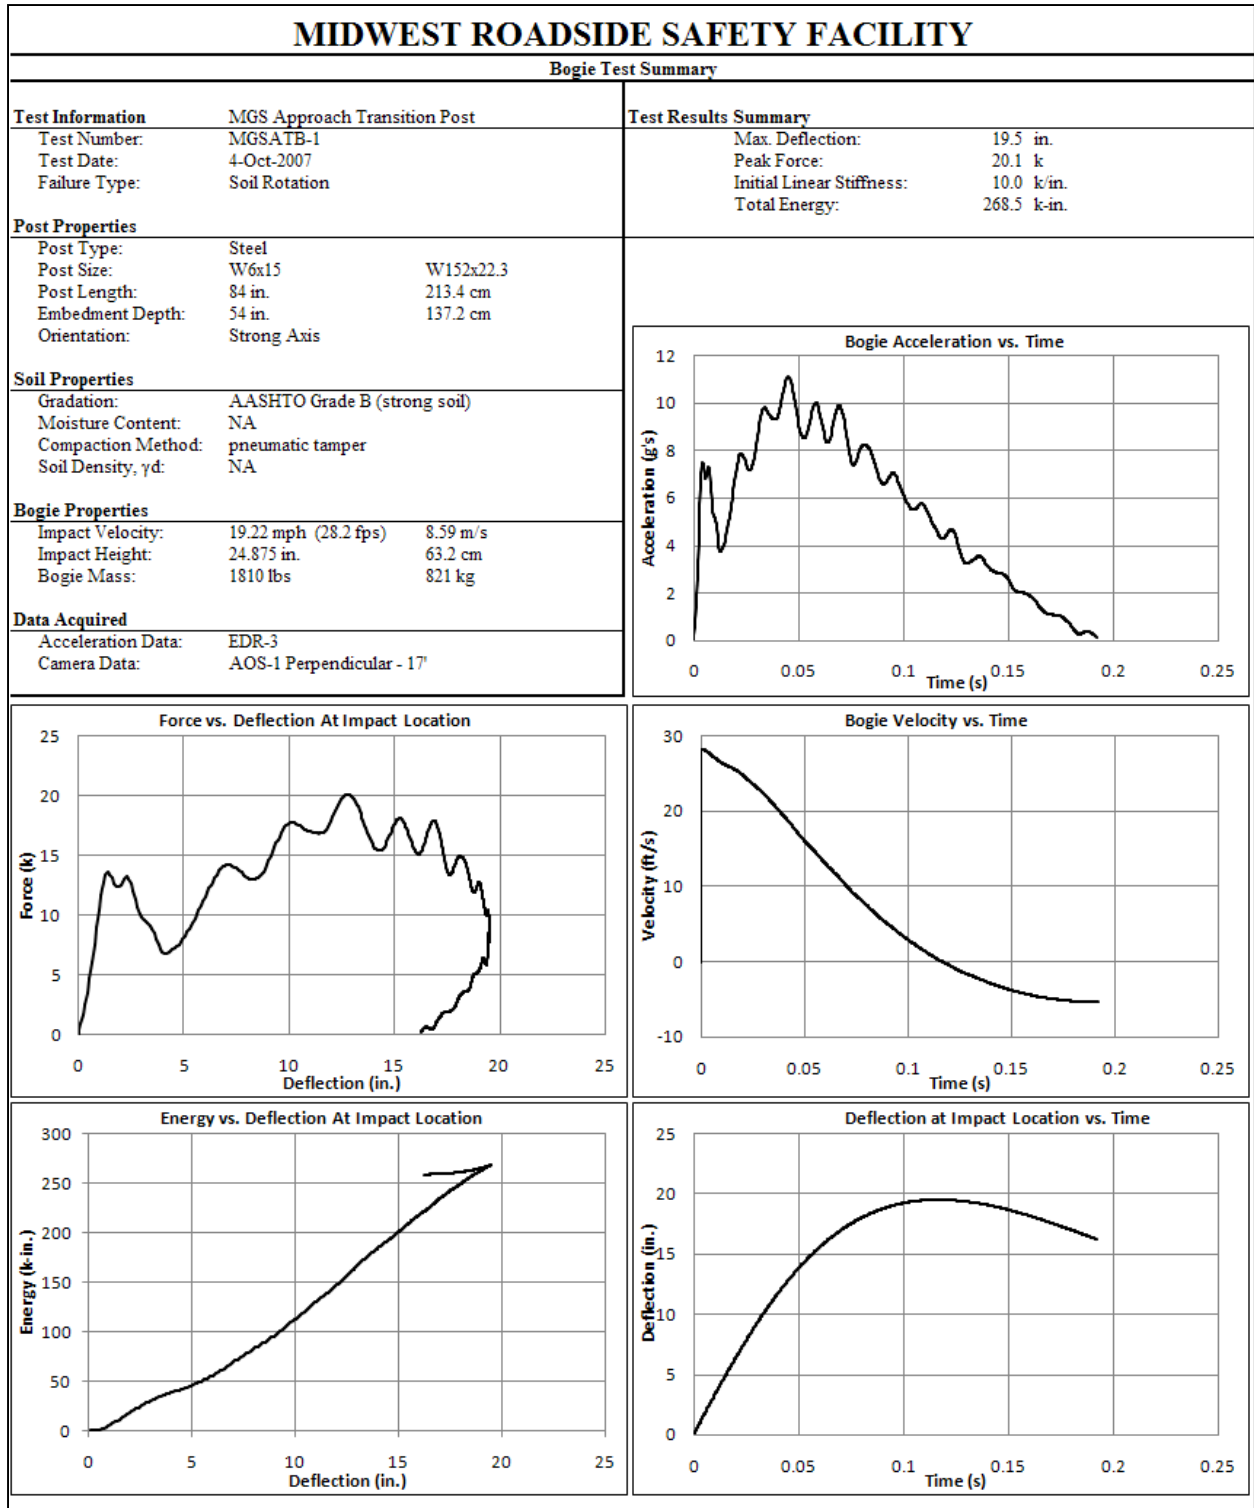
Figure D-1. Results of Test No. MGSATB-1 (EDR-3)

The results of the recorded data from each accelerometer used during the dynamic bogie test are provided in the summary sheets found in this appendix. Summary sheets include acceleration, velocity, and displacement versus time plots as well as force and energy versus displacement plots.
