### Dynamic Testing of Wooden Guardrail Posts - White and Red Pine Species Equivalency Study

*Midwest States' Regional Pooled Fund Research Program  
Fiscal Year 1996-1997 (Year 7)  
NDOR Research Project Number SPR-3(017)*

**DYNAMIC TESTING OF WOODEN GUARDRAIL  
POSTS - WHITE AND RED PINE SPECIES  
EQUIVALENCY STUDY**

**MIDWEST ROADSIDE SAFETY FACILITY**

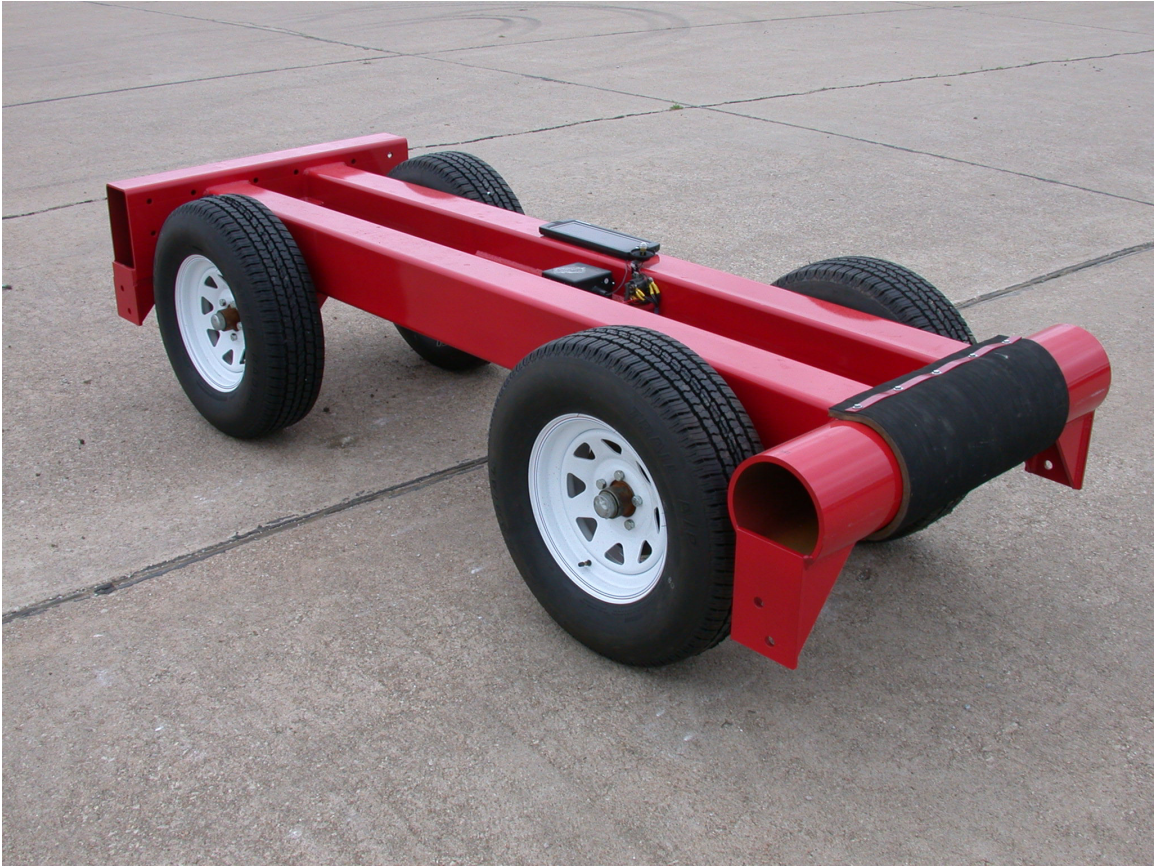
**Figure 2. Rigid Frame Bogie**

A rigid-frame bogie was used to impact the posts. An impact head, made of a 203-mm (8-in.) diameter, 12.5-mm (0.5-in.) thick standard steel pipe, was mounted to the bogie with its horizontal centerline 550 mm (21.65 in.) above the ground. Neoprene belting, 19-mm (0.75-in.) thick, was attached to the steel pipe to minimize the local damage to the post from the impact. The bogie is shown in Figure 2.

The bogie weight was 611 kg (1,346 lbs). Calculations and computer simulations prior to testing indicate that this weight, in combination with a velocity of approximately 32 km/h (20 mph or 8.9 m/s) closely replicates the actual impact conditions that a post as part of a guardrail system would be subjected to in a 100 km/h (62.14 mph) and 25-degree impact with a 2,000-kg (4409-lb) test vehicle.

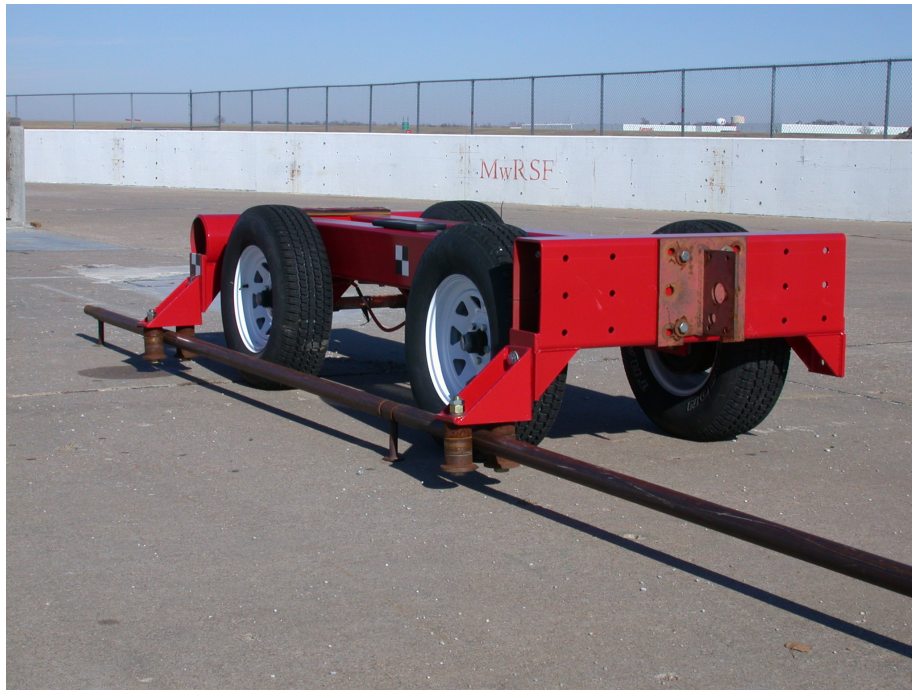
**Figure 4. Bogie Positioned in the Guide Track Configuration**

The tests were conducted using a bogie guidance system developed at MwRSF. This system consists of steel pipe supported and anchored by stanchions placed in the concrete every 3.05 m (10 ft). The bogie vehicle is equipped with bearings at the front and back wheels. These bearings surround the pipe keeping the bogie traveling in the direction of the pipe. A pickup

truck with a cable system was used to tow the test vehicle, accelerating it to the required impact velocity, at which point the cable was released, allowing the bogie to roll free as it came off the guide track. The bogie positioned on the guide track can be seen in Figure 4.

The bearings guided the bogie into the posts to ensure the proper impact direction and position. A remote braking system was installed on the bogie to allow the bogie to be brought safely to a stop after the test. The accelerometer, located at the bogie's center of gravity, records lateral, horizontal and vertical acceleration data.

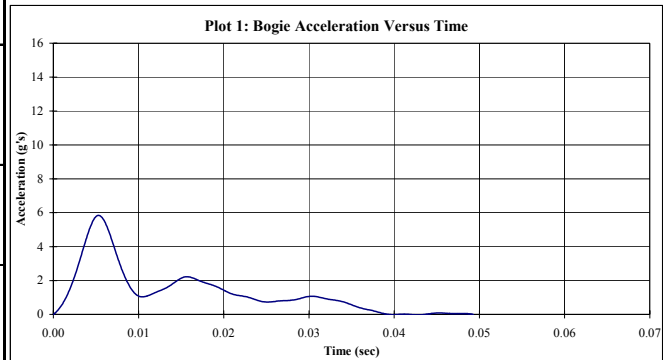
**Figure 9. Results of WP-1**

Bogie Test Summary	
<b>Test Information</b>	
Test Number:	Deep Axis Impact @ 0 degrees WISC WP-1
Test Date:	30-Jun-2003
Failure Type:	Very random splinters on fracture line, splinters are fairly short, break occurs at ground level
<b>Post Properties</b>	
Post Type:	sconsin White Pine
Post Size:	15.2 cm x 20.3 cm metric      6" x 8"
Post Length:	182.9 cm      (72.0 in)
Embedment Depth:	96.5 cm      (38.0 in)
<b>Soil Properties</b>	
Gradation:	Steel Sleeve
Moisture Content:	NA
Compaction Method:	NA
Soil Density, $\gamma_d$ :	NA kg/m <sup>3</sup> #VALUE!
<b>Bogie Properties</b>	
Impact Velocity:	8.8 m/s      (19.6 mph) (28.8 fps)
Impact Location:	55.0 cm      (21.7 in) above groundline
Bogie Mass:	611 kg      (1346 lbf)
<b>Data Acquired</b>	
Accelerometer Data:	EDR-4
Camera Data:	Side View-Digital
