DEVELOPMENT AND EVALUATION OF BEST MANAGEMENT PRACTICES (BMPS) FOR HIGHWAY RUNOFF POLLUTION CONTROL

Project Number: SPR-1(12)M314

Nebraska Department of Roads (NDOR)

FINAL REPORT

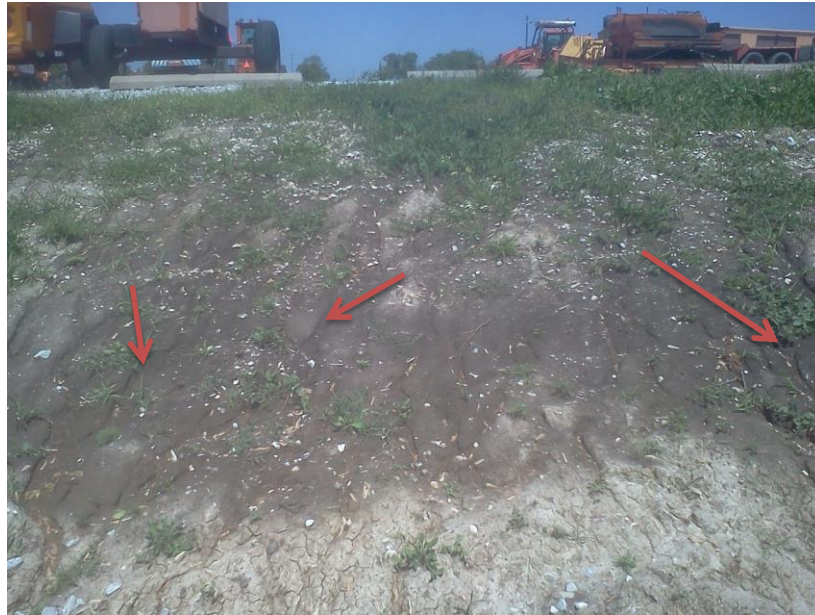
Figure 2.20 Filter trench side slope rills

fencing installed along the bottom of the slope. Because no baseline measurement was taken, accurate monitoring of these rills was not accomplished. In the future, monitoring of rills can be done by counting the number of rills and measuring their size and length to get a volume of soil eroded, which can also be linked with rain events if such measurements are done before and after the rain events.

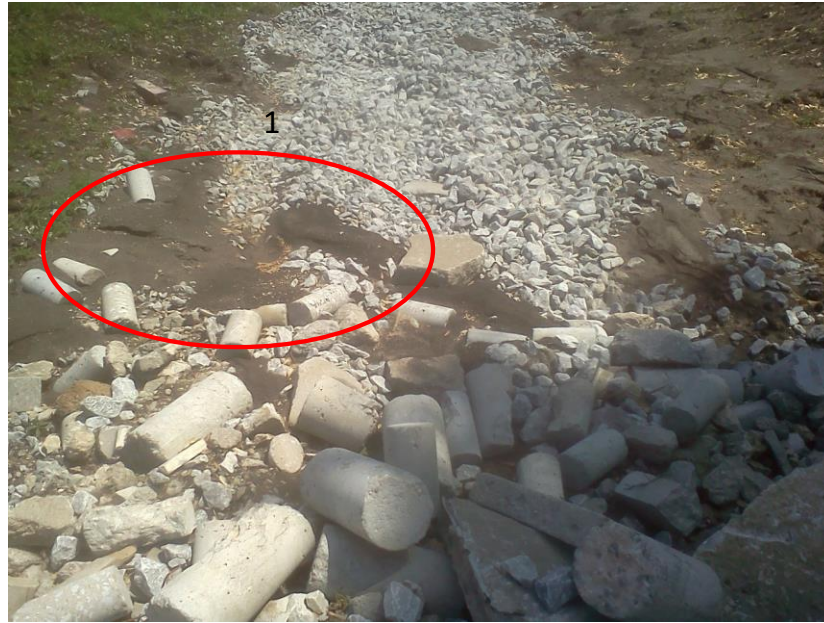
Figure 2.21 Filter trench sediment buildup on armorings and check dams

By the end of the observation period, weeds (cycle 2) and plants (cycle 1) were growing in the accumulated sediment (Figure 2.22). The amount of sediment buildup was enough to sustain root establishment in the trench. The clogging and plant growth can prevent water from being able to enter the trench. The best effort to prevent vegetative growth on the rock covering of the trench is to prevent organic matter or sediment buildup. It may be more feasible to build a BMP designed with a fast infiltrating top layer that support plant growth which would improve infiltration rates and stabilize the plant roots would BMP.

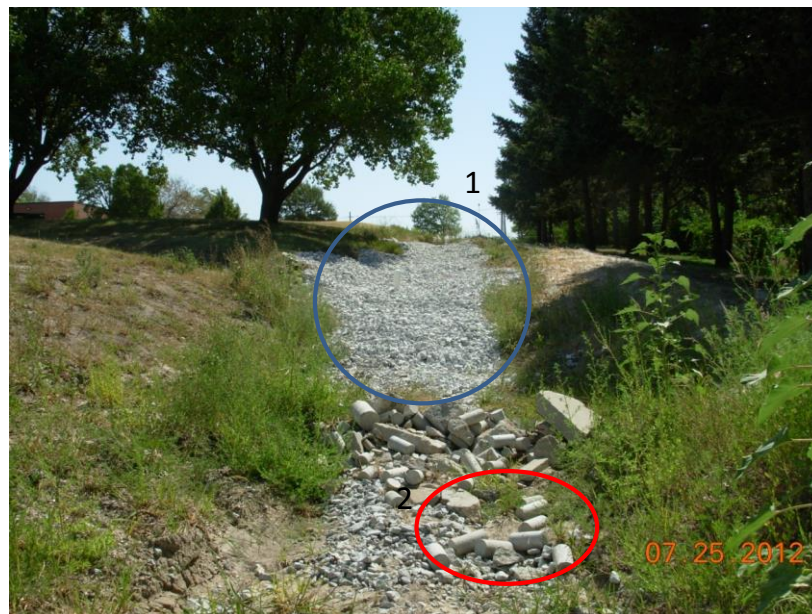
Figure 2.24 Filter trench added 1-3 inch rock at beginning and check dam material migration (water flow direction: from the top to bottom of the picture)

Flows in the ditch were high because evidence shows that some of the check dam material (used concrete core samples) was being washed or moved down slope (shown in the red circle in Figure 2.24). This is a good example that concrete debris (i.e. used core samples and broken concrete) is not as useful as rip rap because the shape of the concrete debris is not irregular or interlocking like rock brought in from a quarry. The force of water can move this concrete debris more easily.

Some problems arose related to the structural integrating of the filter trenches setup. Undermining occurred at the beginning of the trench, creating a hole as shown in Figure 2.23. This problem was mitigated by adding more rock material up to the top of the ditch as shown in the blue circle where the hole was located at the bottom of the blue

circle Figure 2.24. The knowledge gained from this situation is that the armoring needs to extend above the beginning of the trench or the trench needs to start at the pipe outlet to the ditch. Undermining also occurred at a couple spots along the trench as shown in Figure 2.25. This is thought to be from higher than expected flow velocities within the pea gravel filter media eroding the sides of the underground trench. This could be fixed by filling the hole with 1-3 inch rock or in the design of the trench by using smaller treatment media to slow the filter flow rate.

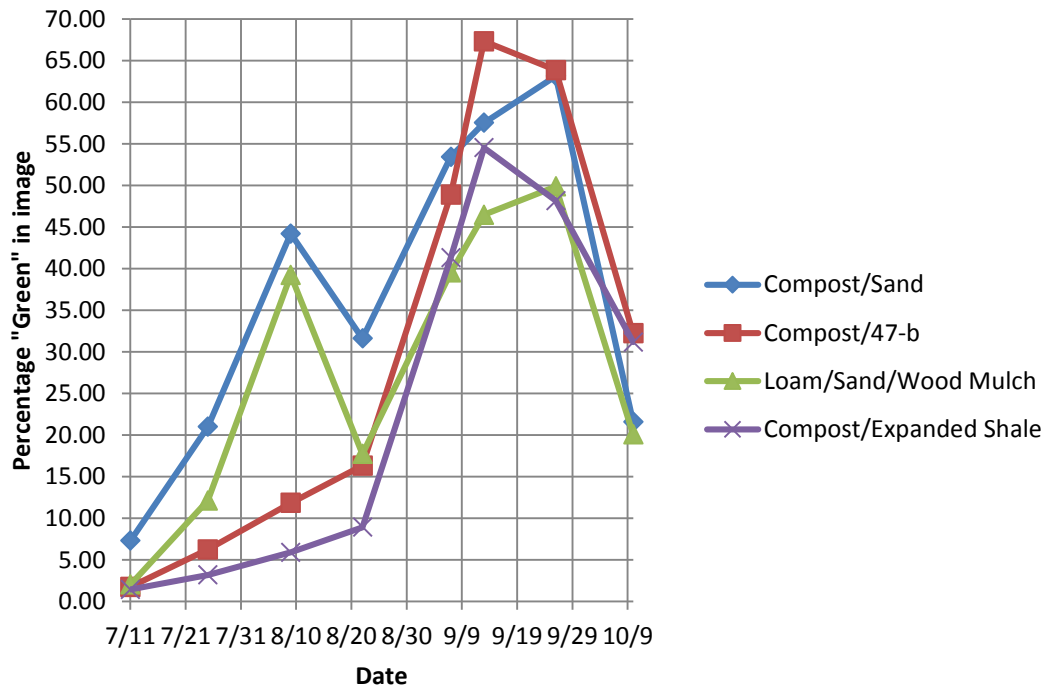
Figure 2.26 Percent of image that is green from Image J analysis

Test plot	Date							
	7/11	7/25	8/9	8/22	9/7	9/13	9/26	10/10
Compost/sand = 50/50	7.29	20.98	44.20	31.60	53.43	57.53	63.15	21.55
Compost/47-B = 40/60	1.73	6.22	11.82	16.30	48.88	67.33	63.85	32.21
loam/sand/wood mulch = 30/50/20	2.02	12.11	39.23	17.70	39.53	46.48	49.88	20.06
compost/expanded shale 33/66	1.42	3.17	5.88	8.91	41.32	54.52	48.16	31.17

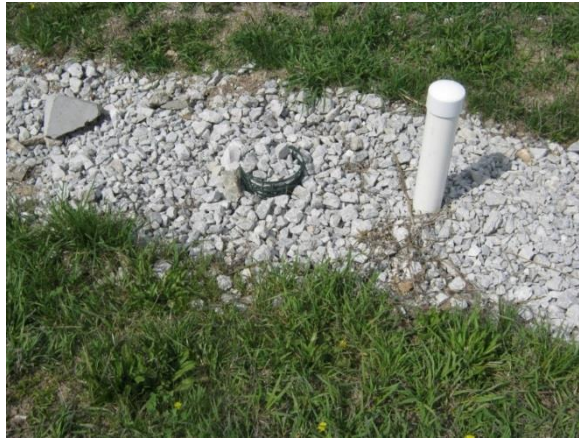
Figure 3.8 Upstream infiltration trench basket rock and observation well

the basket was 0.002905 m^3 , resulting in a bulk porosity of $0.285 \text{ m}^3/\text{m}^3$. The baskets were deployed on 4/20/13 and were collected on 6/20/13, and then deployed again on 4/21/13 and collected on 8/9/13. The collection and extraction process involved taking the baskets back to the lab where the rocks were washed with 2 liters of de-ionized water and rubbed with a brush. The 2 liters of washing water was then evaporated at 105° C in an oven and the mass of the residue was determined.

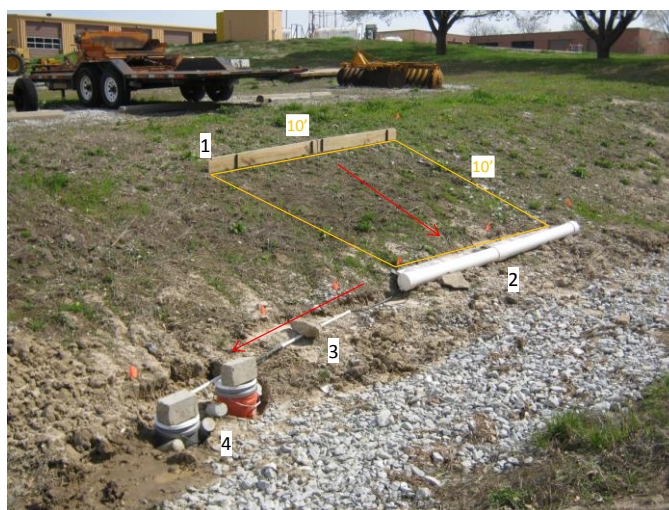
Figure 3.10 Filter trench side slope TSS collector setup

a device was designed as per Ming-Han et al. (2010) and built to monitor the TSS loading from the side slope of the filter trench (Figure 3.10). A 10 ft by 10 ft area of the side slope was sectioned by a board (1) on the uphill slope, and a 6-inch PVC pipe (2) with a collection slot cut into it on the downhill slope. Once water and sediment collected in the 6 inch pipe (2) it traveled through 1- inch tubing (3) to two covered five gallon buckets (4) for collection. The buckets were collected after each or multiple storm events and taken back to the lab for TSS testing per EPA method 2540 D. Figure 3.11 shows the rain events and dates for sampling side slope TSS.
