4th International Conference on the Durability of Concrete Structures
24–26 July 2014
Purdue University, West Lafayette, IN, USA

Flexural Behavior of RC Beams Under Combined Effects of Acid–Salt Mist and Carbon Dioxide

Wu Yuan-Zhou, Lv Heng-Lin, and Fang Zhong-Nian
Jiangsu Key Laboratory of Environmental Impact and Structural Safety in Engineering,
School of Mechanics and Civil Engineering, China University of Mining and Technology

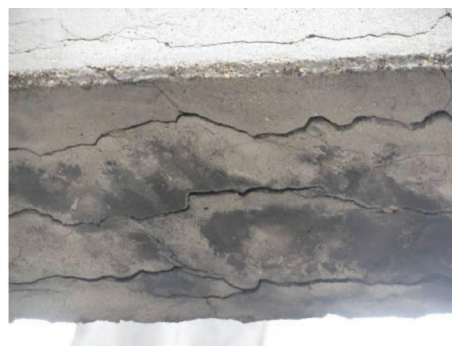
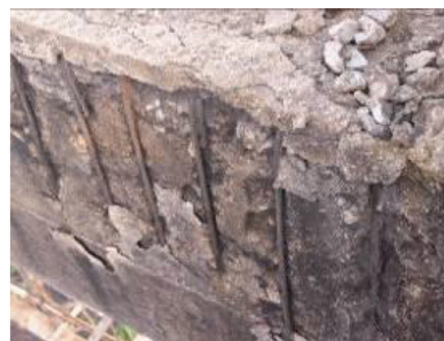
Figure 1. Deterioration of RC beams serving in CGE. (a) Cracks on the bottom of beam with 13 years service. (b) Exfoliation on the side of beam with 21 years service.

Each kind of corrosive medium led to the deterioration of the concrete and rebar, and to coupling. The acidic gases corroded the concrete and formed corrosion pitting on the surface of the concrete or even made it peel off, which facilitated the invasion of liquid. The mediums in the liquid corroded the concrete and rebar, producing cracks in the concrete, and conversely benefitted the gases. CaCl_2 produced by the reaction dissolved in the water on the surface and led to further deterioration. Figure 1 indicated the deterioration of RC beams serving in the CGE.

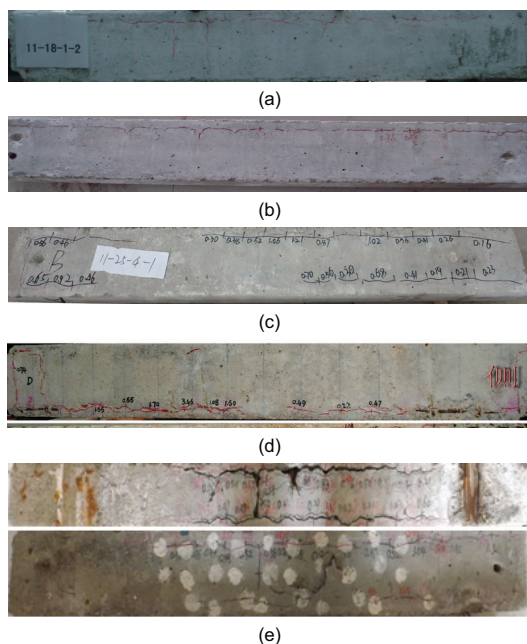
Figure 4. Deterioration characteristics of RC beams. (a) after two cycles. (b) after four cycles. (c) after five cycles. (d) after six cycles. (e) after seven cycles.

Only some rusty spots of stirrup appeared after first cycle, but the cracks caused by expansion of rusty hanger bars appeared on the sides of beam specimens after two cycles, about one-third of the length of beam with the maximum width of 0.60 mm. There was no obvious change happened until the fourth cycle when the cracks caused by expansion of corroded rebar appeared on the sides and bottom of beam specimens, less than half of the specimen with the maximum width of 1.20 mm. Meanwhile the cracks caused by rusty hanger developed to almost the same length of the specimen with the maximum width of 0.72 mm. After five test cycles, the cracks on the sides of the specimens caused by expansion of corroded hanger bars and rebar reached the length of specimens, with the maximum width of 0.74 and 1.39 mm, respectively. Since the sixth test cycle, the length of cracks on the sides and bottom of the specimens were all reached that of specimens, and the maximum width of the crack caused by corroded rebar reached 3.46 mm, with the corroded rebar being seen clearly from the cracks. Some protective concrete layer of rebar began to peel off after seven test cycles because of the development of cracks, and then the maximum width of measurable cracks were nearly 2.00 mm.

The appearance of deteriorated beam specimens after each test cycle was indicated in Figure 4.

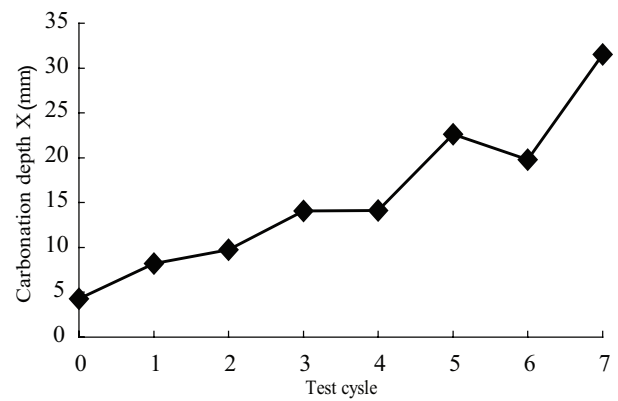
Phenolphthalein alcohol solution with the concentration of 1% was sprayed on the side surface of concrete cores, and the length of the end of the core to the interface where the color of concrete changed was taken as the carbonation depth. The test results were indicated in Figure 6, where the 0 cycle referred to the state just before the experimental investigation. Because being placed in the air about half a year, the original data was not zero.

The carbonation depth was about linearly developed at the initial six cycles, until the development became rapid at the seventh cycle. The carbonation process and influence of hydrochloric acid and sulfate should be blamed for it.

Figure 6. Development of carbonation depth.

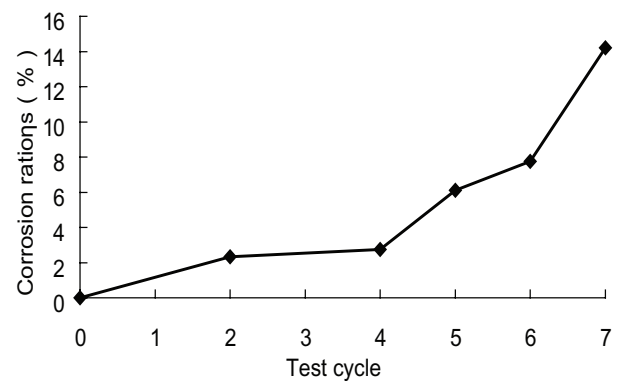
After the failure of beam specimens, corroded steel bars cut out, and the average corrosion rate was tested with weight method. The results of all the cycle were exhibited in Figure 7.

Figure 7. Corrosion of rebar.

Similarly to the growing trend of neutralization depth, the corrosion rate grew linearly with the deterioration time and correlation coefficient of 0.85. The value of sixth cycle was approximately equal to the result got from the project with 20–30 years' service.

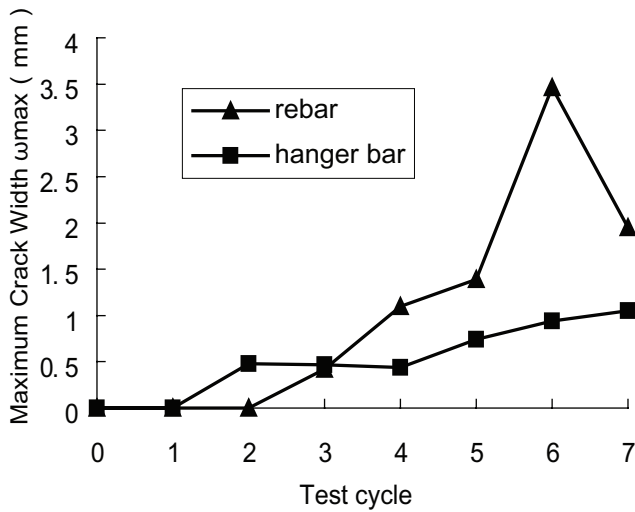
The corrosive crack on the surface of the beam specimens was detected with ZBL-F103 crack width observation instrument and the average results were exhibited in Figure 8.

The corrosive cracks appeared along the distribution of hanger bar and longitudinal steel bar after two and three cycles, respectively. Both of them have linear growth trend with the correlation coefficient of 0.88, but the latter grew slowly until the fifth cycle compared with the former. The crack caused by corroded longitudinal steel bar has a similar growth trend as the corrosion ratio, but the rate (slope) of the former is relatively small. The maximum crack widths along the

distribution of longitudinal steel bars on the corroded beam specimen after six deterioration cycles were close to the data got from the RC beams serving in the CGE for 20–30 years.

Figure 8. Development of corrosive cracks.

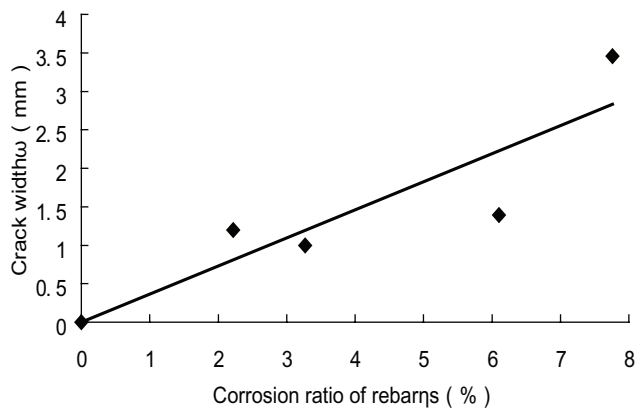
As shown in Figure 9, the maximum width of the corrosive crack along the longitudinal steel bar was marked corresponding to the corrosion ratio.

Figure 9. Relationship between crack width and corrosion ratio.

Large discreteness existed between the crack width and corrosion ratio. Besides the inhomogeneity of concrete, three other factors influenced them, including the corrosion ratio of steel bars and deterioration degree of concrete and the cohesive action between them. With the increase of the corrosion ratio, the expansion crack grew. As the deteriorated concrete became loose, local pores inside the concrete were extruded by the corroded steel bars, slowing down the development of the crack until the corrosion ratio increased to higher degree. Meanwhile, the corrosion of steel bars and

deterioration of concrete caused the great decrease of cohesive action between them. After the crack width grew to a certain value, it would never increase again in spite of the growth of the corrosion ratio.

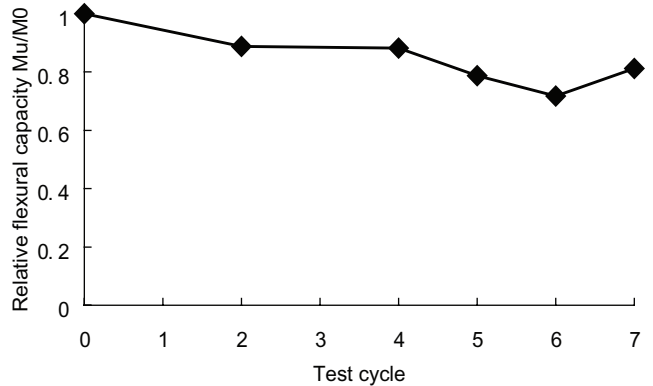
The ultimate flexural carrying capacity of deteriorated beam specimens got from the bending test was exhibited in Figure 10.

Figure 10. Degradation of flexural capacity.

The degradation of flexural capacity of beam specimen indicates approximately linear trend with the correlation coefficient of 0.9377. Both the yield capacity and ultimate capacity decreased slowly at first and then rapidly as the growth of deterioration decreased. Only 10% was lost after four cycles, but the value exceeded 20% after a cycle later.

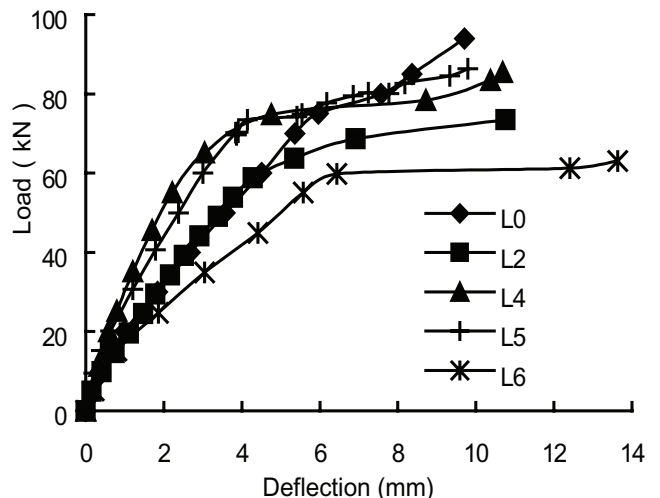
In each deterioration cycle, the curve of load-deflection was similar to the original, including three stages, as shown in Figure 11. The inflection points on the curve referred to the cracking load and yield load.

Figure 11. Curve of load-deflection.

As the test cycle increased, the slope of the curves decreased, due to which the elastic modulus of the deteriorated beam specimens reduced against the increase of the deterioration time, which also explained the reason for the rigidity loss. On the other hand, the increase of crack width caused the decrease of effective area of the beam specimen, and then the carrying capacity decreased.

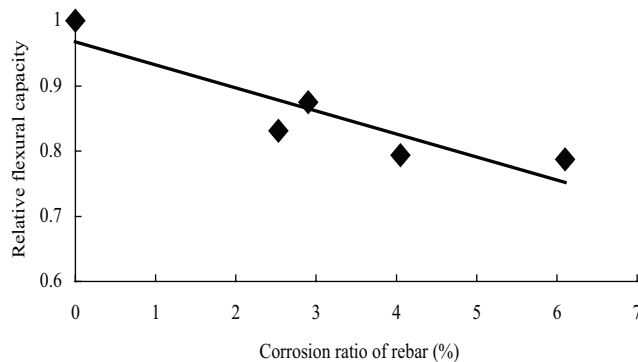
As shown in Figure 12, the relative flexural capacities of deteriorated beam specimens were marked corresponding to the corrosion ratio.

Figure 12. Relationship between flexural capacity and corrosion ratio.

The relationship between flexural capacity and corrosion ratio can be induced by the formulas shown in Equation (1):

$$M_{us}/M_{u0} = -0.0353\eta_s + 0.9674 \quad (1)$$

where M_{us} and M_{u0} are ultimate load borne by deteriorated and original beam specimens, respectively (unit: kN·m); η_s is the corrosion ratio. Because of the loss of sectional area caused by deterioration is ignored, the formula cannot be applied to calculate the ultimate carrying capacity with the data of actual sectional area of beam, corrosion ratio, and the cohesive action between the deteriorated concrete and corroded steel bars.
