Fatigue and Fracture Library for the Inspection, Evaluation, and Repair of Vehicular Steel Bridges

Phil Fish, Curtis Schroeder, Robert J. Connor, Phil Sauser

Fish, P., Schroeder, C., Connor, R. J., & Sauser, P. (2015). *Fatigue and fracture library for the inspection, evaluation, and repair of vehicular steel bridges*. West Lafayette, IN: Purdue University. <http://dx.doi.org/10.5703/1288284315520>

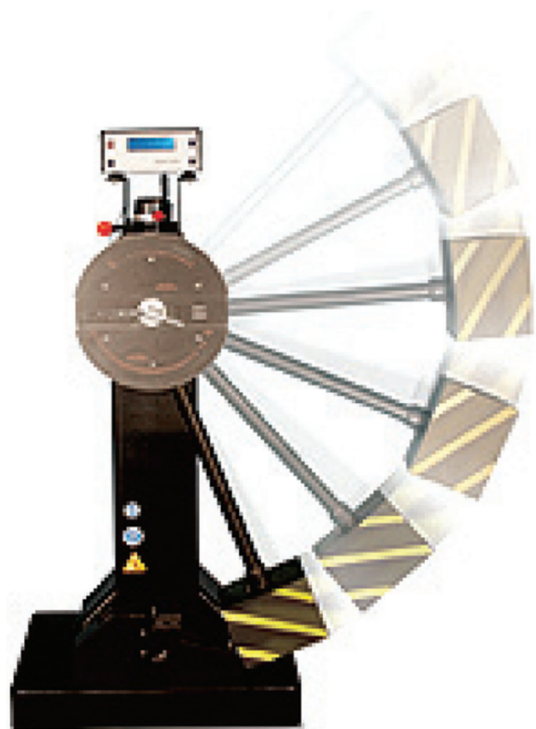
Figure 1.6 Charpy impact test apparatus (courtesy of AWS).

In the production of structural steel, the Charpy V-Notch (CVN) test is used to qualitatively infer fracture toughness as it is not a direct measure of toughness, but rather energy absorption. CVN testing is a standardized, high strain-rate test to determine how much energy a material may absorb before fracture occurs. This method, described in ASTM E23, involves a hammer apparatus which swings into a notched specimen as shown in Figure 1.6. (Videos showing CVN impact testing can be viewed at <http://dx.doi.org/10.4231/R7H41PC8> and <http://dx.doi.org/10.4231/R74T6G98>.) As stated, although

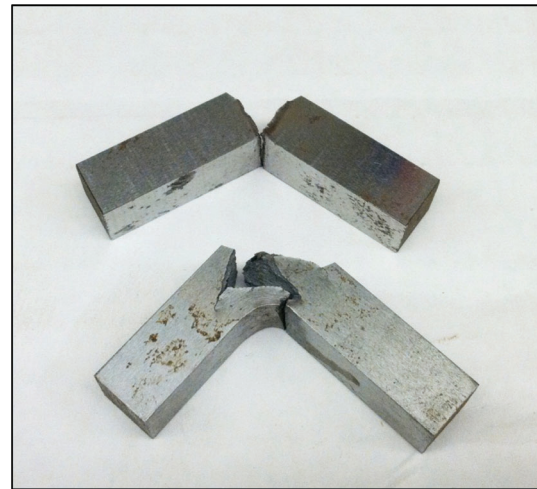
Figure 1.8 Brittle and ductile fracture of CVN specimens.

Going from lower to higher temperature, the steel undergoes a brittle-to-ductile transition in fracture behavior. The plot displays two shelves or regions of relatively constant toughness. The lower shelf is associated with brittle fracture and low plastic deformation of the specimens. The upper shelf is associated with ductile fracture, also called ductile tearing, along with significant plastic deformation and large shear lips on the fracture surface. A transition zone occurs between the upper and lower shelf where the fracture mode is not purely brittle or ductile. Large variability is typical in the transition zone where some specimens show brittle behavior while others show ductile behavior. For some steels, the transitional zone occurs over a short temperature range, such as the Charpy curve shown in Figure 1.7. Other steels exhibit transitional fracture over a wider temperature range resulting in a lower slope for the transition curve. Figure 1.8 shows the difference between brittle behavior (top) and ductile behavior (bottom) for two different CVN specimens.

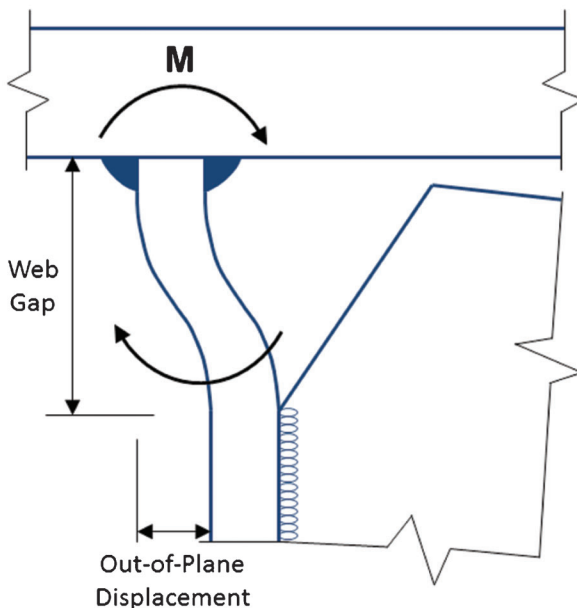
Figure 1.10 Distortion-induced cracking.

Other common issues that are not covered by the fatigue categories are out-of-plane bending which leads to distortion-induced cracking. One type of distortion cracking is driven by out-of-plane bending over a small web gap as shown in Figure 1.10. (A video of an out-of-plane distortion crack observed during a laboratory test can be viewed at <http://dx.doi.org/10.4231/R7125QKV>.) Another example is moments introduced on longitudinal gusset plates used to attach lateral bracing members to web plates. The forces driving the distortion can be either load induced or due to differential thermal

expansion of bridge components. Although the current specifications contain guidance on minimizing distortion-induced cracking, many existing bridges (of pre-1984 design) contain details which are susceptible to this type of cracking. Many of the fatigue cracks found in earlier vintage bridges can be attributed to failure to control distortion.

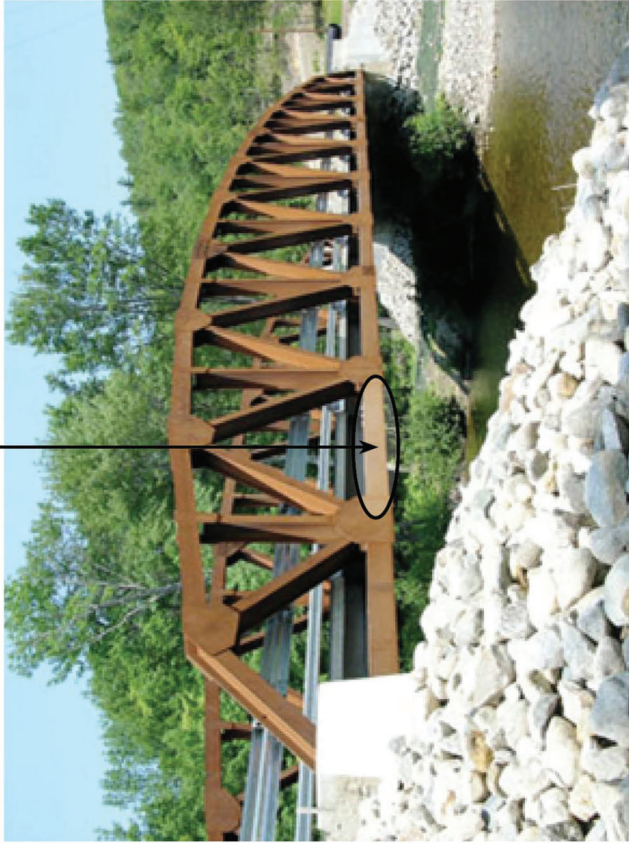
Photo B

AASHTO Fatigue Detail	
Description	1.1 (Steel) & 1.2 (Noncoated Weathering Steel) This detail applies to the base metal with rolled or cleaned surfaces, designed and detailed in accordance with FHWA (1989). Flame-cut edges with surface roughness value of 1,000 μ-in. or less, but without re-entrant corners.
Detail Category	Steel, A Noncoated Weathering Steel, B
Visual Inspection	<ul style="list-style-type: none"> Inspect for cracks, corrosion, and section loss in base metal away from all welds and details. Document crack locations and lengths. However, since the fatigue resistance of this detail category is high, cracking is unlikely.
NDT	<ul style="list-style-type: none"> Conduct MT and/or PT when cracks are suspected. Perform thickness measurements to measure section loss (calipers or UT).
Repair and Retrofit Recommendations	<ul style="list-style-type: none"> Drill holes at crack tips as a preventative measure, but inspection monitoring is still required. Conduct NDT to verify crack was arrested, and insert a pretensioned HS bolt assembly. Repair corroded areas as required. If the member is considered an FCM, cracks should be repaired immediately. If the member is not considered an FCM, crack growth may be monitored through special inspections.

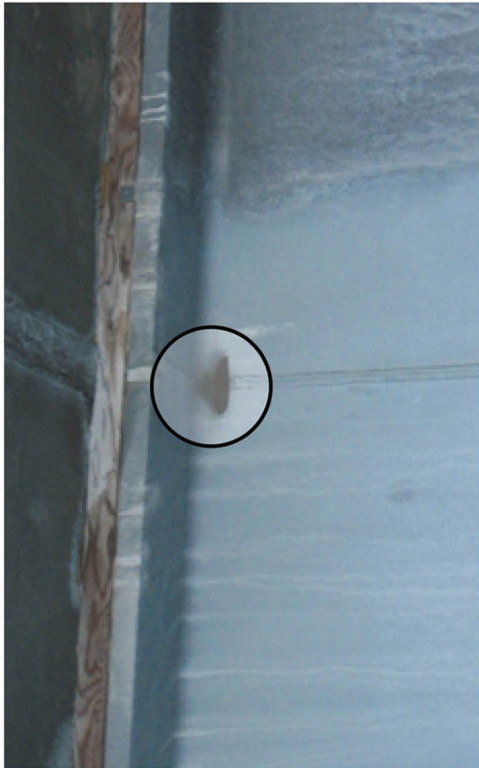
Photo A

Holes : Weld Access Holes

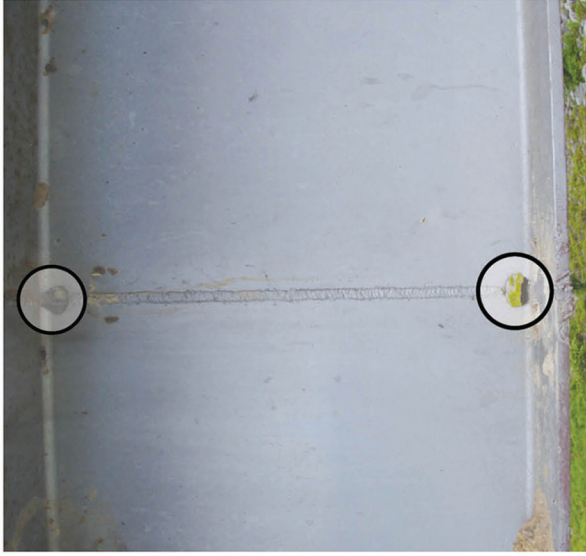
Photo B

BAD DETAIL,
R < 1" due to sharp corner

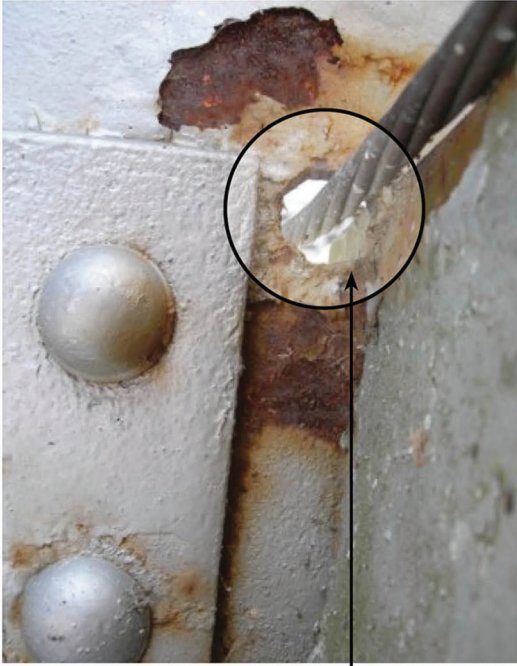
BAD DETAIL,
Sharp Edges not
ground smooth

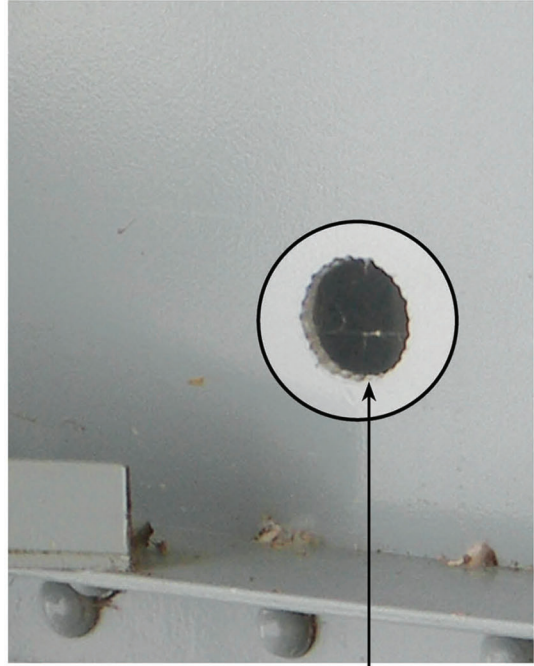
Open Holes

AASHTO Fatigue Detail	1.5
Description	Open holes in members.
Detail Category	Open hole, D
Visual Inspection	<ul style="list-style-type: none"> Inspect for cracks in the base metal in the net section originating at the side of the hole. Inspect that the holes have been ground smooth and edges of the holes are beveled with no notches present.
NDT	<ul style="list-style-type: none"> Conduct MT and/or PT when cracks are suspected.
Repair and Retrofit Recommendations	<ul style="list-style-type: none"> Grind any rough edges smooth. If discontinuities are identified from NDT, document crack locations and lengths and drill holes at crack tips as a preventative measure, but inspection monitoring is still required. Conduct NDT to verify crack was arrested, and insert a pretensioned HS bolt assembly. If possible, ream the hole to provide sufficient quality, insert a high strength bolt assembly of sufficient diameter into hole, and fully pretension, which will raise the fatigue resistance to Category B. If the member is considered an FCM, cracks should be repaired immediately. If the member is not considered an FCM, crack growth may be monitored through special inspections.

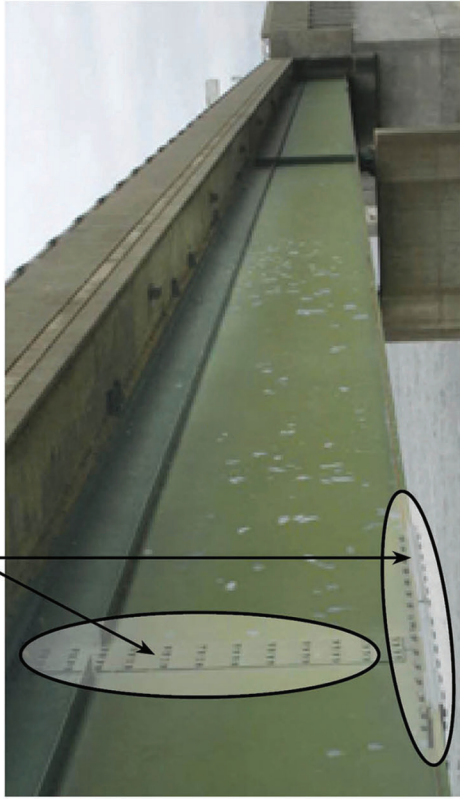
Photo A

Inspect for pack rust, loose bolts, and bent plates

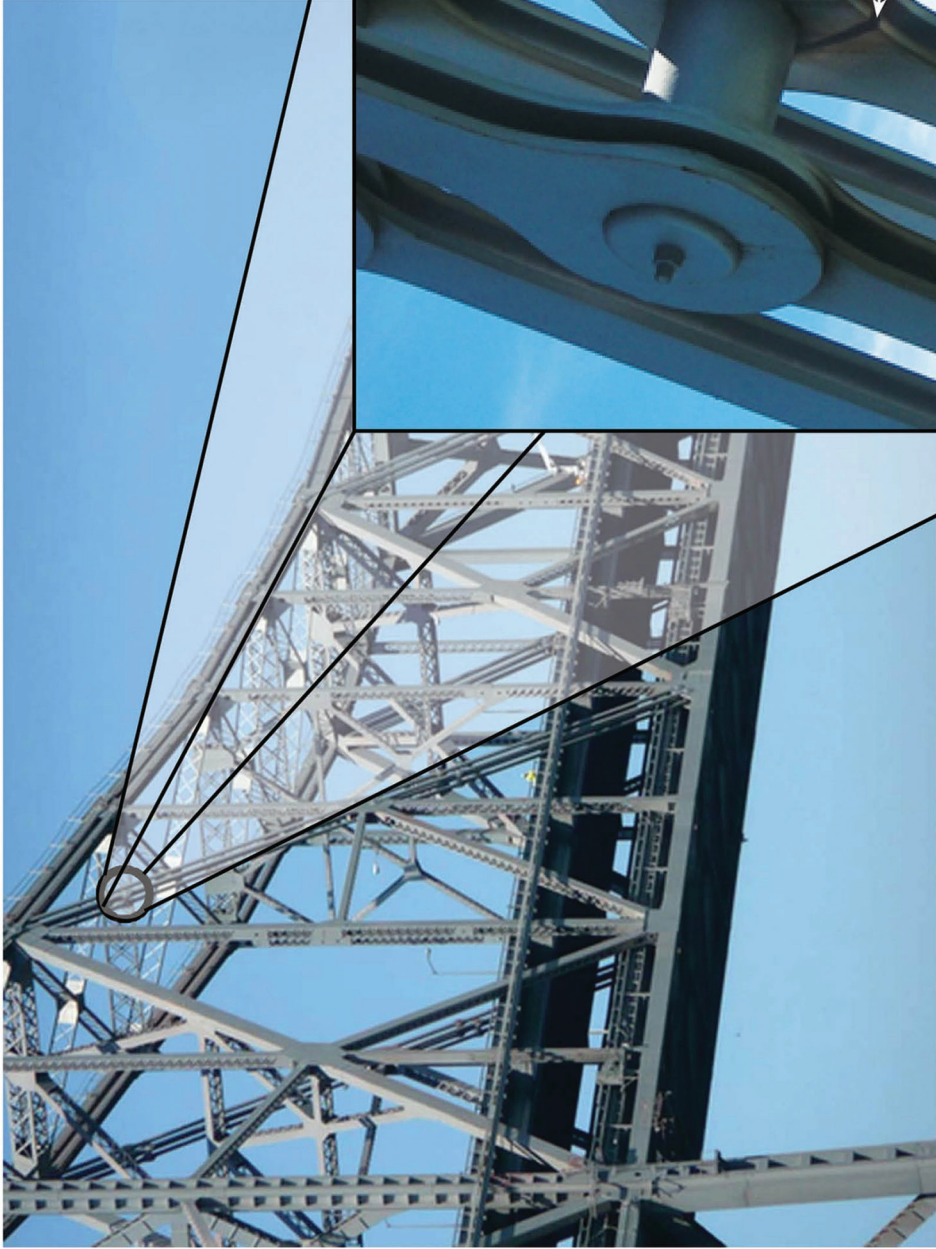
Crack at Net
Section of Pin

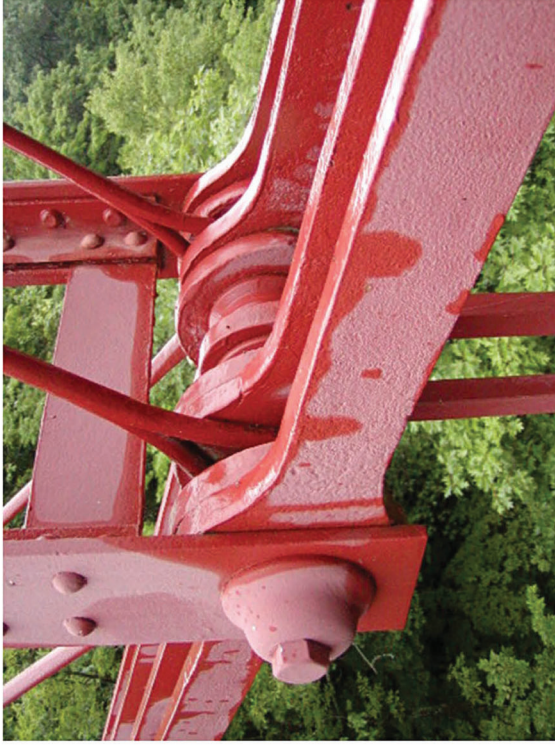
Pin Connected Elements : Pin Connected Truss Eyebars

AASHTO Fatigue Detail	1.1, 1.2, 2.4
Description	Base metal at net section of eyebar heads or pins plates- condition 2.4. (Note: for base metal in the shank of eye bars, see condition 1.1 or 1.2 as applicable)
Detail Category	Base Metal in the Shank of Eyebars, A or B Net Section, Eyebar, E Pin, Undefined (See Unclassified Details) Forging, Undefined (See Unclassified Details – Forged pin connected elements)
Visual Inspection	<ul style="list-style-type: none"> • Inspect for cracks initiating in the base metal away from all welds or structural connections. • Inspect for cracks initiating in the base metal in the net section originating at the side of the hole. • Inspect for corrosion, section loss, pack rust, and frozen pins. • Document crack locations and lengths. • Inspect forging locations (See Unclassified Details).
NDT	<ul style="list-style-type: none"> • Conduct UT on pins and eyebar ends. • Conduct MT and/or PT on pin plates at the hole when cracks are suspected.

Repair and Retrofit Recommendations	<ul style="list-style-type: none"> • Replace deteriorated pins and eyebars. • Remove pack rust and repaint. • If the member is considered an FCM, cracks should be reported and repaired immediately. • If the member is not considered an FCM, crack growth may be monitored through special inspections
Repair Reference	Section 3-3 – Tack Welds, Section 3-4 – Hole Drilling for crack arrest, Section 3-7 – Pin and Hanger Retrofits
Comments	<p>Considerable attention should be given to locations of forgings according to the guidance in “Unclassified Details – Forged pin connected elements”.</p> <p>Truss eyebar systems vary in configuration. The pins can be two different types: threaded nuts on the ends or a threaded rod through the pin with a cap plate on each end. Truss eyebars are generally three types: cut from plate material with holes drilled in the plate, plate material with a welded or forged “upset end” where the hole is drilled, or a forged loop rod which is looped around the pin and forged back to itself.</p> <p><u>Photo A:</u> Truss forged loop rod used as a bottom chord. This rod should be inspected at the net section of the eyebar and the forged location for defects due to the forging process.</p> <p><u>Photo B:</u> Truss forged loop rod and forged eye bar used as a bottom chord. This rod should be inspected at the net section of the eyebar and the forged location for discontinuities due to the forging process.</p>

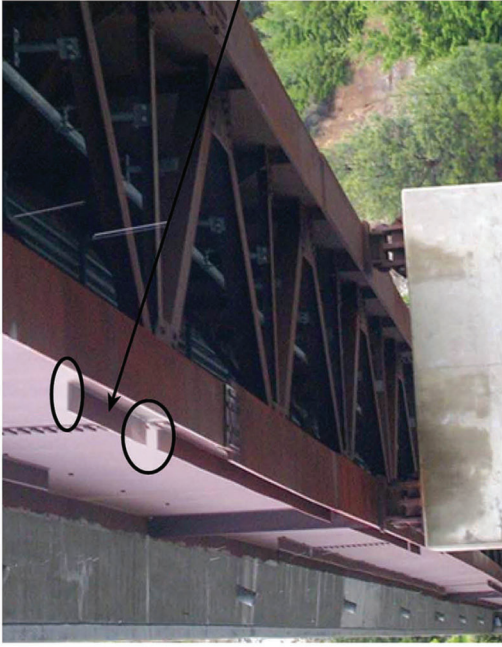
Stiffeners and Transverse Connection Plates : Termination of Longitudinal Welds

Longitudinal stiffener

AASHTO Fatigue Detail	4.3
Description	Base metal at the termination of longitudinal stiffener-to-web or longitudinal stiffener-to-box flange welds
Detail Category (No Transition)	With the stiffener attached by fillet welds and no transition radius provided at the termination: Stiffener thickness < 1.0 in., E Stiffener thickness ≥ 1.0 in., E'
Detail Category (Transition Radius)	With the stiffener attached by welds and with a transition radius <i>R</i> provided at the termination with the weld termination ground smooth: <i>R</i> ≥ 24 in., B 24 in. > <i>R</i> ≥ 6 in., C 6 in. > <i>R</i> ≥ 2 in., D 2 in. > <i>R</i> , E
Visual Inspection	<ul style="list-style-type: none"> Inspect for cracking in the primary member at the end of the weld at the weld toe or near the point of tangency of the radius. While longitudinal stiffeners are designed for compression regions, they typically terminate in a tension or reversal region. However, they have also been used on the tension side of some girders for aesthetic reasons. Therefore, carefully inspect for cracks in web at weld termination of stiffener. Document crack locations and lengths.

NDT	<ul style="list-style-type: none"> Conduct MT and/or PT when cracks are suspected.
Repair and Retrofit Recommendations	<ul style="list-style-type: none"> Drill holes at crack tips as a preventative measure, but inspection monitoring is still required. Conduct NDT to verify crack was arrested, and insert a pretensioned HS bolt assembly. Conduct Ultrasonic Impact Treatment (UIT) of the weld toe at the stiffener terminations prior to crack formation where calculations suggest fatigue-cracking may occur. If the member is considered an FCM, cracks should be repaired immediately. At a minimum, the crack tips should be drilled as soon as possible after detection. If the member is not considered an FCM, crack growth may be monitored through special inspections.
Repair Reference	Section 3-4 – Hole Drilling for Crack Arrest, Section 3-5 – Weld Toe Improvements
Comments	This section deals only with the termination of longitudinal stiffener welds. For information concerning continuous longitudinal stiffener welds, please see “Longitudinal Weld (Not-Termination)”.

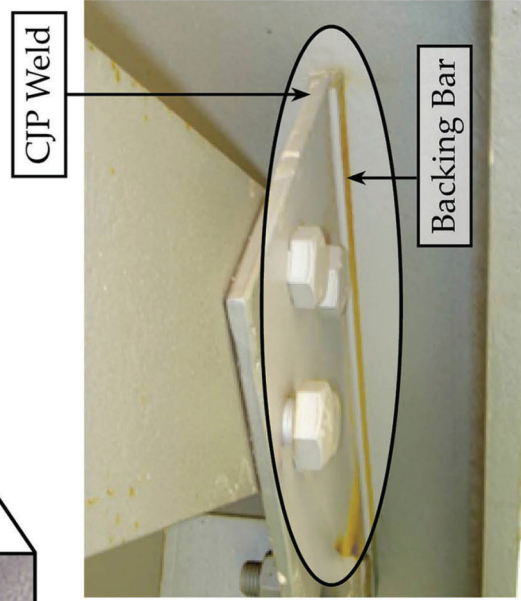
Longitudinally Loaded Attachments

AASHTO Fatigue Detail		7.1
Description	Base metal in a longitudinally loaded component at a detail with a length, "L" in the direction of the primary stress and a thickness, "t", attached by groove or fillet welds parallel and transverse to the direction of primary stress where the detail incorporates no transition radius	
Detail Category	$L < 2 \text{ in.}, C$ $2 \text{ in.} \leq L \leq 12t \text{ or } 4 \text{ in.}, D$ Where $L > 12t \text{ or } 4 \text{ in.}$ $t < 1.0 \text{ in.}, E$ $t \geq 1.0 \text{ in.}, E'$	
Visual Inspection	<ul style="list-style-type: none"> Inspect for cracks in the primary member at the end of the weld toe. Inspect for cracks in the weld toe. Document crack locations and lengths and weld quality for undocumented welds. 	
NDT	<ul style="list-style-type: none"> Conduct MT and/or PT when cracks are suspected. 	
Repair and Retrofit Recommendations	<ul style="list-style-type: none"> Drill holes in crack tips and conduct NDT. Conduct Ultrasonic Impact Treatment (UIT) prior to crack formation if added fatigue resistance required. If the member is considered an FCM, cracks should be repaired immediately. At a minimum, the crack tips should be drilled as soon as possible after detection. If the member is not considered an FCM, crack growth may be monitored through special inspections.

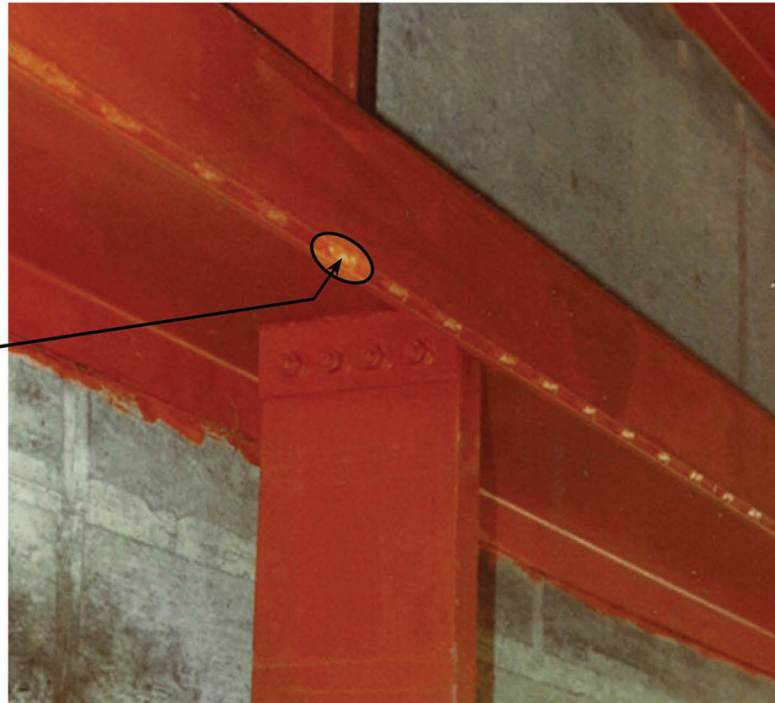
Photo A

Longitudinal Intermittent Welds
(TYP)

AASHTO Fatigue Detail	Undefined due intermittent fillet-weld; Transverse stiffeners and connection plates may be represented by AASHTO Detail 5.4.
Description	Base metal at weld terminations of intermittent fillet welded connections. Does not include tack welds.
Detail Category	Unclassified Detail - Intermittent Welds; Category C may be used for transverse stiffeners and connection plates attached with intermittent fillet welds. For longitudinal intermittent welds parallel to axial stress, poor fatigue resistance may occur at weld terminations for welds greater than 4 inches.
Visual Inspection	<ul style="list-style-type: none"> Inspect for cracks in the base metal at ends of intermittent welds. Document crack locations and lengths.
NDT	<ul style="list-style-type: none"> Conduct MT and/or PT when cracks are suspected.
Repair and Retrofit Recommendations	<ul style="list-style-type: none"> If the intermittent welds are not parallel to the primary stress and no cracks are found, they may not be a major concern. Drill holes at crack tips as a preventative measure, but inspection monitoring is still required. Conduct NDT to verify crack was arrested, and insert a pretensioned HS bolt assembly. Grind out cracks or remove welds and replace with a bolted connection (design required). If the member is considered an FCM, cracks should be repaired immediately. If the member is not considered an FCM, crack growth may be monitored through special inspections.

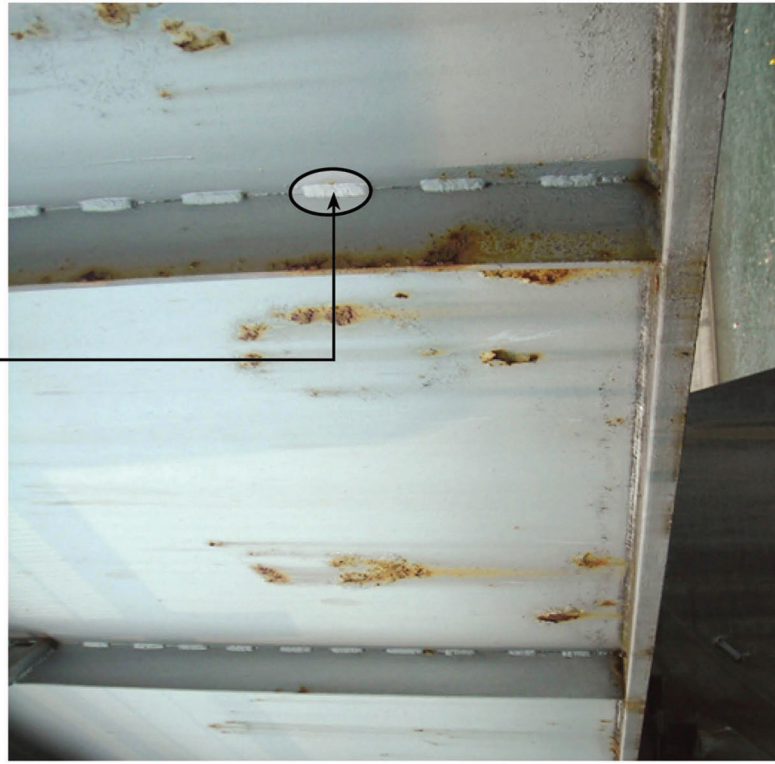
Photo B

Transverse Stiffener Intermittent Welds
(TYP)

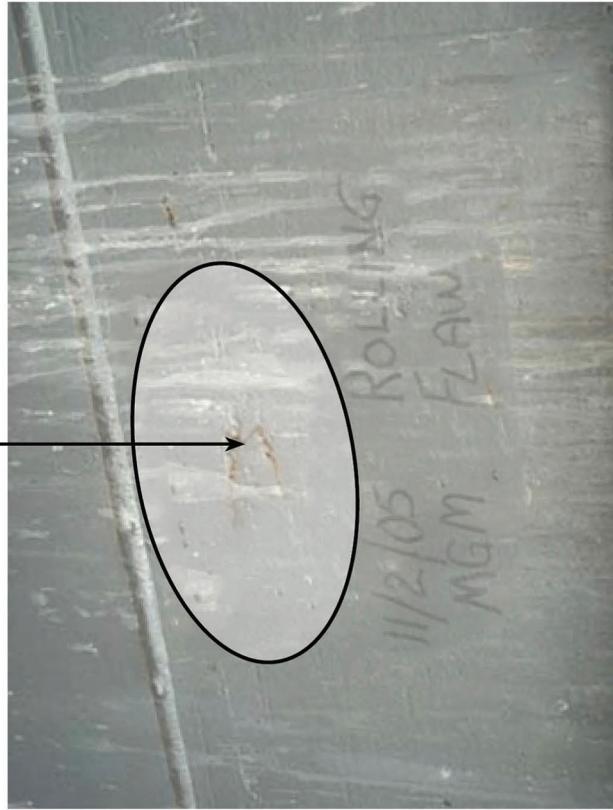
Photo A

Rolling Flaw

AASHTO Fatigue Detail	Undefined due to rolling flaw and surface discontinuities
Description	Base metal with rolling flaws, or other discontinuities.
Detail Category	Unclassified Detail - Rolling Flaws and Surface Discontinuities.
Visual Inspection	<ul style="list-style-type: none"> Inspect for cracks resulting from rolling flaws and surface discontinuities. Inspect member for additional flaws and for cracks initiating from flaws. Document all flaws, discontinuities, and crack locations and mark damage extents.
NDT	<ul style="list-style-type: none"> Conduct UT for internal flaws and MT and/or PT when cracks are suspected.
Repair and Retrofit Recommendations	<ul style="list-style-type: none"> Remove flaw by grinding and test remaining section with MT and/or PT for surface flaws. In general, do not grind to a depth exceeding 1/8 in. without evaluating for reduced section. Provide transitions at a 1:10 slope. All grinding should be in direction parallel with primary stress. For deeper flaws, replace or reinforce section. Drill crack tips and verify with MT and PT. If the member is considered an FCM, cracks should be repaired immediately. If the member is not considered an FCM, crack growth may be monitored through special inspections.

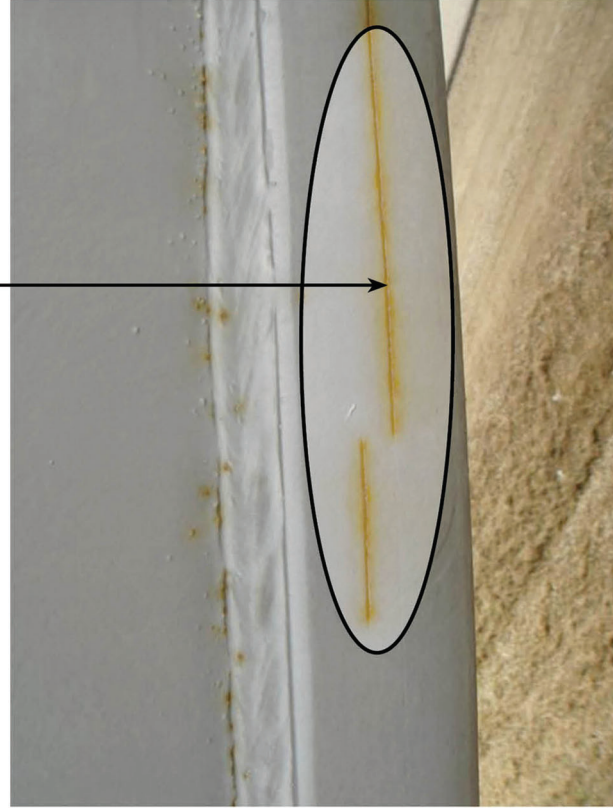
Photo B

Stringer Open to Surface

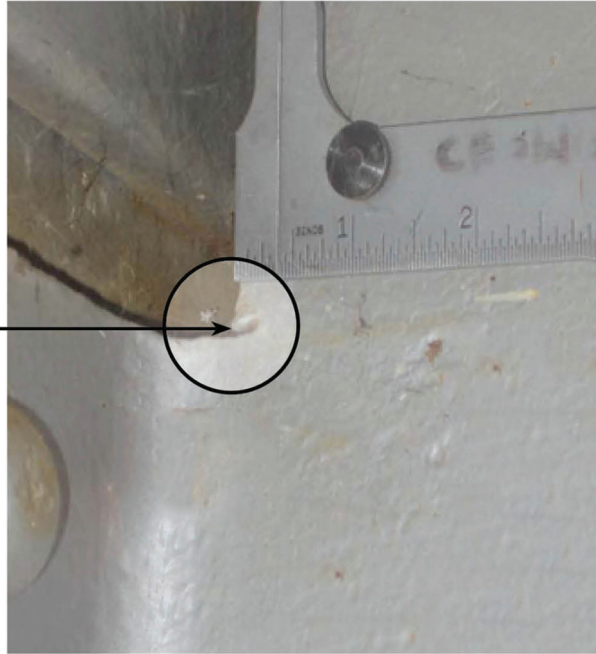
Photo A

Crack Tip

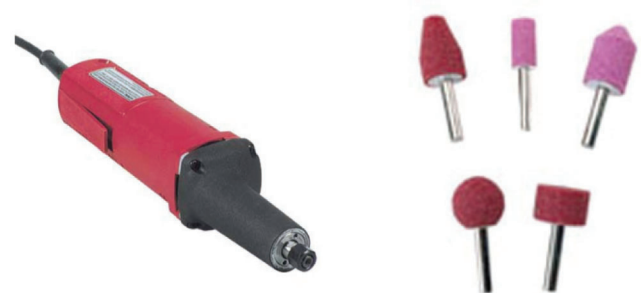
Figure 3.1 Typical die grinder and stone wheels.

Once the limits of the discontinuity have been defined via the evaluation methods described in this section, a common die grinder equipped with a stone wheel may be used to perform the rough grinding. Figure 3.1 shows a typical electric die grinder, although air driven pneumatic die or ‘pencil’ grinders can also be used if available. There are various shaped stone wheels for use in die grinders, some of which are better suited than others for certain access requirements. Grinding for repair of surface discontinuities should be done parallel to the primary direction of the cyclic stress ranges in the member. Care must also be used to ensure that excessive material is not removed during the rough grinding phase. For this reason, carbide burr grinders or burr bits on angle grinders are not recommended, as it may be difficult to control the depth of grinding. If carbide burr bits are used, experienced operators are essential and the depth of grinding should be verified on a similar sample. Additional fine grinding should be performed to meet the surface roughness requirements. Typically, die grinders are used since it allows for the depth of grinding to be controlled. Finished grinding should be performed to 125 μm surface finish.

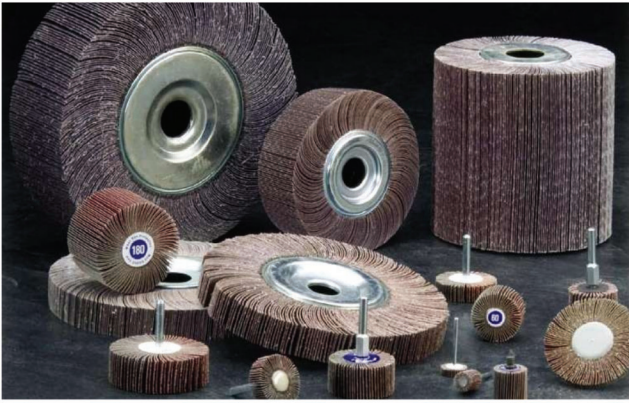
Figure 3.2 Typical flapper-type paper grit sanding/polishing wheels.

After the rough grinding has been completed, it is recommended that the stone wheel be removed and a sandpaper-type abrasive grinder be used for subsequent stages of material removal. These steps are perhaps best accomplished using a ‘flapper’ wheel instead of disk grinders. There are many varieties of the “flapper-type” wheels some of which are shown in Figure 3.2.

Grits of 60/80 sandpaper on flapper-type wheels followed by 100/120 and finer, are recommended for steel to attain a shiny, smooth finish, ensuring that all grinding is parallel to the primary cyclic stress range. Once this stage of grinding is complete, the area should be reexamined using MT to ensure the discontinuity has been completely removed. As general guidance, it is recommended that a 10:1 ratio be used when establishing the limits of the repair with an absolute minimum of 5:1 where there is inadequate room for the 10:1 ratio. Hence, ideally the repair of a 3/16" deep discontinuity should be feathered out about 2" on each side of the

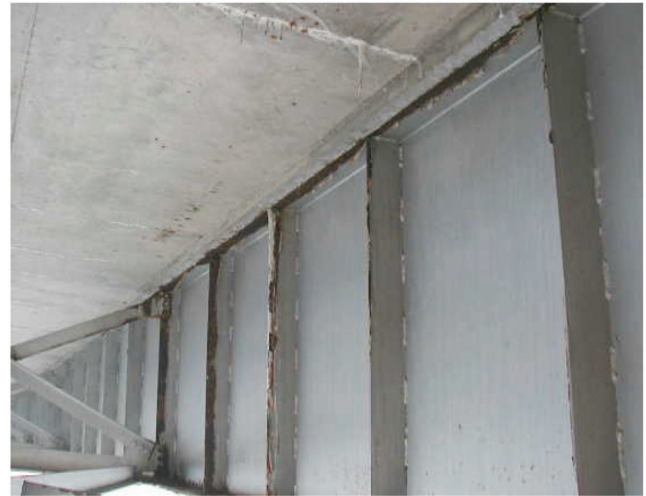
Figure 3.3 Intermittent welds used to attach a transverse stiffener.

As stated previously, intermittent welds must be distinguished from tack welds. Intermittent welds that are oriented transverse to the primary stress range would not be expected to be of great concern since the stress concentration at the weld toe is similar to the condition at a continuous fillet weld. Figure 3.3 illustrates intermittent welds used to attach a transverse stiffener to the web of a plate girder. Assuming the welds are of reasonable quality (e.g., do not contain crater cracks, undercut, overlap, or porosity), they can be considered an AASHTO Category C' details for the purpose of fatigue life analysis. Since the stiffener in Figure 3.3 is considered a short attachment, the same fatigue category applies had a continuous weld been

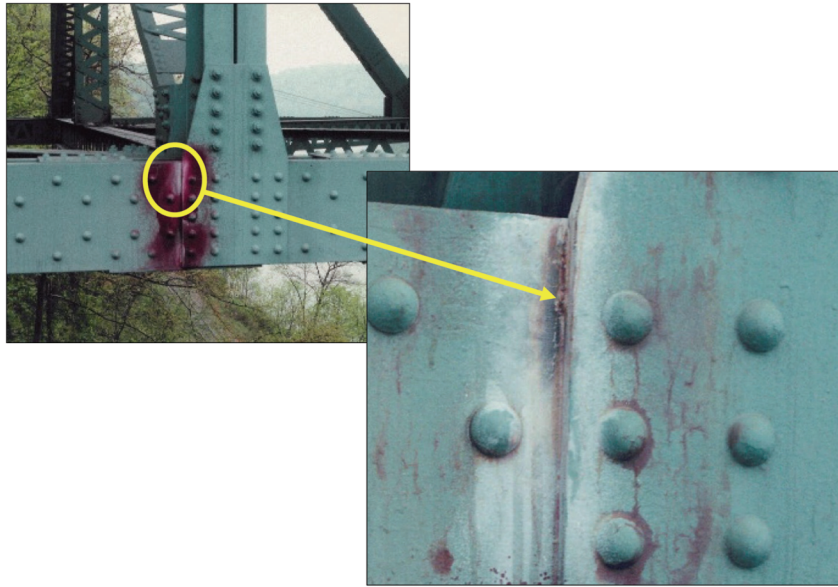
Figure 3.4 Tack weld with 100% throat crack.

Intermittent welds oriented in the longitudinal direction, such as those that are used as for a web-to-flange weld, would generally be of greater concern than welds oriented transverse to primary stresses. The AISC Steel Construction Manual (AISC, 2012) classifies longitudinal intermittent welds as a Category E detail. The intermittent welds in this case are effectively treated like a series of longitudinally loaded welded attachments. Although test data suggest a higher category applies, Category E is specified in the AISC Specifications to discourage the use of intermittent welds in the longitudinal direction. The significant number of weld starts/stops increases the potential for typical discontinuities at the weld termination. One of the most critical situations would be the case of a cover plate welded to a flange. Similar to the case of a continuous weld, the intermittent weld(s) near the end of the cover plate would have reduced fatigue resistance due to shear lag effects making this a critical location for possible toe cracking. Removing the last few welds could be an effective retrofit, but only if a bolted splice is installed at the end of the cover plate to transfer the force between the cover plate and flange ahead of the welds. The welds can be removed by grinding using the processes described previously in Section 3-2.d: Field Directions for Repair of Surface Discontinuities of this document. Grinding should be performed parallel to

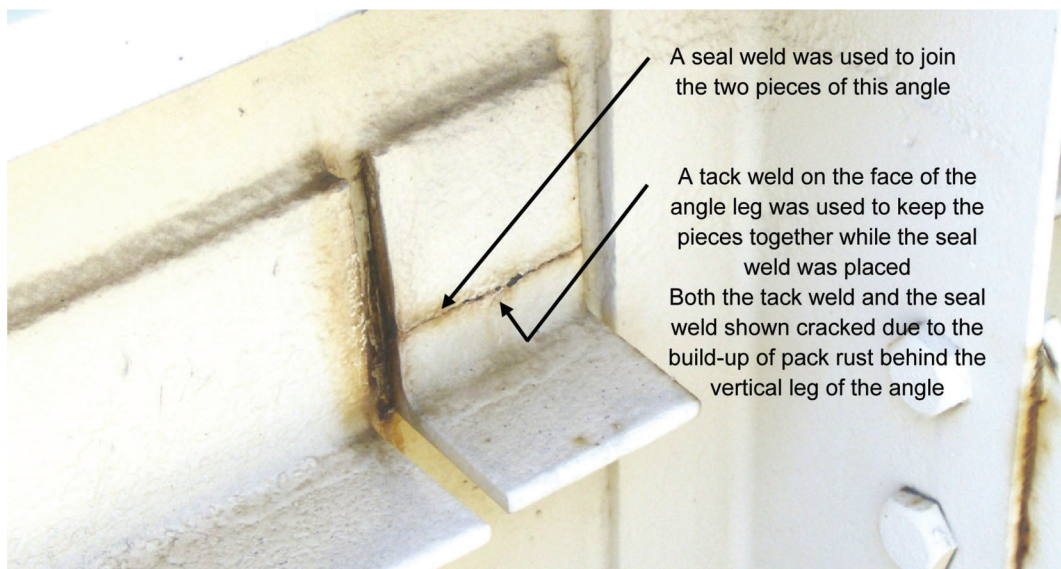
Figure 3.7 Tack weld cracking from pack rust.

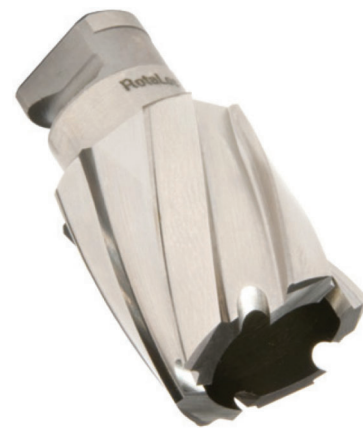
Figure 3.9 Typical broach drill bit.

2. Using a magnetic based drill with a carbide-tipped broach drill bit as shown in Figure 3.9, drill a hole in the steel material 2 to 4 inches in diameter that extends beyond the crack tip. The hole size and location shall be determined by the Engineer. The inside surface of the hole should be ground smooth, preferably with a flapper wheel and the edges should be deburred.

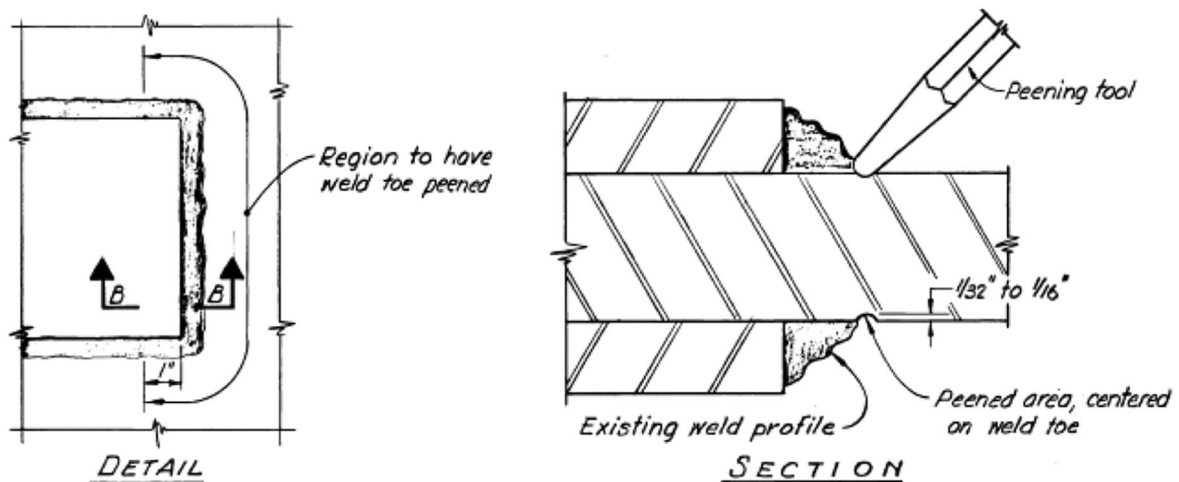
Figure 3.10 Sample peening detail (detail courtesy of Oregon Department of Transportation).

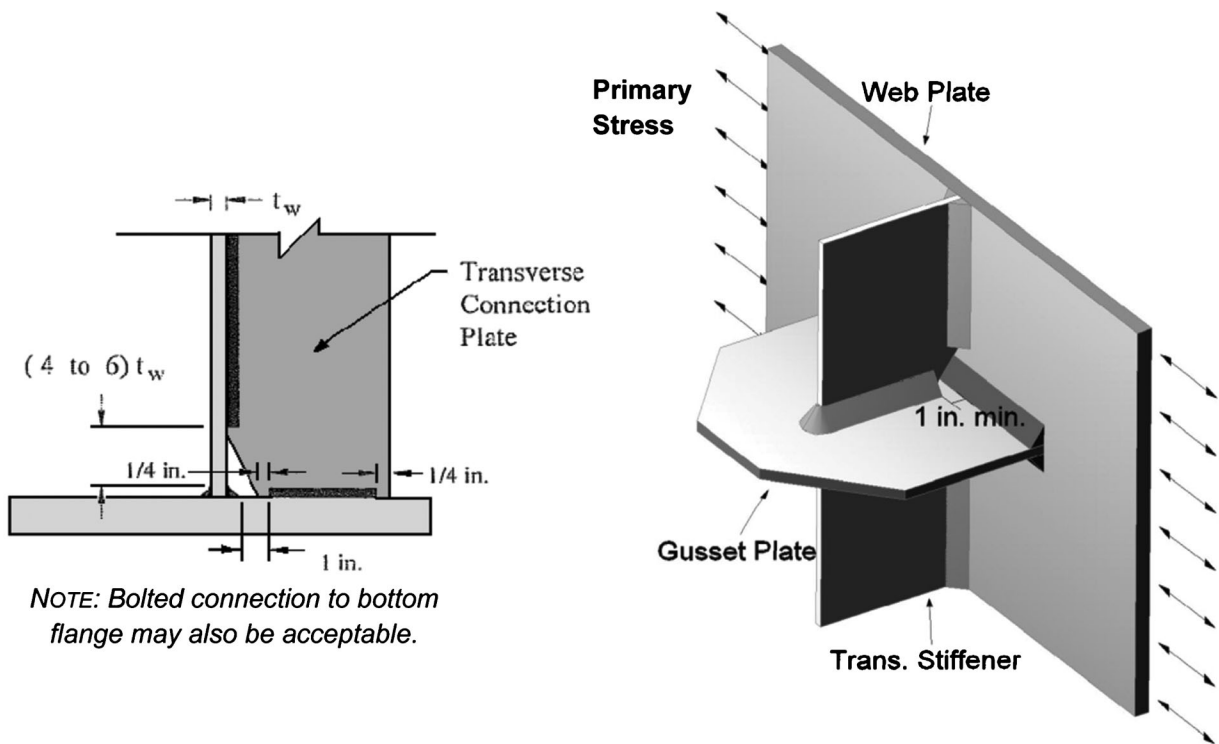
Figure 3.12 Detailing considerations to prevent web gap cracking (left) at transverse connection plate; (right) at gusset plate.

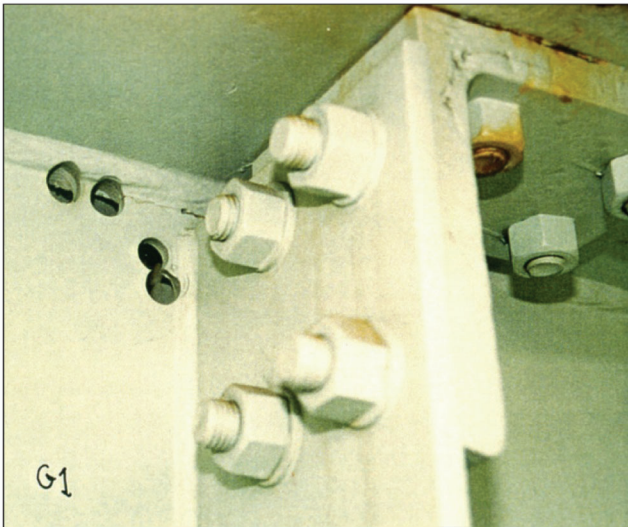
Figure 3.14 Stiffening angle bolted to transverse connection plate and top flange.

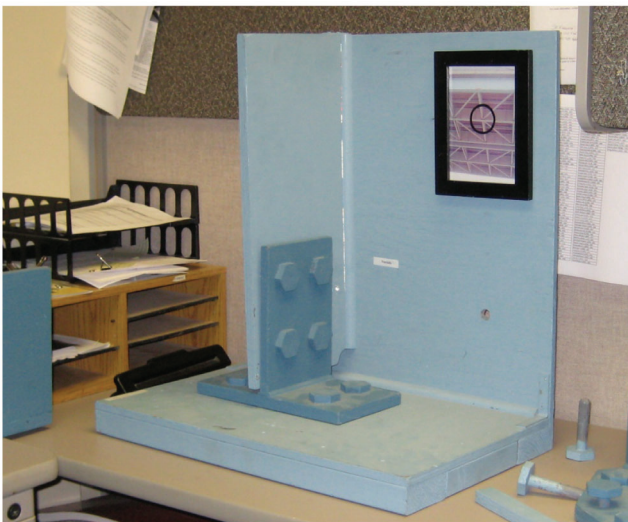
Figure 3.15 Mock-up of WT connection plate retrofit concept.

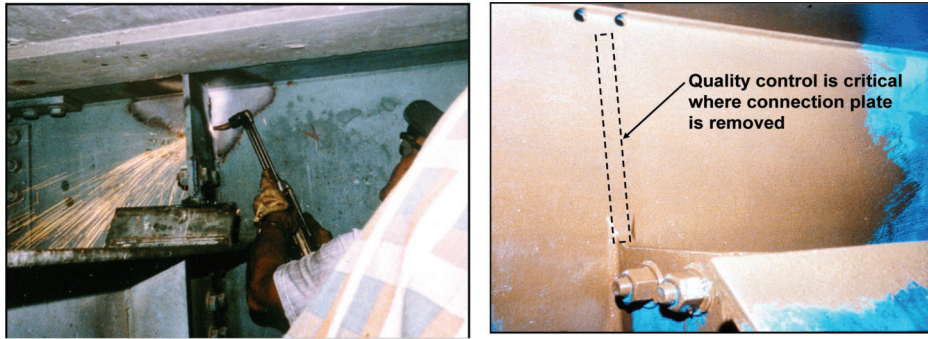
Figure 3.16 Example of web gap softening technique.

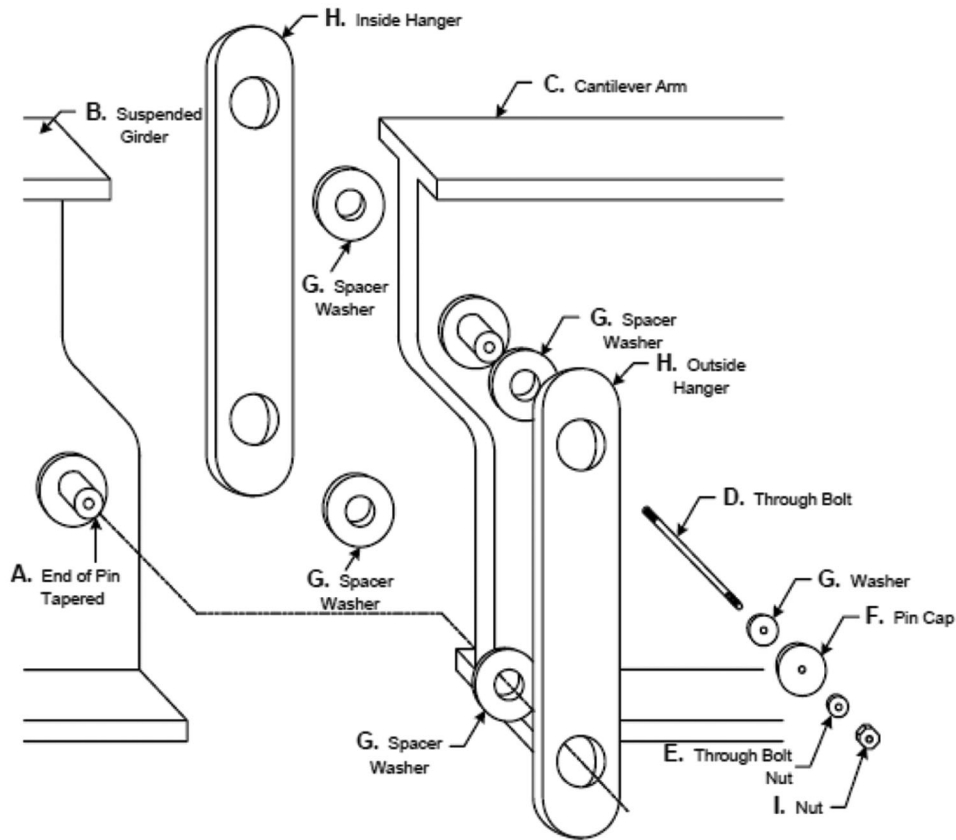
Figure 3.21 Exploded view of typical pin and hanger assembly.

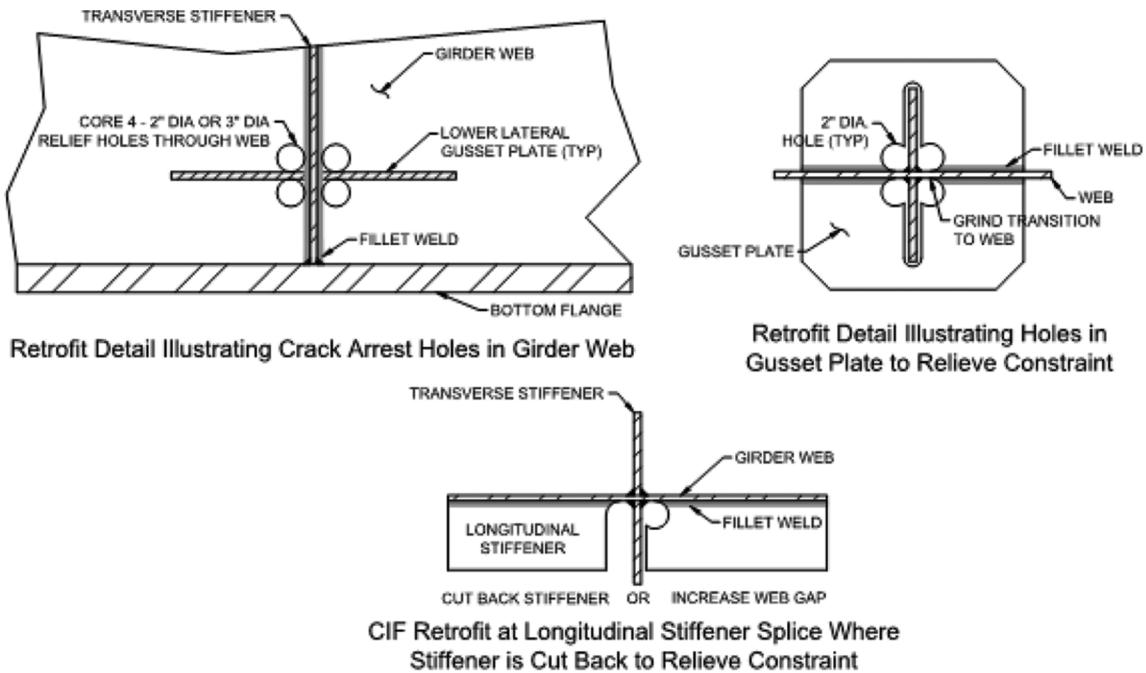
Figure 3.28 Typical retrofits for CIF details at gusset plates and longitudinal stiffeners.

For gusset plate details, the recommended method is to drill holes in the gusset plate near the intersecting welds in order to increase the gap and reduce constraint

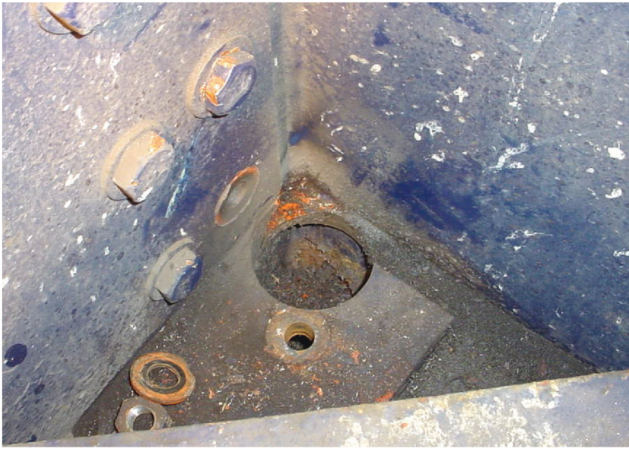
Figure 3.31 Retrofit hole (prior to finish grinding). (Note guide plate used as template to ensure core barrel does not “wobble”.)

Figure 3.30, Figure 3.31, and Figure 3.32 show these repair concepts being applied in the field.

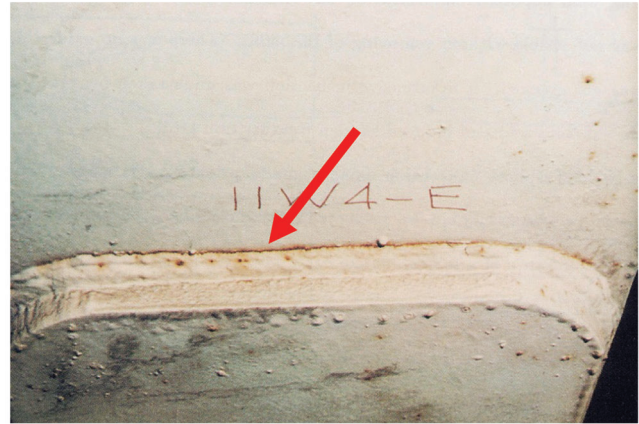
Figure 3.33 Cover plate with weld at termination.

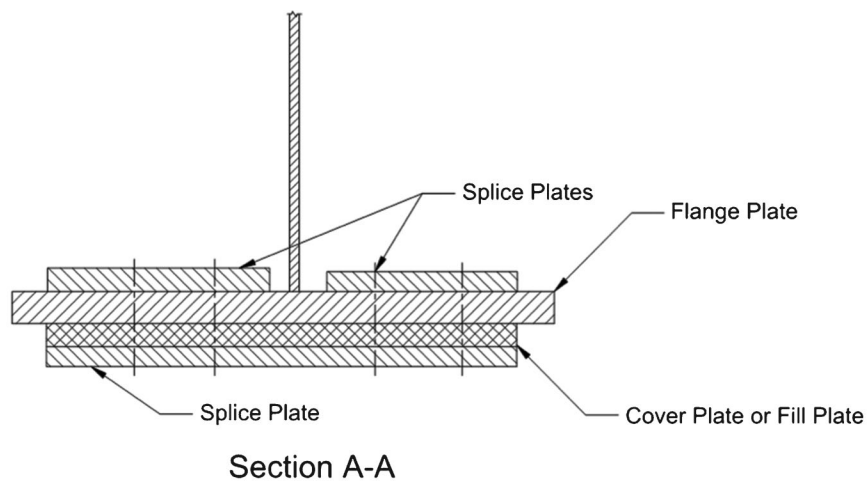
Figure 3.36 Elevation view of bolted cover plate retrofit.

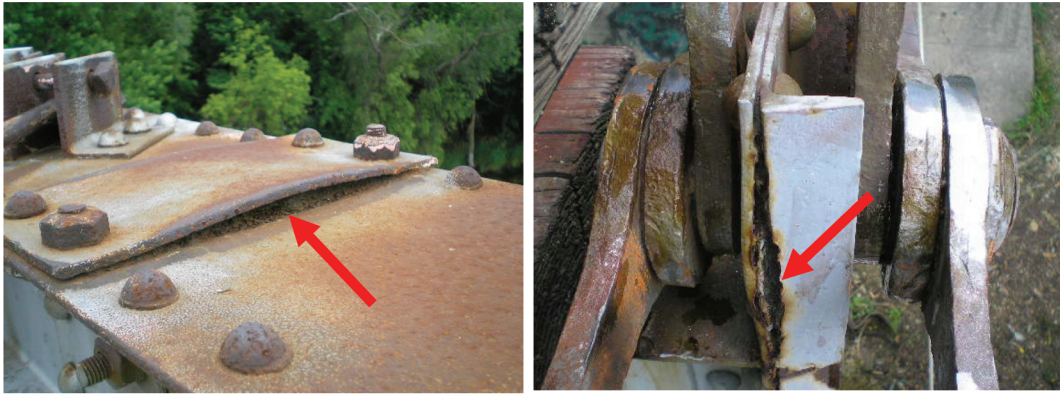
Figure 3.37 Pack rust in mechanically fastened connections.

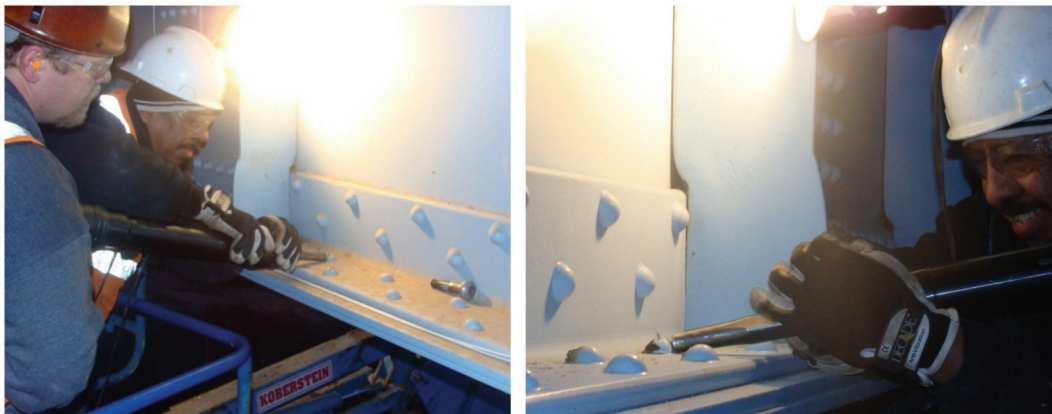
Figure 3.38 Rivet head removal using rivet buster (courtesy of Purdue University).

The first step in the removal of rivets is to use a pneumatic impact gun or, more commonly, rivet buster to remove one of the heads of the rivet. This process can be quite loud and may require two people to control the rivet buster and keep the tip in contact on the rivet head. Figure 3.38 shows the removal of a rivet head using a rivet buster. It is important that the tip of the rivet buster is applied to the side of the head of the rivet in order to fracture the rivet head. As can be seen in this figure, adequate access will be required for the proper use of a rivet buster.

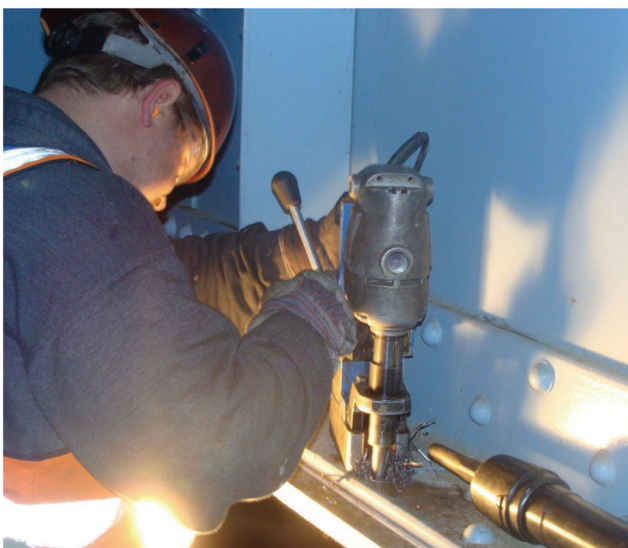
Figure 3.40 Drilling out center of rivet (courtesy of Purdue University).
