Fatigue and Fracture Library for the Inspection, Evaluation, and Repair of Vehicular Steel Bridges

Phil Fish, Curtis Schroeder, Robert J. Connor, Phil Sauser

Fish, P., Schroeder, C., Connor, R. J., & Sauser, P. (2015). *Fatigue and fracture library for the inspection, evaluation, and repair of vehicular steel bridges*. West Lafayette, IN: Purdue University. <http://dx.doi.org/10.5703/1288284315520>

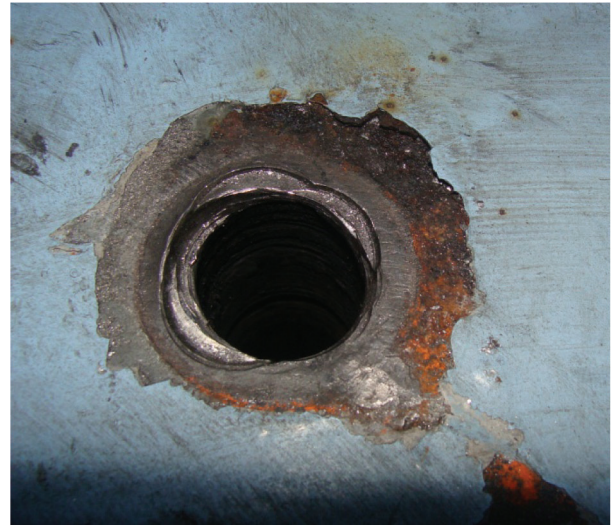
Figure 3.41 Damaged surface after rivet removal around hole (courtesy of Purdue University).

Once the rivet is removed, the surface of the plate around the hole will be gouged and damaged as seen in Figure 3.41. The surface of the plate around the hole should be ground smooth using an abrasive sanding

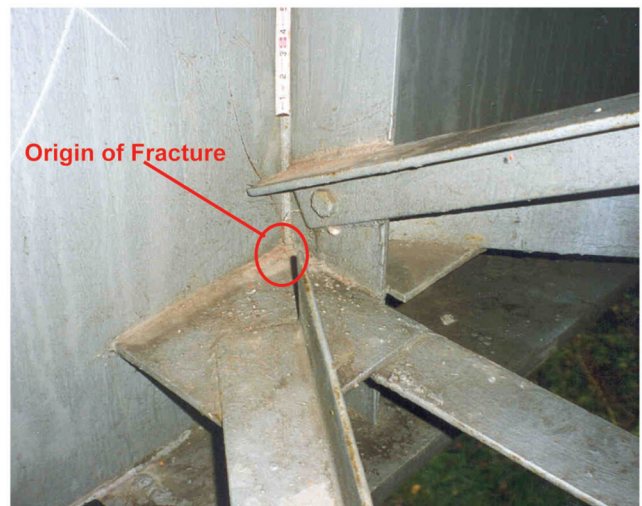
Figure 3.42 Constraint-induced fracture in gusset plate connection.

Historically, gusset plates did not utilize smooth transitions in the connection with the web or the flange. Accordingly, high stress concentrations occur at the ends of the gusset plates. These stress concentrations, coupled with the residual stresses from the weld, increase the likelihood of cracking. Without any transition at the termination of the gusset plates, these details have very low fatigue resistance and may fall under AASHTO fatigue Category E or E'.

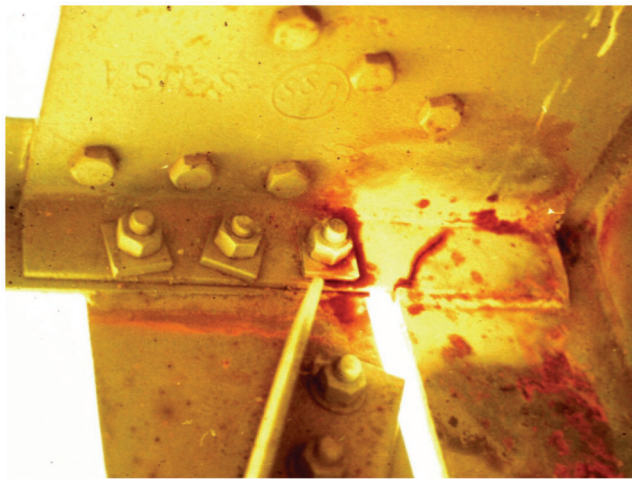
Figure 3.43 Cracking in flange of channel (gusset plate) and girder.

Figure 3.43 shows a channel used as a gusset plate and welded to the bottom flange of the girder using a fillet weld perpendicular to the primary stresses. A crack initiated at the toe of this weld due to the high stress concentration at this detail. Figure 3.44 shows a lateral gusset plate welded to the bottom flange of a girder using a fillet weld parallel to the primary stresses. A crack initiated at the termination of this weld and propagated into the bottom flange. In both cases, the cracking originated due to the gusset plate picking up longitudinal load from the primary member through the “shear lag” effect, which caused a stress concentration at the toe or termination of the weld.

Gusset plates are likely to have fatigue issues when connected directly to the flange due to the high stresses, high stress concentration due to poor connection details, and biaxial stresses in the gusset plate. The gusset plate is not only transversely loaded but will also pick up longitudinal load from the flange of the girder. Figure 3.43 and Figure 3.44 show cracks that have propagated into the flange due to the stresses imposed on this connection.

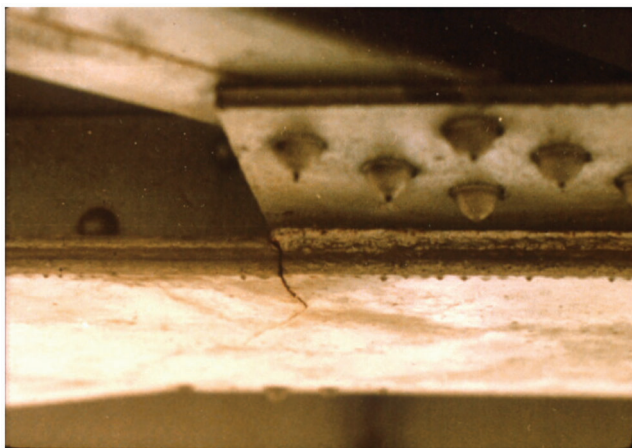
Figure 3.44 Cracking in girder flange.

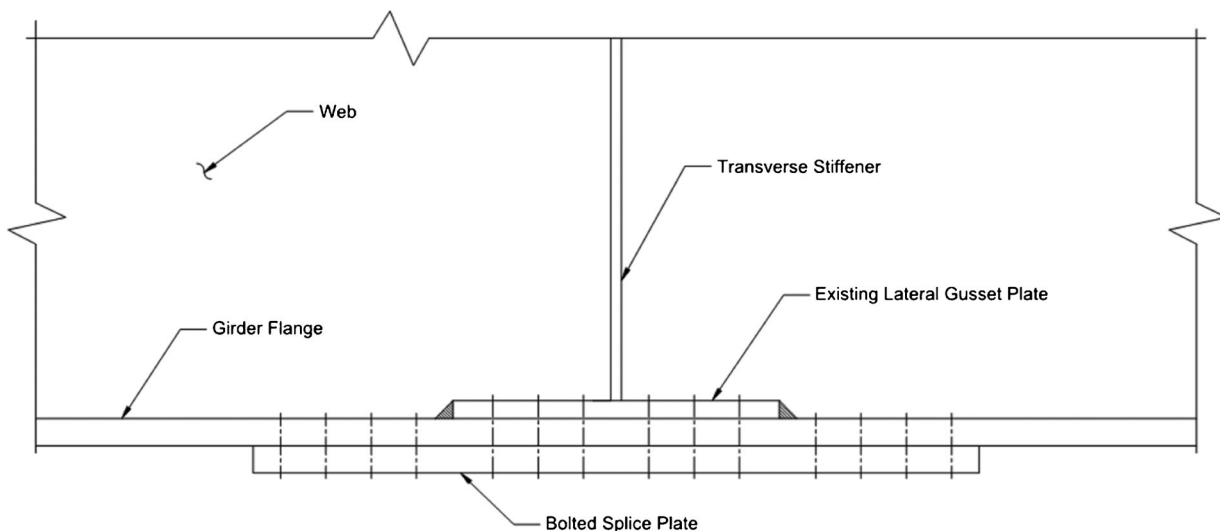
Figure 3.45 Bolted splice gusset plate repair.

For gusset plates on the flange, the weld connecting the gusset plate to the flange will need to be removed using a cutting wheel or air-arc. Care should be taken not to cut into the flange. Flame cutting or a plasma torch should not be used since it is likely that the flange will be gouged. Once the gusset plate has been removed,

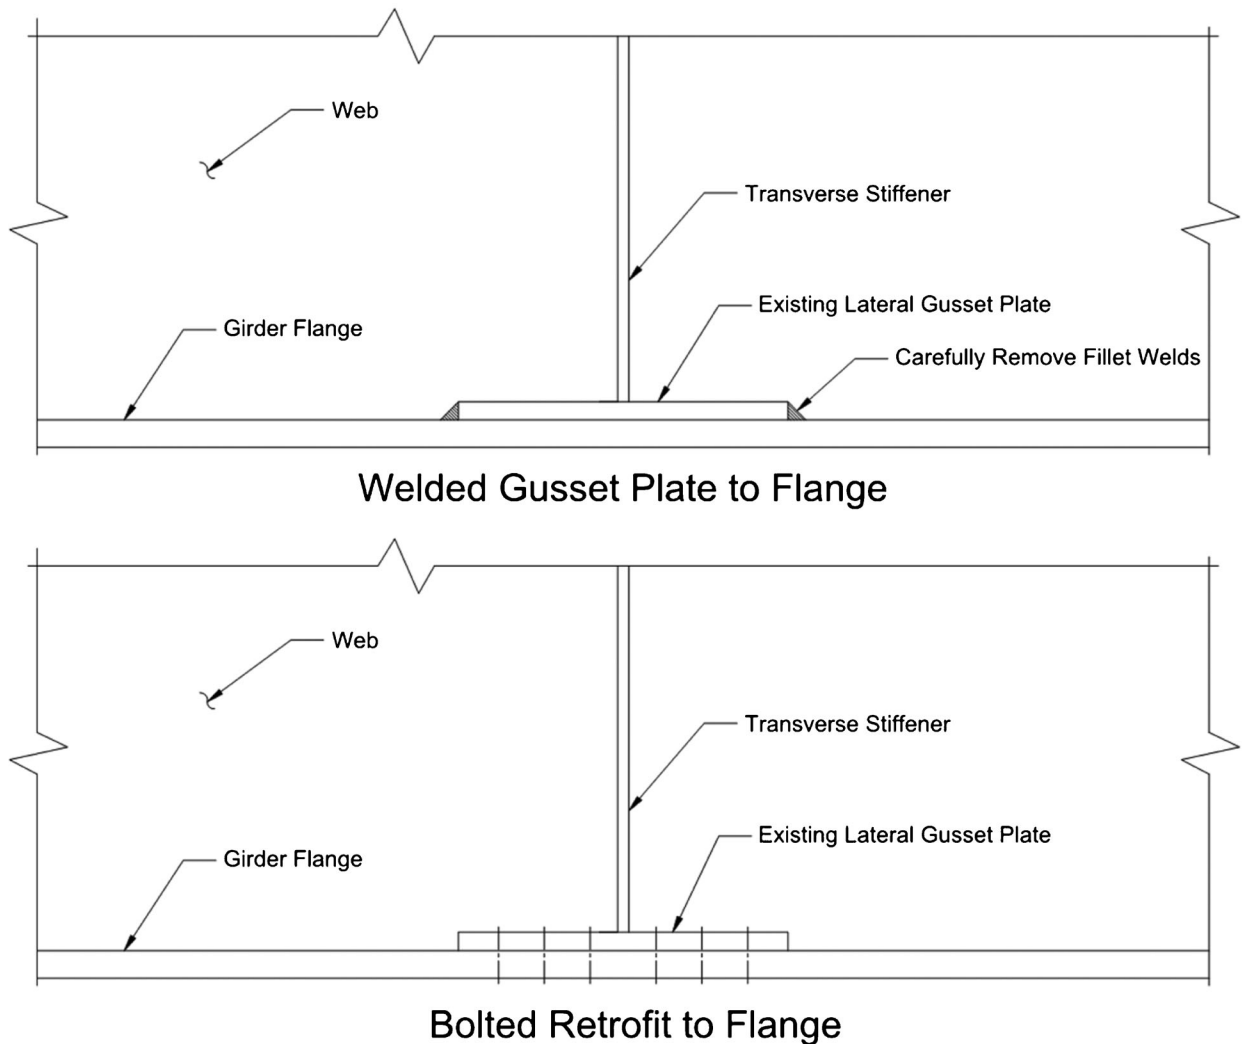
Figure 3.47 Bolted gusset plate repair to flange.

- a. The gusset plate should be verified through engineering analysis that it can be removed from the primary member without affecting the load-carrying capacity of the bridge. Most lateral gusset plates likely can be safely removed, but engineering review should be performed before the gusset plate is removed.
- b. Remove gusset plate from primary member.
 - i. For gusset plates on the web, cut through the throat of the weld at a safe distance from the web itself. A cutting wheel, air-arc, or plasma torch may be used, but do not use a flame torch.
 - ii. For gusset plates on the flange, cut through the throat of the weld while making sure not to gouge the flange. A cutting wheel or air-arc may be used, but do not use plasma cutter or flame torch.
