Performance Data for Some Bituminous Concrete Overlays in Indiana

W. H. GOETZ, RESEARCH ENGINEER
J. F. McLAUGHLIN, RESEARCH ENGINEER
Joint Highway Research Project
Purdue University

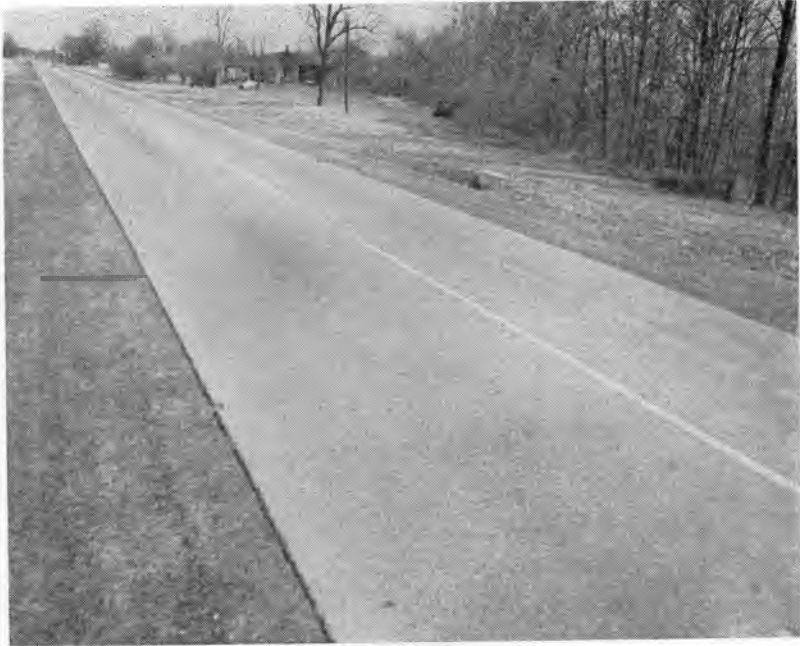
Concrete pavement with both jointed and non-jointed slab design is included in this part of State Road 37 and these experimental overlays of various thicknesses were constructed on each in order to study the effect of the type of concrete pavement on the performance of the resurfacing. This overlay on State Road 37 is now almost seven years old and, except for the presence of reflection cracks, the performance is satisfactory. Fig. 1 shows a view of the road on the jointed concrete section. This is a good example of the successful use of this type of overlay under moderate to heavy moving traffic conditions. Fig. 1 and subsequent illustrations showing condition of this road (Figs. 2 to 4) are from pictures which

Fig. 1. Bituminous concrete overlay on State Road 37.

were taken in March, 1957 when the overlay was about seven years old.

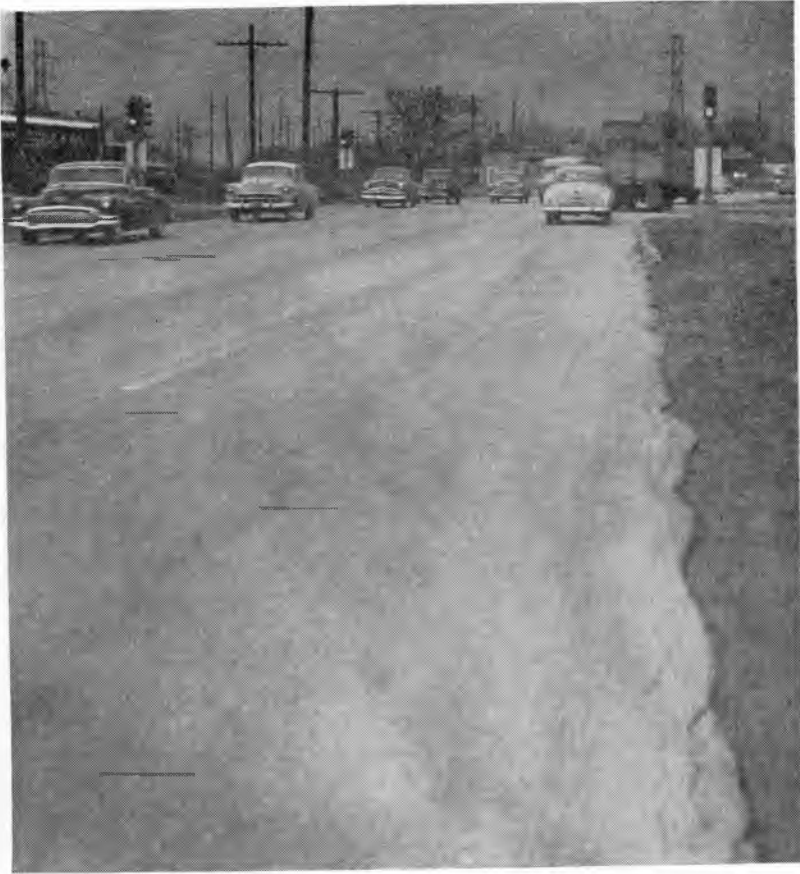
An example of this is shown in Fig. 5 which is a view looking west at the westbound lanes of U. S. 12 and 20 near its intersection with Seventh Avenue just east of Gary. This picture was taken in November, 1953, at which time the overlay was three years old. The fact that the mixture had been subject to plastic movement seems evident from the pavement edge. The ruts were of the order of magnitude of a tenth of a foot. The mixture was literally being squeezed aside under the action of the wheel loads.

It took at least two years for much evidence of instability to show in the case illustrated in Figs. 5 and 6. On another occasion the period was only a few months. Fig. 7 shows a view looking south on Indianapolis Boulevard from the intersection with 151st Street in

Fig. 5. Overlay performance at intersection.

All of these facts lead to the conclusion that the failures under consideration were caused by plastic flow. The realization of these failures and their nature lead the Indiana Highway Department to modify their bituminous concrete by several approaches. Asphalt content generally has been reduced in both the binder and surface layers. In some instances, the maximum aggregate size of the binder has been increased and the thickness of this layer increased with a corresponding decrease in surface-layer thickness. In other instances the ratio of coarse aggregate to fine aggregate has been increased in

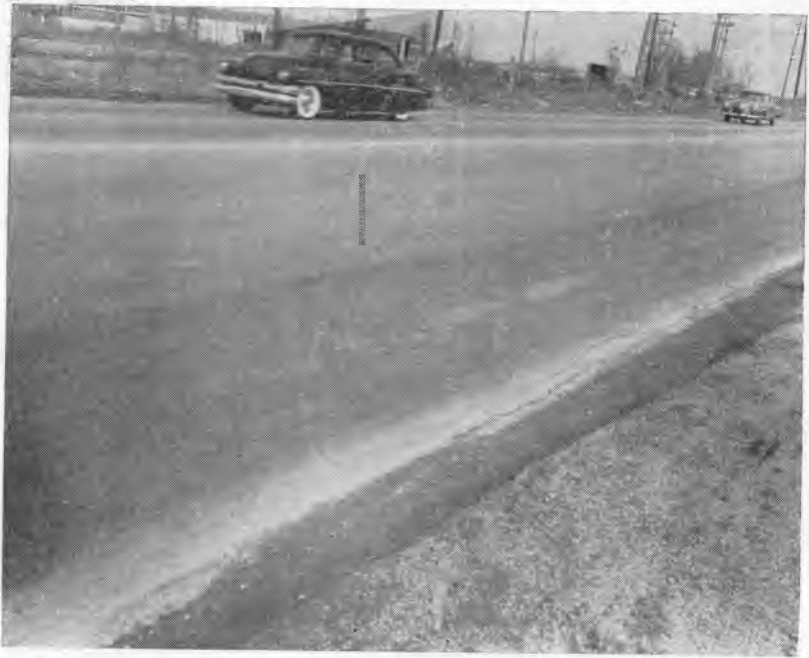
The same intersection in March, 1957, is shown in Fig. 6. This view was taken just across the road from the previous one. The marks in the wheel track areas are not mud or patches, they show the underlying concrete. In this instance, the rutting has progressed to the ultimate. The entire thickness of the mixture has been displaced.

Fig. 6. Concrete exposed by rutting.

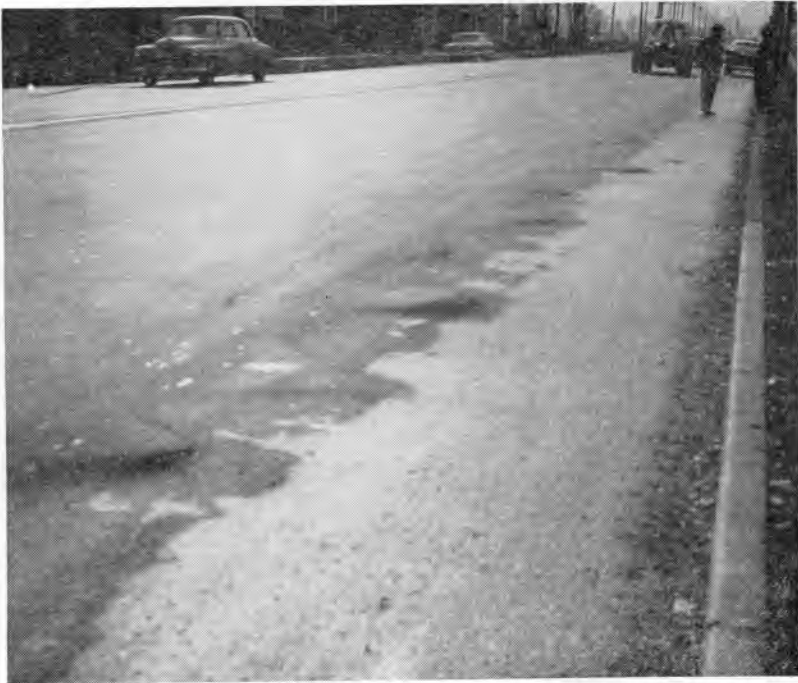
East Chicago. Again, the plastic nature of the mixture is illustrated by the apparent flow of the bituminous concrete.

Fig. 7. "Flow" of bituminous concrete.

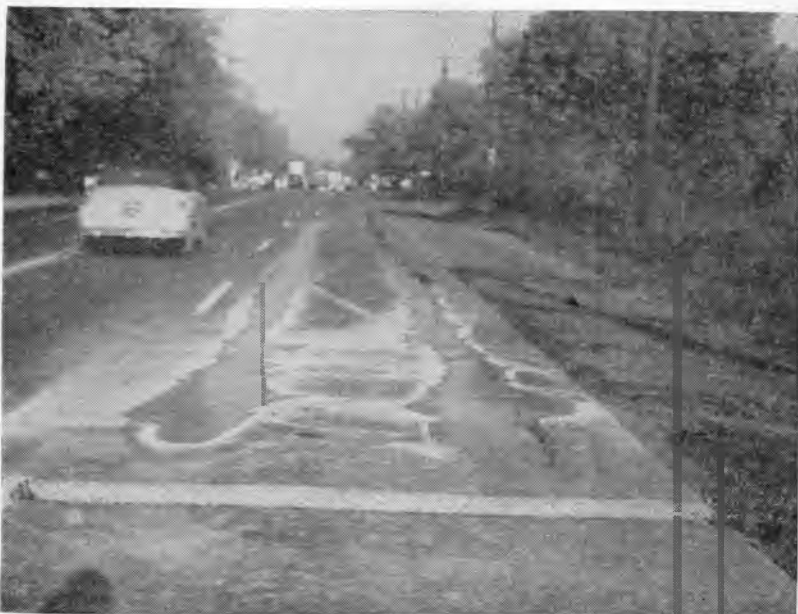
Other locations in the state where extremely severe traffic conditions exist have shown similar results. Fig. 8 shows one of two trenches cut for the full depth of the resurfacing across the outside lane of pavement on U. S. 40 near Indianapolis. The pavement distortion can be seen both from the cut face of the trench and from the water on the pavement which is ponded in the ruts in the wheel-track areas. This trench was cut approximately 750 feet back from the nearest signalized intersection. Another trench cut at the intersection showed more distortion than the case illustrated.

This trenching operation, in addition to enabling one to measure rutting, showed that the overlay had spread out in a transverse direction so that it extended some six inches beyond the edge of the

concrete to which it was placed during construction. Secondly, it was found from an examination of the sawed face that both the binder and surface layers were distorted in the wheel-track areas. Thirdly, and this is illustrated in Fig. 9, it was found from density measurements made on samples taken at closely-spaced intervals across the traffic lane that the density of the mixture was essentially the same regardless of sample position.

Fig. 8. Trench cut in bituminous overlay.

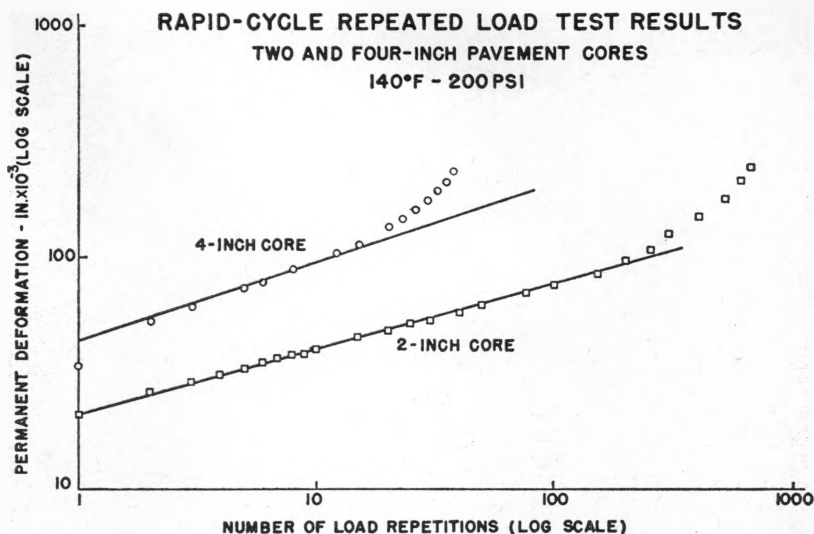
Fig. 11. Rapid-cycle repeated load test results.

By keeping a record of the accumulation of this permanent deformation during the test, one may plot a graph of the sort shown in Fig. 11. In this figure is shown a plot of log cumulative permanent deformation on the vertical scale versus the logarithm of the number of load repetitions on the horizontal scale. This particular illustration is from tests on 2- and 4-inch thick cores of AH-Binder and Type B surface tested at 140° F and under a contact pressure of 200 psi. Without going into any detail, we will comment only that it is believed that the slope of these lines and the point on the line at which the data begin their upward deviation may have some significance with respect to the potential ability of the mixture to
