Pothole Patching

ISHC Research and Training Center, West Lafayette, Indiana

The Division of Maintenance, Indiana State Highway Commission

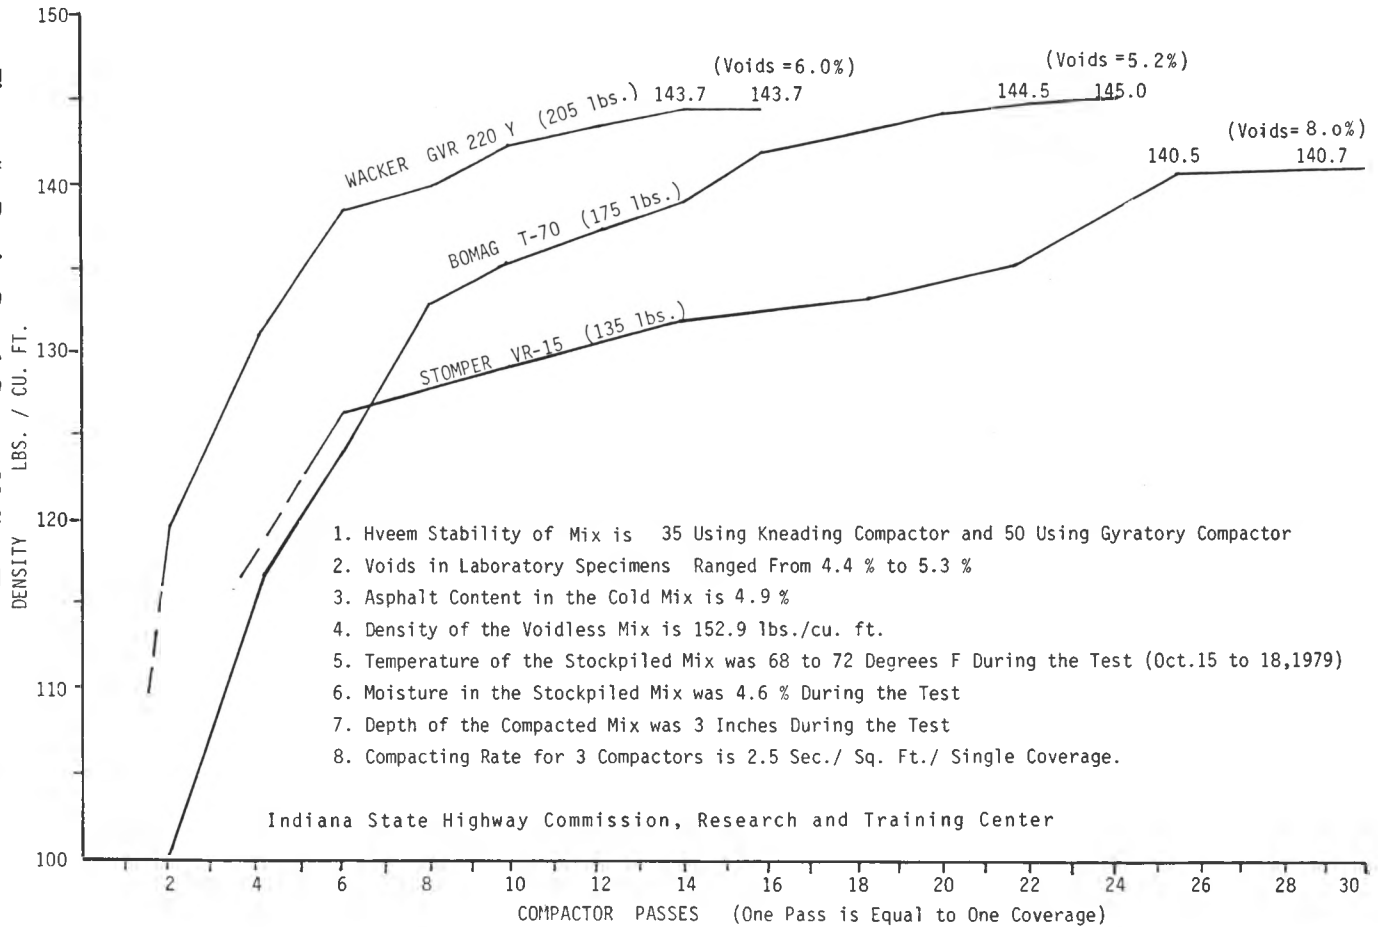
Figure 5. Density Growth Curves—Medium-Texture WS Cold Mix Compacted at 70°F Using Three Different Types of Compactors

1. Hveem Stability of Mix is 35 Using Kneading Compactor and 50 Using Gyratory Compactor
2. Voids in Laboratory Specimens Ranged From 4.4 % to 5.3 %
3. Asphalt Content in the Cold Mix is 4.9 %
4. Density of the Voidless Mix is 152.9 lbs./cu. ft.
5. Temperature of the Stockpiled Mix was 68 to 72 Degrees F During the Test (Oct.15 to 18,1979)
6. Moisture in the Stockpiled Mix was 4.6 % During the Test
7. Depth of the Compacted Mix was 3 Inches During the Test
8. Compacting Rate for 3 Compactors is 2.5 Sec./ Sq. Ft./ Single Coverage.

Additional testing was conducted using three different tamping compactors on a special test pad constructed at the Research and Training Center. The results of this testing are shown in Figure 5.

Each compactor was applied, in a controlled manner, to densify a three inch lay of cold mix until peak density was obtained. The final results in Figure 5 show that peak densities vary somewhat, but based on an acceptable void content from 5 to 8 percent at the time of construction, all three compactors seem to be able to attain the desired density. The main difference between the compactors is the number of passes needed to get the desired density. The "Bomag" Model T-70 compactor was able to attain the highest density even though it was lighter than the "Wacker." This is attributed to the "Bomag's" good handling characteristic. The unit was provided to the Center on a trial basis for this test.

The number of passes required to compact the cold mix in Figure 5 was somewhat greater than anticipated before the test was started. It was also found that the time required to make a pass over an area was nearly the same for all three compactors—2.5 seconds square feet/single coverage. By using this rate and referring to Figure 4, it is possible to estimate the approximate time needed to compact a pothole if the size of the patch and mix temperature is known.
