Pressurized Emulsion Mix— Crack Repair

CHARLES L. HUISMAN

Highway Division—Office of Materials

Iowa Department of Transportation

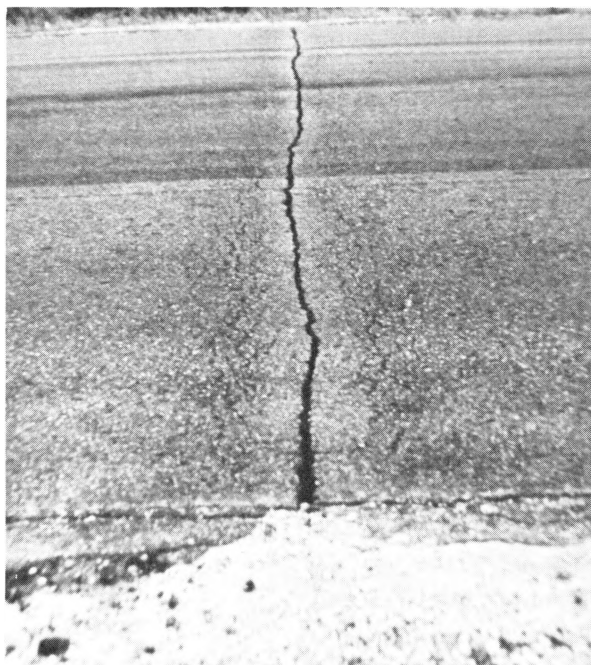
Figure 1. A closeup of a typical thermal crack on a rural asphalt pavement. Note in the close foreground that the fines of the granular base material are actually pumping out of the pavement onto the shoulder, causing an undermining of the pavement slab and the depression along the crack manifested in alligator cracking.

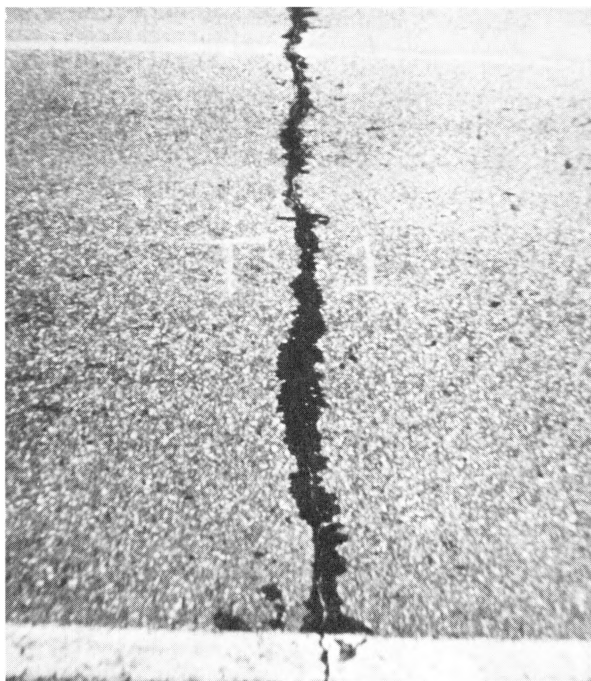
Figure 2. In an earlier analysis of our typical thermal cracks on the Iowa asphalt pavement sections, we have classified cracks into four categories. This is a typical Class 1 crack on a rural asphalt pavement.

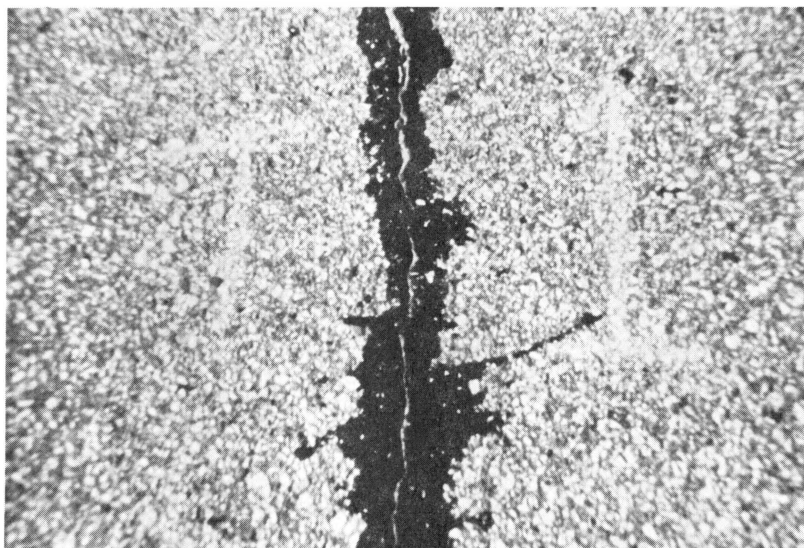
Figure 3. A closeup of that same Class 1 crack with the typical surface crack sealing that had been practiced universally over the state for many years.

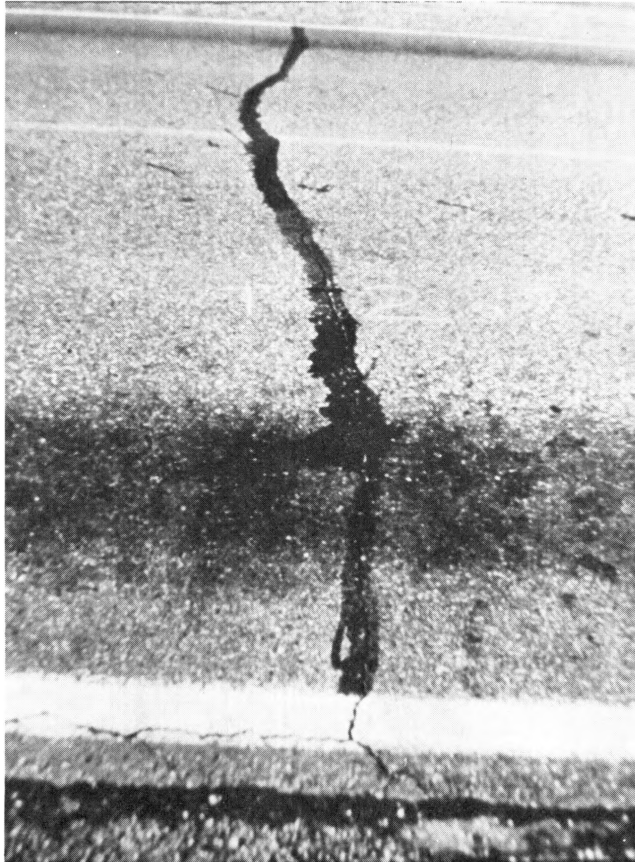
Figure 5. A typical Class 2 crack with maintenance crack filling treatment.

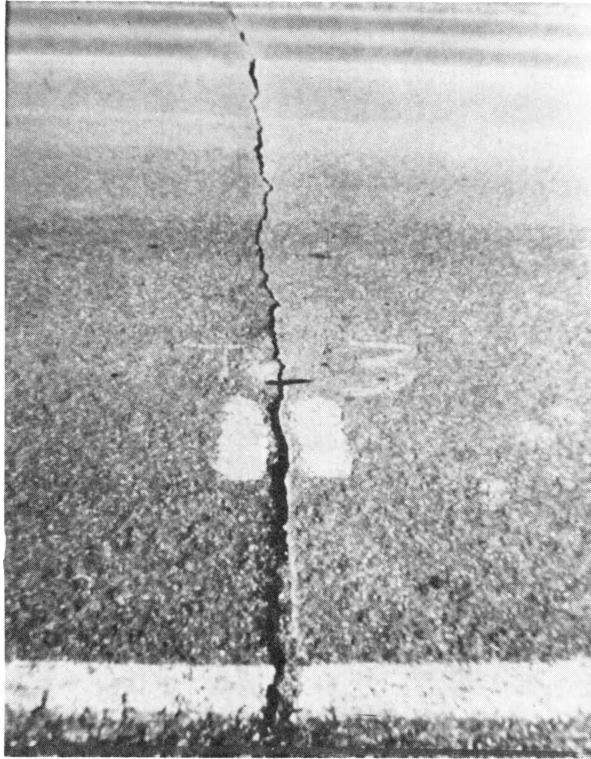
Figure 8. This typical Class 3 crack on the U.S. 71 project had no prior crack sealing or maintenance treatment. The classification of this crack is made by a 1/2-to 1-in. average depression. It is nearly a straight line transverse crack and occasionally a secondary crack develops on either side of the primary crack.

CLASS III A.C. PAVEMENT SURFACE CRACKS	
VISUAL CONDITIONS: 1 0.50" to 1.0" average depression 2 Near straight line crack 3 Occasional secondary crack	METHOD OF REPAIR: 1. Saw 4" wide retracing crack line 2. Full depth patch - (tack, pre-mix or hot-mix & spec. compaction)

Figure 9. Our design method of repair was to saw out a 4-in. wide trench, retracing the crack line, and to make a full depth patch with a tacking, premix, or hot mix by standard compaction methods.

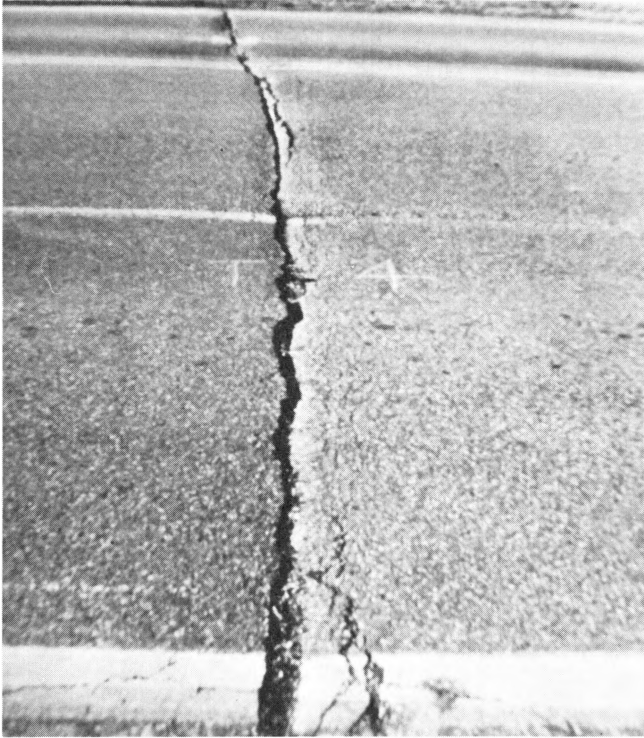
Figure 10. This is a typical Class 4 crack where the deterioration has progressed dramatically from the Class 3 crack. There is no evidence of maintenance repair procedures.

1. 0.75" plus depression
2. Wide (3/4" +) crack
3. Secondary crack or breakup

1. 12" wide removal
2. Full depth patch (per std specs)

Figure 11. A Class 4 crack has these visual conditions: Usually 3/4 in. or more depression, the crack is 3/4 in. or more wide. It has a secondary crack or area of breakup adjacent to the crack. The method of repair is to remove the pavement 12 in. wide full depth and replace it with an asphaltic concrete patch per our standard specifications.

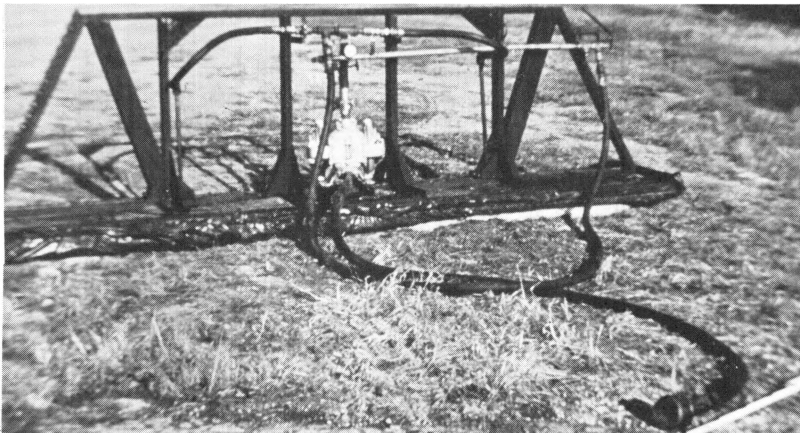
Figure 15. In order to accomplish this, we built this steel truss section that is approximately 11.5 ft. long. The platform is about 18 in. wide, is covered with a 2-in. solid plank platform which is further covered with a 3-in. mat of high density, flexible polyurethane foam covered by a polyethelene membrane. A pneumatic pump is mounted in the center of the truss section and to it's right and left about 4 ft. is the extension of nozzles that protrude through the bottom of this platform. In the foreground, a suction hose sucks slurry into the pump and through the nozzles into the pavement cracks.

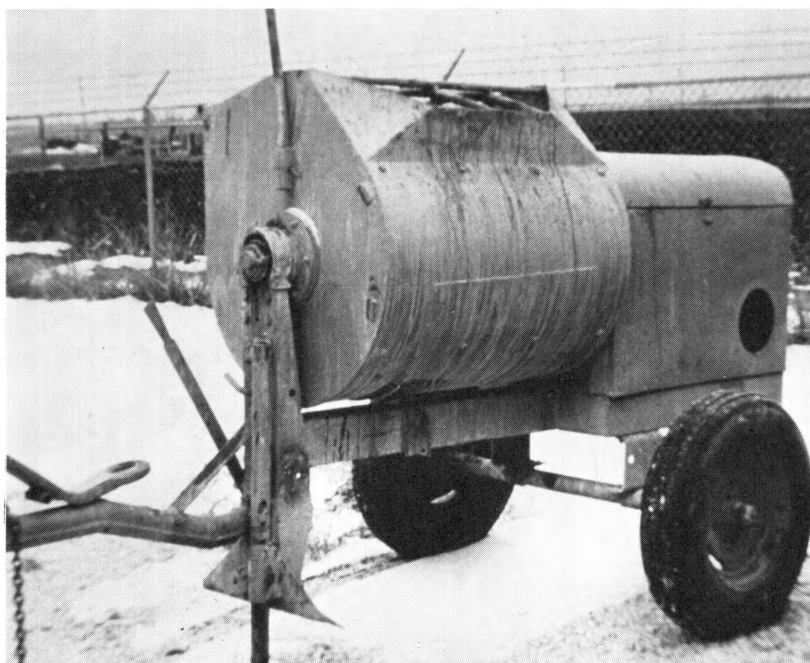
Figure 21. Highway maintenance crews used this typical mortar or plaster mixer for mixing concrete and/or mixing asphalt emulsion and/or slurry mixtures. This was one of the mixers we utilized later on in other crack filling activities. The only modification necessary was the addition of a tapered, threaded tap made in the bottom of the drum so that an elbow, valve, and reservoir could be placed underneath this outlet to control the discharge of the slurry which then was picked up by the pneumatic pump and pumped into the pavement cracks. The pumpable slurry crack sealing mix was designed in our bituminous laboratory and the best formulation for this pumping operation involved a 50% limestone aggregate and a 50% CSS-1 emulsion by weight.

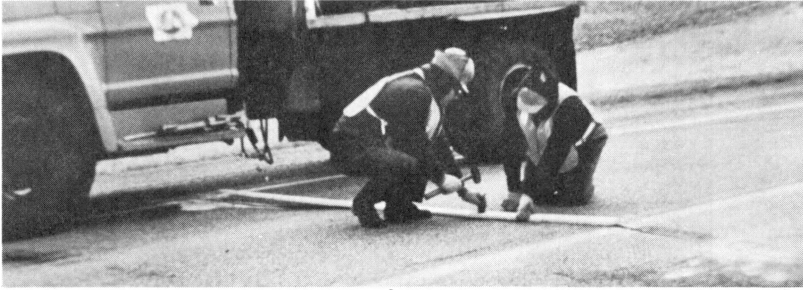
Figure 23. We believe the best time of year to fill asphalt pavement cracks is in the coldest part of the winter or early spring when the cracks are at their maximum opening. This slide shows a two-hole template to mark the positions on the pavement where the nozzles of the pressure truss applicator would be positioned. Only two nozzles are provided on the truss to accommodate positioning along an irregular transverse crack. After the locations were positioned with the template, a hydraulic jack-hammer driven by the maintenance truck's hydraulic system was used to drill the pilot hole for the pressure filling operation.

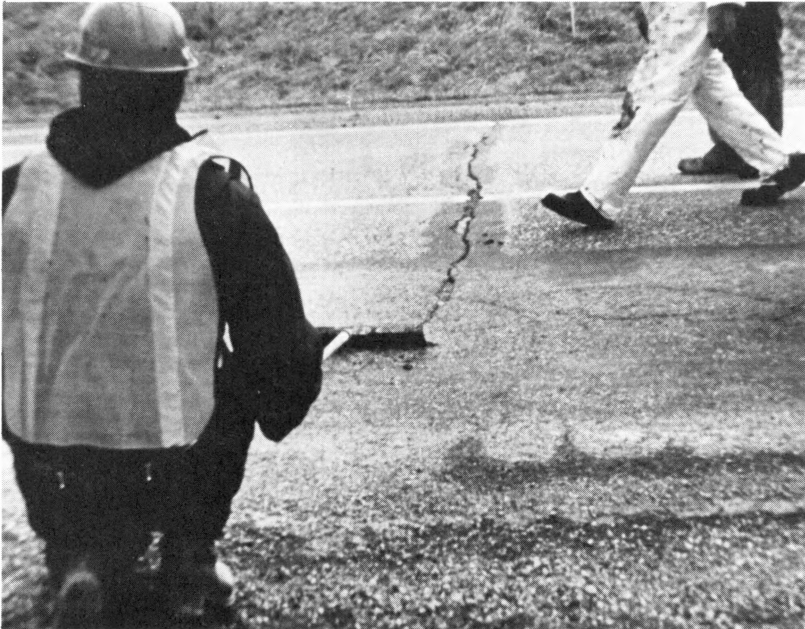
Figure 26. The crack sealing operation described here was limited largely to the Class 3 and Class 4 cracks, of which there were more than 3,500.

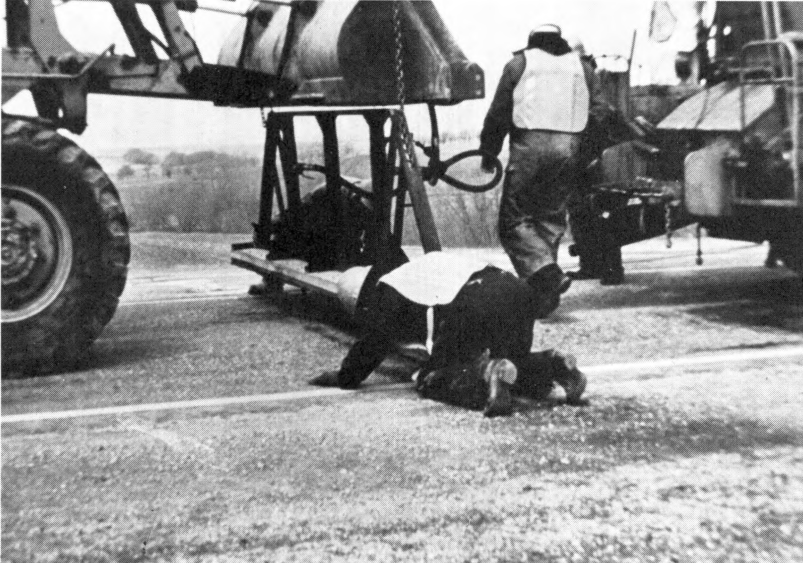
Figure 27. This typical Class 3 crack is being prepared for filling. The truss section was simply suspended under the loader bucket with a log chain in order to make the truss easily positioned as it was centered over the nozzle pilot holes. It then was lowered into position with the loader bucket.

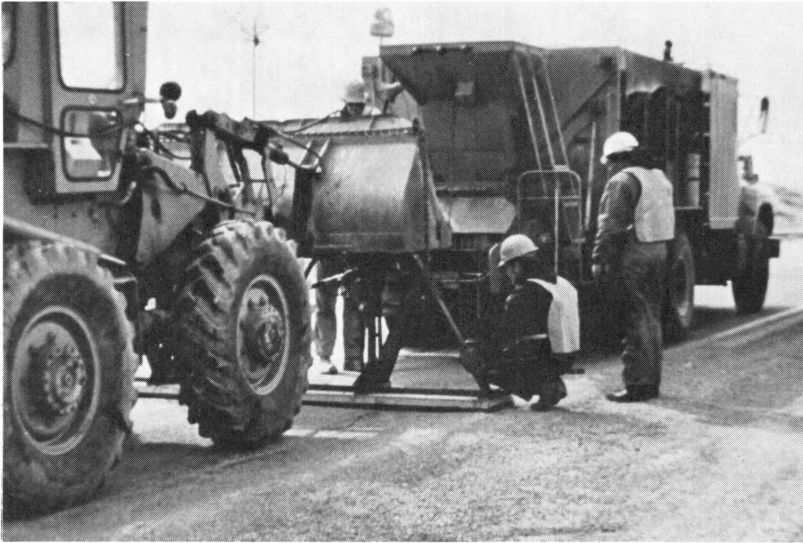
Figure 28. The total down pressure of the loader and its bucket was applied to the truss section. This pressure would compress the high density foam on the underside of the platform which would actually seal off the pavement surface at the crack interface so that high pressures could be applied and slurry injected into the cavities in the lower elevations of the pavement.

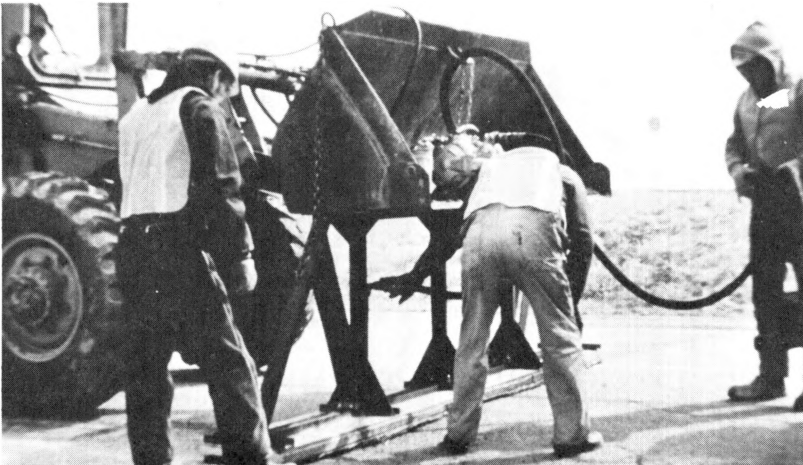
Figure 31. The pressure of the air reservoir of the compressor is applied to the pneumatic pump. We found that usually a 60 psi pressure on the pump was more than sufficient to pressure inject the slurry into the cracks. We would continue pumping until the slurry material started to extrude at the end of the platform section. In one instance where a crack had seriously faulted and the pavement sagged adjacent to it, we applied the full 120 psi to the system. We were slab pumping the pavement and actually lifting the depressed asphalt pavement back up to its original constructed elevation. This did not necessarily work in all situations because it depends on the configuration of the cavity beneath the crack.

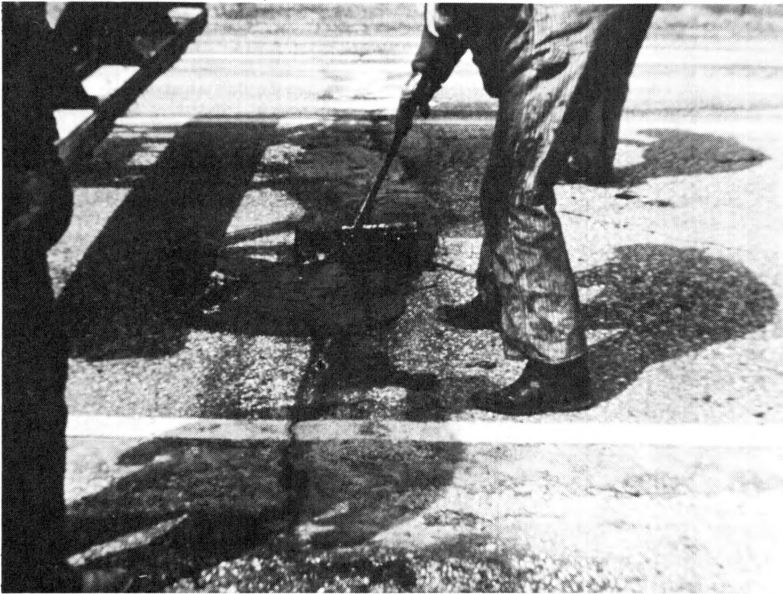
Figure 33. In areas where there was a transverse trough depression along the axis of the thermal crack, this trough was squeegeed full with the pressure injection slurry material. Note a wet spot in the foreground in the shoulder area adjacent to the crack. We found it not uncommon to pump from 7 to 15 gal. of slurry mixture into some of these cracks. In a few minutes a 6- to 10-ft. diameter circular area saturated with moisture would develop on the shoulder which indicated that the pressure slurry material was displacing the water in the cavity of the crack and was filling and waterproofing this area.

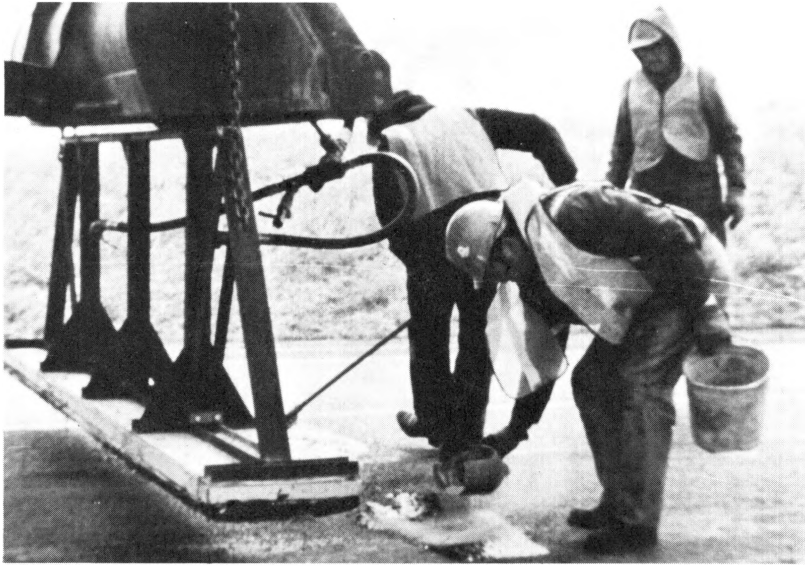
Figure 34. After strike-off of the crack, it was lightly dusted with a fly ash. The fly ash was available because our early inclinations were to use fly ash rather than limestone for the slurry mixture. We found that it did not have the desirable mix characteristics that we found in the limestone-slurry mixture.
