Cold, In-Place Recycling On State Road 38

REBECCA S. MCDANIEL
Materials Research Engineer
Division of Research, IDOH

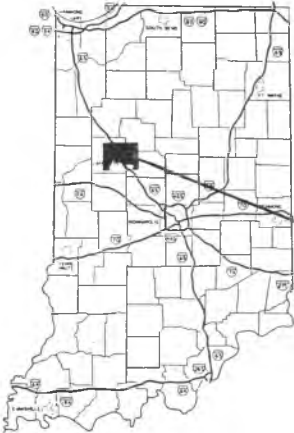
RESURFACE Western 4.87 Miles

RECYCLE Eastern 4.87 Miles

Area Enlarged

The recycling was included as part of contract RS-16019. This contract called for the widening and resurfacing of 9.74 miles of State Road 38 in Tippecanoe and Clinton counties. The location of the project is shown in Figure 1. The traffic volume along this road varied from about 2,400 to 3,450 vehicles per day (total ADT).

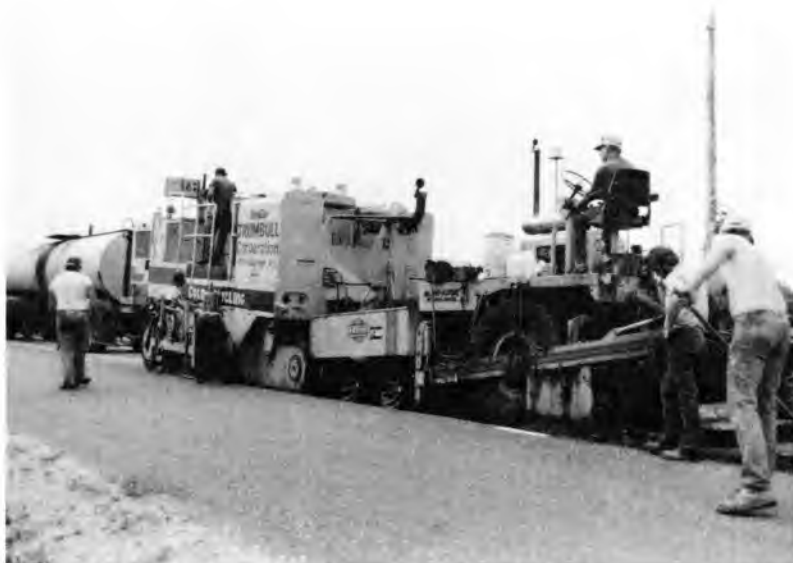
The recycling train consisted of a water wagon, emulsion tanker, recycling machine and asphalt paver. Figure 3 shows the recycling train in action.

Figure 3. The supply trucks, recycling machine and paver work closely together in a recycling train.

The recycling machine was the major piece of equipment used. A downcutting machine was used, so the size of the processed material was

The cutter head did most of the work. It chewed up the old pavement to the depth, width, and size specified. Water and asphalt emulsion were added concurrently through separate metered spray bars. The water and emulsion were mixed into the RAP by the cutter head. Visual observations indicated that this particular machine did a good job of mixing the RAP and coating the particles.

The recycled material was carried on a belt out the back of the milling machine. Oversized particles were returned to the cutter head for more crushing. The reclaimed material was discharged into the hopper of a standard asphalt paver.

The special provisions required that the paver be connected to the milling machine with a stiff leg. A solid paving train was required. The stiff leg assured that the paver kept up with the recycling machine. With this technique, no windrowing was necessary, thus reducing material handling.

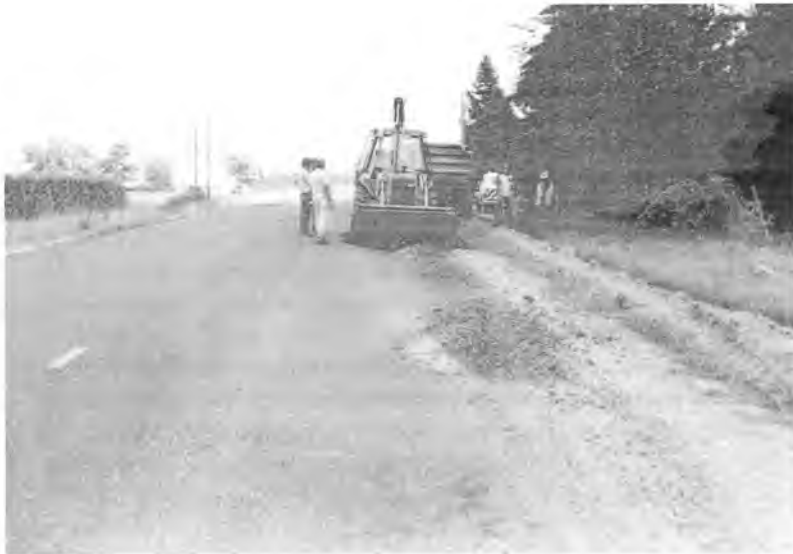
During this time, several “soft spots” appeared in the pavement. The worst of the deteriorated areas is shown in Figure 4. These weak areas were generally in the outer wheelpath. These were cut out and patched with roughly 1 ton of hot mix. The deteriorated areas were generally over soft subgrade in the area near what had previously been the shoulder. The pavement itself did not seem to be failing, but it could not support traffic for weeks over a poor subgrade.

Figure 4. Patching one of the worst deteriorated areas before placing binder and surface.

One basic thing we learned was to use what we already know. Recycling, in this case, was used to widen the road. Our standard specifications require that, when widening a pavement, the subgrade under the widened portion be rolled with a trench roller. When recycling and widening in one step, we should also require that the subgrade be rolled. Compacting the subgrade with a trench roller could have eliminated some of the troublesome soft spots.

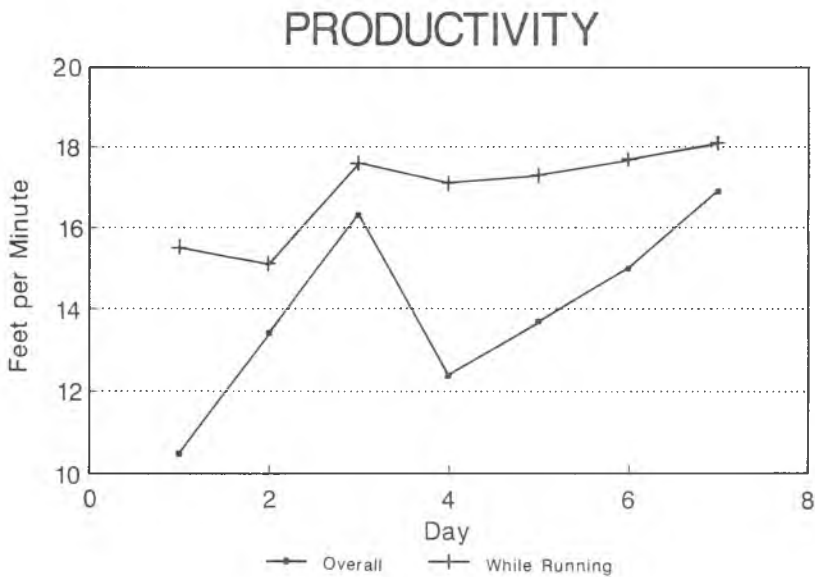
The production rate reflects the learning process that occurred as the local paving crew became accustomed to the method. Productivity is shown in Figure 5. On the first day, overall productivity was just over

10 feet per minute (fpm). By the second day, overall productivity increased to over 13 fpm and by the third day it was over 16 fpm. The next three days of recycling were plagued with equipment malfunctions. The resulting downtime cut the overall productivity by 1 to 4 fpm. On the final day of recycling, the overall productivity was up to about 17 fpm. This is equivalent to about 375 tons per hour.

The productivity while running disregards any downtime and represents the forward progress during recycling. On the first two days of recycling, the forward progress was about 15 fpm. By the third day it increased to about 17.5 fpm. The recycling productivity remained above 17 fpm for the rest of the operation.

The efficiency of the operation is the actual percentag eof time during the working day that recycling is progressing. It is, in effect, the ratio of productivity while running to the overall productivity. The efficiency on the first day was 68 percent. By the last day it had increased to 93 percent.

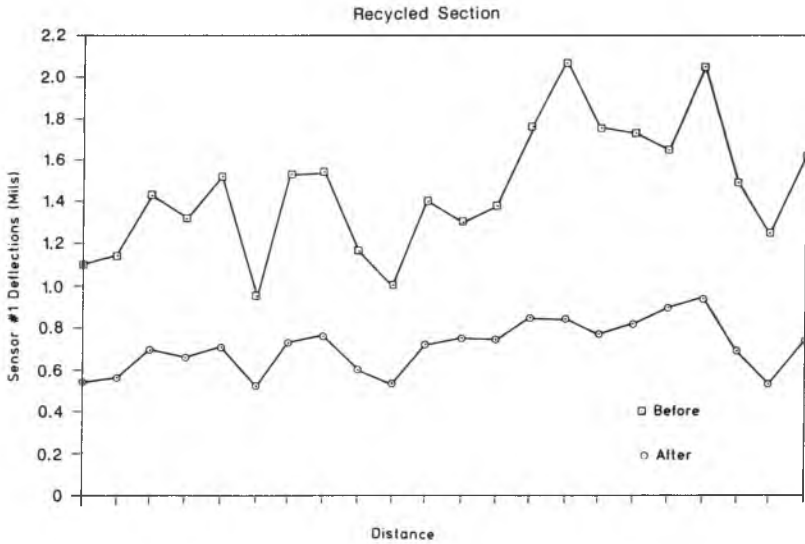
Figure 6. Dynaflect Deflections

Dynaflect deflections were recorded before and after construction on both the recycled and resurfaced sections. Deflections give an indication of the structural strength of the pavement. The Sensor #1 deflection averages and standard deviations are given in Table 1. Figures 6 and 7 show the deflections versus distance.

comparable. This indicated that the sections were about the same before construction and the experiment was not biased. Second, the deflections after construction were about cut in half on both the resurfaced and recycled sections. The standard deviations were also decreased by about half. Third, the deflections on the recycled pavement were slightly lower

than those on the resurfaced section. This is logical since the recycled base had more material placed over it.
