How Tippecanoe County is Improving a Local Intersection by Using an RSA and Federal Funds

Step 1: Identify the Location: Concord Road & CR 430S

Road Safety Audit
County Road 250 E and County Road 430 S
Area Plan Commission of Tippecanoe County
July 2015

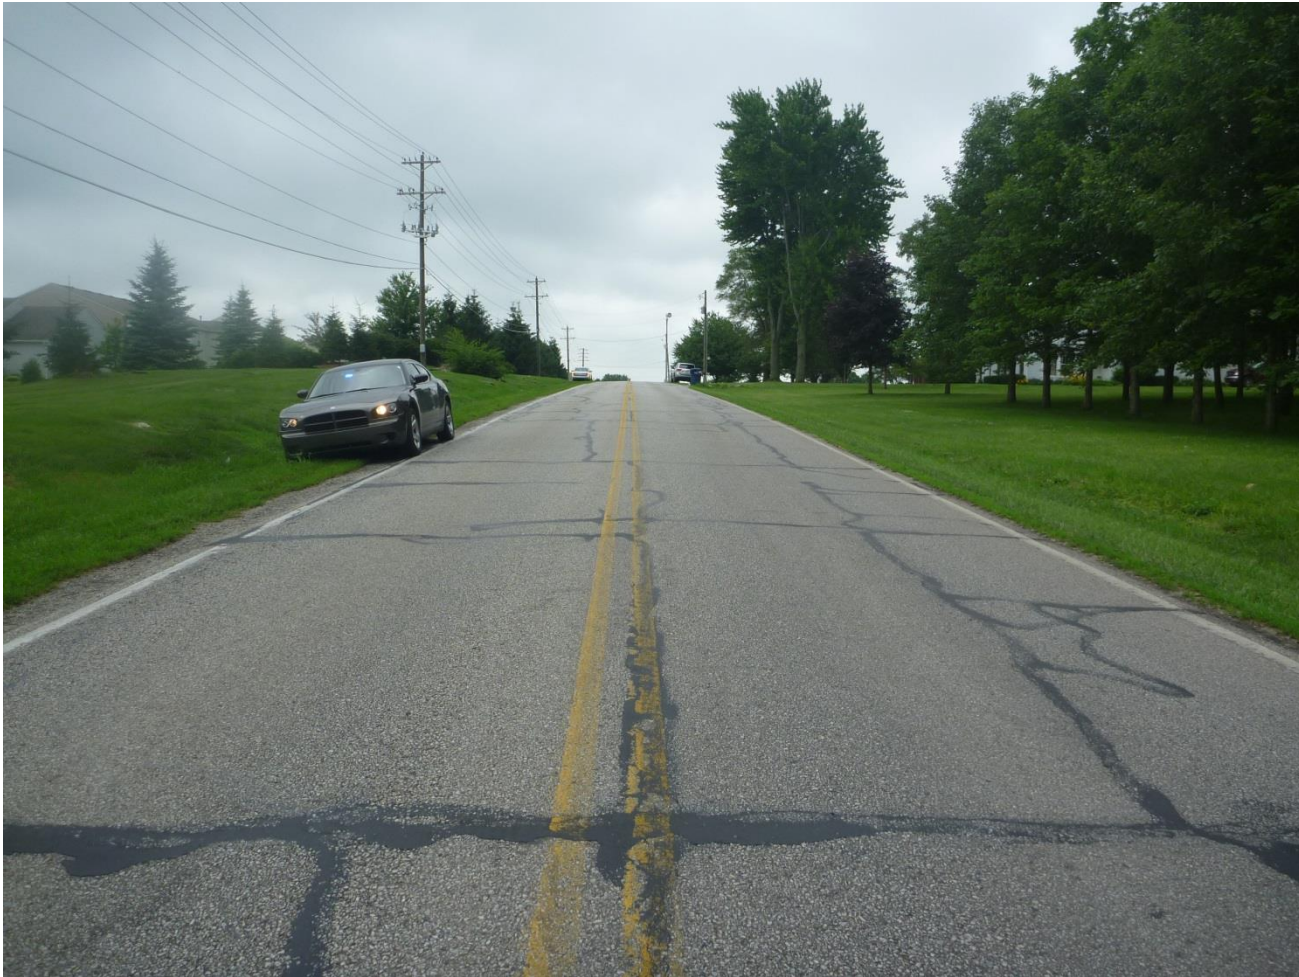
Concord Road

Looking South from Intersection

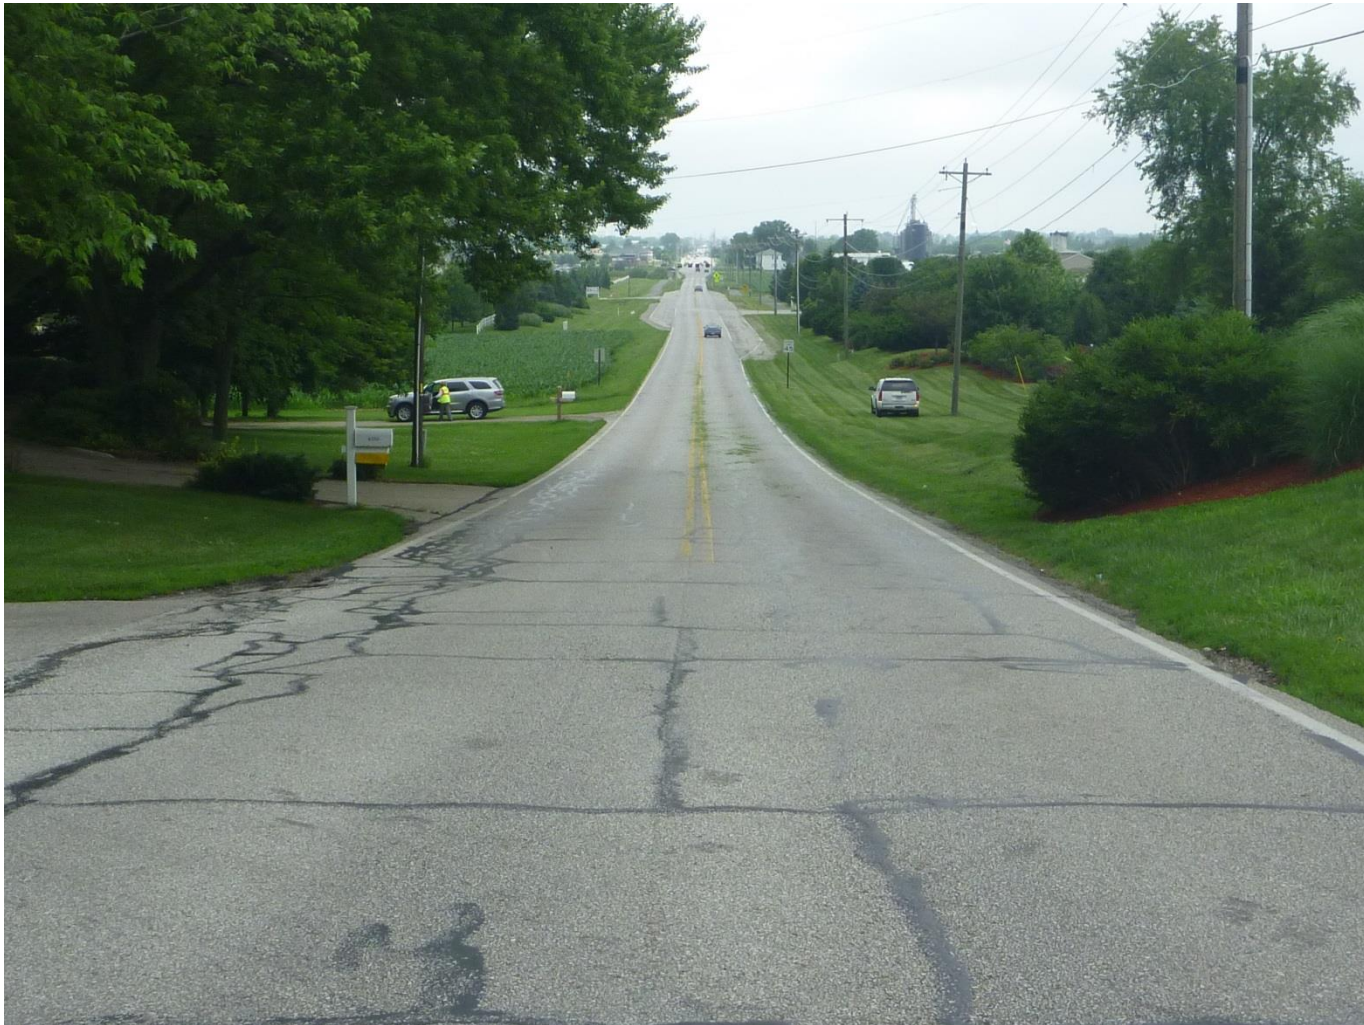
Concord Road

Looking North from Intersection

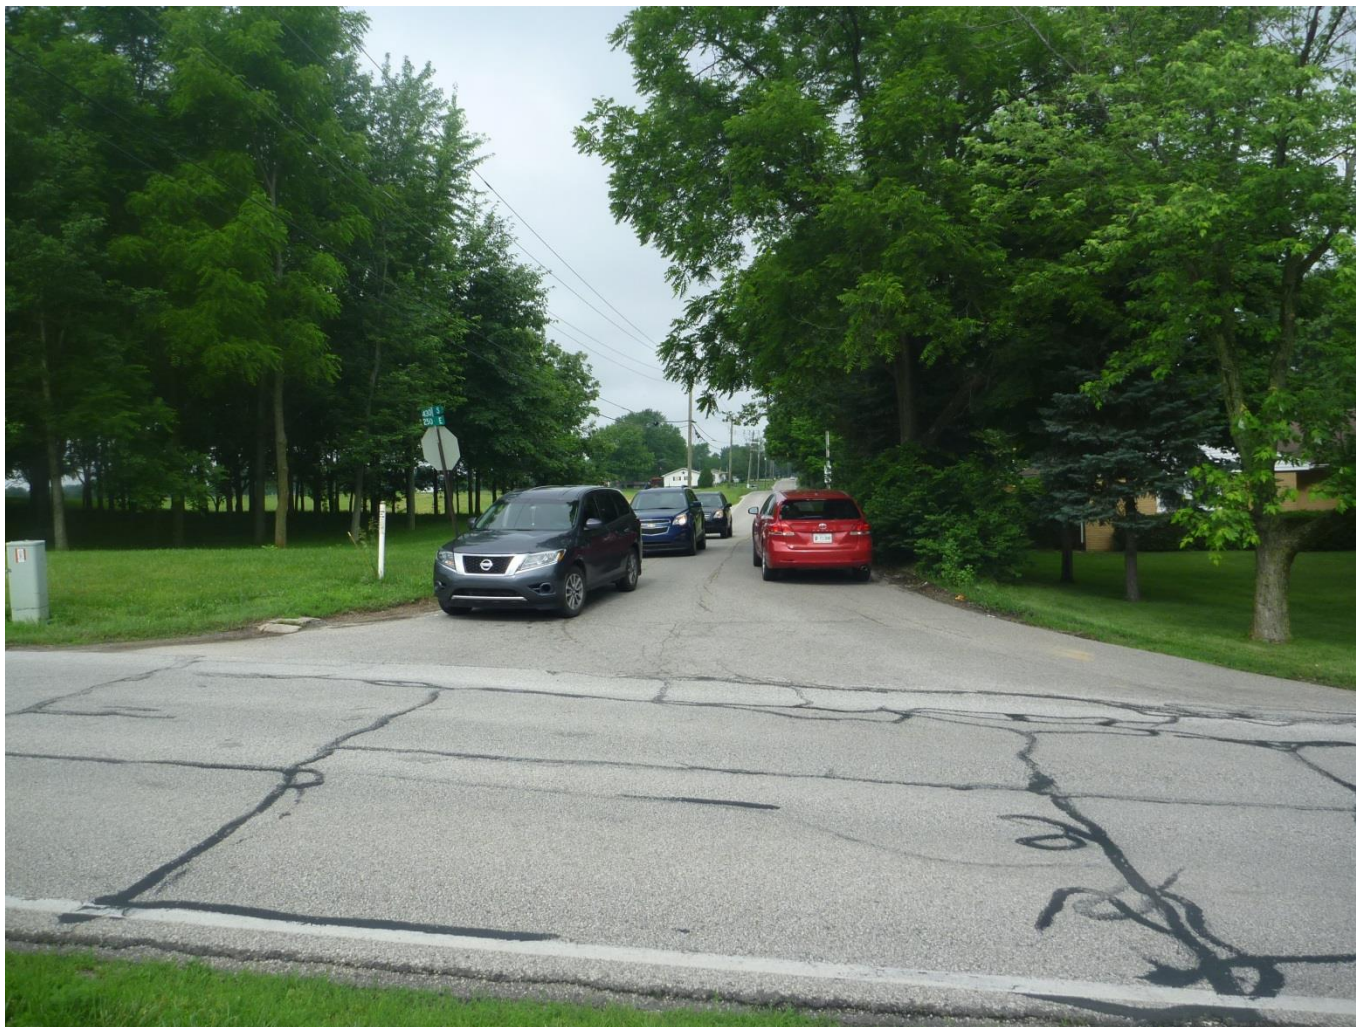
At Intersection Looking West

Greater intersection awareness is needed for east bound vehicles. This can be accomplished with the installation of advanced intersection signing, possibly a stop bar, a larger Stop sign and a double arrow on the far side of the intersection. Vegetation on the west side of the intersection should be trimmed, particularly the northwest corner where it may be in the public right-of-way.
