Continuous Long-Term Health Monitoring using Ultrasonic Wave Propagation

**Continuous Long-Term Health Monitoring using
Ultrasonic Wave Propagation**

Principal Investigator: Ece Erdogmus, PhD

December 2016

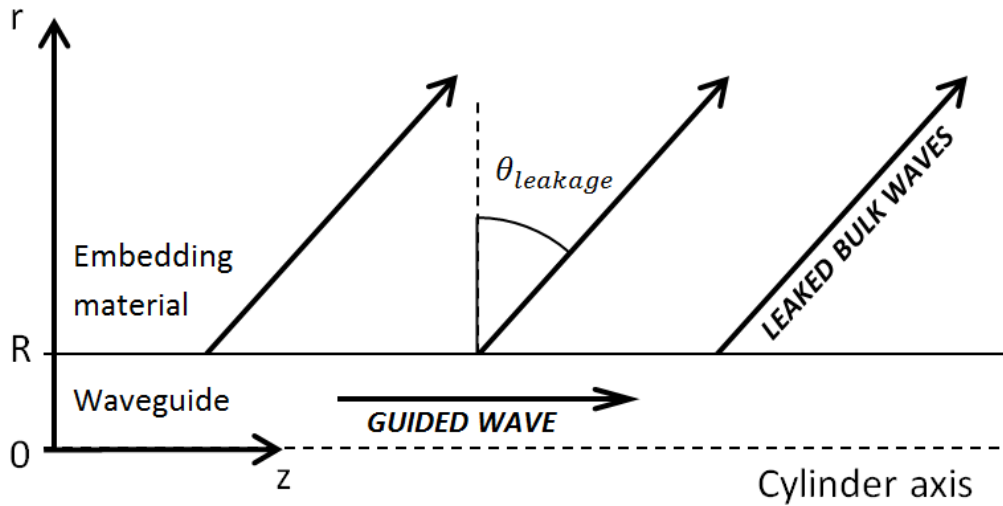
Figure 1– Leakage of bulk waves

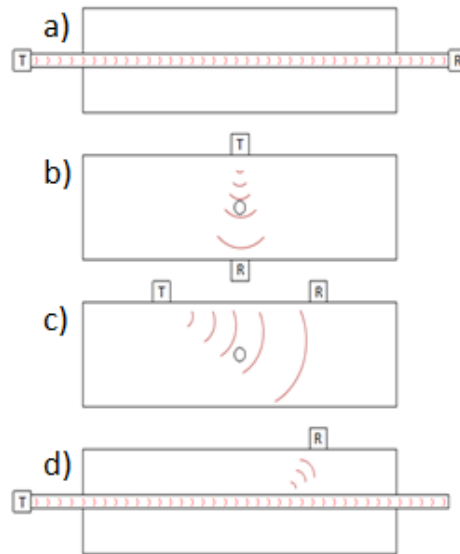
Figure 5. Test arrangements

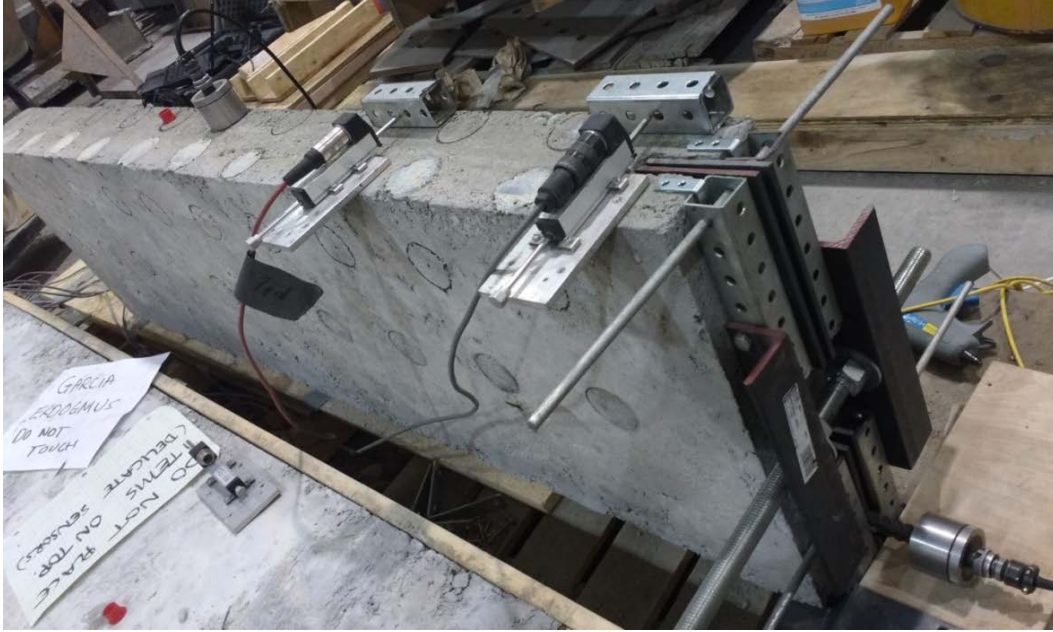
Figure 11. Specimen set 2

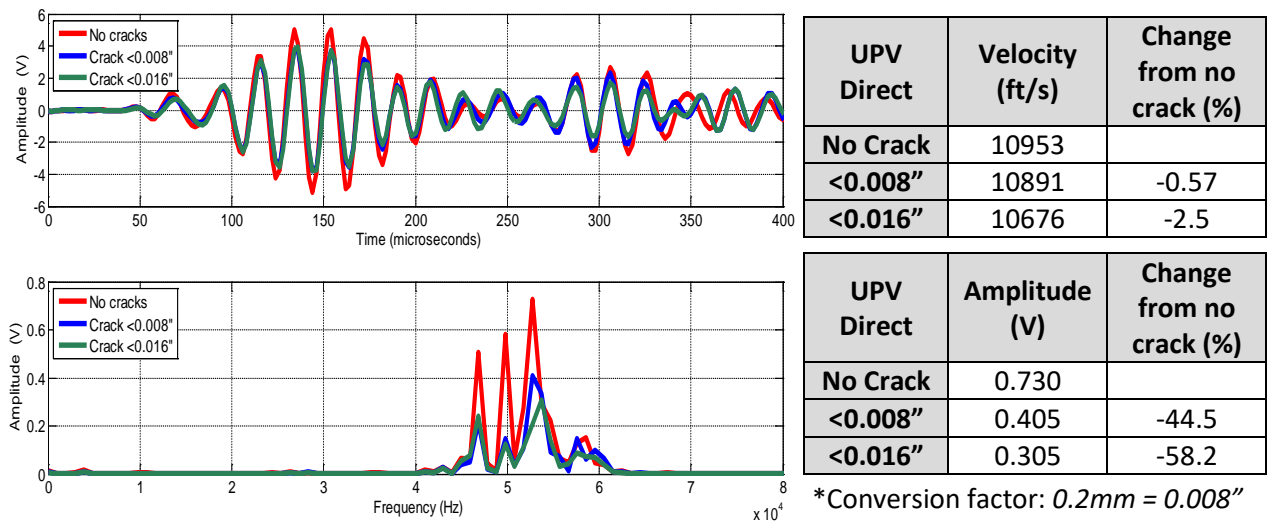
Figure 16. UPV (Figure 5b): Direct (Gain 10)

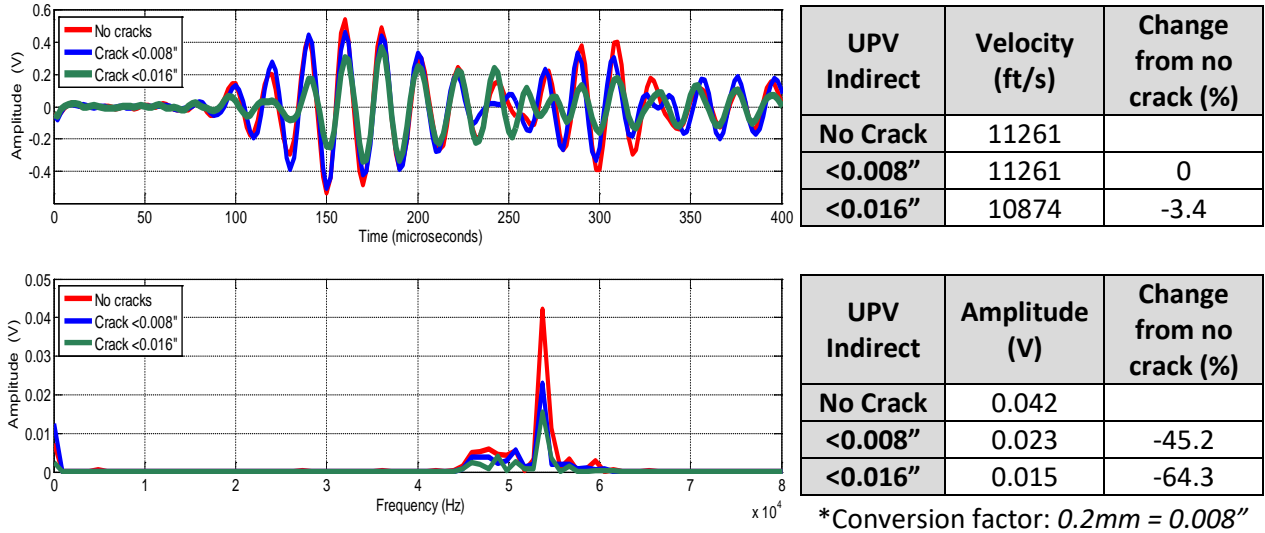
Figure 17. UPV (Figure 5c): Indirect (Gain 10)

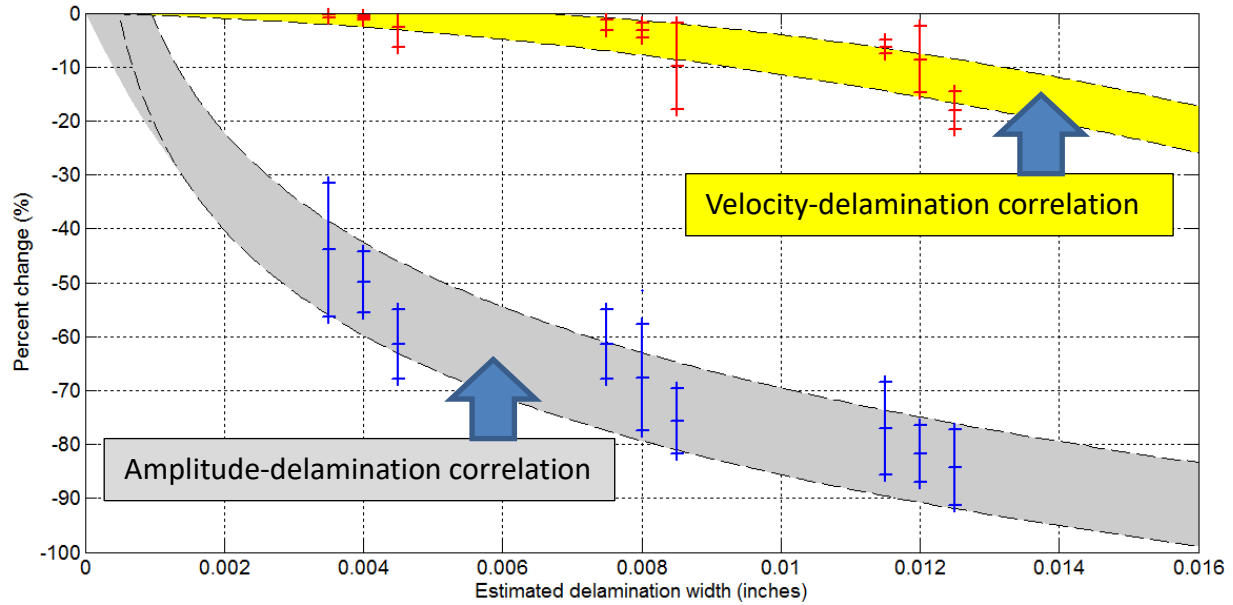
Figure 24 plots the average and confidence intervals of data collected using the UGW leakage set-up against the estimated delamination widths. The grey band gives the estimated correlation between the changes of amplitude and delamination width. The boundaries of the grey band are the fitted logarithmic curves of the lower and upper confidence intervals. The yellow band gives the estimated correlation between the changes of velocity and delamination width. The boundaries of the yellow band are the fitted 2nd order polynomial curves of the lower and upper confidence intervals. The fitted curves are shown as dashed lines in Figure 24.

Figure 24. Percent change of amplitude and velocity of UGWL (Figure 5d and 18a) due to onset of *estimated* delamination (Specimen set 1)

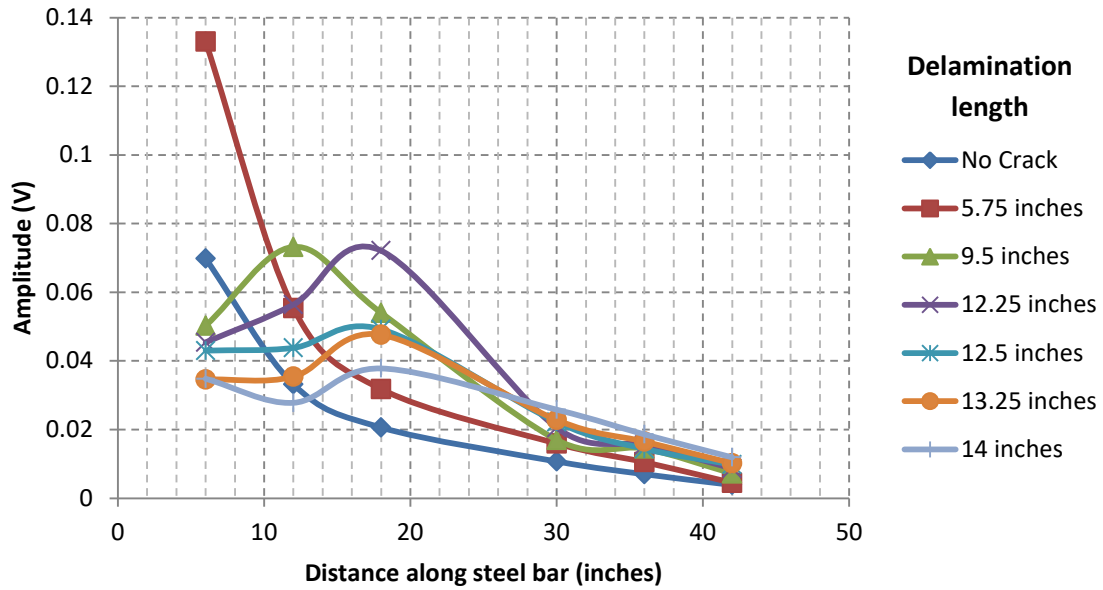
Figure 28. Amplitude with respect to delamination length monitored by the array 2.5 inches away from steel bar.

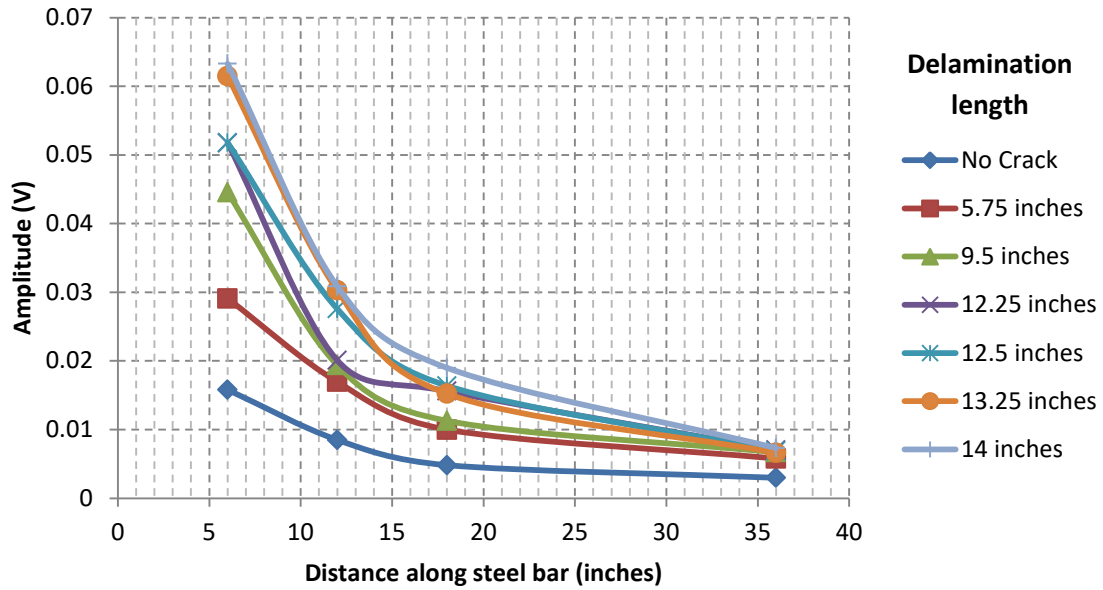
Figure 31. Amplitude with respect to delamination length monitored by the array 15 inches away from steel bar.

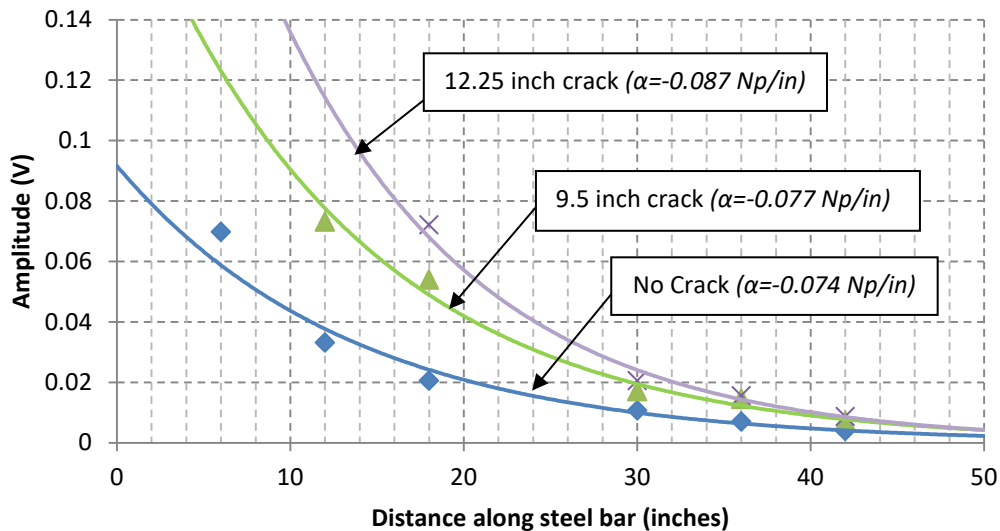
Figure 37. Specimen A: Exponential fitted curves for sensor array 2.5 inches from steel bar for points beyond delamination.

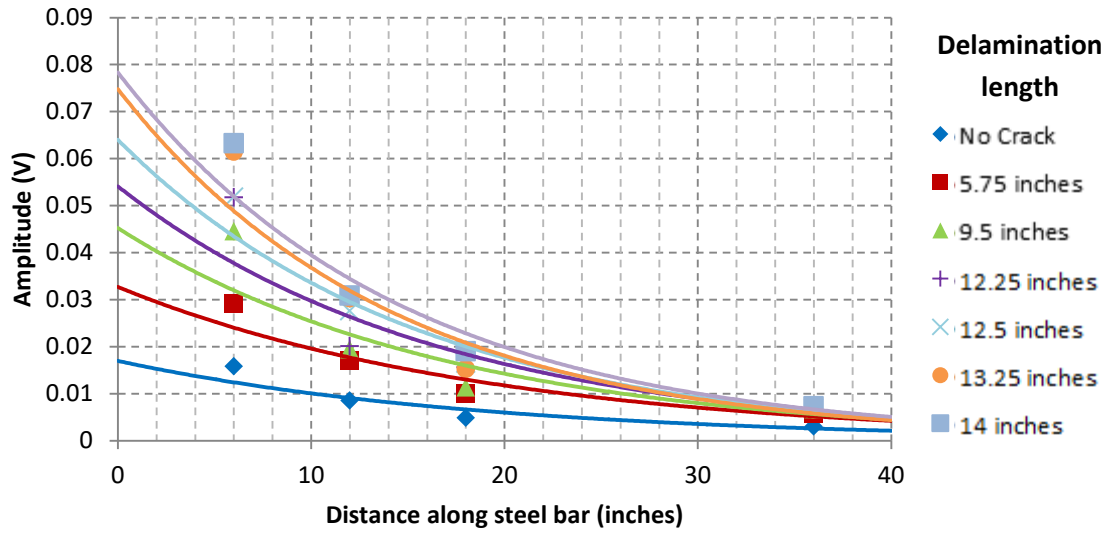
Figure 38. Specimen A: Exponential fitted curves for sensor 15 inches from steel bar for points beyond delamination.

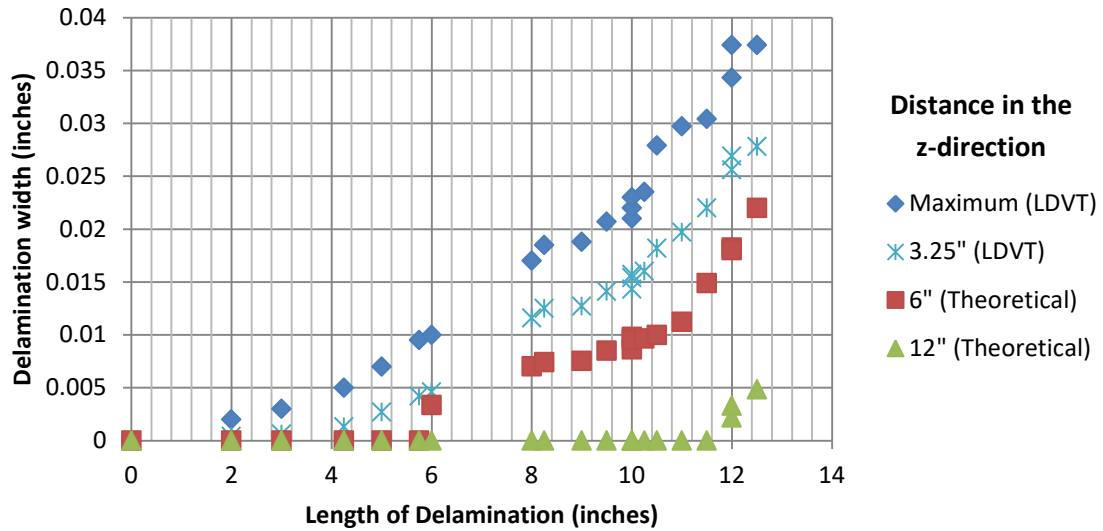
Figure 46. Measured and estimated delamination widths

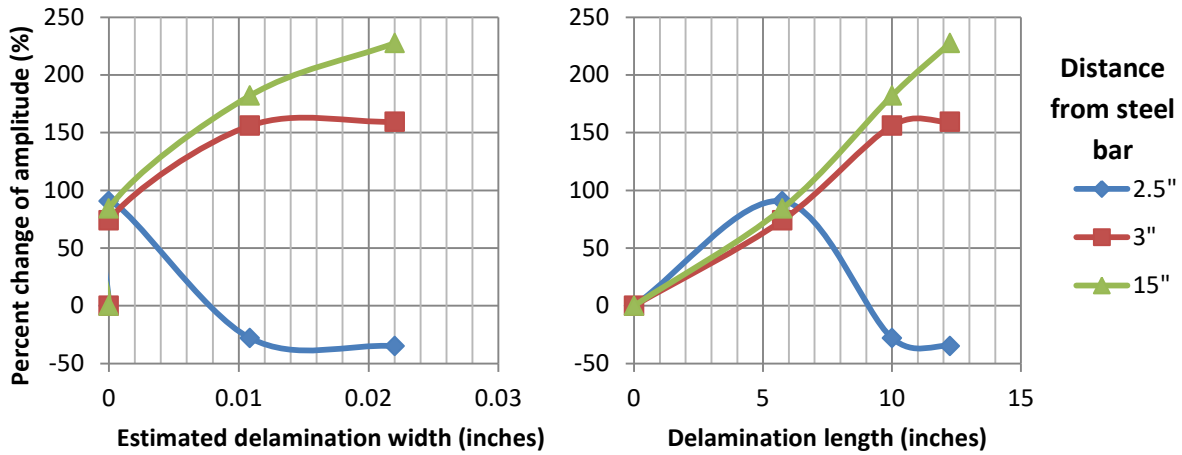
Figure 49. Percent change of amplitude with respect to delamination width and length for sensors located to monitor the 6 inch point along steel bar.
