# SR 57 vs the White River

## June 2008

Mark Bailey, PE – Hydraulic Manager, INDOT  
Dale R. Sedler, PE – Sr. Hydraulic Engineer, INDOT

Road School 2016

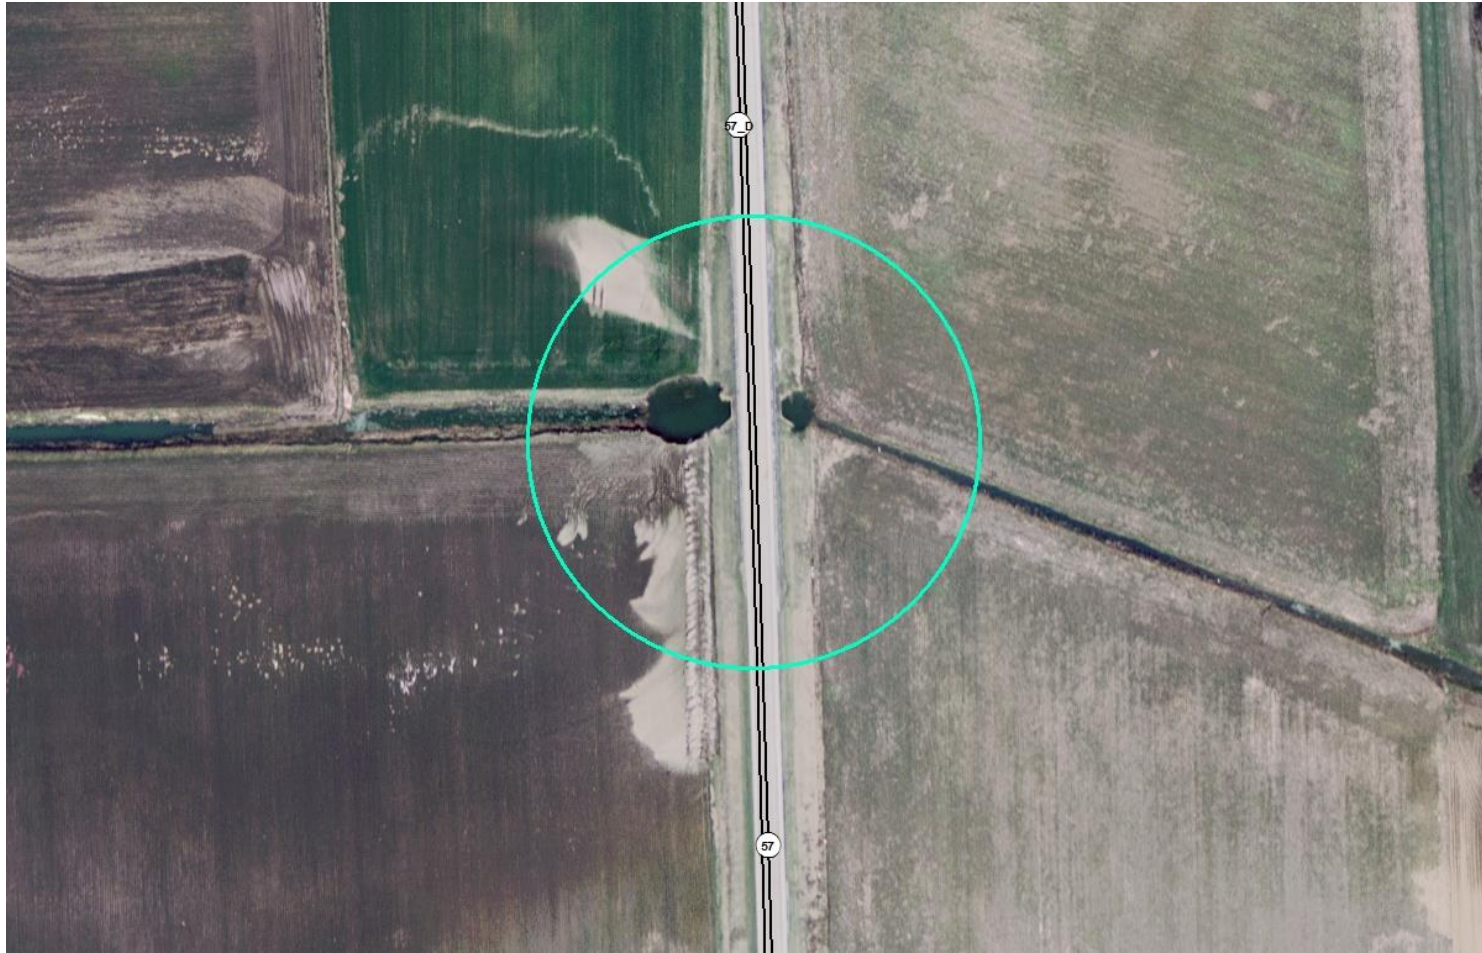
**2005 NAIP Aerial Photo of site**

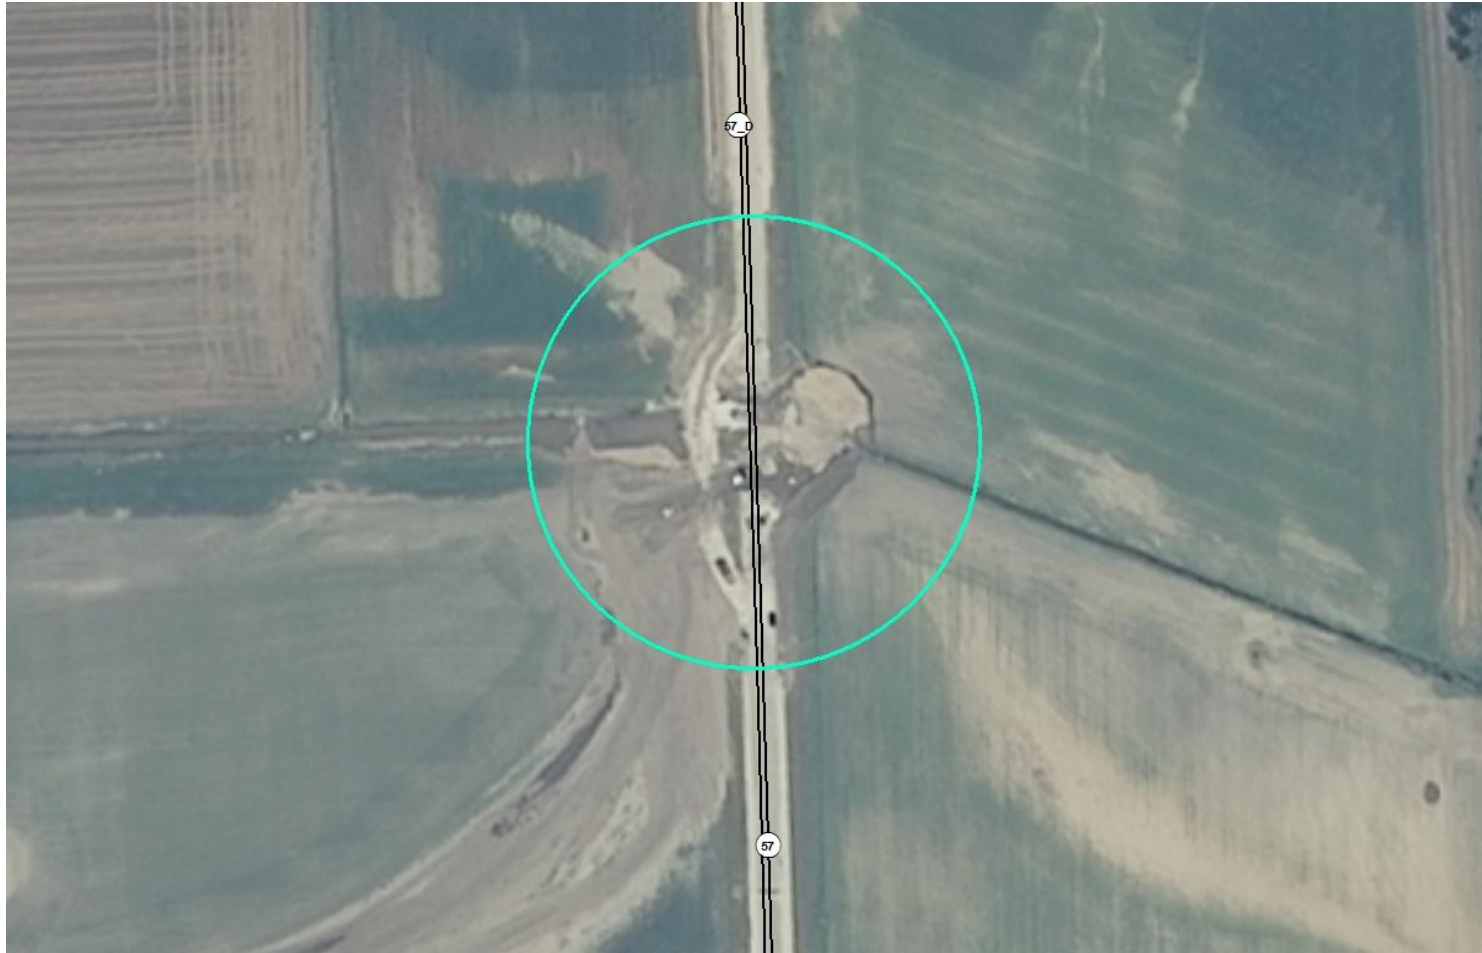
**2008 NAIP Aerial Photo of site**

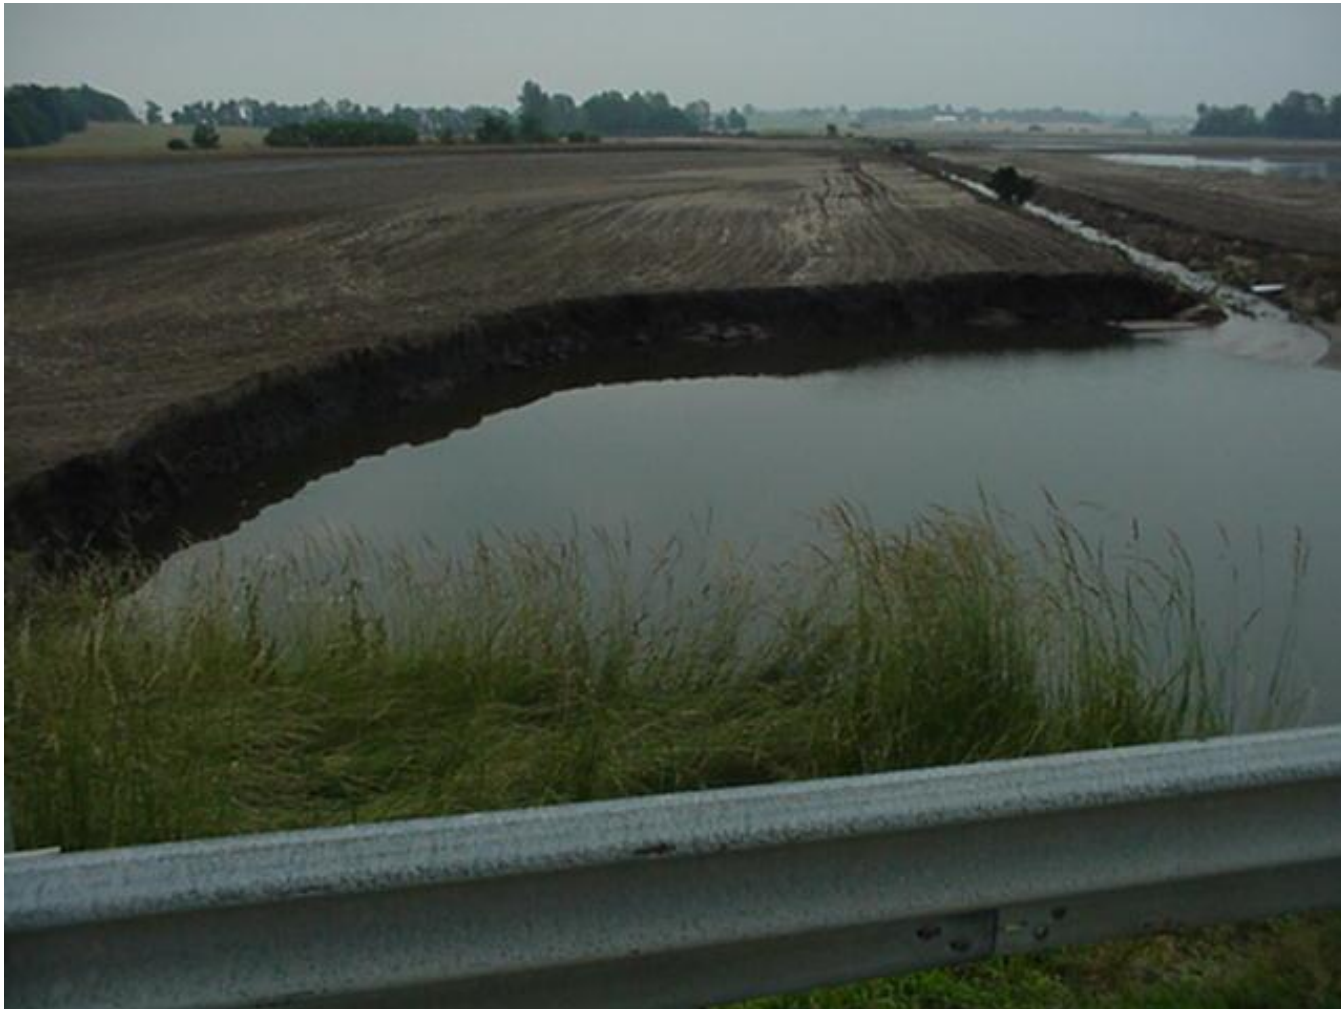
**2008 site photo, overflow upper right**

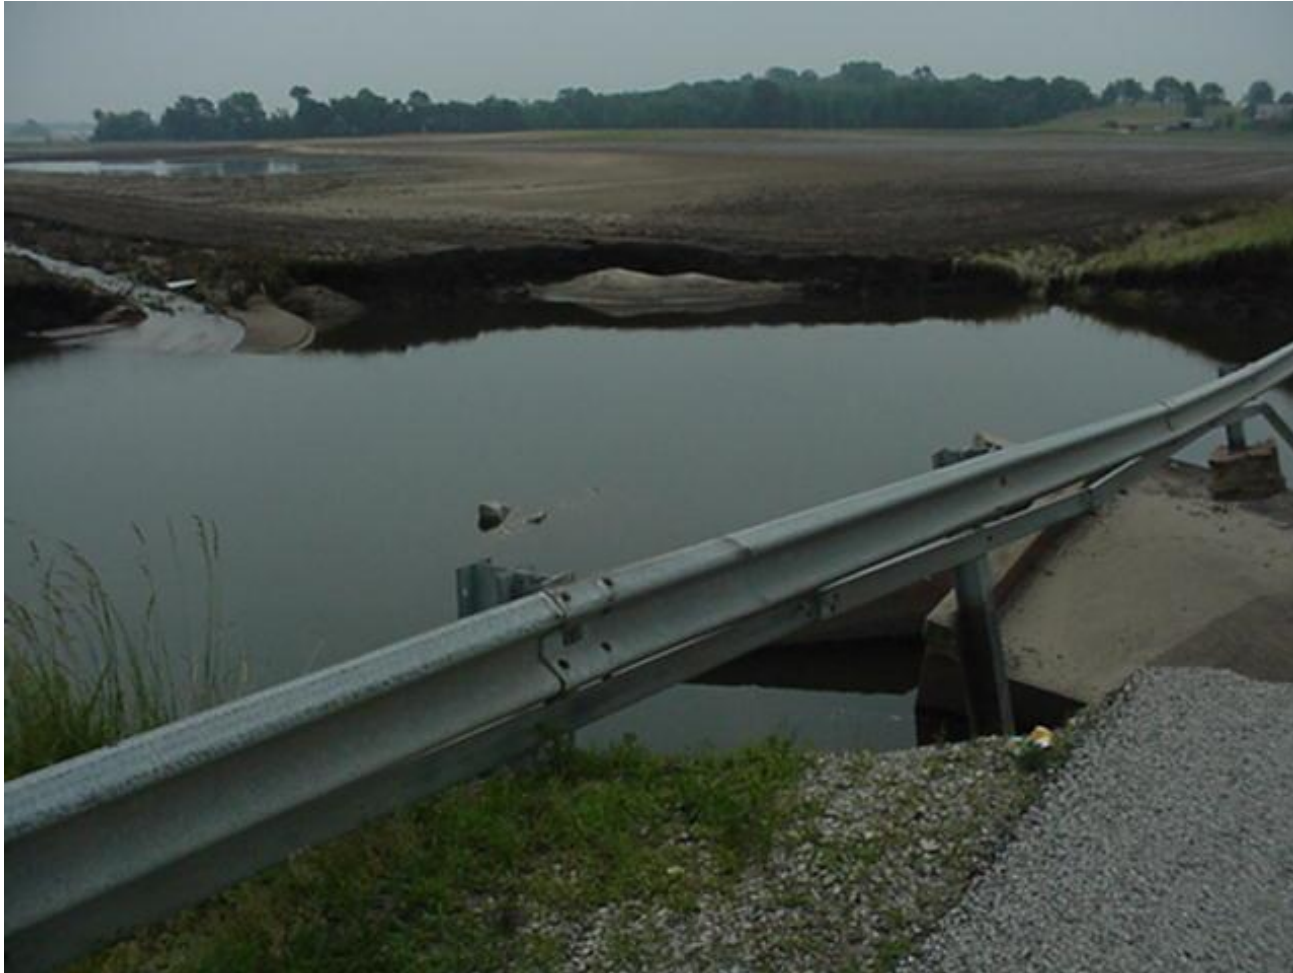
**2008 site photo, contraction scour**

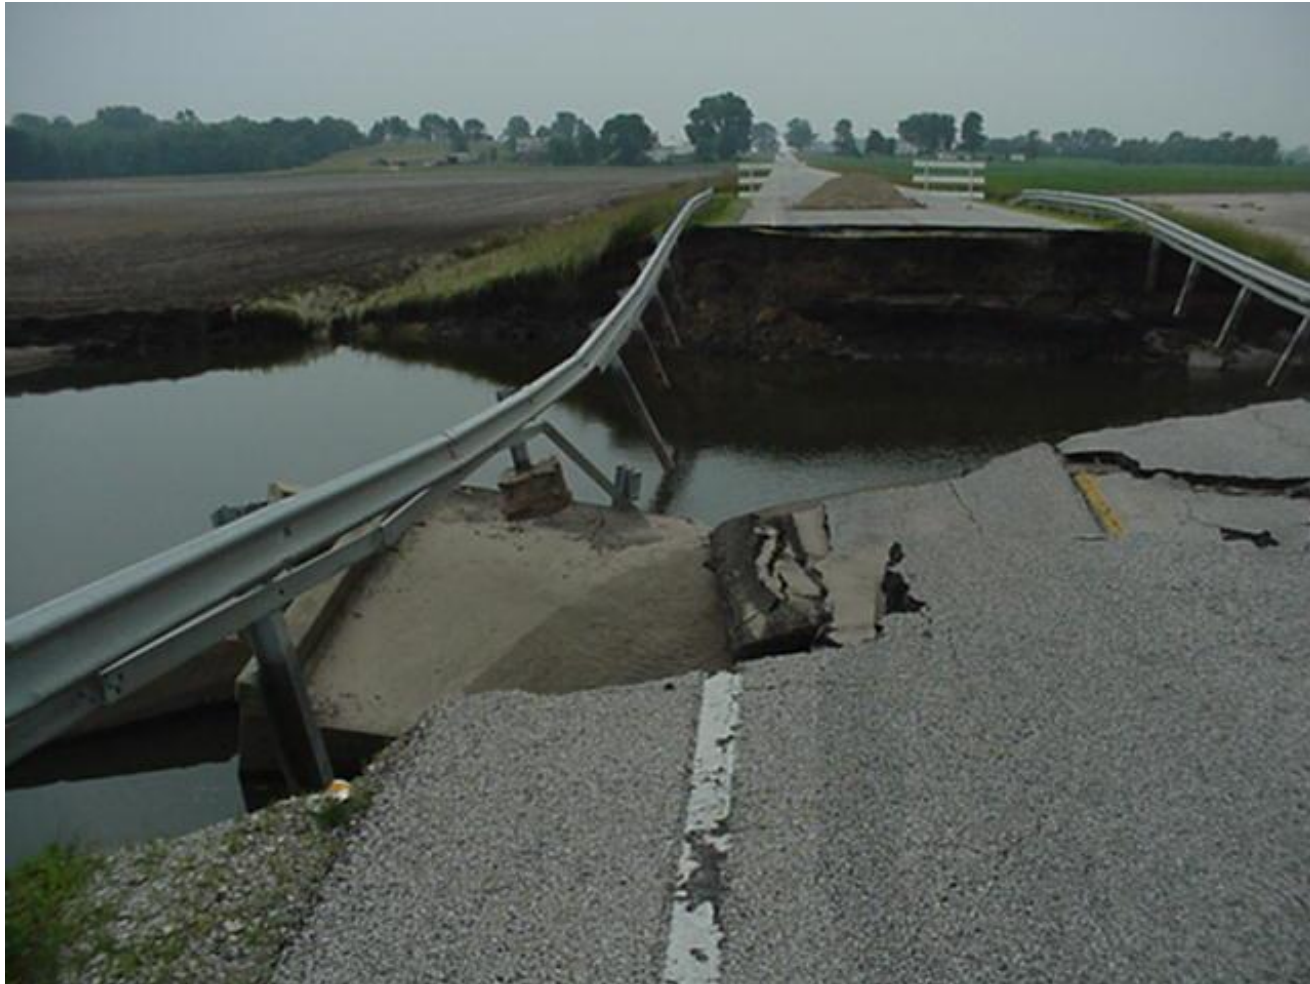
**2008 site photo, structure damage**

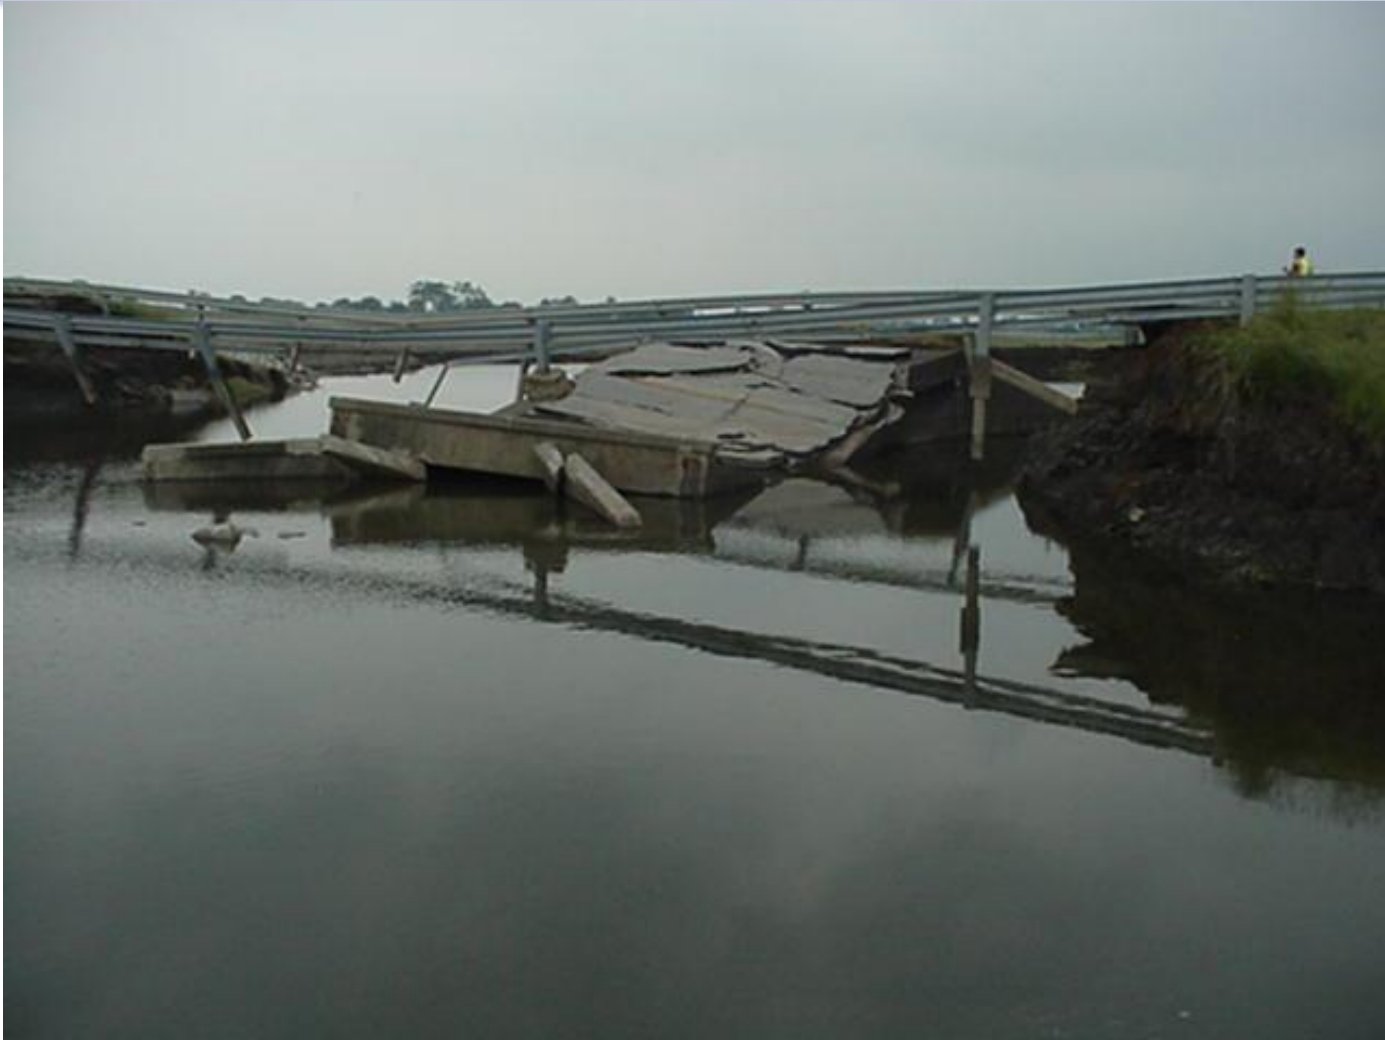
**2008 site photo, structure damage**

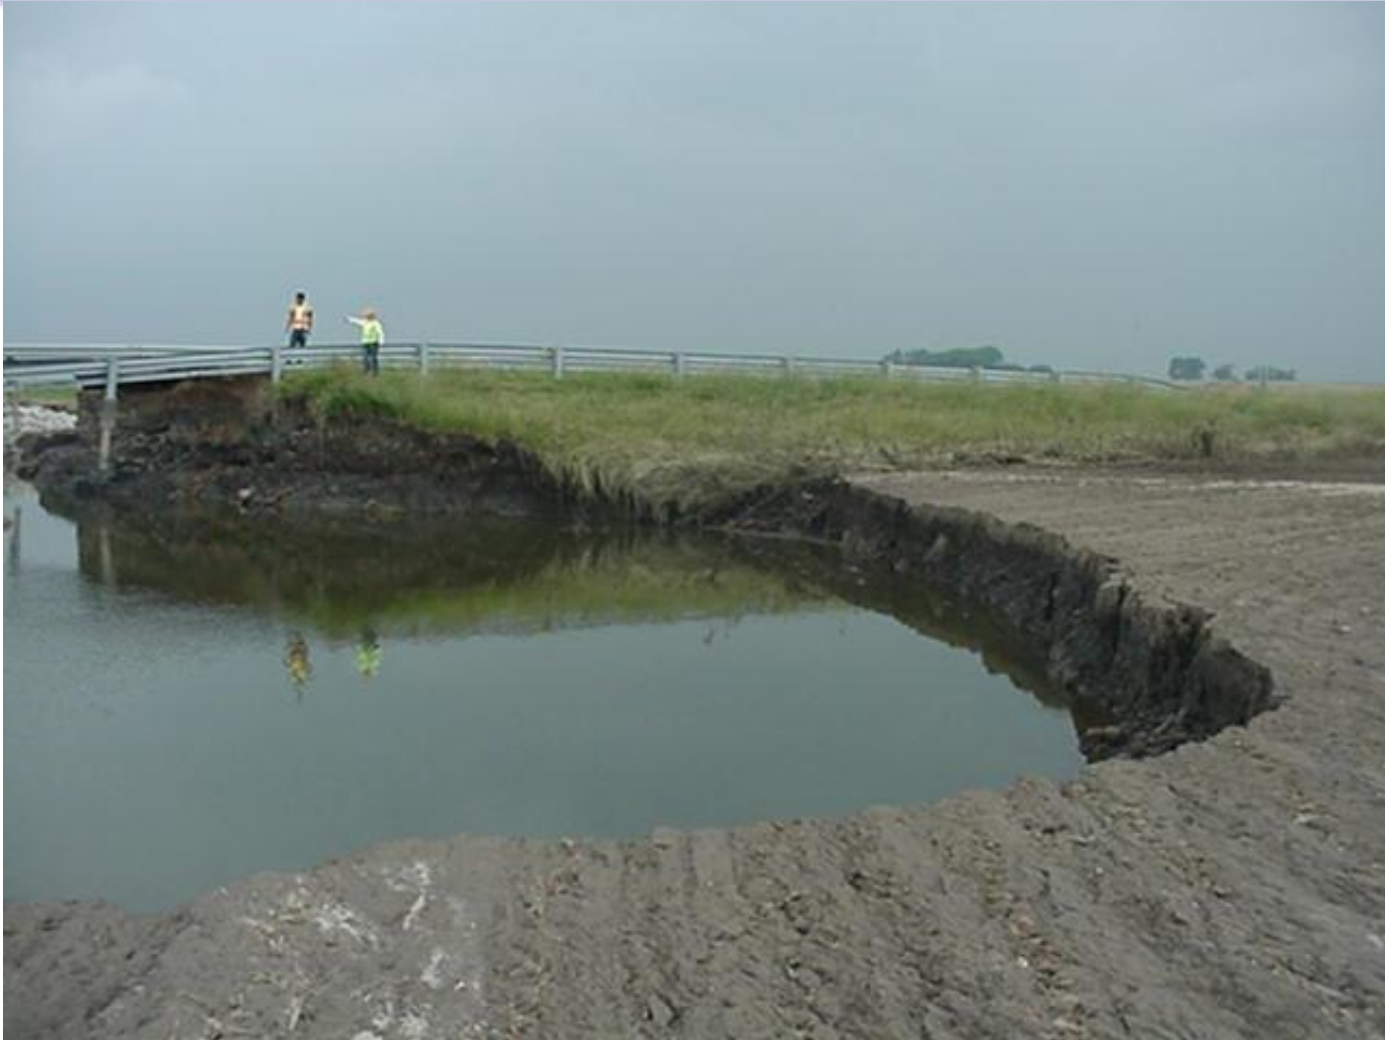
**2008 site photo, structure damage & scour**

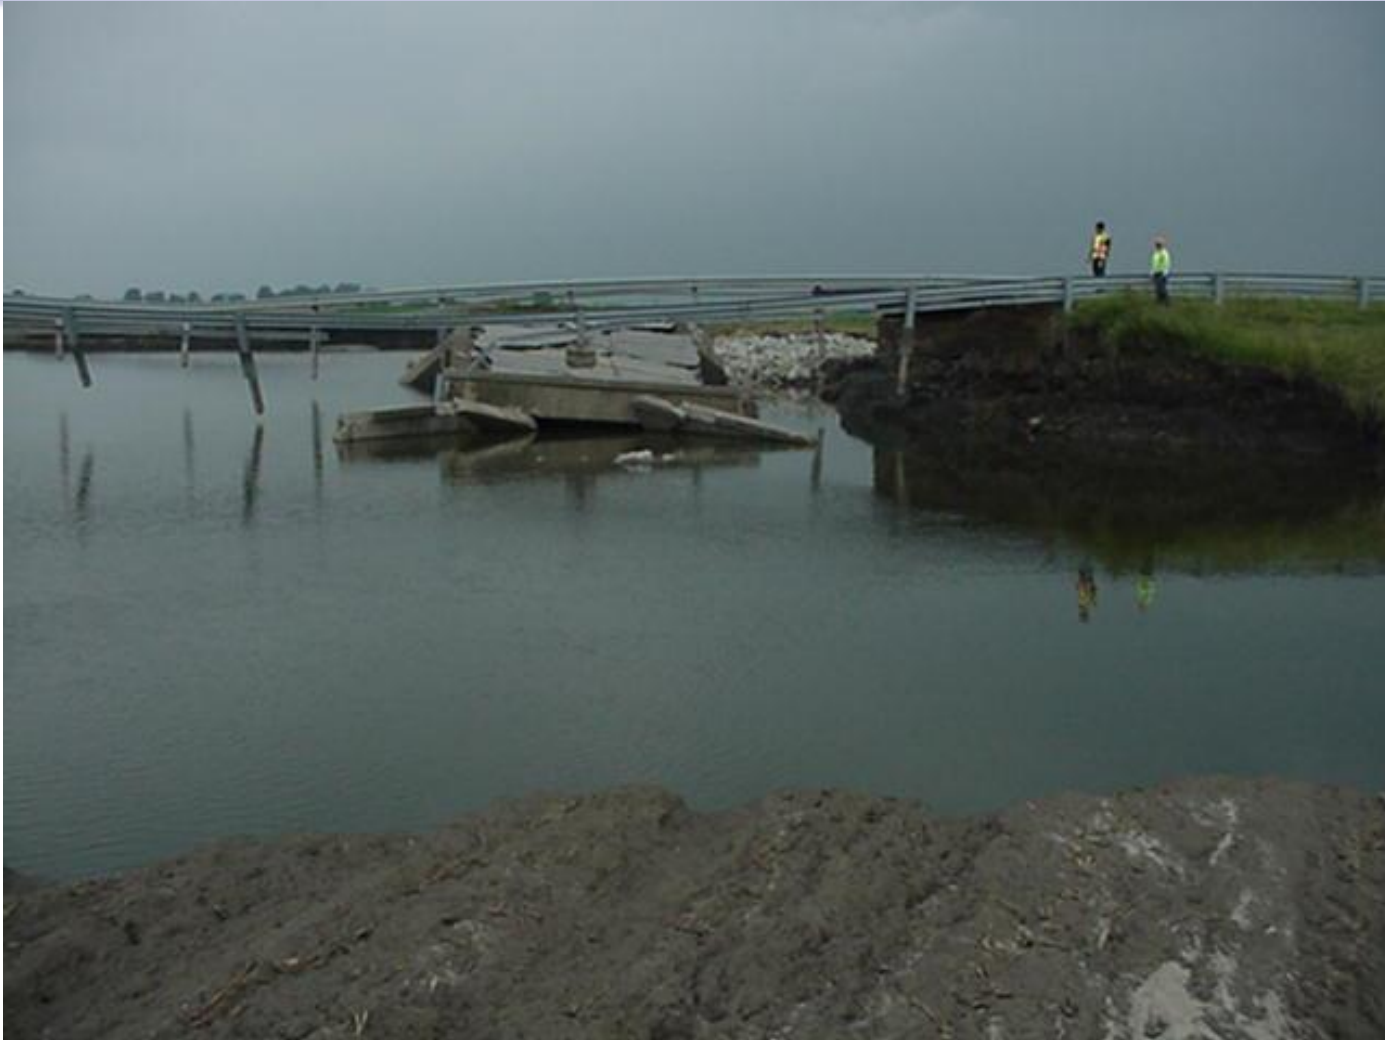
**2008 site photo, structure damage & scour**

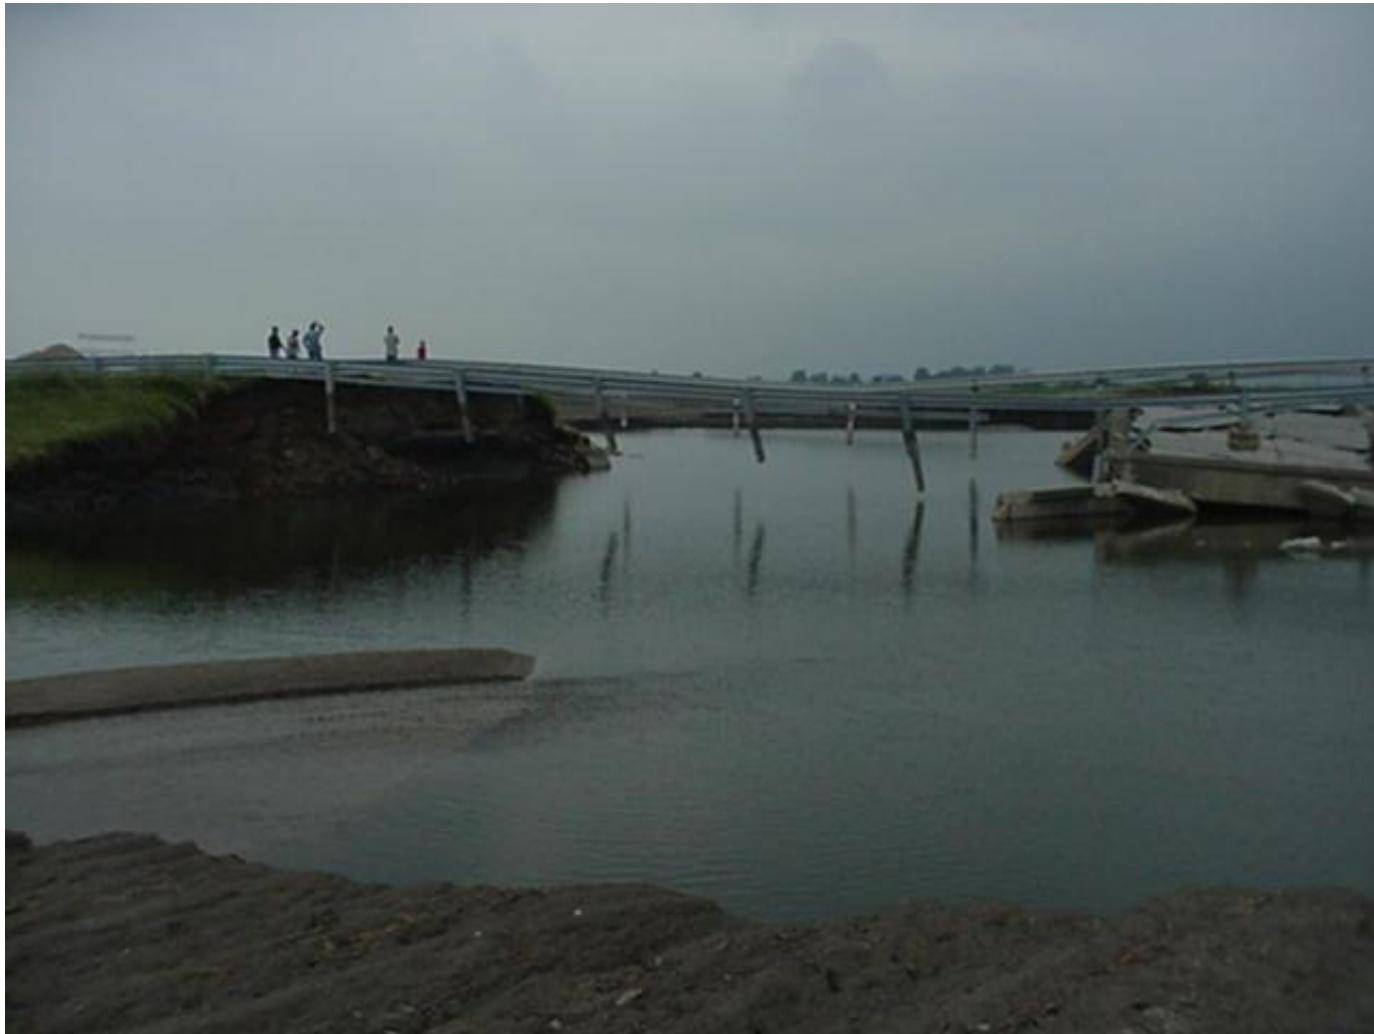
**2008 site photo, structure damage & scour**

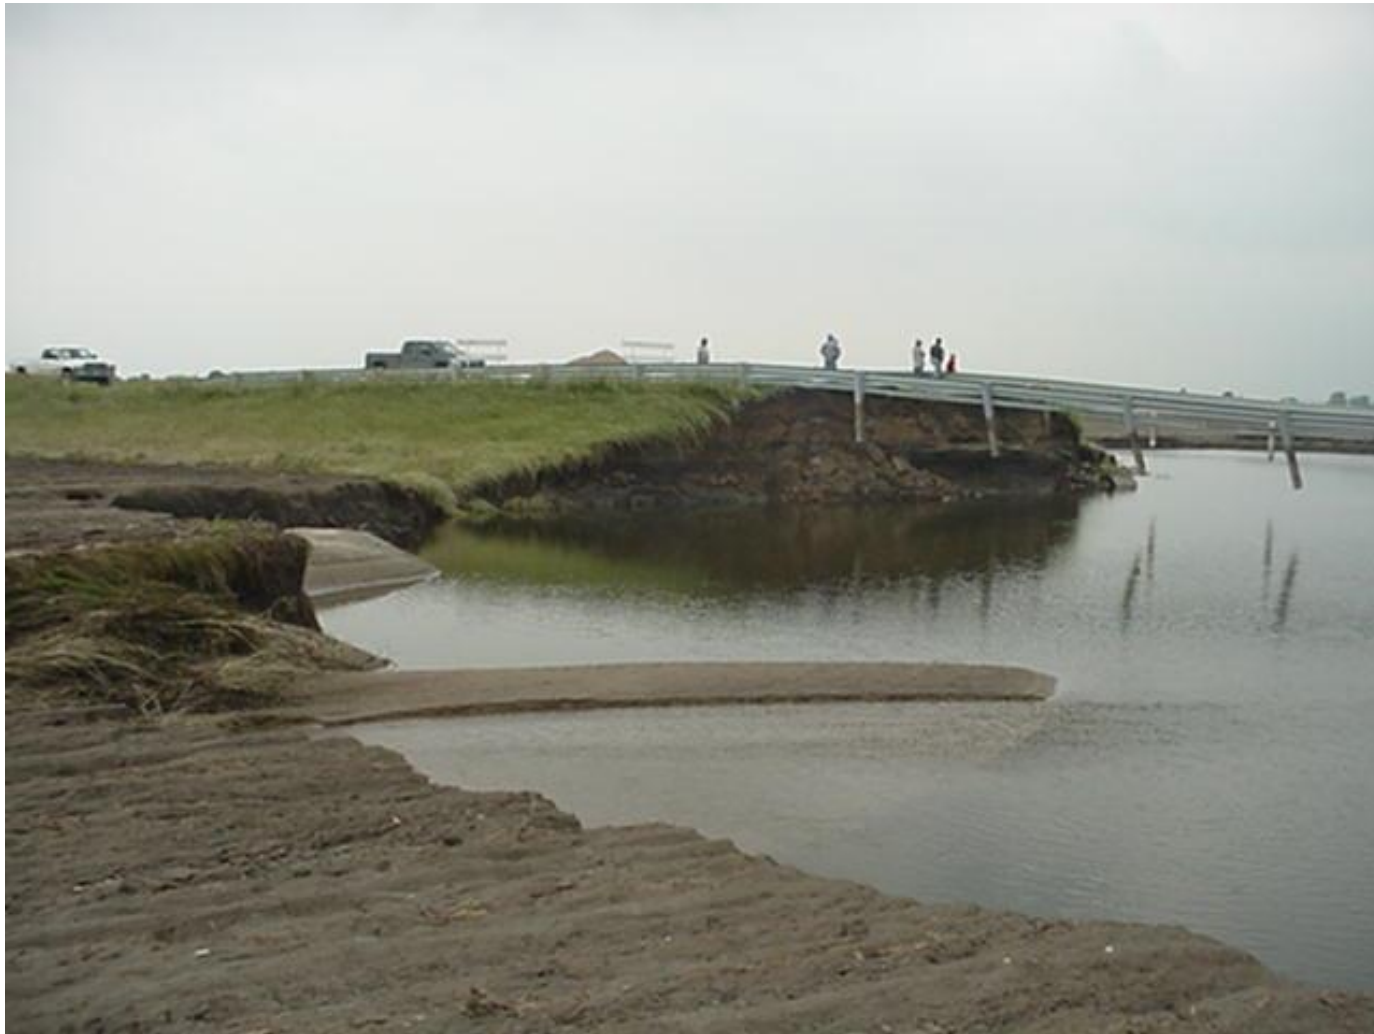
**2008 site photo, structure damage & scour**

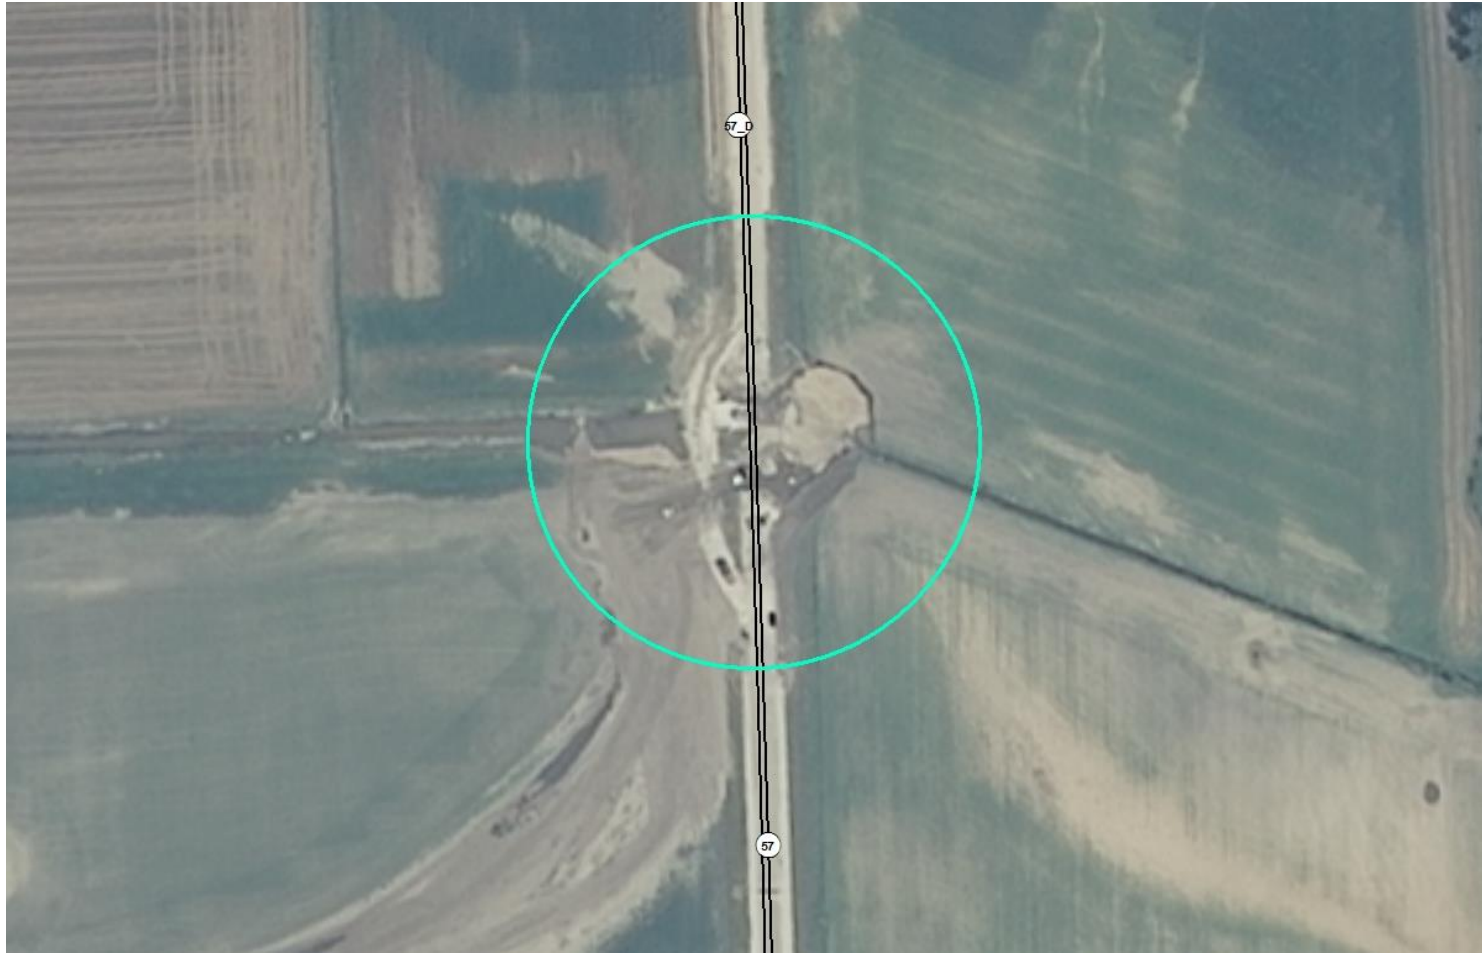
**2008 NAIP Aerial Photo of site**

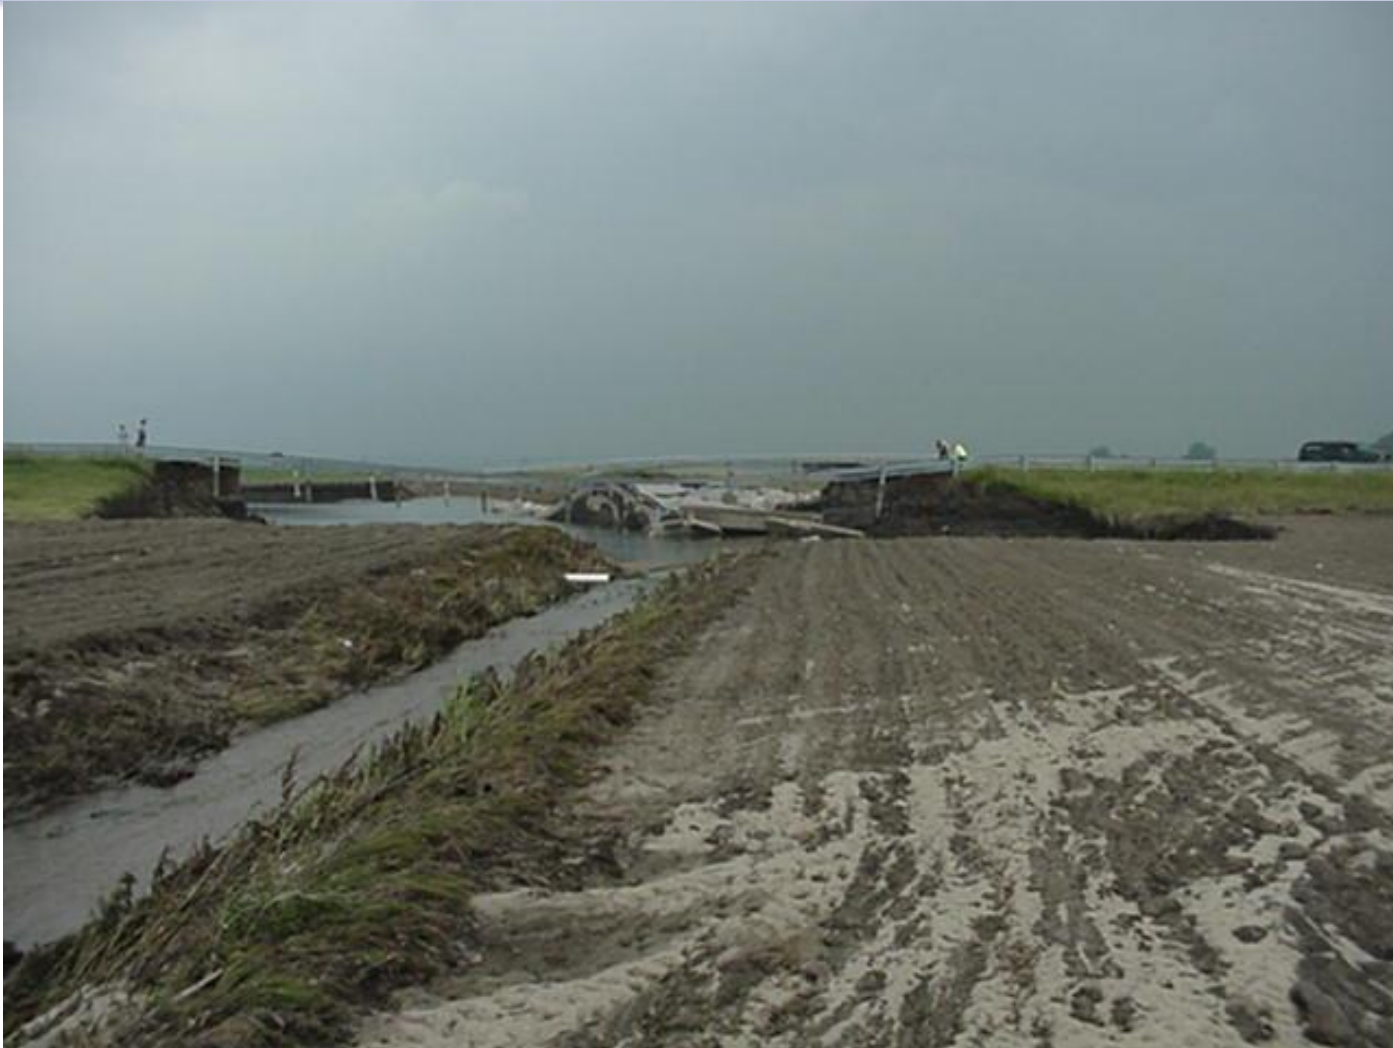
**2008 site photo, structure damage & scour**

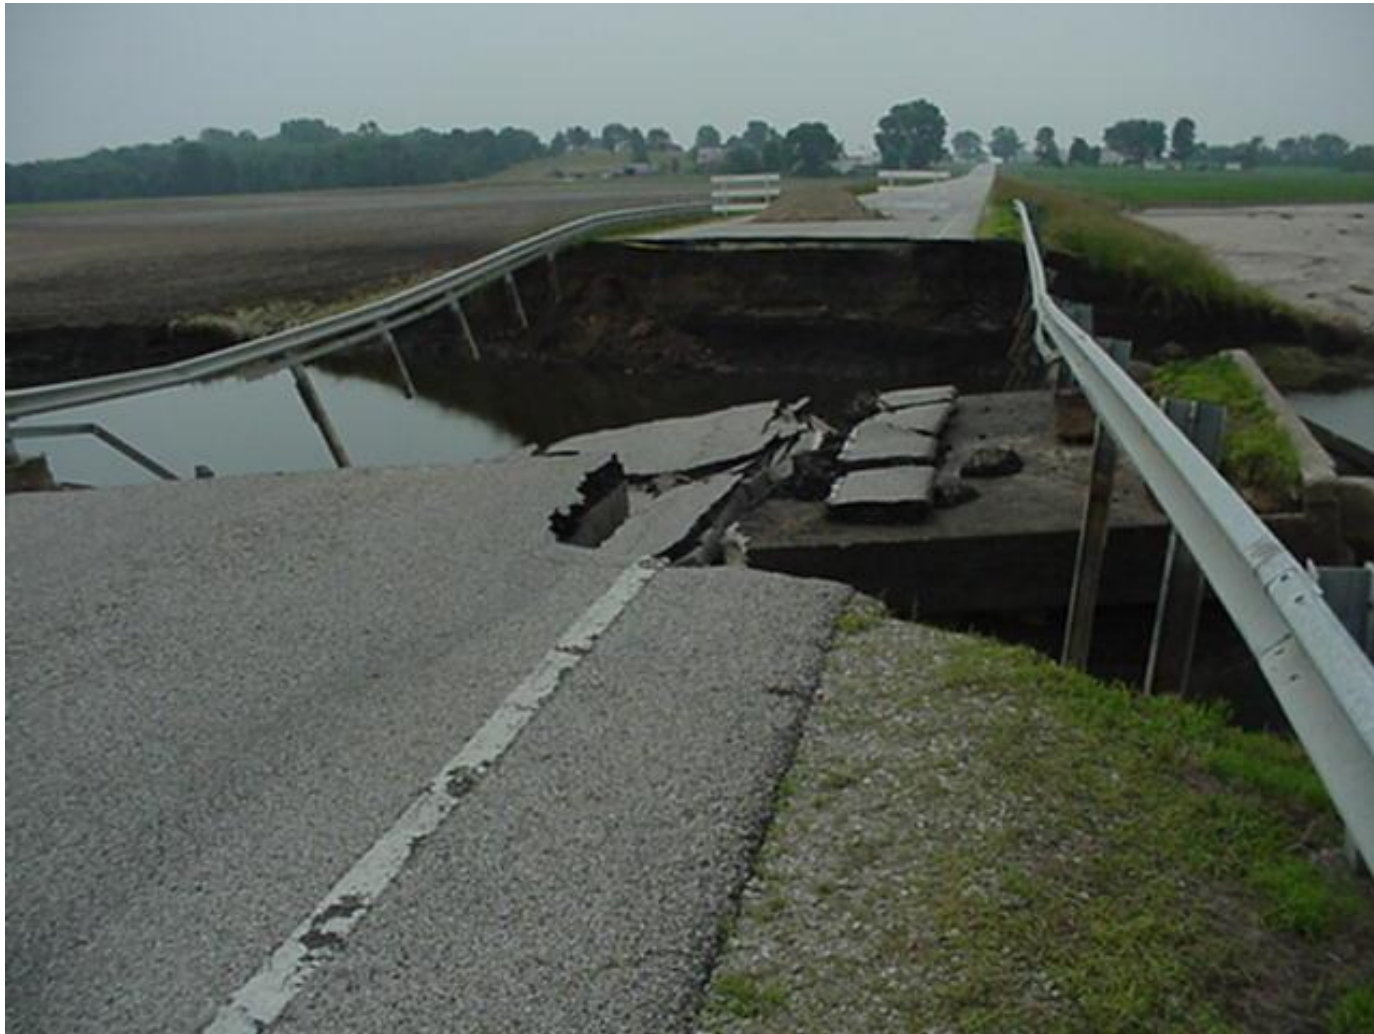
**2008 site photo, structure & road damage**

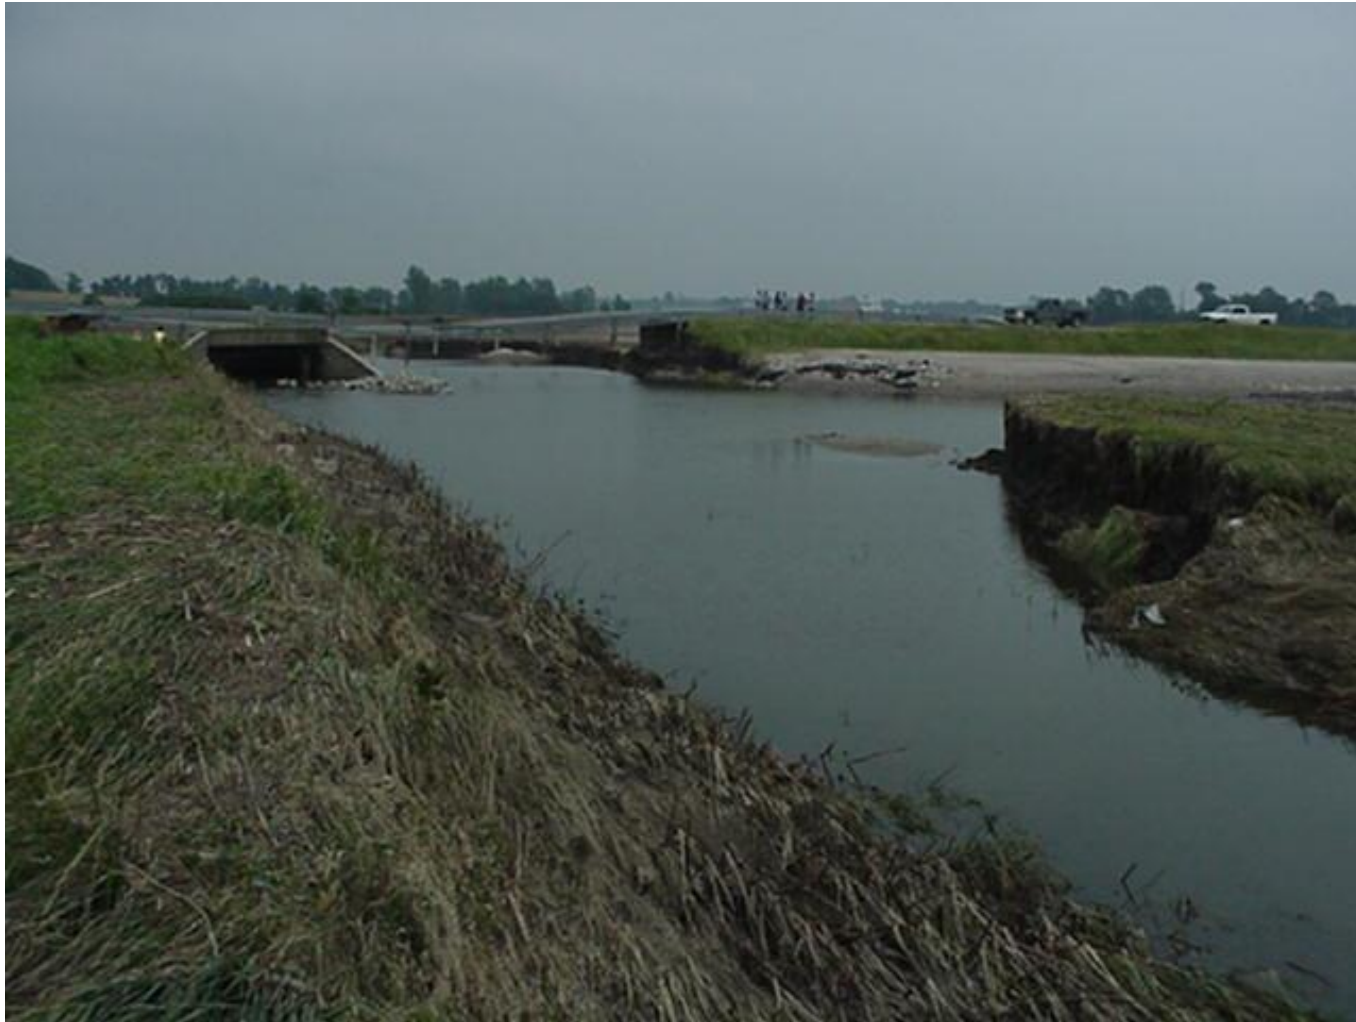
**2008 site photo, view from downstream**

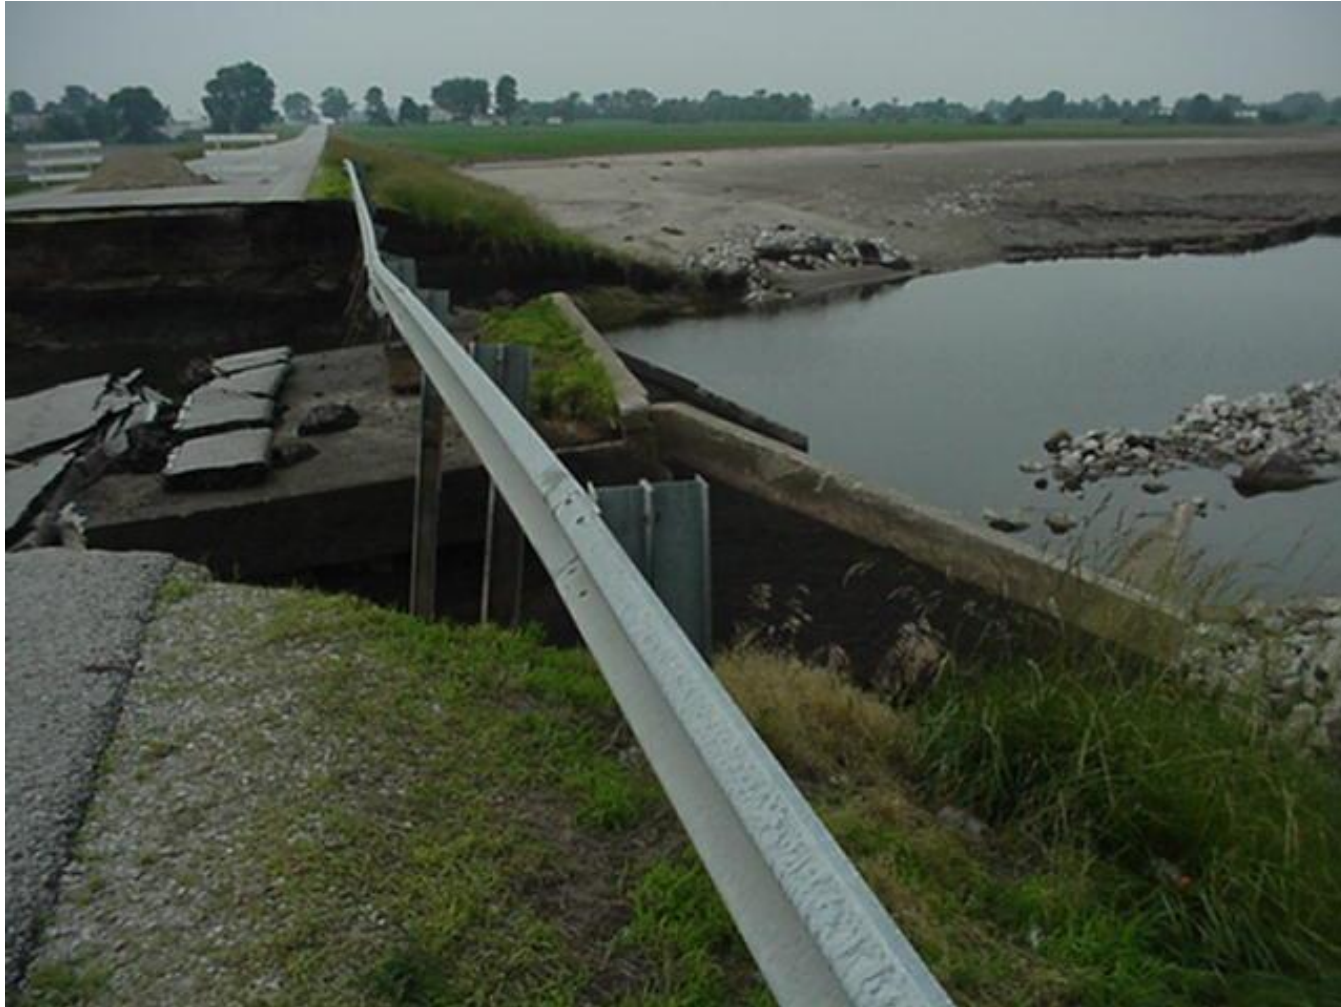
**2008 site photo, outlet and scour hole**

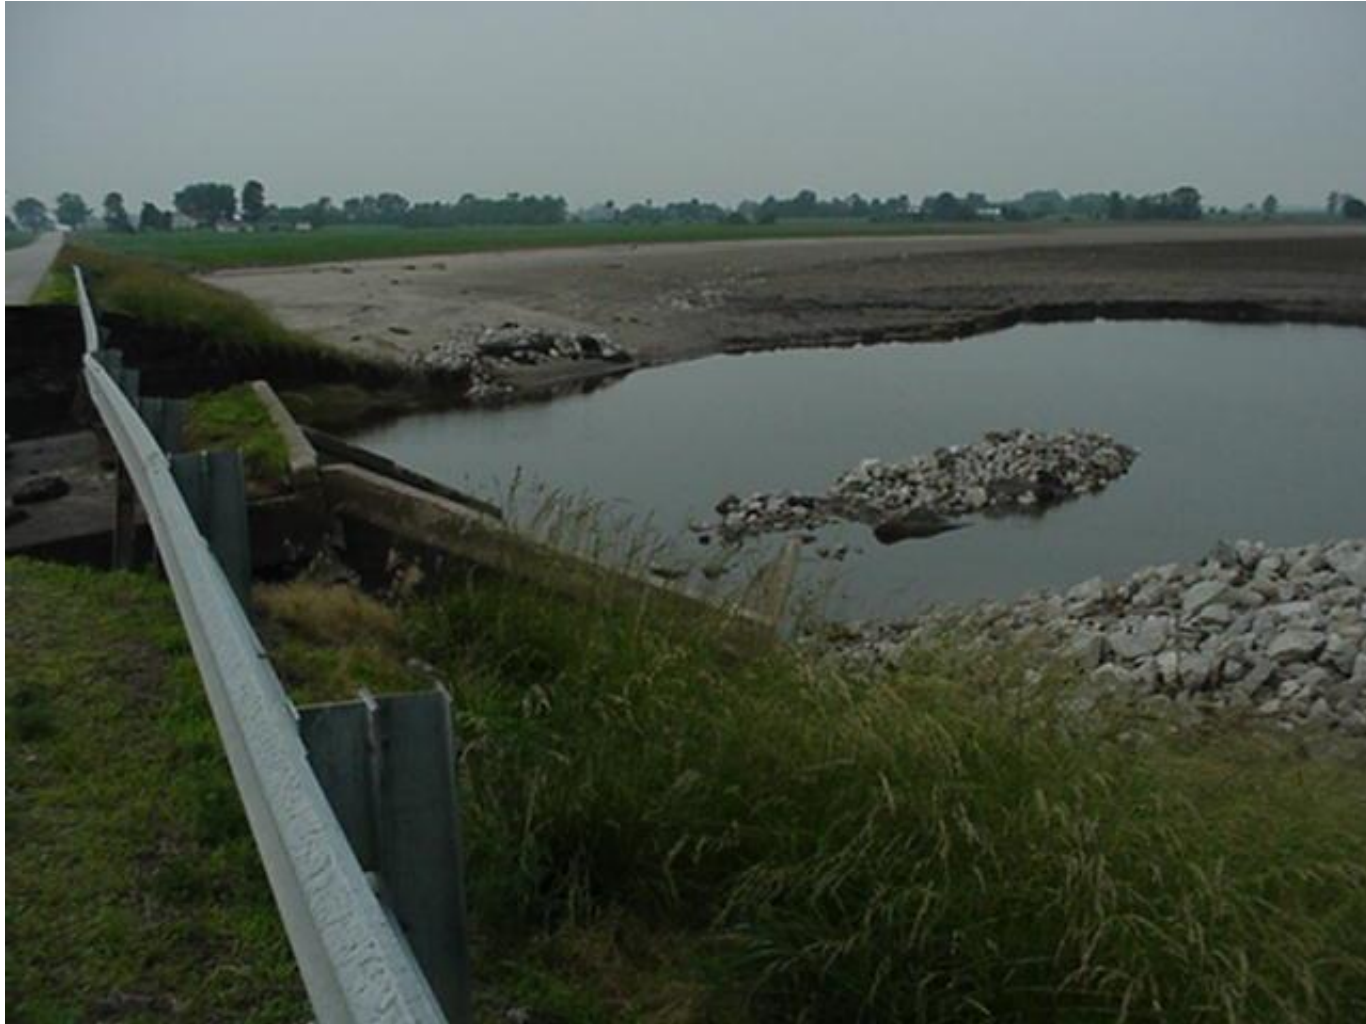
**2008 site photo, outlet and scour hole**
