# SR 57 vs the White River

## June 2008

Mark Bailey, PE – Hydraulic Manager, INDOT  
Dale R. Sedler, PE – Sr. Hydraulic Engineer, INDOT

Road School 2016

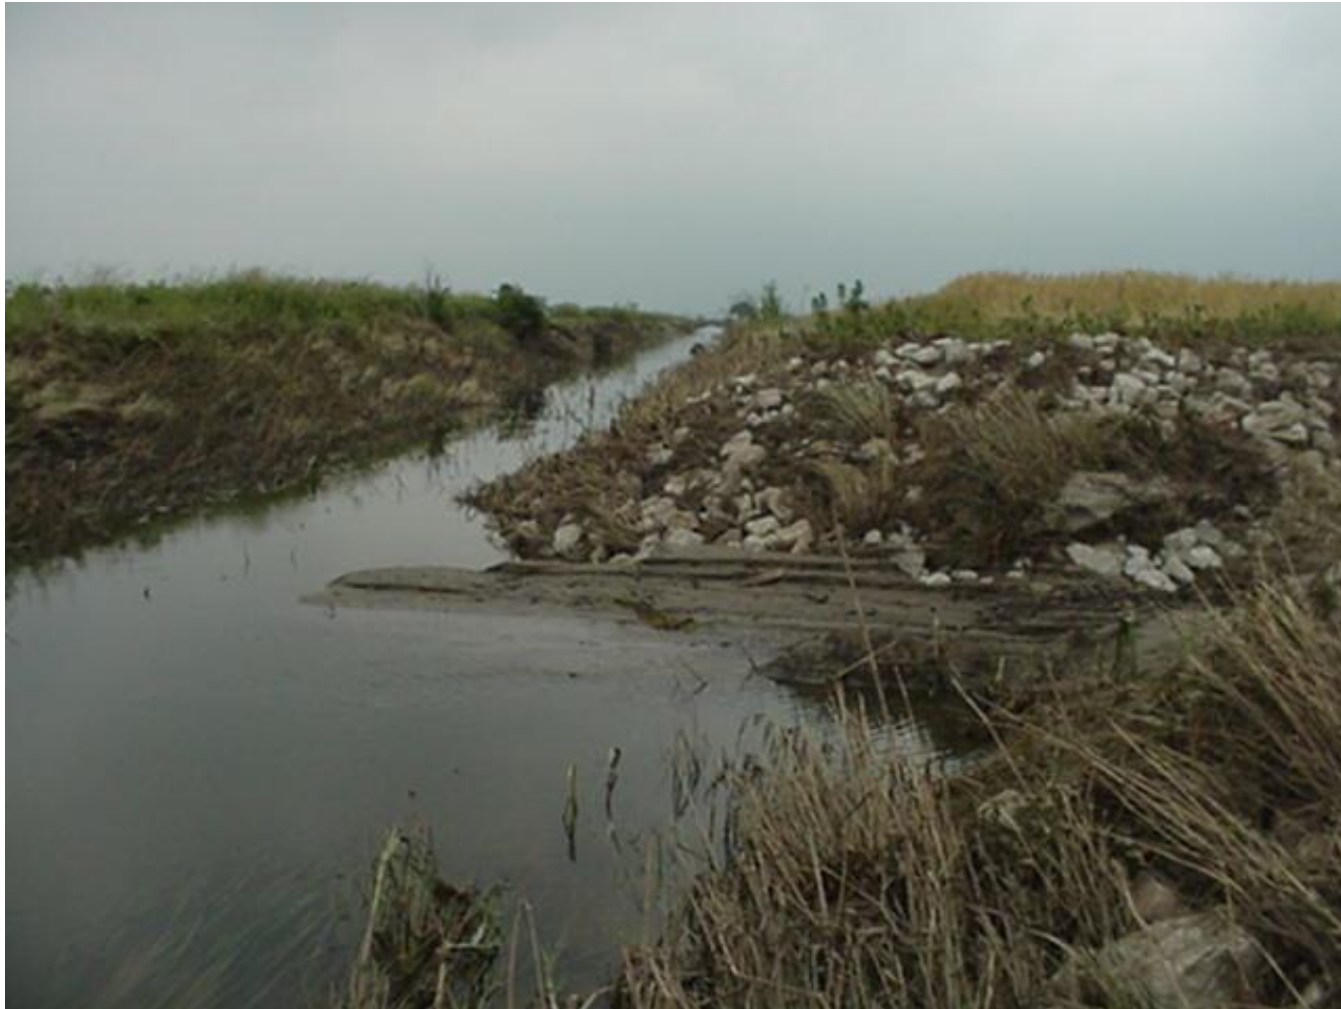
**2008 site photo, downstream channel**

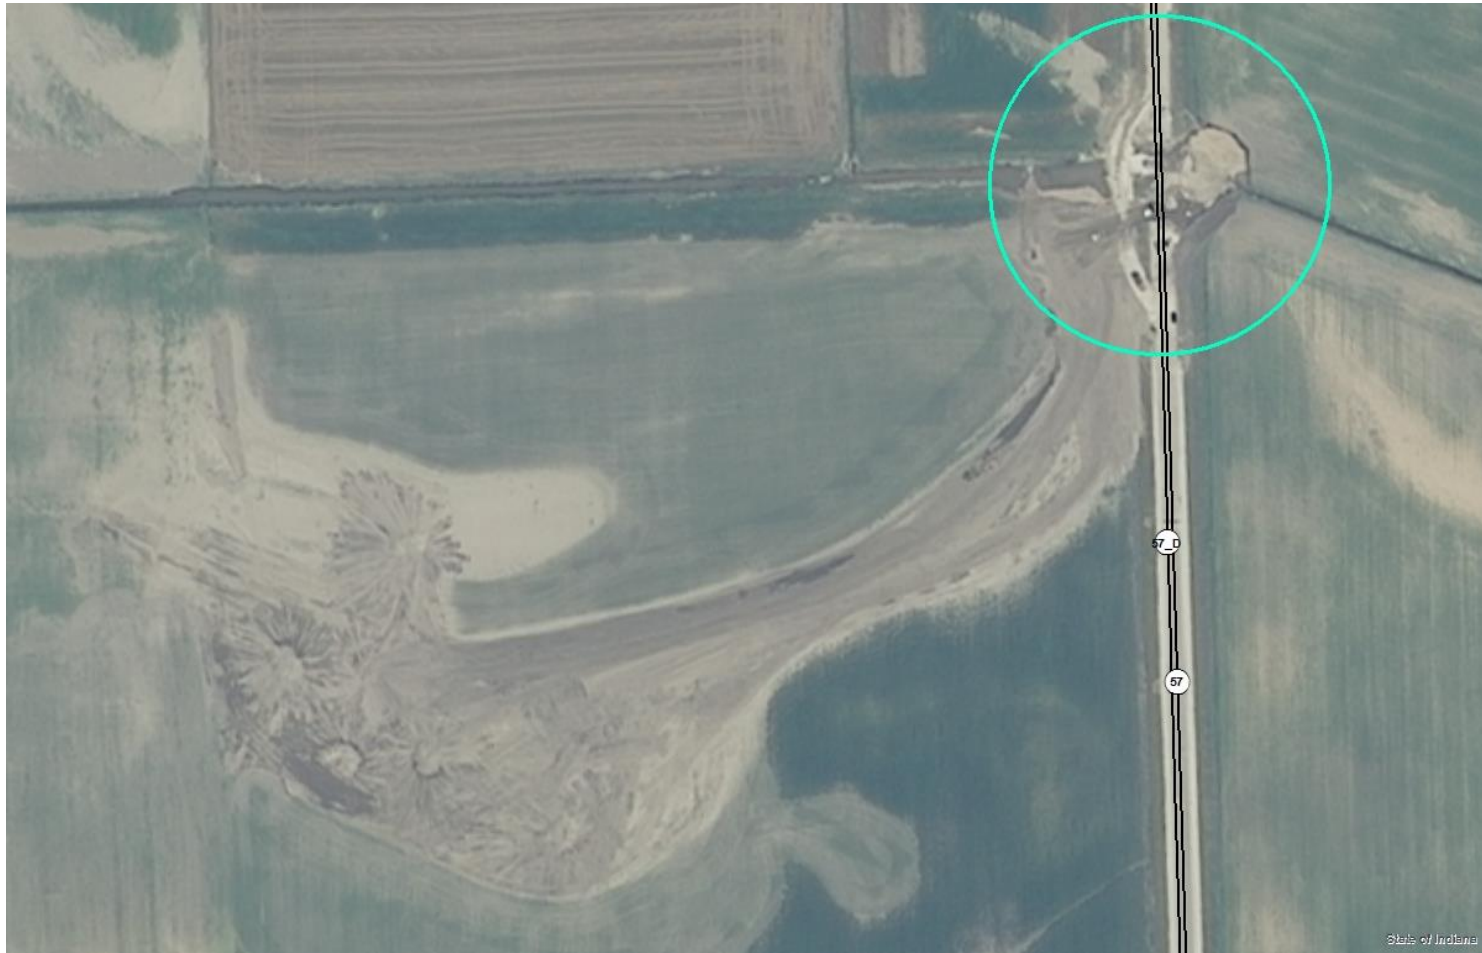
**2008 NAIP, flow pattern-embankment reclamation**

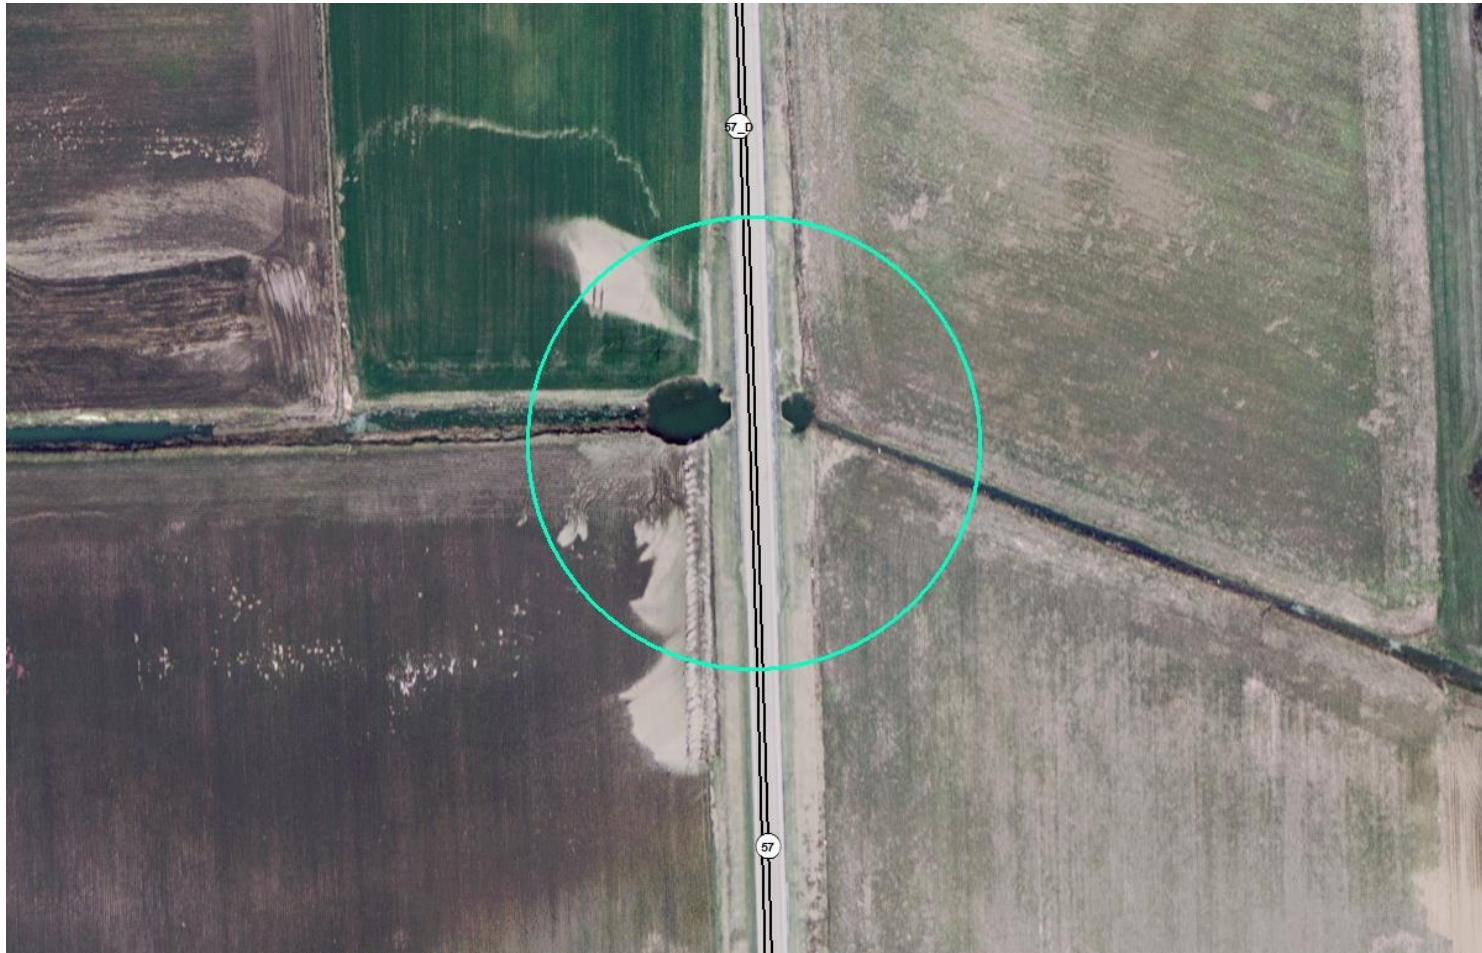
**2005 NAIP Aerial Prior Scour Issue**

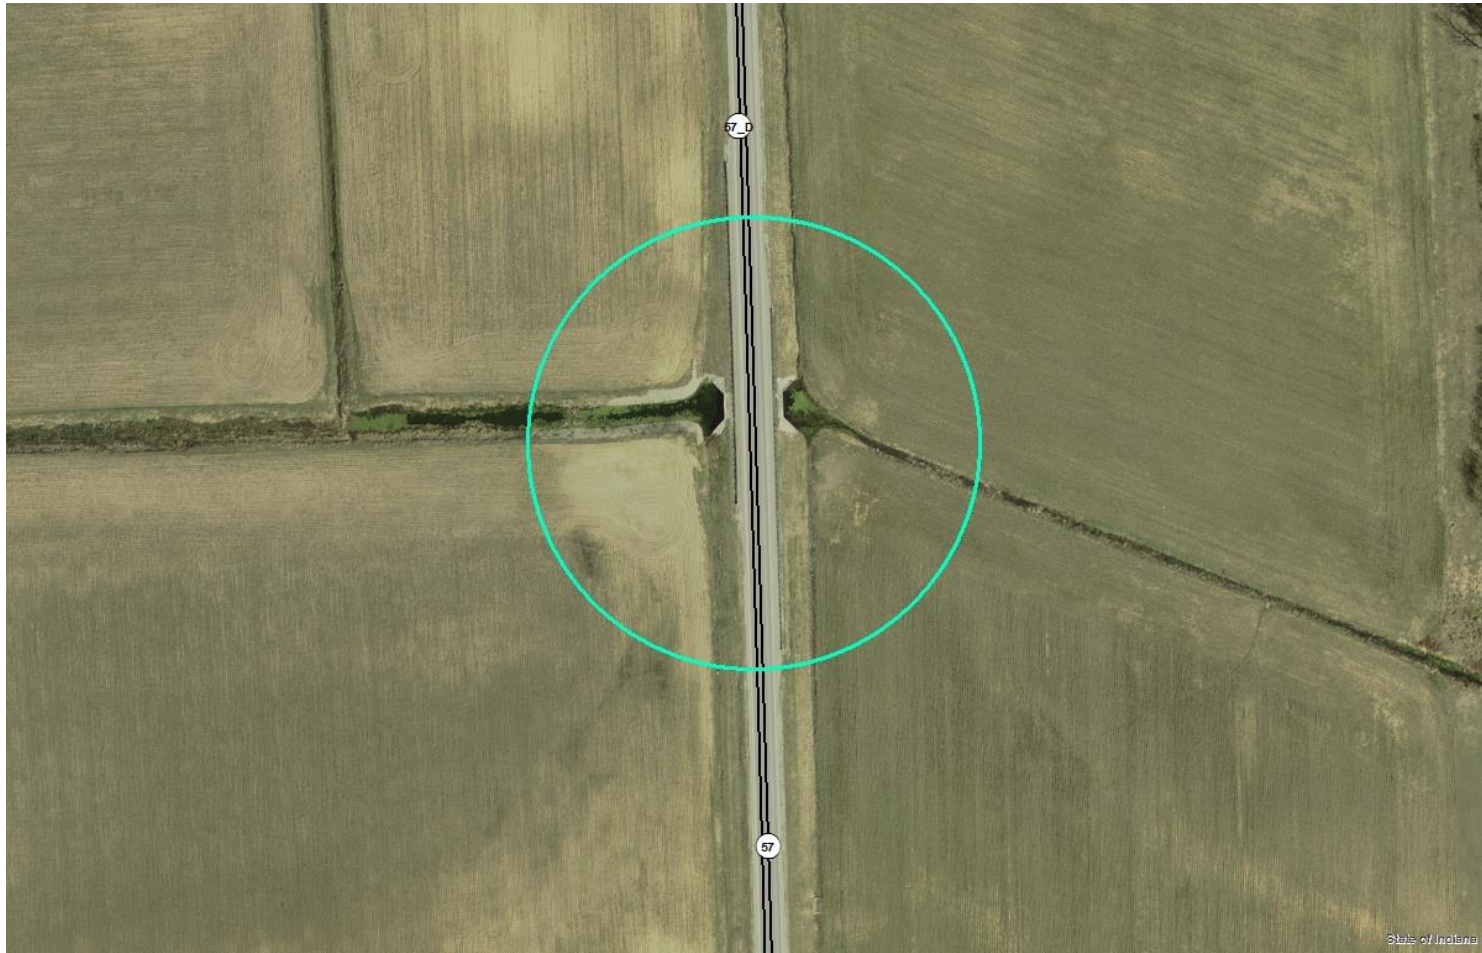
**2011/2013 Indiana Map Aerial**

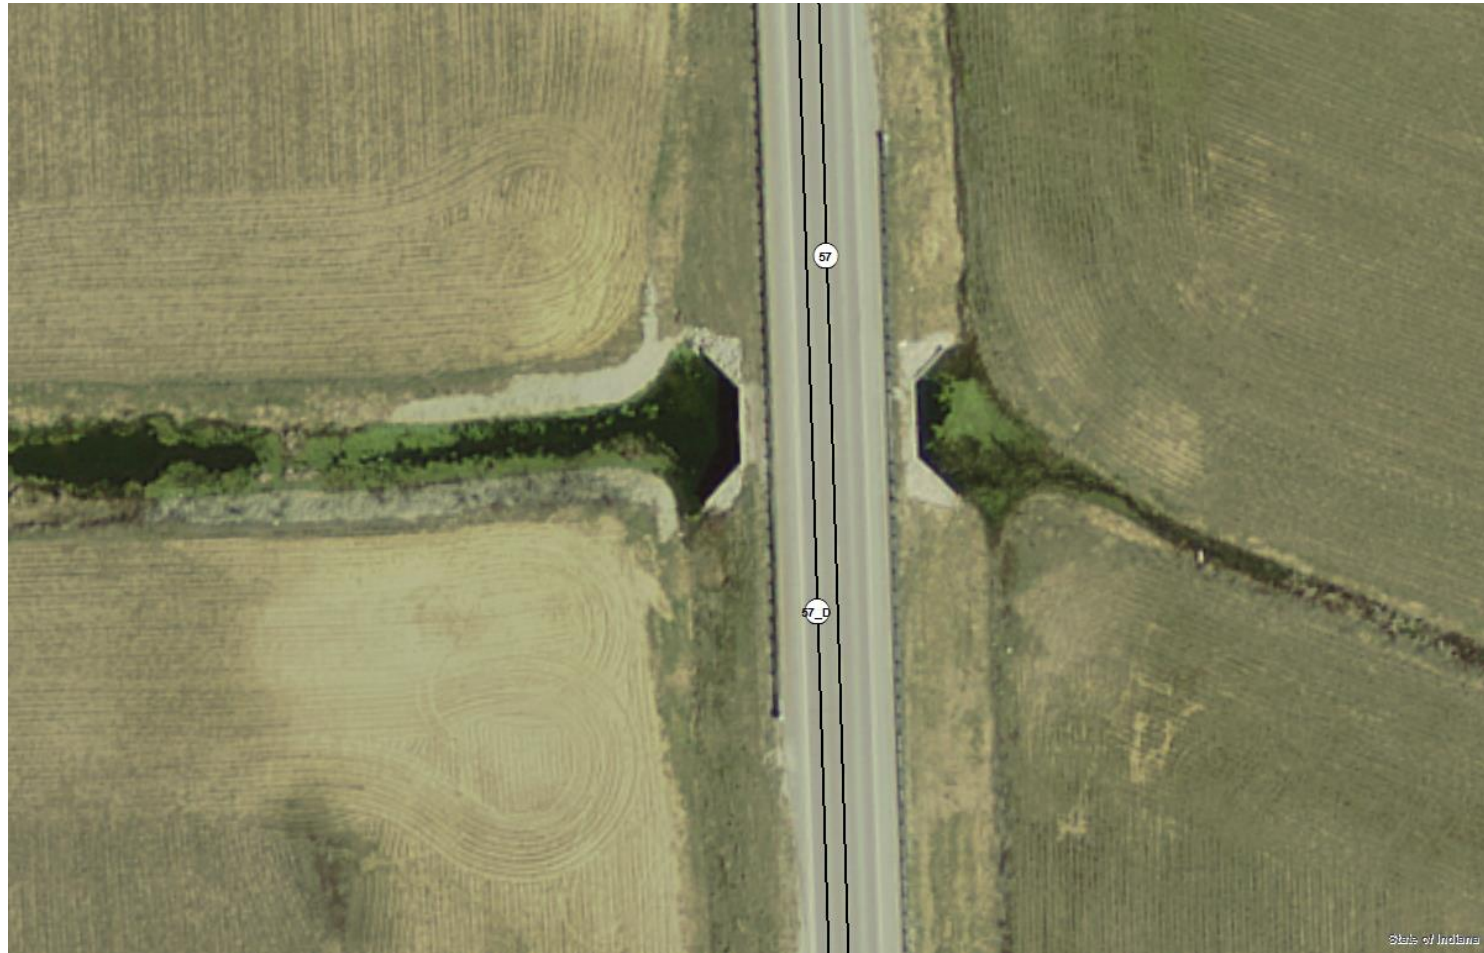
**2011/2013 Indiana Map Aerial – no scour visible  
Per aerial measurement, 26 ft. span.**
