# Investigation Of Microstructural Alterations In M50 And 52100 Steel Using Nanoindentation

Kristin R. Paulson  
*Purdue University*

A Thesis

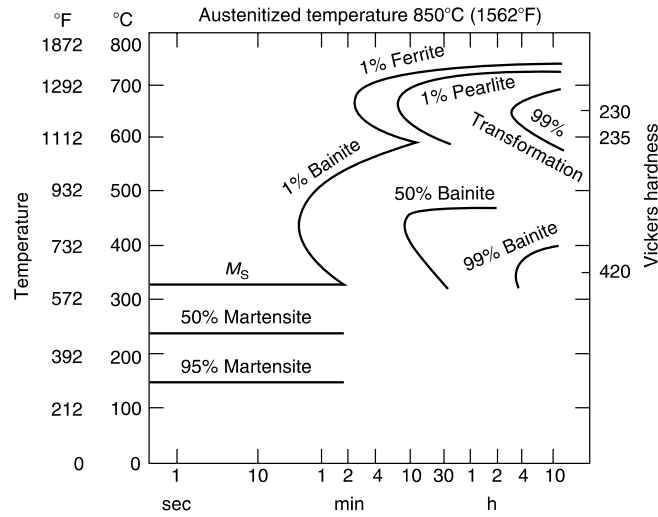
Figure 1.3 Time-temperature-transformation diagram for AISI 52100 steel.<sup>5</sup>

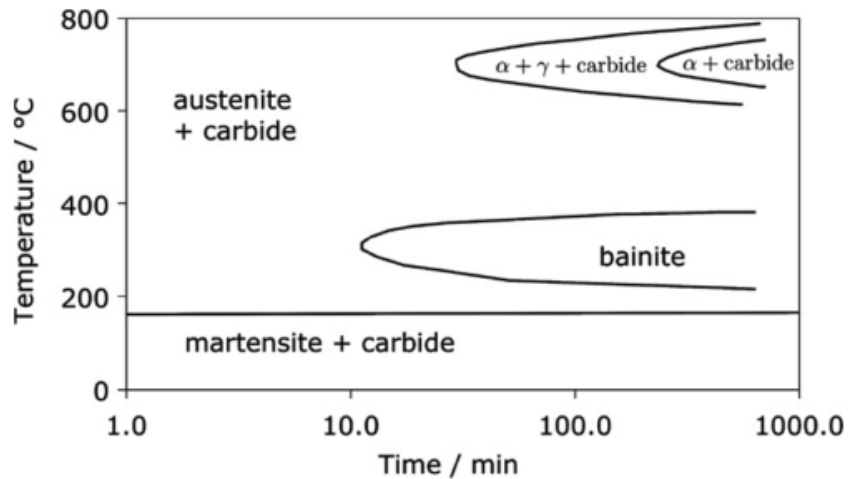
Figure 1.4 Time-temperature-transformation diagram for M50 steel.<sup>8</sup>

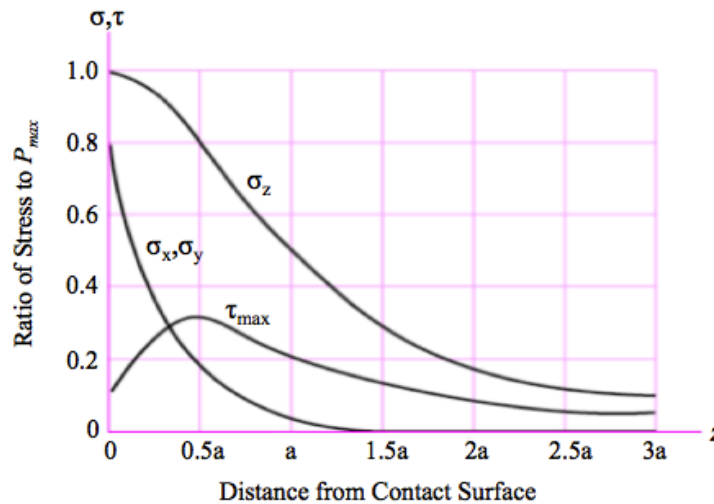
Figure 1.8 Principles stresses and maximum shear stress as a function of distance below the contact surface.<sup>19</sup>

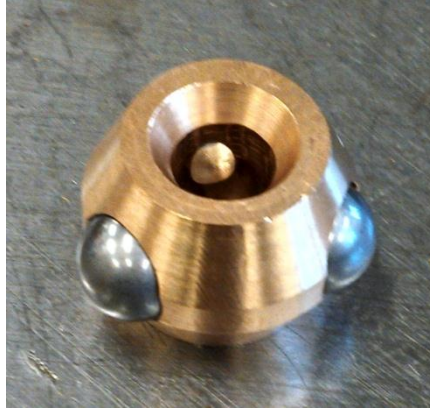
Figure 2.2 A bronze cage is used to separate and keep the balls in place during a rolling contact fatigue test.

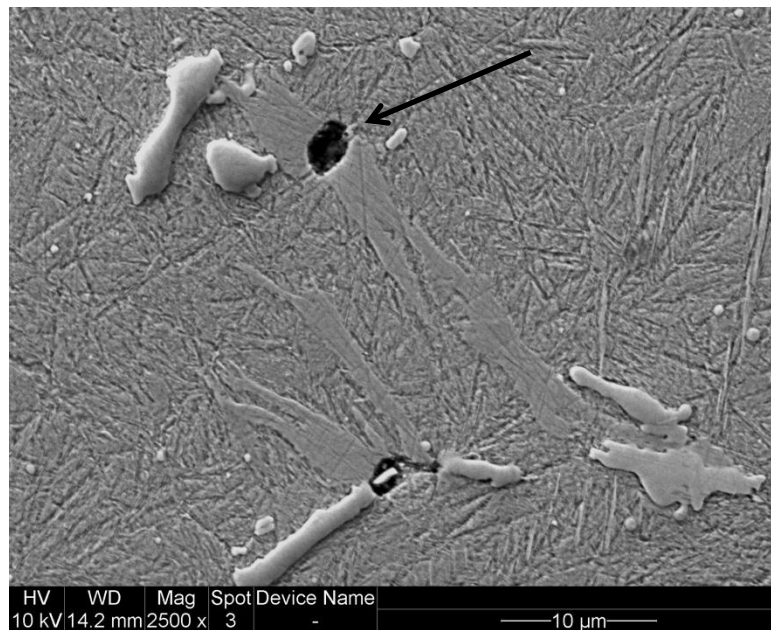
Figure 3.12 SEM image of a butterfly centered around a dark-etching inclusion as shown by the arrow in M50 steel.

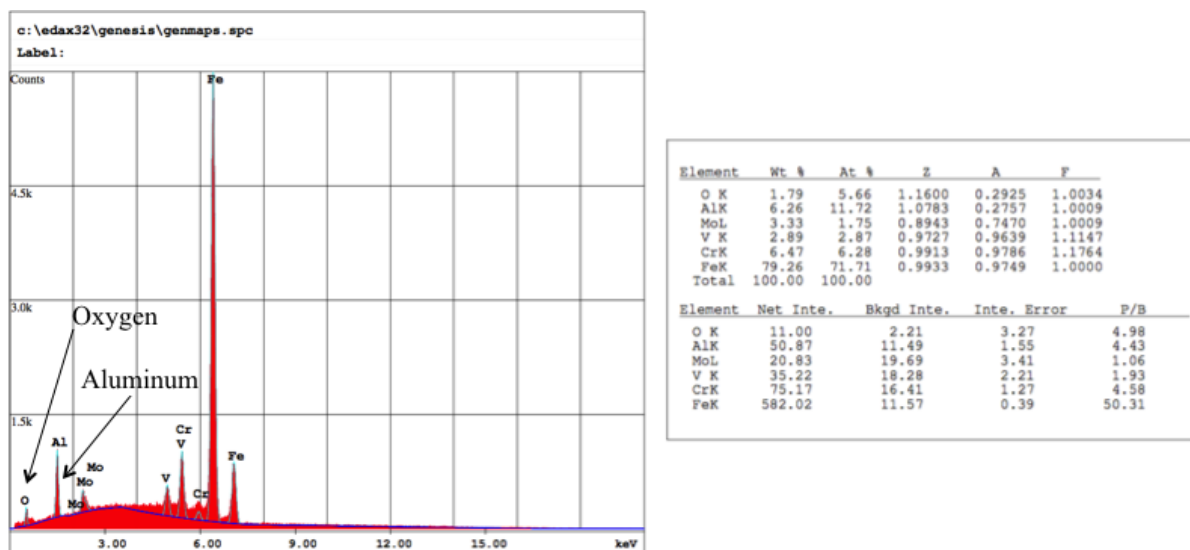
Figure 3.13 All the expected alloying elements of M50 (Mo, V, Cr) as well as Fe are present but aluminum and oxygen peaks are also present suggesting the dark etching center of a butterfly is formed around an alumina inclusion.

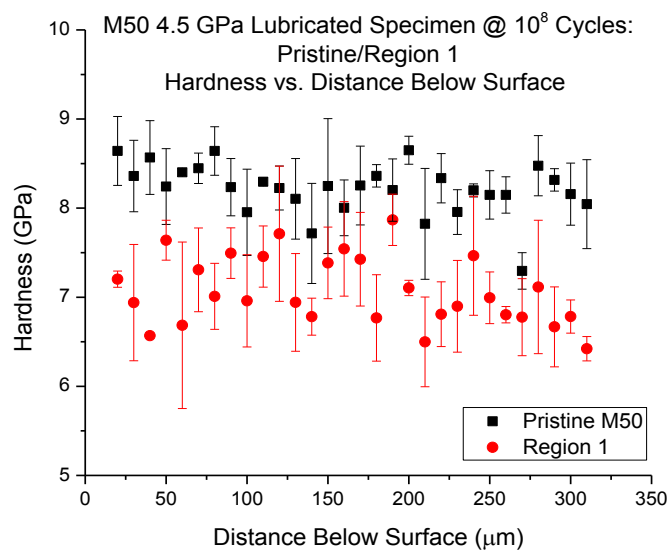
Figure 3.23 Pristine M50 and Region 1 were plotted with standard error bars and compared to observe data overlap.
