The Contribution and Status of Physical Removal in Sustainable Management of Water Hyacinth

**FIRRI Technical Document
Draft 2, April 2002**

By: Eng. Wadda & Mr. E. Rukunya
Water Hyacinth Research Sub - Component
Fisheries Research Component
Fisheries Resources Research Institute (FIRRI)
P.O. Box 343, Jinja, Uganda, Fax: 256-43-120192
Email: firi@infocom.co.ug or firi@firi.go.ug

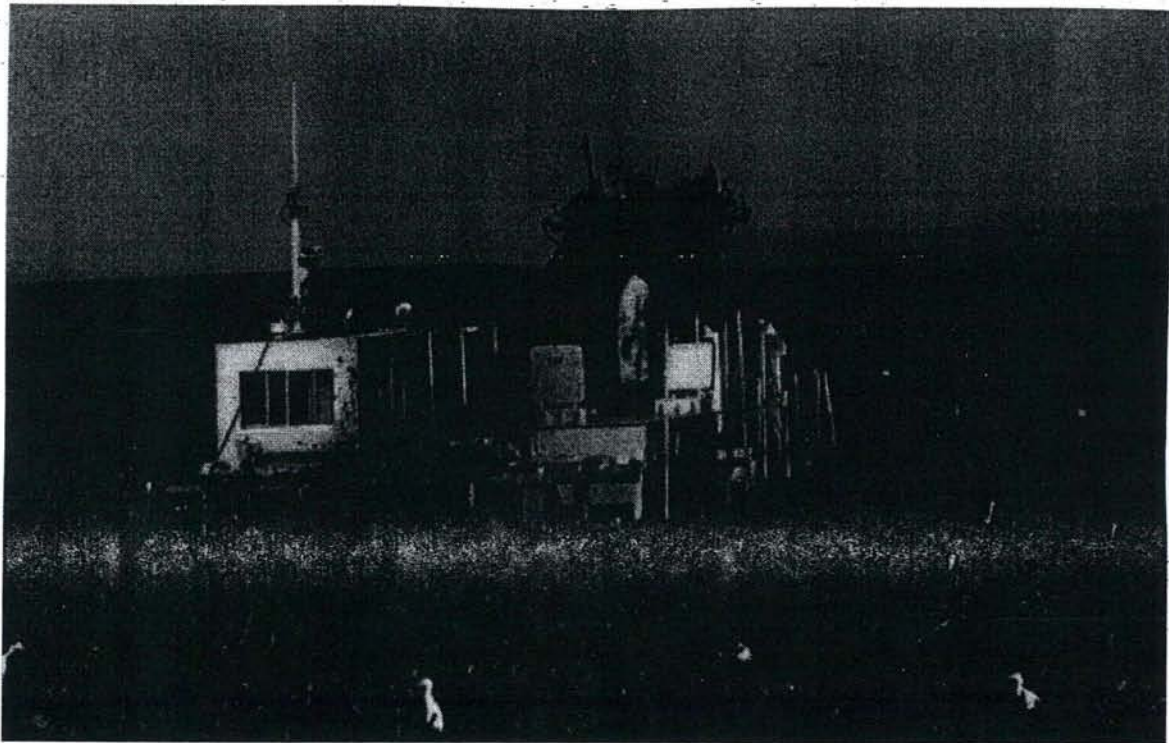
Plate 5.1. Water based mechanical harvester for water hyacinth in Murchison

Port bell pier, Gaba fish landing site and the Kampala water intake points (Gaba I and Gaba II) are located in Murchison bay. This bay, as indicated earlier, is the main production centre of hyacinth in Uganda portion of Lake Victoria. At peak infestation, there was an estimated 250 ha of stationary water hyacinth and 200 ha of mobile weed. This used to cause a 3-hour delay in ship docking or forced ships to dock at Jinja pier. Three hundred retired and retrenched soldiers (veterans) were deployed to remove the weed manually with no success. The first harvester brought in with assistance from the EU could not harvest the weed due to mechanical deficiency in its design. In 1997, a more robust, water borne system (Plate 5.1) capable of harvesting, transporting ashore and loading hyacinth on dumping trucks was acquired

using a US \$ 2 million grant from the Japanese Government and deployed at Port bell. The system consists of one harvesting unit with a harvesting rate of 40 tonnes per hour, four barges, one support boat, one mobile crane, one inspection boat, five four-wheel drive and self loading dumping trucks, eight containers and one excavator. The system started operation in February 1998, handling 40 tonnes per hour. By the end of 1998 the major weed mass had been greatly reduced and docking time improved. However, mechanical removal even with a water-borne system has limitations especially in the shallow nearshore environments. This necessitates alternative approaches to nearshore environments especially in production zones. There is need to integrate the mechanical control currently implemented at Port bell with intensive release of biological control.
