# Electrical and structural degradation of GaN high electron mobility transistors under high-power and high-temperature Direct Current stress

Y. Wu,<sup>1,a)</sup> C.-Y. Chen,<sup>2</sup> and J. A. del Alamo<sup>1</sup>

(Received 23 September 2014; accepted 27 December 2014; published online 9 January 2015)

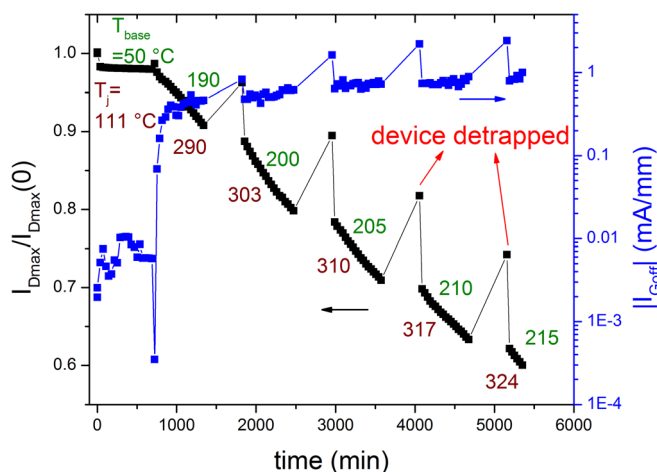
FIG. 1. Evolution of normalized  $I_{Dmax}$  (defined @  $V_{DS}=5$  V,  $V_{GS}=2$  V) and  $|I_{Goff}|$  (defined @  $V_{DS}=0.1$  V,  $V_{GS}=-5$  V) in the course of typical step-temperature stress under high power conditions.  $I_{Dmax}(0)$  is 742 mA/mm. The bias point during stress is  $V_{DS}=40$  V and  $I_{DQ}=100$  mA/mm. Base temperature was raised from  $50^\circ\text{C}$  up to  $215^\circ\text{C}$  where the device blew up.

Fig. 1 shows a typical result. The figure graphs the maximum drain current (defined at  $V_{DS}=5$  V and  $V_{GS}=2$  V) normalized to its initial value and the off-state gate current (defined at  $V_{DS}=0.1$  V and  $V_{GS}=-5$  V) as a function of stress time. These measurements are all made at  $50^\circ\text{C}$ . The base plate temperatures as the experiment evolves are indicated in the figure. The actual junction temperature  $T_j$ 's are also evaluated using a thermal model provided by our industrial collaborator and is also indicated in Fig. 1. The points sticking out in Fig. 1 correspond to measurements conducted at the transitions when the base plate temperature is increased. These points are taken right after the detrapping step and reflect device degradation in the absence of trapping. It is well known that in GaN HEMTs, carrier trapping

The device shown in Fig. 1 degraded rather fast when compared with published data from isothermally treated devices. This is a result of our attempt to expedite the experiment by stressing the device under very harsh conditions. Looking at the junction temperatures in Fig. 1, we can notice that for  $T_{stress}$  exceeding  $190^\circ\text{C}$ , the actual  $T_j$  is above  $300^\circ\text{C}$  which is much higher than the specified maximum operating temperature for these devices ( $200^\circ\text{C}$ ). In Ref. 31, we demonstrated that our stress methodology accelerates relevant degradation modes. Our step-temperature approach allows us to extract activation energies for device degradation rate. Our results agree quite well with those obtained using traditional long term life test experiments on similar device technology. This indicates that our experiments reflect device degradation under high power stress conditions rather accurately.

A typical pattern of degradation is shown in Fig. 1. In all cases, off-state gate leakage current ( $I_{Goff}$ ) degradation happens first and eventually saturates. On the other hand, degradation of the maximum drain current ( $I_{Dmax}$ ) starts at a higher temperature and exhibits a thermally activated

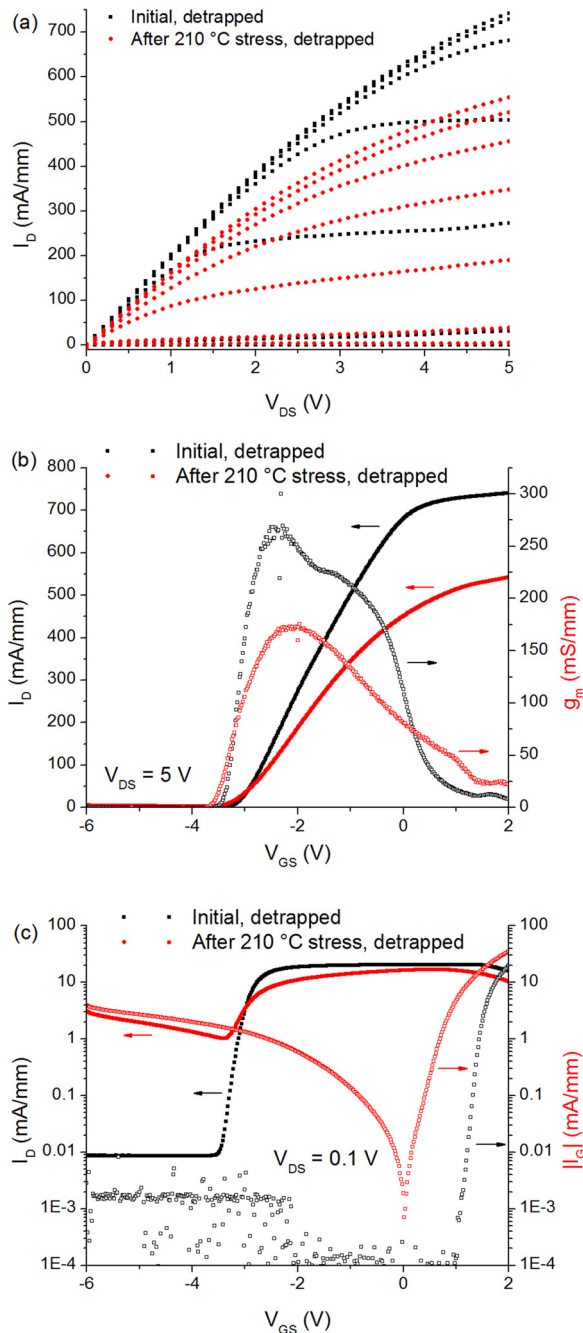
FIG. 2. (a) Output characteristics ( $V_{GS}$  from  $-4$  V to  $2$  V in  $1$  V step), (b) transfer and transconductance characteristics for  $V_{DS} = 5$  V, and (c) sub-threshold and gate characteristics at  $V_{DS} = 0.1$  V for the device of Fig. 1 before stress and after  $T_{stress} = 210$  °C stress. All measurements are under detrapped conditions.

Detrapped output and gate characteristics of the device of Fig. 1 in its virgin state and right after stress at  $T_{stress}=210^\circ\text{C}$  are shown in Fig. 2. These characteristics reflect permanent (non-trapping related) degradation. A noticeable reduction in the saturated current and the ON resistance can be seen. An increase of the gate current of more than two orders of magnitude is also observed.

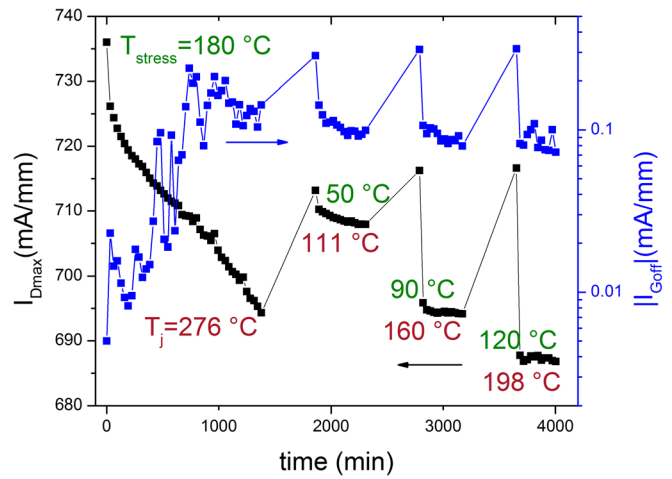
FIG. 3. Evolution of  $I_{Dmax}$  and  $|I_{Goff}|$  for a device stressed first at high temperature and then at lower temperatures.

One concern regarding our stress and characterization methodology is the fact that temperature ramping up and down is repeated for many times during our experiment which might itself impose considerable stress on the device. To prove that this temperature cycling alone does not appreciably degrade the device, we have carried out an experiment where a virgin device is first stressed at  $T_{base}=180^\circ\text{C}$  under high-power DC conditions after which we conduct stress experiments at  $T_{base}$  of 50, 90, and  $120^\circ\text{C}$ . The results shown in Fig. 3 indicate a much faster and severe drain current degradation during  $T_{stress}=180^\circ\text{C}$  period than in the following lower temperature stress periods. This confirms that it is the high temperature that accelerates device degradation instead of the stress imposed by frequent temperature ramping.

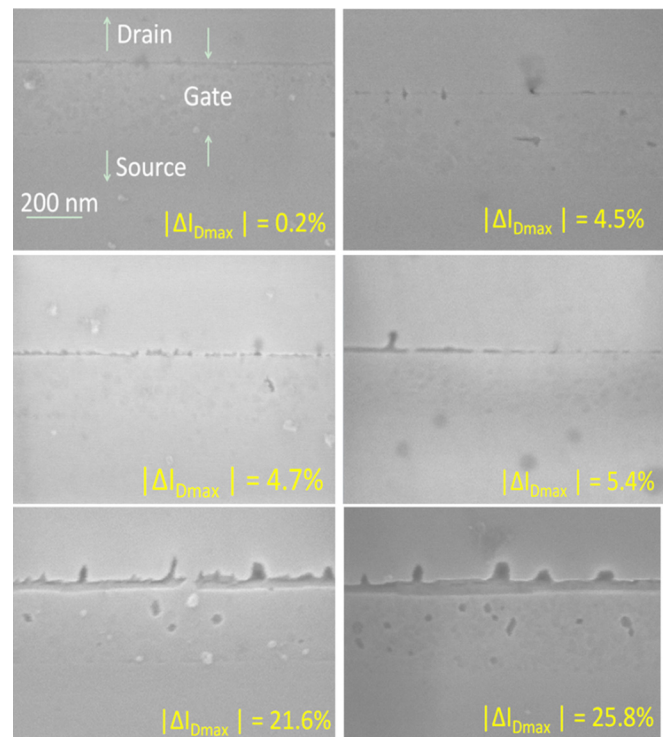
FIG. 4. SEM pictures of six delaminated devices that have been stressed under  $V_{DS} = 40$  or  $50$  V and  $I_{DQ} = 100$  mA/mm. From top left to bottom right picture, overall  $I_{Dmax}$  degradation increases. In all pictures, the drain is towards the top and the source towards the bottom. Prominent structural degradation appears in all cases under the gate edge on the drain side of the device.

Fig. 4 shows SEM pictures obtained towards the center of one of the two gate fingers in six different devices. These six samples were stressed under various conditions (different  $V_{DS}$ ) and ended up with different levels of  $I_{Dmax}$  degradation by the time they blew up. The purpose of using different stress conditions was to reach different levels of degradation. The sample size was limited and we did not attempt to carry out a detailed correlation study between  $V_{DS, stress}$  and degree of electrical degradation.

As seen in Fig. 4, in devices with relatively small  $I_{Dmax}$  degradation, a shallow groove appears along the gate finger on the drain side of the device. For devices with prominent  $I_{Dmax}$  degradation, deep pits are formed that tend to merge and form continuous trenches. When the overall drain current degradation increases from  $0.2\%$  (top left picture) up to  $25.8\%$  (bottom right picture), pits at the gate edge become more prominent and both their width and length increase with the increase in drain current degradation. The relative  $I_{Dmax}$  degradation indicated in the figure are obtained with

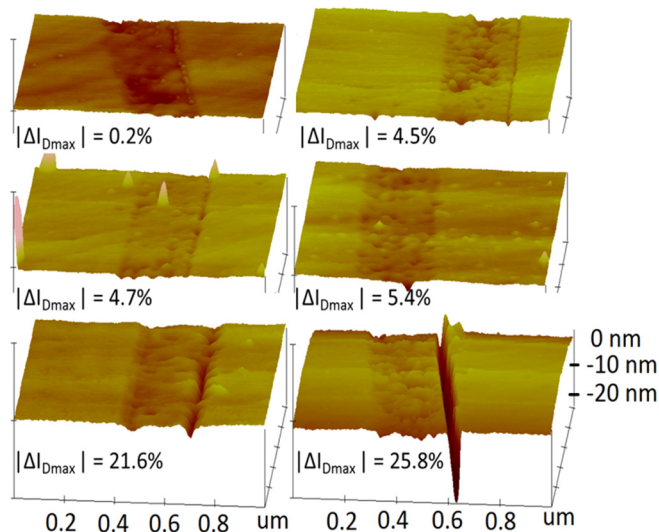
FIG. 5. AFM pictures of six delaminated devices that have been stressed under  $V_{DS} = 40$  or  $50\ \text{V}$  and  $I_{DQ} = 100\ \text{mA/mm}$ . From top left to bottom right picture, overall  $I_{Dmax}$  degradation increases. In all pictures, the source is towards the left and the drain is towards the right.

To get more insight on the correlation between current degradation and structural degradation at the gate edge, a quantitative analysis was conducted using AFM. Fig. 5 shows a 3-D view of the gate area for the same six samples of Fig. 4. The vertical scales are the same for all six AFM pictures. From the top left to the bottom right pictures shown in the figure, as  $I_{Dmax}$  degradation increases, the structural damage formed at the gate edge evolves from a shallow groove to very prominent trenches which are deep enough to penetrate into the GaN buffer layer.

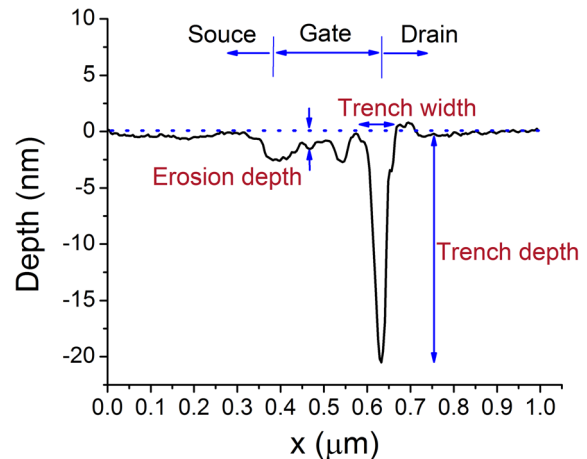
FIG. 6. Cross-sectional topographical view of a delaminated device from a single AFM line scan.  $I_{Dmax}$  degradation is 25.8% for this device. A prominent trench is visible under the gate edge on the drain side of the device. Visible erosion is also evident under the entire gate. The terms “trench width,” “trench depth,” and “erosion depth” are defined as shown in the picture.

Fig. 6 shows a cross-sectional view of the device gate region from a single AFM line scan at the center of the gate finger for a device that suffered 25.8% degradation in  $I_{Dmax}$ . AFM provides a measurement of the actual width of the defects although the depth is likely to be underestimated. In this device, we clearly see that the trench under the gate edge on the drain side penetrates all the way through the GaN cap and AlGaIn barrier layer.

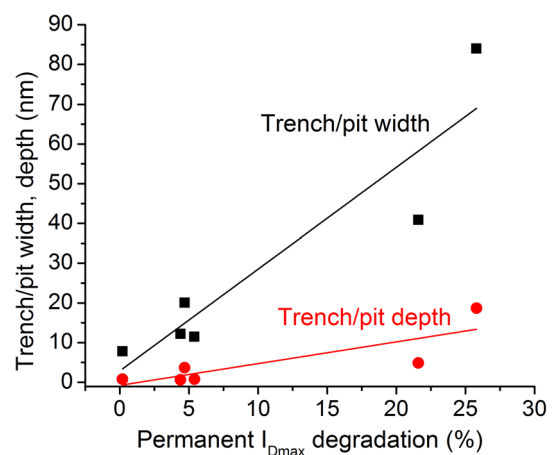
FIG. 7. Correlation between permanent  $I_{Dmax}$  degradation and the geometry of structural degradation under the gate edge on the drain side of the device for the six devices biased in the high-power stress regime. A clear correlation between  $I_{Dmax}$  degradation and trench/pit width and depth are observed.

Fig. 7 shows the correlation between permanent  $I_{Dmax}$  degradation and the geometry of the pits and trenches formed under the drain side edge of the gate. Each point in the graph represents a different device and the value was averaged across five  $1\ \mu\text{m} \times 1\ \mu\text{m}$  scans taken at the center of the gate finger. From the graph, it is clear that there is a strong correlation between  $I_{Dmax}$  degradation and both the depth and width of the pits and trenches. This is the first such observation under ON-state stress and is similar to what has been observed in GaN HEMTs under OFF-state stress.<sup>19,20,26</sup>

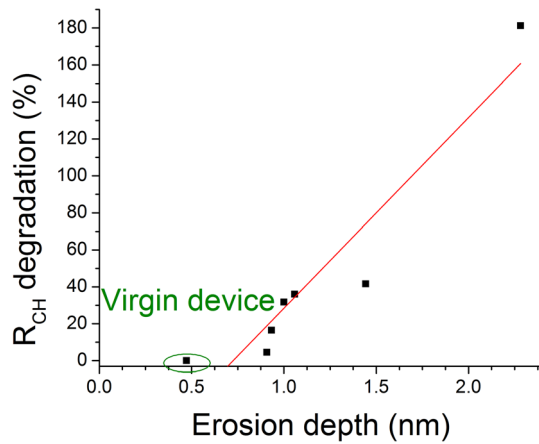
FIG. 8. Correlation between permanent channel resistance degradation (measured under detrapped conditions) and structural erosion under the gate.

Of all the figures of merit that we measure in the course of our experiments, the average depth of this eroded region was found to only correlate with the channel resistance measured with the device completely detrapped. The channel resistance is derived from measurements of the ON resistance,  $R_{on}$ , which is the total resistance between drain and source with the gate floating, and source and drain resistances that are obtained through the drain-current injection technique.<sup>35</sup> The close correlation between the under-gate erosion depth and  $R_{CH}$  is shown in Fig. 8 for the same six devices discussed earlier in this paper. This figure also includes an analysis of a virgin device. The finite erosion depth that we observe in the virgin device indicates that the structural damage originates in the fabrication process and seems to be enhanced as a result of electrical stress.

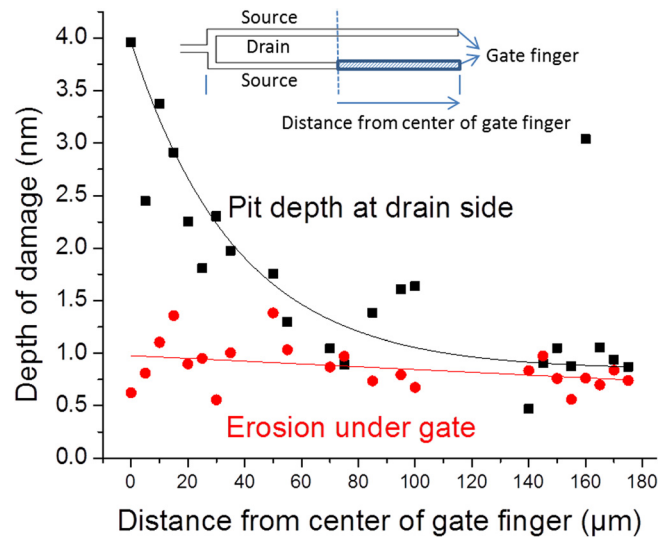
FIG. 9. Distribution of pit/trench depth and under-gate erosion depth along half of the gate width for the device with  $I_{\text{Dmax}}$  degradation of 21.6%. Each point in the graph represents an average value across a  $5\ \mu\text{m}$  scan.

Following the approach of Li,<sup>27</sup> we can evaluate the stress temperature dependence of the observed degradation phenomena by studying the evolution of the geometry of these features across the width of the device. Towards this end, multiple  $5\ \mu\text{m} \times 5\ \mu\text{m}$  AFM scans have been taken across the entire half of one gate finger. The pit/trench and under gate erosion depth obtained from all traces (about 23) in each scan were averaged. Fig. 9 shows the average pit depth and under gate erosion depth as a function of gate finger location starting from the center of the gate, in steps of  $5\ \mu\text{m}$ . Pit depth is the largest at the center of the gate finger and it decreases towards its end. This is consistent with a thermally accelerated degradation process, as was found in Ref. 27. Temperature accelerated degradation of the drain current is also evident in Fig. 1. Furthermore, as described in Ref. 31, the activation energies obtained from the degradation of these devices under high-power DC stress range from 0.84 eV to 1.04 eV. In experiments carried out on similar technologies where devices are stressed under OFF state conditions, activation energies of 1.05 eV (Ref. 36) and 1.12 eV (Ref. 34) have been reported. The close values of our
