Developing Dynamic Web-GIS based Early Warning System for the Communities at Landslide Risks in Chittagong Metropolitan Area, Bangladesh

Landslide Inventory Report August, 2014

Landslide Inventory Report of Chittagong Metropolitan Area, Bangladesh

BUET-Japan Institute of Disaster Prevention and Urban Safety
(BUET-JIDPUS); Bangladesh University of Engineering and
Technology (BUET), Dhaka-1000, Bangladesh

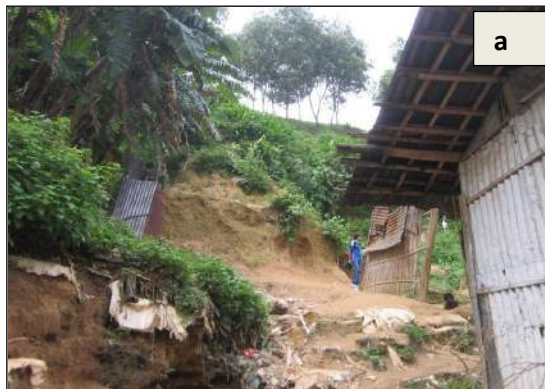
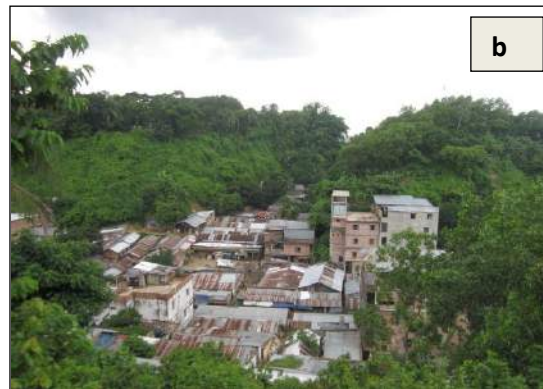
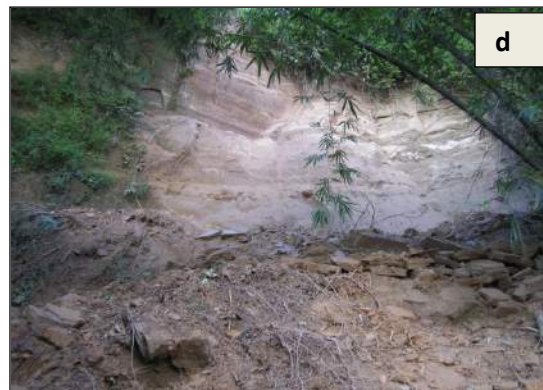
Figure 1.12: Existing condition in the most landslides prone of Chittagong City: a) Instable slope near Batali Hill b) View from Tankirpahar in Matijhorna area where in foothill informal settlement with high landslide risk c) Residential Buildings built by cutting hills d) Hill cutting near Batali Hill area. Source: *Field survey, August 2014*

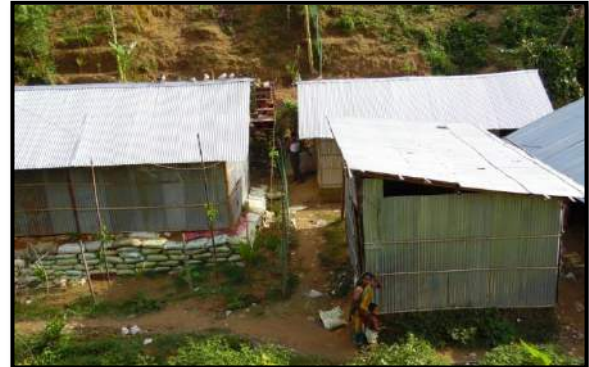
Figure 2.16: Foundation condition of houses (Akbar Shah Mazar Hill, Akbar Shah Area)

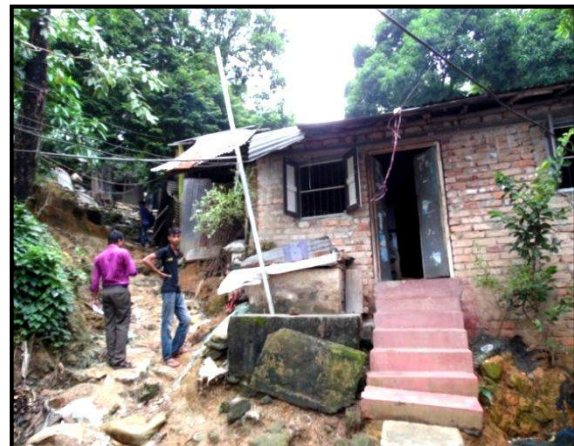
Figure 2.18: Condition of doors and windows (Goachi Bagan Hill, Pachlish area). Source: *Field Survey (August, 2014)*

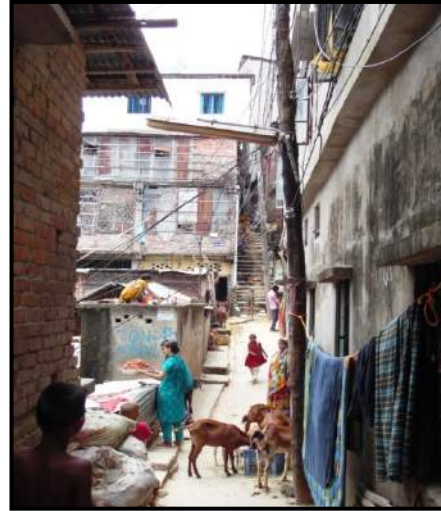
Figure 2.31: Co existence of drainage and water pipelines, Motijhorna hill, Motijhorna. Source: *Field survey, August, 2014*

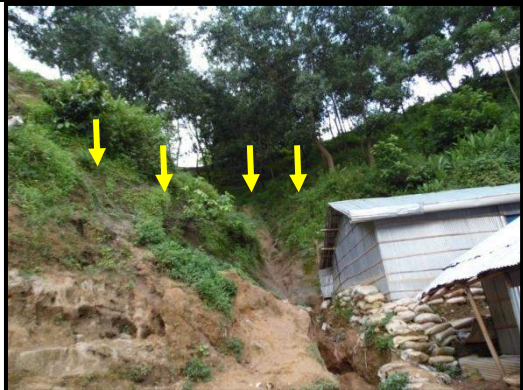
<p style="font-size: small;">Source: <i>Field survey, August 2014</i></p>
Landslide Mechanism	
<p>Type of Movement: topple</p> <p>State: Active</p> <p>Distribution: Confined</p>	<p>Style: Single</p> <p>Water Content: Moist</p> <p>Material: Soil/Earth</p>
<p>Land Cover/Use Type : Herbaceous vegetation is the Primary land cover of Motijhirna hill. Forest/ woodland type is also visible in this hill.</p>	
<p>Causes of Movement: Hill cutting is the major issue that caused landslide in this area and intense rainfall acted as a triggering factor for landslide.</p>	
Land Slide History and Future Risk of Landslide	
<p>Landslide in this site has occurred in 11 June 2007 (Dept. Of Environment, Chittagong). One semi built house partially collapsed. None was found to be injured or dead. Utility facilities did not get damaged in this incident. Economic activities were hampered so does the social life of people. Environment has been found to be severely damaged (Field survey, August 2014).</p> <p>Excessive rainfall has been identified as the major triggering factor for landslide in this site. Houses have been built at the down slope through cutting Hill which has worsened the landslide condition of this area. Moreover the soil of this site has been found to be sandy. The escapement slope is found to be near vertical. The failed mass is a part of upper portion. Vertical Slope characteristics can be considered as a contributing factor to future landslide for this hill. Settlements located at the down slope of this hill are at a huge risk of massive landslide. The risk is moderate (Field survey, August 2014).</p>

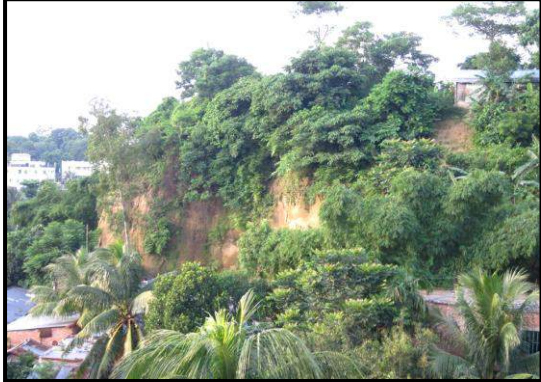
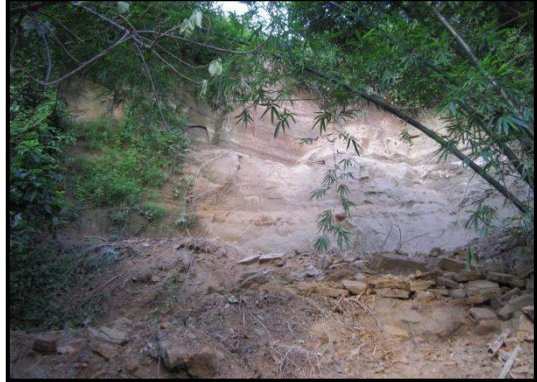
<p>Source: <i>Field survey, August 2014</i></p>	<p>Source: <i>Field survey, August 2014</i></p>
Landslide Mechanism	
<p>Type of Movement: Fall, Slide</p> <p>State: Active</p> <p>Distribution: Advancing</p>	<p>Style: Successive</p> <p>Water Content: Moist</p> <p>Material: Soil/Earth</p>
<p>Land Cover/Use Type :</p> <p>Forest/ woodland are the Primary land cover of Batali hill.</p>	
<p>Causes of Movement:</p> <p>Hill cutting is the major issue that caused landslide in this area and intense rainfall acted as a triggering factor for landslide.</p>	
Land Slide History and Future Risk of Landslide	
<p>Landslide Batali hill has become very common phenomenon of rainy season. Landslide in this hill has been occurring since 2011 on every rainy season. Landslide of 2011 caused damaged to two houses. Heavy and prolonged rainfall easily cause debris flow as soil of this hill is found to be of loose, sandy characteristic. No casualties of landslide have been identified. Utility facilities got damaged during the landslide of 2011. During rainy season, people leave their houses and shift to other places. This incurs a loss to their economic activities. Environment has been found to be severely damaged due to landslides. Still there are many houses located at the down slope of the hill. The escapement slope is found to be near vertical. The failed mass is a part of upper portion. Settlements located at the down slope of this hill are at a huge risk of massive landslide. The risk is high (Field Survey, August 2014)</p>

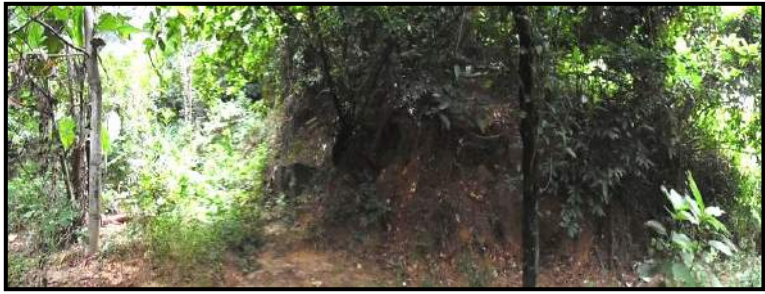
</div> <p>Source: <i>Field survey, August 2014</i></p>	
Landslide Mechanism	
<p>Type of Movement: Fall, Slide</p> <p>State: Dormant</p> <p>Distribution: Confined</p>	<p>Style: Single</p> <p>Water Content: Moist</p> <p>Material: Soil/Earth</p>
<p>Land Cover/Use Type (%):</p> <p>Forest/ woodland is the Primary land cover of Lebu bagan. Herbaceous vegetation is also visible in this hill.</p>	
<p>Causes of Movement:</p> <p>Excessive rainfall event (658 mm in 9 days rainfall event) is the main cause of movement.</p>	
Land Slide History and Future Risk of Landslide

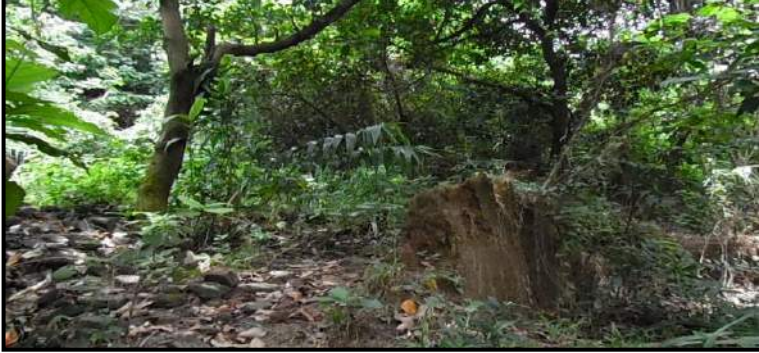
</div> <p style="text-align: center;"><i>Source: Field survey, August 2014</i></p>	
Landslide Mechanism	
<p>Type of Movement: Slide</p> <p>State: Dormant</p> <p>Distribution: Confined</p>	<p>Style: Single</p> <p>Water Content: Moist</p> <p>Material: Soil/Earth</p>
<p>Land Cover/Use Type :</p> <p>Forest/ woodland is the Primary land cover of Lebu bagan. Herbaceous vegetation is also visible in this hill.</p>	
<p>Causes of Movement:</p> <p>Excessive rainfall event (658 mm in 9 days rainfall event) is the main cause of movement.</p>	
Land Slide History and Future Risk of Landslide

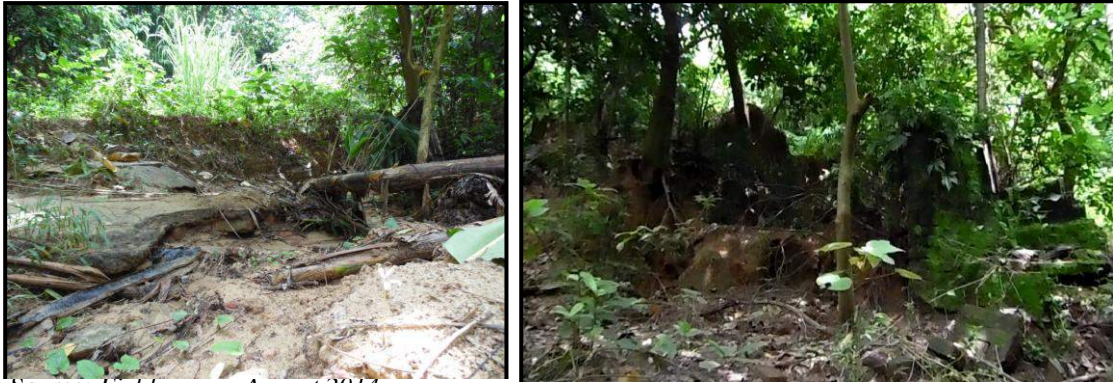
<p>Source: <i>Field survey, August 2014</i></p>	
Landslide Mechanism	
<p>Type of Movement: Fall, Slide</p> <p>State: Dormant</p> <p>Distribution: Confined</p>	<p>Style: Single</p> <p>Water Content: Moist</p> <p>Material: Soil/Earth</p>
<p>Land Cover/Use Type :</p> <p>Forest/ woodland is the Primary land cover of Lebu bagan. Herbaceous vegetation is also visible in this hill.</p>	
<p>Causes of Movement:</p> <p>Excessive rainfall event (658 mm in 9 days rainfall event) is the main cause of movement.</p>	
Land Slide History and Future Risk of Landslide	
<p>A massive landslide occurred in Lehubagan in 11 June, 2007. As many as two persons were killed and 10-15 people were injured in landslide which hit houses at Lebu Bagan of Chittagong Cantonment. The heavy rainfall saturated the hillsides in and around the city giving residents no chance to escape when a tide of mud and water swept down on their homes in the early hours of yesterday morning, burying whole families under mud and debris while they slept. The powerful current simply washed others away. At present there exists no settlement. People were moved from this place. Now this place has become woodland area. Future risk of landslide is low.</p>

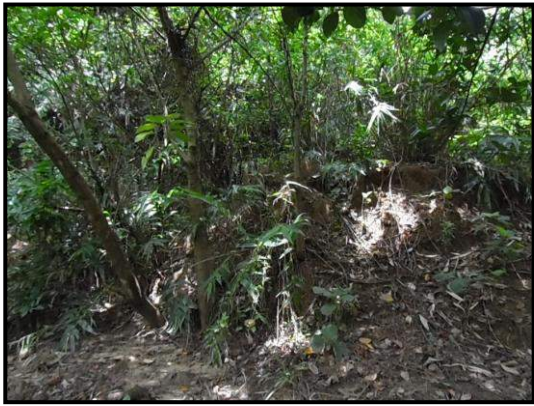
<p style="text-align: center;"><i>Source: Field survey, August 2014</i></p>
Landslide Mechanism	
<p>Type of Movement: Fall, slide</p> <p>State: Stabilized</p> <p>Distribution: Confined</p>	<p>Style: Single</p> <p>Water Content: Moist</p> <p>Material: Soil/Earth</p>
<p>Land Cover/Use Type :</p> <p>Herbaceous vegetation is the Primary land cover of Kaicchaghona. Forest/ woodland type is also visible in this hill.</p>	
<p>Causes of Movement:</p> <p>Excessive rainfall event (658 mm in 9 days rainfall event) is the main cause of movement.</p>	
Land Slide History and Future Risk of Landslide	
<p>A massive landslide occurred in Kaicchaghona in 11 June, 2007. As many as seven persons were killed and 20-30 people were injured and in landslide which hit houses at Kaicchaghona of Chittagong Cantonment (Dept of Environment, Chittagong). Many houses got destroyed in this disaster. The heavy rainfall saturated the hillsides in and around the city giving residents no chance to escape when a tide of mud and water swept down on their homes in the early hours of yesterday morning, burying whole families under mud and debris while they slept. The powerful current simply washed others away. At present there exists no settlement. People were moved from this place. Now this place has become woodland area. Future risk of landslide is low.</p>

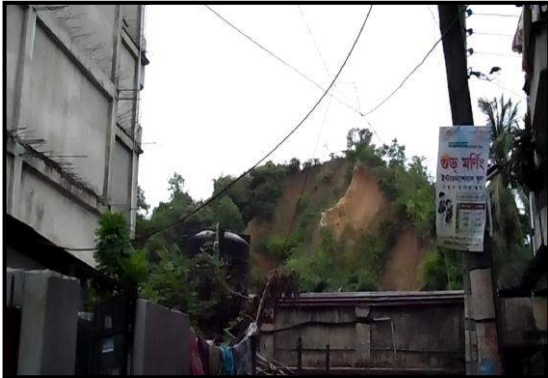
<p>Source: <i>Field survey, August 2014</i></p>	<p>Source: <i>Field survey, August 2014</i></p>
Landslide Mechanism	
<p>Type of Movement: Fall, slide</p> <p>State: Active</p> <p>Distribution: Advancing</p>	<p>Style: Successive</p> <p>Water Content: Moist</p> <p>Material: Soil/Earth</p>
<p>Land Cover/Use Type : Herbaceous vegetation are the Primary land cover of Kushumbagh Housing hill</p>	
<p>Causes of Movement: Excessive rainfall and hill cutting is the main cause of movement.</p>	
Land Slide History and Future Risk of Landslide	
<p>Land slide in Kushumbagh Housing, hill occurs in every rainy season. People cut hill to construct houses at the slopes of hill. There are some tin shed houses are seen located at slopes of Kushumbagh Housing hill. Till now no big landslide has occurred in this place. Landslides that have been occurring in every rainy season have low damage intensity. Soil characteristic of this site is of sandy type. The escapement slope is found to be near vertical. Vertical Slope characteristics can be considered as a contributing factor to future landslide for this hill. Settlements located at the down slope of this hill are at a huge risk of massive landslide. The risk is high.</p>

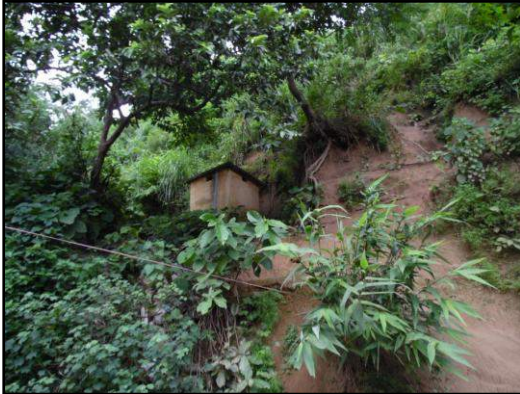
<p>Source: <i>Field survey, August 2014</i></p>
Landslide Mechanism	
<p>Type of Movement: Fall, Slide</p> <p>State: Active</p> <p>Distribution: Advancing</p>	<p>Style: Successive</p> <p>Water Content: Moist</p> <p>Material: Soil/Earth</p>
<p>Land Cover/Use Type: Herbaceous vegetation and forest/woodland are the Primary land cover of Gol Pahar hill.</p>	
<p>Causes of Movement: Excessive rainfall and hill cutting are the main cause of movement.</p>	
Land Slide History and Future Risk of Landslide	
<p>A significant land slide in Gol Pahar, Foy’z lake hill occurred in 1990. None was found to be injured or dead. Landslide in this hill occurs at every rainy season. Soil characteristic of this site is of sandy type. The escapement slope is found to be near vertical. Vertical Slope characteristics can be considered as a contributing factor to future landslide for this hill. Settlements are located at the down slope of this hill. People have constructed their house through cutting hill. Sac filled with sand have been used to protect hill from land slide. Still land slide has been occurring in this site. People located near Goal Pahar hill are in great risk of massive landslide (Field Survey, August 2014).</p>

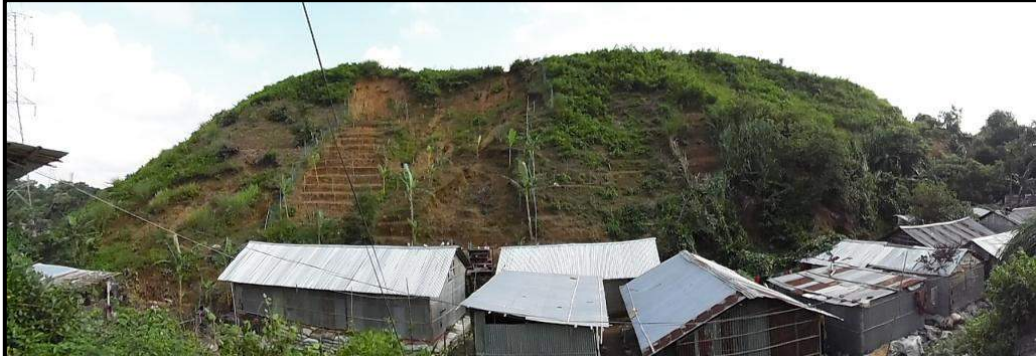
<p>Source: Field survey, August 2014</p>	
Landslide Mechanism	
<p>Type of Movement: Fall, Flow</p> <p>State: Active</p> <p>Distribution: Advancing</p>	<p>Style: Single</p> <p>Water Content: Moist</p> <p>Material: Soil/Earth</p>
<p>Land Cover/Use Type : Herbaceous vegetation and is the Primary land cover of Akbar shsh mazar hill.</p>	
<p>Causes of Movement: Excessive rainfall event (658 mm in 9 days rainfall event) and hill cutting are the main cause of movement.</p>	
Land Slide History and Future Risk of Landslide	
<p>A significant land slide in Akbar Shah Mazar hill hill occurred in 11 June 2007. Seven people were killed and 20-30 people were injured in that land slide occurrence (Feild Survey, August 2014). Twelve tin shed houses were completely destroyed. At present 200-250 families live in 30 houses located just down the slope of the hill. Characteristic of this site is of sandy type. The escapement slope is found to be near vertical. Vertical Slope characteristics can be considered as a contributing factor to future landslide for this hill. Settlements People have constructed their house through cutting hill. Sac filled with sand have been used to protect hill from land slide. People located near Goal Pahar hill are in great risk of massive landslide.</p>

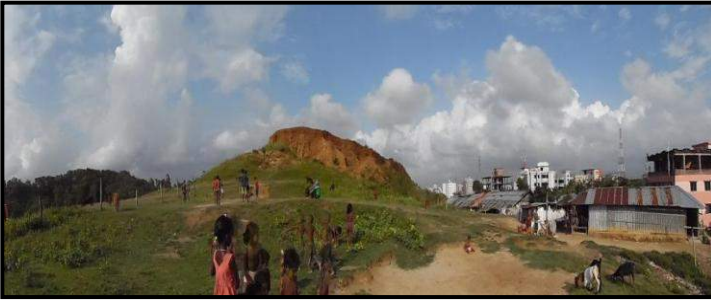
</div> <p>Source: <i>Field survey, August 2014</i></p>	
Landslide Mechanism	
<p>Type of Movement: Topple, Slide</p> <p>State: Active</p> <p>Distribution: Advancing</p>	<p>Style: Successive</p> <p>Water Content: Moist</p> <p>Material: Soil/Earth</p>
<p>Land Cover/Use Type: Herbaceous vegetation and is the Primary land cover of Lal Pahar.</p>	
<p>Causes of Movement: Excessive rainfall and hill cutting are the main cause of movement.</p>	
Land Slide History and Future Risk of Landslide	
<p>Land slide in Lal Pahar occurs at every rainy season. No information about any significant land slide in this site is found. At present 150-200 families live surrounding this hill area. Soil characteristic of this site is of sandy type. The escapement slope is found to be near vertical. Vertical slope characteristics can be considered as a contributing factor to future landslide for this hill. Settlements People have constructed their house through cutting hill. People located near Lal pahar are in great risk of massive landslide.</p>

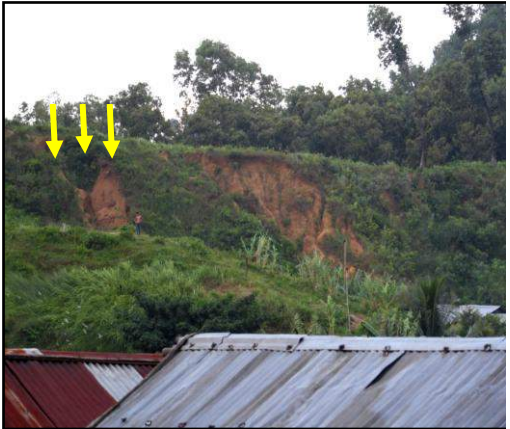
<p style="text-align: center;"><i>Source: Field survey, August 2014</i></p>
Landslide Mechanism	
<p>Type of Movement: Slide</p> <p>State: Active</p> <p>Distribution: Advancing</p>	<p>Style: Successive</p> <p>Water Content: Moist</p> <p>Material: Soil/Earth</p>
<p>Land Cover/Use Type: Herbaceous vegetation and is the Primary land cover Foy’z Lake Zoo hill</p>	
<p>Causes of Movement: Excessive rainfall is the main cause of movement.</p>	
Land Slide History and Future Risk of Landslide	
<p>Land slide in occurs in Foy’s Lake Zoo hill at every rainy season. No information about any significant land slide in this site is found. At present 150-200 families live on the down slope area of the hill. Soil characteristic of this site is of sandy type. No natural or artificial drainage path has been seen in this site. The escapement slope is found to be near vertical to incline. People have constructed their house through cutting hill at the down slope of hill. People located near Foy’s Foy’s Lake Zoo hill are in moderate risk of massive landslide (Field Survey, August 2014)</p>

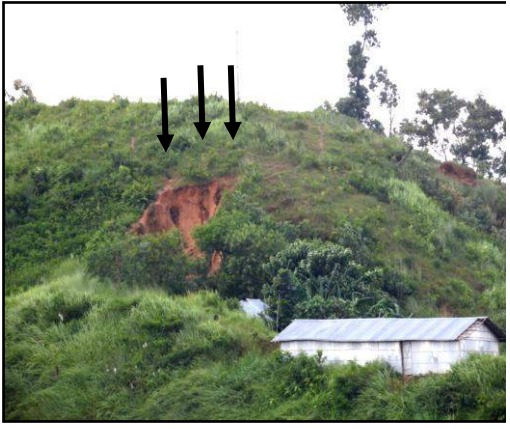
<p style="text-align: center;"><i>Source: Field survey, August 2014</i></p>
Landslide Mechanism	
<p>Type of Movement: Slide</p> <p>State: Active</p> <p>Distribution: Advancing</p>	<p>Style: Single</p> <p>Water Content: Moist</p> <p>Material: Soil/Earth</p>
<p>Land Cover/Use Type: Herbaceous vegetation and is the Primary land cover Foy’z Lake Zoo hill</p>	
<p>Causes of Movement: Excessive rainfall and hill cutting are the main cause of movement.</p>	
Land Slide History and Future Risk of Landslide	
<p>Land slide in this site occurred in 2013. Damage intensity of that land slide was low. None was found to be dead or injured. At present 100-180 families live on the down slope area of the hill (Field survey, August 2014). Soil characteristic of this site is of sandy type. No natural or artificial drainage path has been seen in this site. The escapement slope is found to be near vertical to incline. People have constructed their house through cutting hill at the down slope of hill. People located near Foy’s Lake Zoo hill are in moderate risk of massive landslide (Field Survey, August 2014)</p>

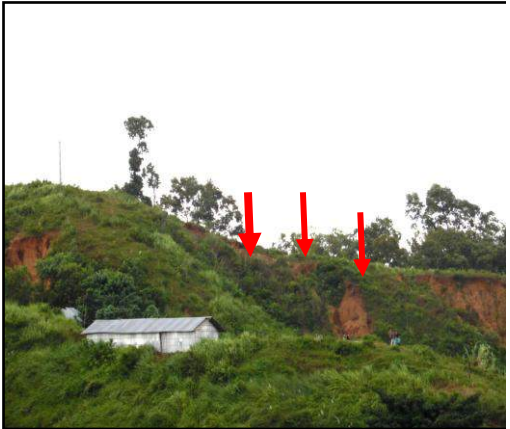
<p style="text-align: center;"><i>Source: Field survey, August 2014</i></p>
Landslide Mechanism	
<p>Type of Movement: Slide</p> <p>State: Active</p> <p>Distribution: Advancing</p>	<p>Style: Single</p> <p>Water Content: Moist</p> <p>Material: Soil/Earth</p>
<p>Land Cover/Use Type : Herbaceous vegetation and is the Primary land cover Foy’z Lake Zoo hill</p>	
<p>Causes of Movement: Excessive rainfall and hill cutting are the main cause of movement.</p>	
Land Slide History and Future Risk of Landslide	
<p>Land slide in this site occurred in 2013. Damage intensity of that land slide was low. None was found to be dead or injured. At present 100-180 families live on the down slope area of the hill (Field survey, August 2014). Soil characteristic of this site is of sandy type. No natural or artificial drainage path has been seen in this site. The escapement slope is found to be near vertical to incline. People have constructed their house through cutting hill at the down slope of hill. People located near Foy’s Lake Zoo hill are in moderate risk of massive landslide.</p>

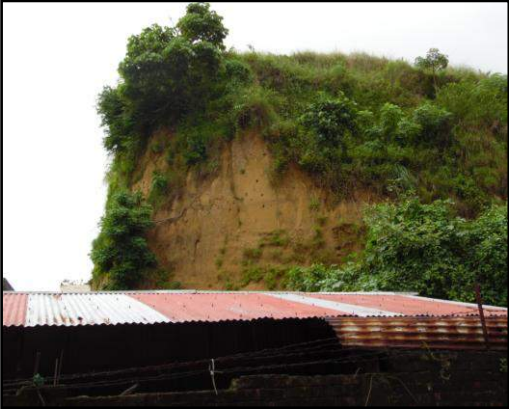
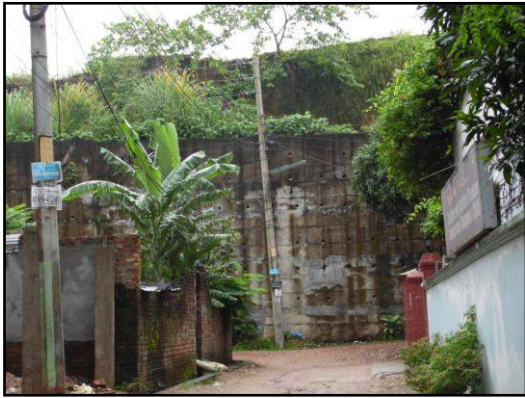
<p style="text-align: center;"><i>Source: Field survey, August 2014</i></p>
Landslide Mechanism	
<p>Type of Movement: Fall, Topple State: Active Distribution: Advancing</p>	<p>Style: Single Water Content: Moist Material: Soil/Earth</p>
<p>Land Cover/Use Type : Herbaceous vegetation is the Primary land cover of Jakir Hossain Road, South Khulshi .</p>	
<p>Causes of Movement: Excessive rainfall and hill cutting are the main cause of movement.</p>	
Land Slide History and Future Risk of Landslide	
<p>Land slide in this site occurred in 2013. None was found to be dead or injured. Damage of the property for this event was insignificant. Zaker Hossain road area is a well developed residential area. This area has been developed through hill cutting. A big retention wall has been constructed to protect the area from being damaged from land slide. Many multi storied buildings are located in this area. Soil characteristic of this hill is of sandy type. No natural or artificial drainage path has been seen in this site. The escarpment slope is found to be near vertical. There is a huge risk of land slide in this hill. But there is less chance of property damage as the area is protected by retention wall. Some semi built shops and houses are located near this hill which may suffer from being landslide (Field Survey, August 2014).</p>

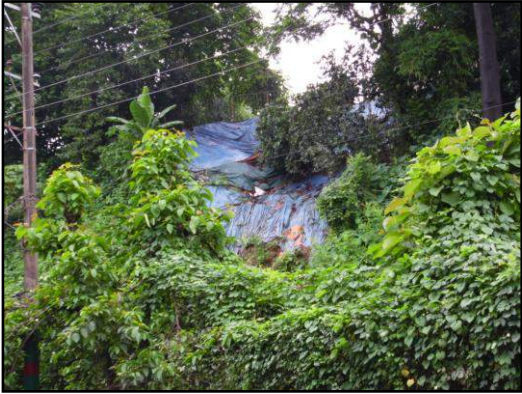
<p style="text-align: center;">Source: <i>Field survey, August 2014</i></p>
Landslide Mechanism	
<p>Type of Movement: Topple, Slide</p> <p>State: Active</p> <p>Distribution: Advancing</p>	<p>Style: Single</p> <p>Water Content: Moist</p> <p>Material: Soil/Earth</p>
<p>Land Cover/Use Type (%): Herbaceous vegetation and Forest/ Woodland are the Primary land cover of Holy Crescent, Khulshi.</p>	
<p>Causes of Movement: Excessive rainfall and hill cutting are the main cause of movement.</p>	
Land Slide History and Future Risk of Landslide	
<p>Land slide in this site occurred in 2013. None was found to be dead or injured. Damage of the property for this event was insignificant. Many multi storied buildings are being constructed in this site. Soil characteristic of this hill is of sandy type. No natural or artificial drainage path has been seen in this site. The escapement slope is found to be near vertical. There is a huge risk of land slide in this hill.</p>

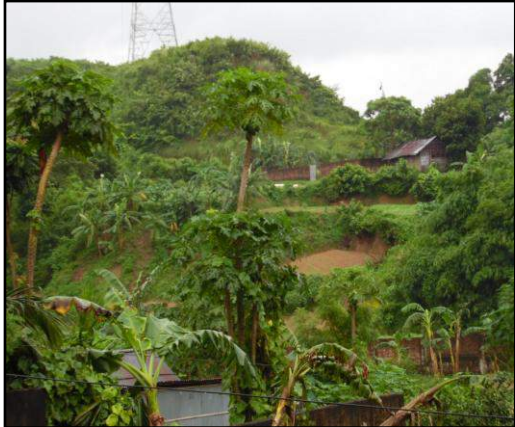
<p style="text-align: center;"><i>Source: Field survey, August 2014</i></p>
Landslide Mechanism	
<p>Type of Movement: Topple, Slide</p> <p>State: Active</p> <p>Distribution: Advancing</p>	<p>Style: Single</p> <p>Water Content: Moist</p> <p>Material: Soil/Earth</p>
<p>Land Cover/Use Type : Herbaceous vegetation is the Primary land cover of Krishnochura Housing</p>	
<p>Causes of Movement: Excessive rainfall is the main cause of movement.</p>	
Land Slide History and Future Risk of Landslide	
<p>No exact date of the occurrence of land slide has been found. A few houses made of tin have been seen in the site. These houses are constructed through hill cutting. People have prepared land for agricultural purpose through hill cutting. Soil characteristic of this site is of sandy type. No natural or artificial drainage path has been seen in this site. The escapement slope is found to be near vertical to incline. There is risk of landslide in this hill.</p>

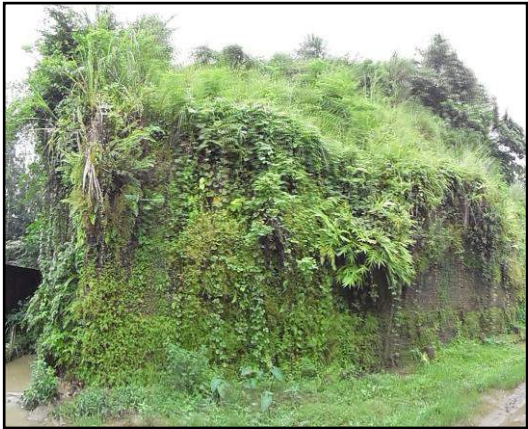
<p style="text-align: center;"><i>Source: Field survey, August 2014</i></p>
Landslide Mechanism	
<p>Type of Movement: Topple, Slide</p> <p>State: Active</p> <p>Distribution: Advancing</p>	<p>Style: Single</p> <p>Water Content: Moist</p> <p>Material: Soil/Earth</p>
<p>Land Cover/Use Type : Herbaceous vegetation is the Primary land cover of Krishnochura Housing .</p>	
<p>Causes of Movement: Excessive rainfall is the main cause of movement.</p>	
Land Slide History and Future Risk of Landslide	
<p>No exact date of the occurrence land slide has been found. A few houses made of tin have been seen in the site. These houses are constructed through hill cutting. People have prepared land for agricultural purpose through hill cutting. Soil characteristic of this site is of sandy type. No natural or artificial drainage path has been seen in this site. The escapement slope is found to be near vertical to incline. There is risk of landslide in this hill.</p>

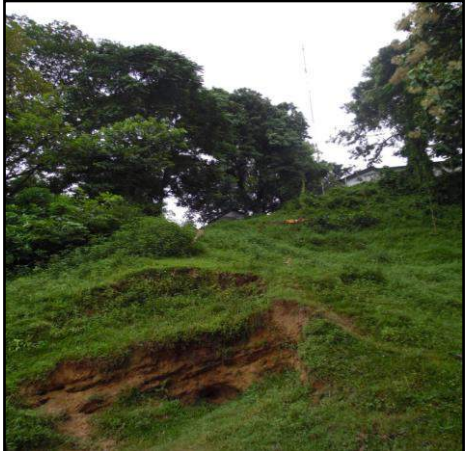
<p style="text-align: center;"><i>Source: Field survey, August 2014</i></p>
Landslide Mechanism	
<p>Type of Movement: Slide</p> <p>State: Active</p> <p>Distribution: Advancing</p>	<p>Style: Single</p> <p>Water Content: Moist</p> <p>Material: Soil/Earth</p>
<p>Land Cover/Use Type: Herbaceous vegetation and forest/ woodland are the Primary land cover of Finley hill.</p>	
<p>Causes of Movement: Excessive rainfall is the main cause of movement.</p>	
Land Slide History and Future Risk of Landslide	
<p>No exact date of occurrence of the Land slide in this site has been found. Damage of the property for this event was insignificant. None was found to be dead or injured. Banglows of the officials have been constructed on the slope of hill through hill cutting. There exists artificial drainage system so that rain water can easily be drained off. Soil characteristic of this hill is of sandy type. The escapement slope is found to be near vertical to incline. There is low risk of land slide in this hill.</p>

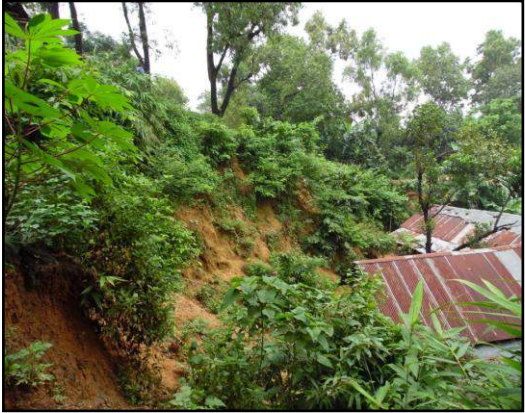
<p>Source: <i>Field survey, August 2014</i></p>
Landslide Mechanism	
<p>Type of Movement: Fall, Slide</p> <p>State: Active</p> <p>Distribution: Advancing</p>	<p>Style: Single</p> <p>Water Content: Moist</p> <p>Material: Soil/Earth</p>
<p>Land Cover/Use Type:</p> <p>Bare soil and Herbaceous vegetation are the Primary land cover of King of Chittagong hill.</p>	
<p>Causes of Movement:</p> <p>Excessive rainfall and hill cutting are the main causes of movement.</p>	
Land Slide History and Future Risk of Landslide	
<p>Land slide in this site occurred on July 2011. One three storied building got damaged. None was found to be dead or injured. People shifted from that house and the building got demolished by the authority. At present many semi built houses have been constructed on this spot. Soil characteristic of this hill is of sandy type. The escapement slope is found to be near vertical. No natural or artificial drainage system has been found in the site. Human activities have destroyed the natural drainage system. There is a huge risk of future land slide in this hill.</p>

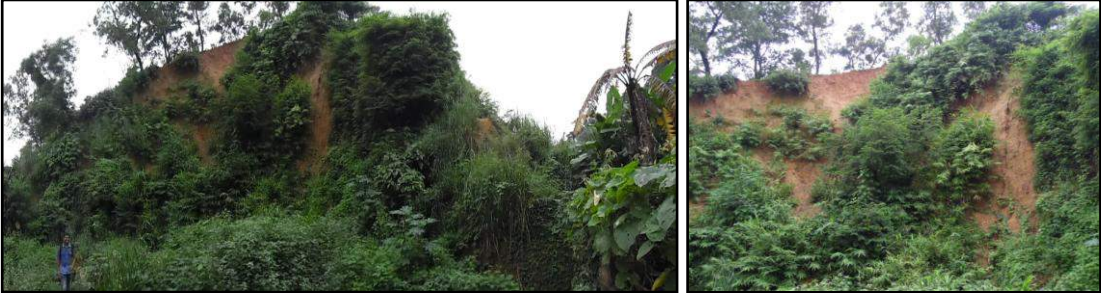
<p>Source: <i>Field survey, August 2014</i></p>	
Landslide Mechanism	
<p>Type of Movement: Fall, Slide</p> <p>State: Active</p> <p>Distribution: Advancing</p>	<p>Style: Single</p> <p>Water Content: Moist</p> <p>Material: Soil/Earth</p>
<p>Land Cover/Use Type :</p> <p>Bare soil and Herbaceous vegetation are the Primary land cover of King of Chittagong hill.</p>	
<p>Causes of Movement:</p> <p>Excessive rainfall and hill cutting are the main causes of movement.</p>	
Land Slide History and Future Risk of Landslide	
<p>Land slide in this site occurred on July 2011. One three storied building got damaged. None was found to be dead or injured. People shifted from that house and the building got demolished by the authority. At present many semi built houses have been constructed on this spot. Soil characteristic of this hill is of sandy type. The escapement slope is found to be near vertical. No natural or artificial drainage system has been found in the site. Human activities have destroyed the natural drainage system. There is a huge risk of future land slide in this hill.</p>
