Numerical investigation of bridges with the aim of condition assessment in applying the Deformation Area Difference method (DAD-method) and selecting appropriate measurement techniques

D. Erdenebat & D. Waldmann

University of Luxembourg, Laboratory of Solid Structures, Luxembourg

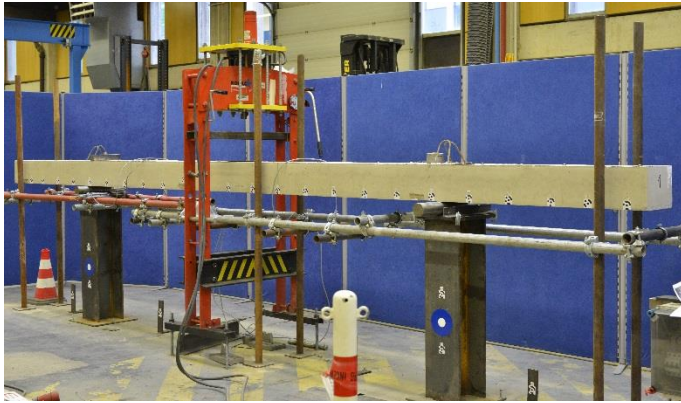
Figure 1. Test specimen: reinforced concrete beam

In this report, the results of the conducted investigations are presented. The test specimen is a reinforced concrete beam (Figure 1). In a first step, the beam was lifted on one side in order to compare the measuring techniques out their resolution to each other.

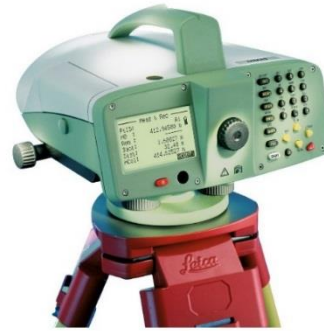
Figure 2. Digital Level Leica DNA03 (Leica Geosystems AG, 2006).

The levelling instrument employed in this study is a “Leica DNA03”, which is generally utilised for precise height measurements (Figure 2). This instrument compares on internal reference barcode with the barcode registered on the levelling rod, which is placed vertically on a point to be measured. Through a correlation process the height reading is determined. Several automatic internal readings are performed for each height measurement whereby a direct control of the verticality of the rod is given during the time of measurement. According to the instrument specification the standard deviation for the height measurement is 0.30 mm for a 1 k double levelling (Leica Geosystems AG, 2006). The significant advantages of a digital level are the high accuracy, the simple and efficient measurement, and the quick data evaluation. The measurement time for the 24 points is about 10-20 min and the evaluation takes about 30-60 min, whereby the latter could be automated to a high degree.

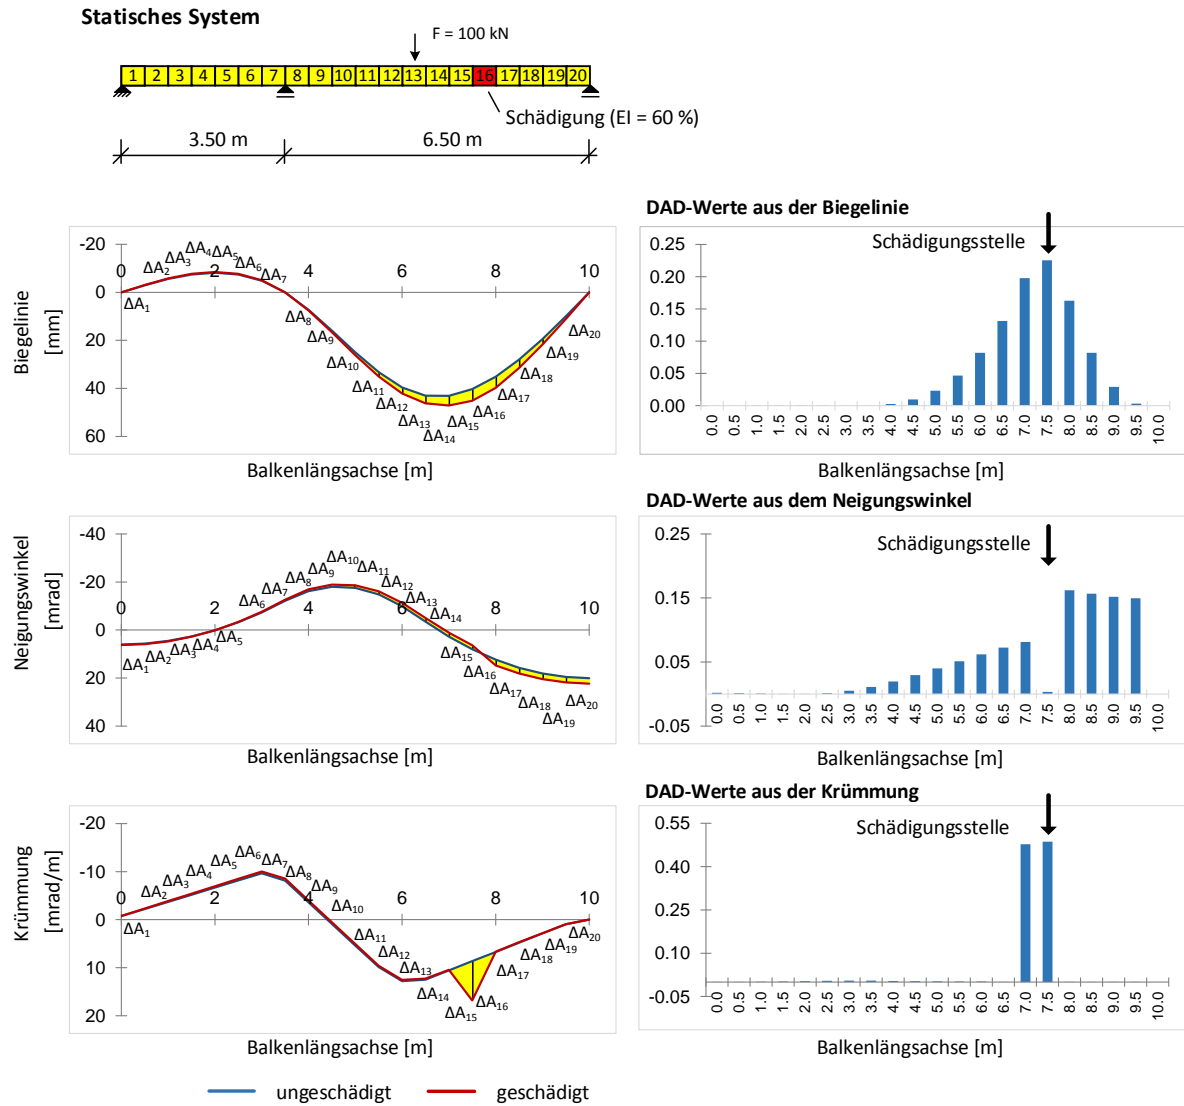
Figure 6. DAD-Method on the example of two span girder.

The objective is to develop a method which allows damage detection in structures using a non-destructive load test. The DAD-Method tries to detect and locate a discontinuity in the deformation courses of a static system by normalisation of individual areas (here until ΔA_{20}) over the total area. During a non-destructive load test, the structure is loaded at the serviceability limit level, whereby only small deformations are observed. The application of this method provides the possibility to detect and show hidden discontinuities in deflections. The DAD-Method is demonstrated on the example of a two-span beam (Figure 6). The non-uniform two-span beam with a total length of 10 m was modelled in a FE-Program with a mesh length of 50 cm. The mesh length provides the deformation values at spacing of 50 cm in the longitudinal direction of the structure. A difference can be observed between the damaged and undamaged system. In this example, a local damage is generated at the spot of element Nr. 16 $x=7.75$ m (Figure 6) by reducing the stiffness of the element to 60 %. However, the degree of damage is not detectable using the DAD-Method. Due to the calculation of deflections, and curvatures, the bending line is given as starting point. Initially, the first derivative of the bending line at the location of damage is determined. However, in most cases, the establishment of the second derivative of the bending line, the curvature, is needed to give a clear statement about the location of the damage. According to Figure 6, under consideration of the DAD-values, the damage to the two-span beam is detected at the position between $x=7.0$ and 8.0 m. The precision of the localisation (here ± 50 cm) depends on the mesh density of the numerical computation. For in-situ measurements, this corresponds to the density of the measuring points on the girder.

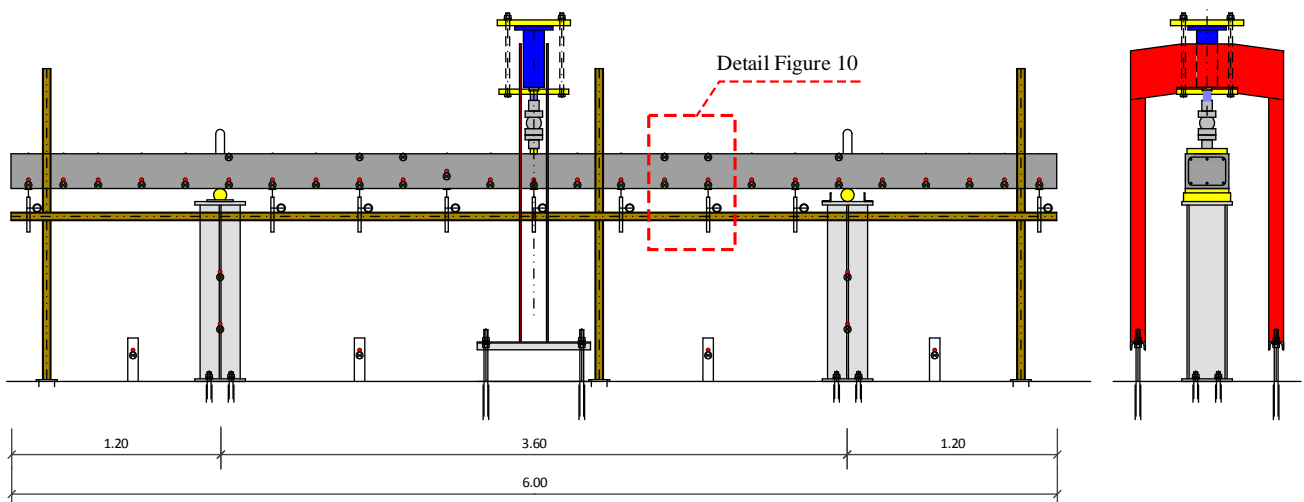
Figure 7. Test specimen: side view (left), cross section (right).

The test beam (Figure 7) prepared was firstly lifted by 2.50 cm in order to perform the first comparison of the applied measurement technologies. The center of

rotation, respectively, the neutral axis of the girder is the left support at $x=1.20 \text{ m}$. On the girder were unilaterally fixed 31 targets for the close range photogrammetry (Figure 13), 25 targets for the total station and above the girder 24 benchmarks for the levelling (Figure 9). Additionally, different benchmarks are positioned at base level as well as at the support.

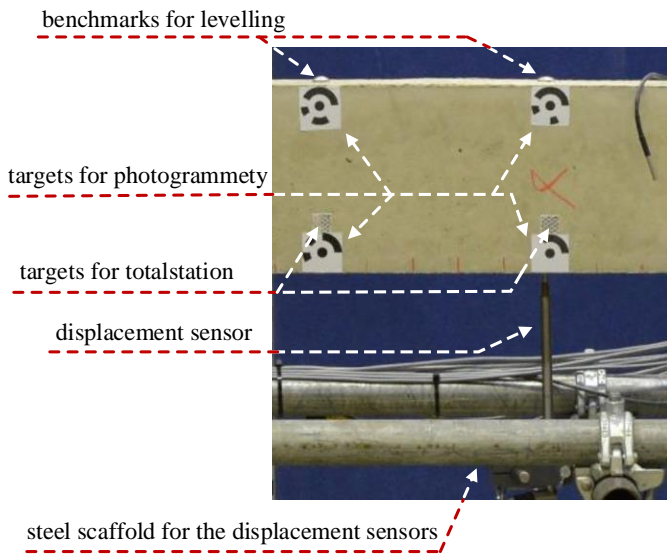
Figure 8. Detail: Position of the measuring points.

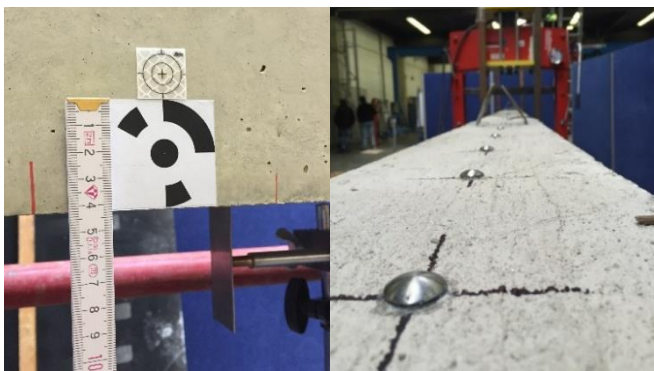
Figure 9. Targets for close range photogrammetry and total station (left figure), benchmarks for levelling (right figure).

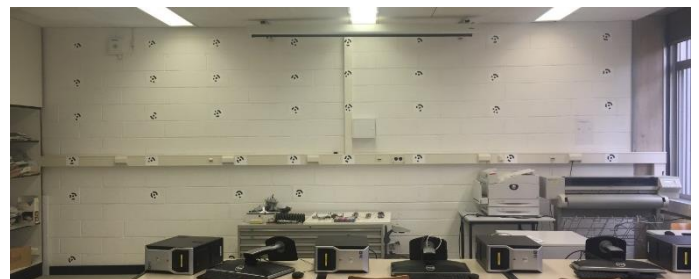
Figure 10. Calibration wall, University of Luxembourg.

The results realised by close-range photogrammetry are very dependent from the boundary conditions like the employed camera, the camera calibration, the distance to the object, the lighting conditions and the quality of the recording. For the calibration, in a separate room, targets were positioned on a 3.00 x 7.00 m white wall. There targets were measured using the total station (Figure 10).

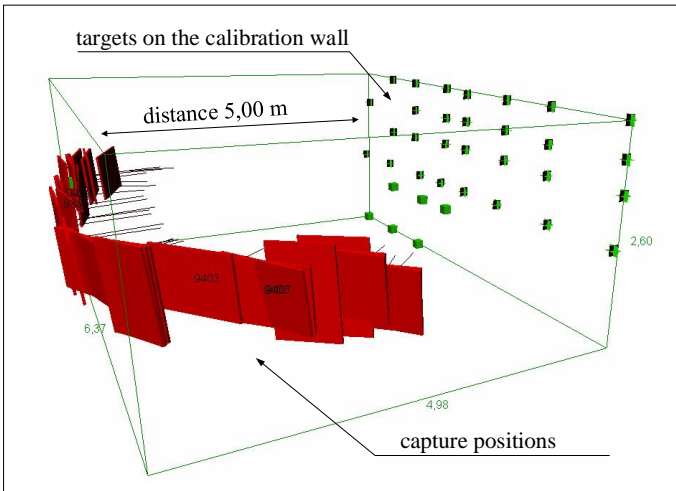
Figure 11. Perspective view: Position of recording to the calibration wall

to the wall, different aperture depths etc. It is recommended to perform the recording from a semi-circular position (according to Figure 11) to the calibration wall. The optimal result is achieved by applying the following camera settings for the Nikon D800 with 50 mm lens: ISO 2000, aperture F/8, image dimension 7360x4712, manual focus, exposure time 1/200 sec. (for higher exposure time, it is recommended to use a stand and a remote release). The quality of the calibration can be seen in Figure 12, in which are indicated the accuracy of the camera data, correlations, the stability of the global orientation and the quality of the camera calibration.

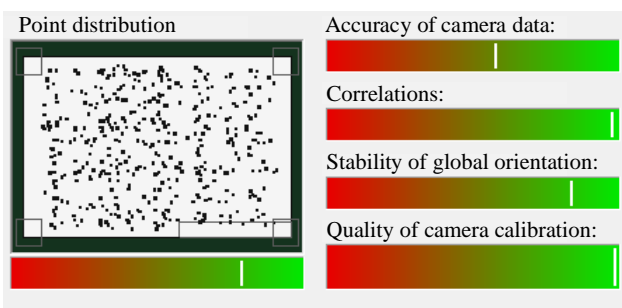
Figure 12. Point distribution and quality of the camera calibration

In the next test, the object is additionally captured from a camera position which is turned by 180 degrees to ensure that each aperture range encloses the left and right edge points of the beam and that at least 4 targets are overlapping in both pictures (manufacturer requirements). The quality of the calibration can be different depending on the distribution of the points (Figure 12) over the imaging sensor.

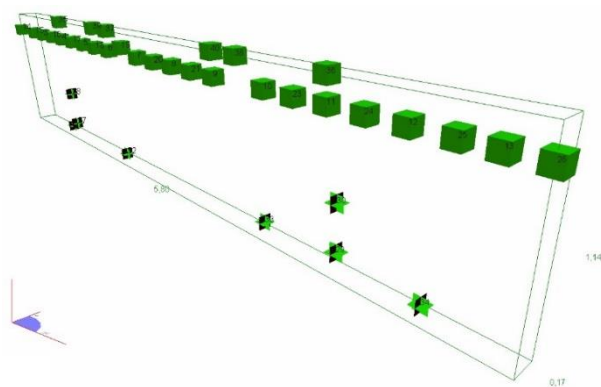
Figure 13. top (cubes): the targets (measuring points) on the test specimen, bottom: reference points (points for orientation).

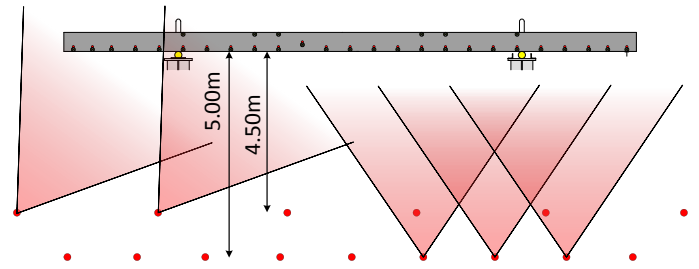
Figure 14. Schematic camera positions and angle of recording for Photogrammetry related to the beam.

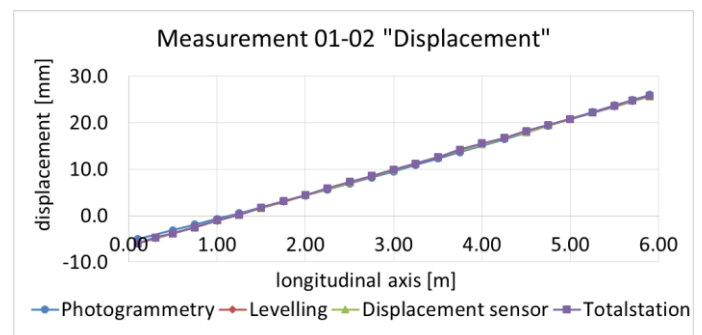
Figure 15. Measured displacements for Measurement 01 and Measurement 02.

Altogether, three measurements were carried out over three days. Measurement 01: Reference positions and initial state, Measurement 02: one side lifted state, Measurement 03: the lowered state, corresponding to the initial state. The measuring points are distributed in the longitudinal direction from $x=0.10$ m to $x=5.90$ m. Figure 15 shows the displacements between the initial state and the lifted state of the beam. At this scale, the results of the measurement techniques show good agreement. Figure 16 represents the deviations between the different measurement techniques with respect for the levelling results.

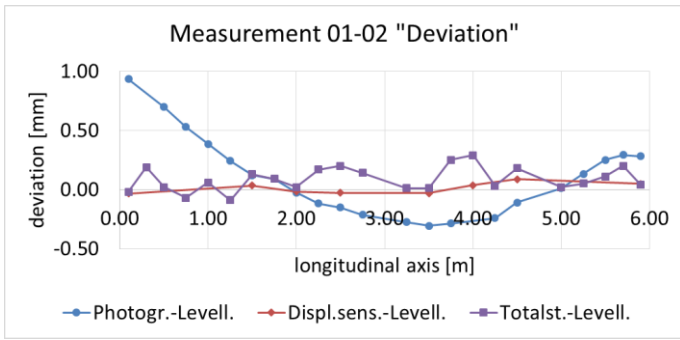
Figure 16. Deviation between each measurement techniques, levelling specified as reference

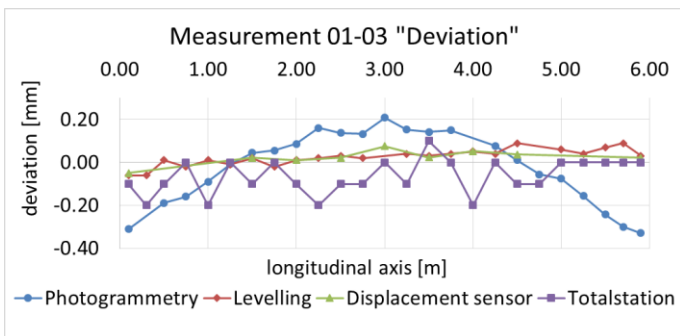
Figure 17. Deviation between Measurement 01 und Measurement 03

Figure 17 shows the difference between Measurement 01 and Measurement 03 i.e. the difference between the initial state and the lowered state. It can clearly be seen that the initial state is not fully restored after lowering of the beam. While the values from levelling and the displacement sensors almost coincide, a scattering of the values from the total station and photogrammetry can be observed. The measurement with the total station show a wider distribution of the values. However, the scattering behaves regularly over the 25 measurement points. This can be explained by the standard deviation as each measurement includes a measurement error. Figure 15 and Figure 16 show the more systematic behavior for the photogrammetric results. This might be explained due to the fact that the reference points are located below the beam. Therefore for further measurements, it is recommended to position additional reference points above the beam (for example on the wall of the experiment hall) to enclose the points of interest within the reference points. In Figure 17 the blue line corresponding to the values from photogrammetry shows an arch-like course instead of a uniform distribution (similar to the line from the total station). This indicates a systematic bias in the current results which is attributed again for the camera calibration or the location of the reference points with respect to the test beam. Hence, the full potential of the photogrammetric technique has not been reached.

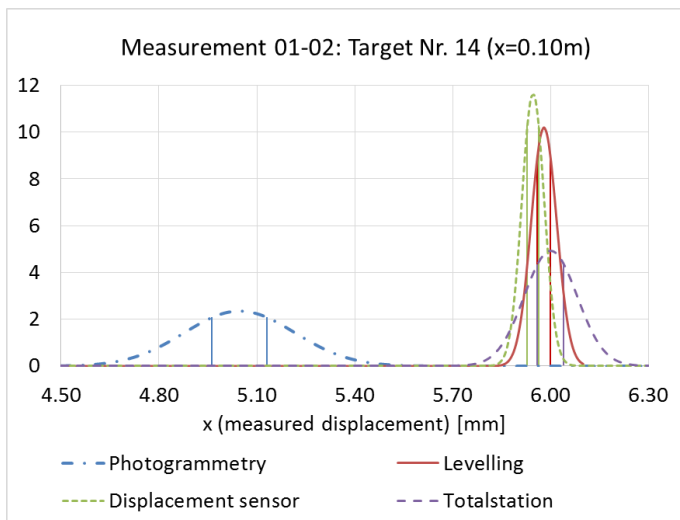
Figure 18. Standard deviation at measuring point $x=0,10$ m

By comparison of the standard deviations, a final statement on the quality of the measurements can be reached. The individual techniques are listed in Table 2 according to their order of precision. At the measuring point $x=2.00$ m the results of photogrammetry show the highest coherence, whereas at $x=0.10$ m the lowest consistency can be observed. From the comparison of the measurement techniques, it can be concluded that the displacement sensors with a standard deviation of 0.034 mm represent the measurement techniques with the most precise results (Table 2). For better overview, these values are illustrated according to the Gaussian distribution (Figure 18 and Figure 19). The horizontal axis represents the measured displacement for the corresponding point, while the width of the curve is defined by the standard deviation.

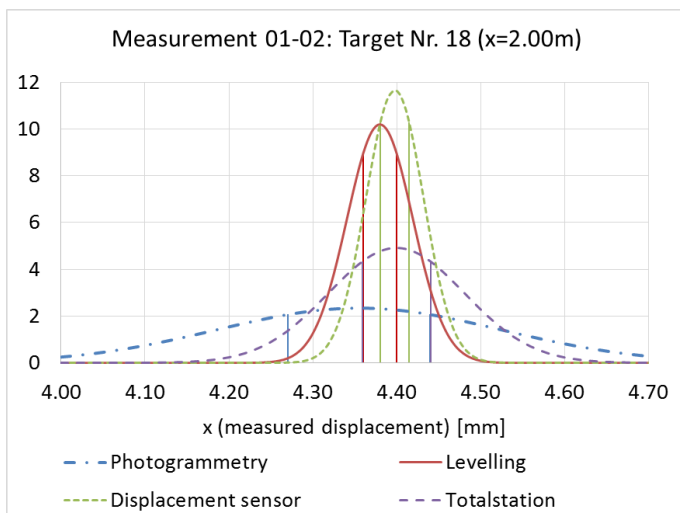
Figure 19. Standard deviation at measuring point $x=2,00$ m
