2015 JINST 10 C05016

PIXEL 2014 INTERNATIONAL WORKSHOP SEPTEMBER 1–5, 2014 NIAGARA FALLS, CANADA

Operational experience with the CMS pixel detector

J. Karancsi on behalf of the CMS collaboration

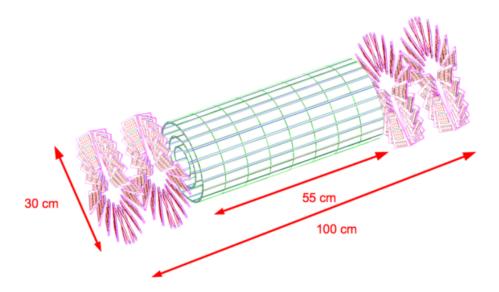
Figure 1. Schematic view of the CMS Silicon Pixel detector. The interaction point is surrounded by three cylindrical barrel layers at radii of 4.4, 7.3 and 10.2 cm and two endcap disks on each side with modules between 6 and 15 cm from the beam axis.

The sensors consist of high dose n-implants inserted into a high resistance n-substrate with rectifying pn-junctions on their backside, and are connected with readout chips (ROCs) by indium bump-bonds. The total number of pixels is approximately 66 million, each with a cell size of $100 \times 150 \,\mu\text{m}^2$. There are all together 15840 ROCs located on three barrel layers and two endcap disks (figure 1).

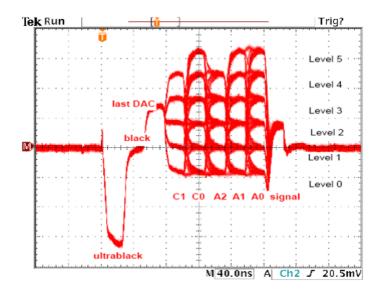
Figure 2. Oscilloscope view of the analogue signal for a pixel hit.

In the commissioning period and throughout running the different components of the detector need to be calibrated in order to ensure fully efficient and reliable data collection. The analogue signal (figure 2) consists of data packets that contain the information about each pixel hit. The pixel coordinates are encoded by using a six-level address scheme, while the charge information is contained in the analogue pulse height of the last clock cycle [4].

The offset of the optical receiver in the Front End Driver (FED) needs to be set such that the baseline level of the converted analogue signal is at the middle of the ADC range. This calibration is sensitive to temperature changes and needs to be done frequently, but small adjustments are done automatically to correct for small fluctuations. The address level calibration, which is usually done after the baselines are set, ensures that the ADC values corresponding to each address level are well separated and pixel coordinates can be decoded correctly.

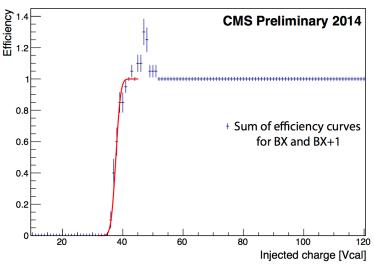
Scan over injected charge values for a single pixel (standard scan)

Figure 3. Sum of in- and out-of-time charge collection efficiencies as a function of injected charge.

Another set of calibrations needs to be done every few months due to the aging of the detector. One of them is the threshold calibration for which electric charges are injected through a circuit on the readout chip and the efficiency is measured. A scan is done for each pixel in units of V_{cal} which corresponds to 65.5 electrons. The efficiency is measured and the threshold is derived from a fitted turn-on curve (figure 3). The measurement [5] is then repeated in an iterative way for various ROC threshold settings in order to minimise the thresholds.

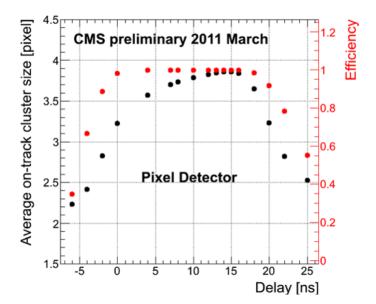
Figure 4. Average cluster size and hit efficiency vs. time delay with respect to the LHC clock.

Usually once per year, at the beginning of data taking the timing calibration of the detector is done in which the pixel detector clock is synchronized with the LHC collisions. A scan is done for various settings of the relative phase delay with respect to the LHC clock. A delay is chosen that ensures the collection of the high pixel charges and also gives enough time for most of the smaller charge pulses to cross the readout threshold in the same 25 ns readout window. The goal is

to maximise both the hit- and the charge collection efficiency (figure 4) and to allow the usage of smaller thresholds which then improves the hit resolution. Therefore a point is chosen near the end of the efficiency plateau.

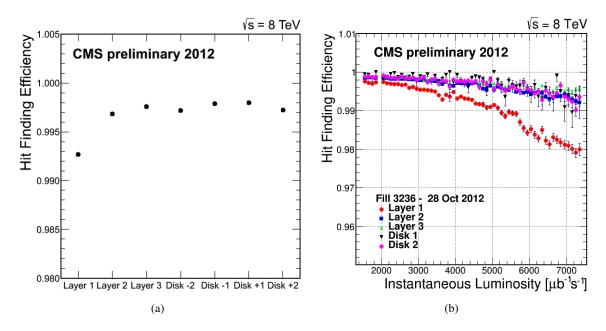
Figure 5. The hit finding efficiency for all barrel layers and endcap disks (a) on average in 2012 and (b) as a function of instantaneous luminosity in a longer LHC fill.

The hit efficiency is an important parameter to monitor throughout data taking. It is defined as the probability to find a cluster along a charged particle trajectory. Nonfunctioning modules or those that were affected by a single event upset are excluded from the measurement. The method is explained in more detail in [6]. In 2012 the average efficiency of the detector was above 99% for all layers and disks (figure 5). Compared to the outer part of the detector, the innermost layer experienced a lower efficiency, on average 99.27%, due to the higher particle flux. This is an expected behavior, due to the limited buffer size in the current readout chip [7]. The inefficiency depends on the instantaneous luminosity as shown in figure 5(b).
