**Damage Analysis of Bridge Structures Using
Vibrational Techniques**

Michael George Wood

Doctor of Philosophy

October 1992

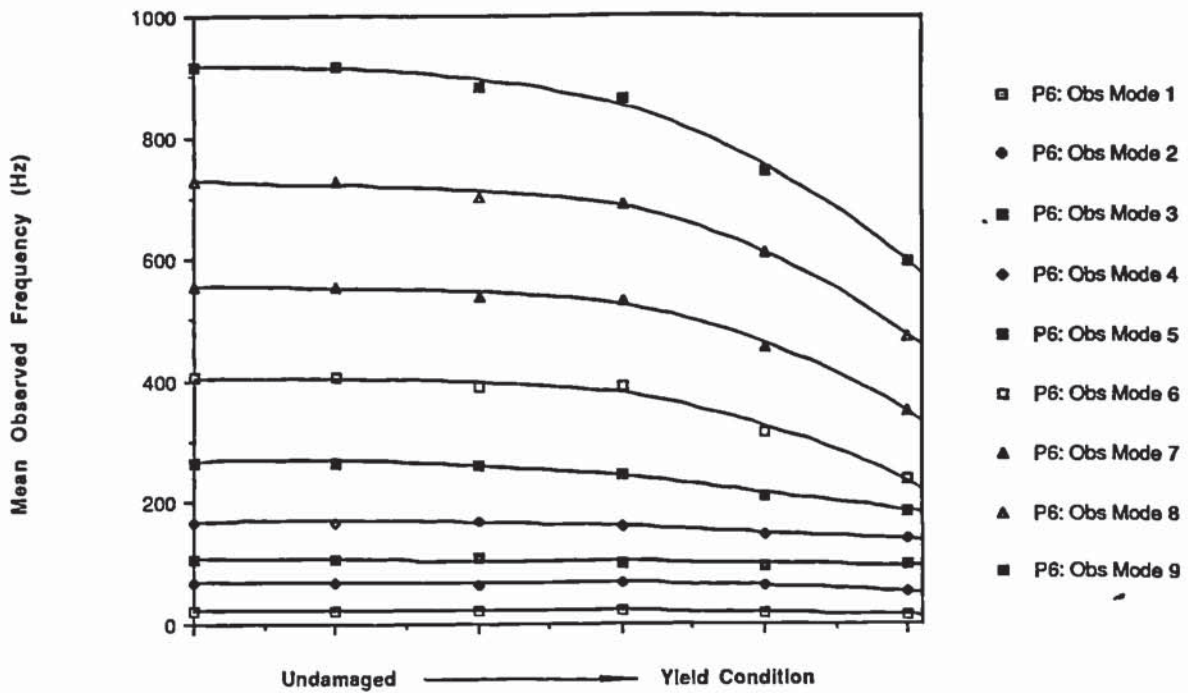
Figure 3.14(b) Post-tensioned beam responses versus load-condition

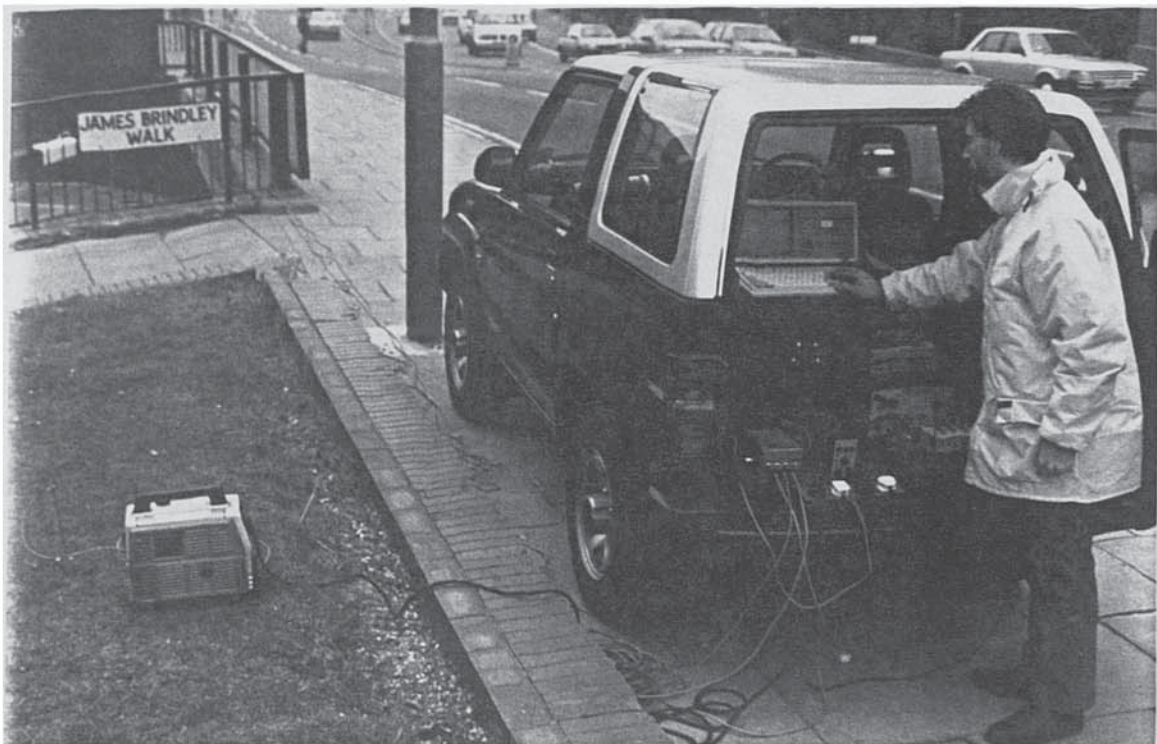
Figure 5.4 Acquiring site vibration data from one impact event

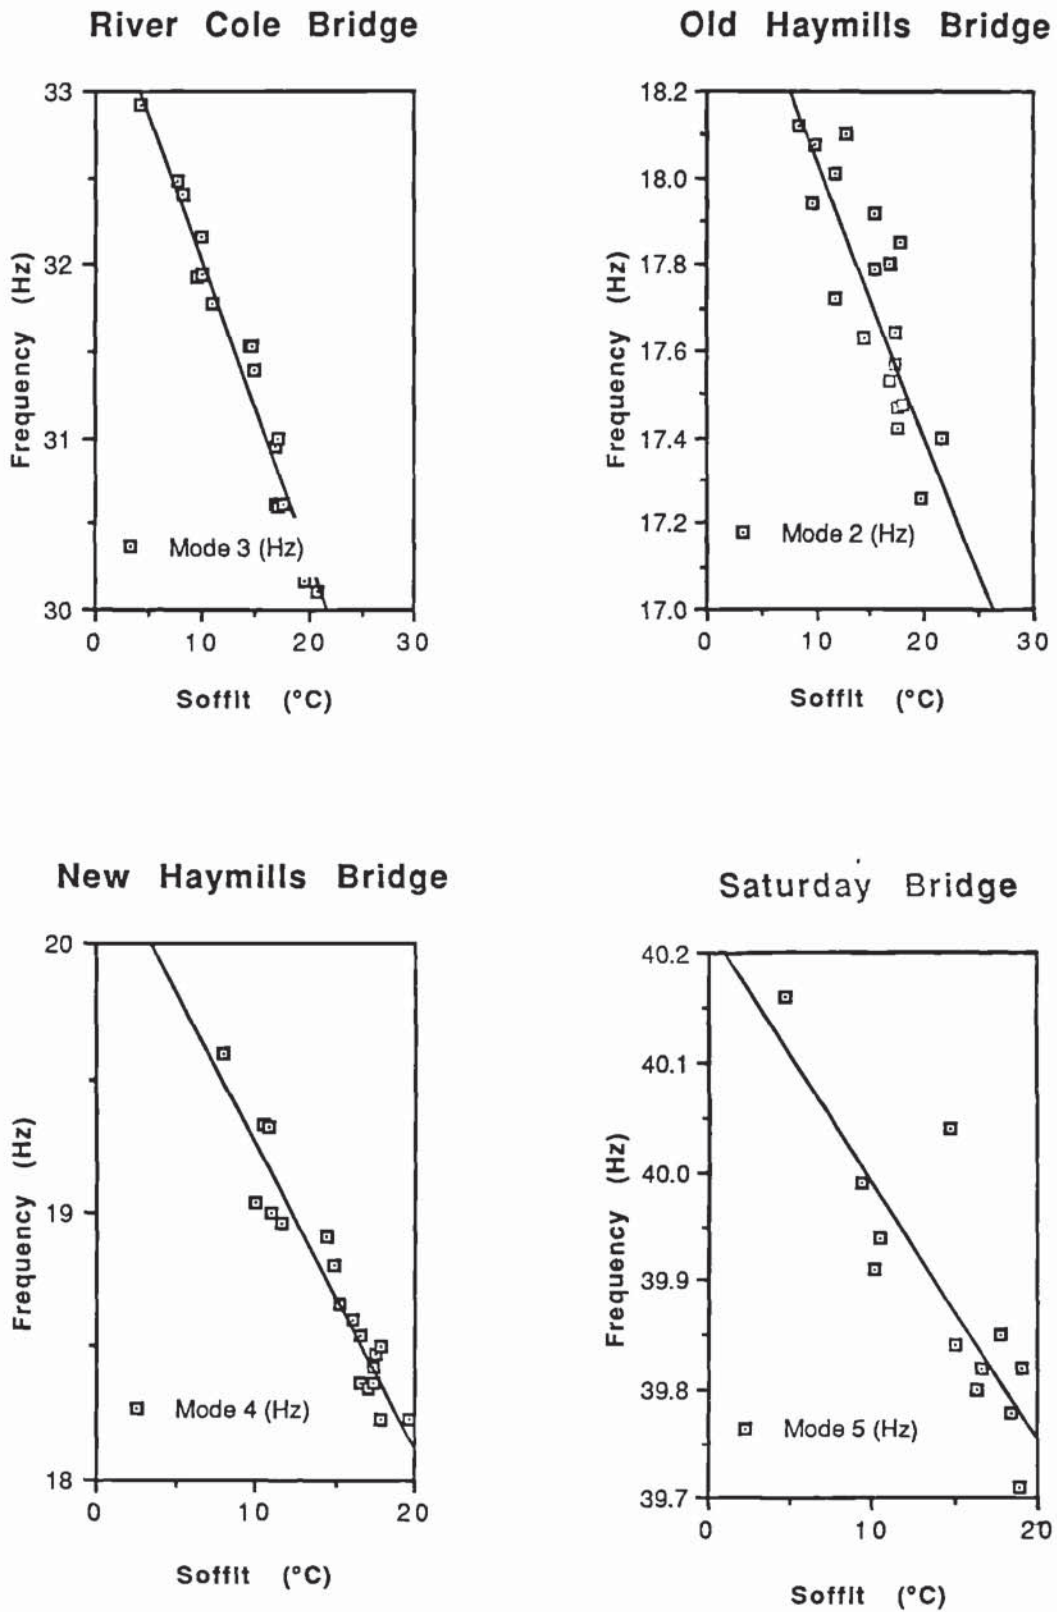
Figure 5.14 Soffit temperature versus frequency for 1 mode of response from River Cole, Old Haymills, New Haymills and Saturday Bridge data
