**ENERGY AUDIT AND SIMULATED CONSERVATION OPPORTUNITIES FOR A RENOVATED
MIXED-USE ACADEMIC BUILDING**

Michael Bejrowski
Mechanical Engineer in Training
HMG and Associates

Randall Manteufel, Ph.D., P.E.
Associate Professor
Department of Mechanical Engineering
University of Texas at San Antonio

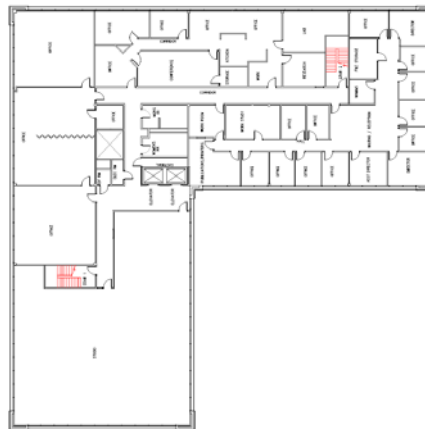
Figure 2. Space Layout of the Tower Building Before and After Architectural Modifications

The all electric mechanical system in the Tower consisted of a single-duct, variable air volume (VAV) system with cooling supplied by two 1.56 MBtu/h (457 kW) chillers, and heating supplied by perimeter zone electric reheat coils with parallel booster fans. The air distribution is accomplished by two 576,000 Btu/hr (169 kW) air-handlers (AHUs) that supply approximately 16,000 cfm (7.55 m³/s) each. Outside-air (OA) is supplied by a large intake louver located in the mechanical room. (Control of the OA intake was non-existent at the time of the survey and the control damper remained at 0% blocking intake of OA). Return air flowed through the plenum and was not fan controlled. Only perimeter zones had electric reheat coils included in the VAV box, which supplied heat to the space with a parallel booster fan. Core zones had no heating capacity and relied on the perimeter zones for heating. The controls for the system are all pneumatic and the thermostats are all reverse-acting. The pressure in the pneumatic system is maintained by a dual motor air compressor. The AHUs are controlled by variable frequency drives (VFDs). The design of the system was based on the original open plan design (Figure 2a). Subsequent architectural modifications, following the building's

purchase by UTSA (figure 2b), which added a large number of interior partitions to the building, did not include any HVAC system modification to accommodate the new situation. This results in poor system control and a large number of user complaints.

2a. Original Open-Plan Space Layout

2b. Existing Space Layout (After Modifications)

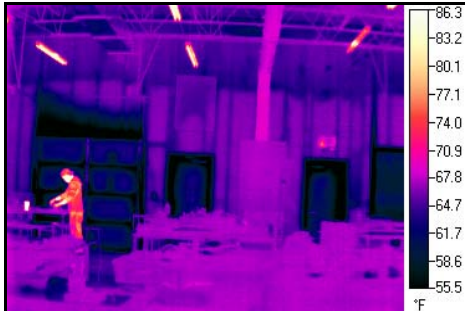
In addition to issues determined from observation and drawings, thermal imaging showed several additional problems. Some of these problems included missing insulation in the upper parts of all annex exterior walls (see Figure 3), severe thermal bridging around exterior doors and windows, especially the overhead doors in the annex, and lack of proper insulation around pipes and ducts. This information was later used in the model calibration phase of the project.

Figure 3. Thermal Image of Annex Studio
(Note: Thermal image taken during cold weather)

T8s and installing occupancy sensors in educational and circulation spaces in the buildings to reduce lighting energy use (which was identified as one of the primary causes of the high base-demand in the building). Similarly, the potential for several modifications to the HVAC systems were evident from both the survey and the simulation results. The measures evaluated in this case included replacing the dated annex fan coil units with more efficient DX units, replacing the existing HVAC system pneumatic controls with electronic ones, which will allow for enforcing a night-time temperature set-back policy for all thermostats in the building, as well as replacing existing pumps with more efficient VFD ones. Finally, several envelope modifications were considered including replacing the single glazed metal windows with double glazed units, replacing the annex overhead metal doors, adding thermal insulation to annex walls, and adding a suspended ceiling to the annex studios.
