INSPECTION OF HISTORIC STEEL BRIDGES USING ULTRASONIC PHASED  
ARRAY

A Thesis

Submitted to the Office of Graduate and Professional Studies of  
Texas A&M University  
in partial fulfillment of the requirements for the degree of  
MASTER OF SCIENCE

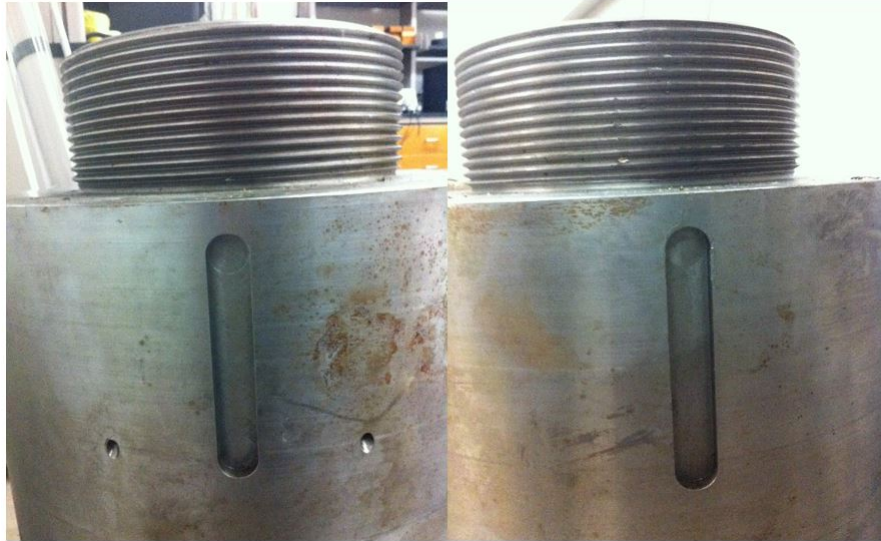
Figure 3.3: Mock-up Pin details: (Left) Keyhole #1 with grease holes, and (right) Keyhole #2.

on each side and the other with no grease holes on its sides. For classifying purposes the latter keyhole is named Keyhole #1 and the former is named Keyhole #2. The grease holes, beginning clockwise from Keyhole #2 shown in Figure 3.4, are labeled Hole #1, Hole #2, and Hole #3.

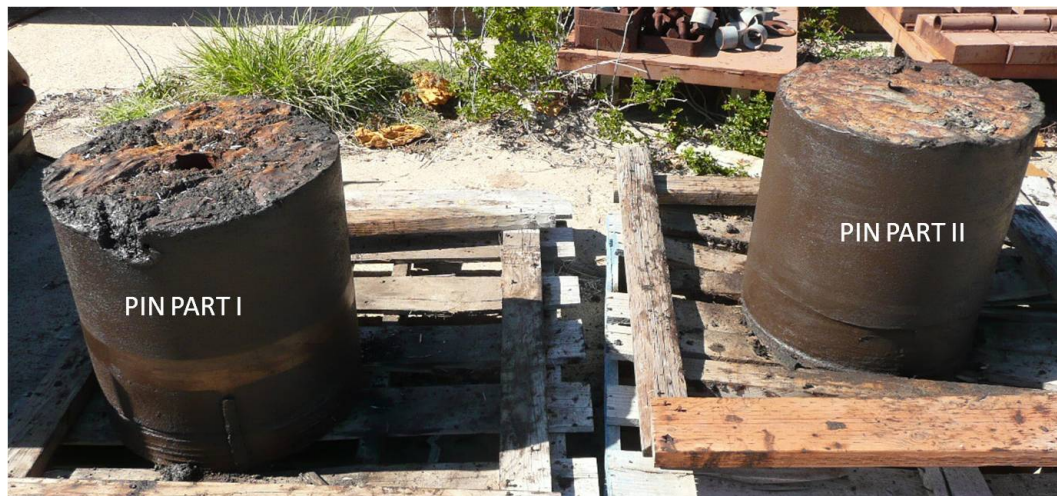
Figure 3.9: Pin parts without the sleeves.

After the removal of the sleeve, Pin Part I was placed upside down and Pin Part II stayed in the same direction. Figure 3.9 shows the pin parts without the sleeves. Both pin parts have keyholes, meaning that they are near one of the East or West side of the original whole trunnion bearing pin, as shown in Figure 3.2.

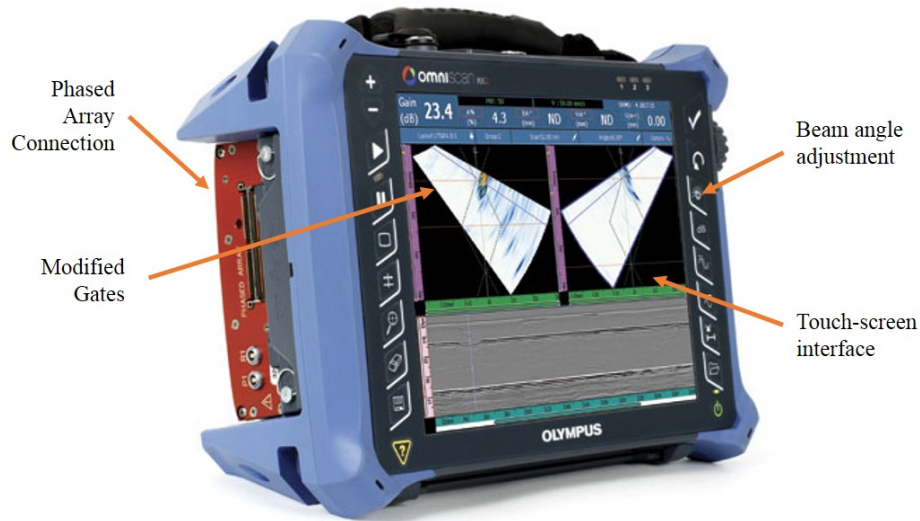
Figure 4.6: The Omniscan MX2 used for Data Acquisition (Olympus 2013).

The Omniscan screen is able to produce A-scan, B-scan, S-scan, and C-scan imaging. The two scans mainly used for this research are the A-scan and the S-scan. The A-

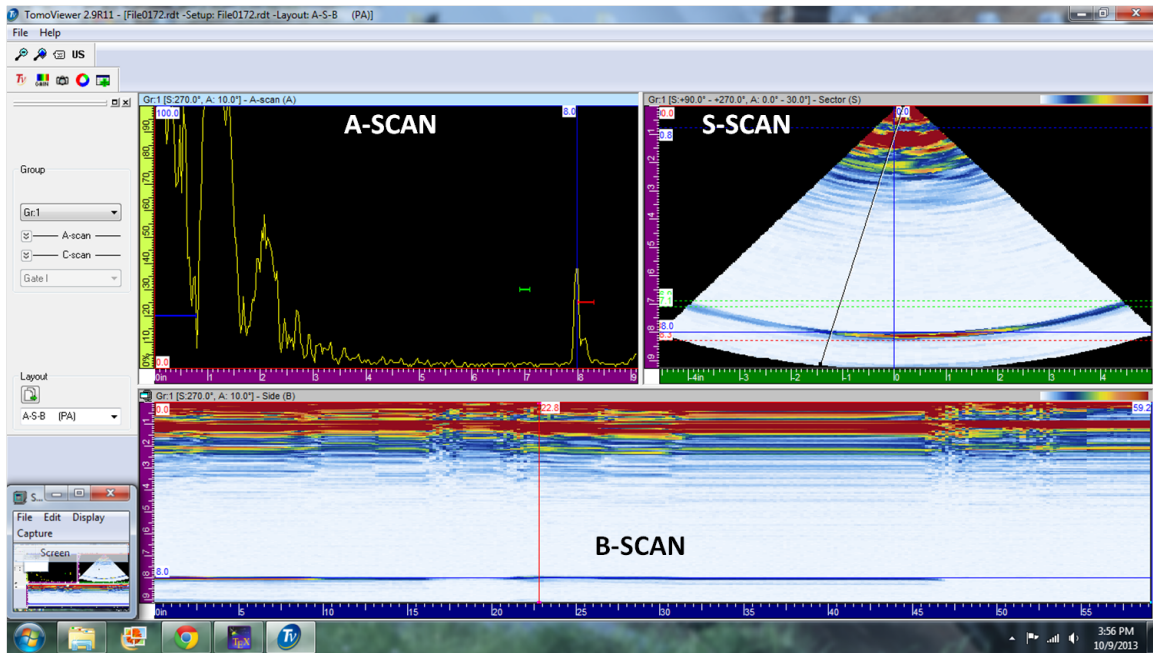
Figure 4.7: Tomoviewer Screen Sample

The data analysis section uses a computer-based system through the software TomoViewer. This software is downloaded from the Olympus website. As shown in Figure 4.7 the TomoViewer screen may show an A-scan, S-scan, and C-scan used to inspect the material through a certain angle section.

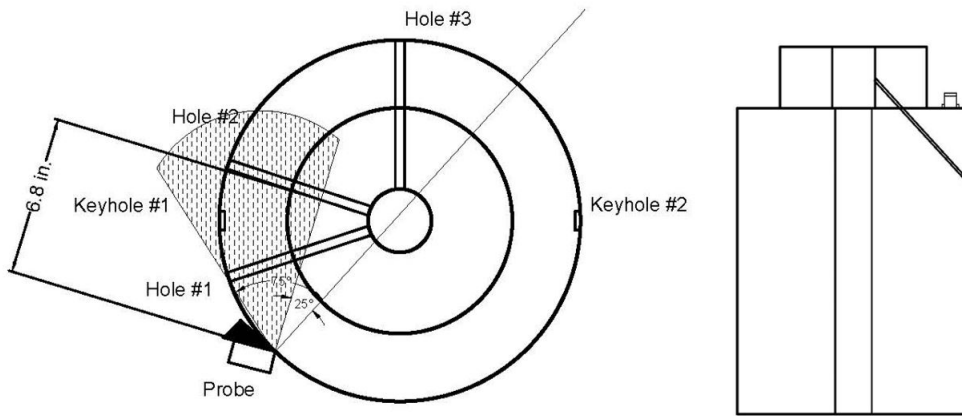
Figure 4.9: Exterior inspections using a SA5-N60S 5L32 probe and wedge. (Left) Probe used on exterior side on the second level of the pin, and (right) Probe used on the top side of the second level.

holes with the probe being placed on the top surface of the pin. The second test places the probe on the curved surface of the second level of the pin. Both of these testing are applied to locate the three diagonal grease holes from the pin. All of the scan readings using a SA5-N60S 5L32 wedge and probe for the holes were taken at a gain of 69dB.

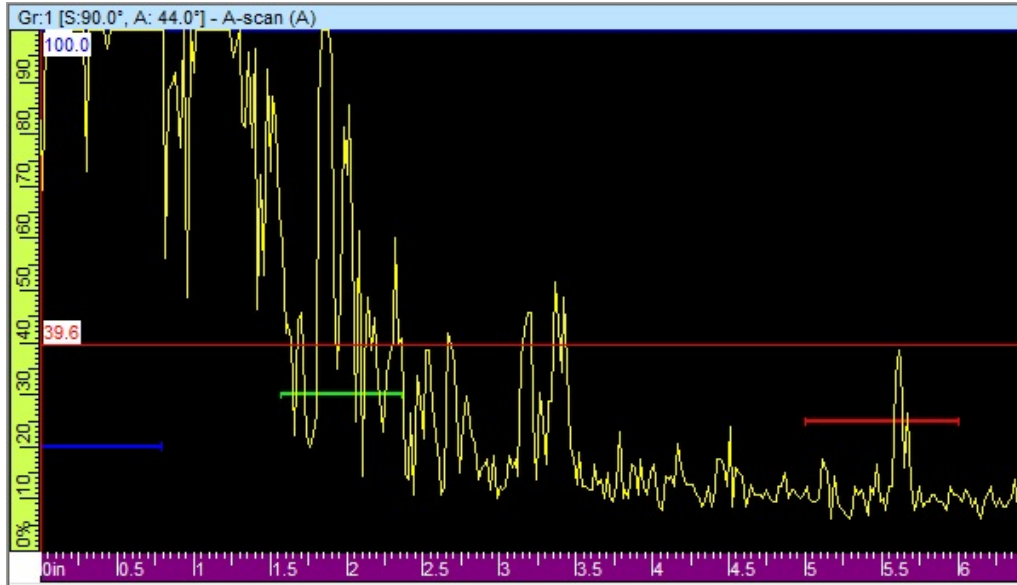
Figure 4.12: File0001 A-Scan of exterior top scan for Hole 1 (Testing E.1).

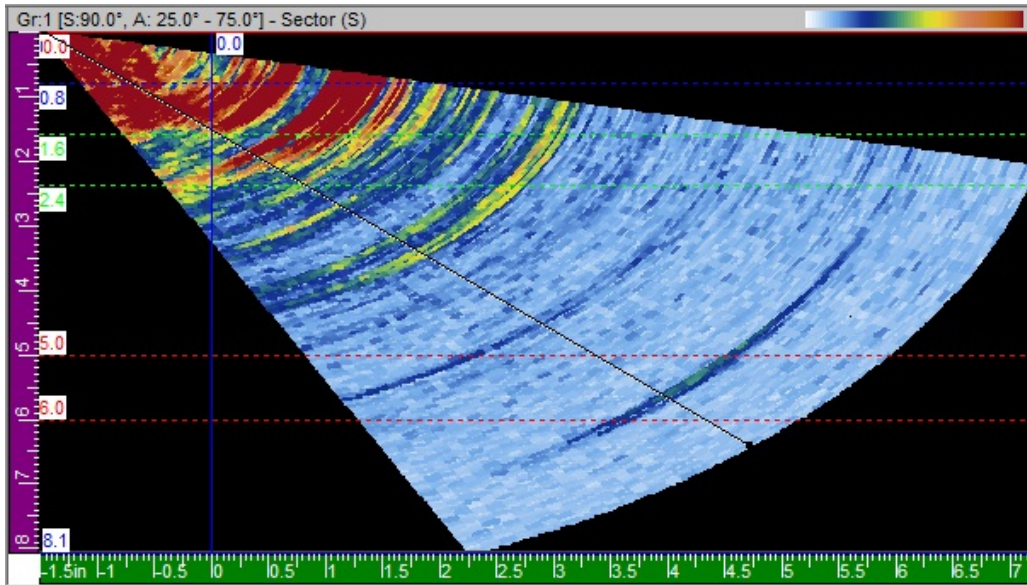
Figure 4.13: File0001 S-Scan of exterior top scan for Hole 1 (Testing E.1).

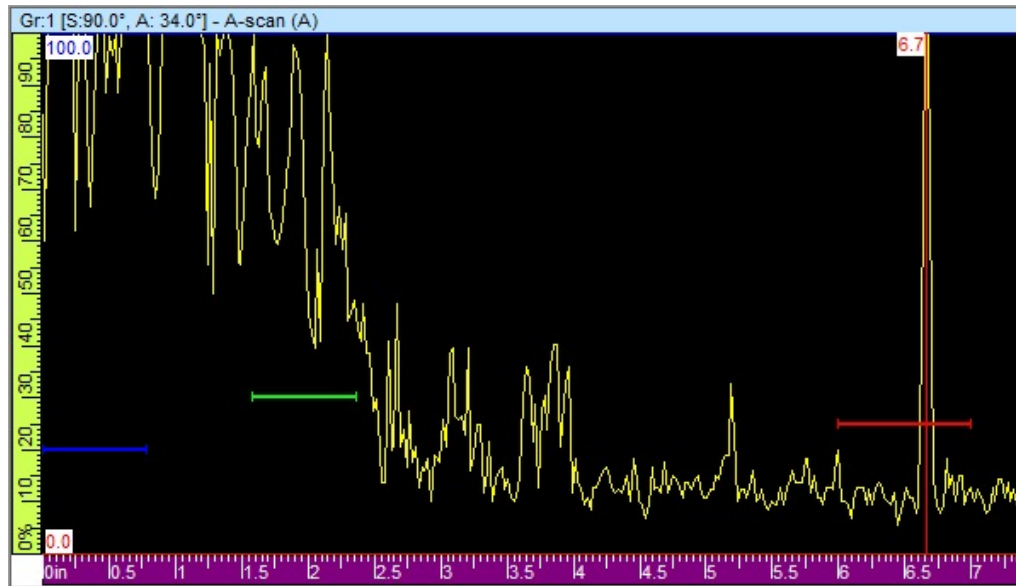
Figure 4.15: File0005 A-Scan of exterior side inspection for Hole 1 (Testing E.2).

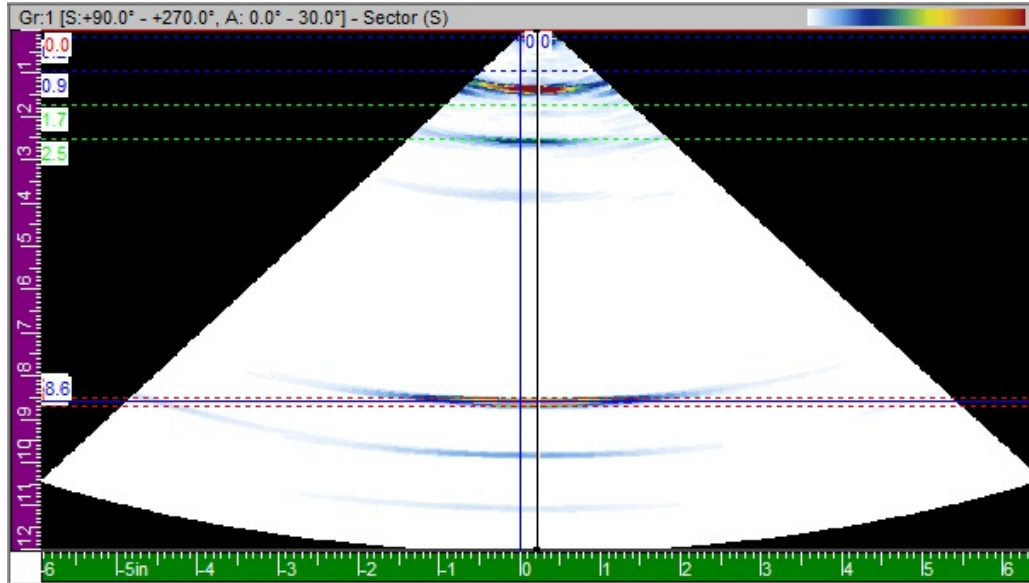
Figure 4.18: File106 S-scan showing the outer edge of the mock-up pin, using a 30dB gain (Testing I.1.1).

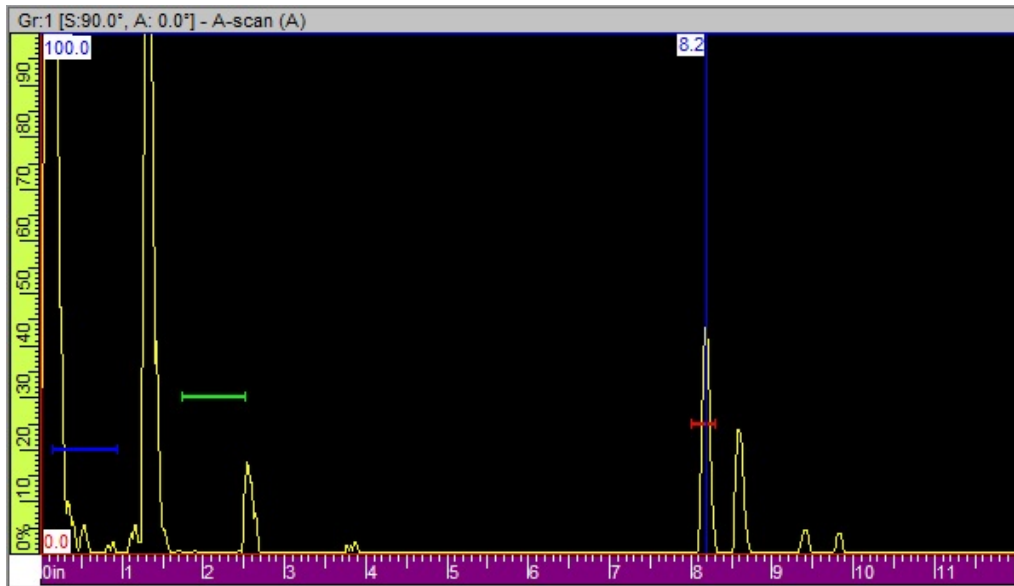
Figure 4.19: File0107 A-scan showing Keyhole #1 at 8.2 in., using a 40dB gain (Testing I.2.1).

between 1 in. to 4 in. are noise from the contact intersection between the probe and the wedge, and the wedge and the interior pin surface. Both noises, shown as two peaks at 1.4 in. and 1.9 in. in Figure 4.19. A small peak at 3.8 in. can be contributed to possible noise. This data can be ignored as it does not provide insight on real defects. For the keyhole inspection, the sound reading at 8.2 in. is followed by a 8.6 in. reading. This is concluded to be the reading from the exterior surface of the pin. Up to this point all of the readings are found in the first leg. The second leg, which is a mirror version of the A-scan readings shown, begins with the peaks at 9.4 in. and 9.9 in. This is also common in UPA readings.

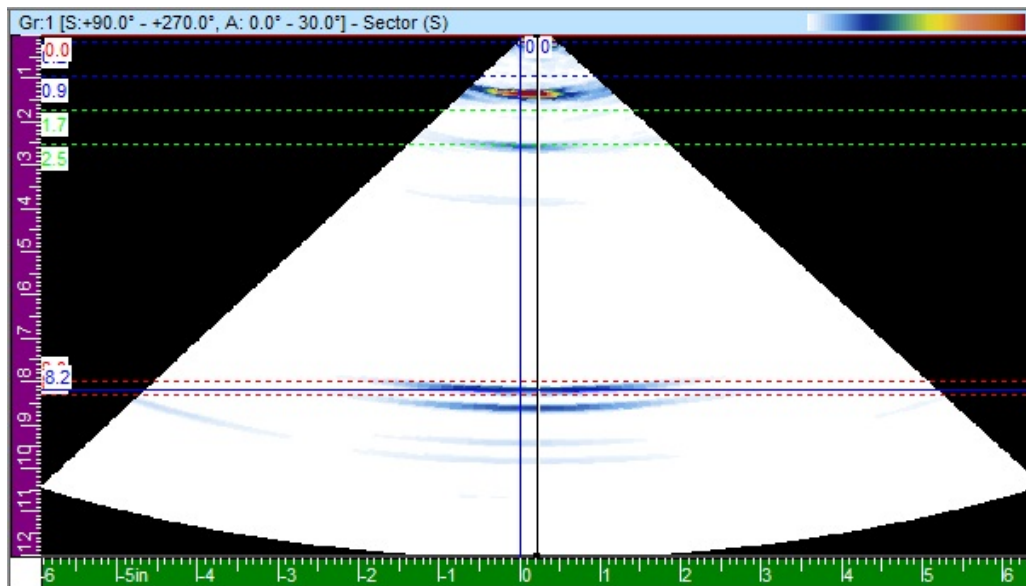
Figure 4.20: File0107 S-scan showing Keyhole #1 at 8.2 in., using a 40dB gain (Testing I.2.1).

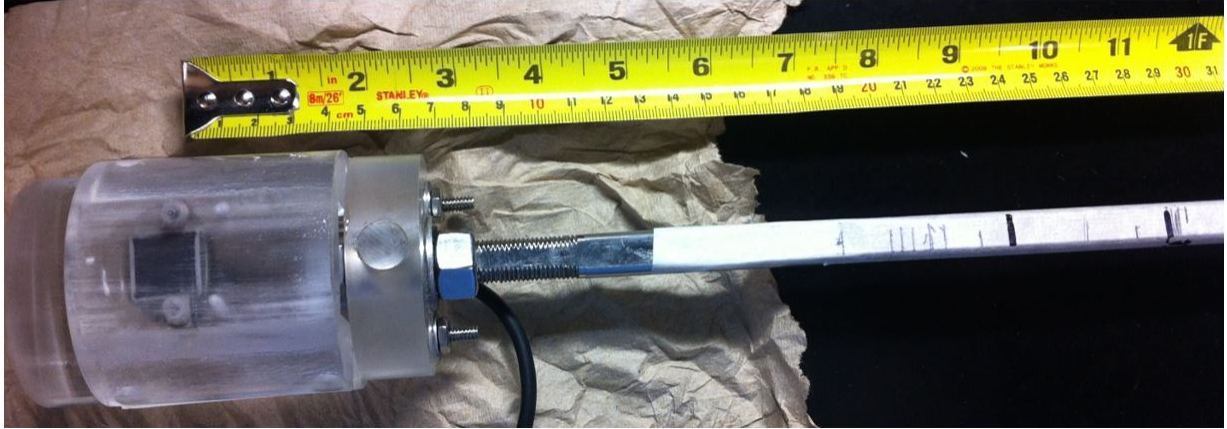
Figure 4.21: Sample readings for Keyhole #1 using the -6dB method (Testing I.3.1).

The inspection of the keyhole height is the last lab testing for Case I. Figure 4.21 and B.13, respectively, show the results for Keyhole #1 and Keyhole #2. The table that lists the different measurements shown from these figures are seen in Table B.3 and B.4.

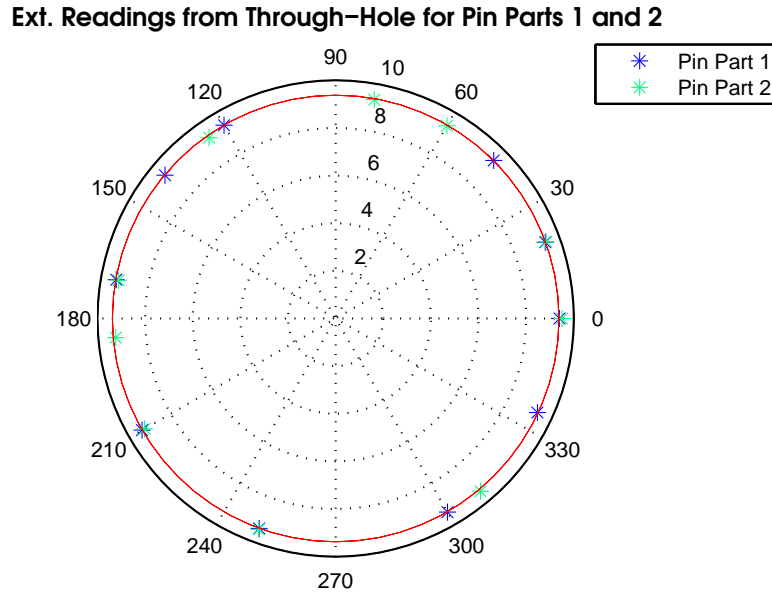
Figure 4.22: Combined data points of Pin Parts I and II showing the location for the Exterior Edge readings at Riverside (Testing I.1.3).

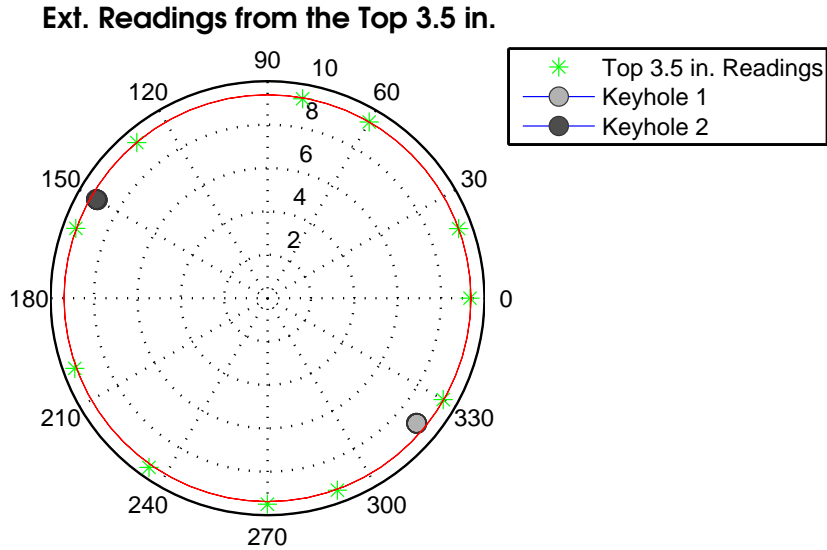
Figure 4.23: The two keyhole readings with respect to the exterior edge readings for the top 3.5 in. of Pin Part I (Testing I.2.3).

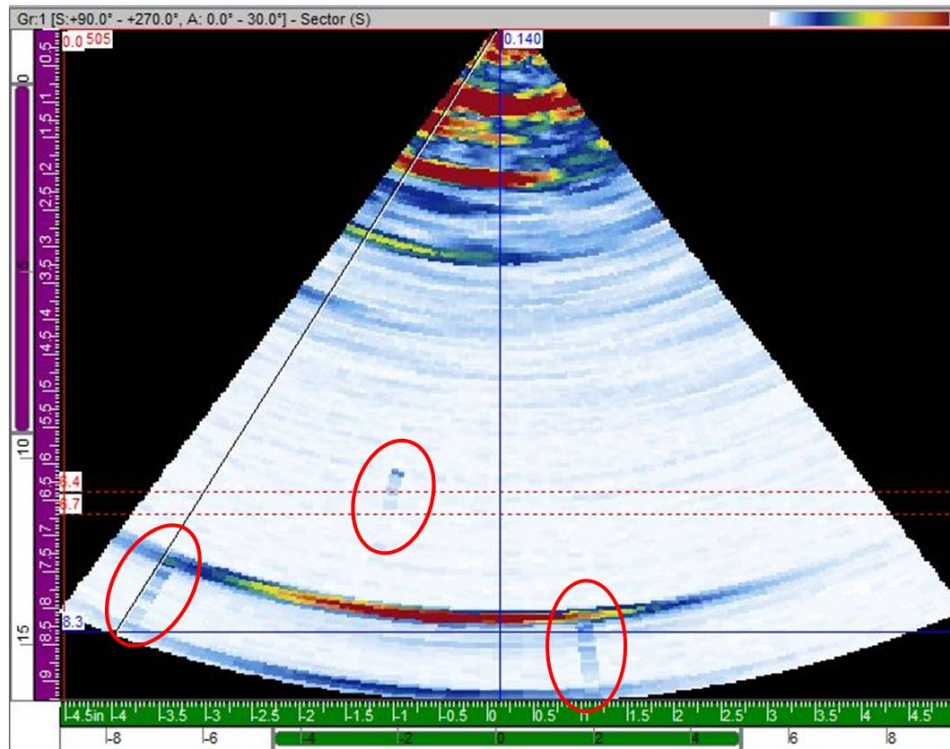
Figure 4.24: File167 S-scan showing error streaks.

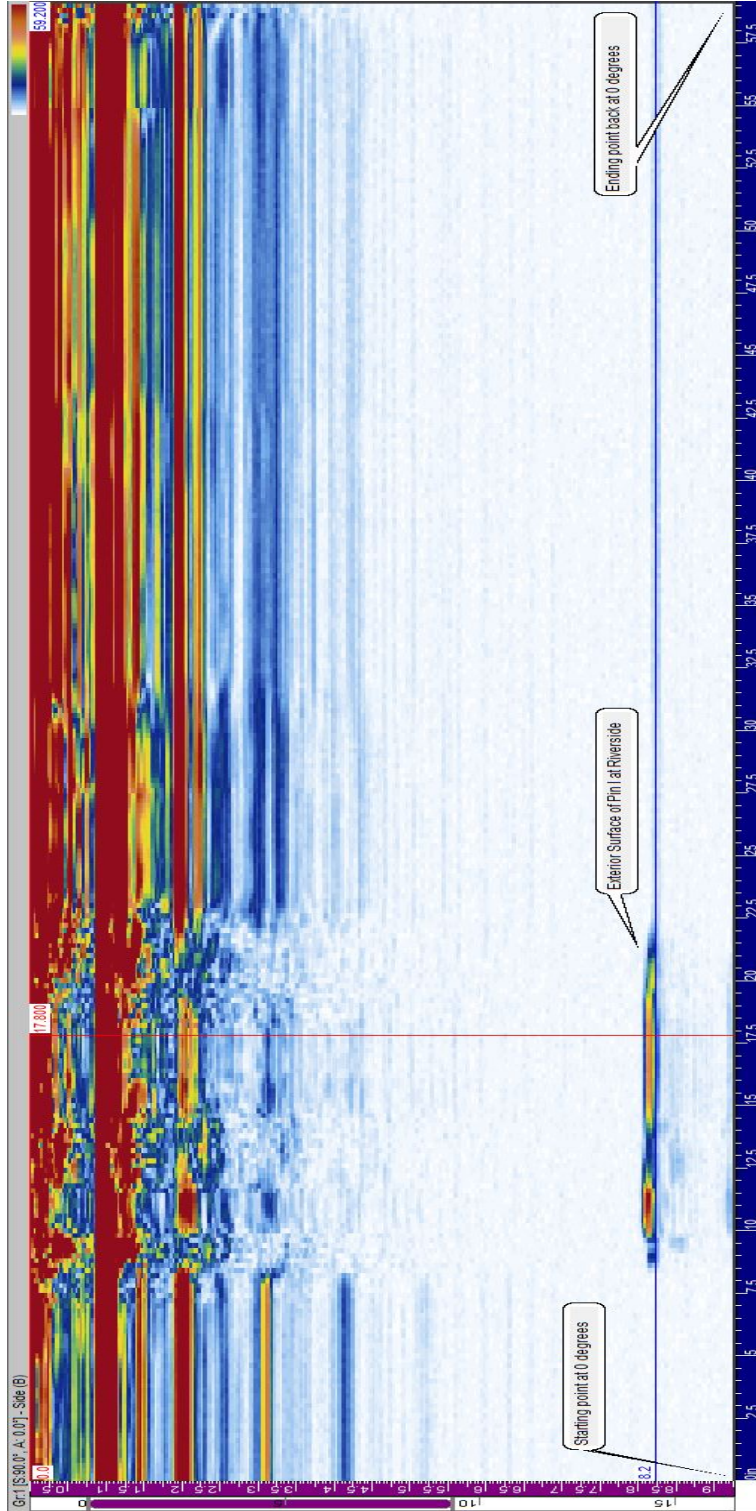
Figure 4.25: File170 showing the 360 degree of Pin Part I at 10 in. below the top of pin.

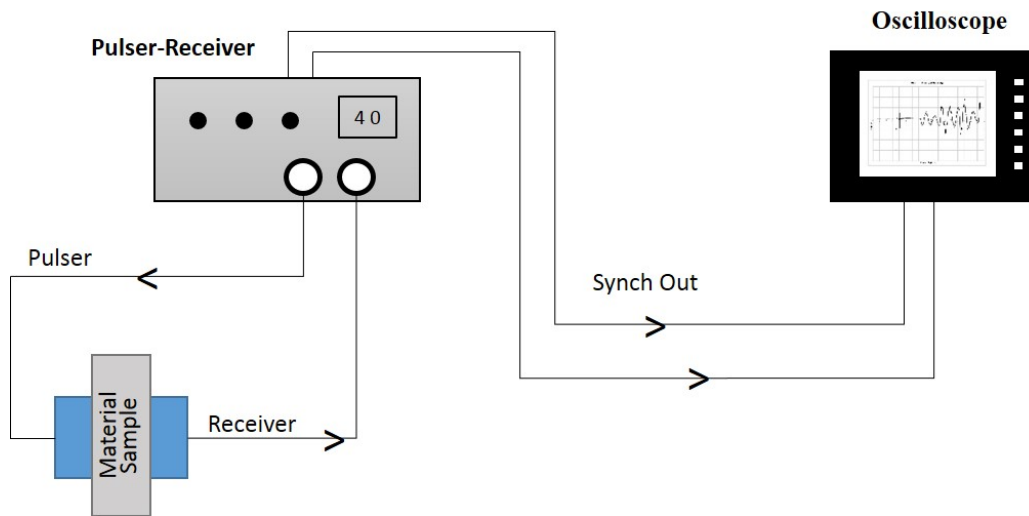
Figure A.1: Experimental Set-up for PMMA material sound velocity.

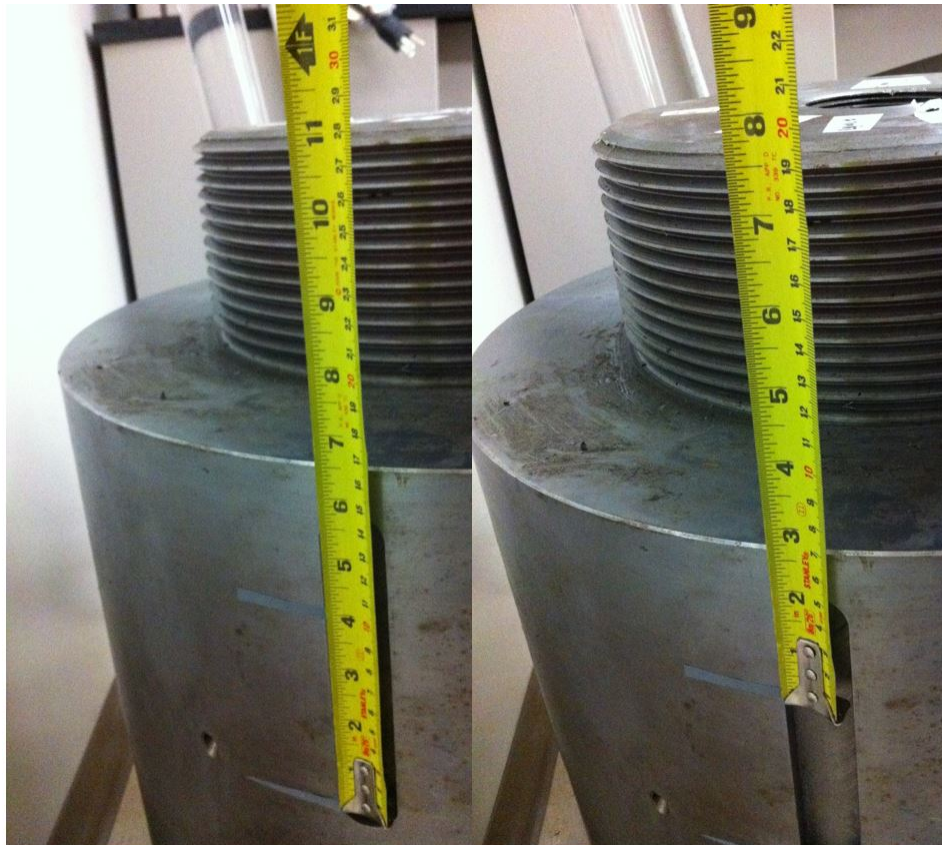
Figure B.14: Measurements of the keyholes used to verify with the -6dB method measurements (Testing I.3).

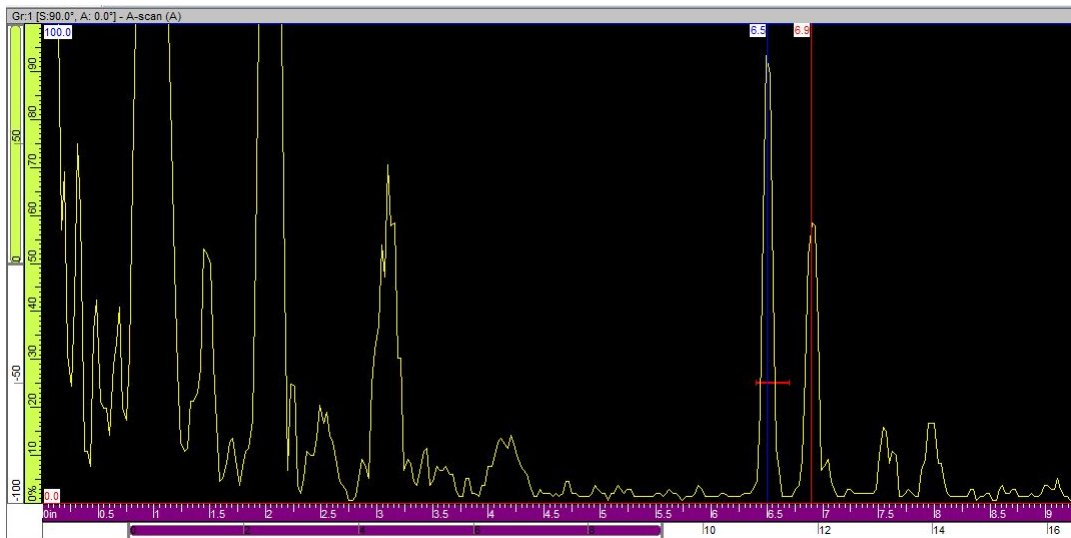
Figure C.8: File165 A-scan for Keyhole 1 of Pin Part I (Testing I.2.3).
