QUANTIFYING *E. COLI* DISCHARGE FROM FAILING ONSITE SEWAGE
FACILITIES IN THE DICKINSON BAYOU WATERSHED, TEXAS

A Thesis

Major Subject: Biological and Agricultural Engineering

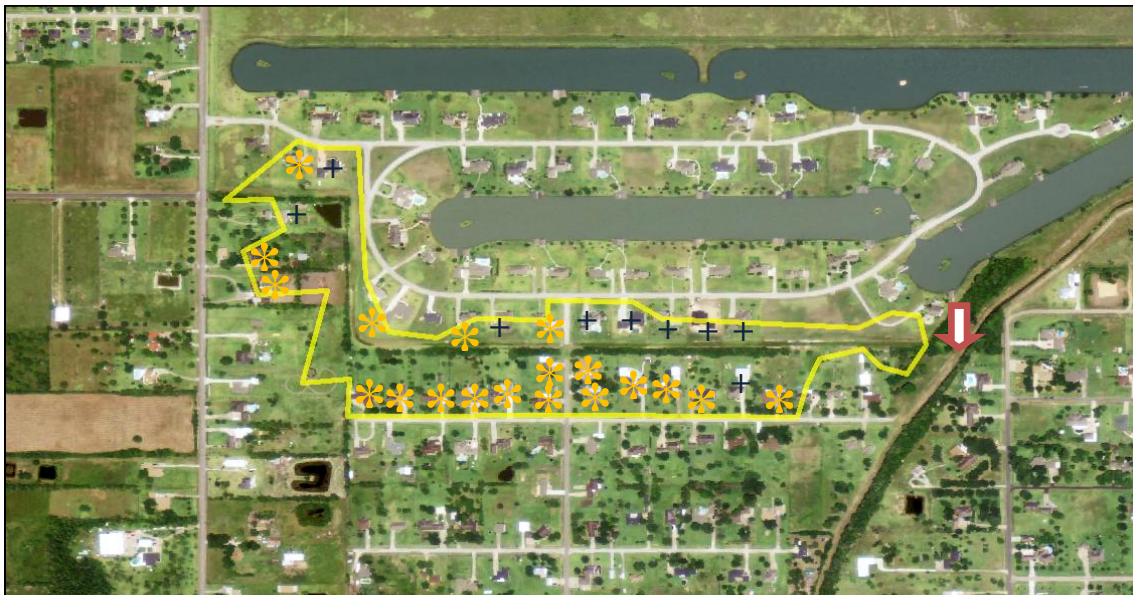
Figure 5. The red arrow indicates the location of the OSSF monitoring station used to collect runoff water sample for *E. coli* analysis in the Dickinson Bayou watershed. The watershed boundary associated with the OSSF monitoring station is shown. Houses marked by the asterisk symbol have anaerobic systems and houses marked with the plus symbol use aerobic systems.

Light Detection and Ranging (LiDAR) data was obtained from the Texas Natural Resources Information System (TNRIS) and input into a Geographic Information System (GIS) program. The LiDAR data was used in the Soil Water Assessment Tool's (SWAT) automatic watershed delineation program to determine the shape and size of the watershed associated with the sampling point. Results from this analysis showed that the watershed was approximately 0.146 km² (36 ac). Using satellite photos from TNRIS the total impervious area was found using the area calculation tool in a GIS program. Impervious areas accounted for approximately 10% of the total area of the watershed. The red arrow in Figure 5 indicates the location of the manhole that is being used as the sampling point.

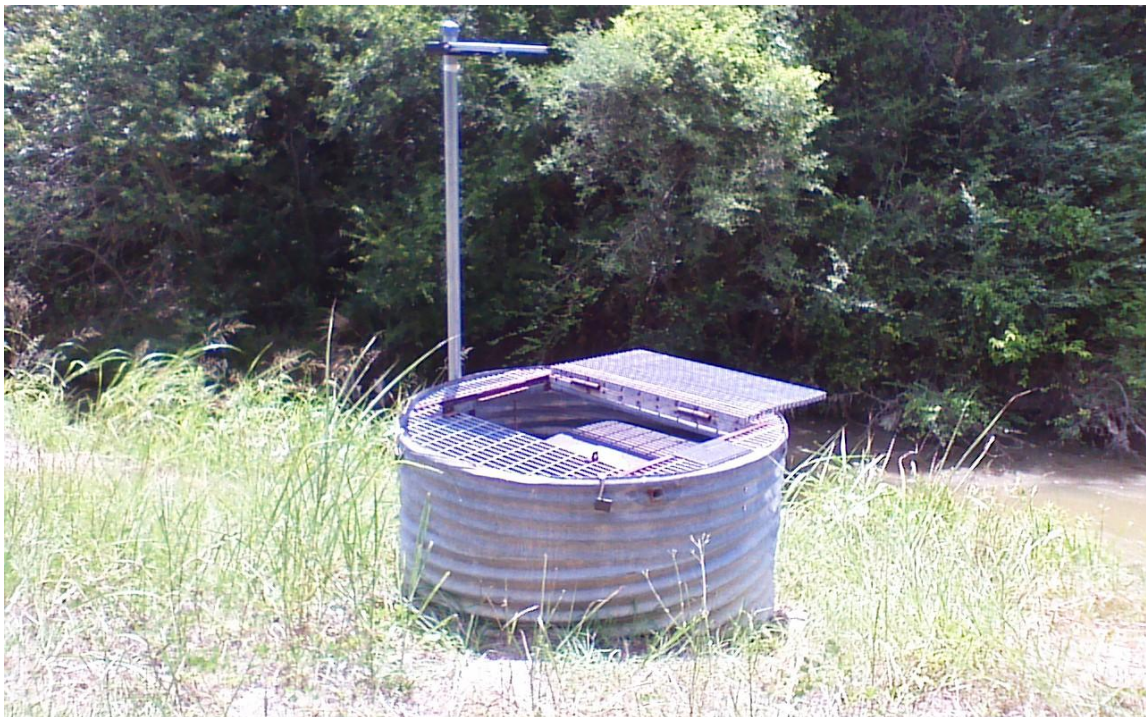
Figure 6. Manhole used for equipment storage and runoff collection at the OSSF site.

The monitoring point at this location is in a manhole approximately 335 m (1,100 ft) east of the neighborhood, as shown below in Figure 6. Stormwater runoff is collected in a ditch that is then diverted into an underground 1.2 m (4 ft) corrugated metal pipe that flows into the manhole. Water levels in the larger ditch, shown in the background of Figure 6, were taken with a Rugged Troll (100, In-Situ, Ft. Collins, CO) and were normalized with a BaroTroll (In-Situ, Ft. Collins, CO). A hydrograph of the data collected from the large ditch is shown at the end of Appendix A.

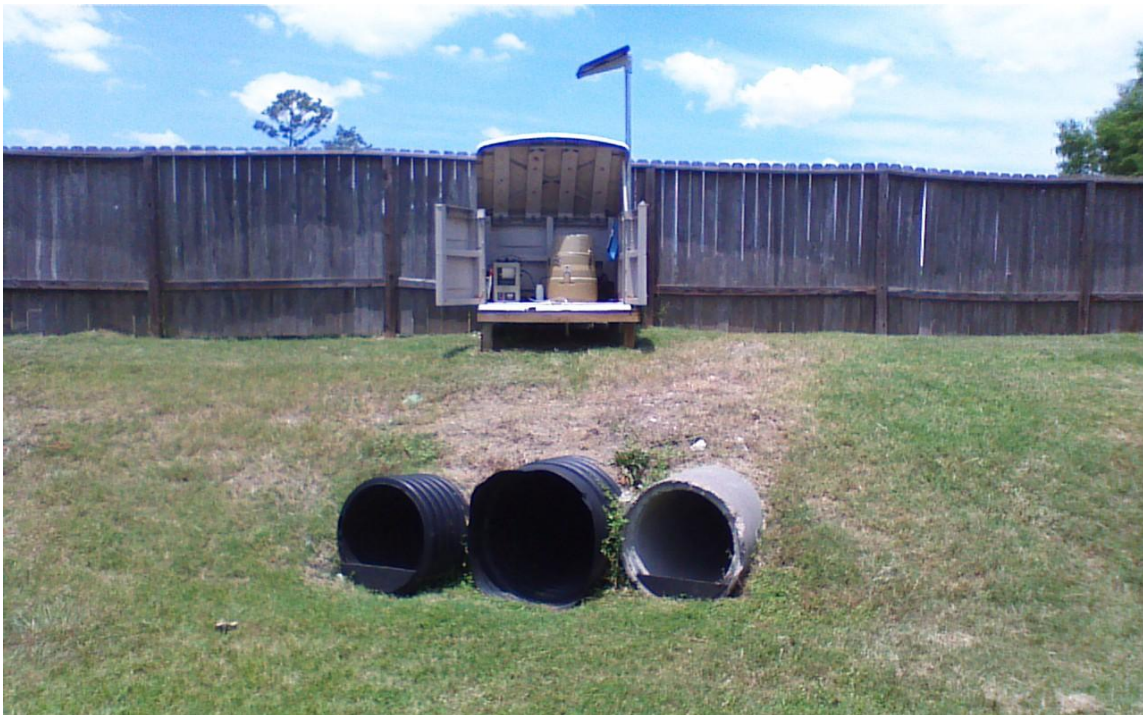
Figure 7. Detention basin used to collect runoff from the control site. All instrumentation is kept inside of a storage box on the apex of the basin.

The control site is located in the town of Dickinson in a neighborhood where all of the houses are directly connected to a sewer main. There are no houses in the neighborhood that are connected to an OSSF system. The monitoring point is the outlet of a detention basin in the middle of the neighborhood. Stormwater runoff from the surrounding neighborhood is collected by a ditch network and routed to the basin. Three drainage pipes take the runoff to a larger retention pond immediately behind the fence seen in Figure 7. The two outer pipes were partially blocked off so that the runoff would flow toward the center pipe, which was used for runoff collection.

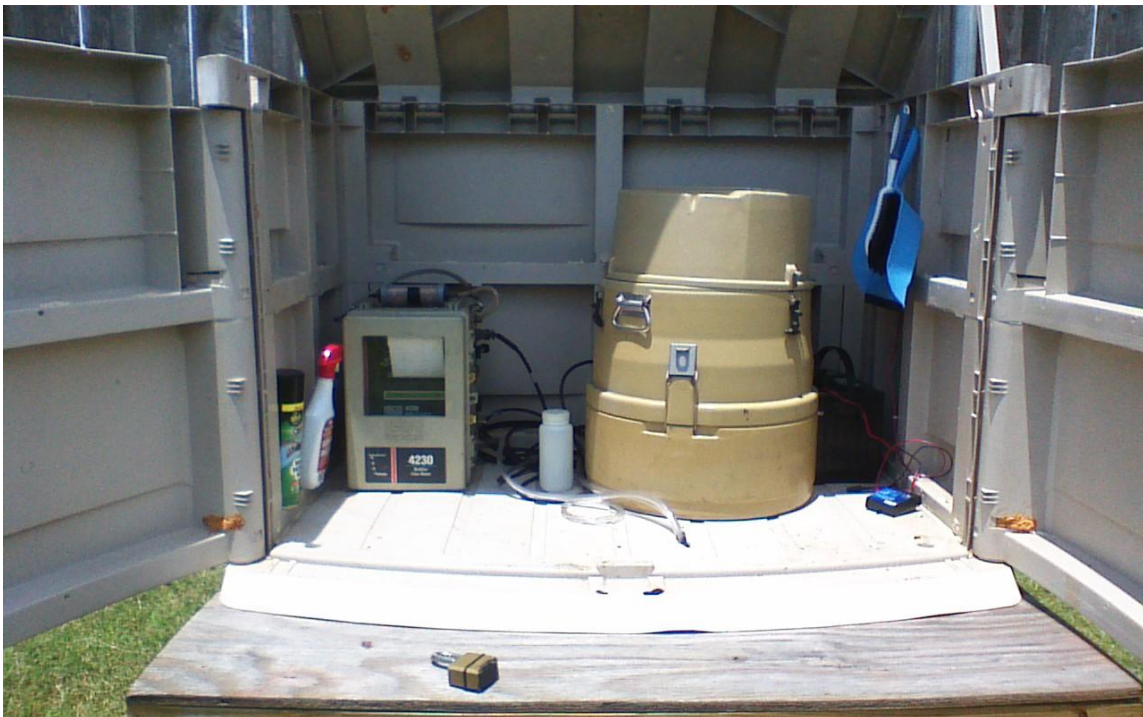
Figure 9. Bubbler flow meter (left) and automatic water sampler (right) used to collect runoff at the control site.

Both monitoring sites were instrumented with a bubbler flow meter (4230, Teledyne ISCO, Lincoln, NE), an automatic water sampler (3700, Teledyne ISCO, Lincoln, NE), and the necessary support equipment to run the two devices. A picture of the bubbler flow meter (left) and automatic water sampler (right) used at the control site is shown in Figure 9. The OSSF site also contained the same instrumentation inside the corrugated metal manhole.

The bubbler flow meter was interfaced with the automatic water sampler which allowed the sampler to be initiated by the flow meter once runoff levels were deep enough to fully submerge the sampler tip, approximately 31.75 mm (1.25 in). The automatic water samplers held 24, one liter polypropylene bottles. In order to ensure that no bacteria were present in the bottles, one bottle always remained empty so that it could be used as a field control. The remaining 23 bottles were used to collect the runoff samples. The flow meter was installed in early December 2012 and collected preliminary data before the addition of the sampler in April 2013. Both the flow meter and the automatic water sampler were installed at the control site in April 2013.

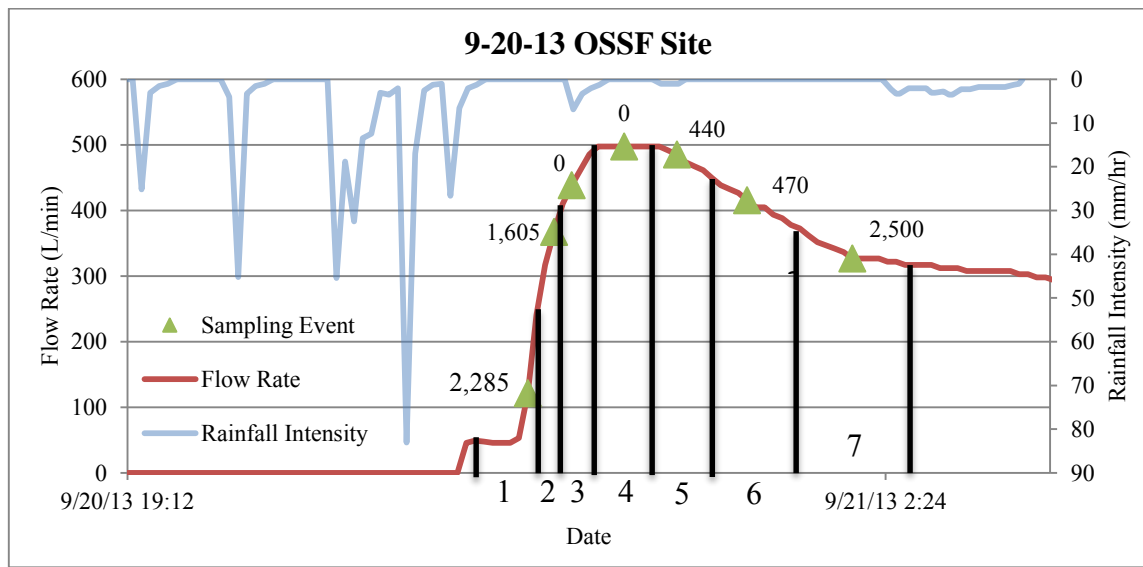
Figure 10. Example hydrograph showing how total runoff was calculated.

E. coli concentrations were found for all sixteen sampling events at the OSSF site and for the twelve sampling events at the control site. Results from these analyses for the OSSF site and the control site are shown below in Tables 6 and 7, respectively. Total CFUs were calculated by multiplying the concentration at one point in time by the volume of runoff that had occurred in a certain time interval. The runoff event was divided into a number of intervals that equaled the number of sampling points. Each interval began at the time that was half-way in between the sampling point and the previous sampling point and the interval ended at the time half-way between the sampling point and the proceeding sampling point. An example of the interval spacing used to determine the total flow and total *E. coli* is shown below in Figure 10. Total

flow, in liters, was calculated by finding the area in each of the seven sections and adding them together.

For the first sampling region, area 1 in Figure 10, the beginning time was selected so that the sampling point would be the center of the region. The same concept was also used for the last sample. The end time of the last sampling region, area 7 of Figure 10, was selected so that the sampling point would be the center of the region because there was no proceeding point. Runoff that occurred after the last sampling region was not used to determine the total CFUs. This method raised some reservations because the entire runoff was not taken into account.

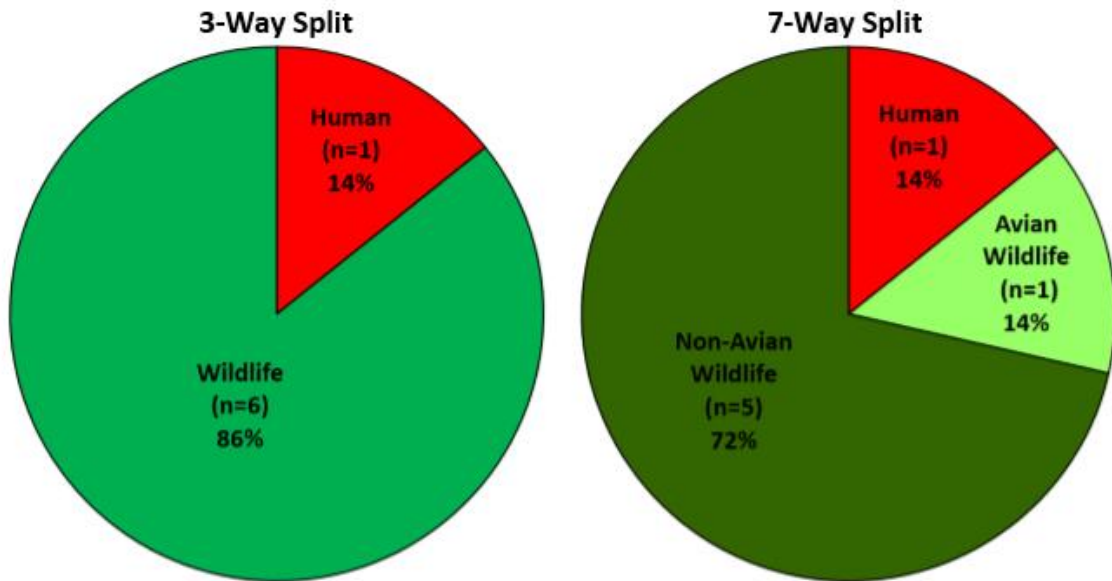
Figure 11. Source classification of *E. coli* isolates from the OSSF sites using a 3-way split (L) and a 7-way split (R).

A bacterial source tracking (BST) method was performed on a total of fourteen samples, seven from the OSSF site and seven from the control site, taken on 3/4/14. *E. coli* colonies were grown in the lab using EPA Method 1603 and were taken to Dr. Terry Gentry's lab in Texas A&M University's Department of Soil and Crop Science for the DNA fingerprinting and analysis. A DNA fingerprint is performed on one individual *E. coli* colony, called an isolate. One isolate was selected from each sample that contained *E. coli* grown using EPA Method 1603. Fingerprints for each of the isolates were compared against the Texas *E. coli* BST Library (ver. 6-13). Isolates were divided into 3-way and 7-way sources splits. Human, Wildlife, and Livestock/Domestic Animals were the three possible categories that each isolate could fit into for the 3-way split. Human, Cattle, Other Livestock (non-avian), Other Livestock (avian), Pets, Avian Wildlife, and Non-avian Wildlife were the seven possible categories for the 7-way split. An isolate's category was chosen based on the highest percentage match, with an 80% being the lowest acceptable percentage match. If an isolate's DNA fingerprint did not match at least 80% of any source in the library then it would be left as unclassified. Due to time and budget constraints, only one *E. coli* isolate from each of the fourteen samples tested in the lab (seven from the OSSF site and seven from the control site) was fingerprinted. Results from the BST analyses at both the OSSF site and the control site are shown below in Figures 11 and 12, respectively.

One immediately recognizable element from the BST analysis is that there seems to be human feces present at both the OSSF site and the control site. Not only is there a human presence at the OSSF site, which was hypothesized, but there was an even stronger presence at the control site. Typically, human-based *E. coli* can be emitted into nature through failing OSSFs, however this can't possibly be true for the control site because there are no homes using OSSFs anywhere near the area. There are no indications that there should be any human feces present at the control site. The single human marker at the OSSF site was expected but the amount of human isolates was hypothesized to be much more substantial. A BST analysis performed on *E. coli* isolates from Oyster Creek watershed (south of the Dickinson Bayou watershed) indicated that 43% of *E. coli* was coming from wildlife, 19% was from livestock, 14% was from humans, and 9% was from domestic pets (Martin, 2013). This same study also found that in the Oyster Creek watershed (north of the Dickinson Bayou watershed) nearly 80% of *E. coli* was from wildlife, 12% was from domestic animals, and 8% was coming from human sources. The percentages found in this study are similar to the OSSF site percentages but are quite different from the control site.

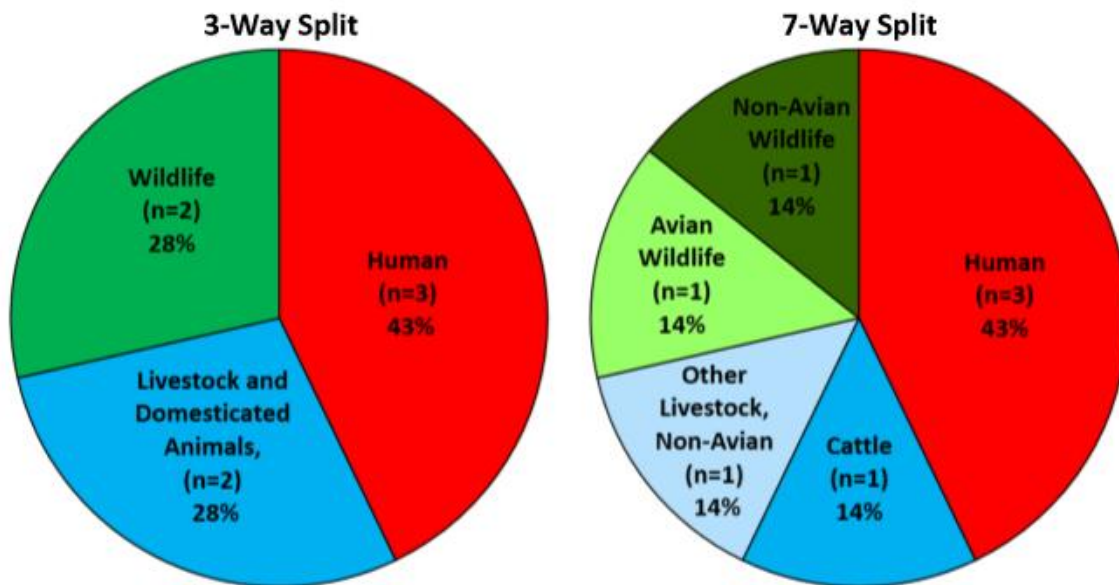
Figure 12. Source classification of *E. coli* isolates from the control site using a 3-way split (L) and a 7-way a split (R).

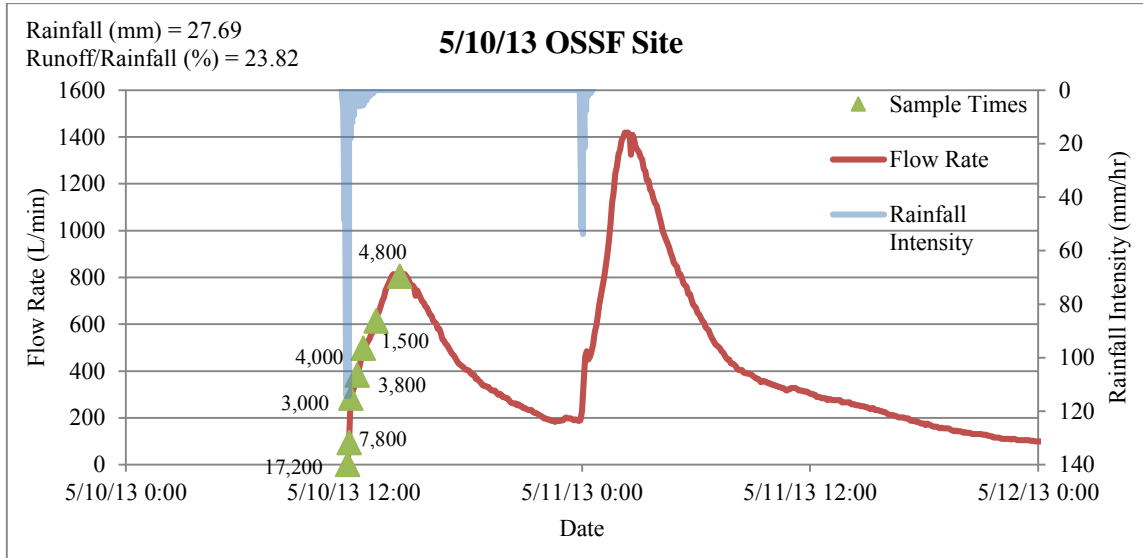
Figure 13. Hydrograph for sampling event on 5/10/13 at the OSSF site. Numbers next to the sample times are the *E. coli* concentrations in CFUs/100 ml.

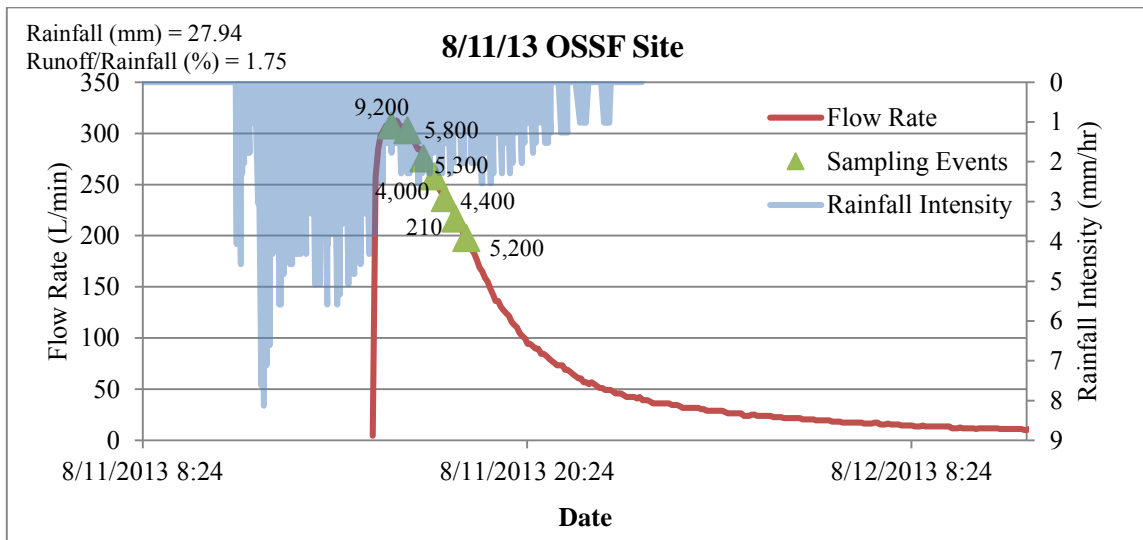
Figure 14. Hydrograph for sampling event on 8/11/13 at the OSSF site. Numbers next to the sample times are the *E. coli* concentrations in CFUs/100 ml.

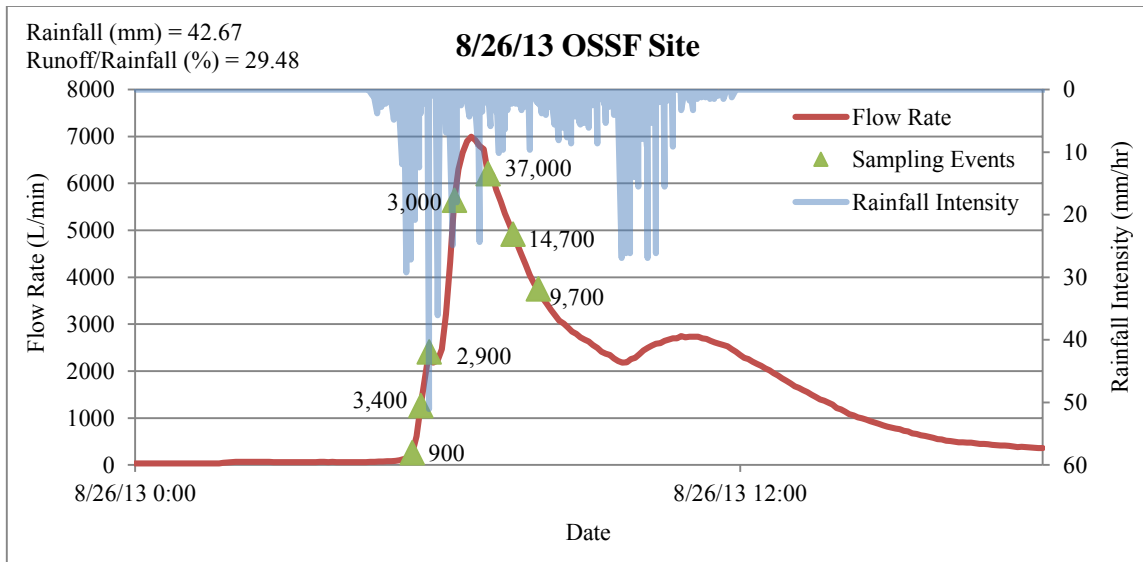
Figure 15. Hydrograph for sampling event on 8/26/13 at the OSSF site. Numbers next to the sample times are the *E. coli* concentrations in CFUs/100 ml.

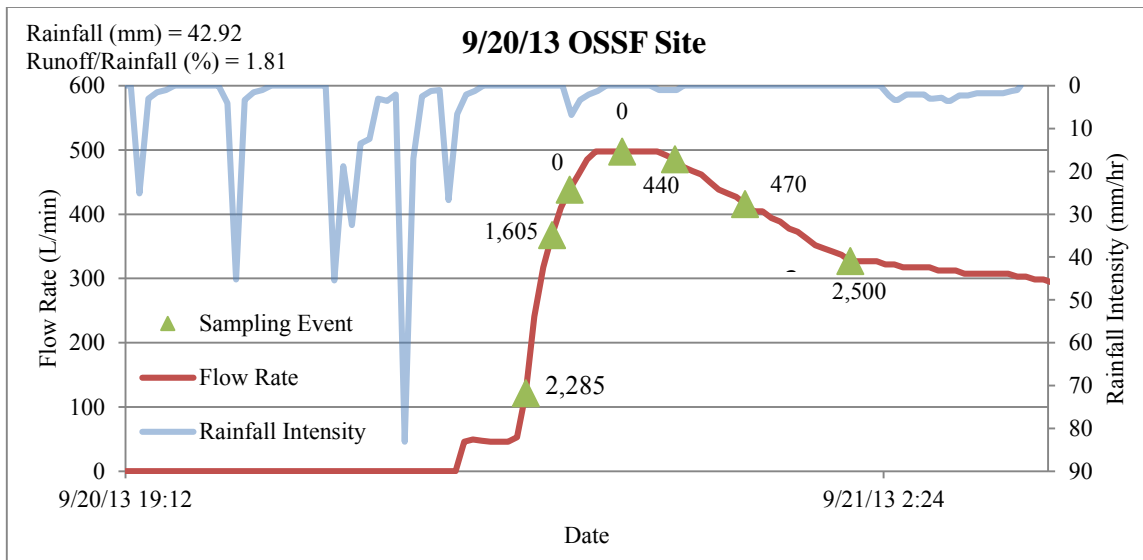
Figure 16. Hydrograph for sampling event on 9/20/13 at the OSSF site. Numbers next to the sample times are the *E. coli* concentrations in CFUs/100 ml.

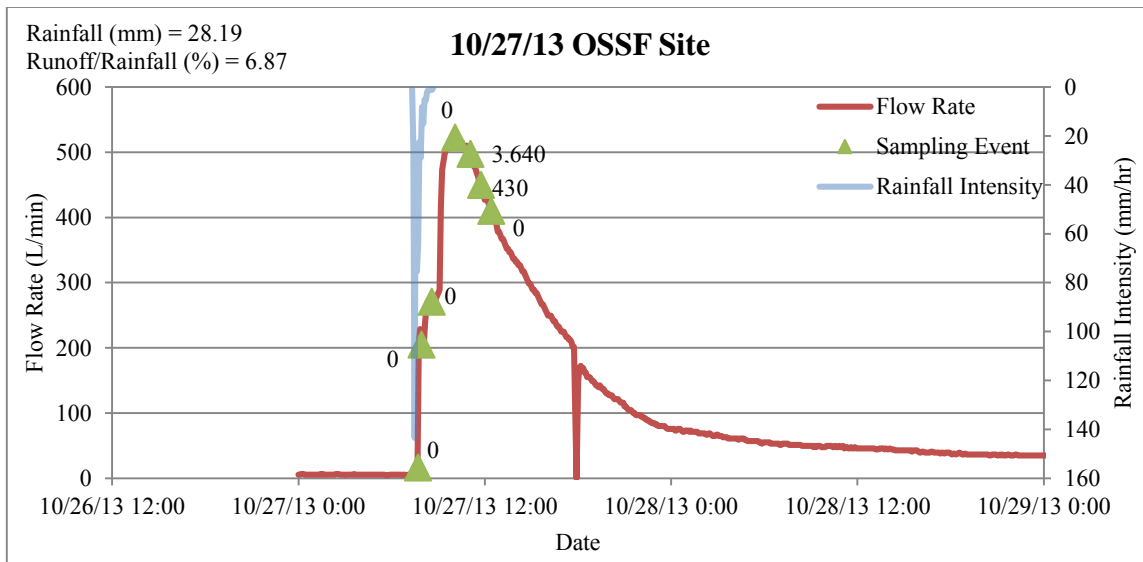
Figure 18. Hydrograph for sampling event on 10/27/13 at the OSSF site. Numbers next to the sample times are the *E. coli* concentrations in CFUs/100 ml.

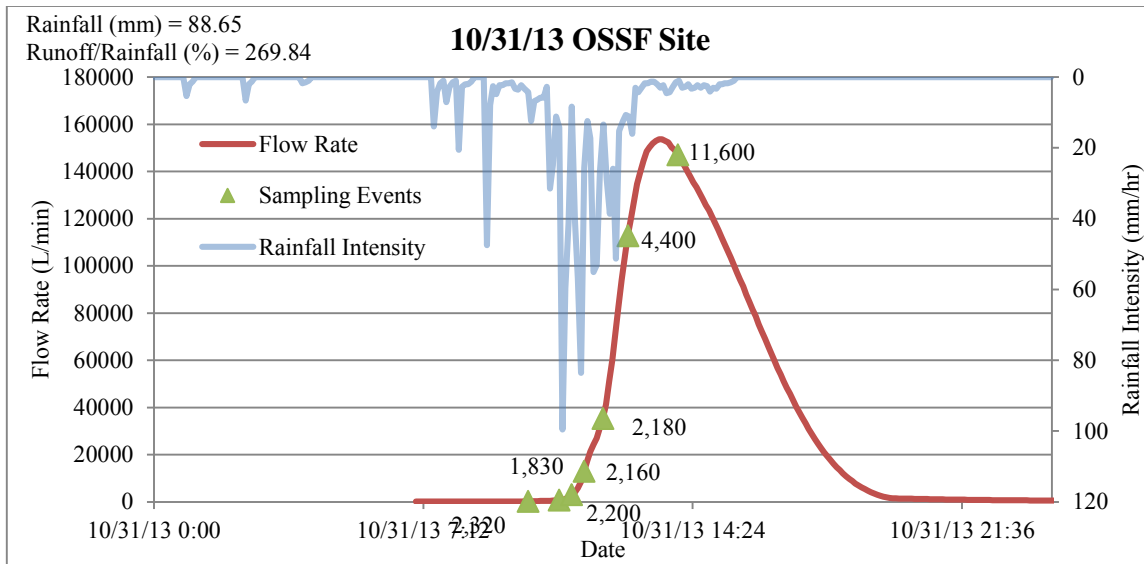
Figure 19. Hydrograph for sampling event on 10/31/13 at the OSSF site. Numbers next to the sample times are the *E. coli* concentrations in CFUs/100 ml.

October 31, 2013 had an exceptionally long, heavy rainfall. In fact, the amount of rain was so significant that the larger drainage ditch next to the manhole at the OSSF site began rising to a very high level and caused the runoff from the neighborhood to back up into the manhole. At the control site a similar issue occurred with the detention pond that

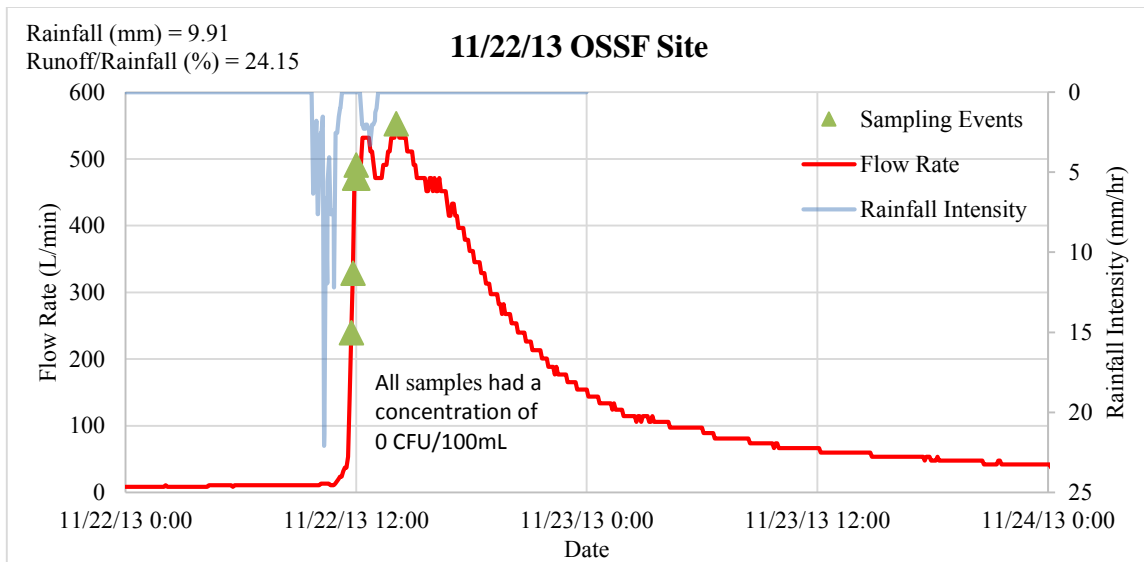
Figure 20. Hydrograph for sampling event on 11/22/13 at the OSSF site. Numbers next to the sample times are the *E. coli* concentrations in CFUs/100 ml.

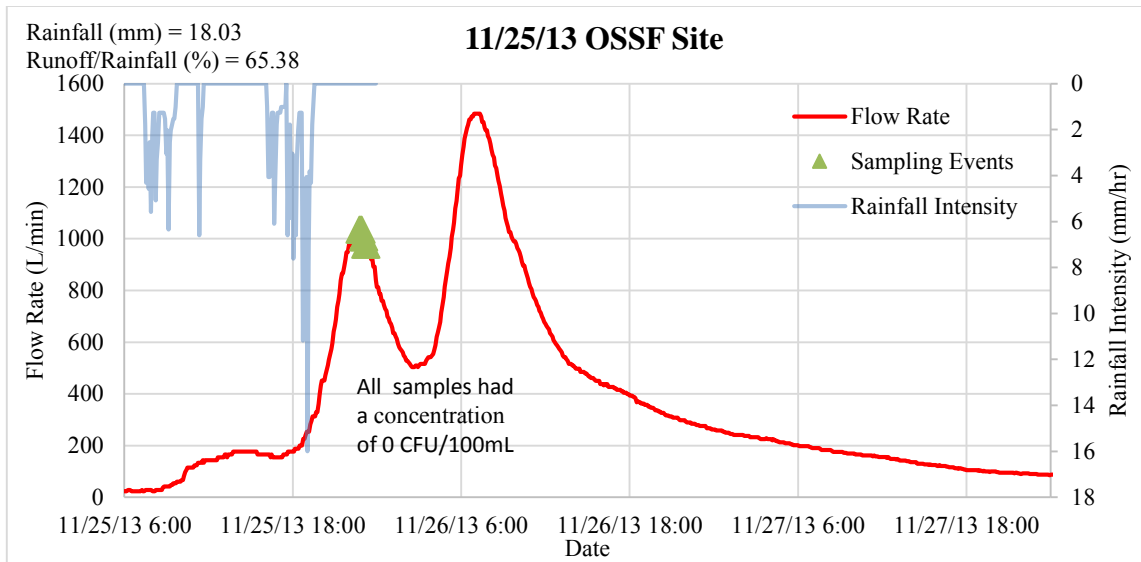
Figure 21. Hydrograph for sampling event on 11/25/13 at the OSSF site. Numbers next to the sample times are the *E. coli* concentrations in CFUs/100 ml.

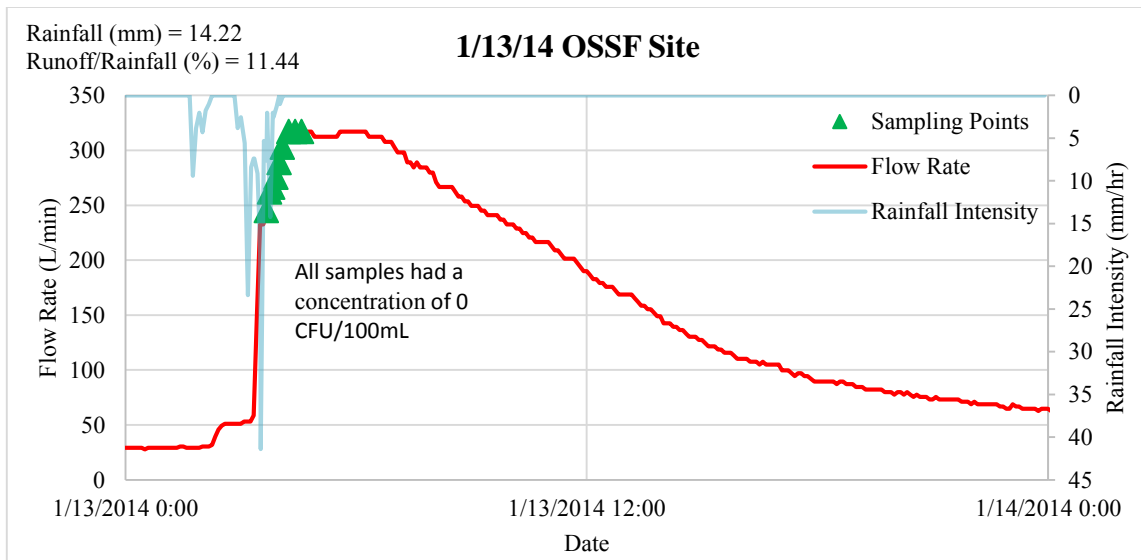
Figure 22. Hydrograph for sampling event on 1/13/14 at the OSSF site. Numbers next to the sample times are the *E. coli* concentrations in CFUs/100 ml.

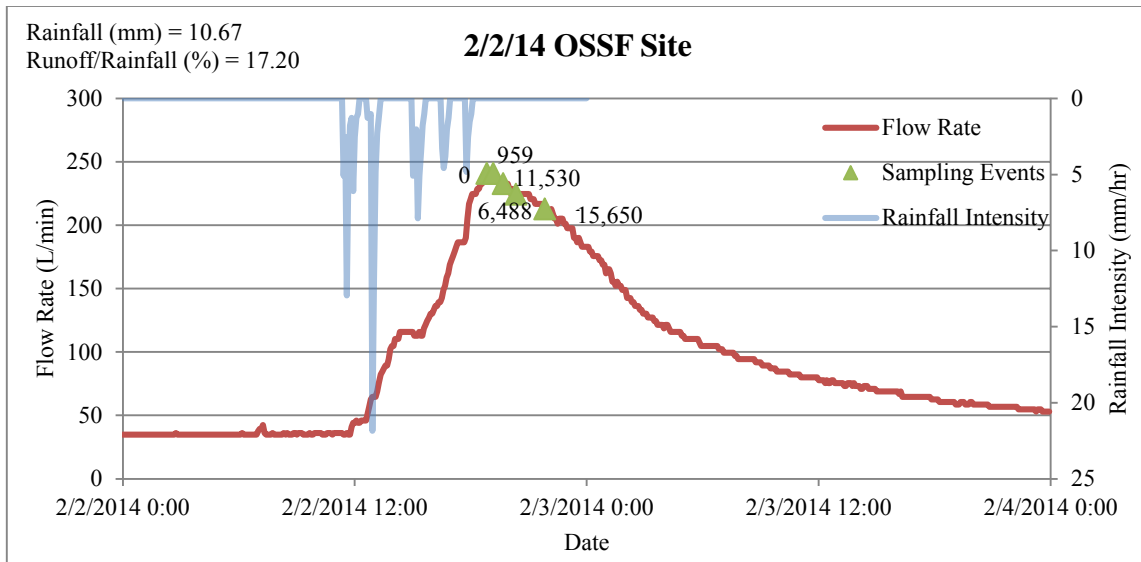
Figure 23. Hydrograph for sampling event on 2/2/14 at the OSSF site. Numbers next to the sample times are the *E. coli* concentrations in CFUs/100 ml.

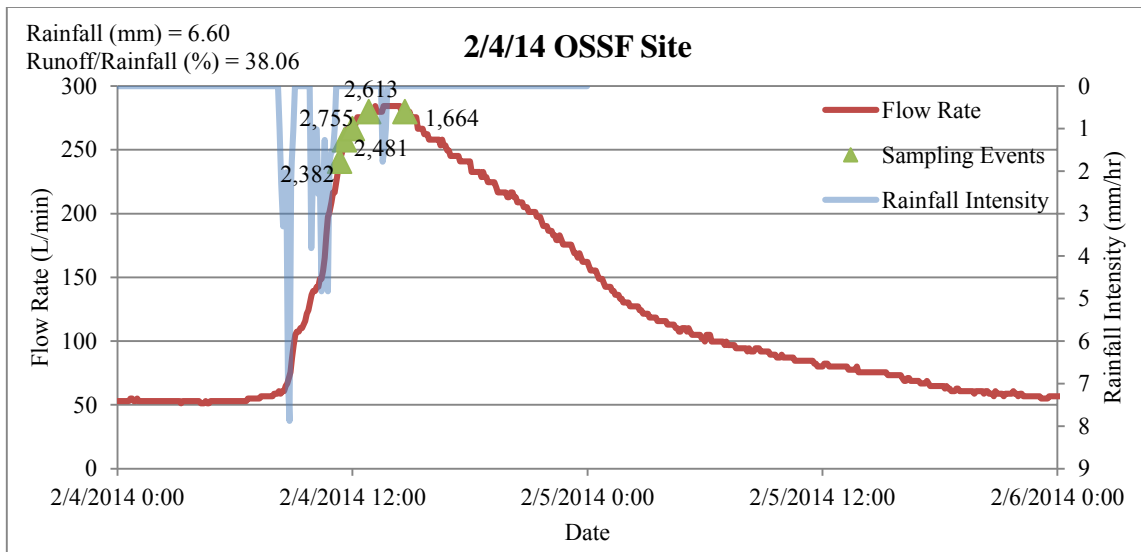
Figure 24. Hydrograph for sampling event on 2/4/14 at the OSSF site. Numbers next to the sample times are the *E. coli* concentrations in CFUs/100 ml.

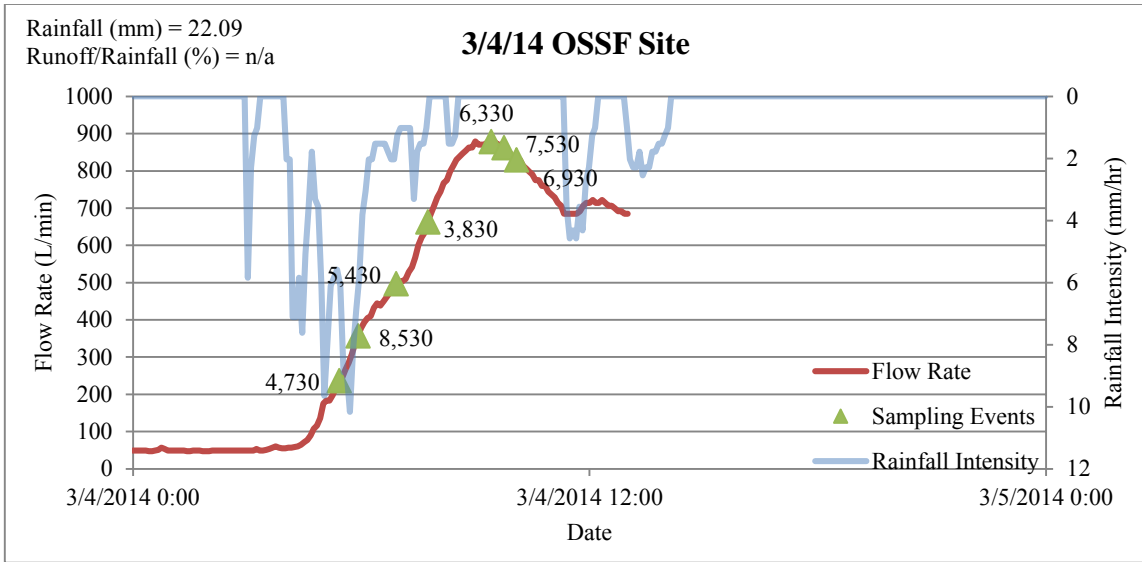
Figure 25. Hydrograph for sampling event on 3/4/14 at the OSSF site. Numbers next to the sample times are the *E. coli* concentrations in CFUs/100 ml.

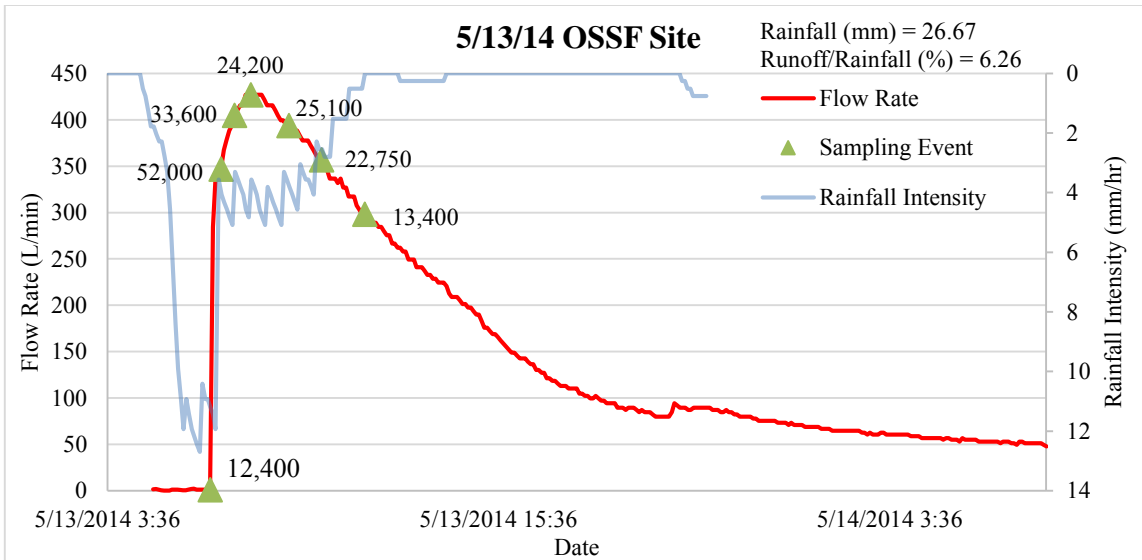
Figure 26. Hydrograph for sampling event on 5/13/14 at the OSSF site. Numbers next to the sample times are the *E. coli* concentrations in CFUs/100 ml.

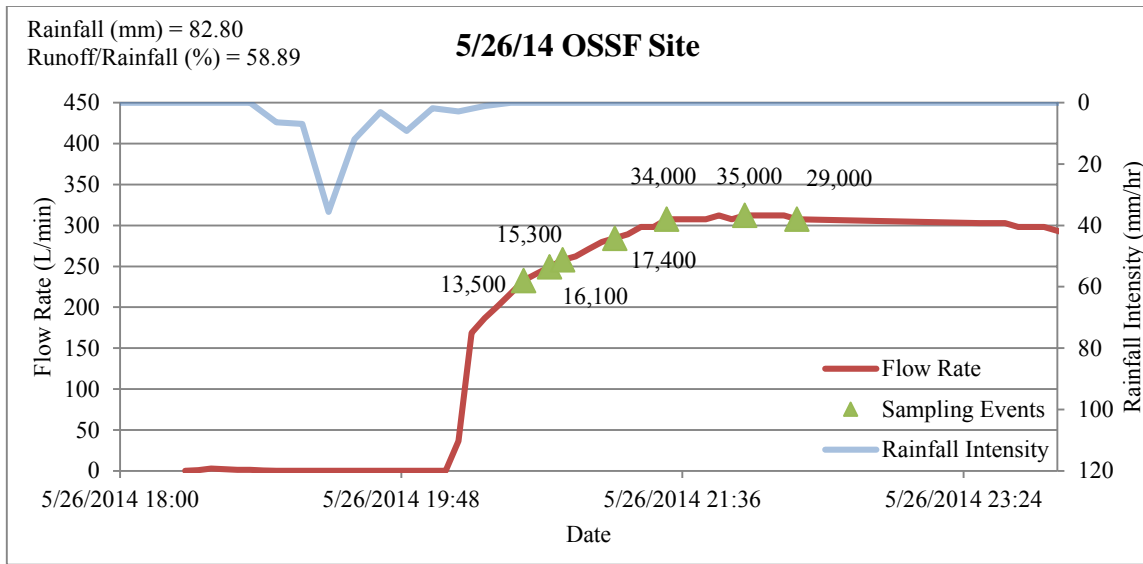
Figure 27. Hydrograph for sampling event on 5/26/14 at the OSSF site. Numbers next to the sample times are the *E. coli* concentrations in CFUs/100 ml.

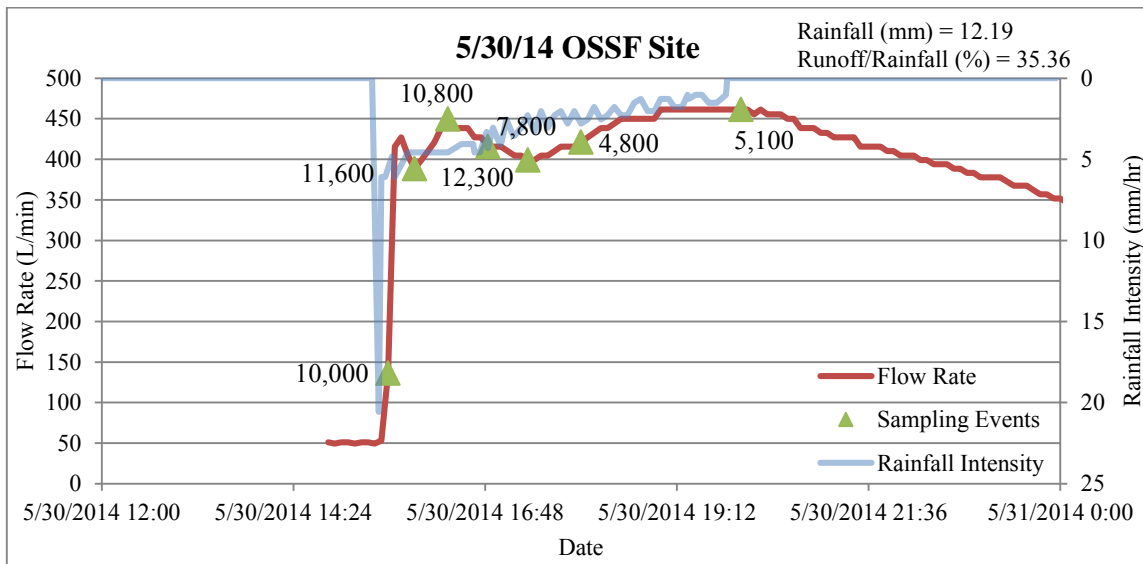
Figure 28. Hydrograph for sampling event on 5/30/14 at the OSSF site. Numbers next to the sample times are the *E. coli* concentrations in CFUs/100 ml.

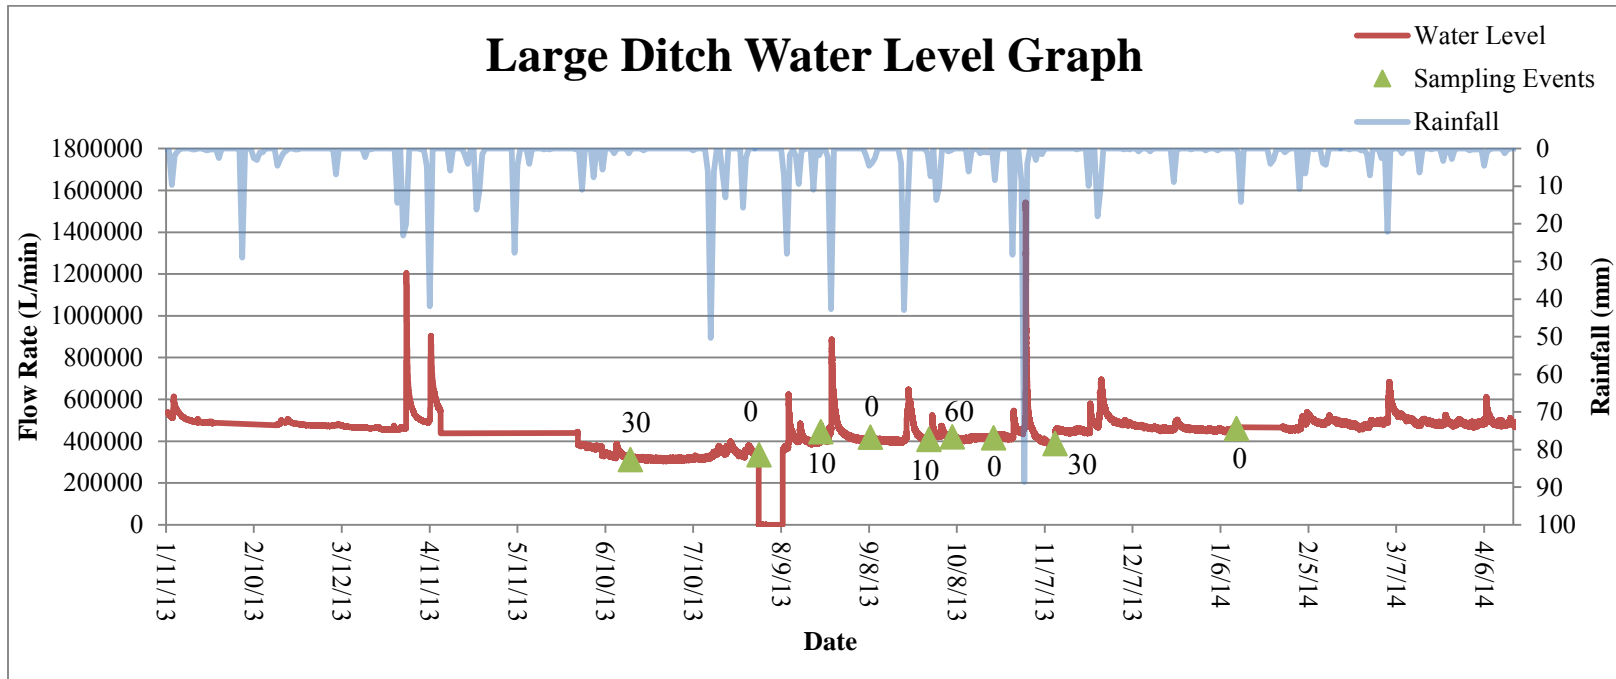
Figure 29. Hydrograph for the large ditch at the OSSF site. Numbers next to the sample times are the *E. coli* concentrations in CFUs/100mL.

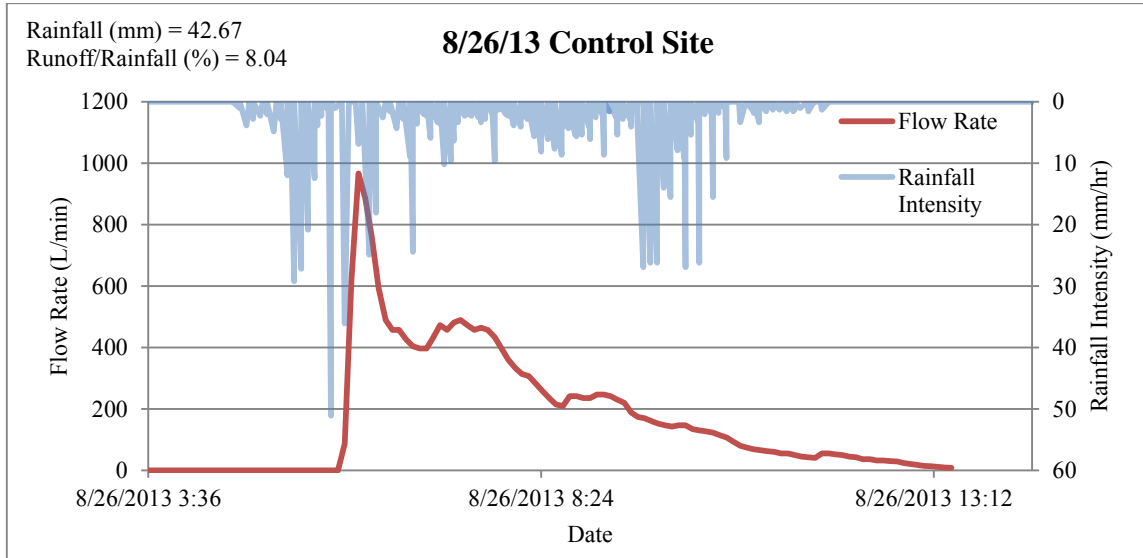
Figure 30. Hydrograph for sampling event on 8/26/13 at the control site. No samples were taken during this rainfall event.

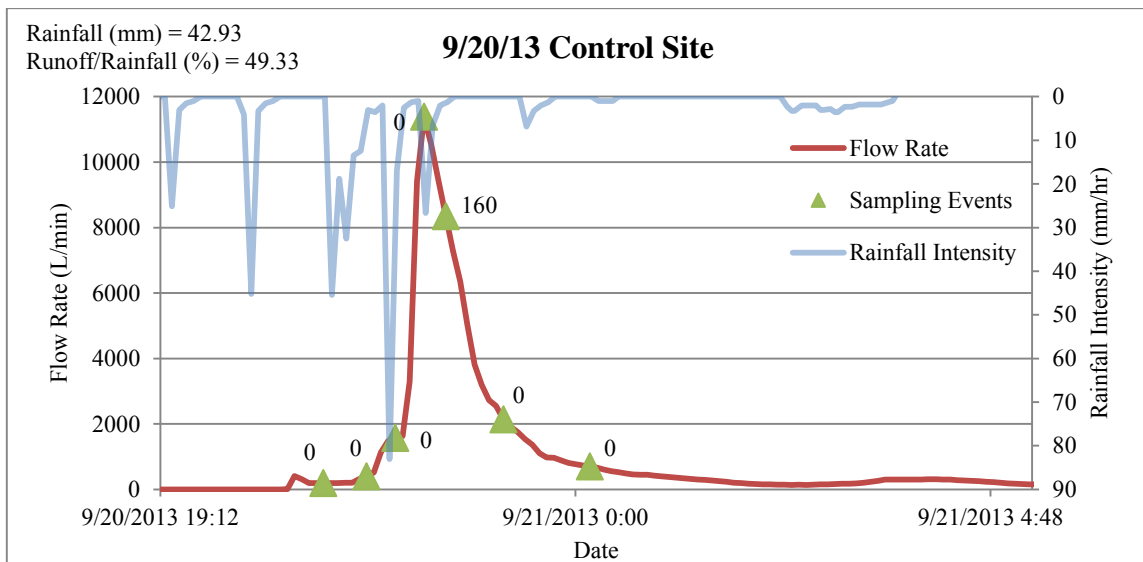
Figure 31. Hydrograph for sampling event on 9/20/13 at the control site. Numbers next to the sample times are the *E. coli* concentrations in CFUs/100 ml.

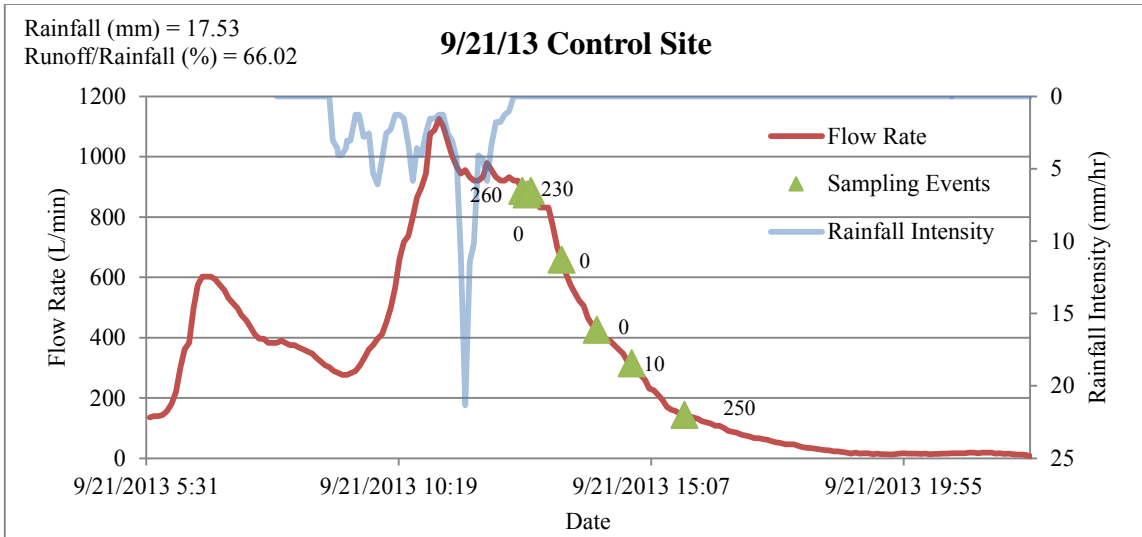
Figure 32. Hydrograph for sampling event on 9/21/13 at the control site. Numbers next to the sample times are the *E. coli* concentrations in CFUs/100 ml.

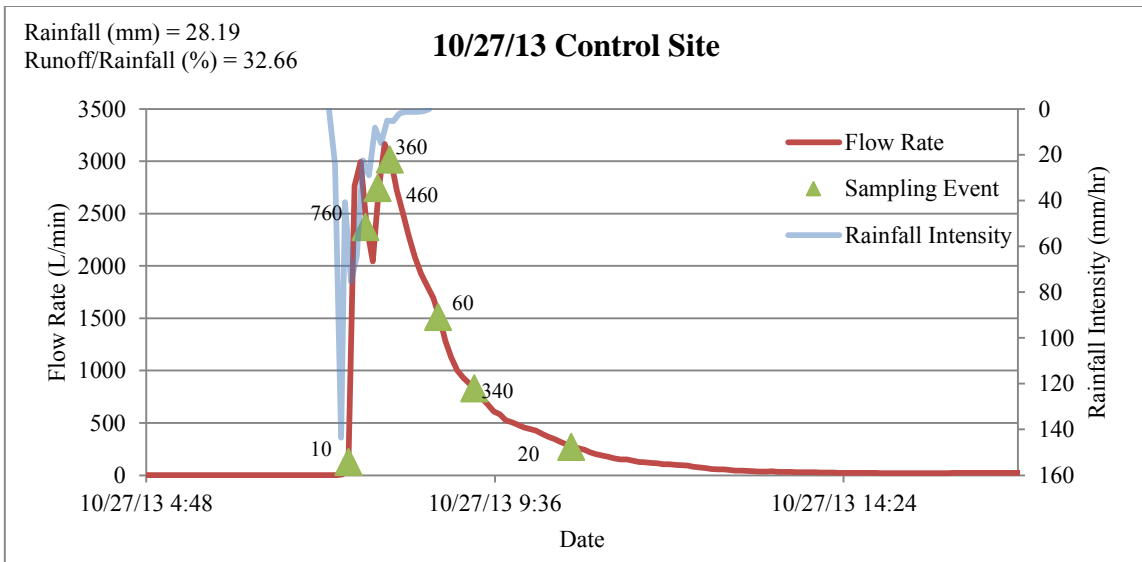
Figure 33. Hydrograph for sampling event on 10/27/13 at the control site. Numbers next to the sample times are the *E. coli* concentrations in CFUs/100 ml.

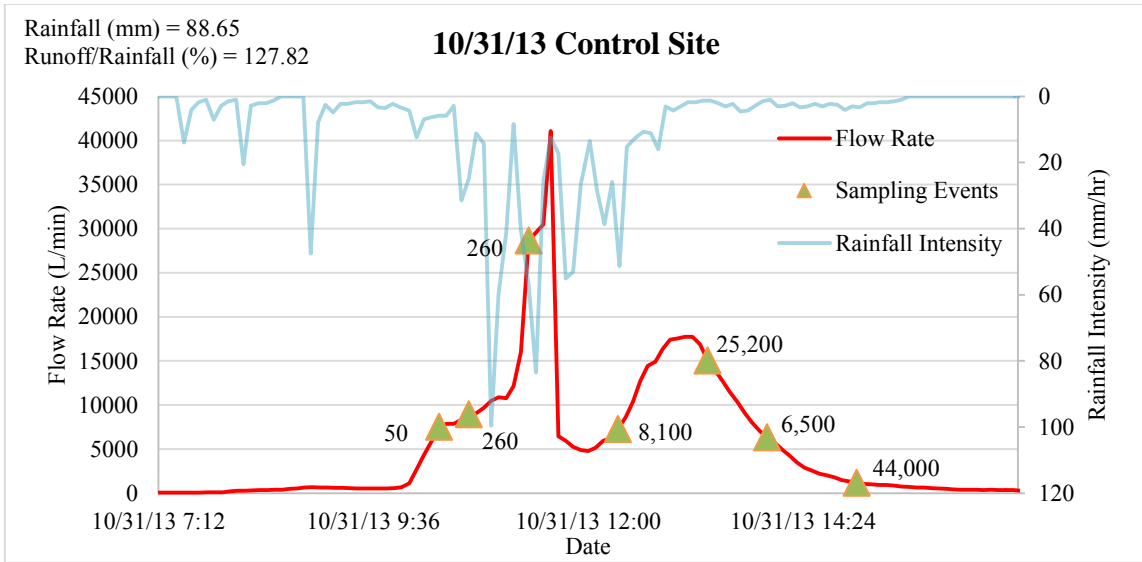
Figure 34. Hydrograph for sampling event on 10/31/13 at the control site. Numbers next to the sample times are the *E. coli* concentrations in CFUs/100 ml.
