QUANTIFYING *E. COLI* DISCHARGE FROM FAILING ONSITE SEWAGE
FACILITIES IN THE DICKINSON BAYOU WATERSHED, TEXAS

A Thesis

Major Subject: Biological and Agricultural Engineering

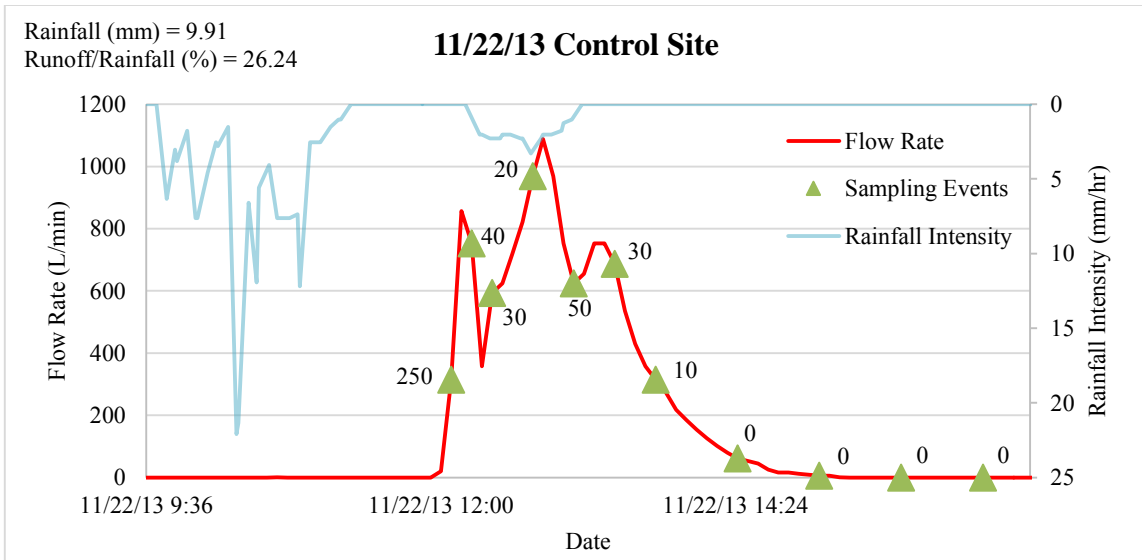
Figure 35. Hydrograph for sampling event on 11/22/13 at the control site. Numbers next to the sample times are the *E. coli* concentrations in CFUs/100 ml.

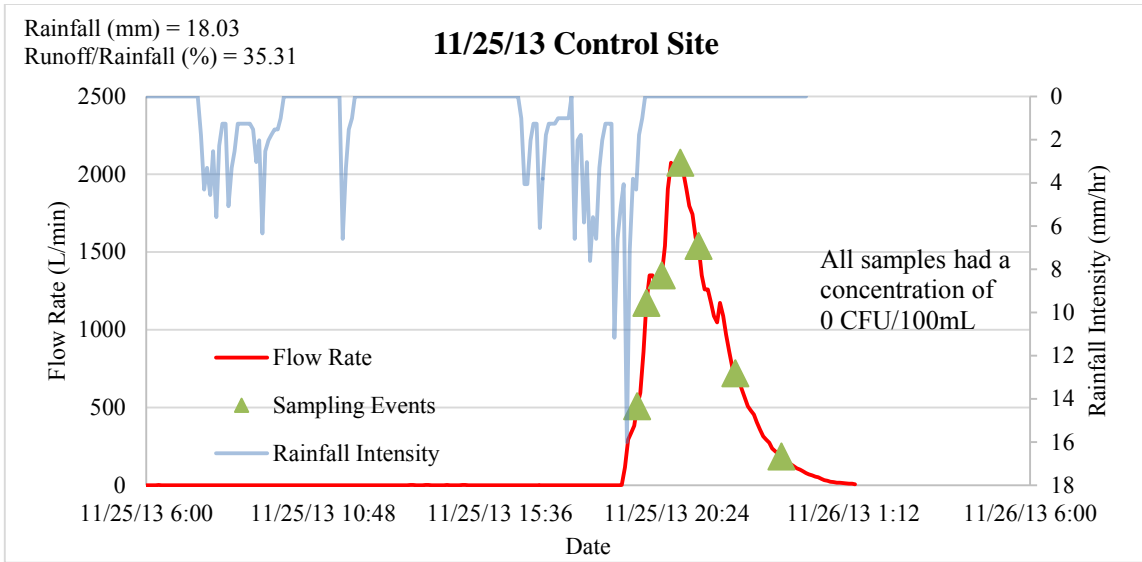
Figure 36. Hydrograph for sampling event on 11/25/13 at the control site. Numbers next to the sample times are the *E. coli* concentrations in CFUs/100 ml.
